Vol. 39 No. 2 December 2022

# FE Investigation into Manufacturing- and Design-Related Issues Contributing to the Failure of a Climbing Treestand

By Jahan Rasty, PhD, PE, DFE (NAFE 768S), Mathew Mills, PE (NAFE 1199C), and Olin Parker

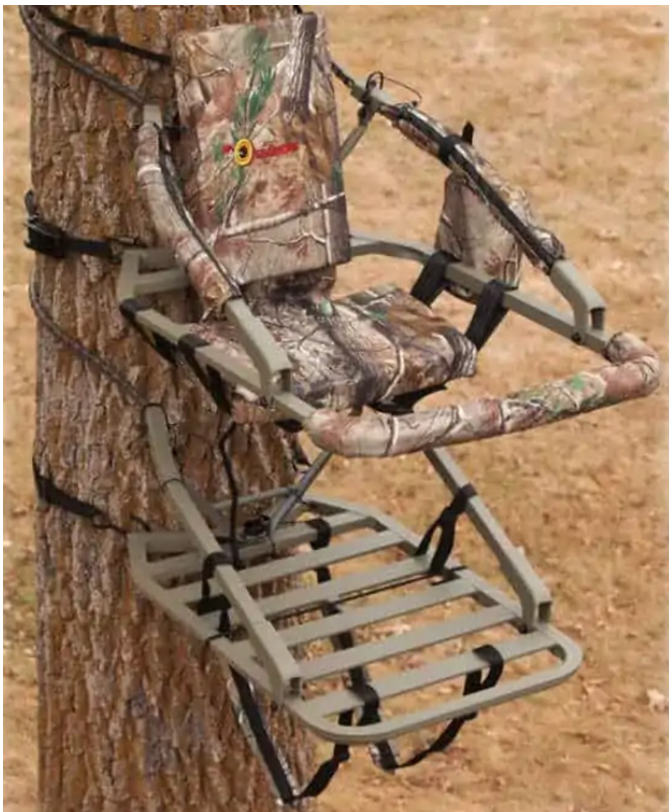
**Figure 1**

Photograph showing a new treestand of the same model as the subject treestand.

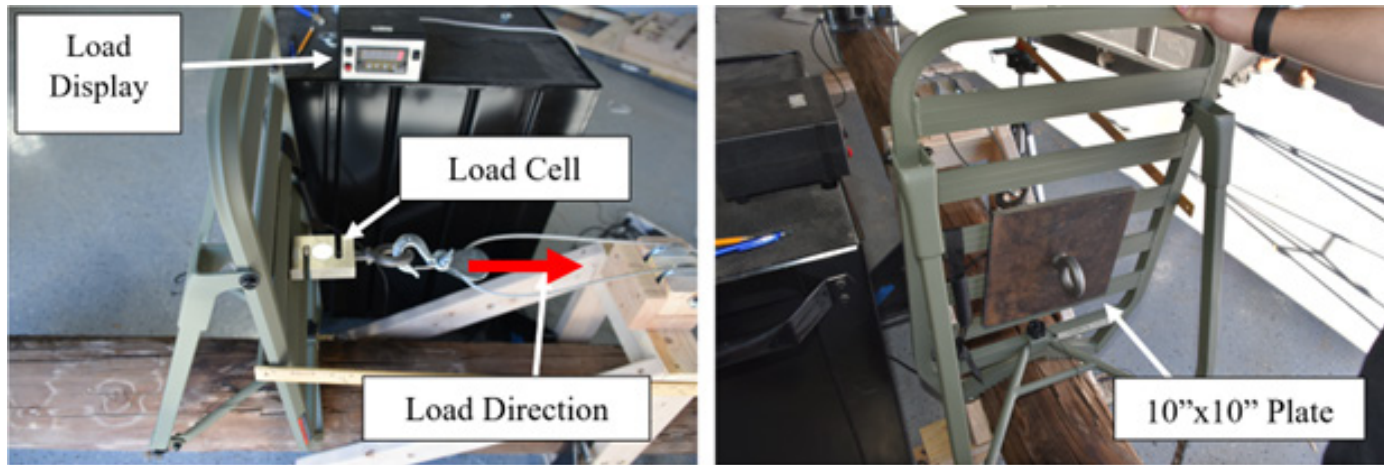
**Figure 9**

Following completion of the tests, comparison of failure characteristics (crack origin and propagation direction) of the exemplar test treestand to that of the subject treestand revealed identical features, which is evidence of the validity of this test setup and

Photographs of test setup with red arrow indicating the direction of the applied load.
