FE Investigation of Design and Quality Control-Related Issues Contributing to Metal-On-Metal Hip Implant Failures

By Olin Parker, Jahan Rasty, PhD, PE, DFE (NAFE 768S), and Matthew Mills, PE, DFE (NAFE 1199A)

Abstract

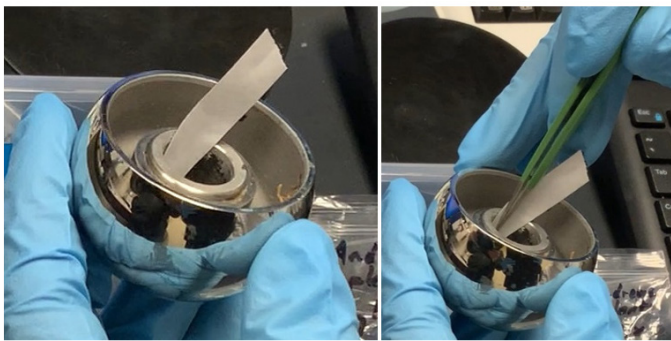
Figure 32

In order to provide insight into the nature of the corrosion debris observed on the head and taper of one of the explants at issue, a piece of carbon tape, typically utilized for affixing smaller samples for SEM analysis, was utilized to extract corrosion particulate from the interior surface of the taper sleeve (**Figure 32**). While there is no specific ASTM standard for debris removal methodology, the use of carbon tape for nondestructively removing corrosion products and residue for observation is a common practice in materials science applications in a wide range

Images showing the process utilized to extract corrosion debris from the interior surface of the taper sleeve.
