FE Investigation of Maintenance and Operational Factors Contributing to the Collapse of a Crane Boom

By Olin Parker, Jahan Rasty, PhD, PE, DFE (NAFE 768S), and Matthew Mills, PE, DFE (NAFE 1199A)

Abstract

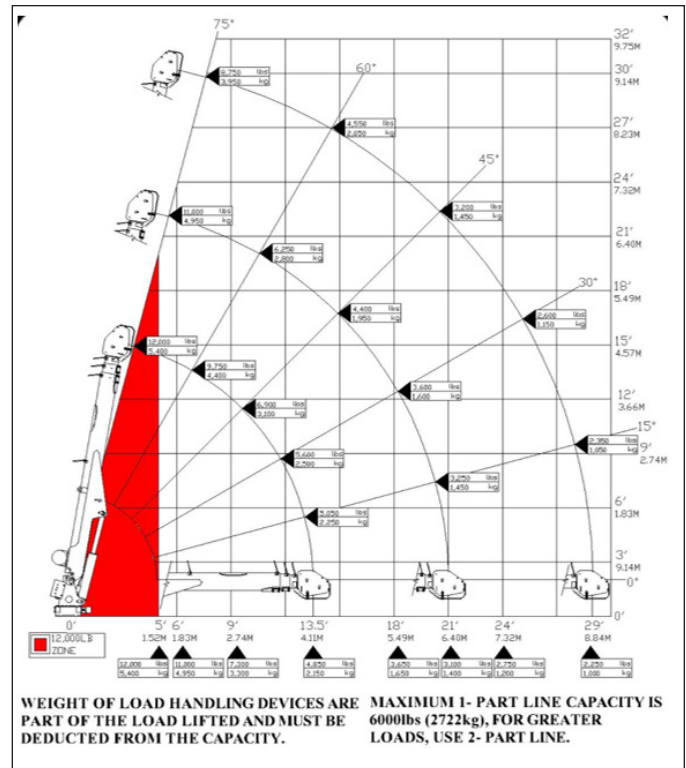
Figure 2

Inspection of the crane revealed that, at the time of the incident, the crane was at a 35° angle and was extended approximately 18.27 feet (219.25 inches). According to the crane's load chart, the crane boom's max load capacity at this angle was over 3,600 pounds (**Figure 2**). Testimony

Chart showing the load capacity of the crane boom at different extension lengths and orientations.

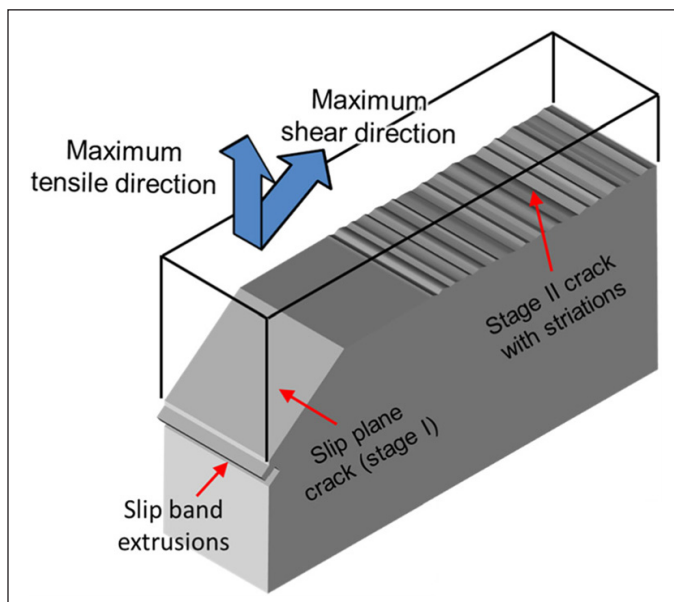
Figure 9

Fatigue is a failure mode that is characterized by the initiation and propagation of cracks within a material over time under the action of cyclical loading^{1,2}. As the load cycles continue, the fatigue cracks progress further through the material's cross section, increasing the stress placed upon the remaining cross section. Eventually, the applied stress exceeds the material's nominal strength, and the remaining cross section of material suffers from an overload failure. The two stages of fatigue failure prior to the final fracture are shown in **Figure 9**.

Schematic showing crack initiation (Stage I) and crack propagation (Stage II) of an advancing fatigue crack⁵.

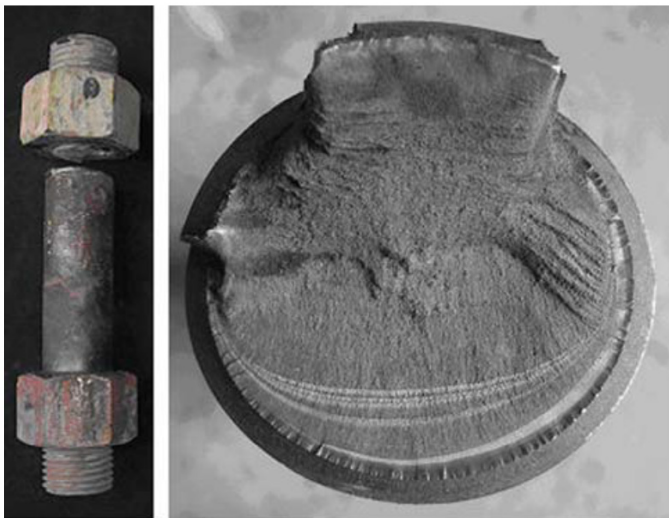
Figure 18

An example of a similar bolt fracture surface as reported in the literature⁷.
