Vol. 38 No. 1 June 2021

Lessons Learned from a Forensic Engineering Investigation of a Scaffold Support Failure

By John N. Schwartzberg, PE (NAFE 639F)

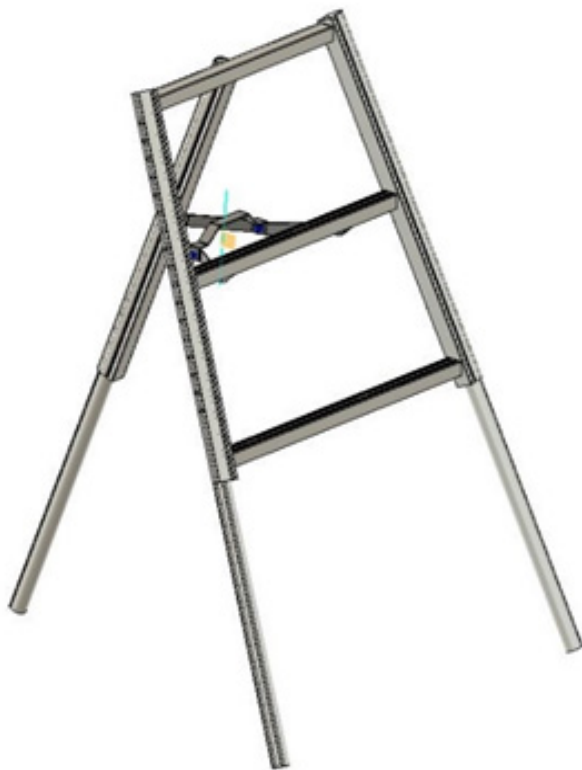
Figure 6

A basic model for the FEA is shown in **Figure 6**. The front two feet are constrained against translation and rotation (as they would be on a flat, level surface with

Overall view of basic model used for finite element analysis.

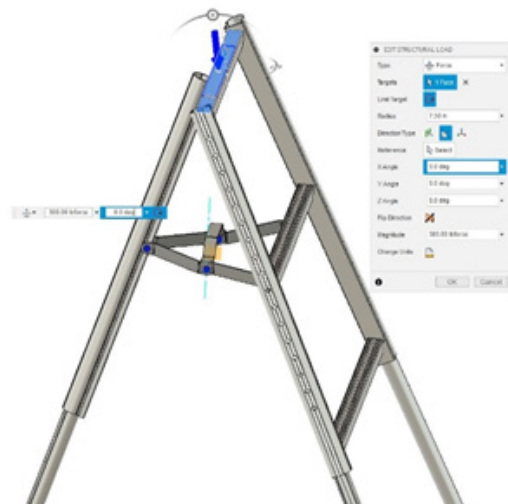
Figure 7

A linear analysis was performed to verify the load rating (300 lbf) of the scaffold support. The loading for this load case consisted of a purely vertical 300-lbf uniform load distributed over the central 15-inch length of the scaffold top brace, as shown in **Figure 7**. This is consistent

Results of this analysis showed that the scaffold easily bore the rated load applied in the manner shown in **Figure 7**, with Factors of Safety (against the yield strength of the materials) in excess of 4.8 and maximum (Von Mises) stress of 6.95 ksi. The maximum stress occurred in the tripod leg near hinge pin hole. The maximum stress in the scaffold frame was approximately 4 ksi and occurred in the scaffold top brace adjacent to (but not in) the weld. Results of the analysis are shown in various views in **Figure 8**.

Applied load for 300-lbf rated load analysis.

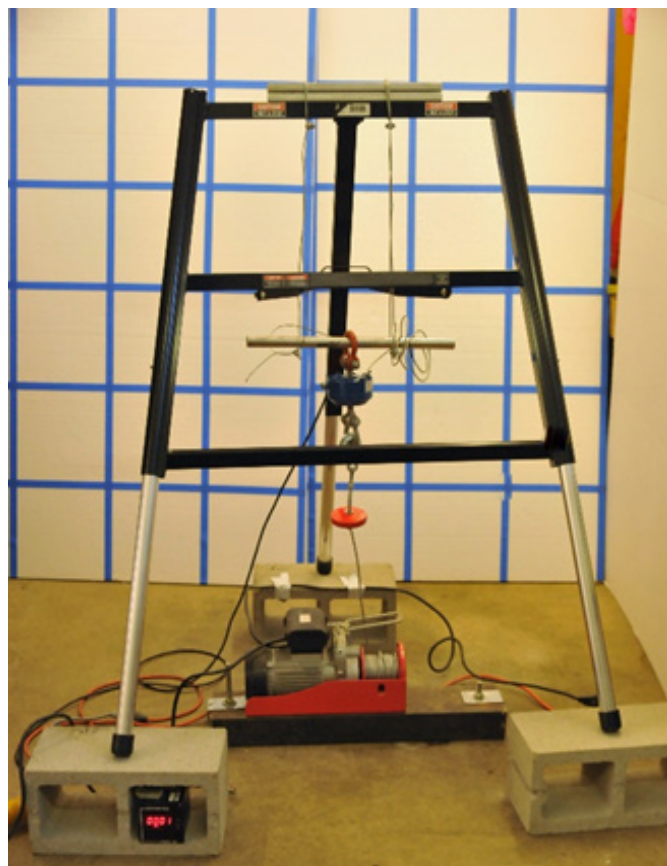
Figure 11

Load tests were performed on exemplar scaffold supports. The scaffold support was set up on cinder blocks, which were resting on a smooth concrete floor. Legs were extended to full length for testing. A piece of aluminum extrusion stock was used to distribute the applied load over a 15-inch length of the top scaffold brace. An electric winch with wire rope was used to apply a tensile load, which was measured using a 2500-lbf capacity load cell. The force value from the load cell was displayed on an indicator paired with the load cell. Smaller ($1/8$ -inch) diameter wire rope was used to suspend a spreader bar from the loading bar, to which the primary loading line was attached. A representative photograph of the test set-up is shown in **Figure 11**.

Several tests were run on an exemplar scaffold. In the first test, the scaffold support design was tested by applying a load in excess of the rated load of the scaffold. A peak load of 414 lbf was observed at the outset of the sustained loading as the load was applied. A sustained load ranging from 330 to 360 lbf was applied to the test article over a period of approximately 4 minutes. No permanent deformation, damage, or compromise in operation was observed to the scaffold support after the load was released.

Load test set-up. Load is applied through wire rope (with load cell) to spreader bar, then to loading bar strapped to top scaffold brace.
