# Failure of a Climbing Treestand Due to Corrosion and Selective Leaching of Cable's Galvanic Layer: Failure Analysis and Experimental Study

By Olin Parker (NAFE 1334A), Jahan Rasty, PhD, PE (NAFE 768S), and Matthew Mills, PE (NAFE 1199A)

*Both supporting cables of a climbing treestand failed when a user stepped onto the stand's foot platform. Analysis of the failed cables revealed extensive corrosion and selective zinc leaching of the galvanized steel cables due to an electrical connection between the treestand cables and the steel frame. Experimental measurements of corrosion rates were performed through accelerated immersion tests utilizing mass-loss and DC current measurements as well as cyclic voltammetry. Results indicated a ~79% to 300% increase in the rate of corrosion as measured by millimeters of cross-sectional area reduction per year. Flaws in the design that led to the creation of a galvanic cell between the treestand cable and its frame are discussed, and alternative designs are proposed. Finally, the manufacturer's failure to properly account for anticipated use environment of the treestand in its design while being aware of similar prior incidents as well as their

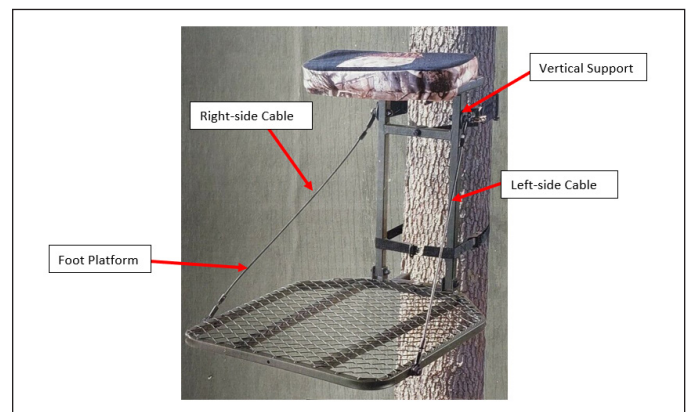
**Figure 2**

The subject treestand was a fixed treestand marketed by a U.S.-based manufacturer. Discovery documents, however, revealed that the treestand was actually designed and manufactured in mainland China, and the U.S. manufacturer was a shell company that falsely advertised the stand as being made in the United States. The treestand was comprised of a foot platform and a seat platform that were both connected to a vertical support (Figures 1 and 2).

Image of a treestand from the owner's manual, labeled to show the components of the subject treestand.

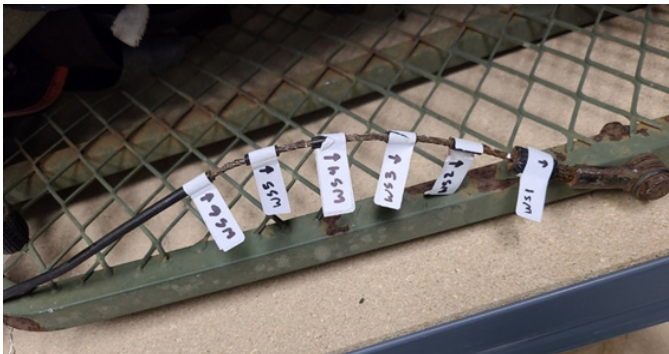
**Figure 10**

As seen in **Figures 10 and 11**, the average percent composition of zinc decreased as samples were taken closer to the foot platform. This phenomenon is consistent with the zinc being selectively leached by the cable eyelet, copper crimp, uncoated wire, and foot platform.

Variation of zinc content on the subject cable as a function of distance from the frame (WS1 closest to frame; WS6 farthest from the frame).

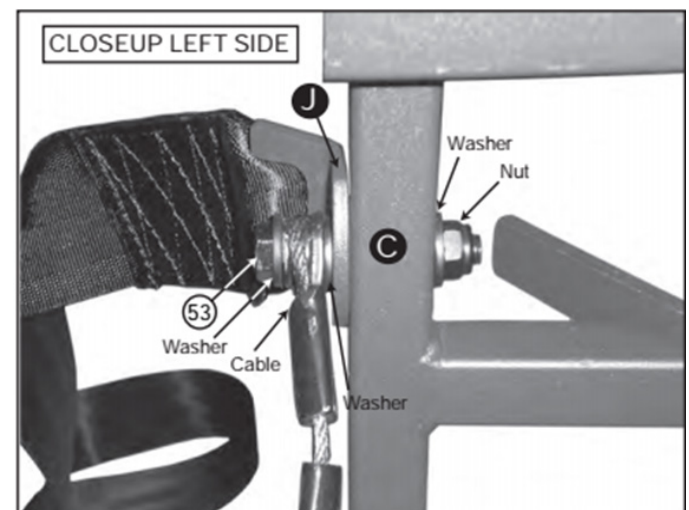
**Figure 13**

According to the owner's manual, one is intended to use washers as shown in **Figure 14**. However, there are no warnings in the owner's manual (or on the treestand itself) that warn a user of the danger associated with not placing the washers on correctly. Even if a user installed

Connection between the vertical support and left-cable eyelet on the subject treestand, displaying the direct coupling of the nut and frame.

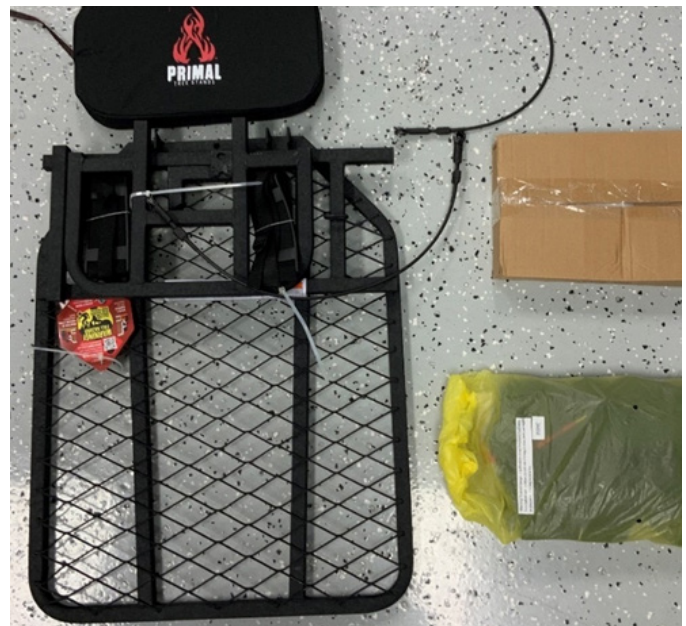
**Figure 16**

In order to quantify the degree to which the coupling of the galvanized steel cable with the treestand increased corrosion, accelerated corrosion testing was performed on an exemplar treestand from the manufacturer (**Figure 16**),

Exemplar treestand utilized in accelerated corrosion testing.<sup>22</sup>

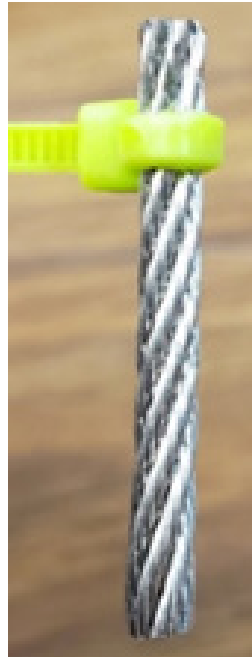
Multiple 1.25-inch-long samples of  $\frac{1}{8}$ -th-inch 7-7 galvanized steel cable were cut to size and weighed (**Figure 17**). In order to maintain a similar ratio of exposed wire-to-treestand surface area as that used in the full-scale treestand, the foot platform of the exemplar treestand was sectioned into 5"x5" square samples, with the bolt hole at the middle of the frame side (**Figure 18**). Where there was no bolt hole along the frame's edge, additional 5"x5" square samples were cut from the remaining part of the frame, and a  $\frac{5}{16}$ -th-inch hole was drilled into the frame to emulate the bolt hole present on the first two samples. The defense refused to (or was not able to) provide information regarding the OEM hardware for the drilling of these holes. As such, these holes were drilled utilizing an industrial drill press in the possession of the Texas Tech Department of Mechanical Engineering. Each 5"x5" square treestand section used in the authors' corrosion tests consisted of a portion of the

**Figure 17**  
Cable samples used in corrosion testing.

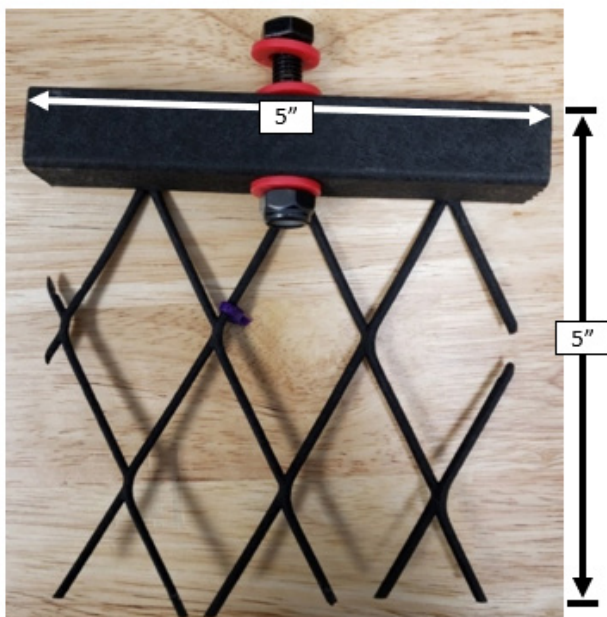
**Figure 18**  
5"x5" square samples utilized in corrosion tests.

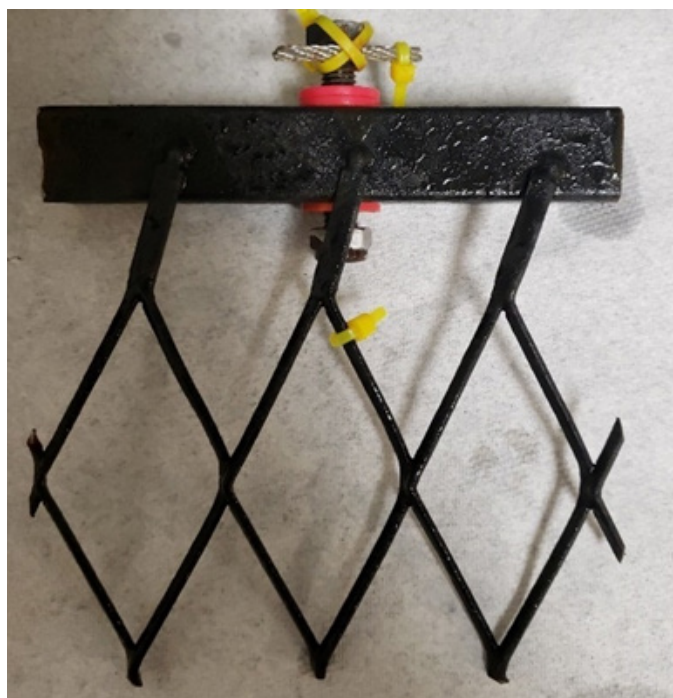
**Figure 20**

Sample of treestand and wire physically connected via zip ties.

Based on these results, the direct-connection test result showed that the galvanic connection increased the corrosion of the cable by ~79%. This lower percent increase in corrosion rate of 79% for the direct-connection samples as compared to the 300% increase in corrosion rate obtained from potentiostat measurements (**Figure 19**) is due to the imperfect and limited connection between the wire and bolt (**Figure 20**). It would be expected that the connection between the bolt and treestand would be better than this, so the overall corrosion rate of the subject treestand would likely lie somewhere between the results shown in **Figure 19** and **21**.

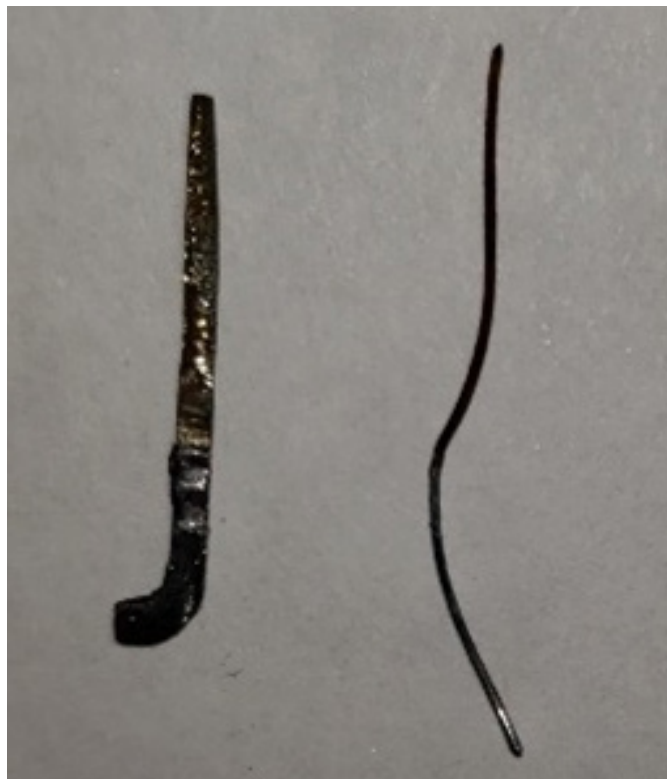
**Figure 24**

Treestand frame material (left) and cable strand (right) used in CV testing.

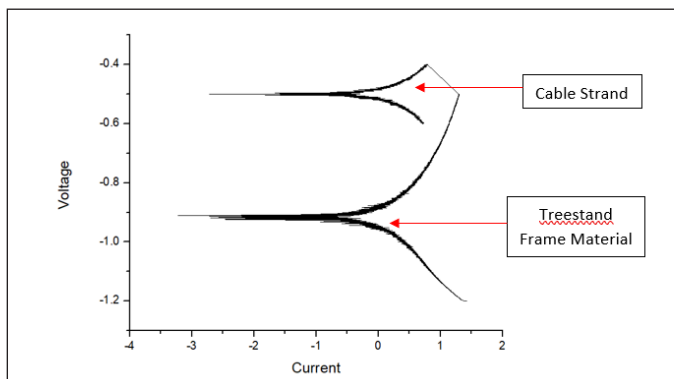
**Figure 25**

The potential and corresponding current were plotted and converted to a Tafel plot from which the galvanic potential, corrosion current, and Tafel constants were extracted (**Figure 25**). The corrosion currents for the galvanized steel cable by itself and the cable galvanically connected to the treestand were then converted to corrosion rates via Faraday's Law, as given in ASTM G102.

Tafel plots extracts for treestand frame material and cable strand.

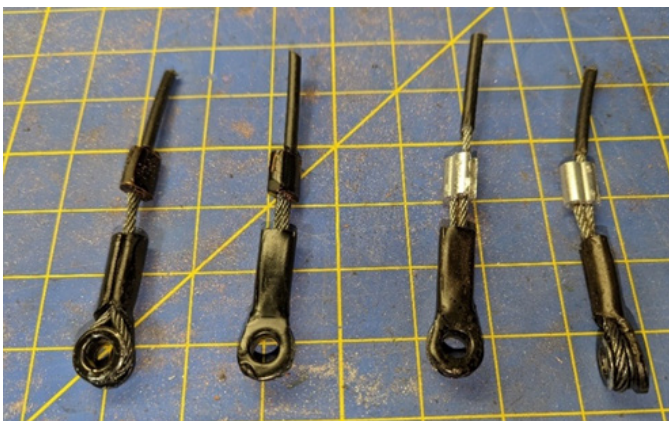
**Figure 39**

As previously noted, the usage of a copper crimp on the subject cable increased corrosion by a considerable amount. It was determined that aluminum was an alternative crimping material the manufacturer could have used, as it is relatively easy to form and is already extensively used in crimping applications. In order to determine how the usage of an aluminum crimp would have affected the corrosion rate of the galvanized steel cables, additional accelerated immersion corrosion testing was conducted.

The copper (right two) and aluminum (left two) crimp samples.

and replaced with a commonly available aluminum crimp of a similar size. These samples were then weighed and immersed in 1.025 specific gravity salt water (typical seawater) for 14 days. As shown in Figure 40, visual observation alone shows that the cables with the copper crimp corroded significantly more.

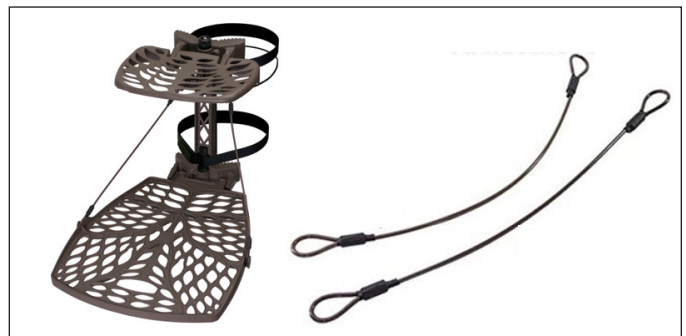
**Figure 41**

Various competitor treestands displayed an alternative cable attachment method, which allows the cables to be coated in a plastic sheath that prevents contact with air or water, cutting off one of the required conditions for corrosion to occur. While it is possible that this coating could degrade over time, constructing it out of UV-resistant materials would greatly reduce the likelihood of this occurring. The plastic sheath could also be made out of a semi-transparent material, which would allow users to see the cable corroding should water find a way in (Figure 41).

Competitor treestand displaying fully coated cables and an alternative attachment mechanism.

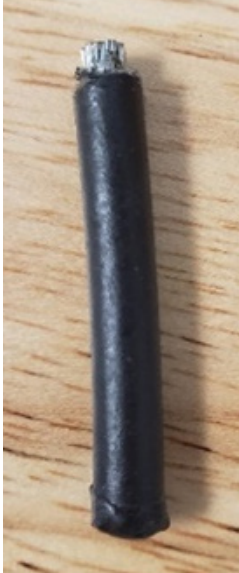
**Figure 42**

In order to verify that cables coated in a plastic sheath would not experience significant corrosion, additional accelerated corrosion testing was conducted utilizing cable samples cut from the midsection of the exemplar treestand cable. One of the ends of the cable was sealed in a flexible polymer sealant to prevent the ingress of water on this end (Figure 42). These samples were then partially

Sample cut from middle of exemplar cable; one end coated in polymer sealant.
