# Investigation and Root Cause Analysis of Transformer Metering Destruction by Arc Flash

By John F. Wade, PhD, PE, DFE (NAFE #1174A) and David J. Icove, PhD, PE, DFE (NAFE #899F)

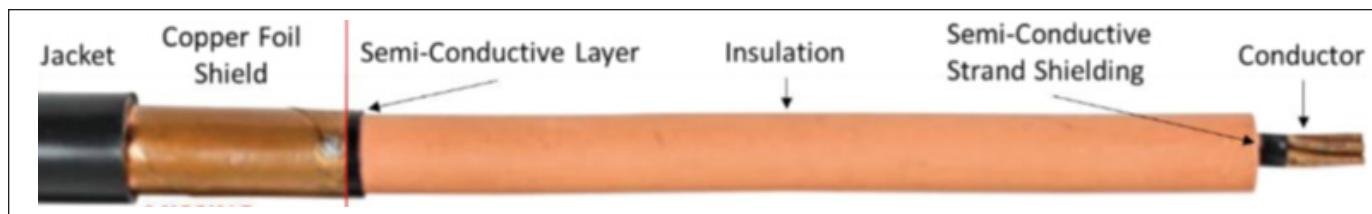
**Figure 5**  
Medium-voltage electrical cable components.

A critical piece of information came from careful examination of the VT cables. Medium-voltage cable consists of six layers<sup>12</sup> (**Figure 5**): the central current-carrying conductor, a semi-conductive shield, insulation, another semi-conductive layer, a wound copper foil shield layer, and a protective outer jacket. When properly terminated and grounded, the copper foil shield equalizes the strong electric field (**Figure 6**) across the cable's insulation to prevent concentrated energy and burn-through.

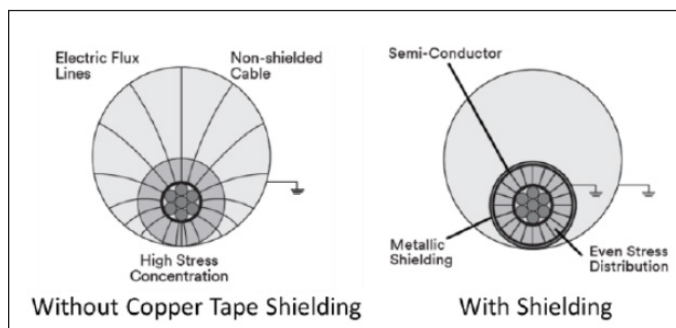
**Figure 6**  
Electric field illustration from 3M power cable splicing and terminating guide<sup>12</sup>.
