Journal of the
National
Academy OF
Forensic
Engineers[®]

Forensic Engineering Analysis of a Residential Fire Caused by an Open Neutral

By Steve Pietropaolo, PE, DFE (NAFE 769S) and Yoandi Interian, PE, DFE (NAFE 1260M)

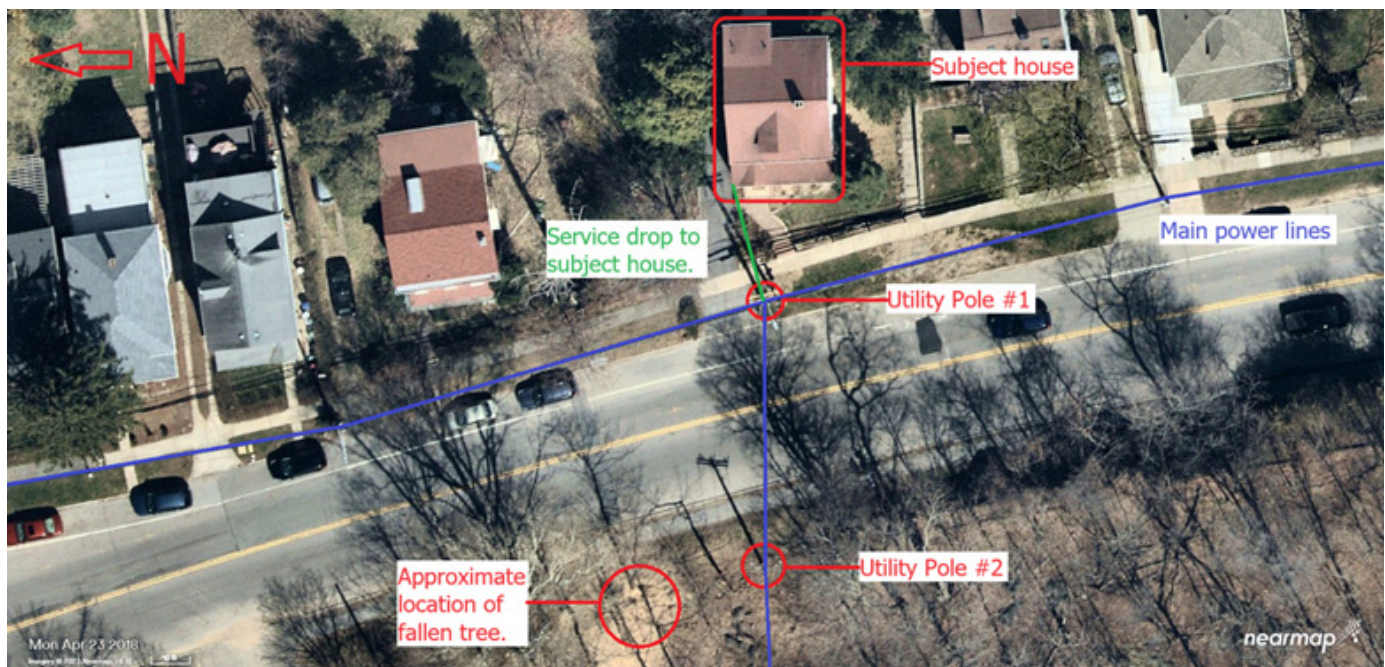
Figure 2

Aerial view of the subject property and surrounding area obtained from Nearmap.com (dated April 23, 2018).

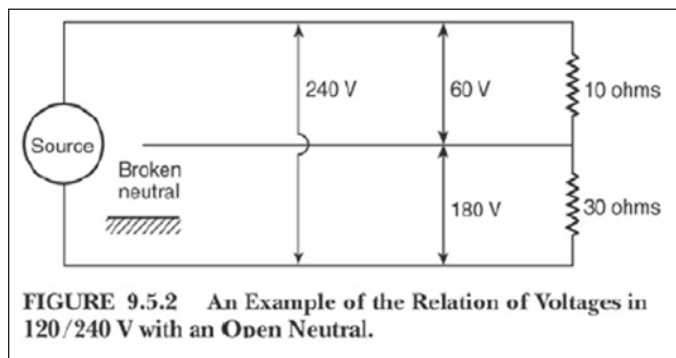
Figure 8

Per Section 9.5.2 of NFPA 921-2017, “[a]n electrical installation with an open neutral conductor will not have a fixed 120V between each hot leg and the neutral. There will still be 240V between the two legs, but instead of the voltages of the two legs being fixed at 120V to neutral each, they may vary to some other values that add up to 240V (**Figure 8**). All 120V circuits connected to the open neutral conductor will be affected. The actual voltages in the legs will depend on the loads on the two legs at any particular time. For example, the voltages might be 60 and 180 as in Figure 9.5.2. The higher voltage can overheat or burn out some equipment, and the lower voltage can damage some electronic equipment. Occupants may have seen incandescent lights that were too bright or too dim or appliances that overheated or malfunctioned in some way. A floating neutral condition is not dependent on proper grounding of the service. Removing the grounding electrode connection does not cause an open neutral¹”.

Figure 9.5.2 from NFPA 921-2017.
