Vol. 42 No. 1 June 2025

# Forensic Deformation Analysis of a Farm Clevis Using Photographs and Exemplar Tests

By Michael Stichter, PhD, PE, DFE (NAFE 1162S) and Wade Lanning, PhD

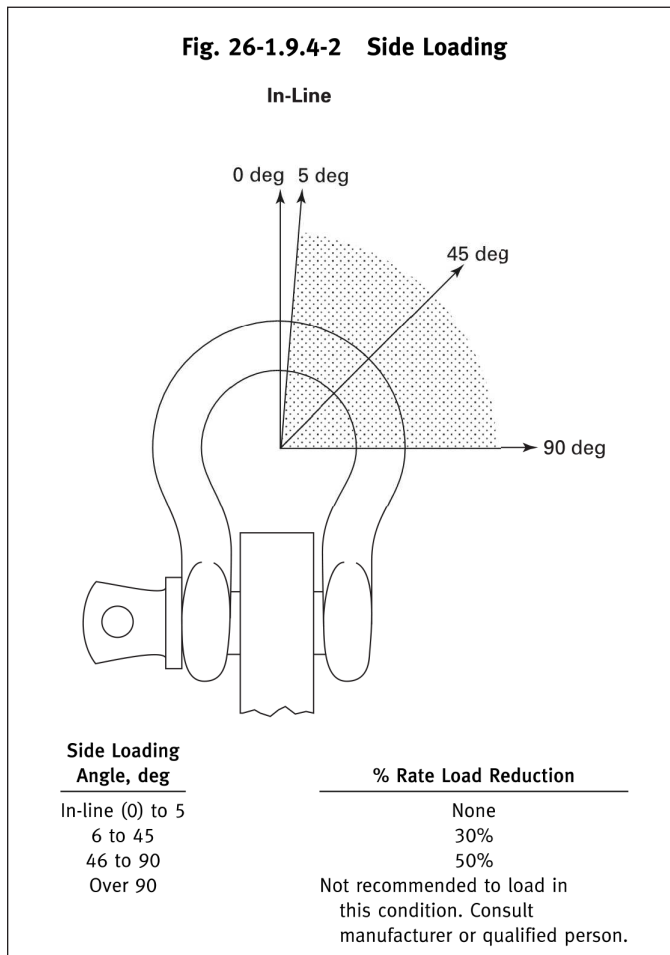
ASME B30.26-2015 provides Fig. 26-1.9.4-2, which describes side loading and corresponding WLL reduction.

The side-loaded exemplar clevises — where the clevis ears were oriented transverse ( $90^\circ$ ) to the applied tensile force as shown in **Figure 11** — are straightforward to interpret. The tensile forces would be parallel or near-parallel to the pin in extreme side loading, which would result in minimal load transfer through the pin, limited to the shear strength of the cotter pin and friction between the pin and clevis ears. The pin in the side-loaded clevises exhibited no deformation because in side-loading, the pin never experienced a bending stress in excess of its yield strength. The bow of the clevis would transmit the majority of the force exerted by the tow rope and mired equipment. Thus, the bow was the part that exhibited deformation in the extreme side-loading case. The lateral offset

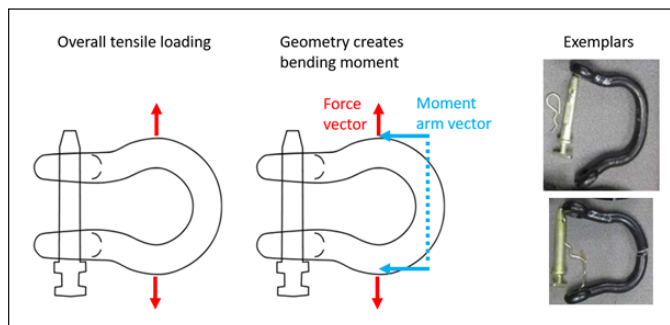
**Figure 12**

between the loading axis and the load-bearing clevis bow would produce a bending moment (**Figure 12**) that would cause the bow to open up when it deformed, which is what the authors observed in testing the exemplar, side-loaded clevises.

In transverse tensile loading,  $90^\circ$  (side loading), the overall loading condition is tensile (left). Because load transfer is primarily through the clevis bow, which is offset from the tensile axis, the bow is in bending (center). Thus, the exemplars tested in side loading exhibited bending of the bow and the ears spread apart (right).

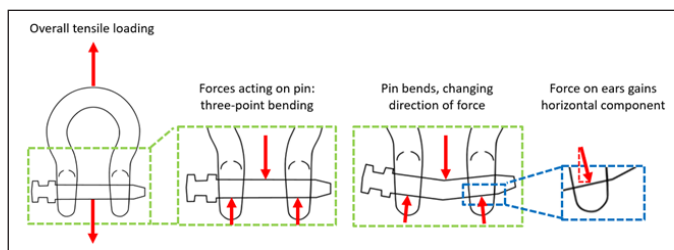
**Figure 14**

Longitudinal tensile loading on the clevis resulted in three-point bending of the pin. Bending deformation of the pin resulted in a horizontal force spreading the ears of the clevis apart.

and the horizontal component would have caused the clevis ears to spread apart (**Figure 14**). Bending of the pin would also have exerted a bending moment on the ears, which would also have caused the ears to spread apart.

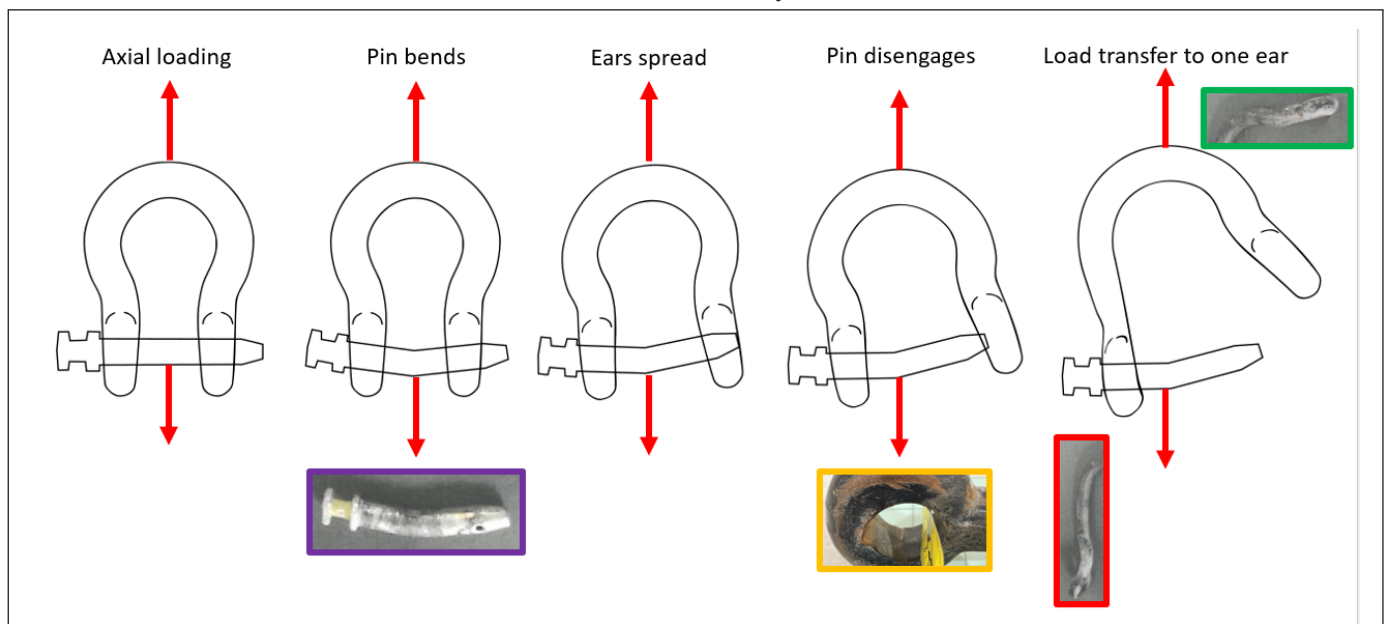
**Figure 15**

From photographs, it appeared that shearing of the cotter pin did not induce enough stress on the ear to cause visible deformation. The tip of the pin sliding out of the eye created the contact damage present on the inside of one ear (**Figure 13B**). Before the pin disengaged, both sides of the clevis bow and both ears would be under load — and, to the extent they deformed, would be symmetrical. After the pin disengaged, only the side of the shackle that retained the pin would be under load, and deformation would no longer be symmetrical (**Figure 15**).

The shackle deformed until the pin disengaged from one ear, creating localized deformation inside the ear.

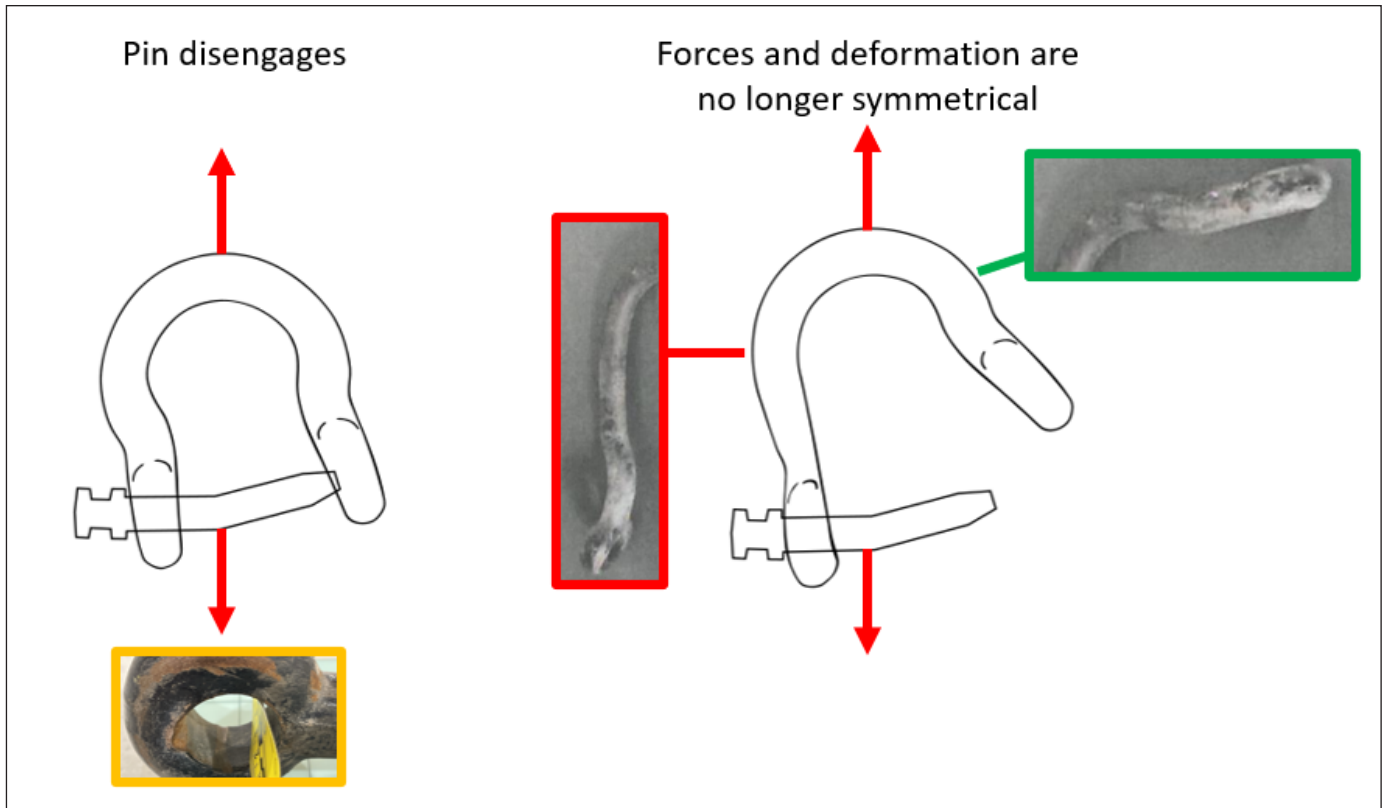
**Figure 16**

Once the pin disengaged from one ear of the shackle, that ear would no longer participate in load transfer and would no longer deform (**Figure 16**). This is why the relatively undeformed side of the shackle was on the same

Once the pin disengaged from one ear, deformation would no longer be symmetrical. Thus, the left side of the shackle, which remained connected to the pin, deformed significantly more than the right side, which disengaged from the pin first.

side as the ear with the contact damage — because that ear disconnected from the pin first. All load transfer would be through the other ear, which would continue to deform (**Figure 13C**). Deformation would continue to change the angle of the pin relative to the tensile direction, up until the point where the pin was able to slide out of its connection point to the mired equipment (**Figure 17**). This is why the other leg was more severely deformed, and went from its original curved shape to nearly straight. Deformation of the left side of the shackle bow continued until the shackle slid off of its connection point to the mired vehicle (**Figure 17**).

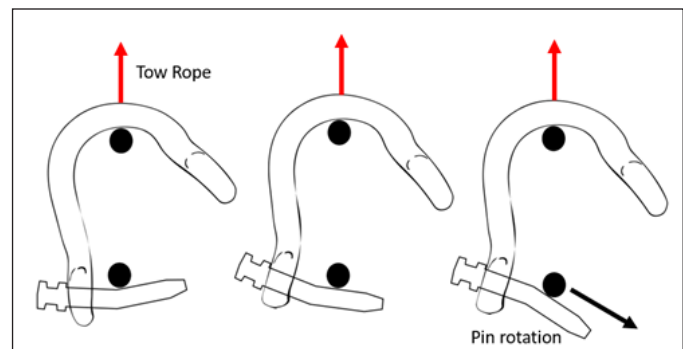
**Figure 17**

Deformation would continue until the angle of the pin allowed it to slide off of its connection point to the mired equipment.
