Analysis of a UTV Axle Fracture Associated with Rollover

By Stephen A. Batzer, PhD, PE (NAFE #677F)

Abstract

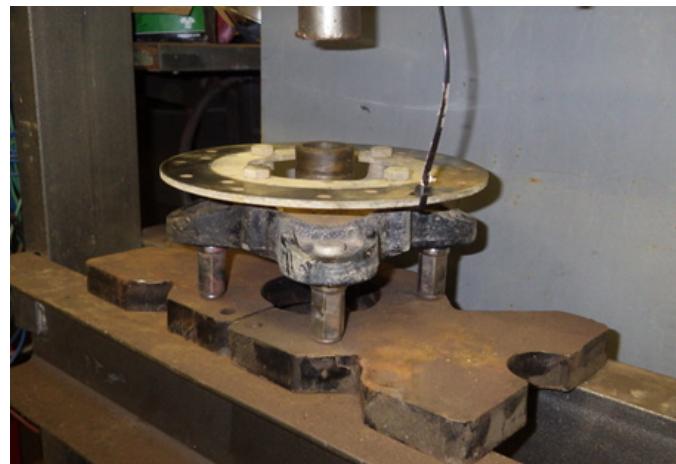
Figure 13

were purchased from an on-line salvage retailer and axially loaded using a manual arbor press to develop a concentrated active load on one side and a diffuse reactive load on the other, thus producing outside-in and inside-out loading fracture (**Figure 13**). Note the wheel studs and brake disc attached to the black aluminum wheel hub.

The general shape of the fracture surface from the in-board-to-outboard loading produced an angular wheel hub fracture surface, reasonably matching the incident wheel hub (**Figure 14**). While the incident hub was rotating at least 5 revolutions per second at the initiation of yaw and of loss of control, the fracture is a form of “Hertzian cone” in which the principal tensile stresses within the brittle material subjected to focal compressive loading ensures an angular, conical crack progression⁷. As an analogy to the instant fracture, a lead pellet that is discharged from an air rifle into common annealed window glass will produce an entry hole the same diameter as the pellet, a conical fracture downstream of impact through the glass thickness, and, finally, a larger damage diameter hole at the exit plane.

Exemplar wheel hub and arbor press used to apply a concentrated inboard force against the wheel hub.

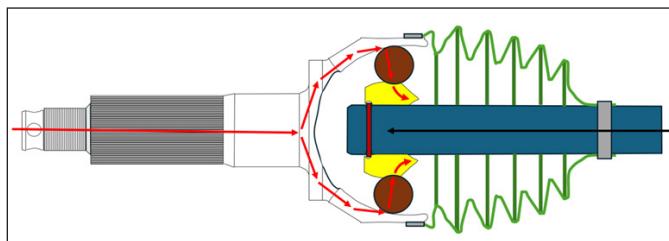
Figure 15
Free body diagram of wheel force from outboard to inboard against the axle.

Pushing on a UTV tire or wheel inboard produces no compressive or tensile stress on the drive axle. This is easily seen when comparing two-wheel drive and four-wheel drive vehicles — in that the deletion of a drive axle does not require a change to the suspension, as the suspension resists the loading in all directions. Second, as a counterfactual thought experiment, suppose excessive slop existed in the mounts of the incident UTV A-arms that allowed the tires and wheels to objectionably move inboard and/or outboard. The half shaft could, in this hypothetical case, be loaded axially by a wheel strike. However, a wheel strike during barrel rollover would displace the wheel assembly inboard against the half shaft (**Figure 15**).

In this diagram, the components mating to the CV joint end of the half shaft are not shown. What is shown is the driving outer race “bell” end, the ball bearings as brown spheres, the inner race in yellow, the main axle in blue, the retaining circlip in red, the flexible rubber boot in green, and the boot clips in gray. The red arrows show the impact force that could potentially be transmitted to the axle, which is resisted by the black arrow that is traceable to the inboard mounting end of the axle assembly at the transaxle. The combined impact force (red) will tend to move the inner race (yellow) toward the right, while the

resisting force will tend to move the axle and circlip to the left. This would act to seat the outboard end of the main axle shaft to the CV joint inner race — not to overcome the fixation of the circlip and move the main axle shaft inboard. Thus, a conceptual free body diagram of an inboard directed wheel strike loading path further indicates that a substantial wheel strike would not cause the damage observed in the incident overturned UTV.
