Vol. 37 No. 1 December 2020

# Forensic Engineering Analysis of a Wheel Spindle Failure Due to Pre-Load and Fatigue

By David A. Danaher, PE (NAFE 703F)

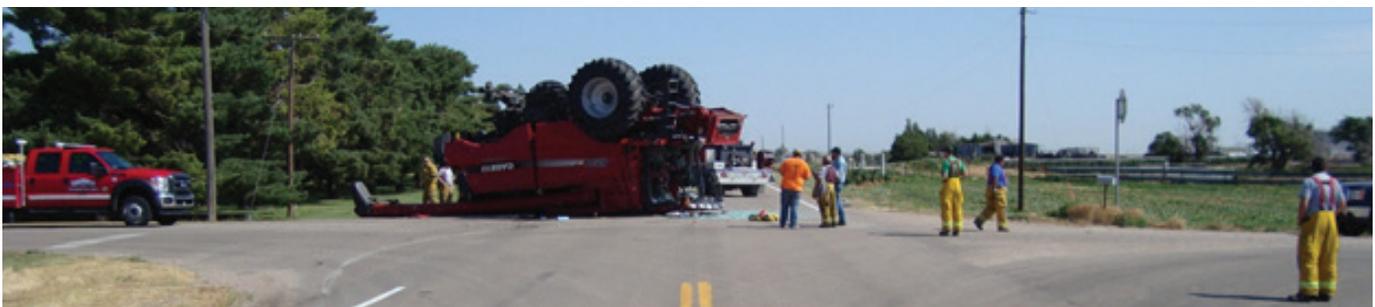
**Figure 1**  
Rest position of combine.

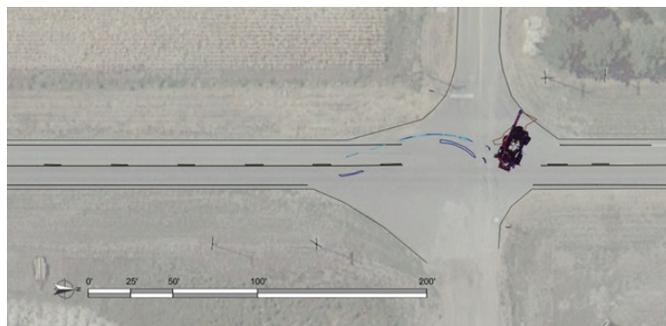
**Figure 3**  
Scene diagram showing the physical evidence and the rest position of the combine.

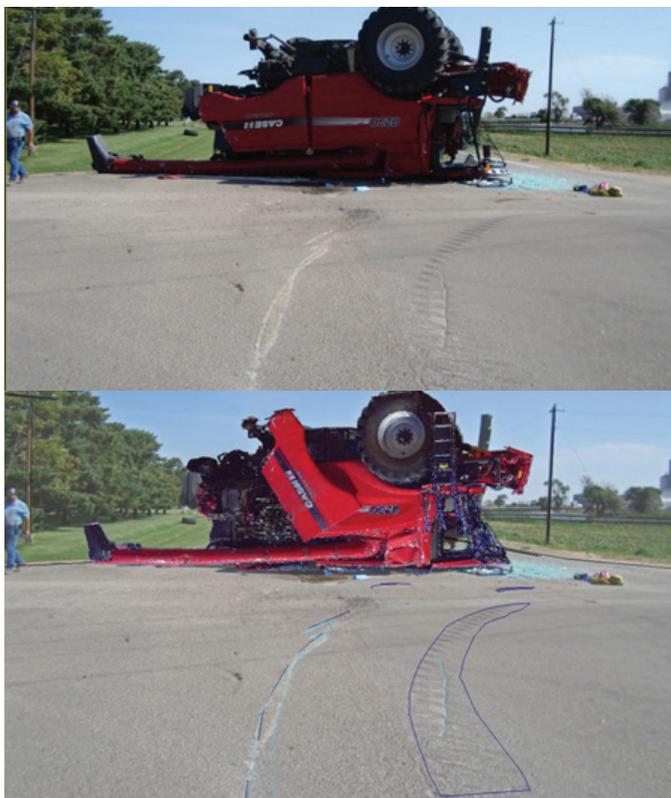
**Figure 2**  
Camera matched rest position of the combine.

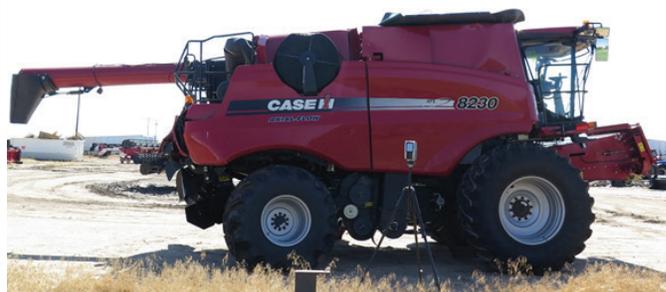
The Case IH Axial-Flow 8230 involved in this crash was a 2013 model year combine. A placard on the vehicle listed the unladen weight as 18,100 kg (39,904 lb). This agricultural equipment was equipped with Firestone 28L-26 tires on the rear and Deep Tread 23° tires on the front, which have a maximum speed of 25 mph and 30 mph, respectively. The tires on the vehicle were directional and intended to be mounted in a specific orientation. The front tires were mounted in the correct orientation. The rear tires were mounted backward, such that they rotated in the incorrect direction.

**Figure 4**  
Right side of combine.

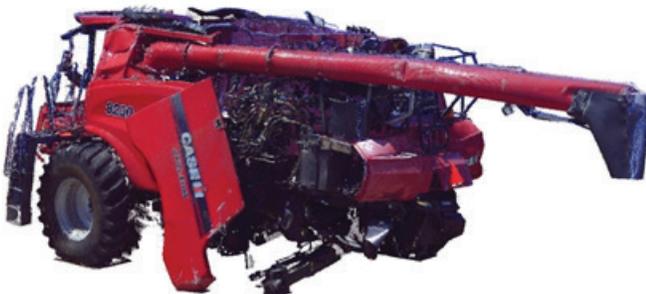
**Figure 6**  
Scanned three-dimensional model of the combine.

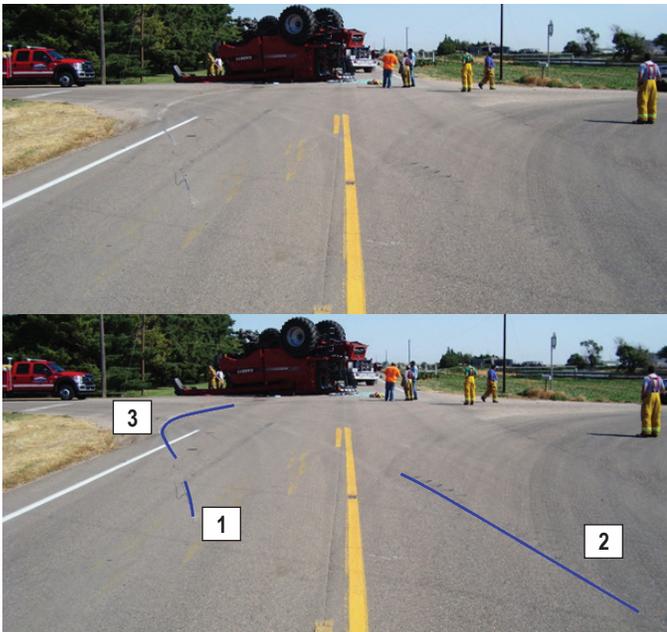
analyzed in a scaled environment. The gouge found in the roadway matched with the left-rear axle prior to the vehicle rolling over. Furthermore, the tire marks that run parallel to the gouge also matched the right-rear tire of the combine. The gouging could only occur with the left rear tire already separated from the vehicle and therefore did not separate as a result of the rollover. Based on the above, the following sequence was determined.

**Figure 7**  
Top image by police; bottom image highlights the physical evidence.

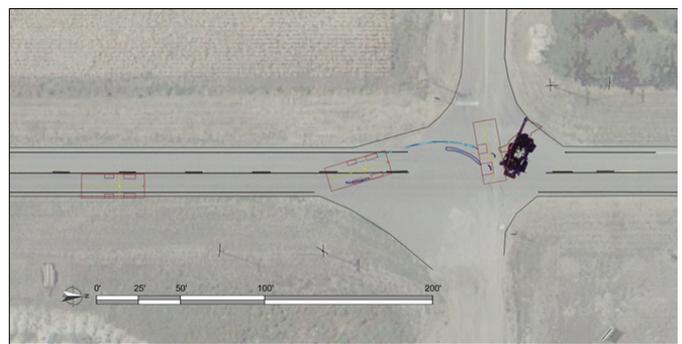
The combine was initially traveling north on the highway. The 14-ft-wide vehicle was likely occupying the shoulder and the entire (or nearly the entire) 11-ft-wide northbound lane. As the left-rear tire and rim detached, the vehicle was pulled to the left when the left-rear axle began gouging the southbound lane (labeled 1 in **Figure 7**). As the vehicle was pulled to the left, the right-side tires deposited yaw marks in the northbound lane (labeled 2 in **Figure 7**). The driver then steered to the right, causing the vehicle to yaw clockwise and curve to the right (as indicated by gouge number 3 in **Figure 7**). The combine then rolled one half time before coming to rest on its roof. **Figure 8** depicts the approximate motion of the combine through the physical evidence.

The evidence at the scene and the dynamics of the accident<sup>8,9,10,11,12,13,14,15</sup> showed that the failure and separation of the wheel assembly was not due to any environmental factors or interaction with another vehicle — and not as a result of, but rather the cause of, the rollover. Had the wheel separated from the combine due to an external force, there would have been significant damage to the tire and rim, which showed no evidence. Also, had the wheel assembly been attached before the rollover, there would have been no gouging left in the roadway prior to the rollover. Therefore, the wheel assembly separated prior to the rollover, requiring a deeper look at the damaged components of the wheel assembly (specifically the tapered bearings and spindle).

**Figure 8**  
Motion of the combine prior to rest along the physical evidence.

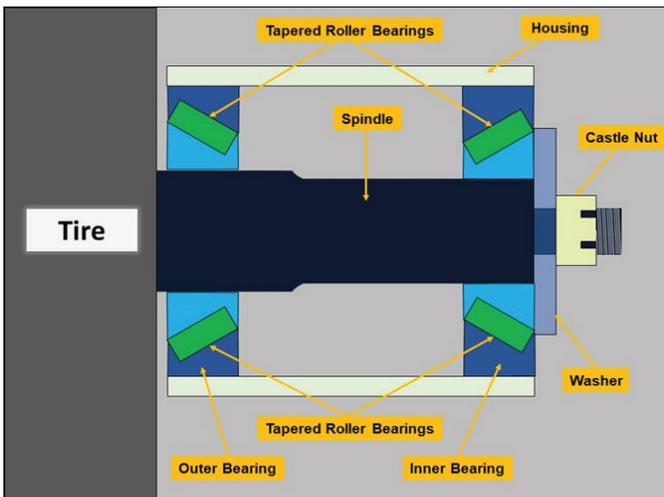
**Figure 9**

As can be seen in **Figure 9**, the roller bearings are set at an angle relative to the spindle to allow for force along the axle. The relative angle of the bearing also generates thrust that will force the bearing off the spindle, requiring the use of a retention nut that is tightened to a specific torque, applying the proper amount of pre-load. The purpose of the pre-load is to maintain the location of the bearings relative to the spindle both radially and axially, maintaining the running position of the shaft and properly distributing the loading. The pre-load of the assembly is specified by the manufacturer.

An example of a spindle and tapered bearing assembly.

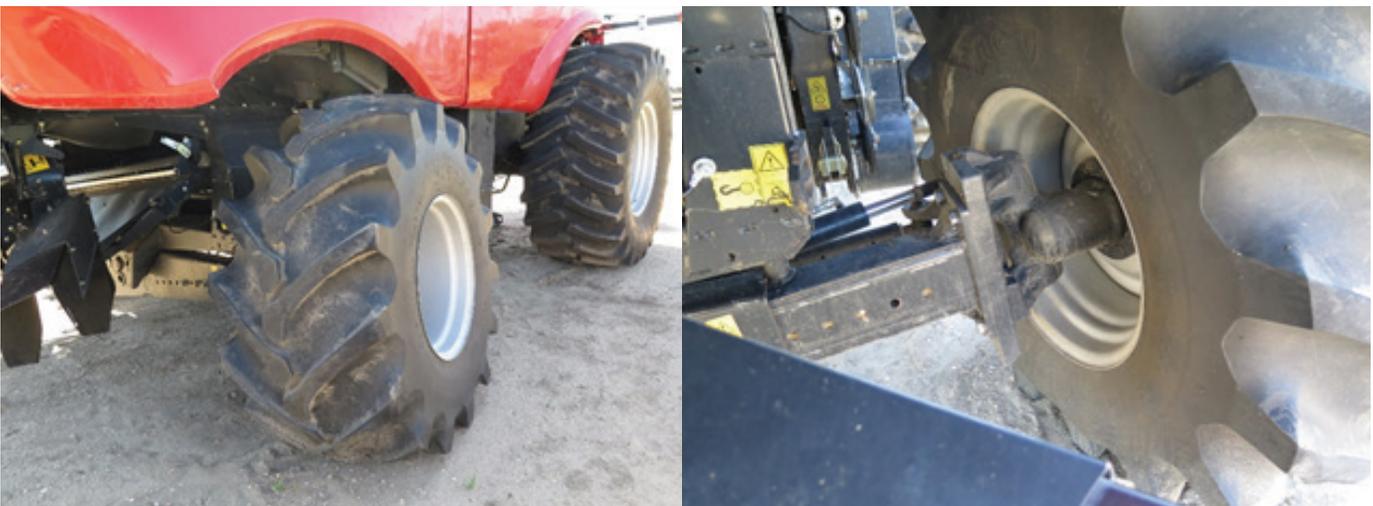
To better illustrate how the spindle and bearing assembly is attached to the combine, **Figure 10** shows the right rear of the combine where the assembly is still intact. The image from **Figure 9** has now been overlaid onto the hub assembly in **Figure 11**.

Right rear tire and hub assembly.

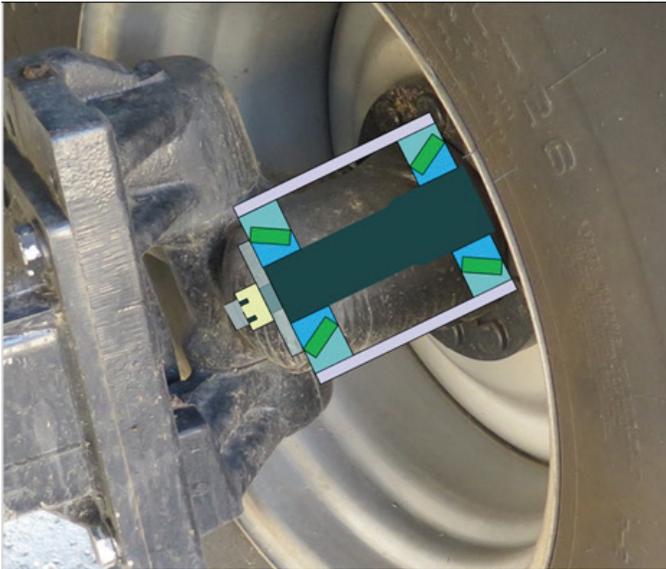
**Figure 11**  
Right rear tire and hub assembly showing spindle and bearing diagram.

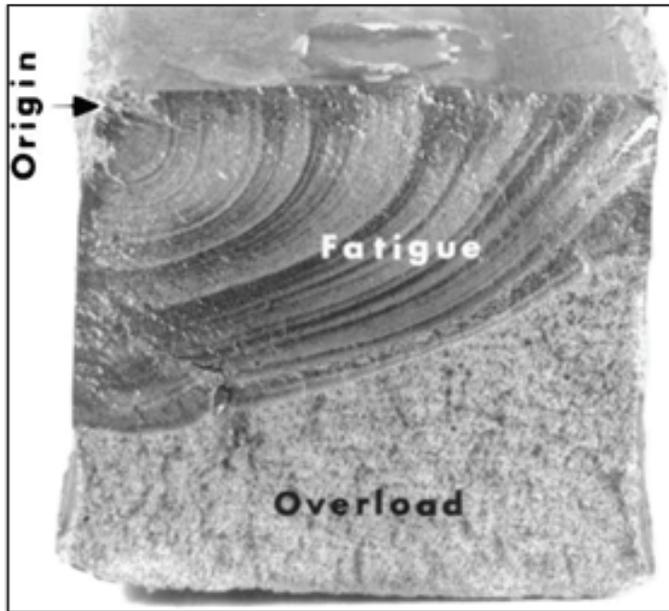
Examination of the fracture surface shows that the threaded area was subjected to repetitive overloading and fatigue. For comparison, the fracture surface of the spindle thread is shown in **Figure 25**, and an example of a fracture surface that failed due to fatigue is shown in **Figure 26**.

In **Figure 25**, a relatively smooth area with beach marks can be seen as well as a rougher area with no beach lines. This is consistent with the example of a fatigue failure in **Figure 26**, specifically the presence of an area of fatigue and an area of overload.

**Figure 26**  
Example of fatigue<sup>21</sup>.

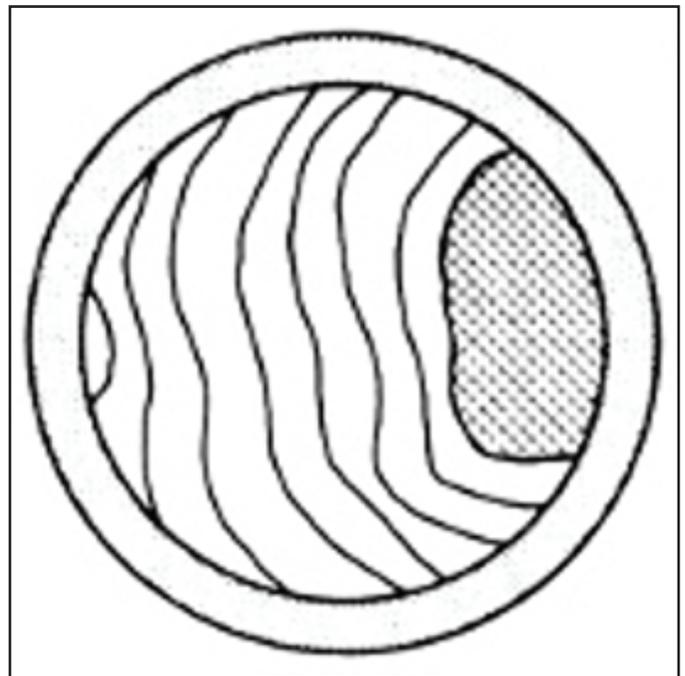
around the overloaded area. **Figure 28** shows an example of unidirectional bending from the ASM handbook<sup>22</sup>.

**Figure 28**  
Unidirectional bending – ASM Handbook<sup>22</sup>.
