Vol. 42 No. 1 June 2025

# FE Analysis of a Modular Fireplace Fire with an Improperly Constructed Hearth Extension

By Jerry R. Tindal, PE (NAFE 642S)

## Abstract

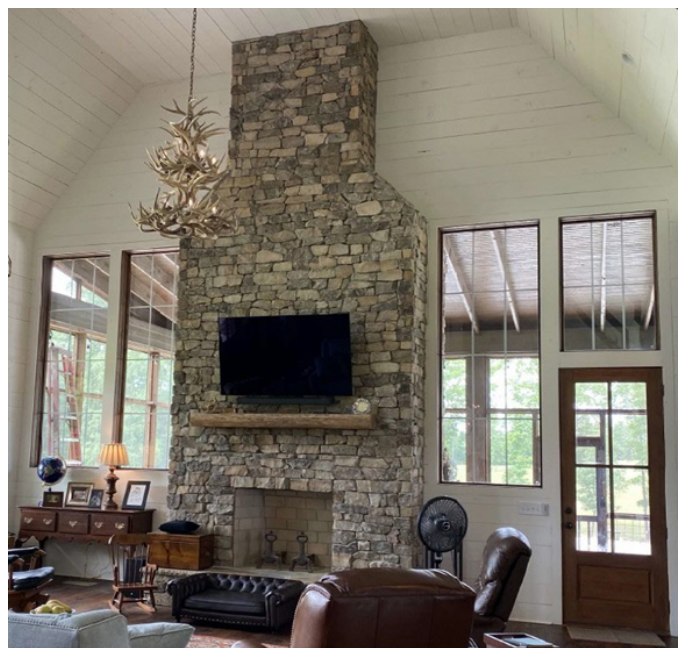
**Figure 3**

A view of the finished living room fireplace and stone veneered chase enclosure prior to the fire.

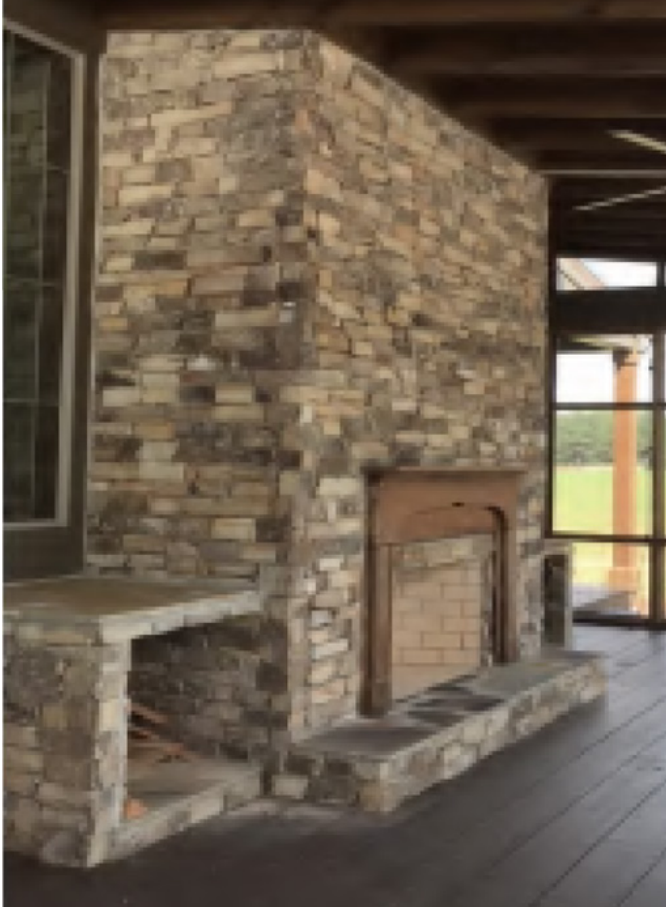
**Figure 4**  
A view of the porch fireplace and stone veneered chase enclosure prior to the fire.

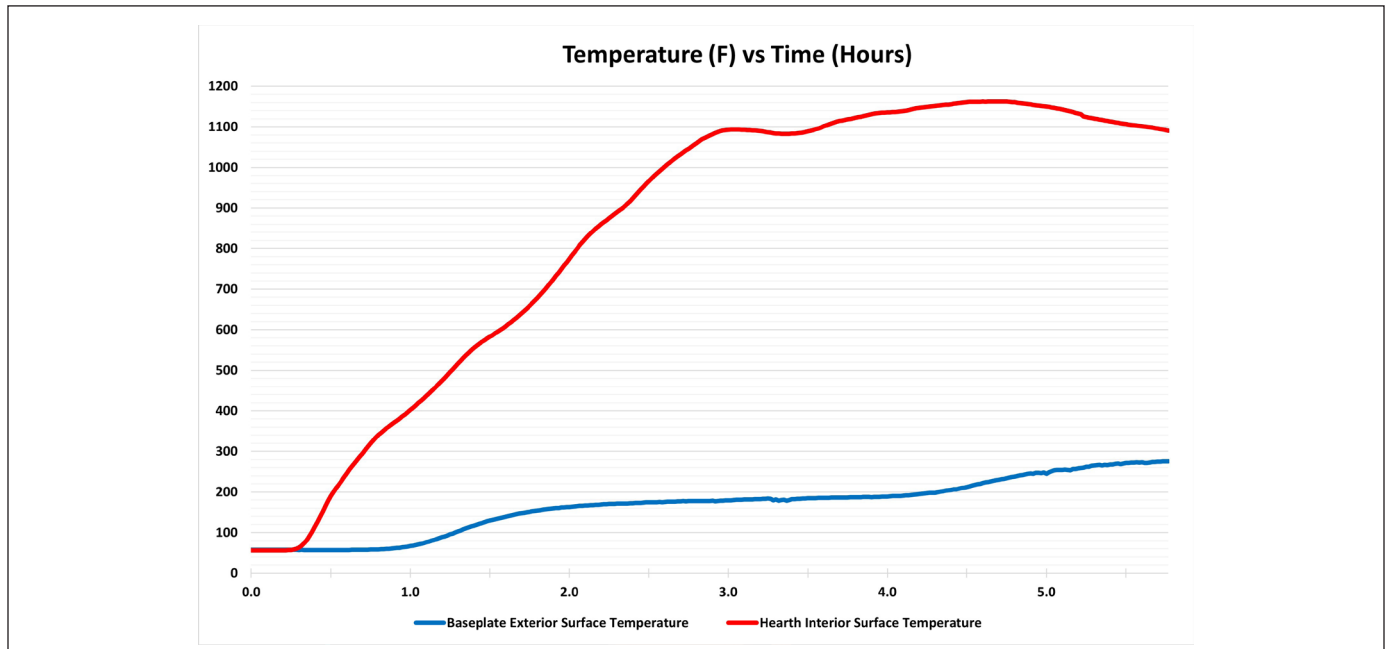
**Figure 5**

Prior Case#1 temperature results for the hearth interior surface temperature and the base plate exterior surface temperature for a burn test of approximately 5 hours and 45 minutes. Combined hearth refractory and base plate thickness of 5¼ inches. The exterior surface of the base plate was open to ambient air of 77°F average temperature. The exterior base plate surface temperature reached approximately 276°F after 5 hours and 45 minutes.

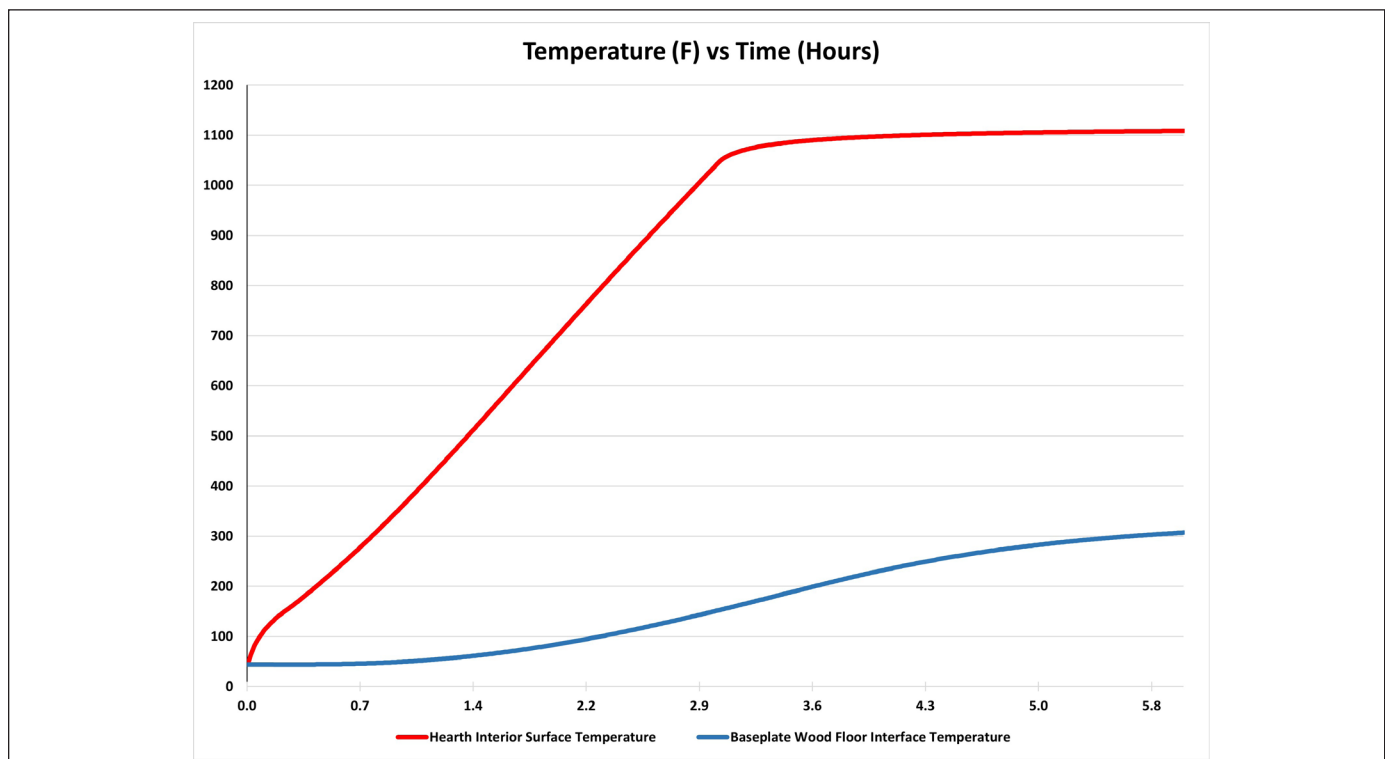
**Figure 6**

Prior Case #2 FDS modeled temperature results for the hearth interior surface temperature and the base plate exterior surface wood floor surface interface temperature for a burn test of approximately 5 hours and 45 minutes. A combined hearth refractory and base plate thickness of 5¼ inches. Models the exterior of fireplace and base plate sitting on a wood floor surface. The exterior base plate and wood floor interface temperature reached approximately 300°F after 5 hours and 45 minutes.

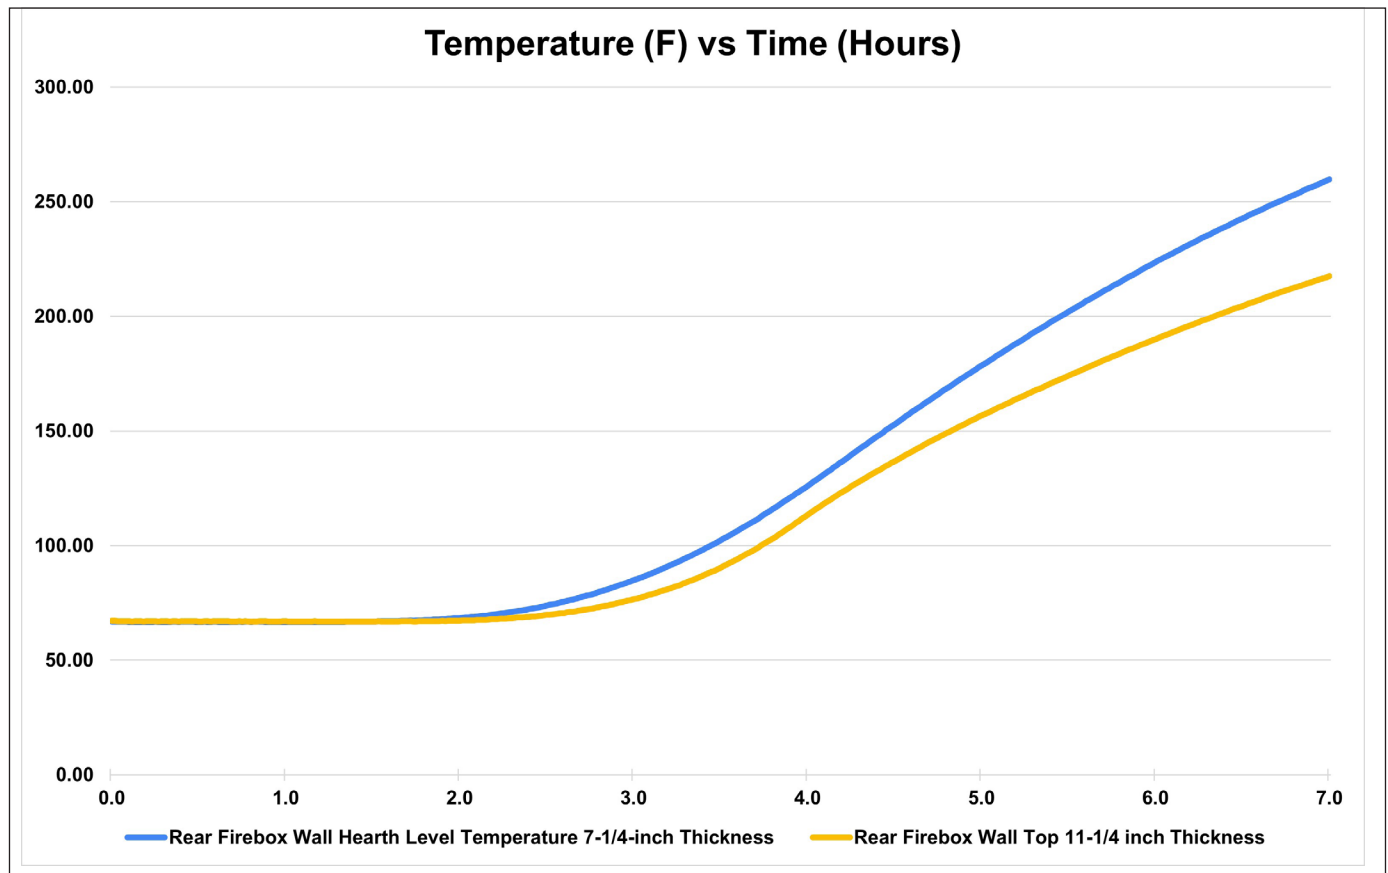
Figure 7

Again, it should also be reiterated that as fuel continues to be added to the fireplace for extended burn times, the temperatures in the masonry will continue to rise, creating an imminent fire hazard to wood materials in contact or close proximity to the masonry riser surfaces. **Figure 7** depicts some data collected from the testing for a period of up to approximately 7 hours.

Prior Case #3 temperature results for the rear firebox wall and wood stud interface after approximately 7 hours of active burn testing. Note temperatures continue to climb as the fire is fed and the active burn time continues. Temperatures at the 7¼-inch thickness at the heart level and 11¼-inch thickness at the top of the firebox at the interfaces with the contacting wood studs reached approximately 205°F and 182°F, respectively after approximately 5 hours and 45 minutes.

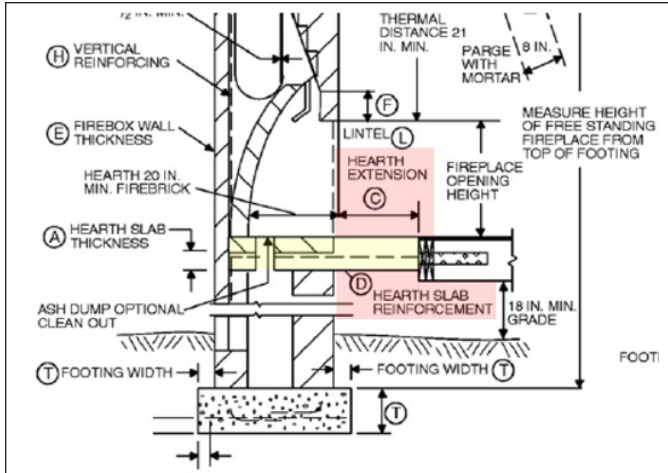
**Figure 8** is an annotated excerpt of IRC Figure R1001.1 that illustrates the proper construction of hearth and hearth extensions for masonry fireplaces. There should be no combustible materials, including wood framing or sheathing, within or beneath the hearth or hearth extension.

Annotated excerpt of IRC Figure R1001.1, illustrating the proper construction of hearth and hearth extensions for masonry fireplaces.

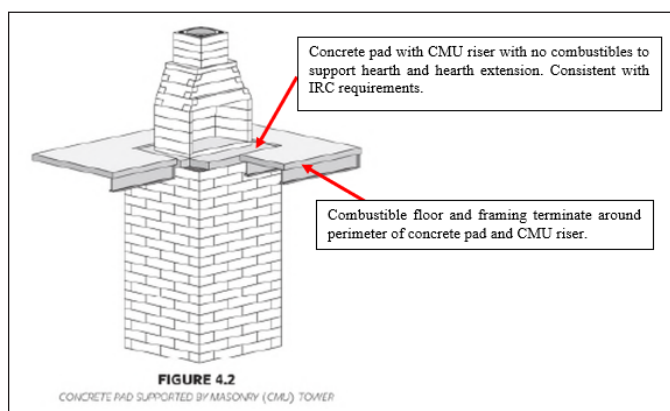
**Figure 11**

*Concrete Pad Supported by Masonry (CMU) Tower (Figure 4.2): Typically used when the fireplace is placed over a ... crawl space. The noncombustible pad is best made from a 6" thick concrete slab with #4 rebar... poured on top of corrugated metal. Concrete pad must be supported by a full masonry tower with no combustible underpinnings...*

Concrete pad and foundation support structure drawing excerpted from the manufacturer's installation instructions where the fireplace is to be installed in a home with a combustible floor and with a crawl space.

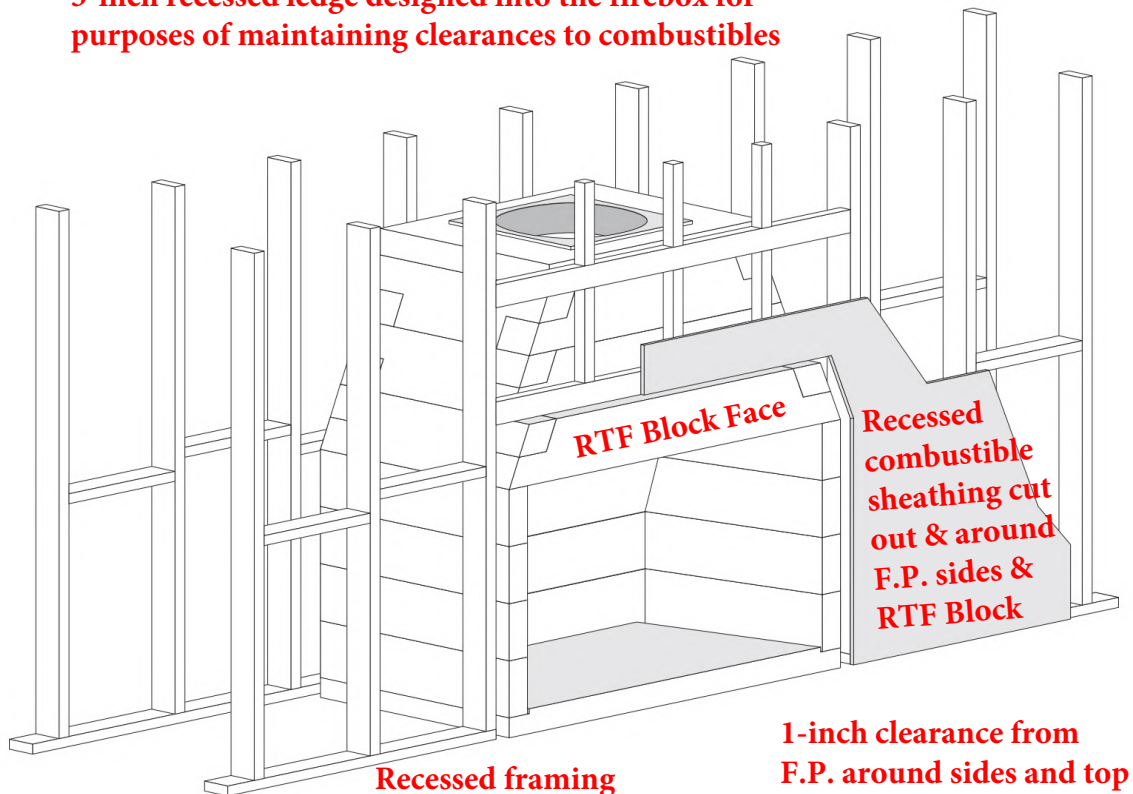
**Figure 15**

**3-inch recessed ledge designed into the firebox for purposes of maintaining clearances to combustibles**

An excerpted and annotated view of an isometric drawing and the instructions above the drawing from the manufacturer's installation instructions.

illustrating and describing the fireplace design for framing and combustible sheathing installation around the firebox for the purposes of maintaining required clearances to combustibles. The fireplace is designed with a 3-inch ledge over the top of the RTF block to allow framing and combustible sheathing to be recessed and brought flush with the front vertical face of the firebox. For the case in question, OSB was installed across the face of the RTF block as well as the faces of the sides of the firebox and base plate. The OSB further projected beyond the vertical face of the firebox opening, creating a “trim” around the opening. **Figure 16** is another excerpted and annotated drawing from the manufacturer’s installation instructions that depicts the proper construction around the firebox above the opening to maintain clearances to combustibles.

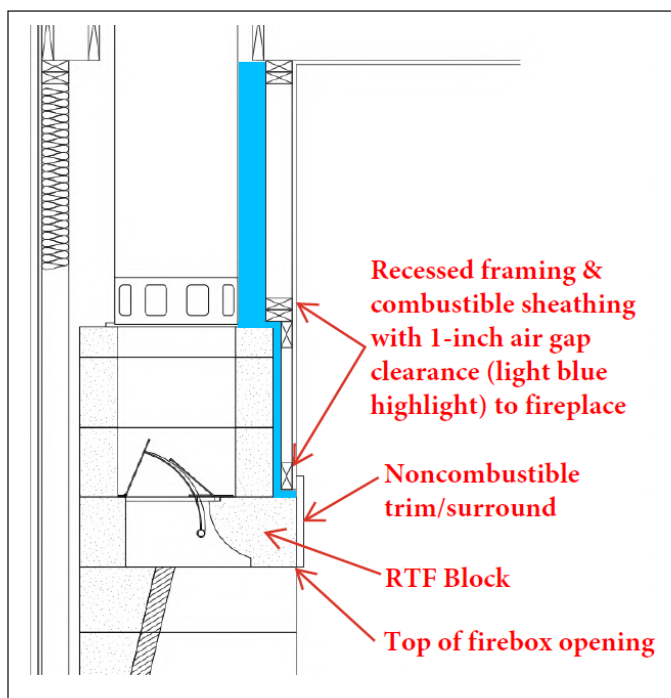
**Figure 16**

An excerpted and annotated profile drawing from the manufacturer’s installation instructions pertaining to the combustible framing and sheathing around the top of the firebox. Note also the required cooling air spaces which are annotated in blue.

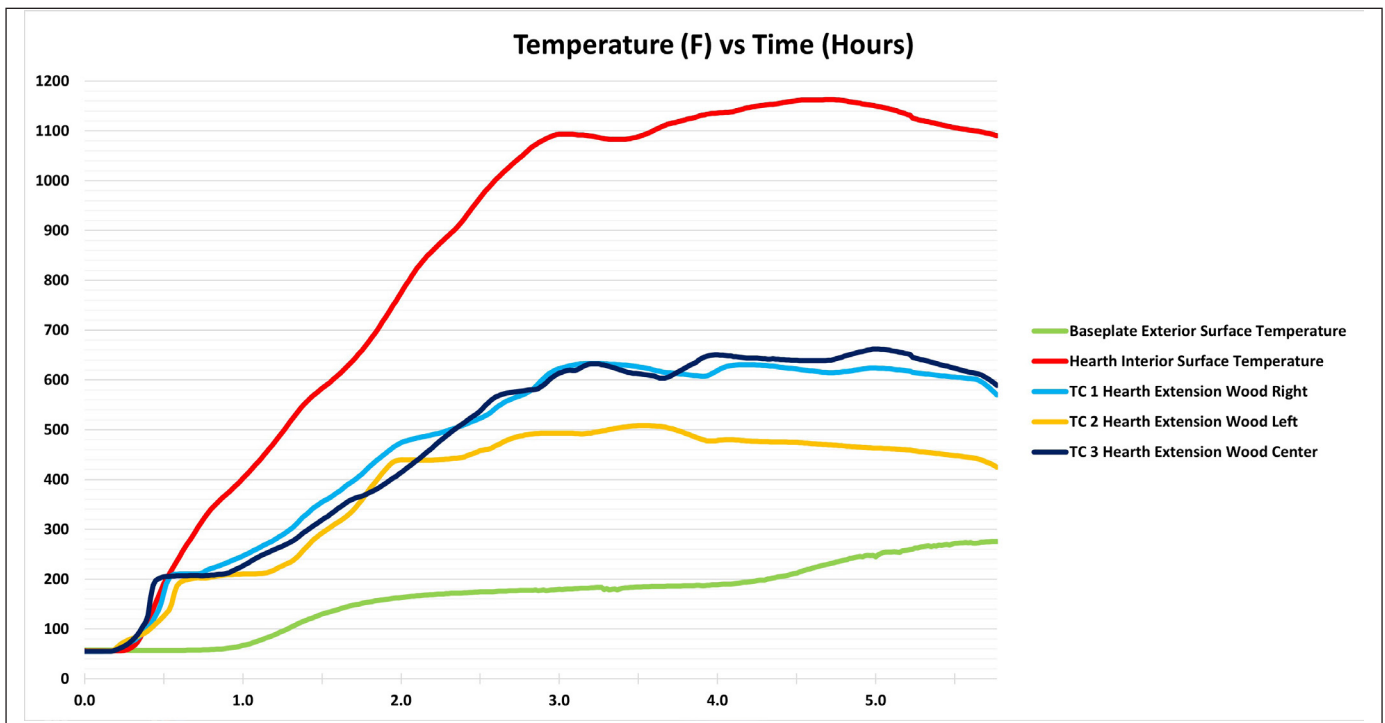
**Figure 22**

Fire investigators and engineers (including the author) examined the scene and delayed the fireplace brick veneer. It was concluded that the fire originated within the OSB sandwiched between the fireplace base plate (beneath the hearth) and the masonry hearth extension. The OSB was ignited via smoldering ignition. Once sufficient degradation occurred to the embedded OSB structure and sufficient oxygen pathways were available, the smoldering fire transitioned to flaming combustion and spread into the chase enclosure, vertically up the interior of the chase, and then into the rest of the home. As a result, the home was completely destroyed.

Prior Case #4. Data plot of thermocouple temperatures on the wood approximately 1.5 inches below the mortar joint between the hearth and the hearth extension. Also included are the hearth interior surface temperature and the exterior bottom surface of the base plate.

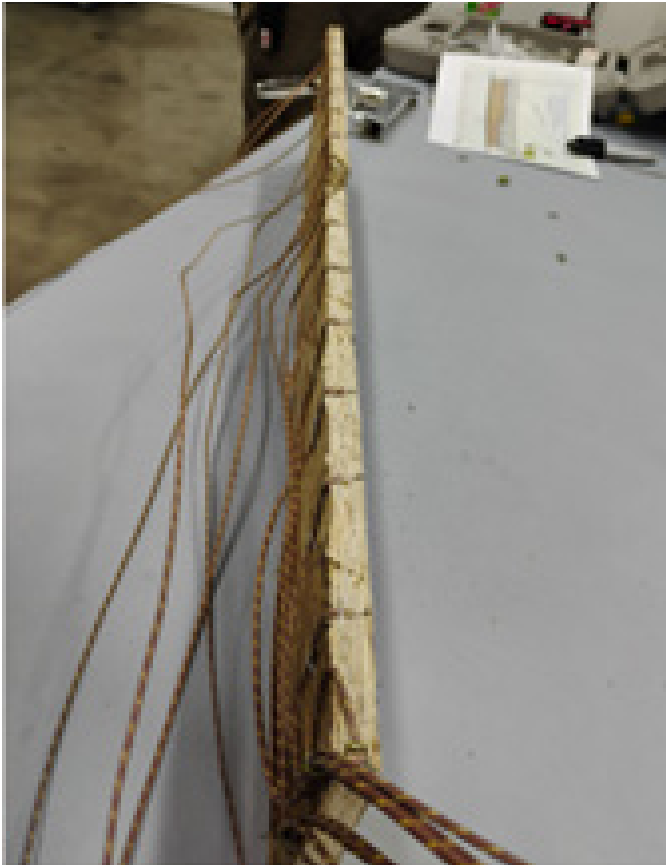
**Figure 27**

A view of the thermocouple instrumented stepped OSB sheathing installed in the joint between the hearth and hearth extension.

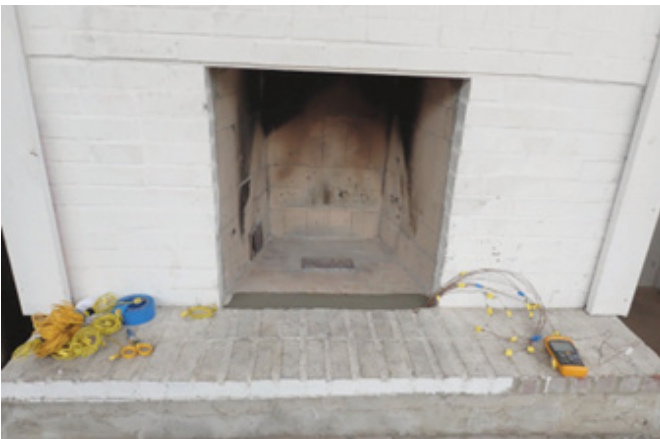
**Figure 28**

A view of the thermocouple instrumented joint between the hearth and the hearth extension after installation of the OSB.

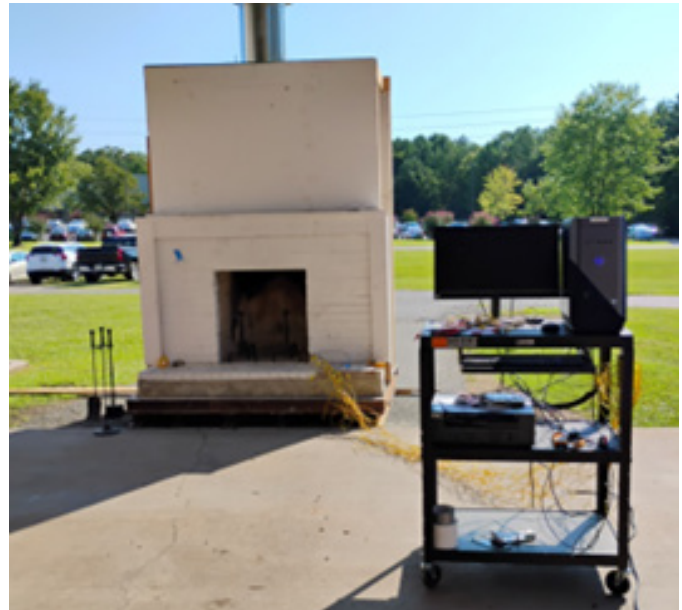
**Figure 29**

A view of the equipment and fireplace setup.

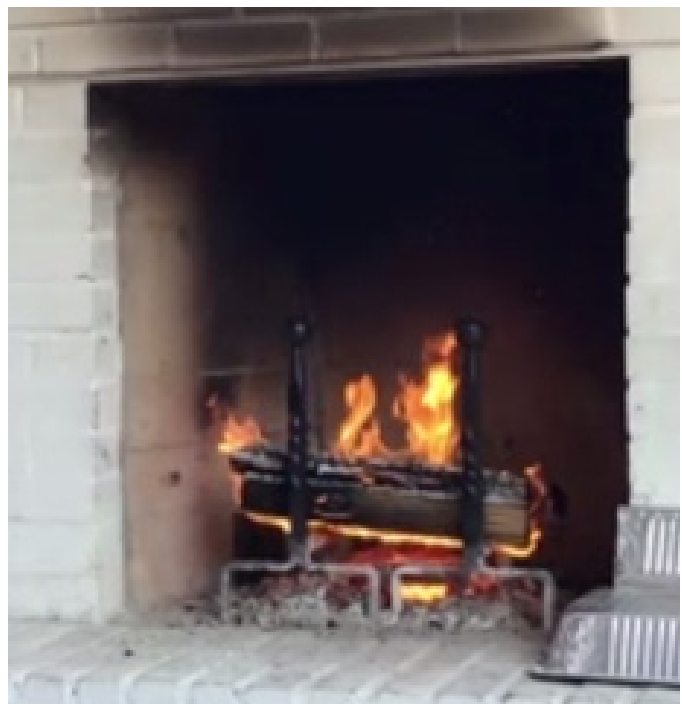
**Figure 30**

A view of the small to modest fire maintained in the fireplace during testing.

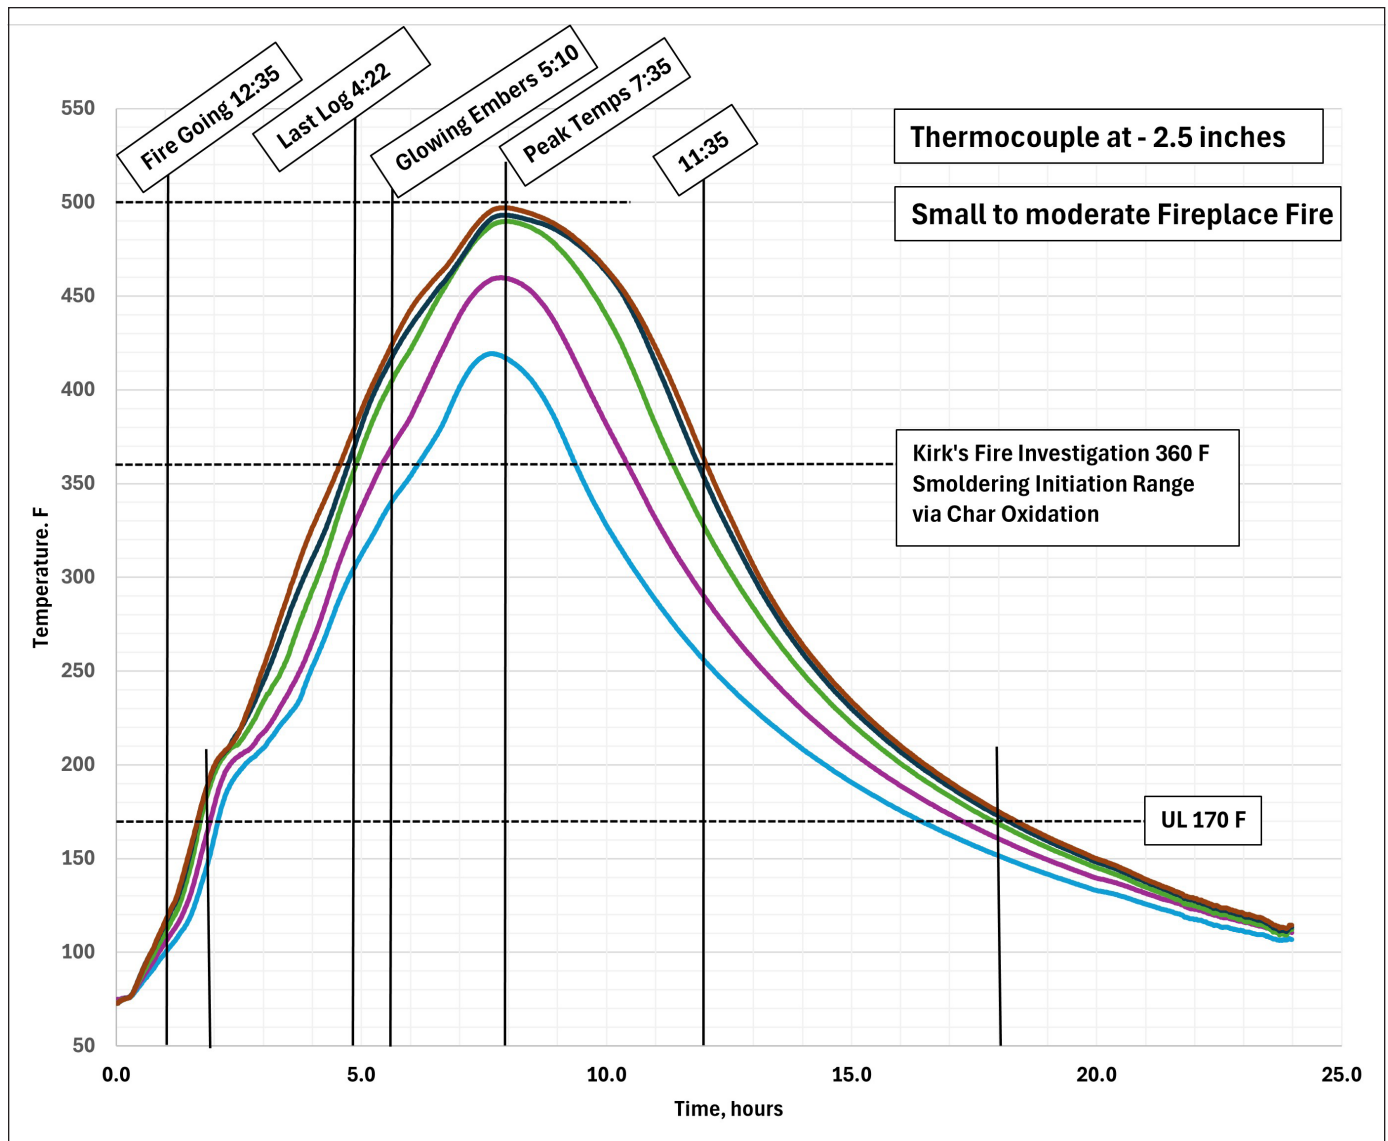
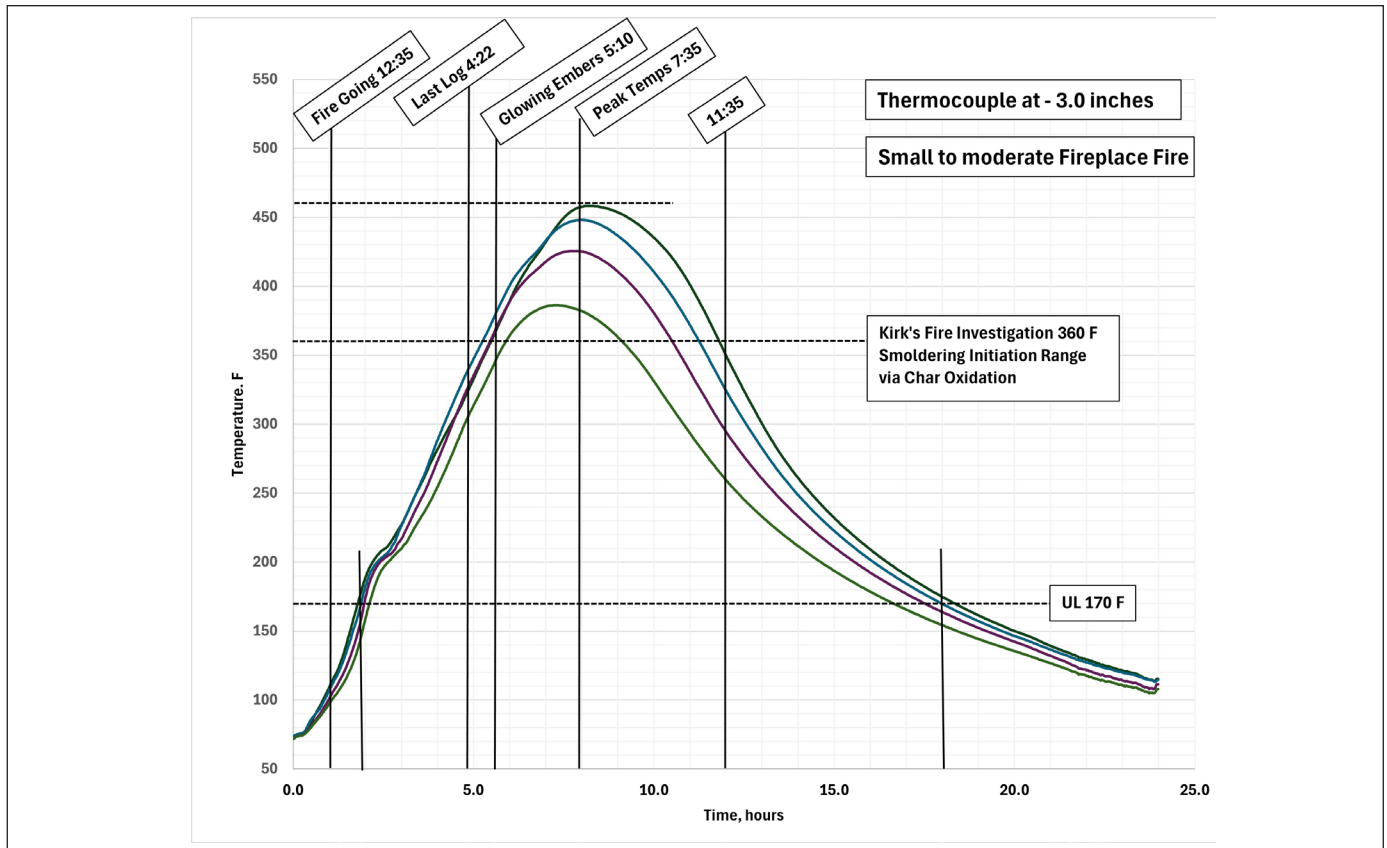
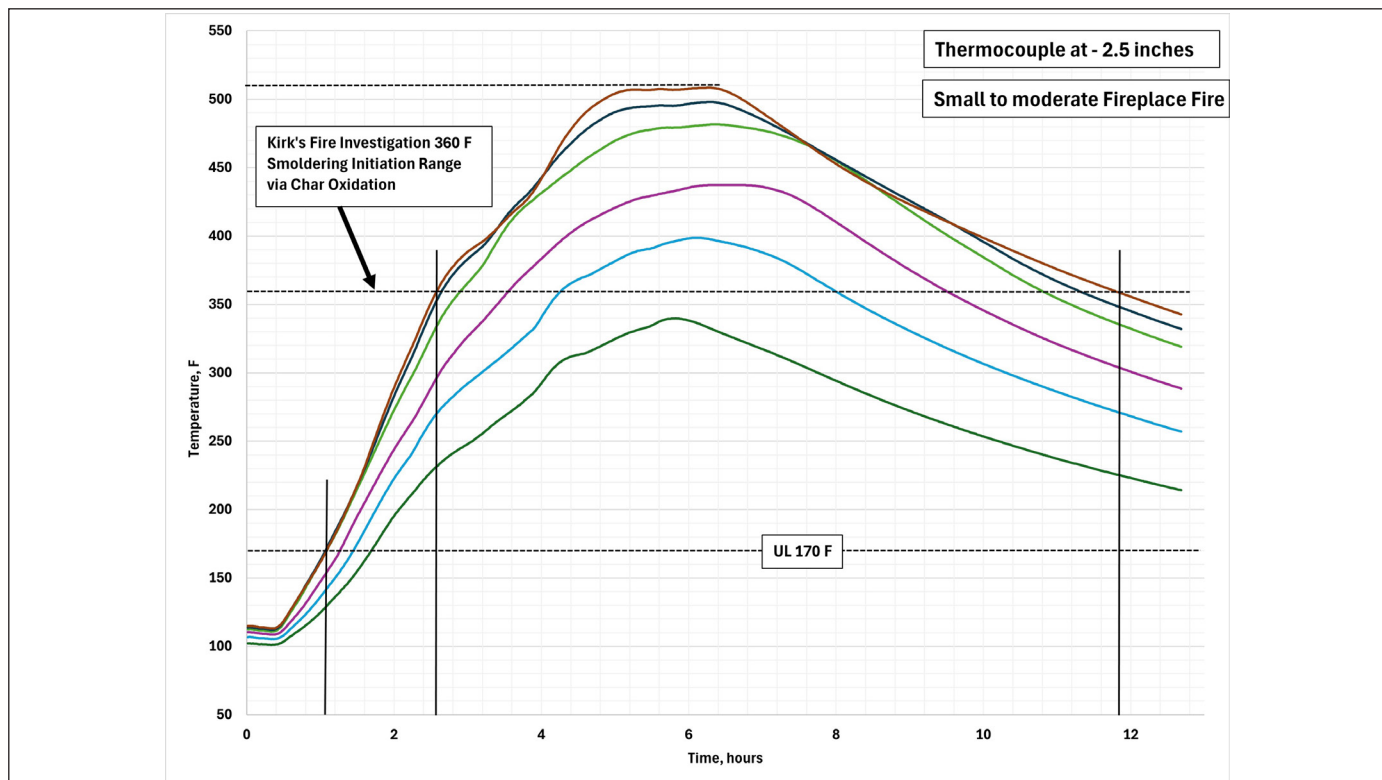
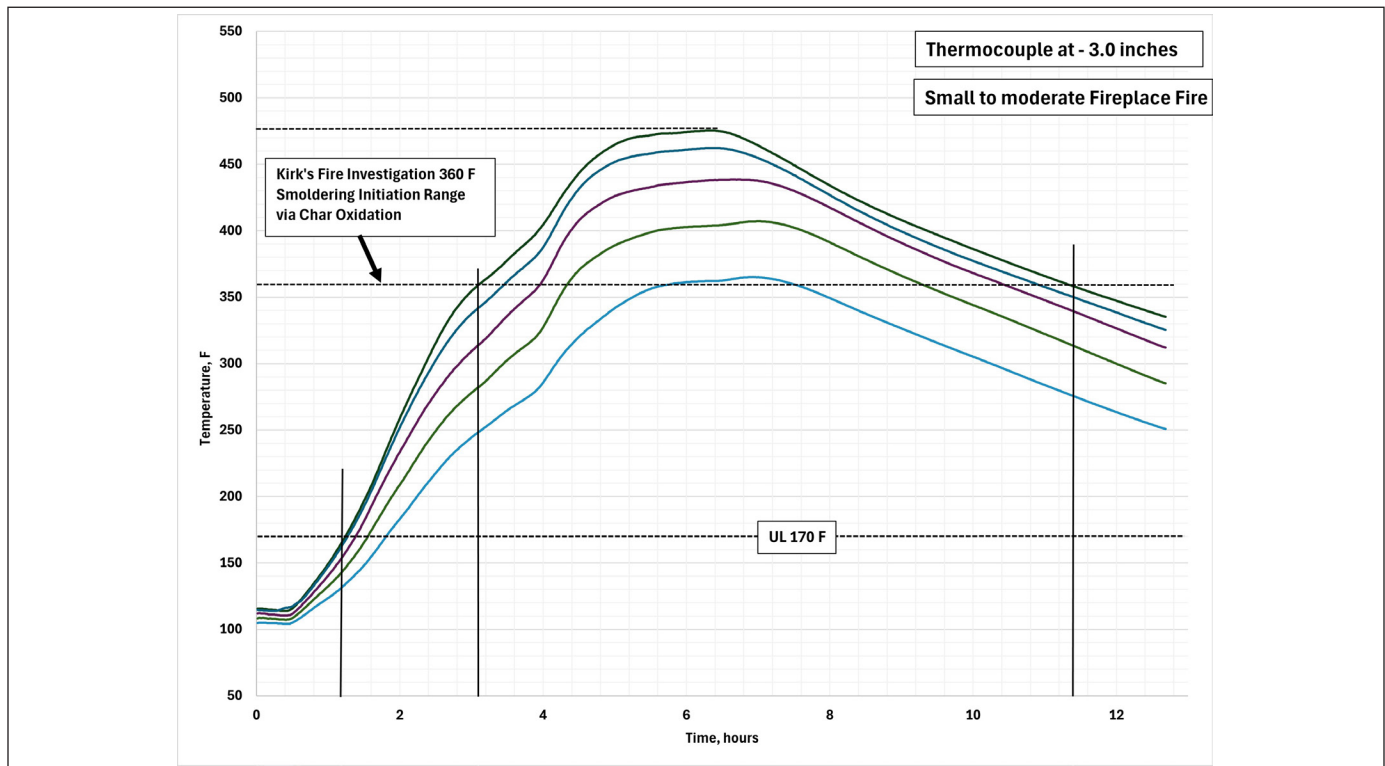
**Figure 31**  
A view of thermocouple data at 2.5 inches depth from Test 1.

Temperatures in the demonstration testing reached 460°F/500°F (3 inch / 2.5 inch) in test one and 475°F/508°F (3 inch / 2.5 inch) in test two. Temperatures at 1.5-in depths would therefore be even higher for the testing undertaken utilizing a small to moderate fire and controlling large ember and log collapse migration onto the joint. The temperatures obtained reached and exceeded common

**Figure 32**  
A view of thermocouple data at 3.0 inches depth from Test 1.

**Figure 33**  
A view of thermocouple data at 2.5 inches depth from Test 2.

A view of thermocouple data at 3.0 inches depth from Test 2.

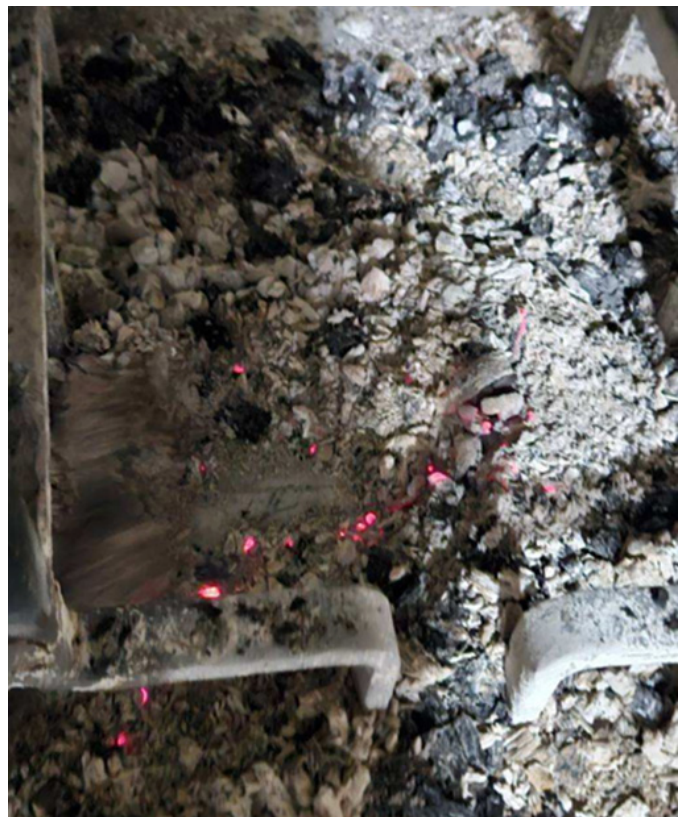
Figure 35

A view of hot glowing embers hidden in the ash and uncovered 7 hours after active burning ceased in the fireplace.

A smoldering fire in the masonry embedded OSB may initiate at any time during operation of the fireplace and continue to smolder for an extended period of time (many hours), well after the active fire in the fireplace has ceased. For example, approximately 7 hours after active (flaming) fire had ceased in the second burn test, ashes within the firebox were stirred, and substantial glowing/smoldering embers were still present (**Figure 34**) though not visible or otherwise detected until the ash was moved around. Ash covering the embers had functioned to insulate and sustain slow smoldering combustion (with a low heat release rate) without the production of any detectable smoke. In like manner, charred and smoldering wood embedded within the hot masonry joint would continue to smolder in a manner even less detectable due to the masonry embedded concealed nature. Not until the smoldering combustion transitioned into flaming combustion (not a predictable event<sup>18</sup>) within the chase would the fire likely become detectable. *Kirk's Fire Investigation 8th Edition* [pp. 258] notes:
