Vol. 43 No. 1 June 2026

# Barrel Failure in an Over and Under Shotgun

By Stephen A. Batzer, PhD, PE (NAFE #677F)

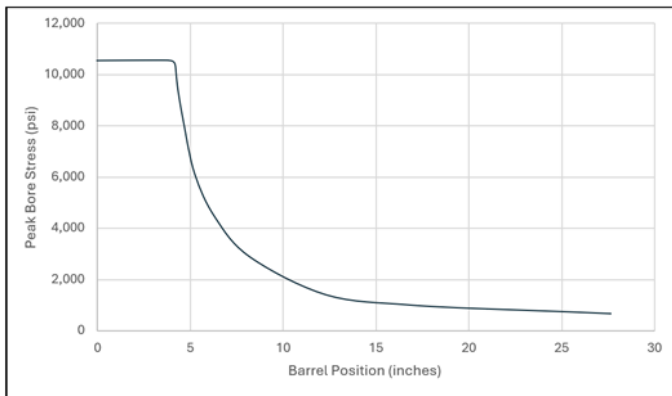
pressure diminishes rapidly past peak manifestation due to increased gas volume from axial projectile movement, adiabatic cooling that is associated with the volume increase, heat transfer to the barrel and shell, and interfacial friction, as illustrated by the representative shotgun barrel pressure trace in **Figure 2** [1]-[4].

Schematic shape of shotgun barrel maximum bore pressure by axial position.

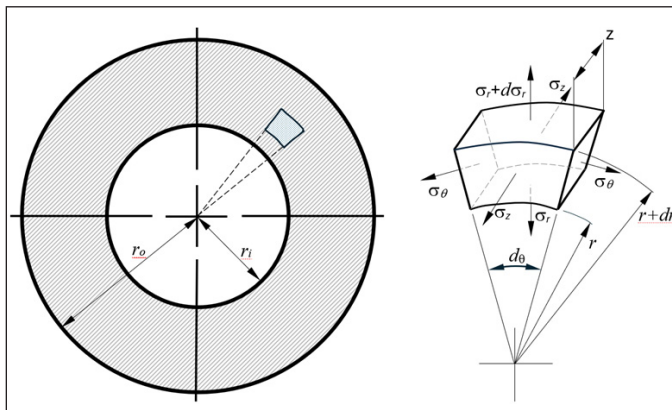
**Figure 3**

The stress distribution within the barrel wall comprises three orthogonal principal components as illustrated in **Figure 3**, expressed in cylindrical coordinates. Isostatic atmospheric pressure is disregarded. The radial compressive stress at the inner wall ( $\sigma_r$ ) corresponds identically to the local combustion pressure ( $p$ ) as measured by the compression gauge. Additionally, axial tensile stress ( $\sigma_z$ ) and circumferential hoop tensile stress ( $\sigma_\theta$ ) are induced.

Orthogonal stress components associated with a shotgun barrel cylinder wall describing axial stress  $\sigma_z$ , radial stress  $\sigma_r$ , and hoop stress  $\sigma_\theta$ .

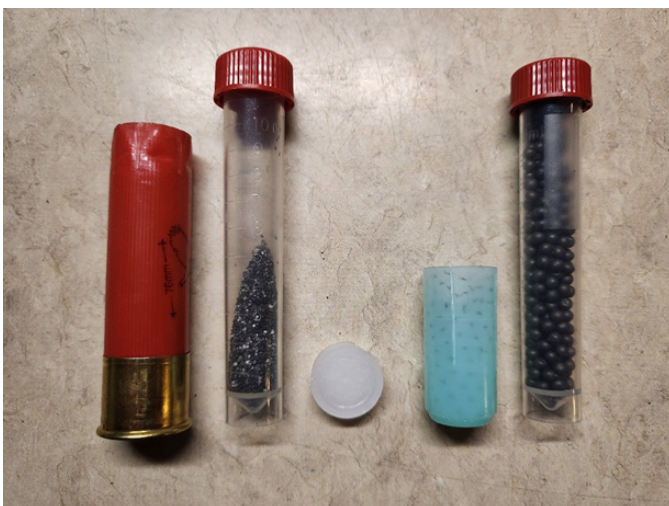
**Figure 8**

The exemplar rounds have the following mass characteristics, based upon an average of four deconstructed shells:

1. Empty hull with primer	136.6 grains
2. Smokeless propellant	30.9 grains
3. White plastic wad disk	13.9 grains
4. Blue polymer cup	38.0 grains
5. Steel shot	<u>543.3 grains</u>
6. <b>Total</b>	<b>762.6 grains</b>

Components of an exemplar 12-gauge shotgun round displaying decrimped plastic and brass hull, smokeless flake propellant, polymer wad, polymer shot cup, and steel shot.
