Journal of the
National
Academy of
Forensic
Engineers[®]

Unreliable at the Boundary: Analysis of Two Sub-Optimum Crossbow Trigger Designs

By Stephen A. Batzer, PhD, PE (NAFE #677F)

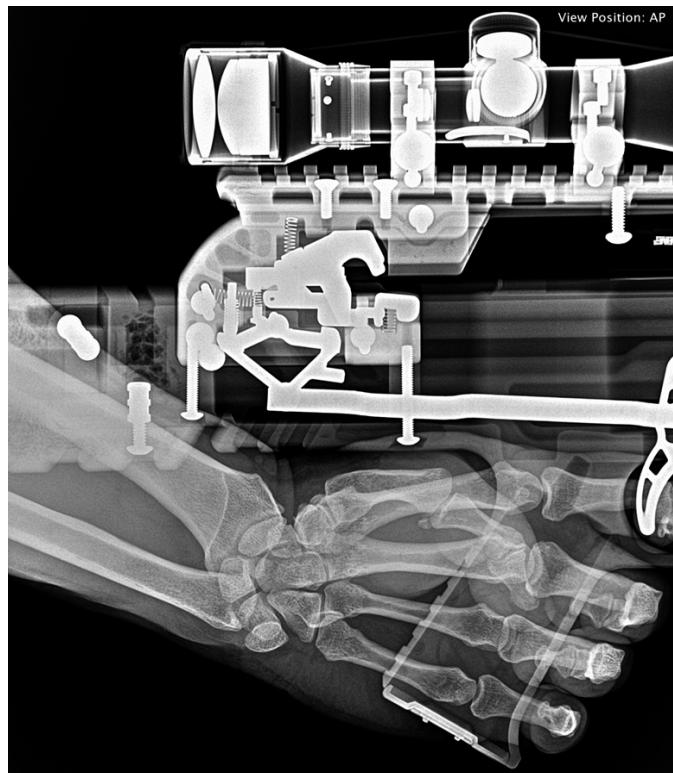
Figure 2

Modern crossbow trigger mechanism, safety off,
trigger drawn, and bowstring clasp up.

the X-ray in **Figure 2**, which details the significant number of interconnecting components. At the lower right of the image is the polymer pistol grip with the trigger shoe just visible. This trigger interface pivots about an axle, moving an actuating bar backward to trip the clasp through intervening linkages.
