Journal of the
National
Academy OF
Forensic
Engineers[®]

Vol. 37 No. 1 December 2020

Forensic Engineering Investigation of the Catastrophic Breakdown of a Diesel Engine in an Emergency Generator Set

By Daniel P. Couture, PEng (NAFE 951M)

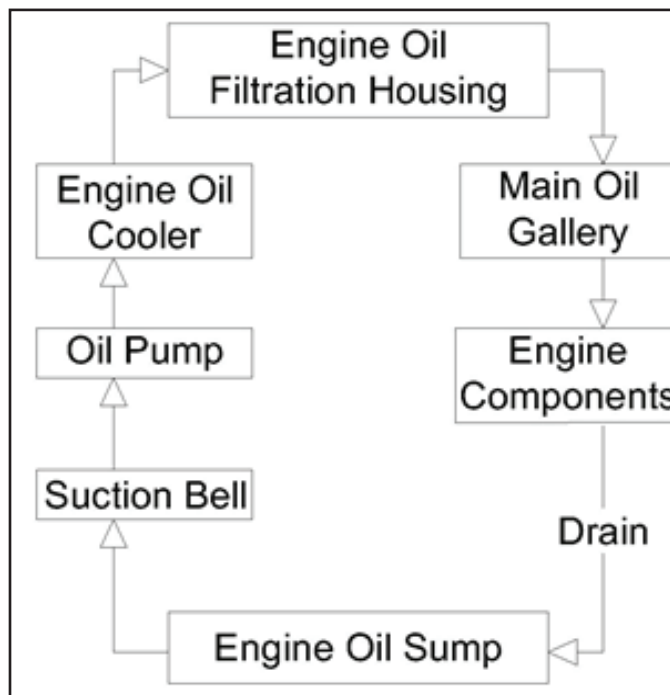
Figure 16

The engine oil pump gears are driven by the front gear train, and the engine oil is pulled by the oil pump from the pan through a suction bell (with a screen) and elbow. The engine oil is pumped past the engine oil cooler (**Figure 16**) and the engine oil filter housing via the pipe to the main oil gallery in the cylinder block.

The engine oil bypass valve will open if the oil cooler becomes plugged or the engine oil is too thick. According to the engine service manual, if the oil filters become blocked during operation, this regulator opens the bypass to keep oil flowing to the engine. The pressure difference for this to occur is from 26 to 29 +/- 1 p.s.i. (180 to 200 +/- 7 kPa). The oil flow regulator and the bypass assembly were found to be in normal operating condition, ruling out oil starvation because of blocked filters or bypass malfunctions at the cooler or the filter housing. Given that most

Approximate oil path configuration in the engine.
