Journal of the  
**National**  
**Academy** OF  
**Forensic**  
**Engineers**<sup>®</sup>

Vol. 37 No. 1 December 2020

<b>‡ Forensic Engineering Analysis of Projectile Thrown from Phantom Vehicle.....</b>	<b>1</b>
<i>By Richard M. Ziernicki, PhD, PE (NAFE 308F), William H. Pierce, PE (NAFE 846C), and Angelos G. Leiloglou, M Arch., (NAFE 956C)</i>	
<b>‡ Misapplication of Pressure Vessel Codes in Forensic Applications .....</b>	<b>15</b>
<i>By Bart Kemper, PE (NAFE 965S)</i>	
<b>‡ Forensic Engineering Analysis of Residential Underdrain Design Methodologies, Performance, and Failures .....</b>	<b>27</b>
<i>By Edward L. Fronapfel, PE (NAFE 675F)</i>	
<b>* Machine Safeguarding: Theory, Practice, and Case Studies .....</b>	<b>43</b>
<i>By Nicholas A. Petrucci, PE, CSP (NAFE 650M)</i>	
<b>* Forensic Engineering Analyses of Right-Turning Trucks Impacting Bicyclists .....</b>	<b>53</b>
<i>By Richard M. Ziernicki, PhD, PE (NAFE 308F), William H. Pierce, PE (NAFE 846C)</i>	
<b>† Forensic Engineering Analysis of a Failed ROPS .....</b>	<b>65</b>

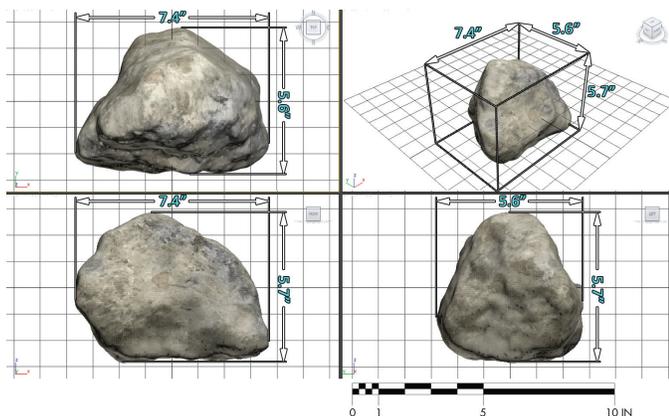
The concrete projectile was documented using photography and high-definition (HD) 3D scanning. Six HD scans were taken around the entire surface of the concrete projectile. A virtual model of the concrete with textures was created with a high degree of engineering precision from the HD scans and photographs<sup>1</sup>. **Figure 2** shows the virtual model generated from the HD scans and the general envelope (or overall dimensions) of the concrete. The concrete was, at its widest extents, 7.4 in. by 5.6 in. by 5.7 in. and weighed approximately 8 lb.

General envelope of the concrete projectile based on HD scans.

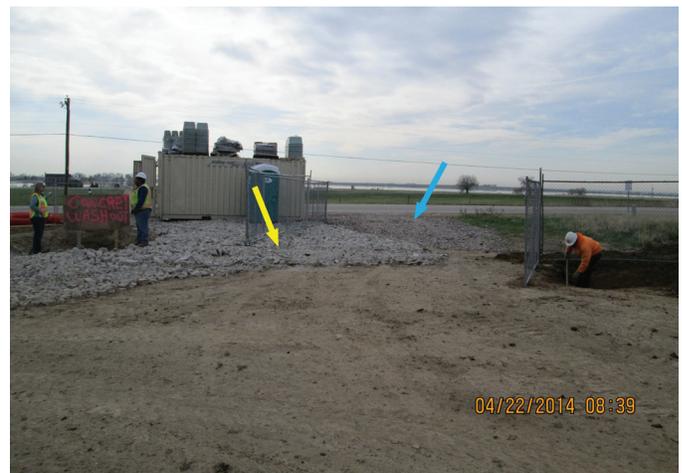
**Figure 6**

The construction entrance had a vehicle tracking pad comprised of 3-in. aggregate. Next to the vehicle tracking pad was the stabilized staging area, consisting of much larger recycled concrete. **Figures 6** and **7** are photographs of the vehicle tracking pad (VTC) and stabilized staging area (SSA) approximately two weeks before the incident.

The photographs show that, in general, the recycled concrete in the SSA is larger than the material installed on the VTC. However, the photographs also show that recycled concrete from the stabilized staging area overlapped a large portion of the VTC. Therefore, as trucks entered and exited the site, they would have likely run over the larger pieces of recycled concrete from the stabilized staging area that overlapped the VTC.

Photograph of vehicle tracking pad (VTC) and stabilized staging area (SSA) at the park taken by city inspectors, approximately two weeks prior to incident. Yellow arrow shows material in concrete washout area; blue arrow shows material on VTC.

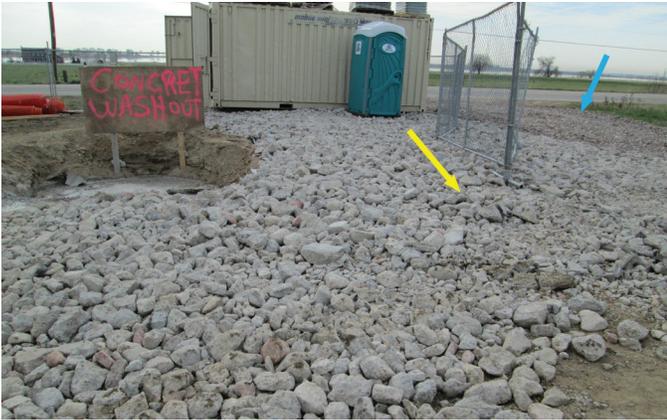
**Figure 7**

Photograph of concrete washout/SSA and VTC taken by city inspectors on April 22, 2014, approximately two weeks prior to incident. Yellow arrow shows material in concrete washout area; blue arrow shows material on VTC.

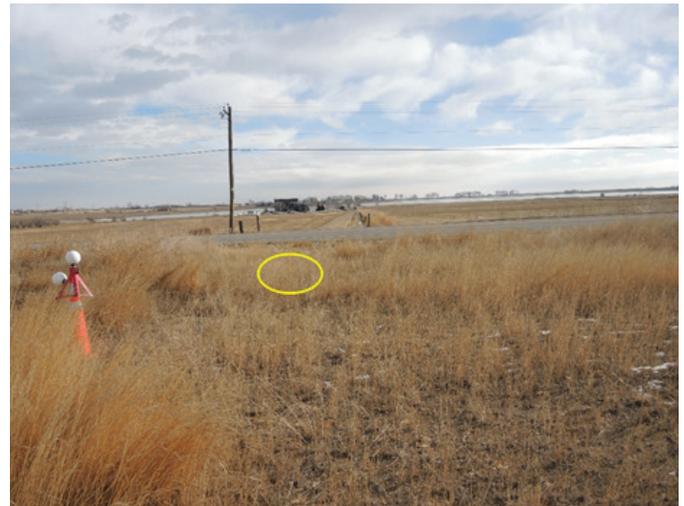
Figure 13

The construction project had long been completed prior to the inspection, and the vehicle tracking pad was no longer in place. The recycled concrete that had been spread over the VTC during the construction project had been removed prior to the inspection, and most of the inspection area was covered in grass (**Figure 13**).

The area where VTC was previously installed is shown here. The circle represents general area that sample concrete was collected during inspection.

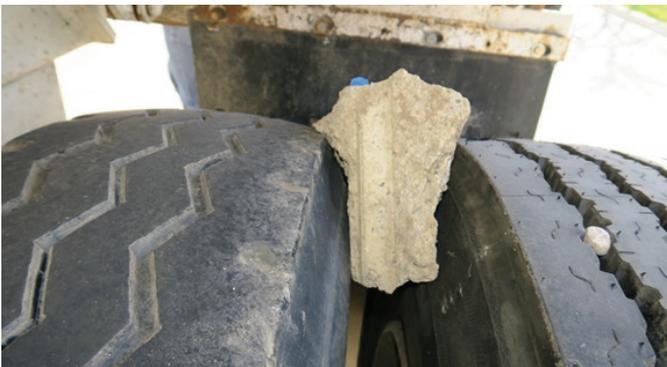
**Figure 15**

Concrete of similar size and shape as projectile concrete obtained from the park embedded within the defendant trailer rear left set of dual tires.

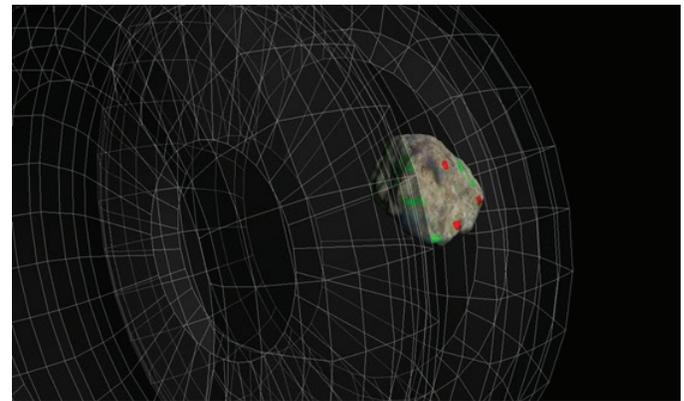
**Figure 16**

Geometrical analysis with a virtual model of the trailer tires and concrete projectile was done to determine how the projectile concrete would have fit within the set of dual tires, matching the areas where the black material was observed on the concrete with where the concrete made contact with the tires (Figure 16 and Figure 17). The analysis also showed how the concrete would have been pressed fit into the set of dual tires (Figure 18).

Graphic showing a scaled model of the concrete wedged in scaled dual tires. (Green marks = locations of black material embedded; red marks = locations of soil.)

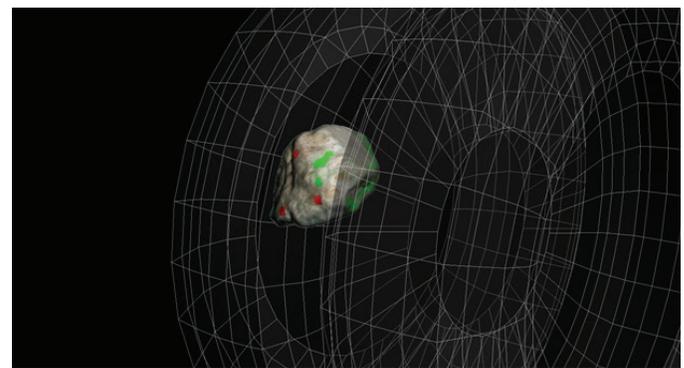
**Figure 17**

Graphic showing a scaled model of the concrete wedged in scaled dual tires from the other side. (Green marks = locations of black material embedded; red marks = locations of soil.)

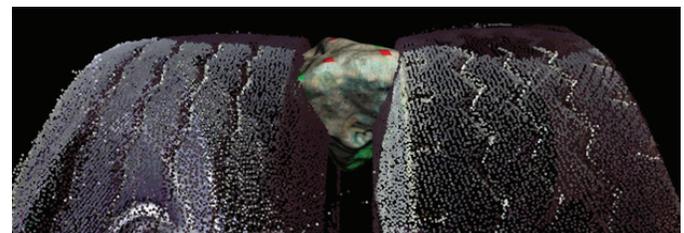
**Figure 18**

Visualization of the projectile concrete press-fit in HD scan of the dual tires.

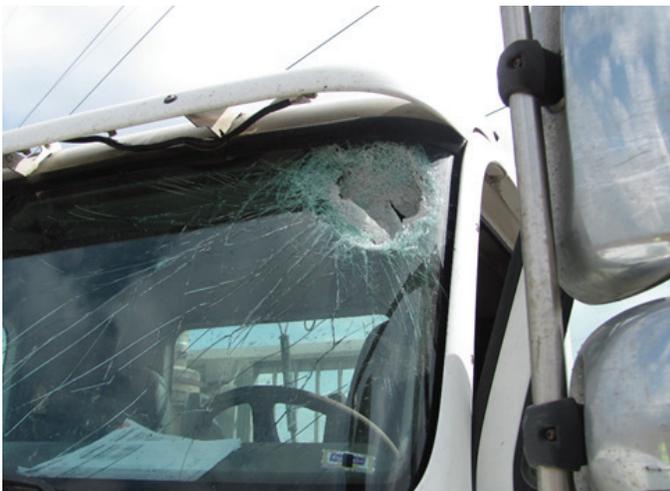
The truck’s windshield was severely damaged during the incident. The damage was concentrated near the upper-left most corner of the windshield (Figure 19). The damage to the windshield included a hole that was consistent with a spheroid-like object striking and penetrating the windshield. The shape of the hole was generally consistent with the shape of the piece of concrete projectile that fell out of the cab when the witness opened the cab door.

**Figure 19**  
Damage to windshield consistent with projectile concrete impact (scene photograph).

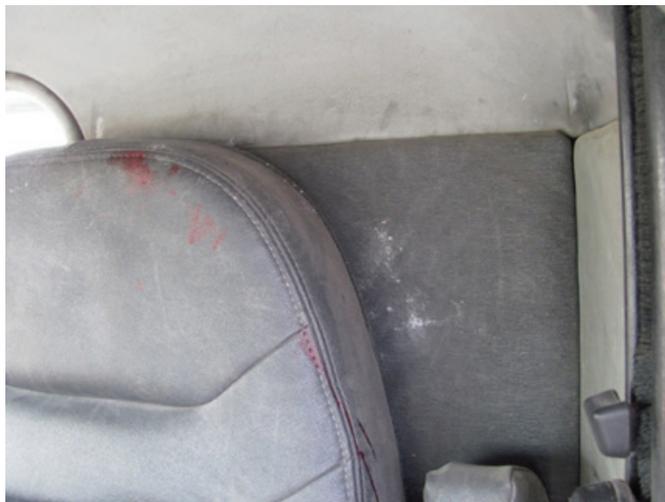
There also were concrete fragments found on the rear cab wall (**Figure 20**), and the rear cab wall was dented, consistent with the concrete striking the rear cab wall after striking the windshield and the plaintiff.

**Figure 20**  
Concrete fragments along panel behind driver’s seat.

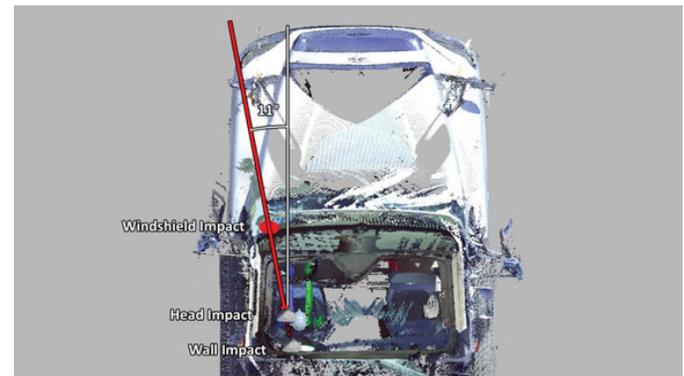
After identifying the location of the hole in the windshield, approximate seating location of the plaintiff, and the location of the dent in the rear of the cab, the trajectory of the concrete projectile through the windshield was determined (**Figure 23**). The projectile entered the windshield at a height of approximately 96.6 in. The trajectory shows that the projectile entered from the left (driver’s)

**Figure 23**  
Trajectory of the projectile concrete through the cab top view.

side and traveled both rearward and right relative to the truck. This lateral (left-to-right) trajectory is consistent with the projectile originating in the northbound lane of the county line road, in contrast to coming from the southbound lane of the county line road from a leading vehicle.

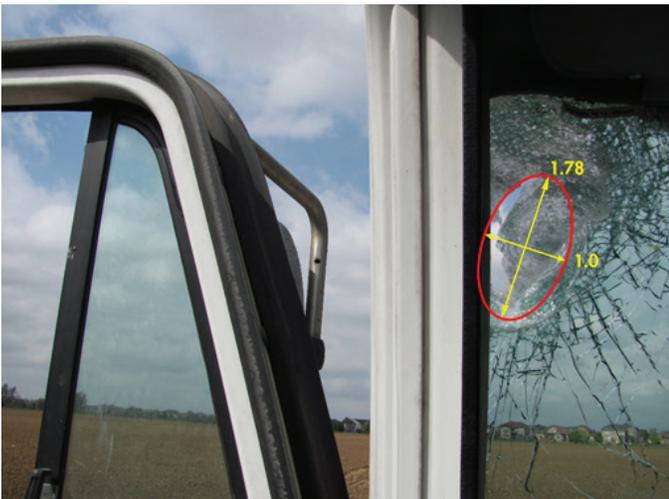
**Figure 24**

The windshield damage pattern and entry hole form a diagonal oval that extends from the left, upward to the right. The oval has a length to width ratio of 1.78 to 1 (**Figure 24**), which is a higher ratio than concrete projectile's length to width ratio. Therefore, the oval in the windshield is elongated compared to the shape of the concrete projectile. The angle, size, and shape of the oval provide insight to the direction that the projectile entered the windshield.

Elongated oval-shaped opening in windshield from left to upper right. Oval length to width ratio is 1.78 to 1.

This shooting reconstruction method was applied to the physical evidence in the subject incident. The entry oval in the windshield is substantially longer than the longest dimension of the concrete projectile (similar to a cylindrical bullet forming an elongated oval when shot at an angle), and the elongated oval distinctly forms an angle from the left upward to the right (**Figure 24**). Like the example shown in **Figure 26**, this elongated oval shape and angle is consistent with the concrete projectile entering the cab with a lateral velocity component from the left to right side of the cab.

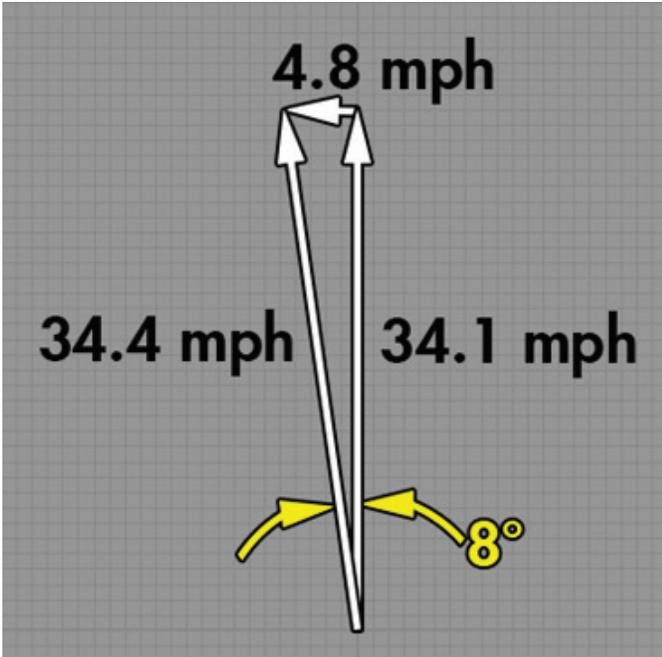
A velocity vector diagram was created. The concrete projectile had a rearward velocity component resulting from the initial tangential rearward launch and interaction with the mud flap. The concrete projectile also had an initial forward translational movement, consistent with the speed of the truck (40 mph). Combined, the exit speed of the projectile was approximately 34 mph forward (northbound direction). Based on the lateral trajectory of the concrete projectile, as determined from the physical evidence, the longitudinal and lateral velocities were determined (**Figure 28**).

**Figure 28**  
Forward trajectory of the concrete projectile after interaction with the mud flap.

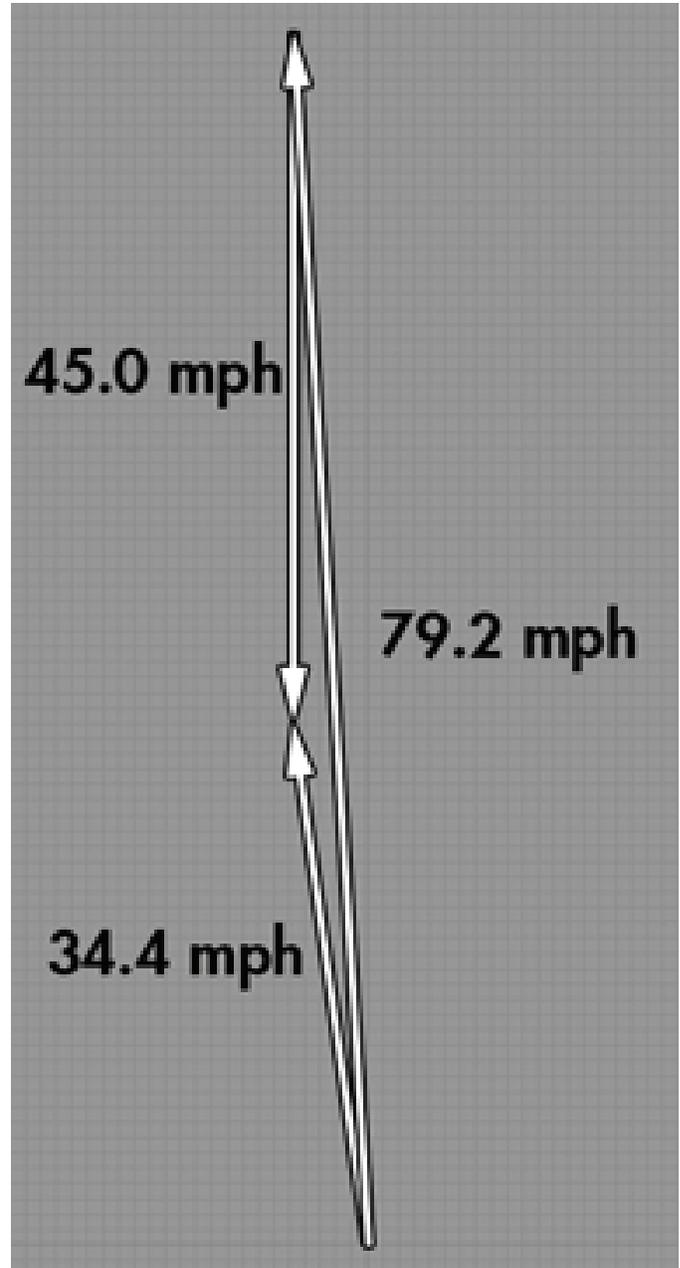
The closing speed of the projectile and the southbound truck, assumed traveling the posted speed limit of 45 mph, was calculated as approximately 79 mph (**Figure 29**). After determining the concrete projectile’s trajectory and motion, the motion of the both trucks were simulated in PC-Crash<sup>14</sup>.

**Figure 29**  
Concrete projectile’s closing speed relative to the truck.

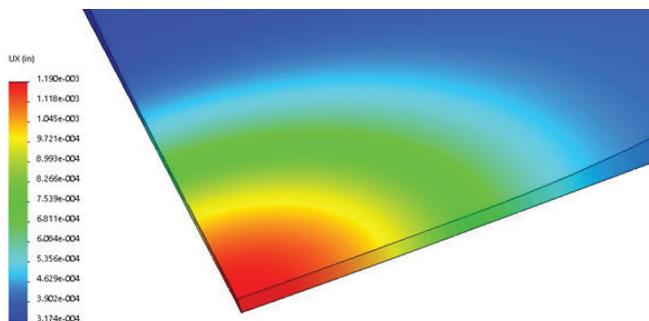
Figure 8

Linear deflection results (inches, undeformed plot) of an interim model (6.0 mm × 6.4 mm). The linear deflections calculations for the elliptical disc with fixed edges is 0.025 mm (0.0010 in.). It is with simply supported edges is 0.058 mm (0.0023 in.). These linear calculations bracket the linear FEA results of 0.030 mm (0.0012 in.).

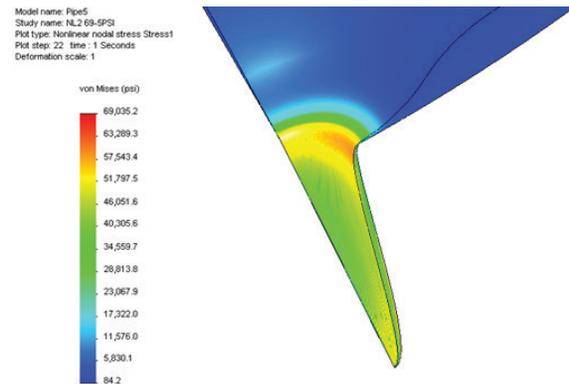
Figure 9

Nonlinear von Mises stress results (psi) of the final iteration. This plot shows the deflection to scale. This is significantly different than the original team’s prediction. The high stress regions are localized to the formation of the plastic hinge and show far greater stress and strain than the rest of the thinned section. The stress in the non-thinned section is around 2,000 psi, which is consistent with linear calculations. The paper-thin section of the one-quarter model “blisters” outwards in tension while the thicker 3:1 transitional area forms a plastic hinge, pivoting radially outwards in response to the load. Increasing the size of the thinned section another millimeter resulted in the model failing to converge. Note the magnification and angle of this view of a one-quarter model gives a distorted view of the shape. The view was chosen for the clarity of the stress distribution.

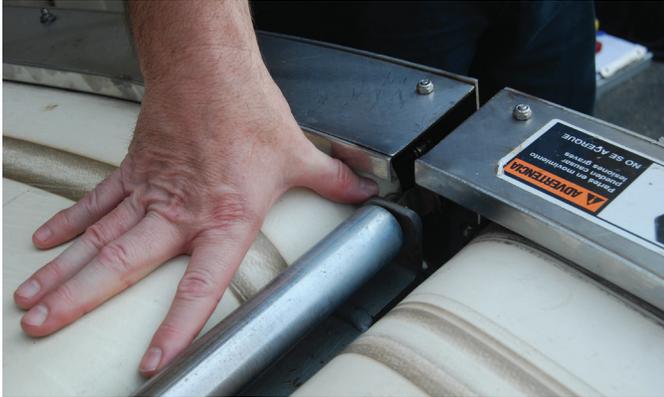
**Figure 4**

Incident pinch point showing how a worker severed her right thumb. Product moves from right to left.

There are inherent dangers at the interface of two conveyor sections. The incident pinch point would have been eliminated by using a single 180° conveyor section instead of two abutting 90° sections (compare **Figures 3** and **5**). However, similar hazards would still have existed at the interfaces between other abutting conveyor sections.

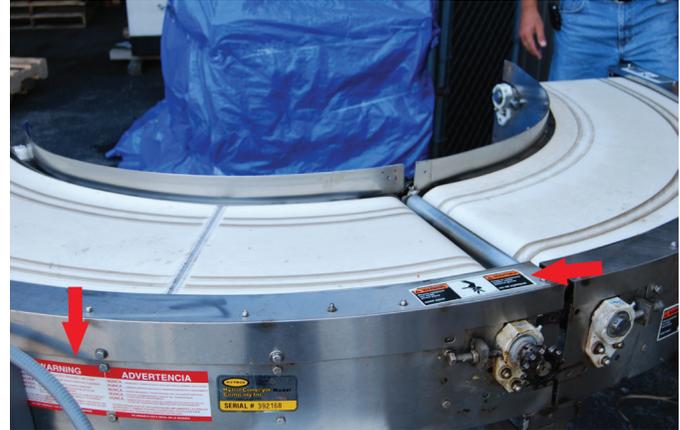
**Figure 6**

Warning labels in the vicinity of the incident location.

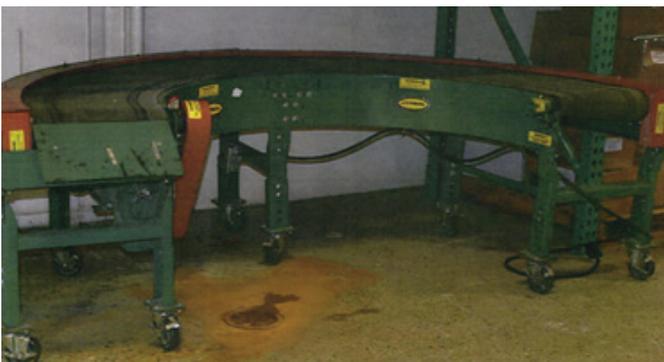
**Figure 5**

180° conveyor section.

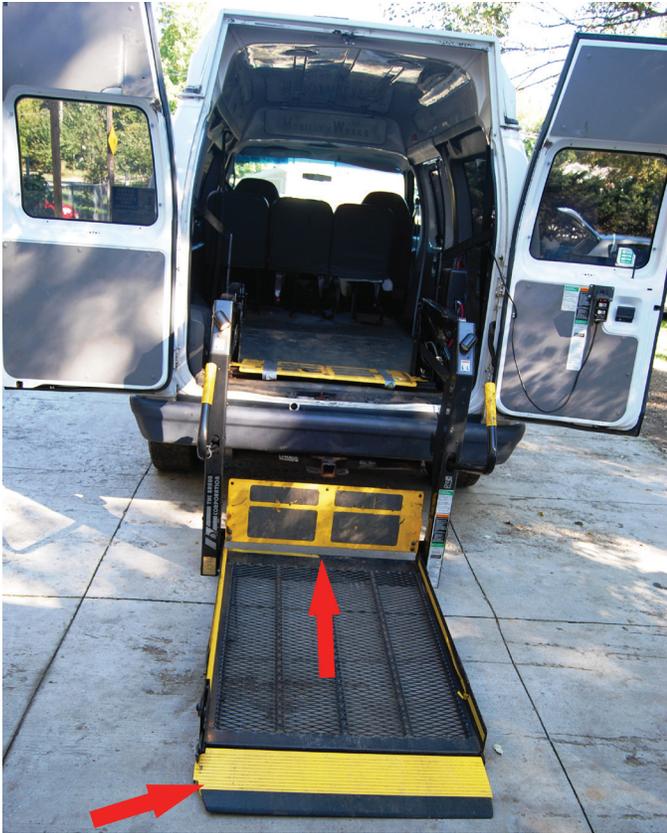
**Figure 7**

Wheelchair lift in the lowered position. Upper arrow shows the inboard roll stop in the vertical position. Lower arrow shows the outboard roll stop in the horizontal position.

An individual in a wheelchair was being lifted from the ground to the floor level of a transport vehicle (**Figure 7**). There were vertically oriented inboard and outboard roll stops that prevented the wheelchair from rolling off of the ends of the lift platform. When the lift platform was at the ground level, the outboard roll stop was oriented horizontally to allow for loading and unloading of the wheelchair passenger. Similarly, when the lift platform was at the transport vehicle floor level, the inboard roll stop was oriented horizontally (**Figure 8**). During the initial portion of the lift, the wheelchair occupant's right foot entered the approximate 1.5-in. gap between the inboard edge of the platform and the inboard roll stop (**Figure 9**). When the lift was near its raised position, the inboard roll stop transitioned to the horizontal position, the gap between the inboard roll stop and the platform closed, and the occupant's right foot was crushed (**Figures 10 and 11**).

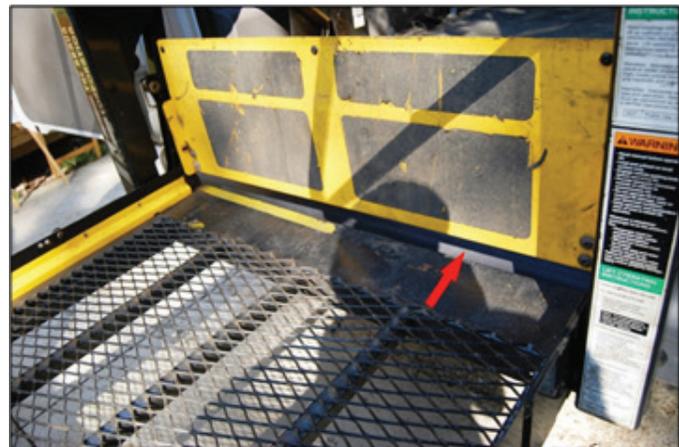
**Figure 9**

Inboard roll stop in the vertical position. Arrow shows an approximate 1.5-in. gap between the inboard roll stop and the platform.

The incident pinch point between the inboard roll stop and the platform should not have existed. An example of

The most effective safeguard, eliminating the hazard with a hinge connecting the inboard roll stop to the lift platform, was reportedly the least costly. It is the author’s opinion that this is an example of spending too much time and effort on awareness safeguards — warning labels in particular. Many of these could be considered self-preserving, and unfortunately appeared to have stifled the manufacturer’s ability to identify and relatively easily eliminate a clear hazard. Further, although a manufacturing company’s legal counsel may advise otherwise, awareness safeguards should contain few words and include some type of relevant pictorial. Wordy awareness safeguards may reduce legal exposure, but are frequently not read, which compromises safety.

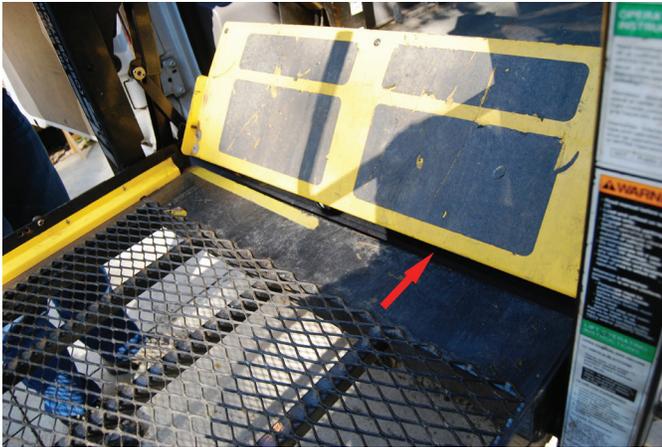
**Figure 10**

Inboard roll stop about halfway between its vertical and horizontal positions. Arrow shows the reduced gap between the inboard roll stop and the platform.

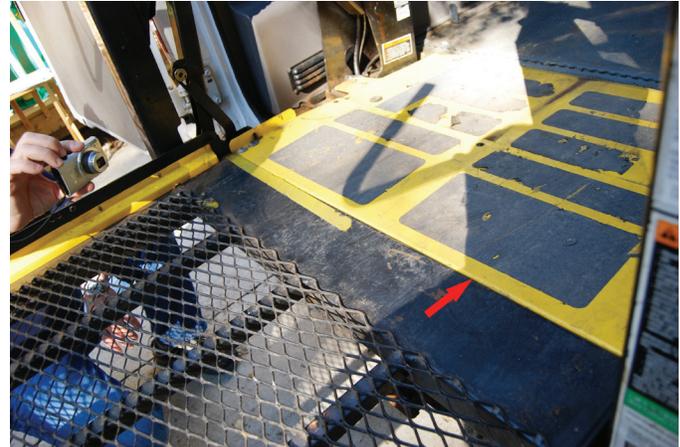
**Figure 11**

Inboard roll stop in the horizontal position. Arrow shows essentially no gap between the inboard roll stop and the platform.

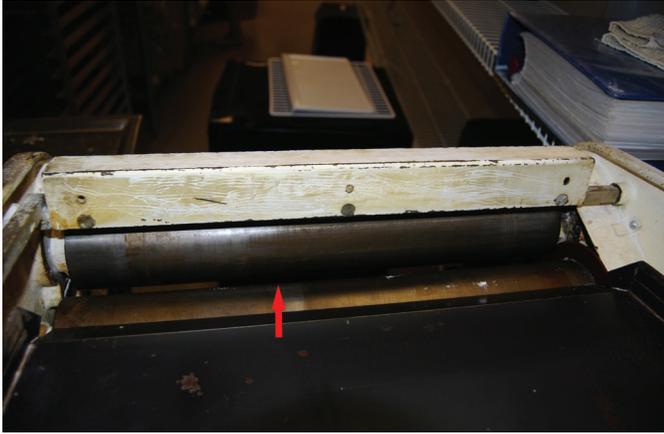
**Figure 13**

Pinch point between the rollers where the worker injured her hand.

The dough roller could have been fitted with a point of operation guard, such as a hopper, that would have prevented contact with the rollers during its normal operation. However, the incident occurred during a cleaning operation, and any such guard would likely have been removed to clean the rollers. In addition to preventing personnel from putting a body part into a hazardous area of a machine, physical guards can also prevent the inadvertent energization or activation of a machine. In these cases, hinged or limited access guards are placed over machine switches (see **Figure 14**).

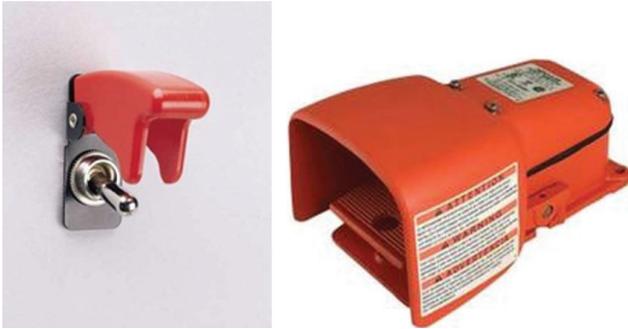
**Figure 14**

Toggle switch guard (left). Foot pedal guard (right).

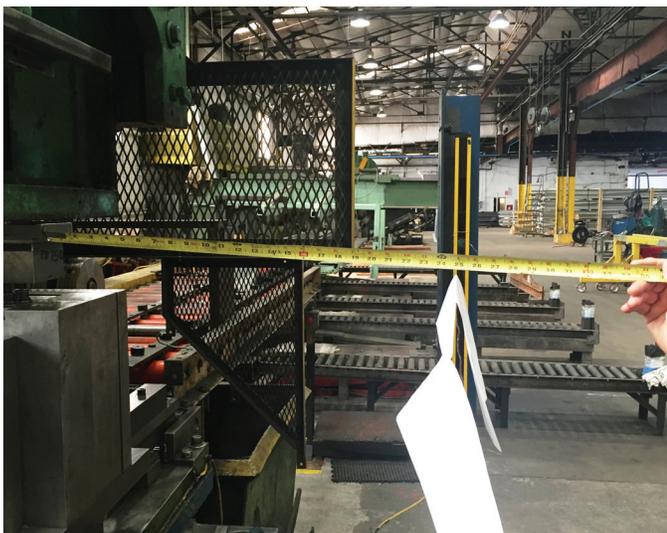
**Figure 16**

**Figure 15** shows a sheet metal power press with a presence-sensing light curtain. A stopping time of 0.360 seconds was measured from when the light curtain was tripped until the downward stroke of the press ram was stopped. This time coupled with OSHA's stipulated 63 in./second hand speed yielded a minimum safety distance of 22.68 in.<sup>4</sup>. The actual shortest distance from the light curtain to the press was approximately 25 in., which was acceptable (**Figure 16**). It should be noted that if the presence-sensing device is too far from the hazard, other safeguards may be necessary between these two items.

Distance of approximately 25 in. from the light curtain to the closest hazard of the press.

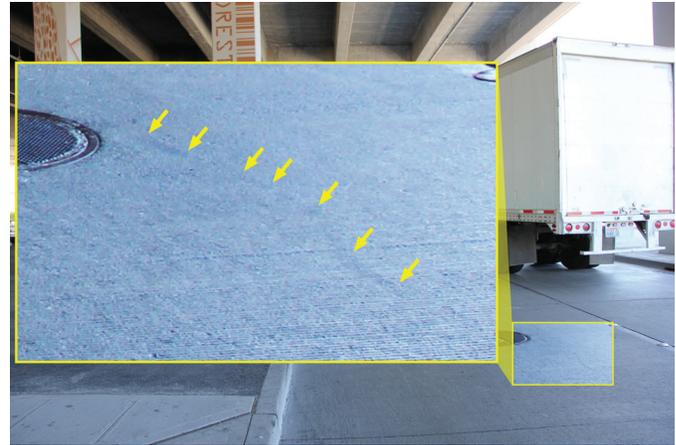
**Figure 2**

Scene photograph with brightness and contrast adjusted to identify faint physical evidence related to impact.

A useful technique for identifying potential physical evidence related to impact is through the adjustment of brightness and contrast of digital scene photographs. **Figures 2 and 3** show scene photographs taken by police with the brightness and contrast adjusted to identify potential evidence related to the area-of-impact in the first case study.

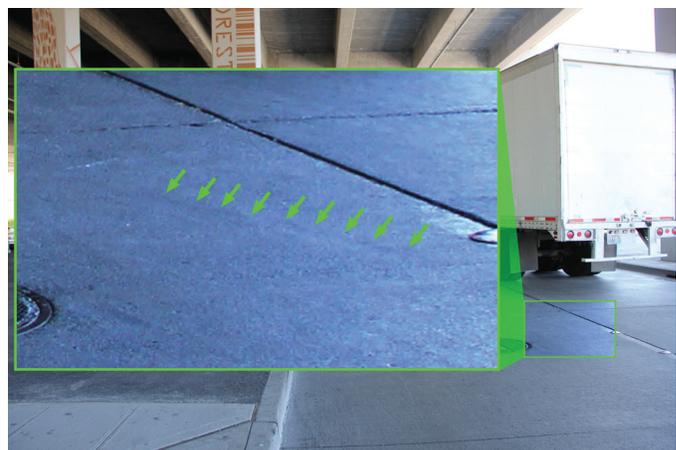
**Figure 3**

Scene photograph with brightness and contrast adjusted to identify faint physical evidence related to impact.

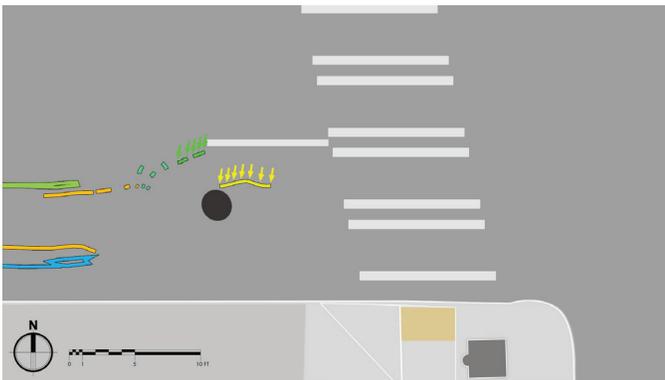
**Figure 5**

Locations of the faint tire marks from top view (shown with arrows).

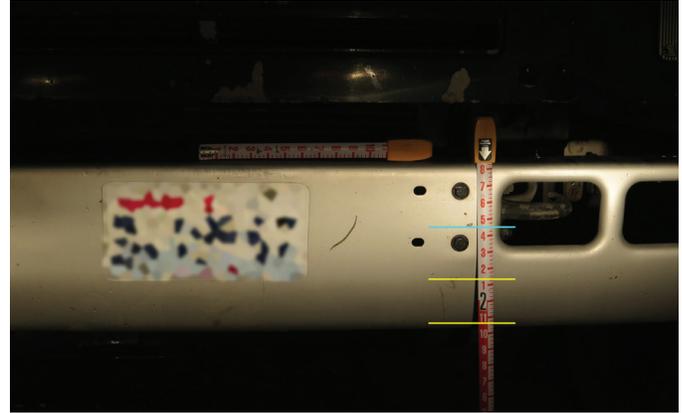
**Figure 6**

The impact configuration between the right-turning truck and bicycle was established using physical evidence on the truck’s front bumper and bicycle. Scratches were observed on the truck’s front bumper consistent with an impact with a bicycle (Figure 6).

Evidence on truck bumper. Horizontal lines added to show scrape heights.

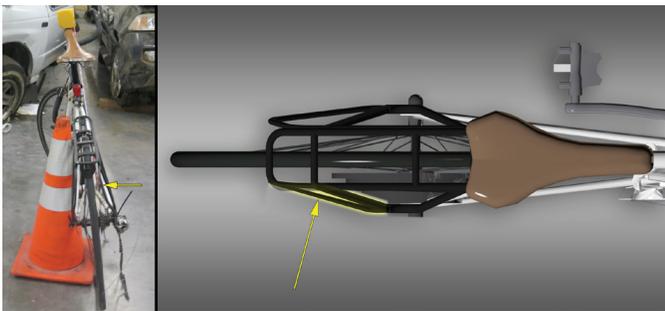
**Figure 8**

Inspection photograph of subject bicycle. Yellow arrow showing deformation to the right side of the bicycle’s rear rack.

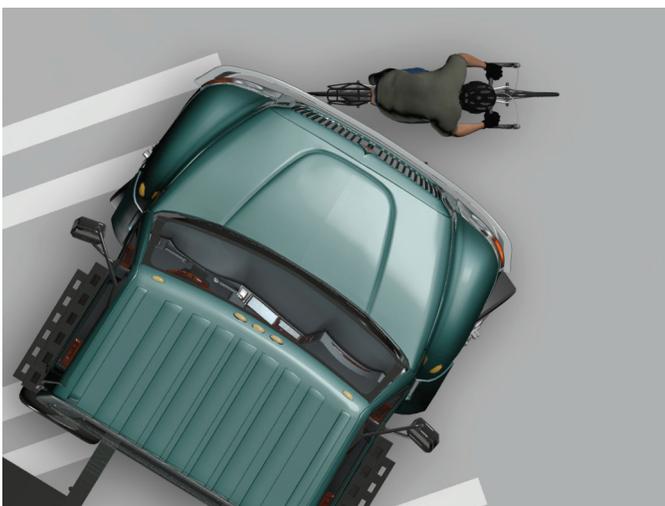
The bicycle’s rear rack was deformed, consistent with impact between the semi’s front bumper and the right side of the bicycle’s rear rack. Figure 8 shows the rack damage and approximate principal direction of force (PDOF), a term defined to simplify collision analysis. The PDOF is the direction of the summation of all collision forces required to deform the vehicle. The PDOF was consistent with an angled impact between the truck bumper and bicycle (Figure 9).

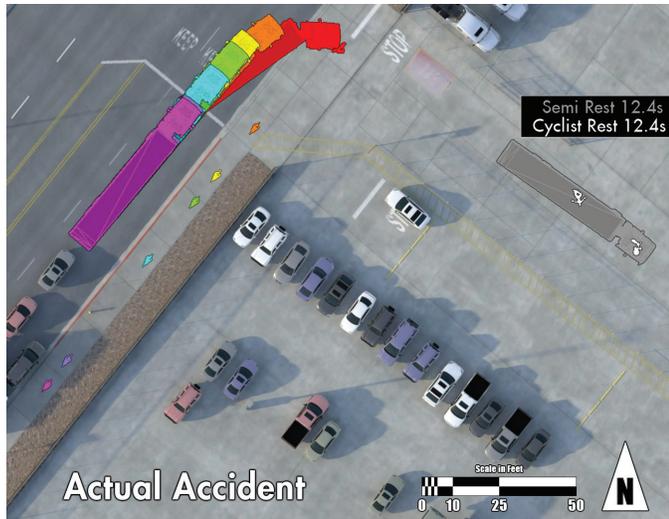
**Figure 15**

Bicyclist was riding on sidewalk and was struck by right-turning semi. Bicyclist was dragged 95 ft after impact.

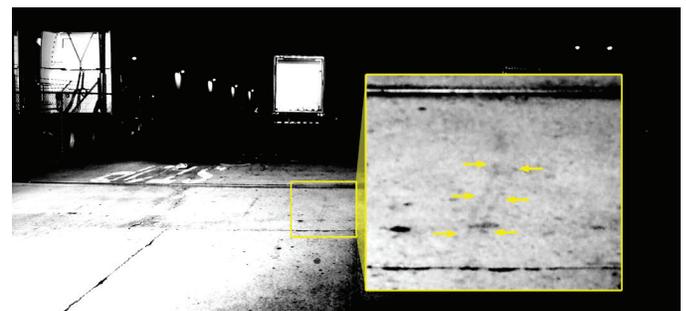
**Figure 18**

Scene photograph in black-and-white with adjusted brightness and contrast. Arrows pointing to suspected tire scrub marks related to impact.

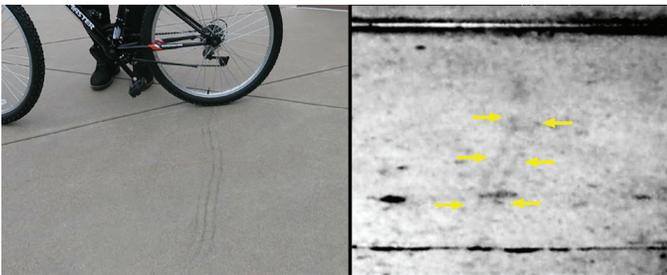
Tire scrub marks generated through testing (left) consistent with scrub marks identified in scene photograph (right).

The exemplar's bicycle tires were inflated to the manufacturer's recommended operating pressure. The bicycle was then pushed down and dragged, closely replicating the motion of the bicycle pushed down by a semi's bumper. **Figure 20** shows the bicycle tire formed parallel scrub marks similar to the faint marks identified in the scene photographs. Therefore, the parallel scrub marks identified in the scene photograph is consistent with scrub marks left by the subject bicycle's rear tire as it is pushed down by the truck.

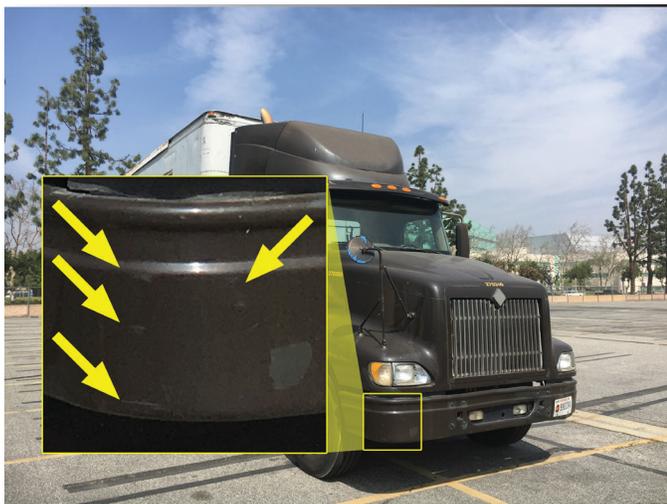
**Figure 21**

Scrapes on right corner of truck's front bumper consistent with the bumper impacting the bicycle's frame.

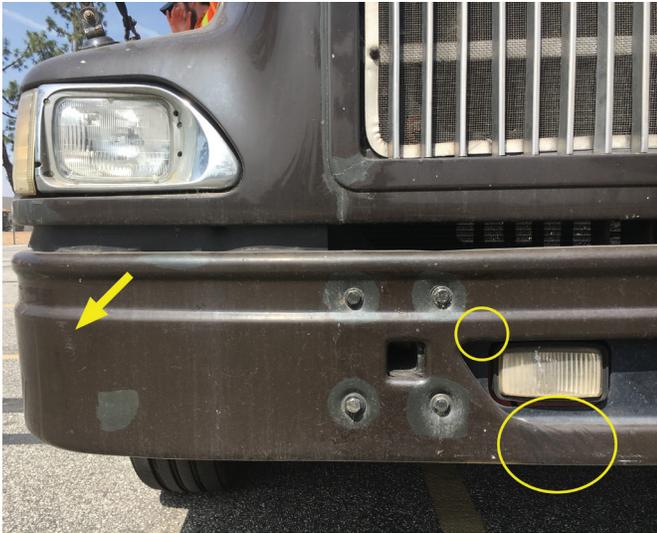
**Figure 22**

Scrapes on front corner (arrow) and front bicycle tire scrub marks (circles) on truck's front bumper.

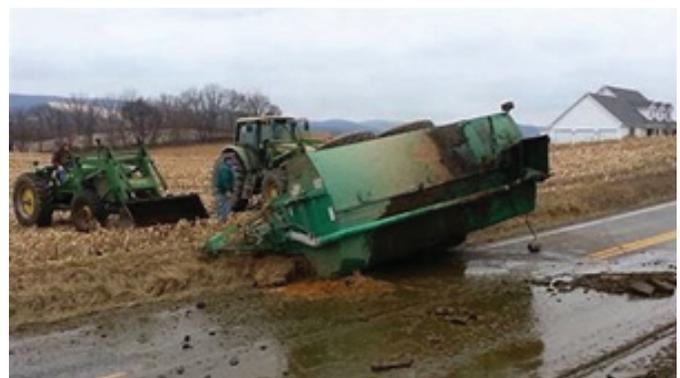
**Figure 6**

Overturned spreader along the roadway due to icy road conditions  
from The Sentinel (2013). Reprinted with permission.

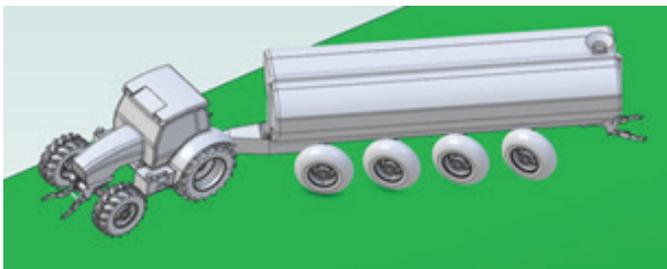
A free-body diagram of the spreader would demonstrate an increasing longitudinal force on the tractor at the height of the drawbar as a result of the lateral forces on the articulating tires of the spreader. The largely resistive forces of the articulated tires would eventually initiate a counter-clockwise roll of the implement. The up-slope tires of the tractor are raised off the ground when the spreader starts to tip over as shown in Figure 13.

**Figure 11**  
Spreader accelerating down slope as a result of articulated axle steer of the spreader.

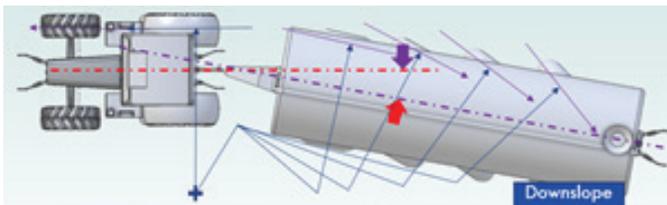
**Figure 12**  
On a slope, the spreader mass pulls the spreader downslope in the direction of the articulated tires, loading the tractor drawbar.

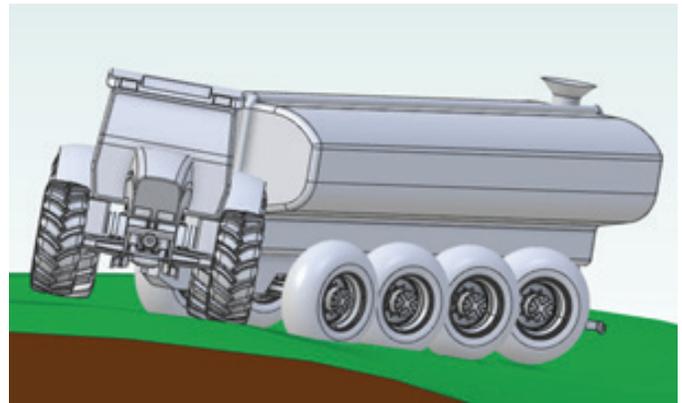
**Figure 13**  
Spreader accelerating down slope as a result of articulated axle steer of the spreader.

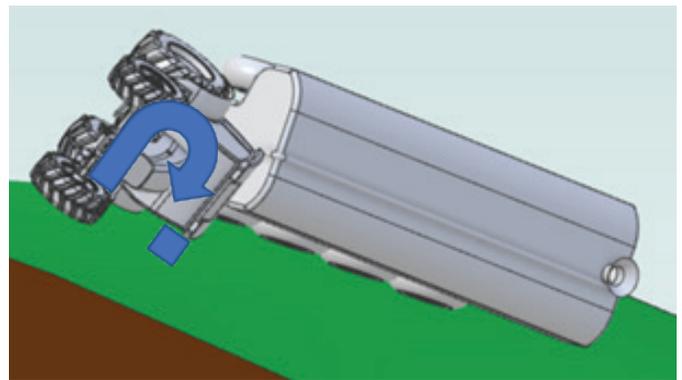
**Figure 14**  
Spreader tips and drives the tractor roll, which applies the enormous side impact to the ROPS.

Once the implement slides far enough down-slope from the tractor, the moment generated by the draft force applied by the drawbar to the spreader's tongue, tips the spreader over (Figure 14 and 15). When the hitch pin connection remains intact and the implement is a spreader, the rotational inertia properties contribute greatly to the energy the ROPS must absorb in the roll-over event. The spreader tongue lifts and rolls the tractor's drawbar. This additional rotational inertia contributed by the spreader is extremely significant, adding much more energy that the cab must absorb. This will be discussed further in the analysis section of the paper.

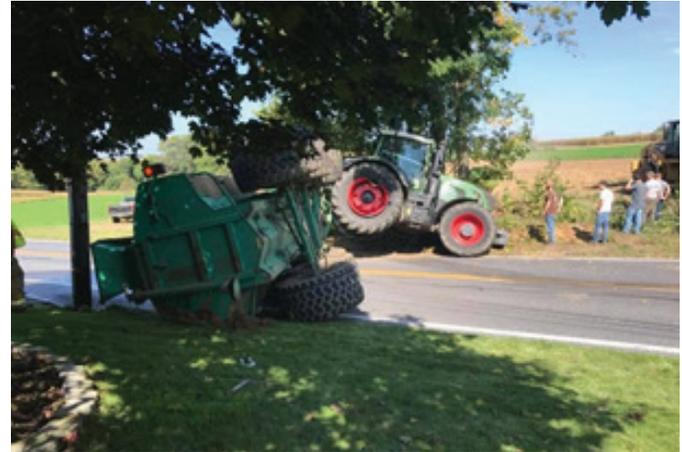
**Figure 17**  
Overturned spreader along the roadway.  
LNP – Lancaster Online (2017)<sup>10</sup>; reprinted with permission.

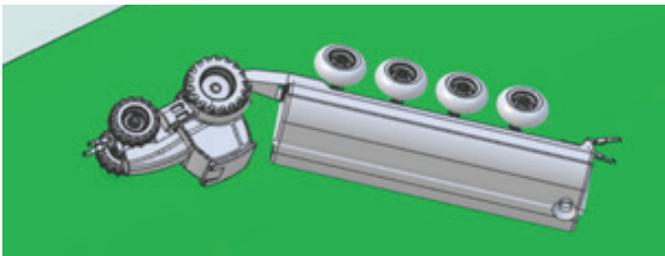
**Figure 15**  
Spreader tips and drives the tractor roll, which applies the enormous side impact to the ROPS.

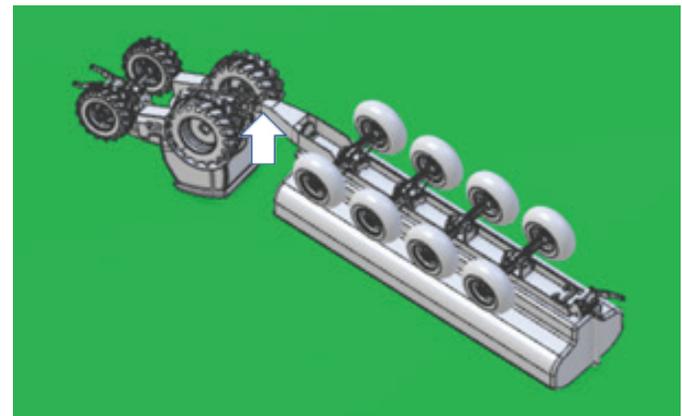
**Figure 18**  
Spreader lifts the tractor up by the drawbar, causing tractor frame damage.

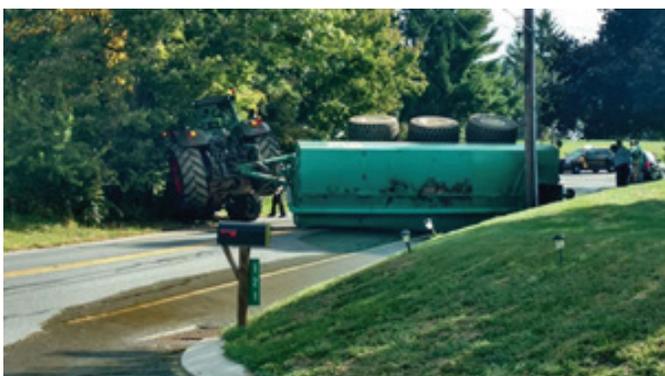
**Figure 16**  
Overturned spreader along the roadway.  
LNP – Lancaster Online (2017)<sup>9</sup>; reprinted with permission.

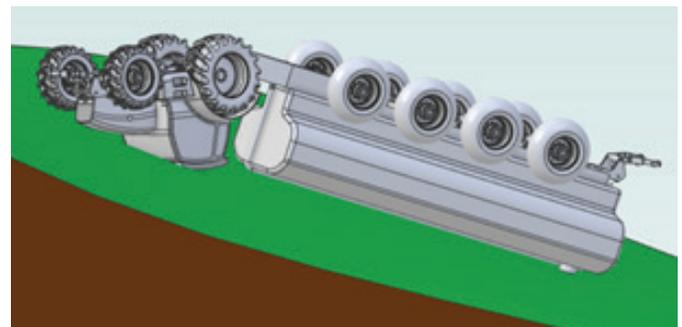
**Figure 19**  
Spreader lifts the tractor up by the drawbar, causing tractor frame damage.

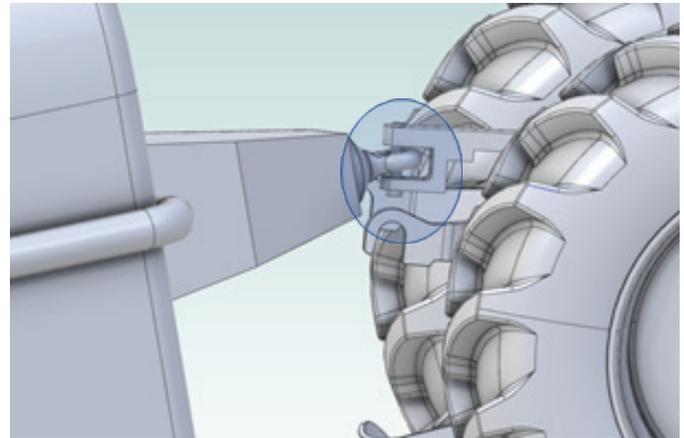
**Figure 22**

the occupants of the ROPS. When the tractor and spreader remain coupled (Figure 22), high vertical forces (Figure 23) are introduced to the tractor by the spreader.

Hitch pin connection remained intact after the roll-over event.

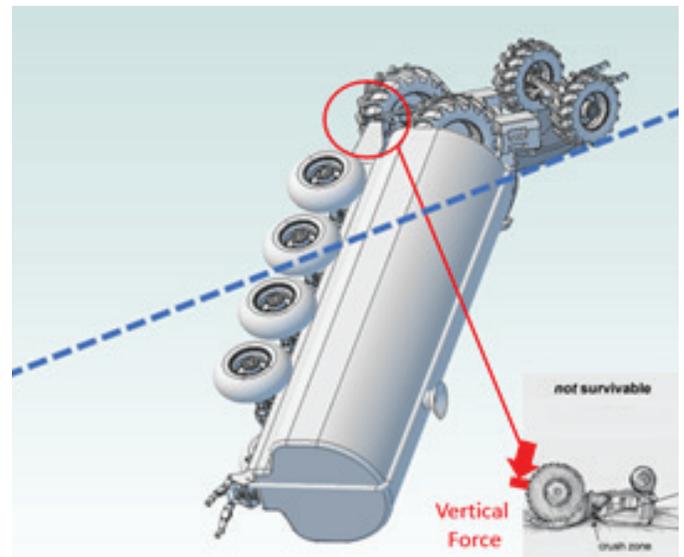
**Figure 23**

Final position tractor and spreader after the roll-over event.

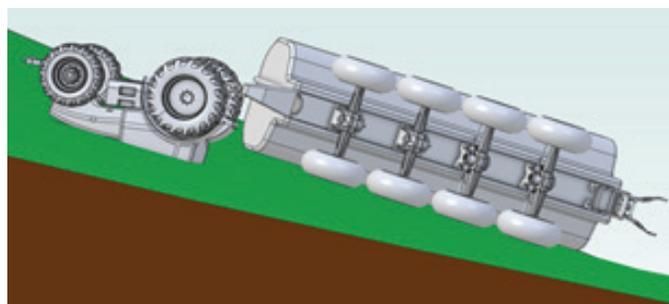
**Figure 21**

In the worst scenario, the ROPS is crushed to the height of the hood and rear wheels in the overturn (Figure

20 and 21). There is no room left in the crush zone for operators, especially if they are properly wearing their seat belt. The roll-over event under these circumstances is catastrophic, and survivability is low (Figure 2). The resulting crush is unreasonably dangerous to the operator and

Spreader tongue crushes the tractor down by the drawbar causing further damage to the ROPS.

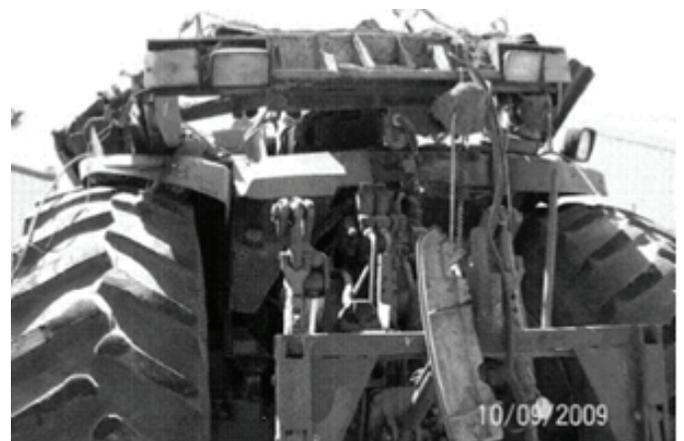
**Figure 24**

In addition to the case the author investigated, authorities from Workplace Health and Safety Queensland, Australia, recognize the limitations of ROPS under the special circumstances and issued a bulletin in 2010 titled, “Tractor roll-over protective structure (ROPS) limitations,” which stated that use of large spreaders are not permissible with the ROPS standards in place today. They showed a tractor whose ROPS had failed as a result of a roll-over event with an articulated spreader (Figure 24).

Exemplar photograph of failed ROPS From WorkCover Queensland (2010). Used with permission.

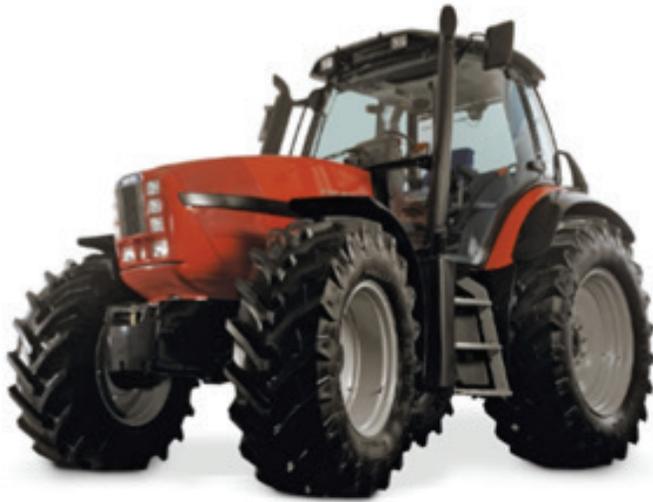
**Figure 25**

Exemplar photograph of failed ROPS.

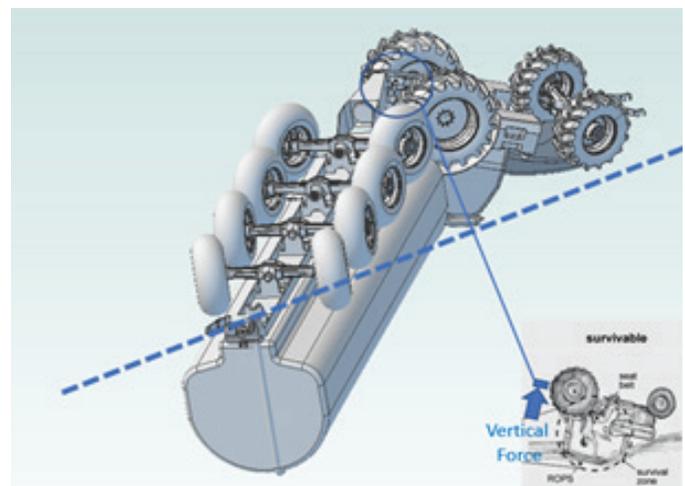
**Figure 26**

Considering the mass of a spreader, the tall shape of the tank and the low attachment point of the hitch, the tongue on the spreader acts like a crane when the spreader starts to tip, lifting the rear of the tractor (**Figure 26**). As the spreader rolls, the swiveling clevis and tongue of the spreader follow the contour of the upper tank (since the tank is full of liquid, little apparent deformation of

Spreader tongue acting like a crane raises the rear of the tractor.

During the lift described above, the spreader's tongue also introduces a very large vertical load on the drawbar that jeopardizes the integrity of the ROPS mounting points. The vertical load physically lifts the tractor off the ground by the drawbar and can cause tractor chassis components that provide ROPS mounts to fail. ROPS standards should be revised to introduce spreader induced drawbar vertical loading consist with a roll-over event in future testing procedures. Additionally, the logic used to steer the spreader on relatively flat ground works well (**Figure 27**). However, when on slopes, this logic is flawed — making the problem of controlling the position of the spreader on a slope worse, if not impossible, for the tractor operator to maintain control.

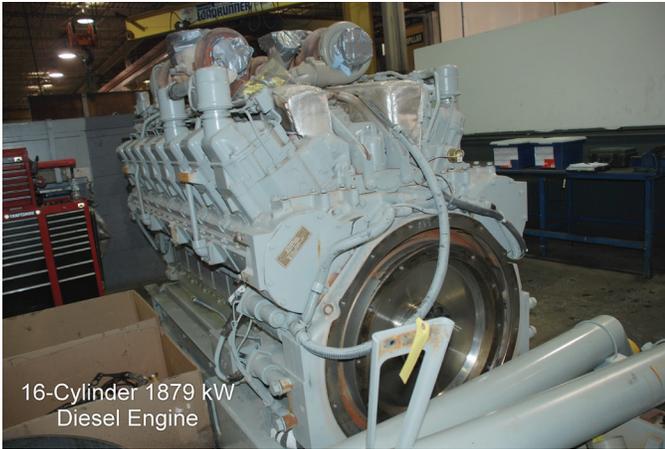
**Figure 1**  
Diesel engine for parking garage generator set.

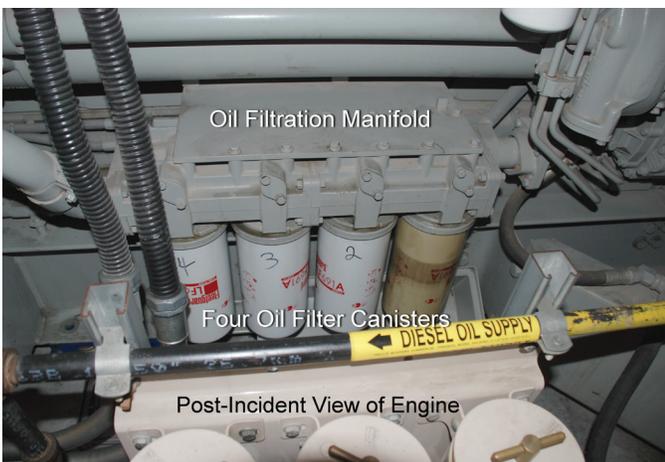
The check sheets from the local maintenance company for Sept. 27 and Oct. 26, 2010 were reviewed and found to be uneventful. The engine oil levels were described as “good.” The annual service procedures, including an oil change and replacement of oil filters, had been undertaken on the date of failure (**Figure 2**). Documents submitted for the maintenance history confirmed this narrative.

**Figure 2**  
Post-incident view of oil filter housing.
