Journal of the  
**National**  
**Academy** OF  
**Forensic**  
**Engineers**<sup>®</sup>

Vol. 37 No. 1 December 2020

<b>‡ Forensic Engineering Analysis of Projectile Thrown from Phantom Vehicle.....</b>	<b>1</b>
<i>By Richard M. Ziernicki, PhD, PE (NAFE 308F), William H. Pierce, PE (NAFE 846C), and Angelos G. Leiloglou, M Arch., (NAFE 956C)</i>	
<b>‡ Misapplication of Pressure Vessel Codes in Forensic Applications .....</b>	<b>15</b>
<i>By Bart Kemper, PE (NAFE 965S)</i>	
<b>‡ Forensic Engineering Analysis of Residential Underdrain Design Methodologies, Performance, and Failures .....</b>	<b>27</b>
<i>By Edward L. Fronapfel, PE (NAFE 675F)</i>	
<b>* Machine Safeguarding: Theory, Practice, and Case Studies .....</b>	<b>43</b>
<i>By Nicholas A. Petrucci, PE, CSP (NAFE 650M)</i>	
<b>* Forensic Engineering Analyses of Right-Turning Trucks Impacting Bicyclists .....</b>	<b>53</b>
<i>By Richard M. Ziernicki, PhD, PE (NAFE 308F), William H. Pierce, PE (NAFE 846C)</i>	
<b>† Forensic Engineering Analysis of a Failed ROPS .....</b>	<b>65</b>

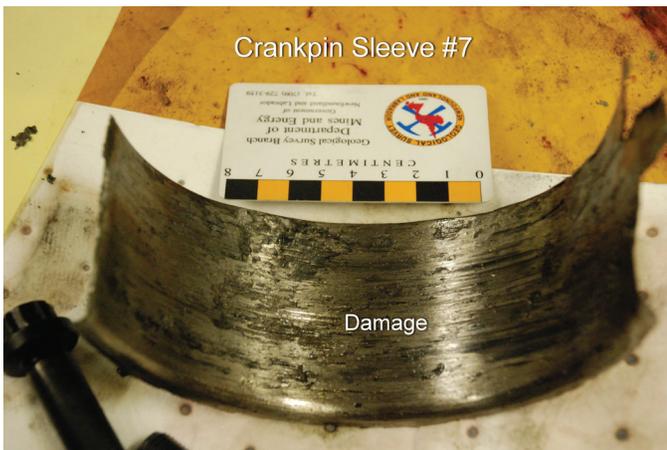
In the lower engine, each of the bearing shells for the main and rod journals had notable contamination, again from metal particles, with some concentrated damage on big end and rod cap inserts for #7 and #8 cylinders (see **Figures 4 through 8**). Light wear was reported on the shanks of some cap bolts, showing movement and contact with the rod cap had occurred, such as bolt thread impressions (**Figure 9**). The crankpin journals for cylinders #7 and #8 were examined, and these showed (**Figure 10 through 13**) symptoms of frictional overheating and premature wear.

**Figure 4**  
Shell damage on rod cap for cylinder #7.

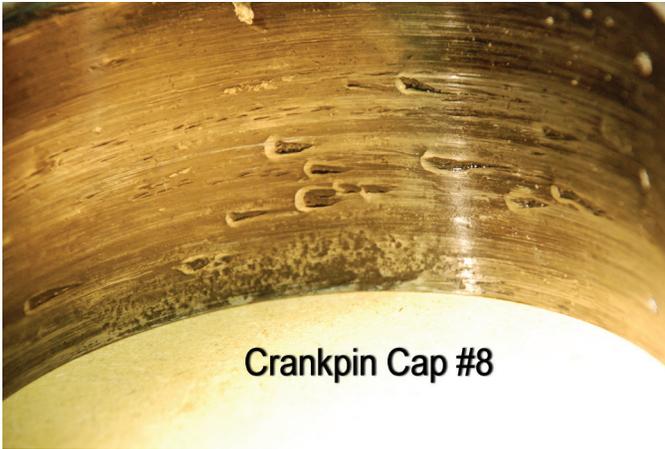
**Figure 8**

Shell contamination and damage on rod cap, cylinder #8.

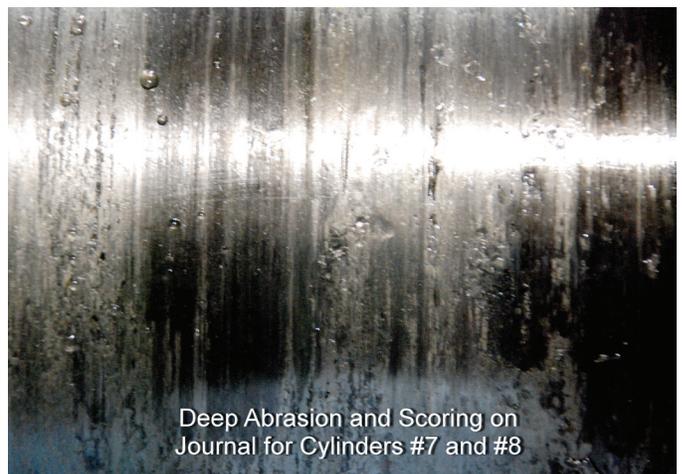
**Figure 13**

Deep abrasion and scoring at the rod journal for cylinders #7 and #8.

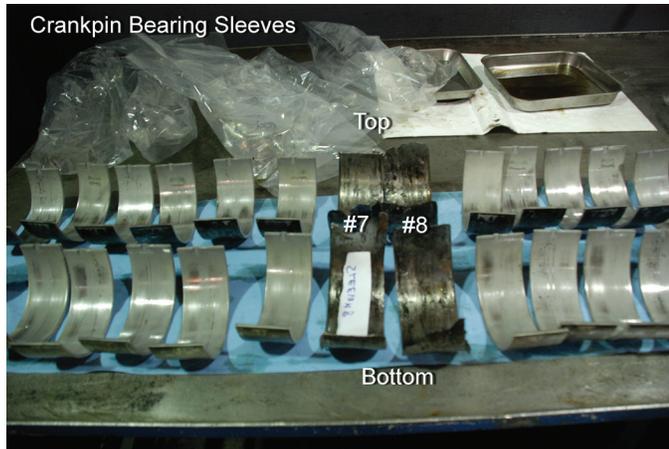
**Figure 14**

**Figures 14 and 15** depict the crank throw shell sets, with the significant difference in appearance for cylinders #7 and #8 sets, while the heat discoloration damage can be seen in the shell on the fourth support block.

Crank throw shell sets — big end (top) and rod cap (bottom).

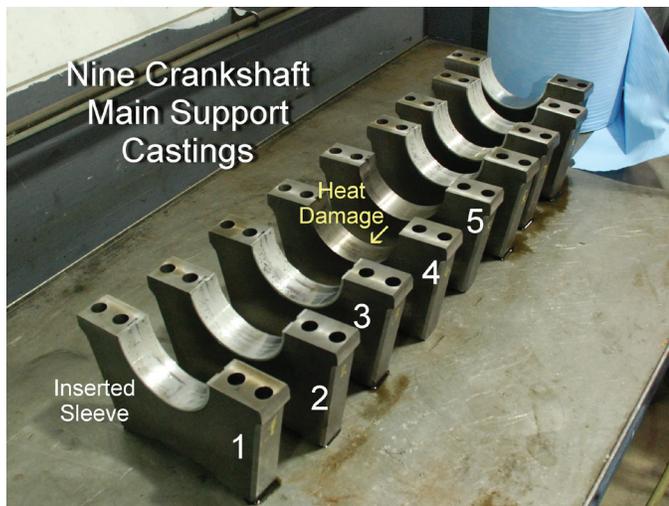
**Figure 15**

Crankshaft support castings with inserted shells for the main journals.

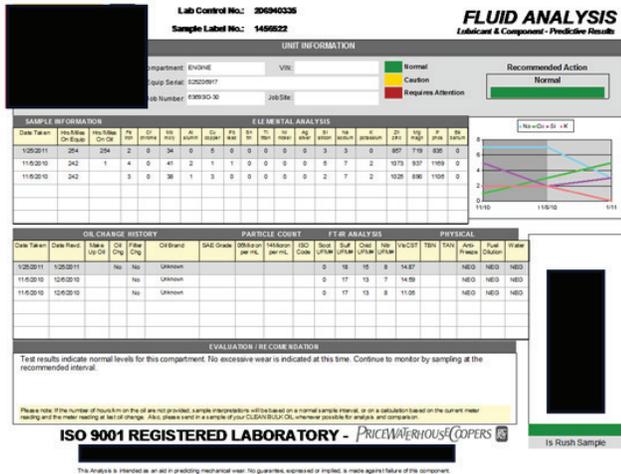
An oil analysis was completed after the incident on the new oil supplied on Nov. 10, 2011, and the findings compared to previous yearly oil test results. These were found to be in the normal range for wear elements such as copper and zinc (**Figures 17 and 18**). Given the normal range of results from the prior year, when extra elemental content would arise from premature wear, it followed that the degradation of the sleeves was a recent event, rather than one that occurred years earlier.

**Figure 17**  
Oil analysis history for the engine.

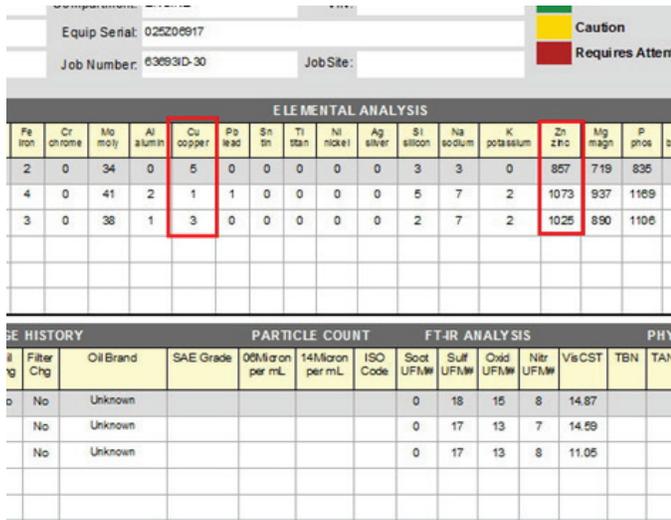
**Figure 18**  
Zoom in on oil element analysis.

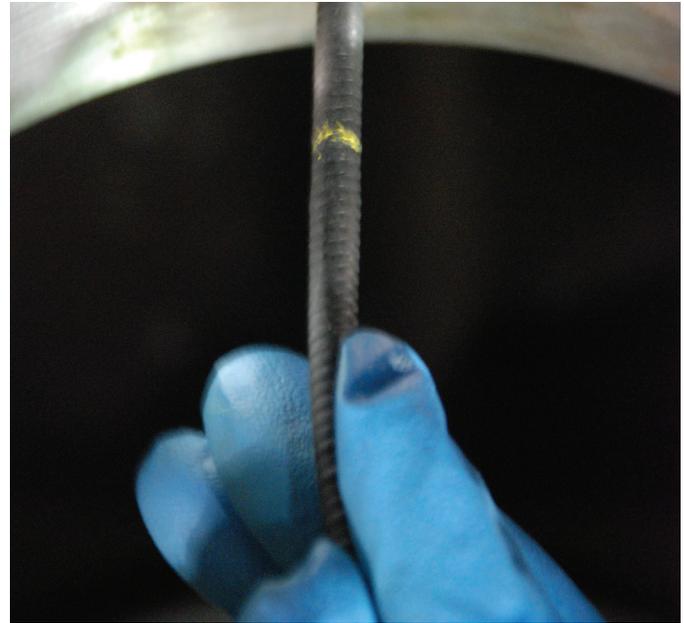
**Figure 20**  
Recreation of the detection of obstruction within the port for main #4 and cylinders #7 and #8.

(222 mm). However, during the inspection of the lateral port leading to cylinders #7 and #8, the probe met an obstruction at 7.5 in. (190 mm) depth, as shown in **Figure 20**.

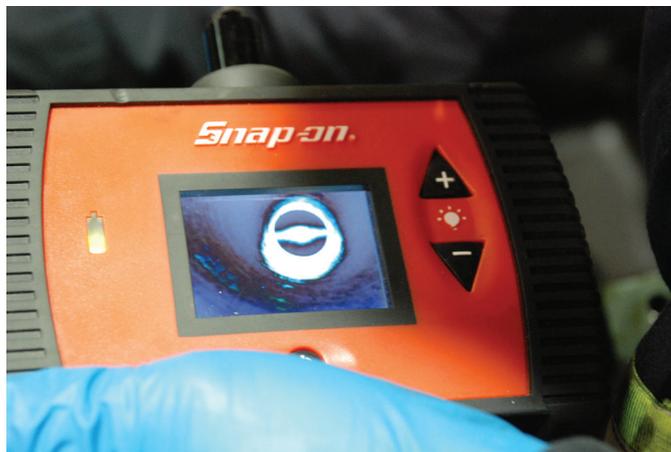
The symptoms of localized overheating and major oil supply failure to just two of the bearings on a common crank pin required that careful attention be paid to the side passages supplying oil to those areas. A boroscope with digital viewing screen was used to probe the side passages (**Figure 19**). The length for the probe to reach within to the other side of the main gallery in the block was 8.75 in.

**Figure 19**  
Probe of side passage from main oil gallery to cylinders #5 and #6 — all clear.

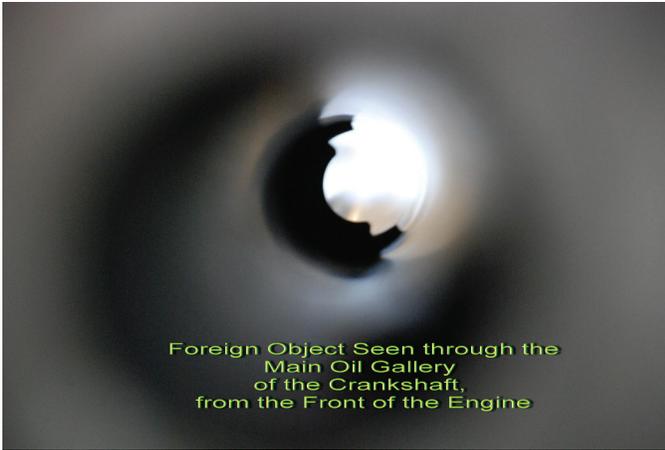
**Figure 22**

A longitudinal view toward the foreign object in the main oil gallery.

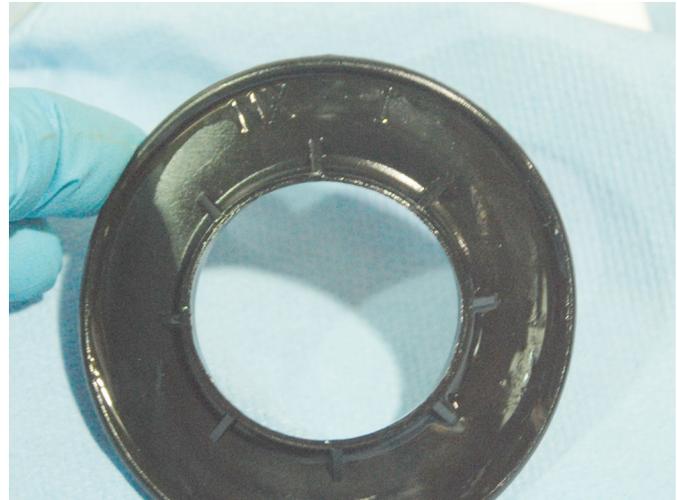
**Figure 24**

Foreign object extracted from the engine.

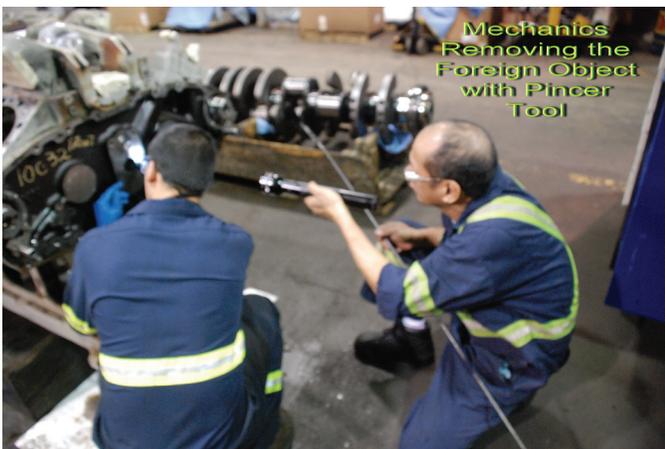
**Figure 23**

Removal of the object with a telescopic tool.

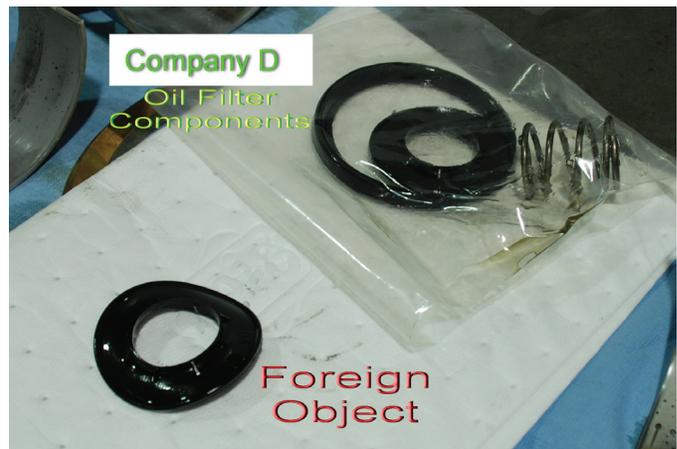
**Figure 25**

Comparison of Company D gaskets and the foreign object.

When compared to the components of a Company D brand oil filter taken from the site, it was immediately apparent (Figure 25) that the foreign object was an inner end gasket from such a filter. The found object was still flexible, soft to the touch, and did not appear to have physically degraded by heat, when compared to the one just removed from the Company D filter. It wanted to retain its curved shape, matching the diameter of the main oil gallery, suggesting that some permanent set had been acquired. The width of the ring was wide enough to fully block the oil

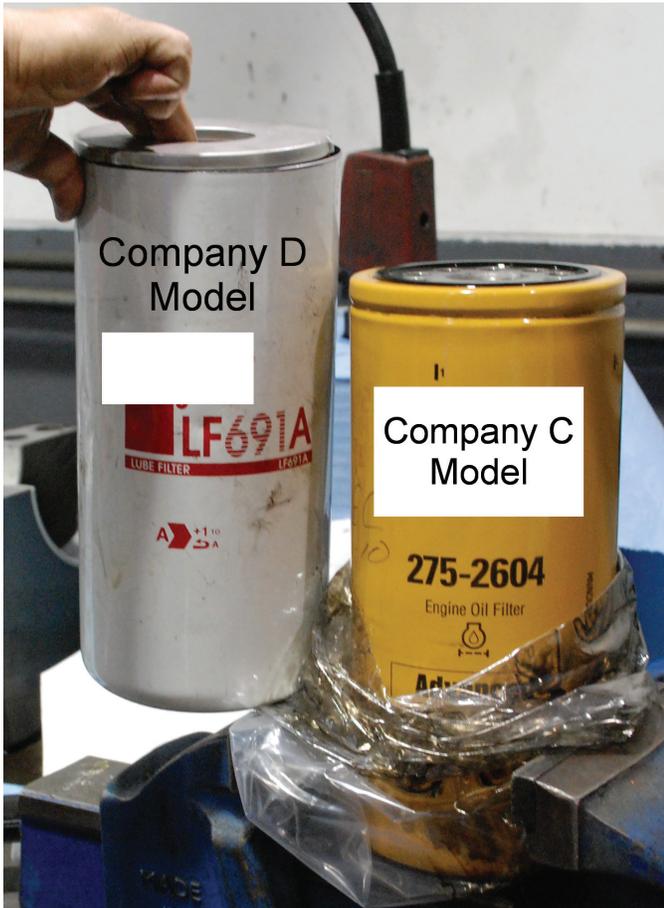
Figure 26

Company D and Company C OEM canisters were compared.

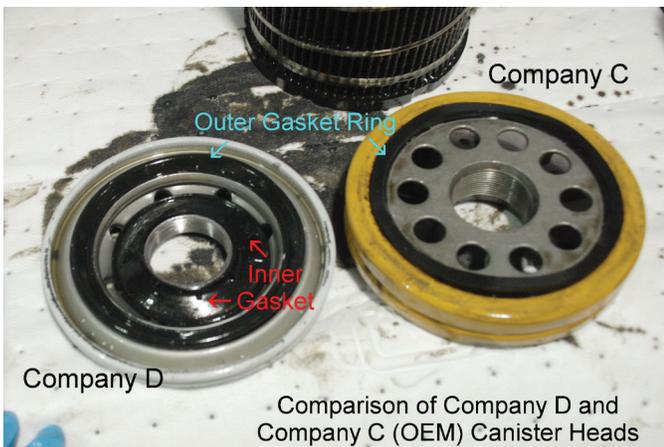
Figure 27

Comparison of Company D and Company C (OEM) Canister Heads

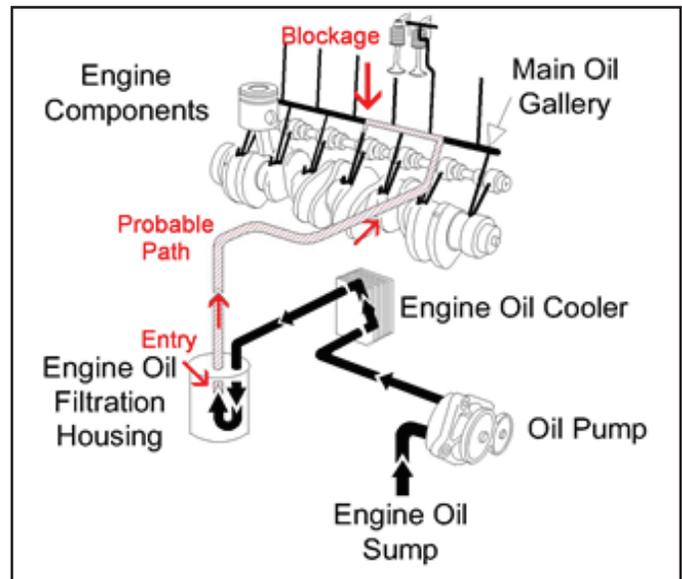
Figure 28

The evidence showed that the rubber gasket escaped from the end of a canister and entered into the oil delivery system manifold and piping — and that it became lodged at the main oil gallery port for cylinders #7 and #8. This reduced and restricted oil flow to the journal, and initiated the overheating and wear issues.

Probable path of the gasket from the oil filtration housing to the blockage location.

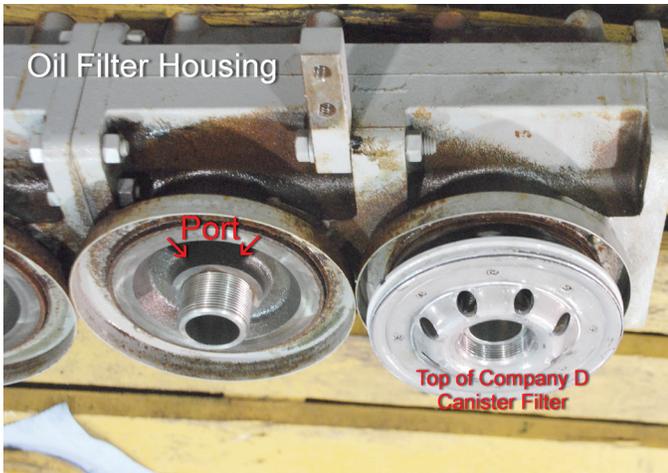
The gasket had to pass from the top of the Company D model canister, into the port in the oil filter housing, shown in **Figures 29** and **30**. Each of the four housing positions contains one port, but there were no means of determining which port the gasket had entered. In **Figure 29**, the cut-away end of the Company D model canister is shown. Note: This is put on from below, such that if a gasket “stayed behind” as seen in **Figure 30**, it might not be visible from above (**Figure 2**).

**Figure 29**  
Underside view of housing with port, with underside tope of a Company D filter.

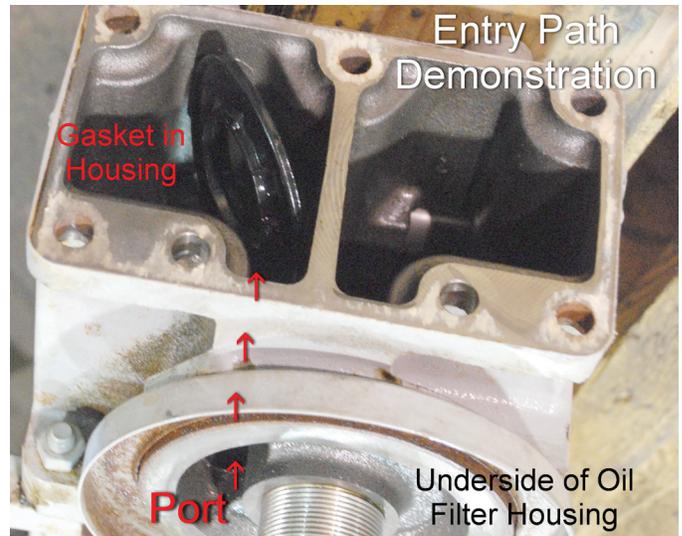
**Figure 32**  
Entry path demonstration from port into housing.

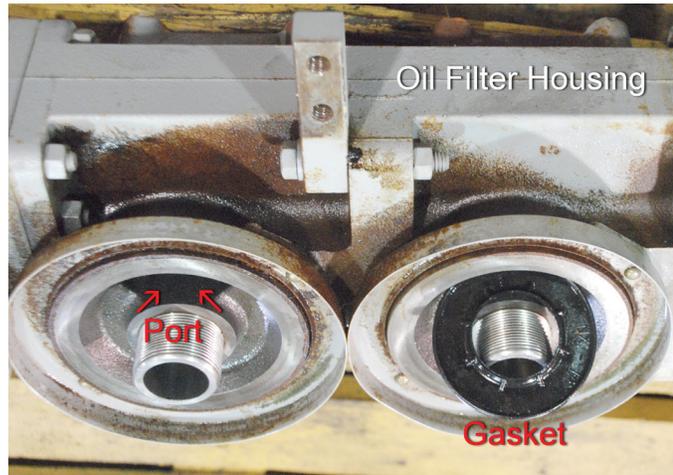
**Figure 30**  
Underside of housing with port and gasket in loss position.

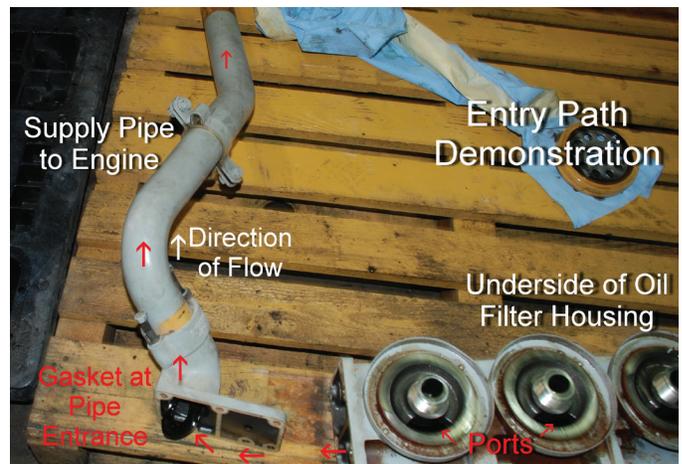
**Figure 33**  
Entry path from housing into supply pipe.

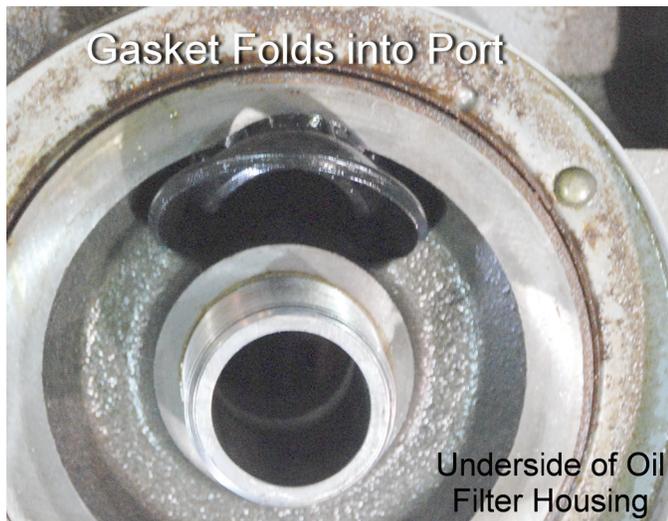
**Figure 31**  
Gasket folded into port demonstration.

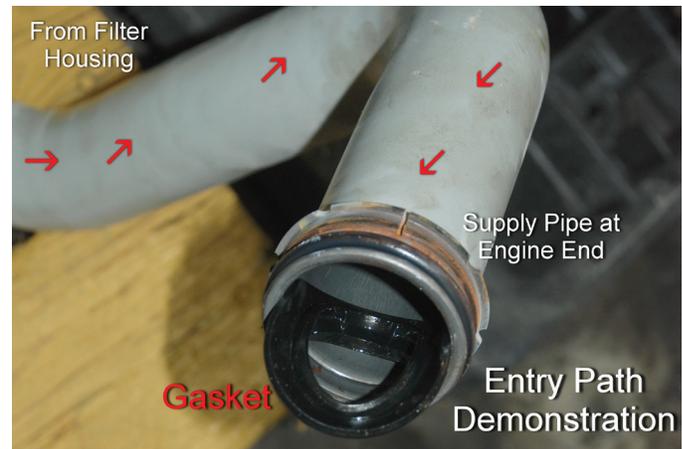
**Figure 34**  
Continued entry path into end of supply pipe.

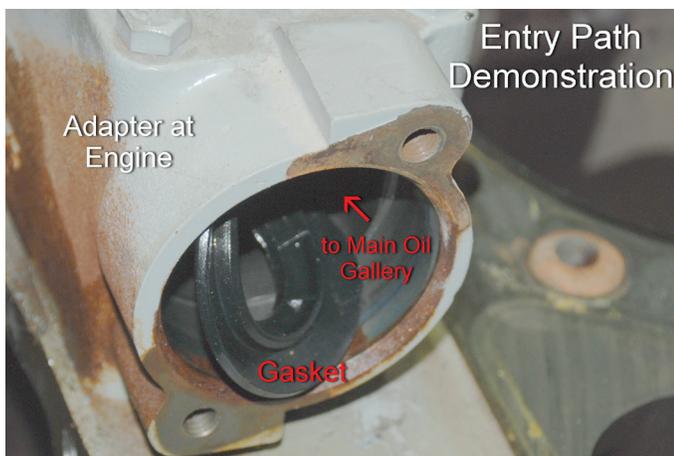
**Figure 35**

Entry path of gasket at the adapter on the engine.

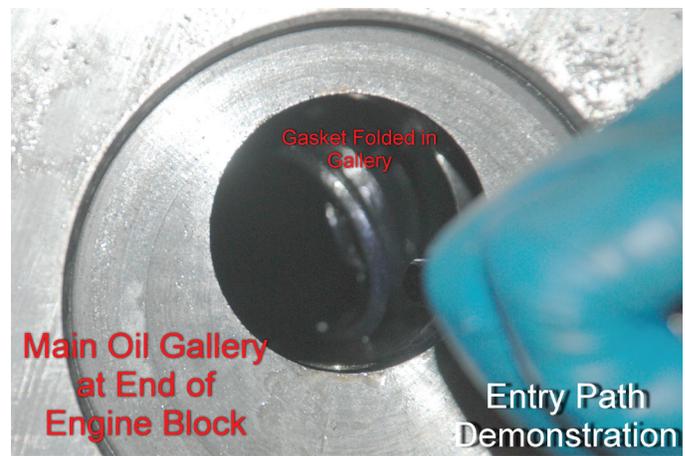
**Figure 36**

Entry path at the side of the engine block into the main oil gallery.

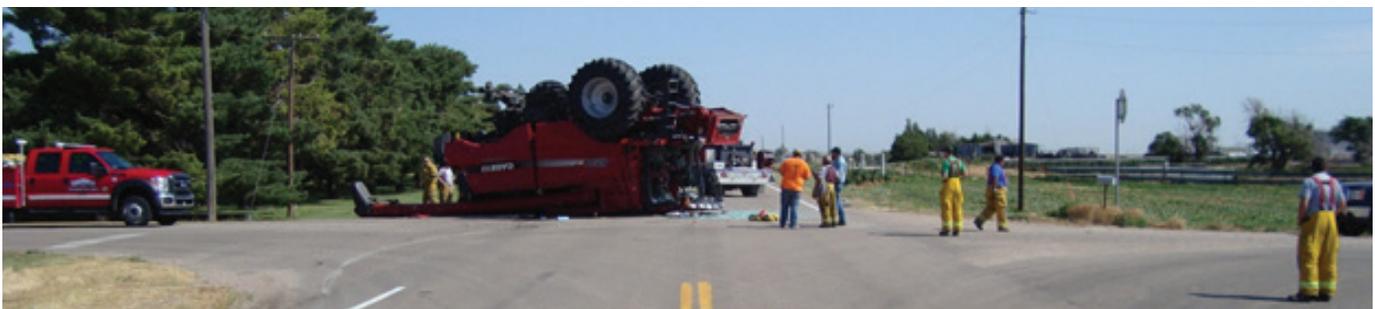
**Figure 1**  
Rest position of combine.

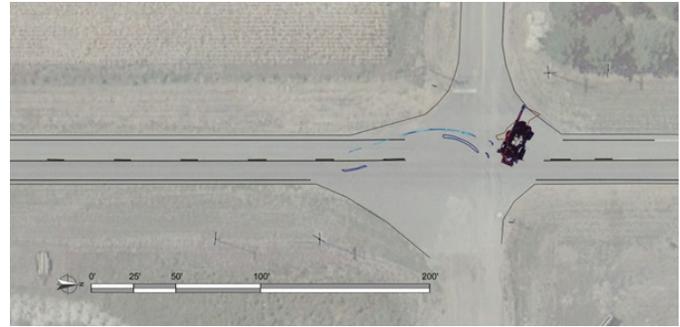
The accident site was inspected, surveyed, and scanned to document any remaining physical evidence as well as the geometry of the roadway. At the time of the inspection, numerous gouges and fluid deposits were visible on the road. The evidence at the scene was surveyed with a total station and scanned with a Faro Focus 3D Laser scanner. The Faro collected 65,525,091 data points that captured the geometry of the roadway, roadway markings, signage, physical evidence, and other features around the area of the incident<sup>1</sup>. The data from the site inspection was then used to create a scaled diagram of the accident site. The site data was supplemented with photogrammetric analysis<sup>2,3,4,5,6,7,8</sup> of the photographs taken shortly after the accident. **Figure 2** depicts an example of the author’s photogrammetry analysis. The upper image is the original photograph; the lower image depicts the results of our analysis. **Figure 3** depicts the scene diagram overlaid with an aerial photograph. The diagram is oriented with north to the right.

**Figure 3**  
Scene diagram showing the physical evidence and the rest position of the combine.

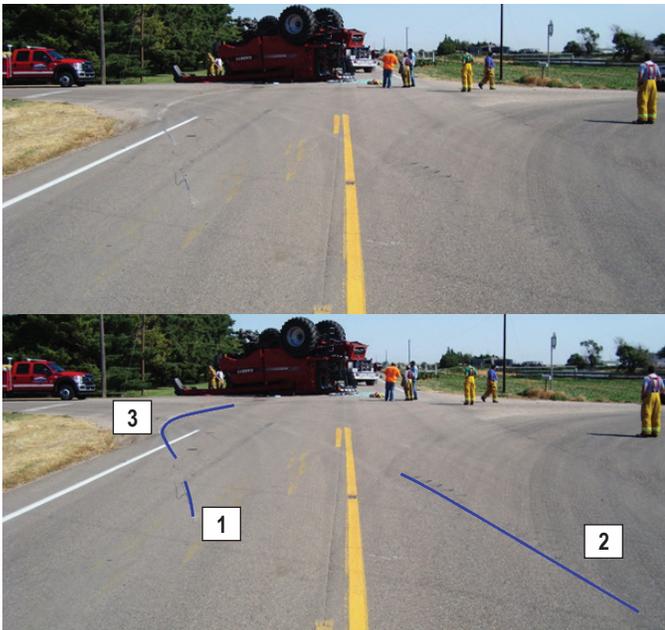
analyzed in a scaled environment. The gouge found in the roadway matched with the left-rear axle prior to the vehicle rolling over. Furthermore, the tire marks that run parallel to the gouge also matched the right-rear tire of the combine. The gouging could only occur with the left rear tire already separated from the vehicle and therefore did not separate as a result of the rollover. Based on the above, the following sequence was determined.

**Figure 7**  
Top image by police; bottom image highlights the physical evidence.

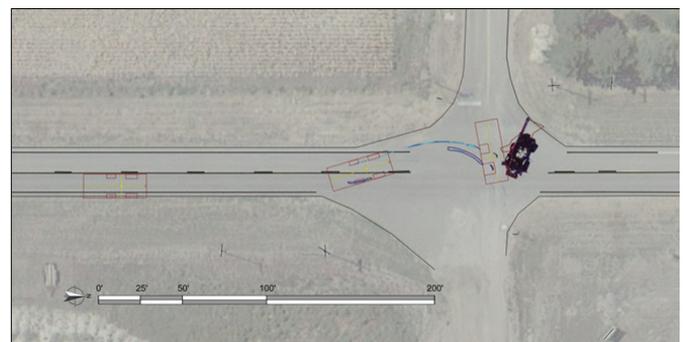
The combine was initially traveling north on the highway. The 14-ft-wide vehicle was likely occupying the shoulder and the entire (or nearly the entire) 11-ft-wide northbound lane. As the left-rear tire and rim detached, the vehicle was pulled to the left when the left-rear axle began gouging the southbound lane (labeled 1 in **Figure 7**). As the vehicle was pulled to the left, the right-side tires deposited yaw marks in the northbound lane (labeled 2 in **Figure 7**). The driver then steered to the right, causing the vehicle to yaw clockwise and curve to the right (as indicated by gouge number 3 in **Figure 7**). The combine then rolled one half time before coming to rest on its roof. **Figure 8** depicts the approximate motion of the combine through the physical evidence.

**Figure 8**  
Motion of the combine prior to rest along the physical evidence.

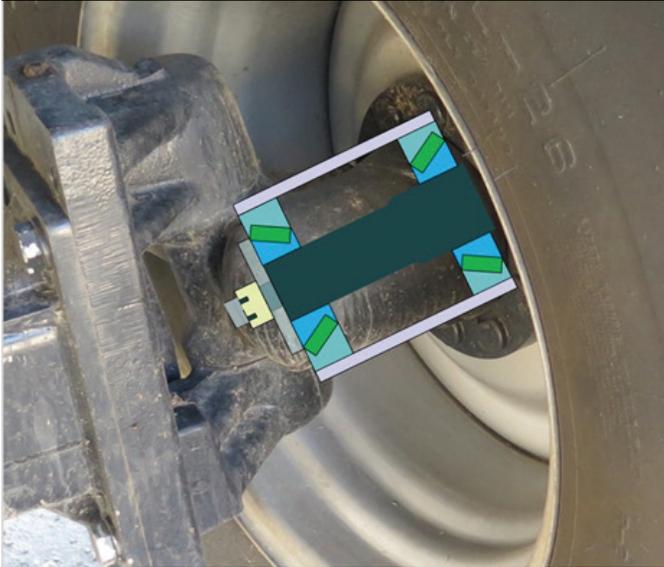
**Figure 11**  
Right rear tire and hub assembly  
showing spindle and bearing diagram.

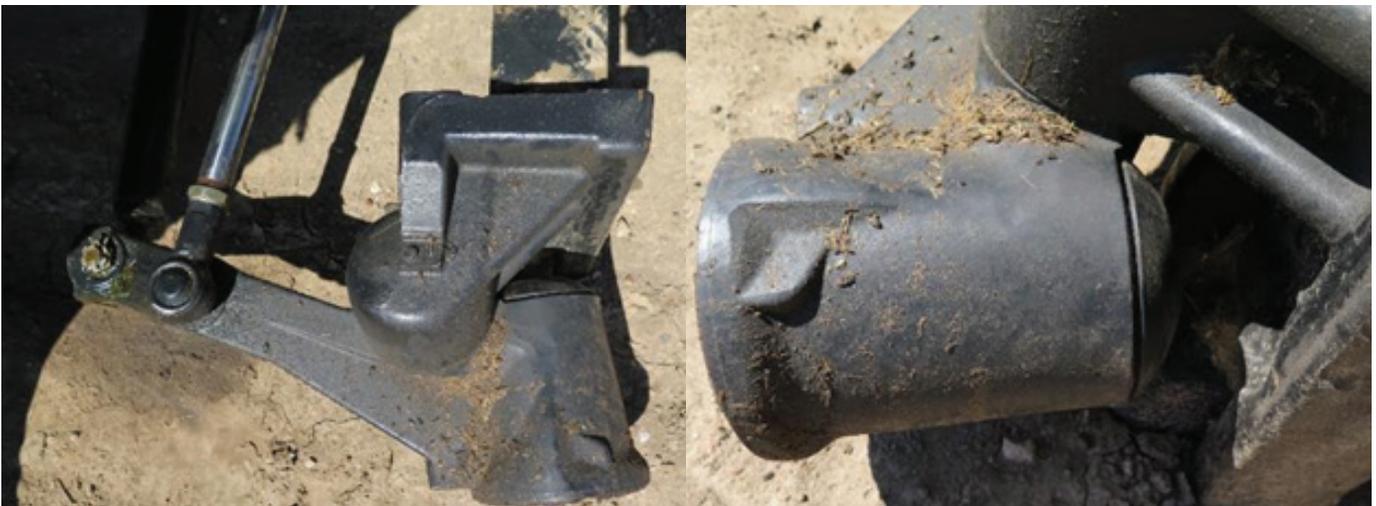
At the time of the inspection, the left rear steering knuckle/housing were still attached to the rear axle. As depicted in **Figure 12**, the outer surface of the knuckle did not show signs of failure and was still attached to the combine.

**Figure 12**  
Left and right images oriented with vehicle's front to the left and top, respectively.

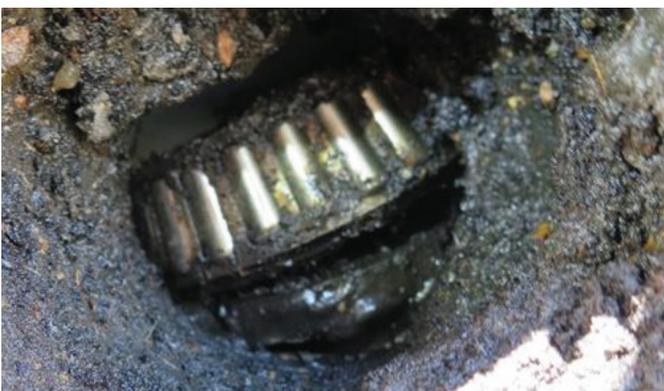
Additionally, the dust/grease cap was still attached to the inboard portion of the steering knuckle. At the time of this engineer's inspection, several components (such as the inner bearing, washer, and nut) were found inside the housing as well as an adequate amount of grease (see **Figure 13**). Within the steering knuckle housing, the tapered roller bearing, washer, castle nut, and cotter pin were removed and cleaned. **Figure 14** depicts these components cleaned as well as the dust/grease cap.

**Figure 13**  
View inside left rear steering knuckle  
showing spindle components and grease.

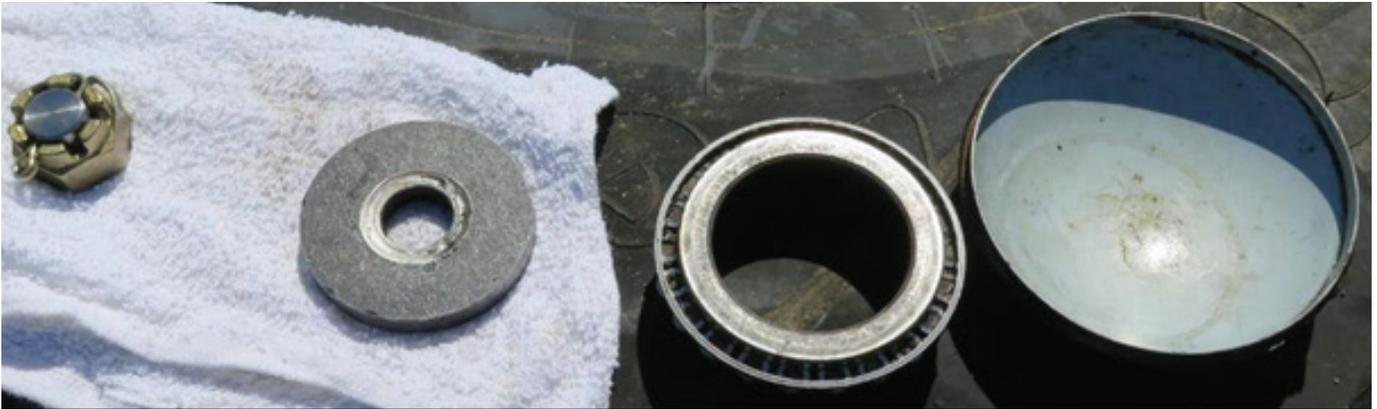
**Figure 14**

Inspection of the components revealed that the spindle, spindle threads, washer, and nut were damaged and showed signs of wear prior to the failure. The following

From left to right – castle nut, washer, inner bearing, and dust/grease cap.

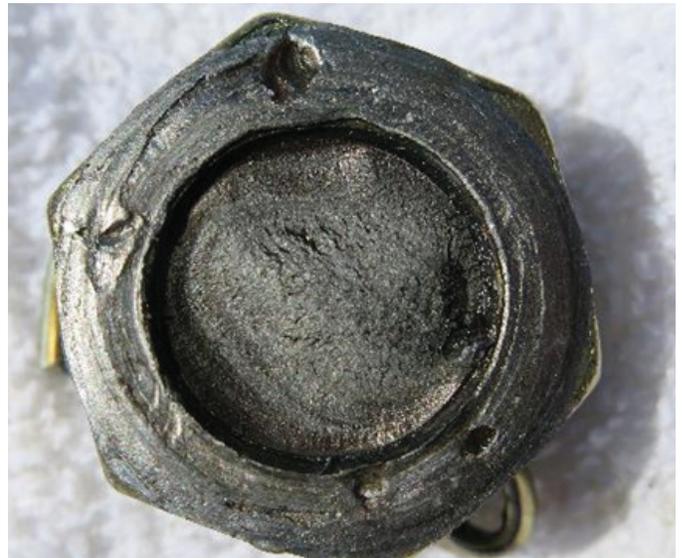
**Figure 17**

Nut, washer side.

is still attached to the nut, and there is damage to the surface of the nut that mates to the washer. The damage to the surface of the nut was due to the rotation of the nut relative to the washer and displaced/removed material from the mating surface. Furthermore, the damage and removal of the material to the nut would have increased the distance in the assembly, thereby decreasing the axial load, allowing more displacement of the bearing, and increasing misalignment in the assembly.

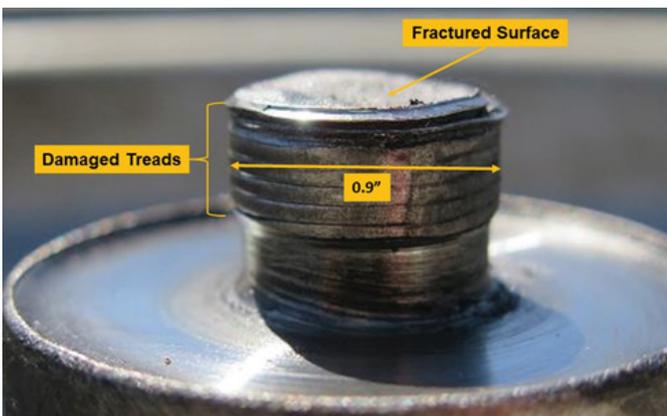
**Figure 16**

The diameter of the threaded portion of the spindle measures approximately 0.9 in. Examination of the spindle shows that the threaded portion where the castle nut attaches was damaged (**Figure 16**). The threads were damaged in two ways: the end portion of the threads was fractured off and remained in the castle nut, and the remaining threads were flattened around the circumference of the shaft.

Spindle threads.

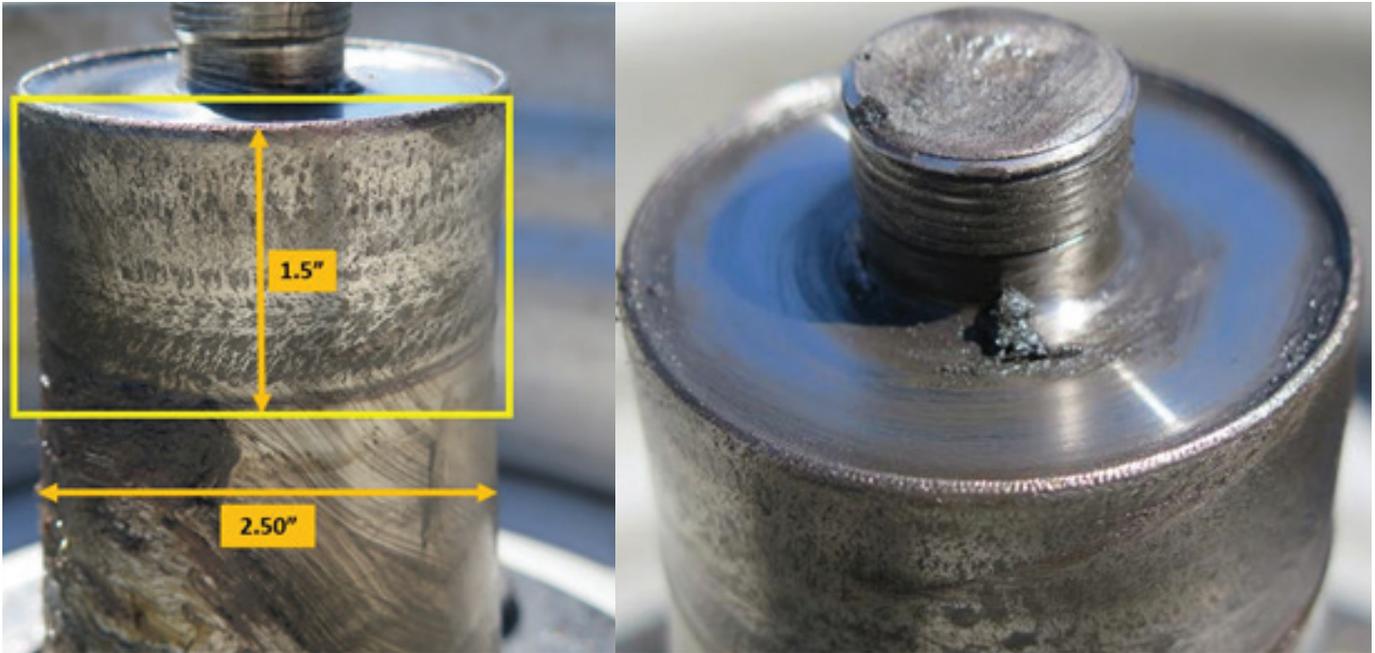
**Figure 20**

Spindle section attached to the separated wheel of the combine.

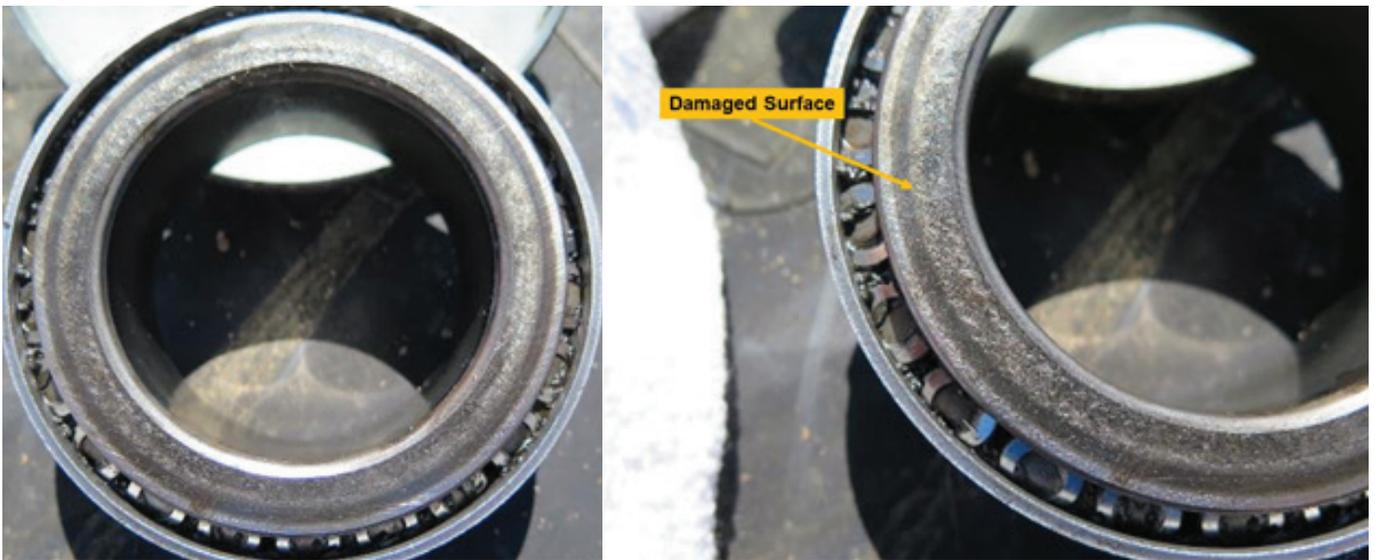
**Figure 21**

The thickness of the bearing measures approximately 1.25 in. with an inner diameter of approximately 2.50 in. The inner bearing showed markings on the edge of the inner race from contact with the washer. The bearing shown in **Figures 21** and **22** shows the scratches to the race and the condition of the cylindrical roller bearings.

In the right image of **Figure 21**, marks can be seen from the bearing moving against the washer, causing abrasion marks. This indicates that the inner race of the bearing was allowed to move relative to the washer<sup>16,17</sup>. **Figure 22** depicts the rollers of the bearing. The faces of the roller bearings are smooth with no gouge or pitting marks evident as well as no discoloration, which would indicate that there was proper lubrication to the bearing at the time of the spindle failure<sup>17</sup>.

Scratch pattern on inner race edge.

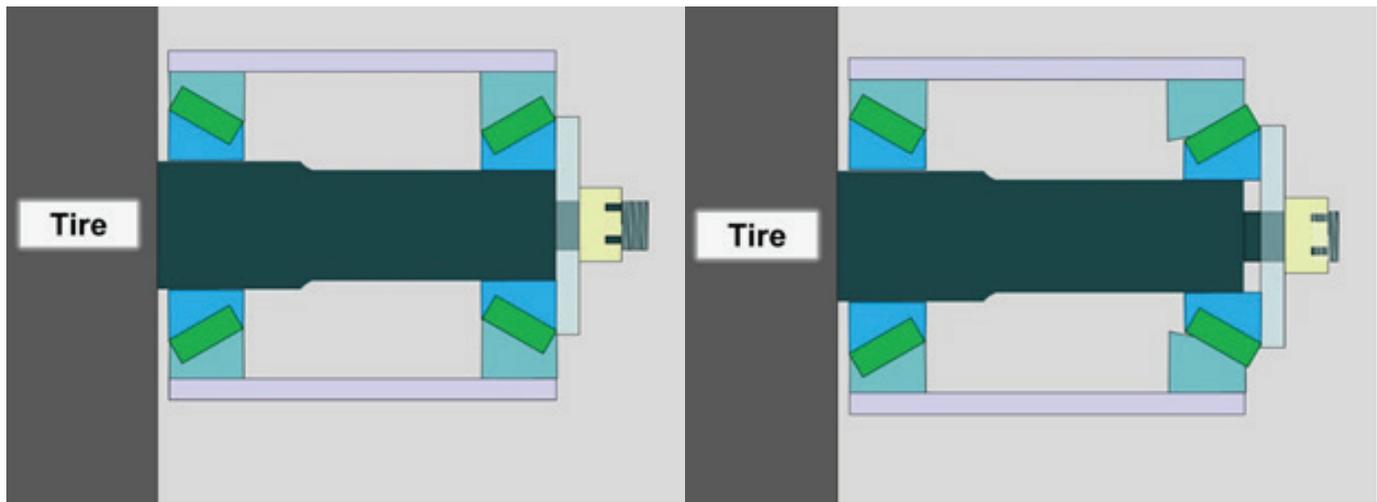
**Figure 23**

The root cause of the spindle, bearing, washer, and nut moving independently of each other was the insufficient pre-load on the bearings<sup>18,19,20,21</sup>. The lack of pre-load resulted in insufficient frictional force between the components and allowed relative rotation of the mating parts. The lack of pre-load also allowed the increase in axial force from the weight of the combine, which results in a thrusting force toward the castle nut that should be applied perpendicular to the axel. Once the components started to move relative to each other, the washer and spindle began

to wear, further exacerbating the problem. The increased axial and radial motion increased the stress in the spindle thread area and generated an unintended moment about the threaded portion of the spindle. In the left image of **Figure 23**, the castle nut is properly tightened, and the tapered bearings are fully seated on the spindle. In the right image of **Figure 23**, the nut is now loose, allowing the inner bearing to unseat from the outer race and the spindle.

(Left image) properly tightened nut – (right image) improperly tightened nut.

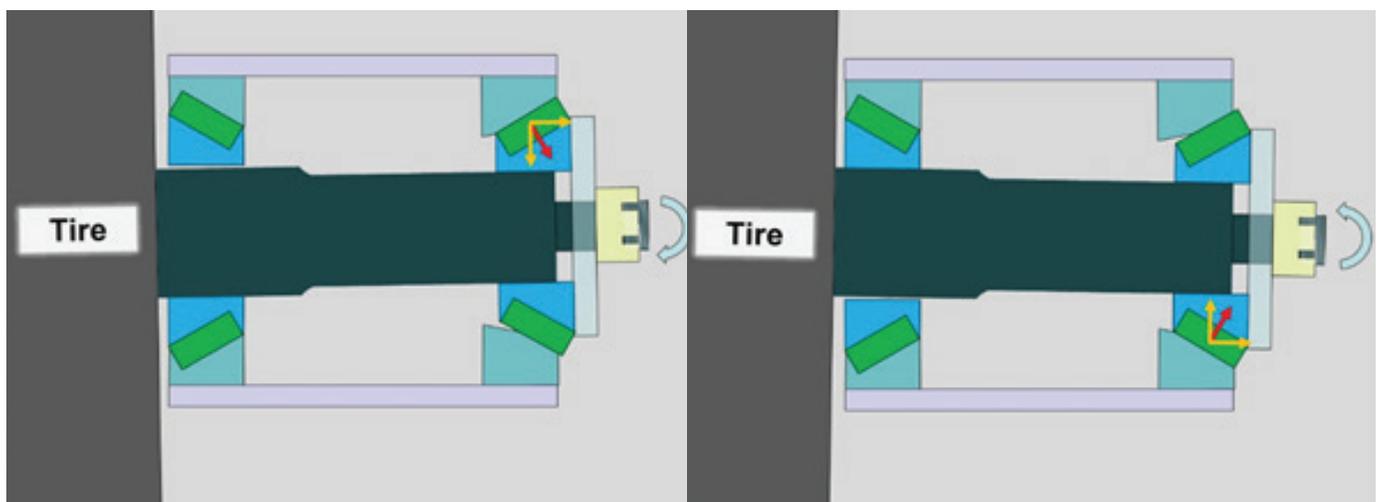
**Figure 24**

Moment placed on the threaded portion of the spindle.

stress in the spindle thread area and generated an unintended moment about the threaded portion of the spindle. The movement of the inner bearing toward the threaded portion of the spindle placed a moment not only on the smallest cross section of the spindle, but also on the greatest location of stress concentrations, namely the threads.

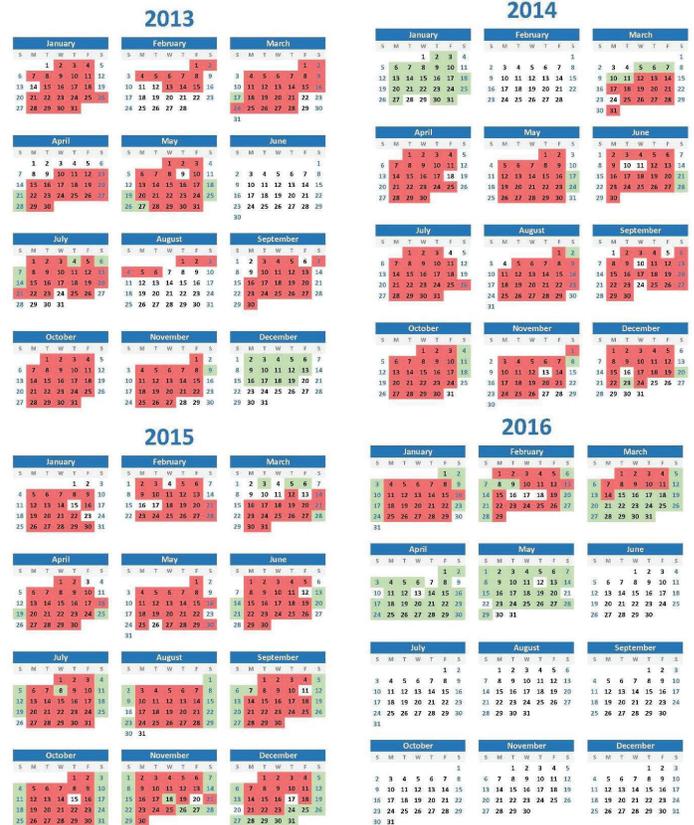
**Figure 17**

The maximum noise producing equipment on the project for each day was summarized and plotted on a calendar (Figure 17) to show the court the chronic and routine exceedance of the noise threshold (85 dB) at the construction easement.

Summary of daily maximum noise level based on utilized contractor equipment over the course of the project. Source: Author.

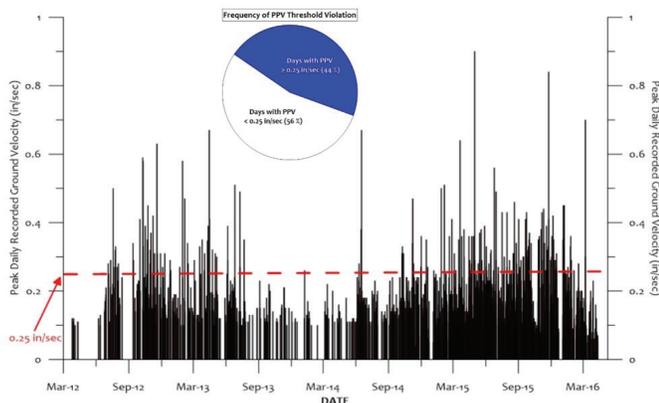
Figure 20

Vibration monitoring days where the maximum PPV exceeded the allowable threshold. Source: Author.

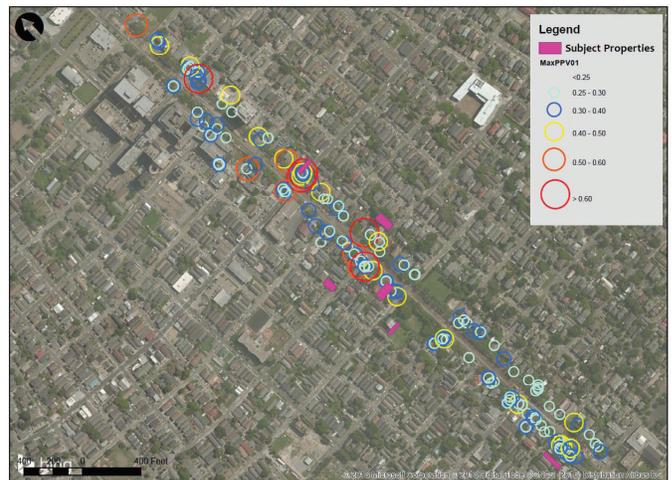
Figure 21

**Figure 21** presents a spatial plot of setup locations of the vibration monitoring equipment and scaled circles are associated with each monitor location with a max PPV greater or equal to 0.25 in. per second. The recordings are representative of the ground vibrations observed at the unique vibration monitor location from all surrounding vibration sources.

Plot of recorded maximum daily PPV values (in./second). Source: Author.

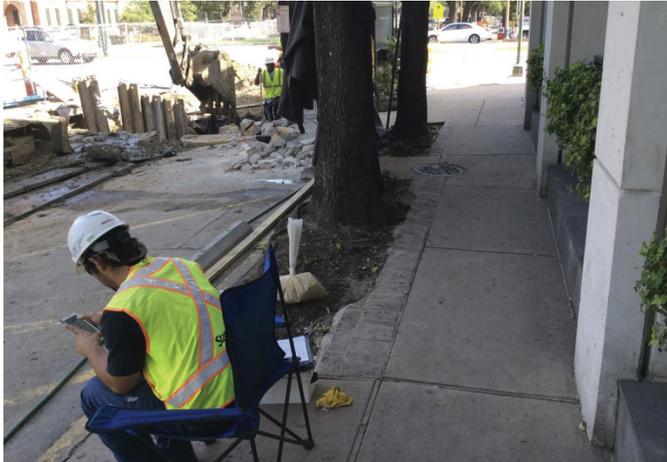
**Figure 22**

Vibrations attenuate over distance. While the project specifications require monitoring "at the closest structure," the vibration monitors were frequently situated at more distant structures, with no monitoring at the "closest

These factors lead to “under-reporting,” where the reported values do not satisfy the project specifications, which require reporting values at the “nearest structure,” rather than “at the monitoring device.”

Example where vibration monitor was not situated at a location representative of vibrations experienced “at the nearest structure.” Source: Discovery Docs.

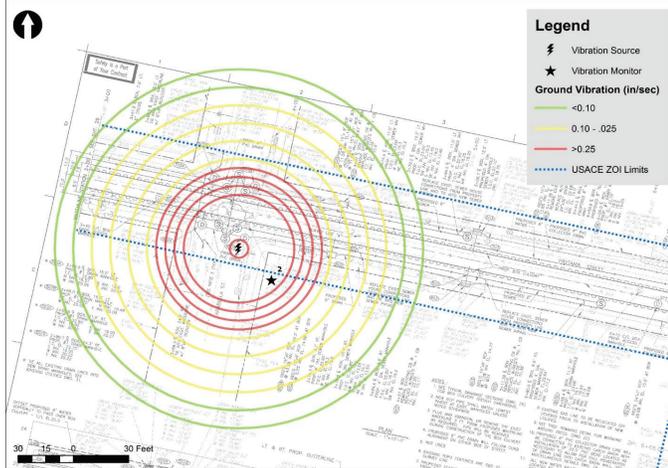
**Figure 27**

Attenuation of Event “I” with project plan overlay showing event origin relative to planned work. Source: Author.

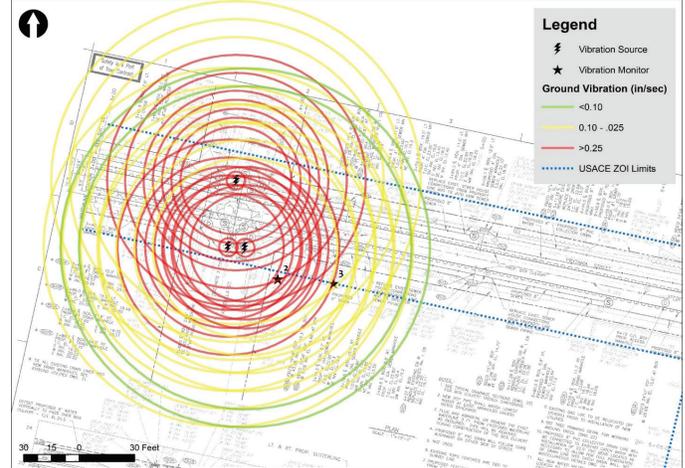
**Figure 30**

Overlay of attenuation of all three events (I, J, and K). Source: Author.

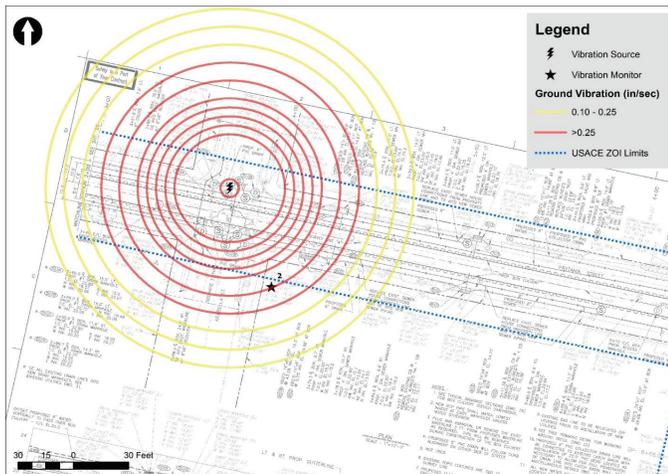
**Figure 28**

Attenuation of Event “J” with project plan overlay showing event origin relative to planned work. Source: Author.

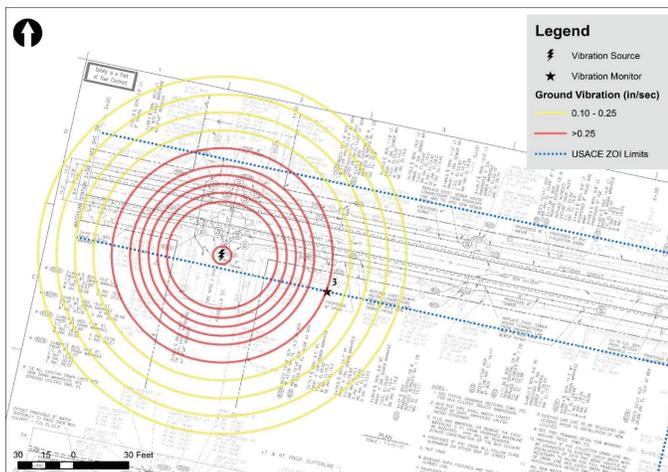
**Figure 29**

Attenuation of Event “K” with project plan overlay showing event origin relative to planned work. Source: Author.

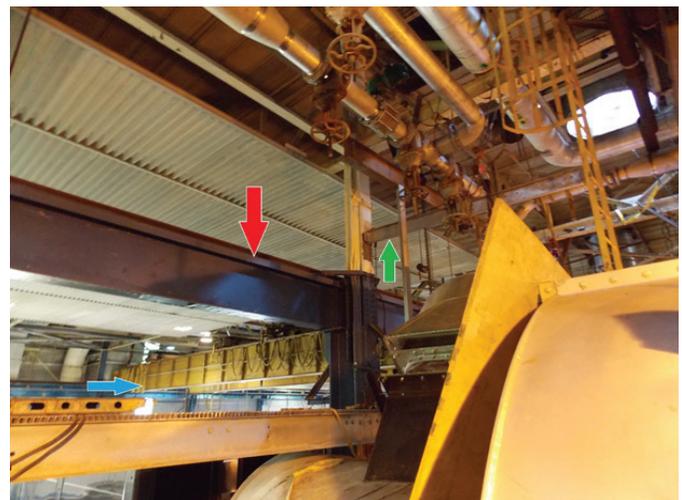
**Figure 1**

Accident location. Cross-beam to be removed pointed out with a green arrow. Overhead crane in the background pointed out with a blue arrow. Overhead crane rail pointed out with a red arrow.

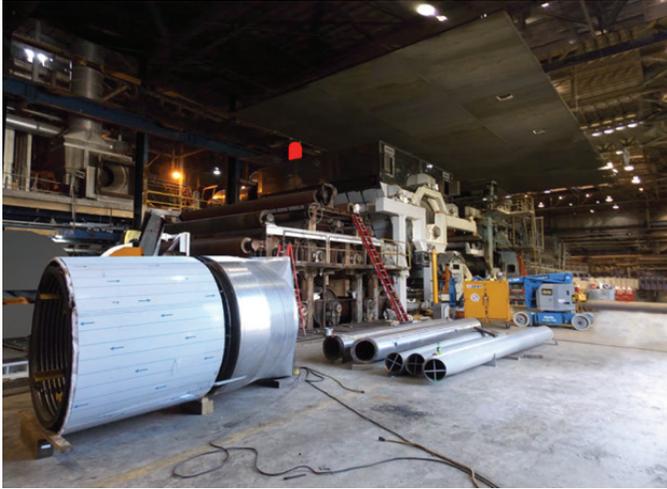
**Figure 9**

The location where the decedent was crushed, highlighted in red in the reconstructed accident scene.
