Journal of the  
**National**  
**Academy** OF  
**Forensic**  
**Engineers**<sup>®</sup>

Vol. 37 No. 1 December 2020

<b>‡ Forensic Engineering Analysis of Projectile Thrown from Phantom Vehicle.....</b>	<b>1</b>
<i>By Richard M. Ziernicki, PhD, PE (NAFE 308F), William H. Pierce, PE (NAFE 846C), and Angelos G. Leiloglou, M Arch., (NAFE 956C)</i>	
<b>‡ Misapplication of Pressure Vessel Codes in Forensic Applications .....</b>	<b>15</b>
<i>By Bart Kemper, PE (NAFE 965S)</i>	
<b>‡ Forensic Engineering Analysis of Residential Underdrain Design Methodologies, Performance, and Failures .....</b>	<b>27</b>
<i>By Edward L. Fronapfel, PE (NAFE 675F)</i>	
<b>* Machine Safeguarding: Theory, Practice, and Case Studies .....</b>	<b>43</b>
<i>By Nicholas A. Petrucci, PE, CSP (NAFE 650M)</i>	
<b>* Forensic Engineering Analyses of Right-Turning Trucks Impacting Bicyclists .....</b>	<b>53</b>
<i>By Richard M. Ziernicki, PhD, PE (NAFE 308F), William H. Pierce, PE (NAFE 846C)</i>	
<b>† Forensic Engineering Analysis of a Failed ROPS .....</b>	<b>65</b>

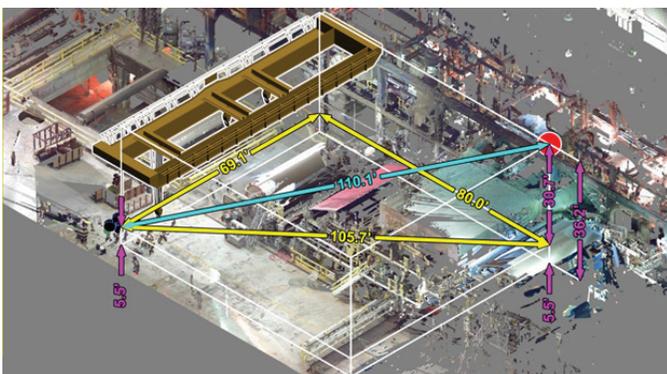
**Figure 10** demonstrates the position of the crane operator and crane, relative to the decedent at a specific point in time. From the line-of-sight study, it was determined that the crane operator would have been able to see the decedent, had the crane operator checked for personnel near the crane’s travel tracks/rail before and during crane operation, as required by the ANSI B30.2 standard, the crane operator’s manual, and the plant policies.

Graphic showing the spatial analysis for the line-of-sight study at a specific point in time. Analysis to determine where the crane operator was spatially located to the decedent.

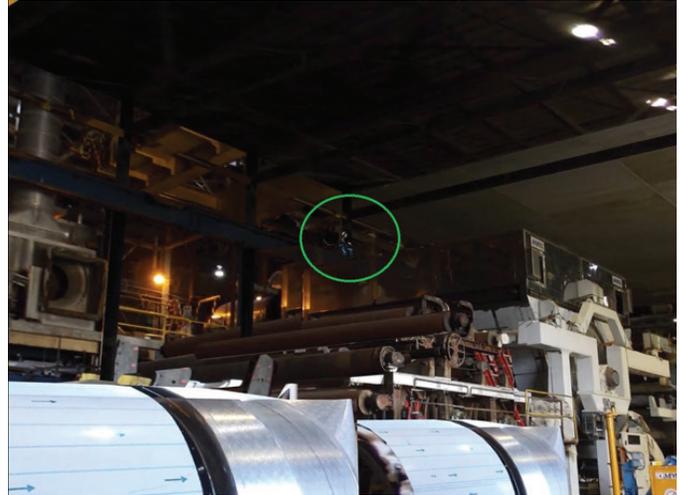
**Figure 11** is a graphic of the reconstructed accident scene from the point of view of the crane operator, showing the decedent was visible to the operator before he operated the crane and for at least 21 seconds before the decedent got crushed, assuming the operator was traveling at an average walking speed. From the line-of-sight study, it was determined that had the crane operator checked for personnel near the crane’s travel track/rail, he would have seen the decedent near the crane’s travel track/rail,

Graphic showing the reconstructed accident scene from the point of view of the operator 30 seconds before the decedent got crushed. The decedent circled in green.

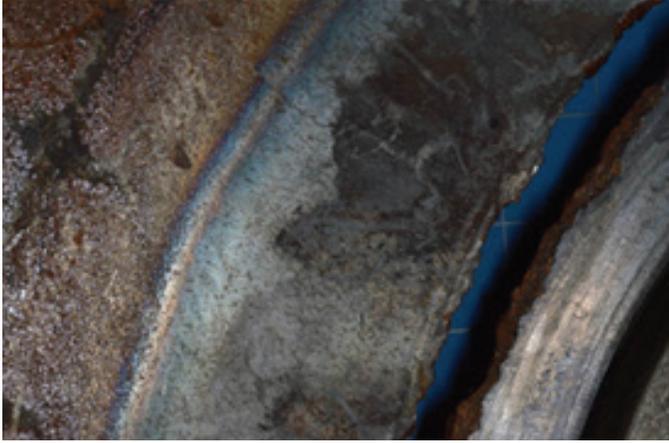
**Figure 2a**

Macroscopic inspection photographs of the fracture surface are shown in **Figure 2** at locations A, B, and C as indicated in **Figure 1**. These surfaces show heat tinting, discoloration, and radial fissure cracks on the side of the flywheel that would make contact with the clutch pad disk. The central portion of the remnant flywheel containing the bolt holes for mounting the flywheel to the crankshaft had a complete circumferential fracture surface that was examined in detail using visual examination, optical microscopy, and scanning electron microscopy techniques. Location C was unique, as it was the only area that contained both radial and circumferential fracture surfaces, as shown in **Figure 2c**.

Close-up photomicrograph in location A shows heat tinting and fissure cracks.

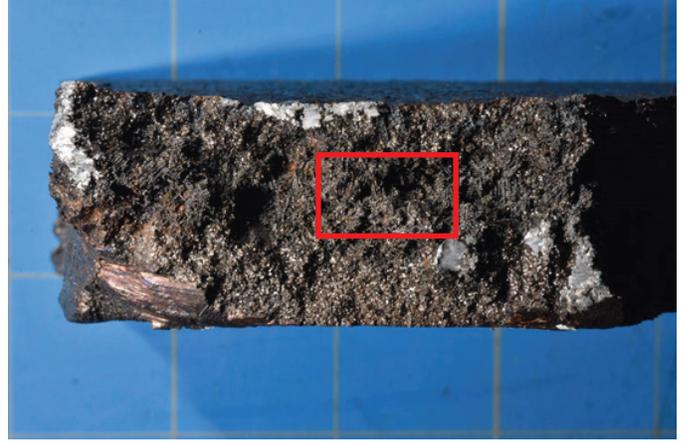
**Figure 3a**

End on view of location C shows dull fracture surface.

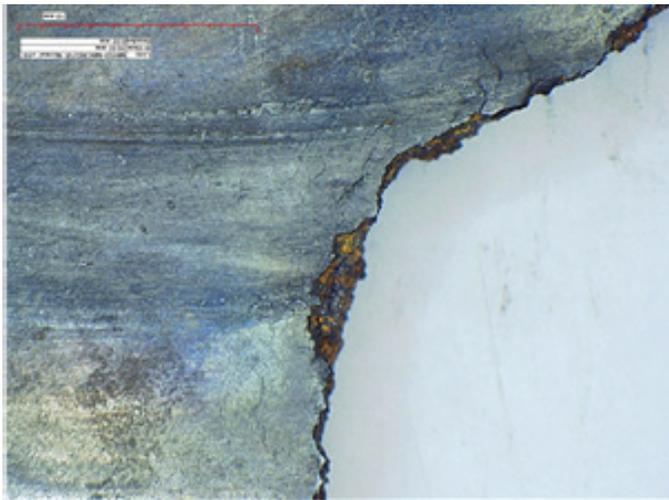
**Figure 2c**

Close up photomicrograph in location C shows heat tinting and fissure cracks.

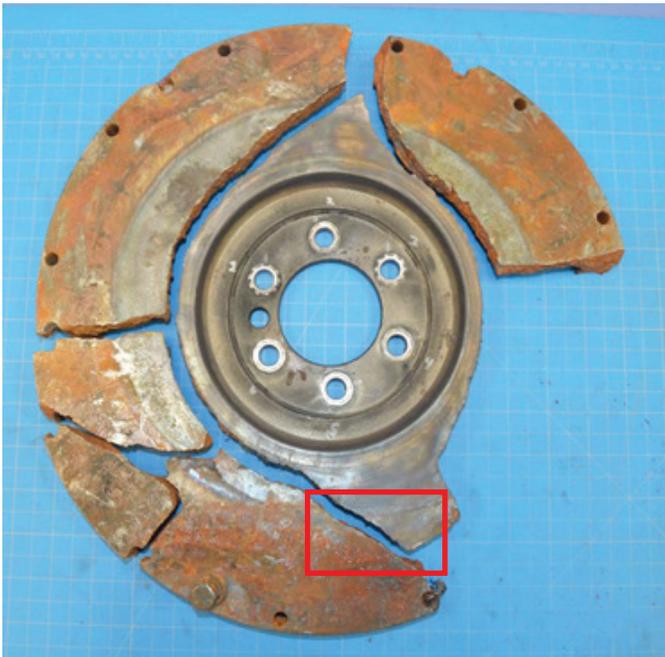
**Figure 4a** shows the location of area C in the flywheel and the reference CT slice data in **Figure 4b**. **Figure 5**, a magnified CT slice view of area C, indicates that the porosity envelopes the entire width of the fracture surface, which is 1.6 in. in length.

Overall view of flywheel remnants and location for computed tomography.

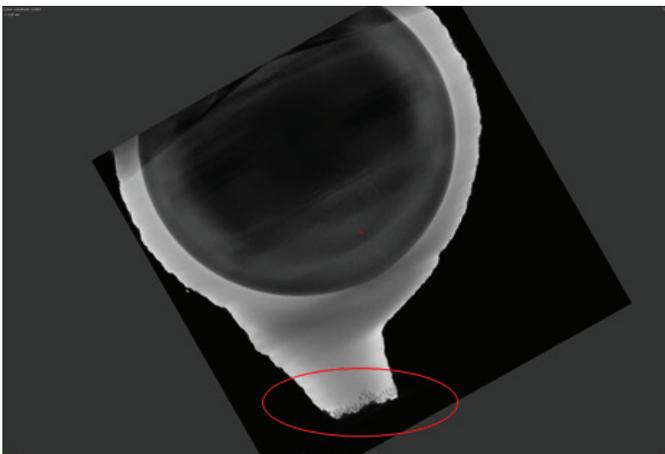
**Figure 4b**

CT slice shows no porosity except near fracture surface as indicated.

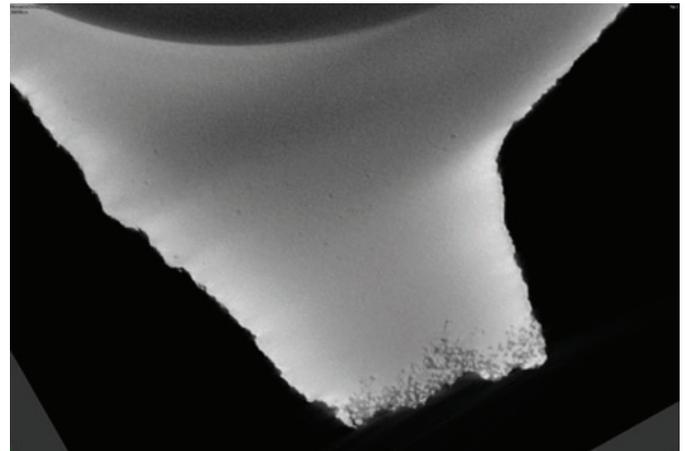
**Figure 5**

High magnification CT slice shows porosity and dendrites along fracture surface location.

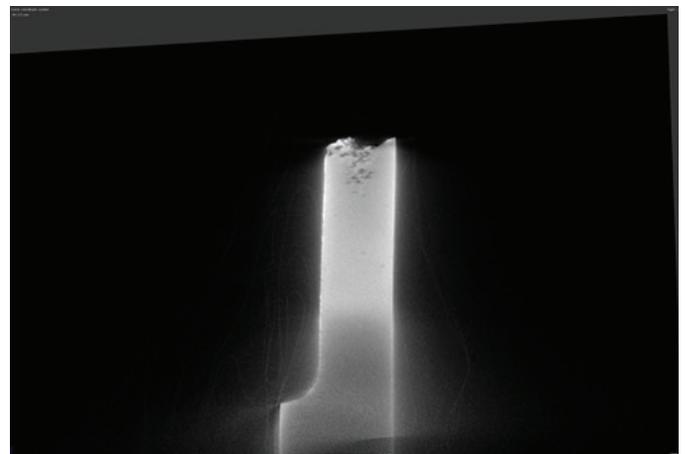
**Figure 6** shows a CT slice transverse view of location C, an indication to the depth of the porosity, which was measured to be 0.4 in. deep. The slices provide information regarding the amount of porosity and proximal location to the fracture surface, which cannot be seen using

High magnification transverse CT slice shows porosity depth and dendrites along fracture surface.

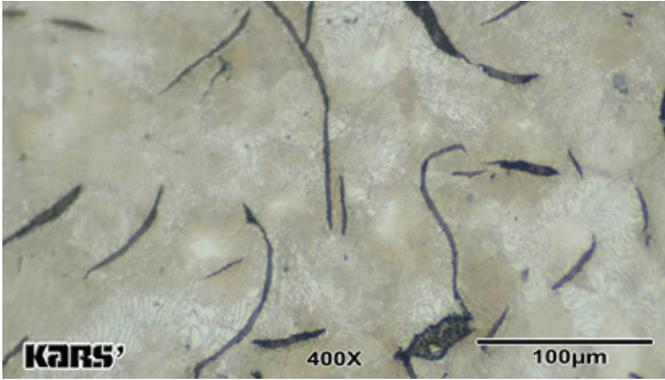
**Figure 7a**

Photomicrograph of base cast gray iron microstructure shows ferrite pearlite matrix with graphite flakes.

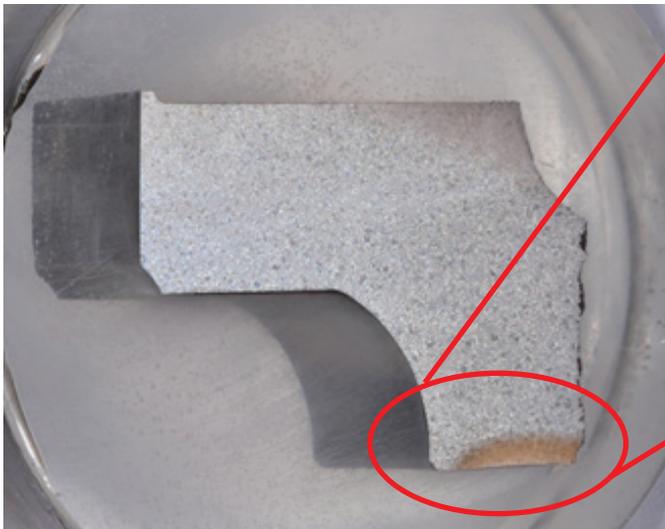
**Figure 7b**

Photomicrograph of heat-affected zone shows fissure cracks and microstructural changes to include needle and lath features similar to bainite or martensite phases. Photomicrograph of base cast gray iron microstructure shows ferrite pearlite matrix with graphite flakes.

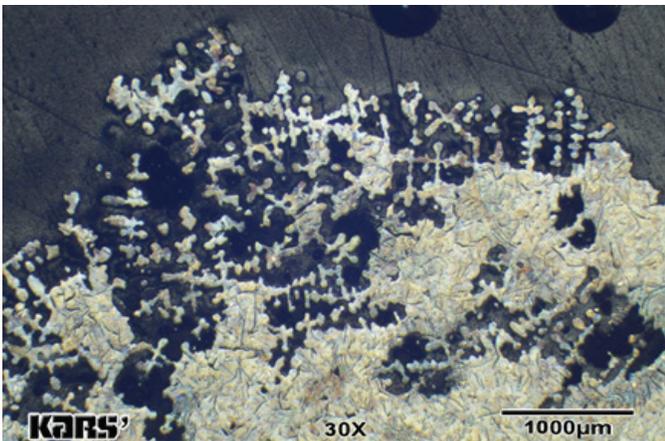
**Figure 7c**

Photomicrograph shows casting porosity and dendrites, indicating poor casting procedures.

and porosity due to rapid solidification and shrinkage during casting are shown in **Figure 7c**. This cross section was taken from area C as discussed in **Figure 3** and **4**. These areas were found on, and within the radial and circumferential fracture surface (Area 3), where it is believed the failure initiated.

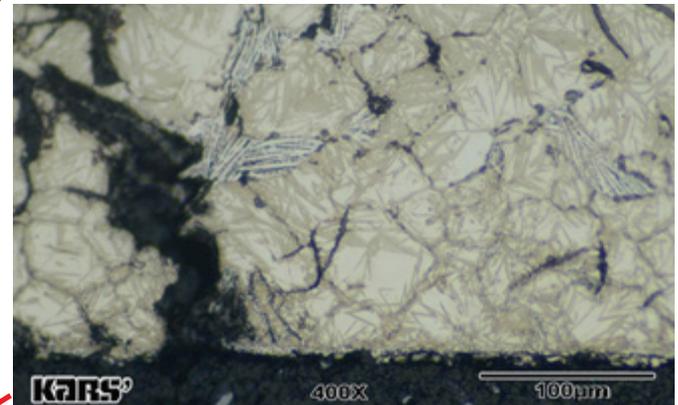
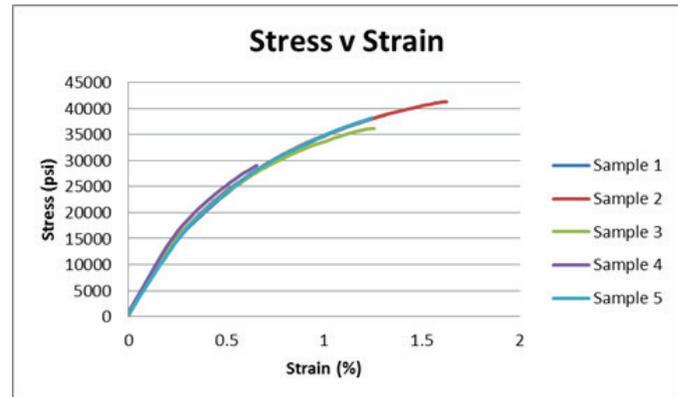
Sub-specimen flat dogbone tensile coupons consistent with ASTM E8 were machined away from the heat-affected zone in the subject flywheel to determine mechanical properties, the results of which are shown in **Figure 8** and **Figure 9**. These results confirm that the material was manufactured from gray cast iron with a tensile strength similar to that of SAE G3500 (35 KSI) and

Tensile stress versus elongation of five tensile coupons machined from failed flywheel away from heat affected zone.

hardness of 215 HRB. Similar testing was performed on an OEM flywheel, and the testing results showed the OEM flywheel was manufactured out of ASTM A536 ductile iron with a tensile strength of 80 KSI, a yield strength of 55 KSI and an elongation of 6%. Gray cast iron materials are brittle, and — when subject to metallurgical defects — heat and substantive stresses rapid and catastrophic fracture can occur.

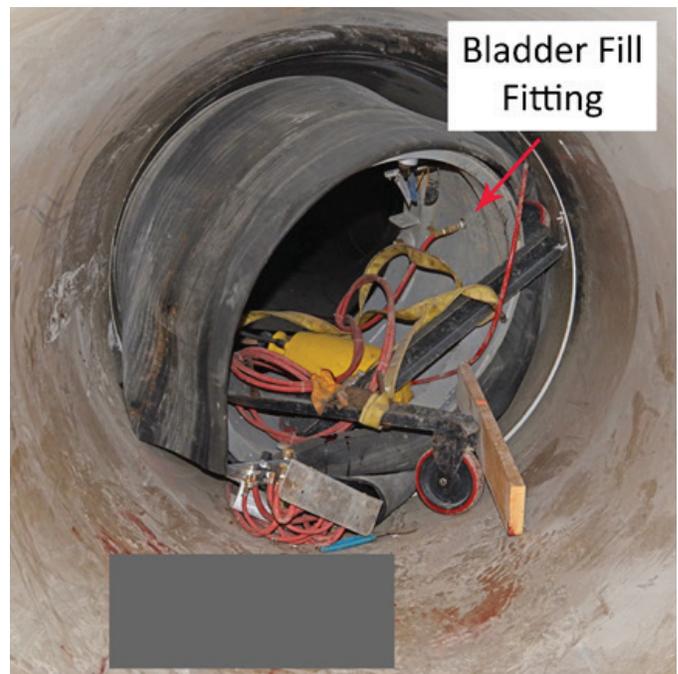
**Figure 11**

Pipe joist tester in pipe after incident.

- The axis of the tester frame was not parallel with the pipe axis. The frame was rotated slightly counterclockwise about a vertical axis (viewed from above) and slightly clockwise about a horizontal axis (viewed from the left).

- The bladder contained a rupture parallel with the pipe and pipe tester axis. The rupture appeared to extend the entire width of the bladder. The bladder was partially separated from the frame.

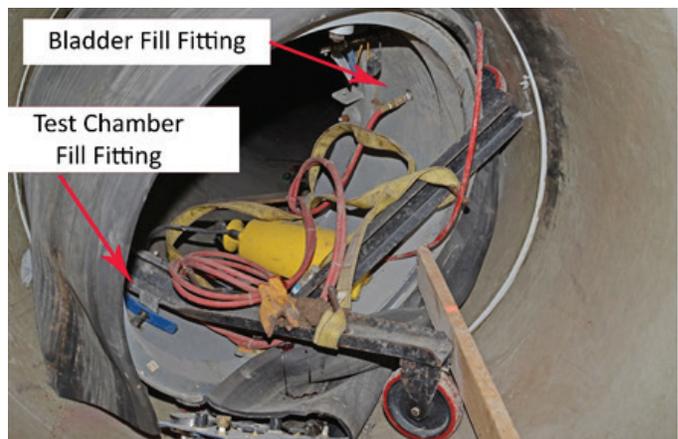
**Figure 12**

Pipe joist tester in pipe after incident.

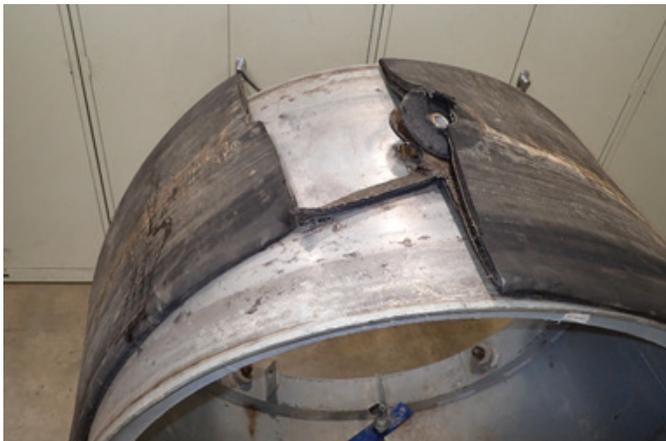
- The damaged bladder was loosely attached to the tester frame. The bladder was held in place by the telescoping tubes of the test cavity fill fitting and the test cavity bleed-off fitting, which extended from the bladder through the frame. The bladder fill fitting was wedged between the bladder and the outer surface of the frame.
- The bladder was ruptured along a line parallel with the axis of the joint tester frame. The rupture was roughly centered on the test cavity fill fitting tube. This would have been located at the 12:00 position when the joint tester was set up for use in the pipe. The rupture extended almost completely through the entire bladder. A 1¼-in.-wide strip of material still connected the two sides of the rupture (**Figure 14** and **Figure 15**).

**Figure 14**  
Top of joint tester showing ruptured bladder.

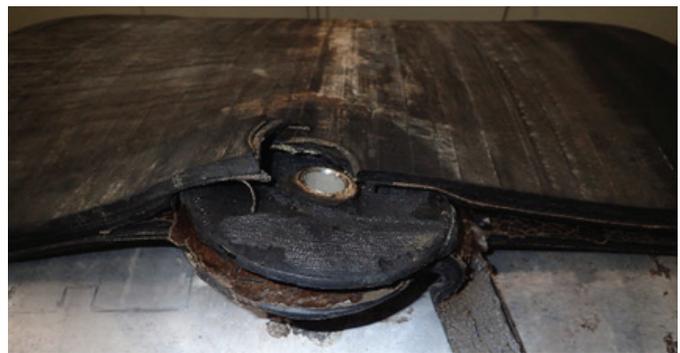
each location where the telescoping tube extended through the bladder. These reinforcing discs were about 5 in. in diameter, and each was sandwiched between the two layers of rubber material of the bladder wall adjacent to the reinforcing cords. At the site of the rupture, the disc in the inner wall was still partially connected to one side of the bladder rupture. At the outer wall, the reinforcing disc had completely separated from the bladder (Figures 18 and 19).

**Figure 18**  
Bladder rupture at test cavity fill tube.

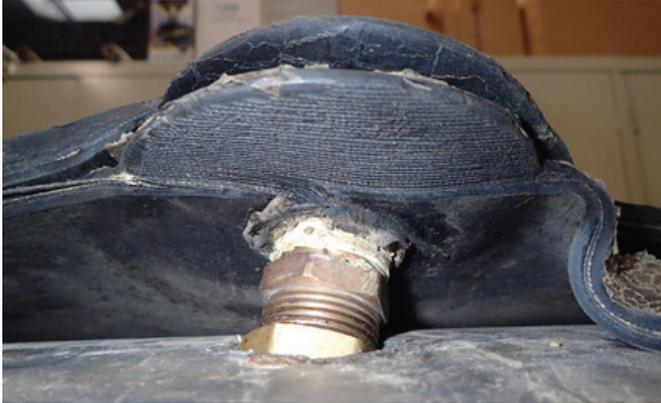
**Figure 19**  
Bladder rupture at test cavity fill tube.

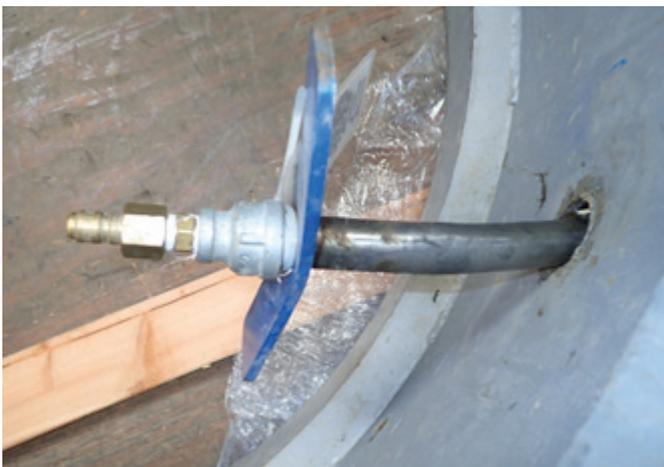
- The test cavity fill tube was bent. A male quick-disconnect fitting was attached to the inlet end of

**Figure 20**  
Test cavity fill tube.

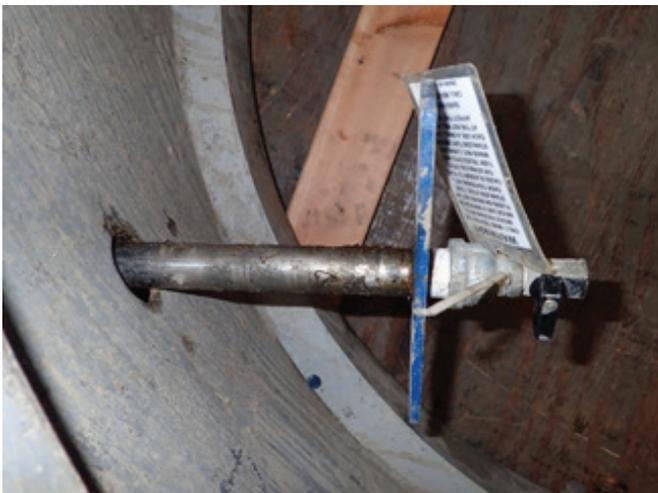
**Figure 21**  
Test cavity bleed-off tube and valve.

of the tube. The valve was in the closed position (Figure 21).

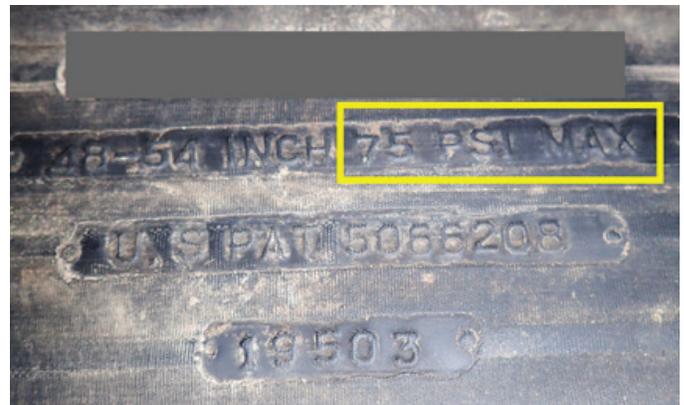
- A label molded into the exterior surface of the bladder indicated a maximum pressure of 75 psi (Figure 22).
- Both transport wheel frames had separated from the joint tester frame. Each wheel support frame consisted of a 4-in.-wide steel channel with an 8-in. diameter wheel mounted on each end. Each wheel frame had been attached to the inner diameter of the joint tester frame with two 3/4 in. nominal diameter acme thread bolts. Each wheel frame was positioned at a 45-degree angle from vertical. One of the wheel frame channels contained a severe bend extending from the end to the connecting bolt. The end of the channel was bent upward about 5 in. from the bolt and was twisted to the side. The other channel was bent upward about 1/2 in. All four of the 3/4-in. connection bolts for both channels had fractured just below the adjusting nuts on the underside of the channel (Figures 23 and 24).

**Figure 22**  
Label embossed on outer bladder surface.

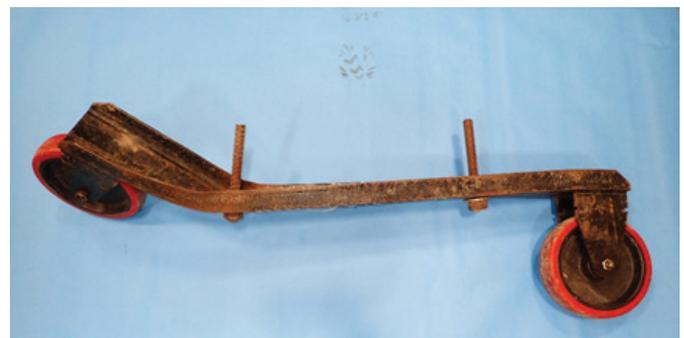
**Figure 23**  
Damaged wheel frame.

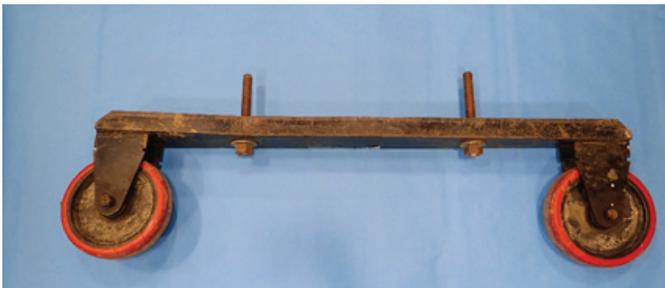
**Figure 24**  
Damaged wheel frame.

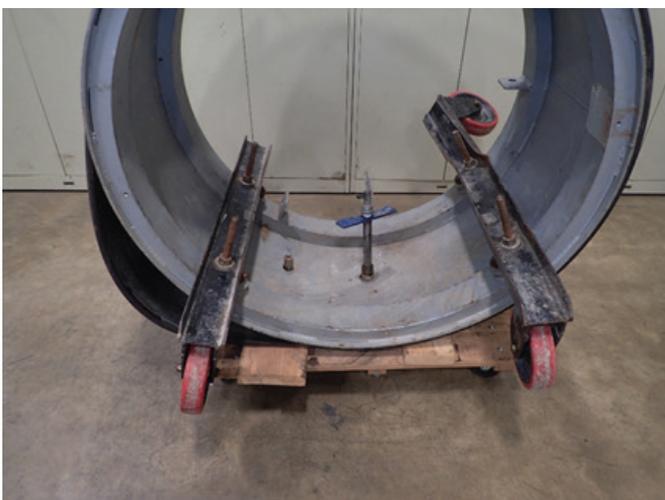
- The wheel frame connection bolts had been threaded into four cylindrical extensions on the inner diameter of the tester frame. The fractured ends of the  $\frac{3}{4}$ -in. bolts remained in the tester frame. Comparison of the fracture surfaces indicated that the deformed ends of the wheel frames had extended out the side of the joint tester frame equipped with the lifting lugs (**Figure 25**).

**Figure 25**  
Wheel frames repositioned in tester frame.

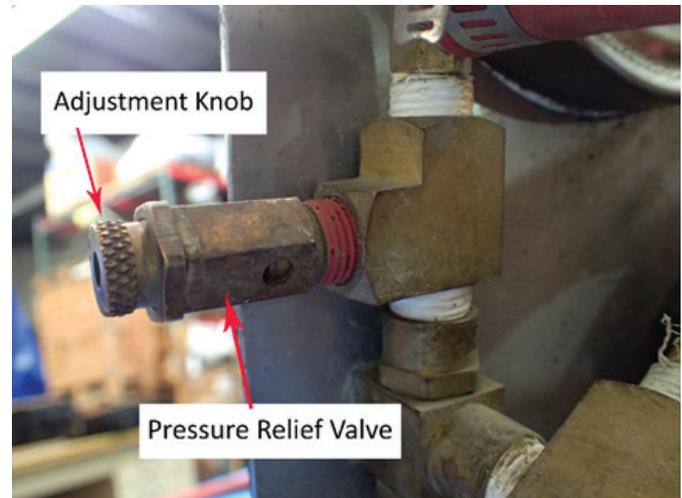
**Figure 26**  
Bladder pressure relief valve.

line extending out of the bladder pressure regulator. This pressure relief valve was adjustable, and the relief valve manufacturer's specifications indicated that the adjustable range was 50 to 100 psi (**Figure 26**).

- When first tested the pressure relief valve leaked at 89 psi and popped full open at 93 psi. On two subsequent trials, the valve leaked at 84 psi and popped full open at 90 psi.

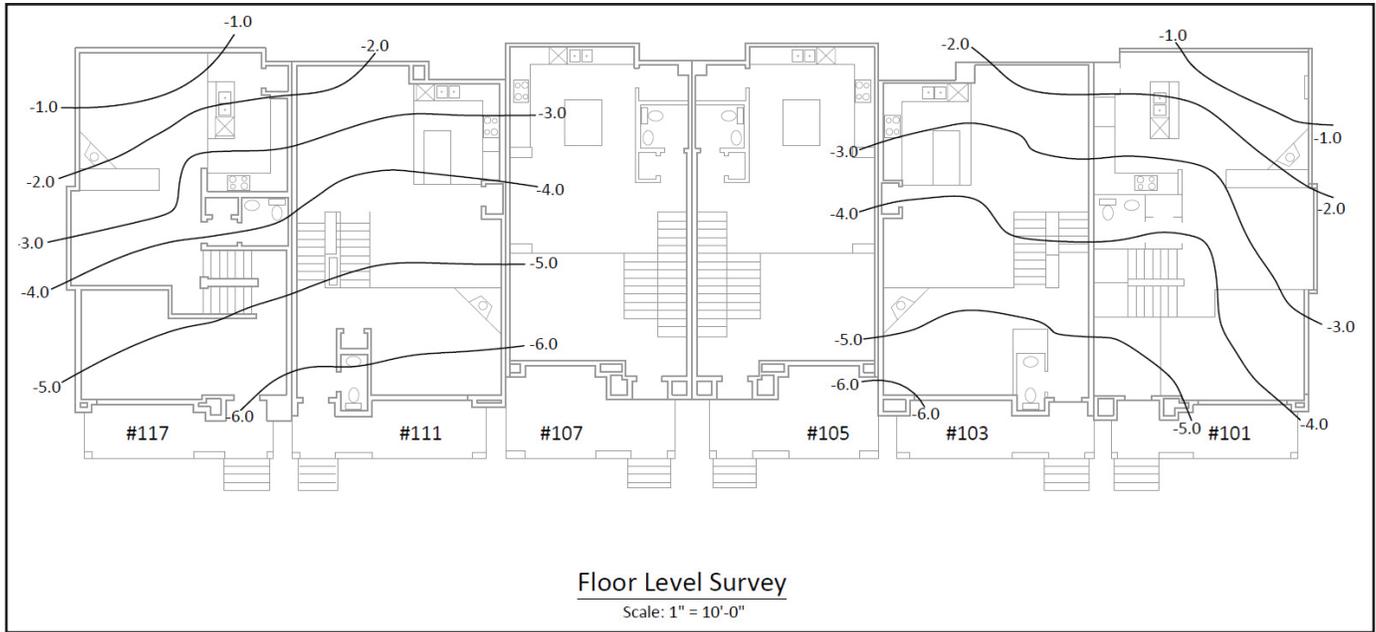
**Figure 7**

Example floor level survey showing differential settlement trends across the multi-unit structure. Source: Discovery Docs.

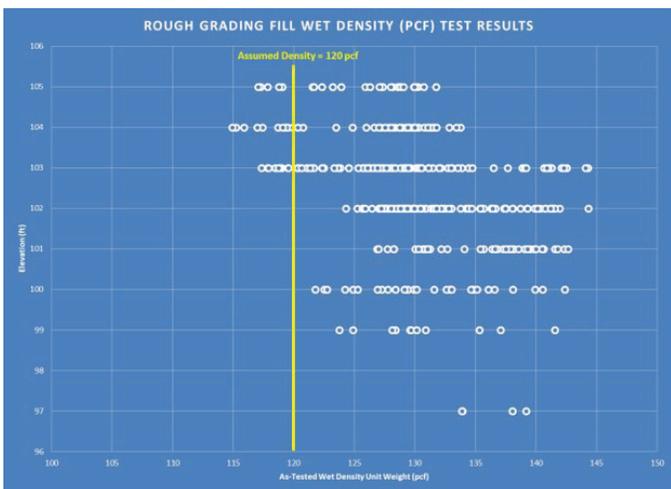
**Figure 11** shows a plot of measured soil densities during fill placement. The assumed density of 120 pcf is highlighted in yellow. The white circles are individual test results and span a density range of about 115 pcf to just under 145 pcf. Of the 359 soil density tests, 330 tests were in excess of 120 pcf, which is approximately 92% of all the tests. Additionally, the spatial distribution of the varying soil densities was not uniform, resulting in heterogeneous distributions of differing soil densities across the spatial footprint of the development. In addition to the large skew between assumed soil density and actual soil density, the complexity of the finish grading for the development further exacerbated the magnitude of realized differential settlements.

Distribution of actual in-place soil densities as a result of differing import sources and compaction effort. Source: Author.

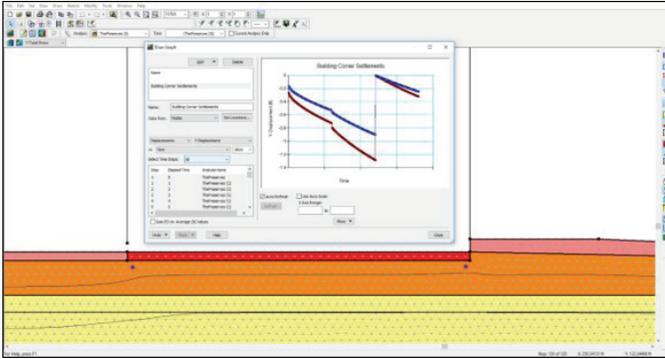
**Figure 13**

The results of the numerical modeling of Building B-B are illustrated in **Figure 13**. The model evaluated the impact on differential settlement across the building. Point “A” is situated on the street side of the building with site grade at approximately El. +102 ft. Point “B” is located on the opposite side of the building, with site grade at approximately El. +106 ft. The numerical analyses of the simplified model show the impact of this fill thickness differential has the ability to increase the magnitude of differential settlement by a factor of two to three. Thus, the project geotechnical engineer’s predicted differential settlements of 2 in. in 40 ft, would increase, as a result

Calculated settlements at building edges with micro-topography effects accounted for. Source: Author.

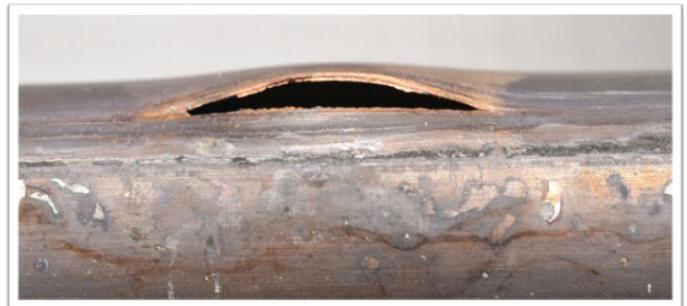
Figure 2

Failed copper pipe “fish mouth.”

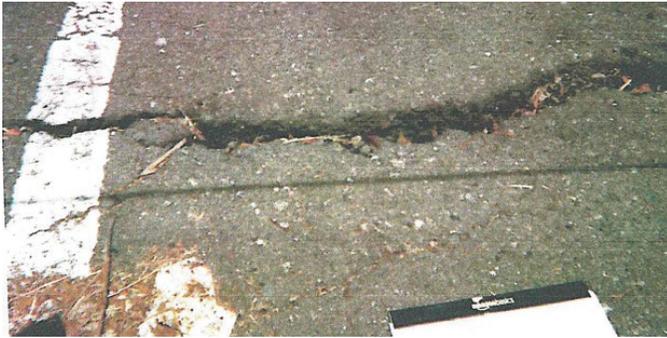
**Figure 3**

Extension cracks were visible in the defendant's parking area (**Figure 3** and **Figure 4**). These cracks formed as a result of translation/rotation of the retaining wall, with the top of the retaining wall displacing away from the defendant's property toward the plaintiff's property. Drain

Extension cracks were visible in the defendant’s parking area as a result of rotation of the retaining wall toward plaintiff’s property.

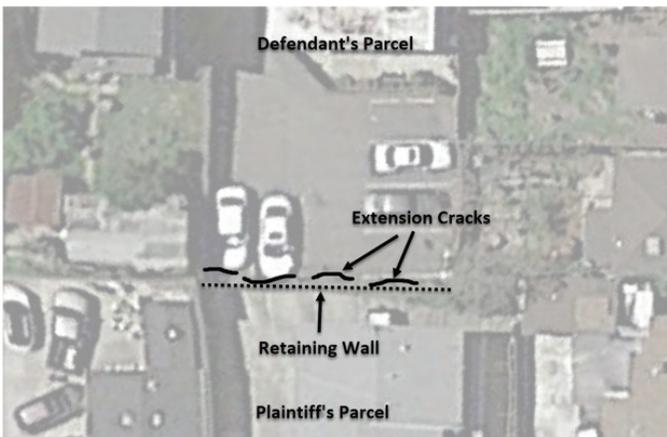
**Figure 4**

Location of extension cracks relative to the location of the retaining wall.

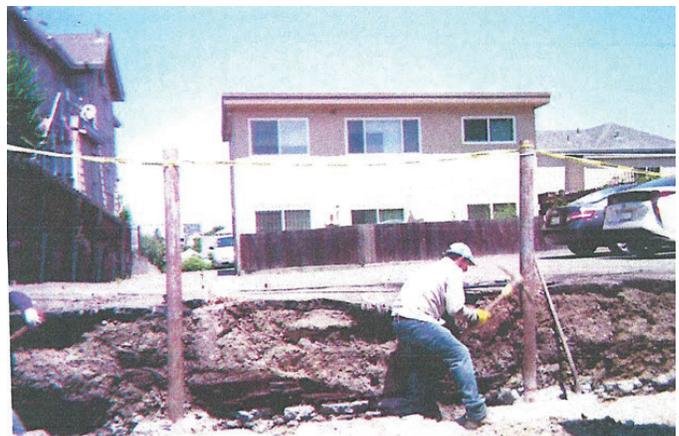
**Figure 6** shows the exposed soil conditions following removal of the distressed retaining wall in 2018. These soils appear to consist primarily of cohesive clayey soils,

Exposed soil conditions following removal of the distressed retaining wall in 2018. Steel posts are bollards.

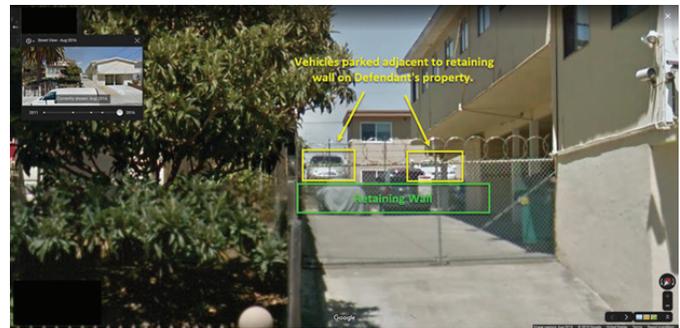
**Figure 11**

Vehicles parked immediately adjacent to the retaining wall exerting a surcharge load.

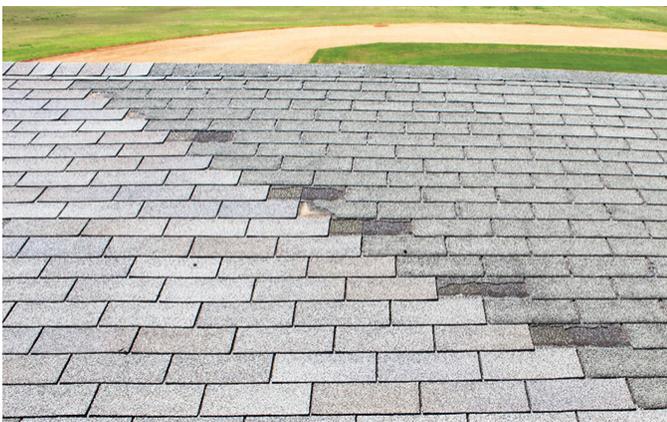
**Figure 1** provides a visual example that demonstrates the results of a failed asphalt-composition shingle repair. In this example, the new material was not properly integrated with the existing shingles. In addition, the older shingles had lost their pliability; therefore, the stress of the repair caused extensive cracking and breakage, resulting in a failure at the junction between the old and new shingles.

Failure of shingles along the perimeter of a previous repair. This represents a typical result of a nondurable and unreliable repair to a three-tab-style asphalt-composition shingle roof surface.

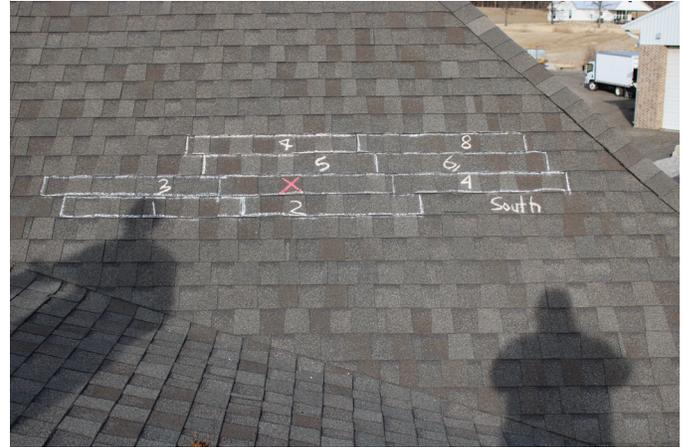
**Figure 12**

in **Figure 12**, the shingle marked with an “X” represents a single damaged shingle. In order to remove and replace this shingle, approximately eight other shingles surrounding this one would be impacted.

- The sealant on the bottom of the damaged shingle, “X,” is adhering to the top surfaces of shingles 1 and 2. Therefore, there is potential to damage shingles 1 and 2 as the sealant is pried open in order to loosen the bottom edge of the damaged shingle.

- Conversely, the same thing exists for shingles 5 and 6, except in this case the sealant strip on the bottom edges of these shingles is bound to the top surface of shingle “X.” Again, there is potential to damage these shingles when prying the sealant loose.

- Because of the nailing pattern previously discussed (**Figure 10**), the underlying shingles, 1 and 2, would be subjected to additional damage during the nail removal process. In these cases, the nail often strips through the shingle material, leaving tears and unsealed holes.

- In order to access the nailing strips of shingles 5 and 6, the bottom sealed edges of shingles 7 and 8 must also be pried loose.

- Finally, shingles 3 and 4 are also susceptible to damage, resulting from the unsealing of the seal strips for shingles 5 and 6 above.

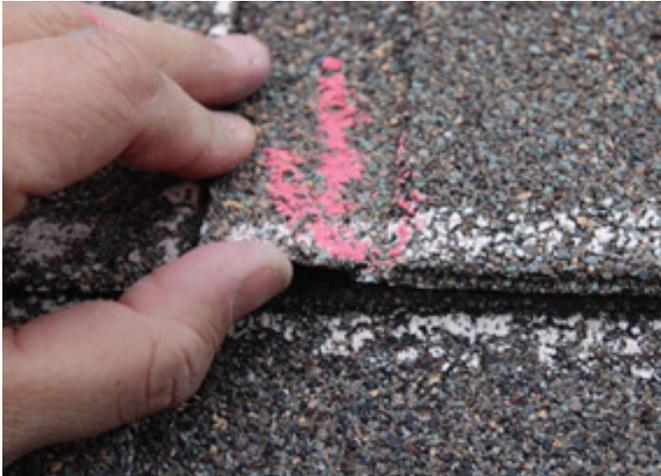
**Figure 14**

View of a narrow tear along the bottom edge of an asphalt-composition shingle.

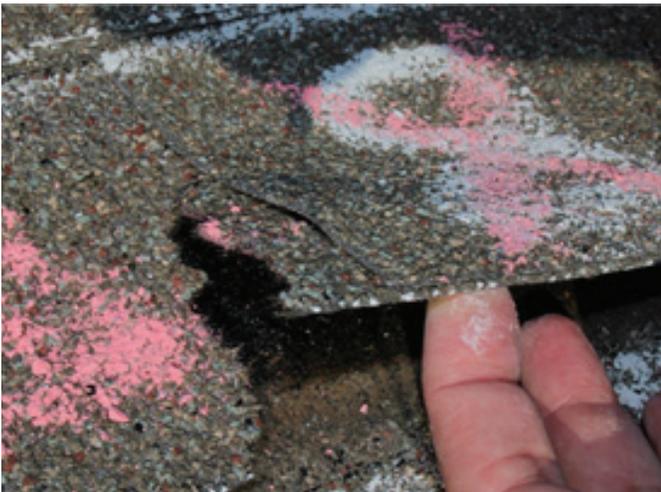
**Figure 15**

View of a tear along the bottom edge of an asphalt-composition shingle.

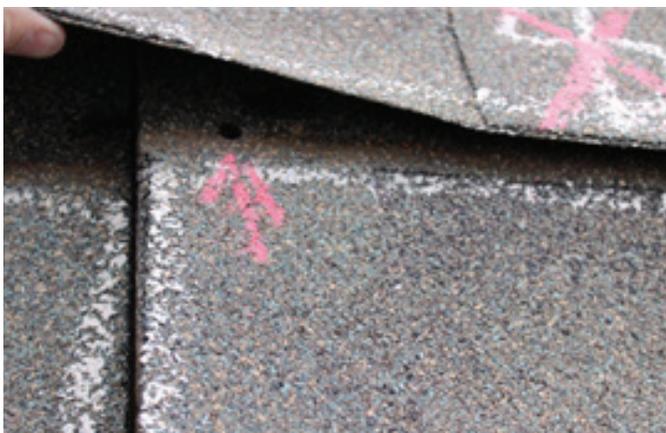
**Figure 16**

Shingle pulled past the nail head during the repairability assessment.

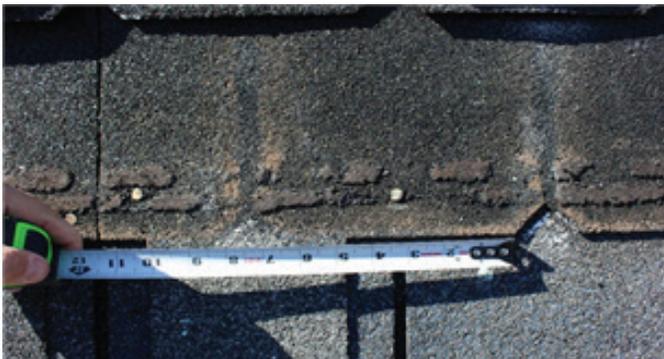
**Figure 17**

Transfer and accumulation of asphalt from the overlying shingle.

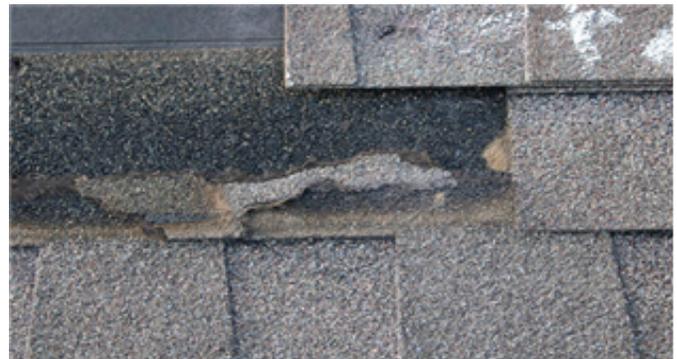
**Figure 19**

Shingles torn, and sections remained bonded to the underlying shingle.

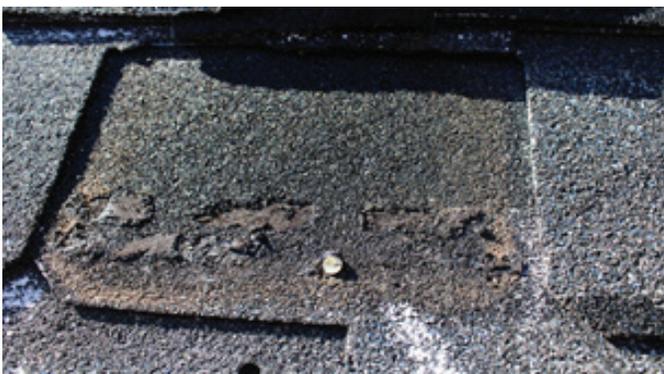
**Figure 18**

Displaced sections of granules at the lower seal strip. In this case, the granules and binder asphalts were transferred to the overlying shingle.

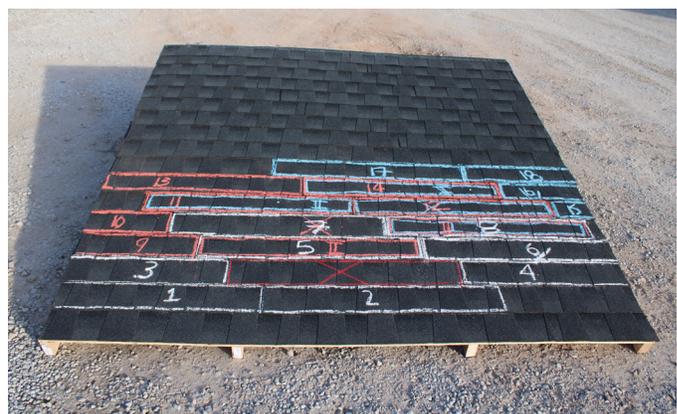
A roof surface is considered to be repairable when individual damaged shingles can be removed and replaced without causing additional damage to the surrounding shingles. However, when adjacent shingles are weakened or unable to maintain their integrity during the repair action, it is likely that any subsequent repairs to fix these newly damaged shingles will result in a continued propagation of damage. **Figure 20** shows an 8-ft by 8-ft demonstration area that underscores this repair issue.

Initial area of influence located within a demonstration roof section.

In this example, the shingle marked with a red “X” demonstrates a shingle undergoing a repair by replacement, and the shingles outlined in white represent the area of influence for this repair. In this case, assume that shingle 7 was damaged during the repair process. The damage rate would be “1,” and the damage ratio would be “1 to 8.” While a 1 to 8 damage ratio sounds nominal, it has the potential to cascade. Since shingle 7 was damaged during the repair process of shingle X, it must now also be replaced. Thus, the repair process must now be repeated and moves into its second iteration.
