Journal of the
National
Academy OF
Forensic
Engineers[®]

Vol. 38 No. 2 December 2021

Forensic Engineering Investigation and Analysis of Crack Formation in Acetal Resin Nuts Used for Water Supply Lines

Non-destructive and destructive techniques were used to document and model crack formation in acetal resin nuts used for household toilet water supply lines. The morphologies of creep rupture and overload failure were documented using optical microscopy and scanning electron microscopy (SEM). The forensic investigation stemmed from litigation between a homeowner, plumbing contractor, and parts supplier related to a failure at a single residence. Fortuitously, 447 fittings in service for approximately two years under similar conditions were available for examination. In many properly installed fittings, cracks had initiated at the notch created by the sharp thread root radius, as predicted by engineering mechanics and finite element analysis. This study found that the cracks had propagated via plastic creep.

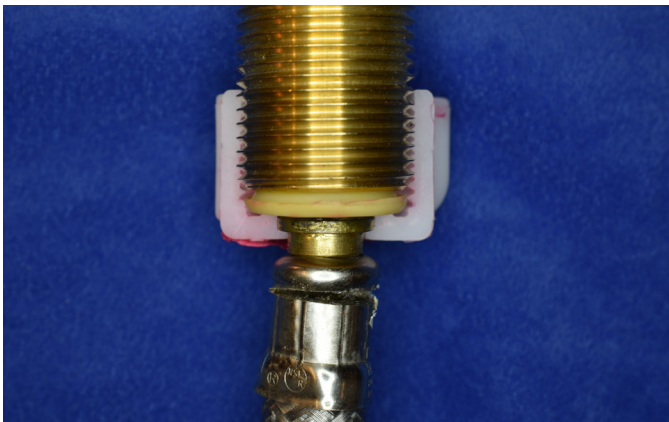
Figure 2

Cross-section showing connection to male-threaded fitting at base of toilet tank.

In use, the toilet connector threads onto a male pipe at the bottom of the toilet tank, compressing a rubber gasket between the interior surface of the connector and the end of the male pipe to prevent water leakage (**Figures 2 and 3**). The contact between the end of the male pipe and the connector creates an outward-directed longitudinal force on the interior surface of the connector. This force creates a shear stress and bending moment within the wall of the connector, with the highest stress located at the interior surface at the bottom of the wall (as shown in **Figure 4**). In addition, the threaded wall of the cap is subjected to a

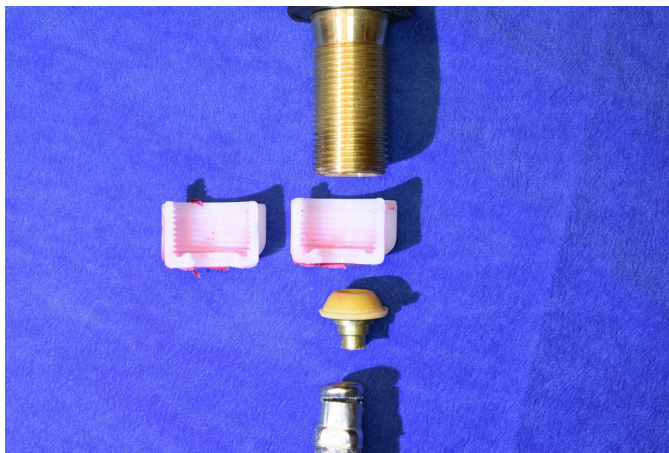
Figure 3

Exploded view of cross-section of connector components.

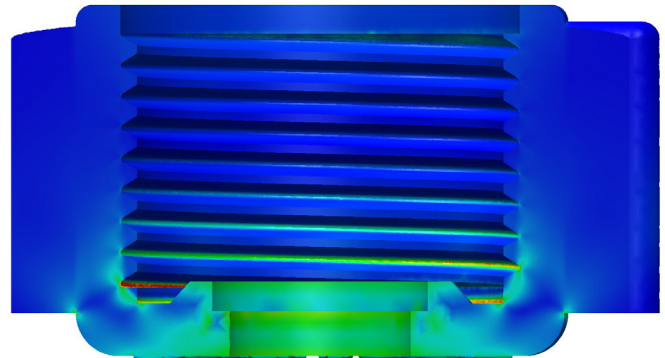
Figure 7

The interior thread extends to the base of the cap. The sharp-edged roots of threads are known as stress risers, which lead to local stress concentrations many times greater than the stress that would be present without the stress riser⁵. **Figures 5** and **6** show a cross-section of a nut examined during this investigation that revealed the presence of a crack that formed at the root of the base thread, as predicted by static analysis of the applied forces and illustrated in the output of FEA performed during this investigation (shown in **Figure 7**).

FEA analysis was performed using a standard simulation software. The geometry of the fitting was based on measurements of a cross-section. Material properties were obtained from material datasheets. A tensile force was applied to the base of the fitting. The goal was not to determine stress values but to identify the most probable location for stress risers in this type of loading. The static simulation performed on the resulting model revealed a stress riser in the root of the base thread of the nut (**Figure 7**), consistent with both the physical findings and predictions based on engineering mechanics.

Qualitative FEA image, showing peak stress at root of base thread in red.

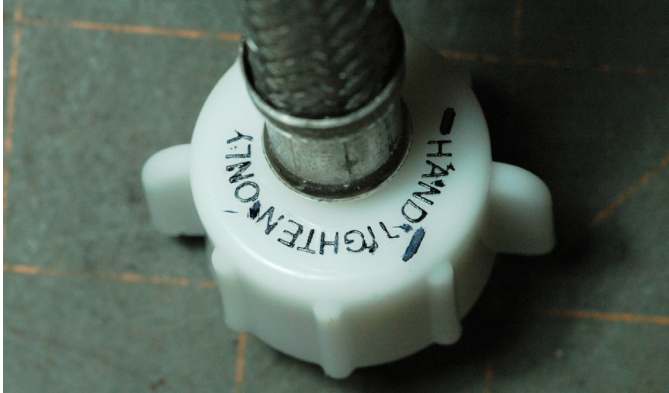
Figure 8

End of nut embossed with instruction to “hand tighten only,” which has been colored for this photograph.

The subject nut in the original case appeared to have tool marks on the outer surface. Experts opined that the nut had been over-torqued, causing creep to occur and leading to the failure. Raised lettering on the end of the nut cap stated “HAND TIGHTEN ONLY” (**Figure 8**). However, this is not a reliable or accurate torque specification. Several studies have identified many factors that determine torque when hand tightening a nut^{3,4}, including age, gender, strength of the individual doing the tightening, and the location of the nut being tightened. Arguably, this means there is no torque specification for these nuts.

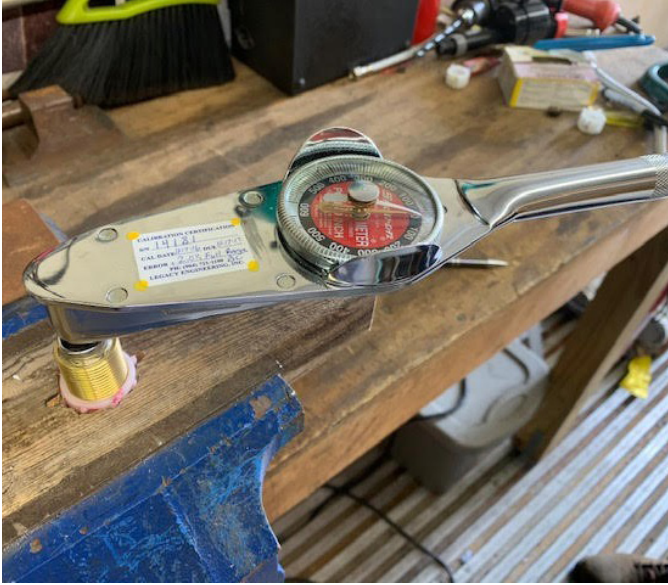
Figure 10
Torque wrench and nut in wood block.

and the load required to do so was recorded (**Figures 10 through 12**). The required torque to cause the part to fracture ranged from 14 to 22 nanometers (nm) 125 to 200 inch-pounds, consistent with data reported by Timpanaro, Shcerzer, Keifer and Eason⁴, who reported torque values of 16.9 to 26.8 nm (150 to 237 inch-pounds).

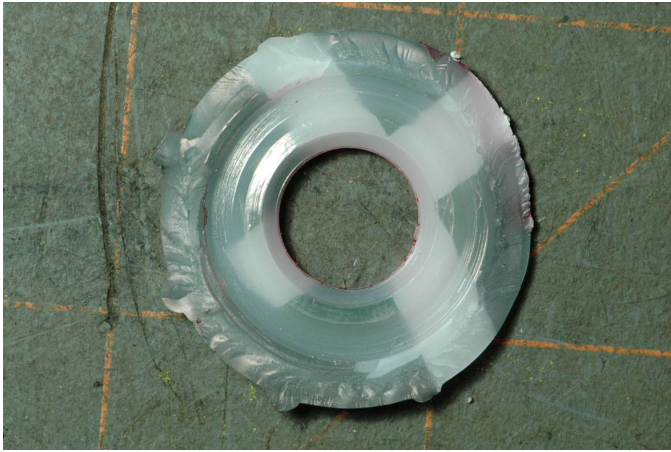
Figure 15

Sample #17, sputter coated.

analytical SEM. The fracture surface was imaged in an uncoated state, using a 5kV accelerating voltage, and spot size of between 96 and 117 nm with the average spot size of 100 nm with a resulting absorption current of 0.58 pascals, to avoid sample charging. After imaging the fracture surface at multiple magnifications, the sample was removed and coated with gold, using a vacuum sputtering system (**Figure 15**). The sample was placed back in the analytical SEM, and the series of fractographs was replicated with respect to location and magnification, at 5kV accelerating voltage, and slightly higher absorption current to illustrate the ability of gold coating to permit higher quality imaging (without changing the features and morphology of the fracture surface). Note that at 20,000 times magnification, the gold coating is invisible

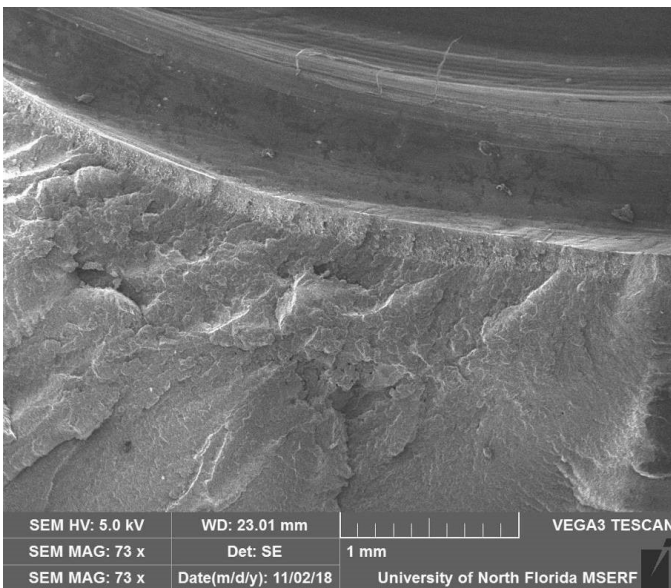
Figure 16

The SEM images after gold coating clearly show two different types of fracture morphologies present in the surface of the same sample. One has plate-like fracture zones corresponding to a fast overload fracture achieved with the torque wrench, while the other (crack that visually showed as red in color) has a tufted appearance associated with sustained loading over time, resulting in creep rupture morphology. See **Figures 16** through **20**. Under sustained

Medium magnification, Sample #17.

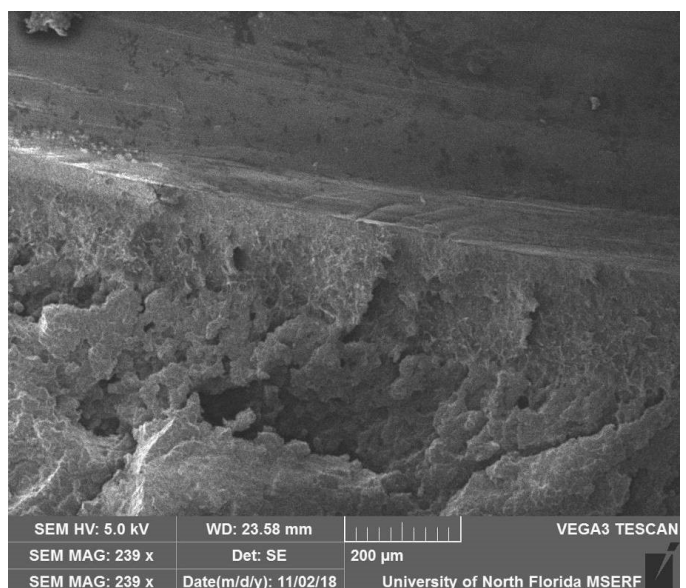
Figure 18

Higher magnification, Sample #17.

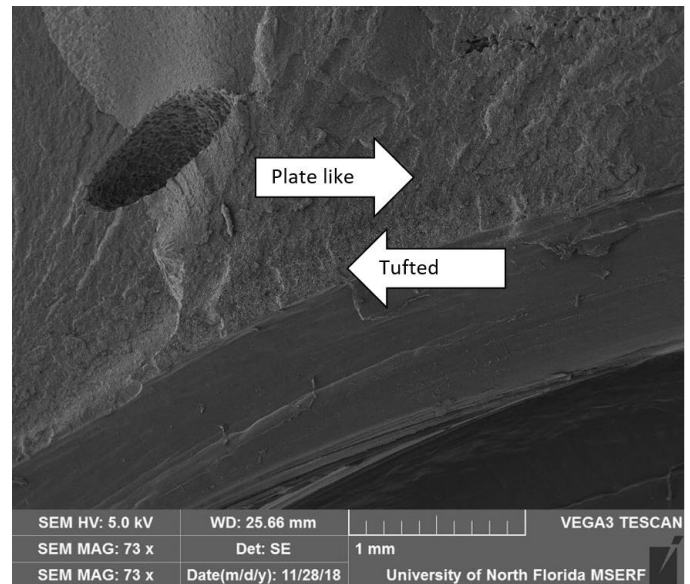
SEM was also performed on two more cracked parts, Sample #9 and Sample #27, which were picked at random from the 10 parts with visible cracks. The SEM photographs for these two samples reveal the same two types of fracture morphology (plate-like and tufted), as described above and shown in **Figures 21** through **24**.

Figure 21
Sample #9, medium magnification.

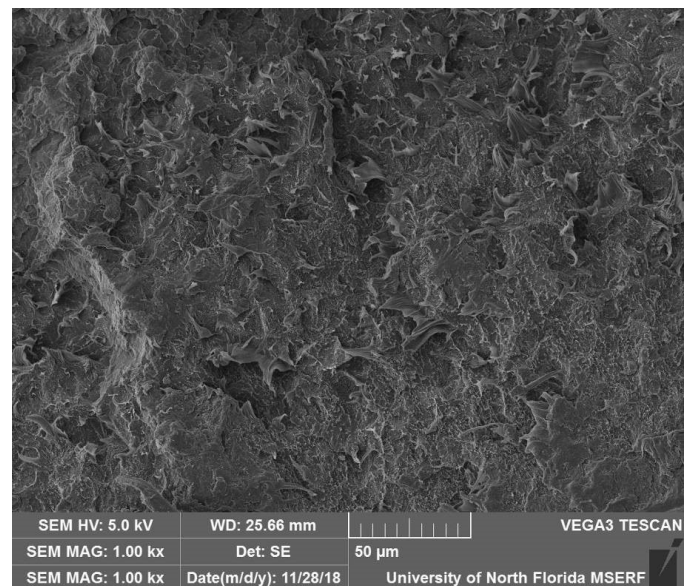
Figure 22
Sample #9, higher magnification of tufted area.

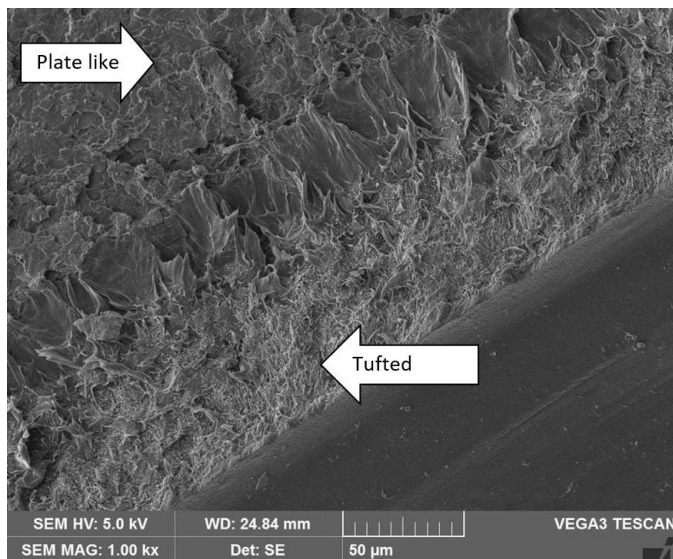
Figure 24
Sample #56 at higher magnification.

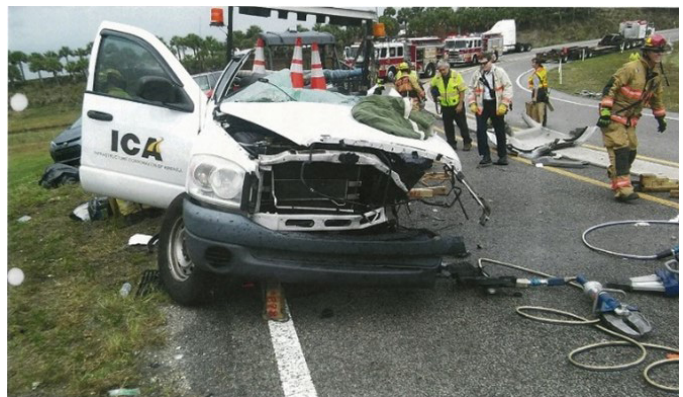
Figure 3

Traffic was described as moderate-to-heavy, and witnesses each reported traveling at or slightly below the advisory speed of 35 mph. **Figure 3** shows the post-impact locations and condition of the pickup.

Collision scene photo taken by investigating officer.

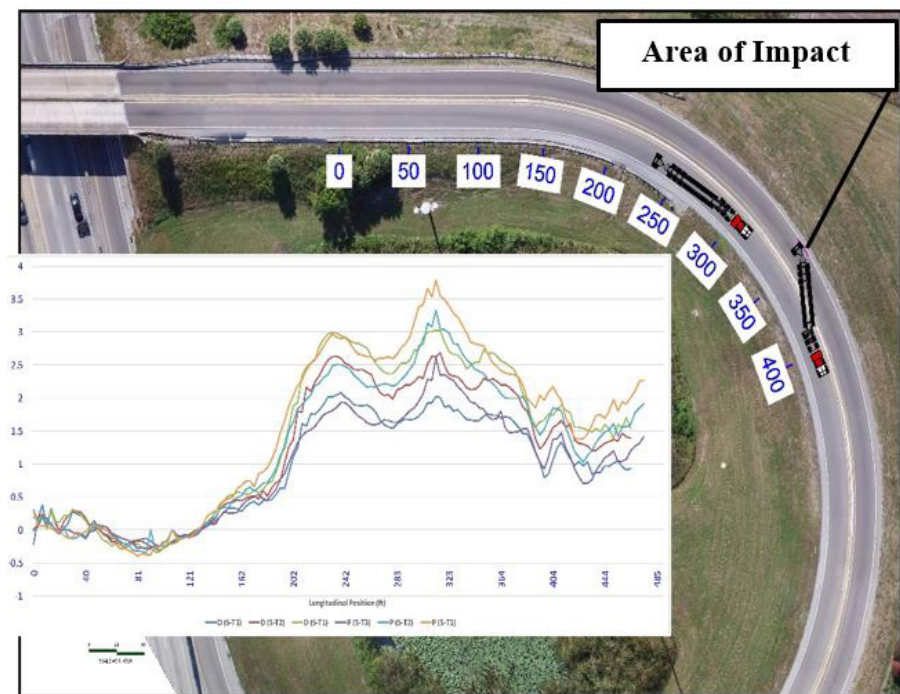
axle geometries were matched to a detailed model of the actual roadway geometry. **Figure 9** demonstrates the trailer wheel lift and gap analysis along the roadway in the area leading up to the collision event. The graph illustrates the difference in height between the asphalt and each of the trailer wheels, driver (D) and passenger (P), for each of the three axles (T1, T2, T3). The figure illustrates the tractor-trailer position when the trailer tires are in the area of maximum height difference and maximum horizontal curvature. This position correlates with the likely loss of traction and subsequent impact. Note that this analysis assumes no droop in the trailer suspension.

Figure 9
Elevation difference of trailer tires above roadway surface from the tractor-booster axle.

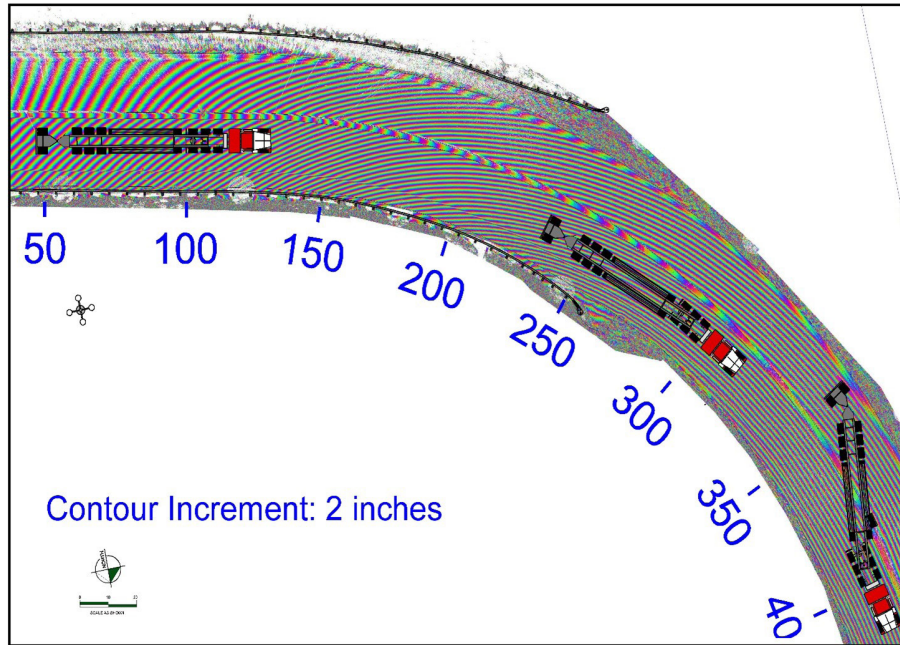
Figure 10 is a contour map of the road surface elevation and shows the tractor-trailer positions at the beginning of the wheel height difference and at the maximum height difference. **Figure 11** is a graphic representation of the trailer tire lift. **Figure 12** illustrates the bridging created by the idealized lift of the trailer due to booster axle loading. This illustration does not include suspension droop. In real-world conditions, the tires were significantly unloaded but did not lose complete contact with the road surface. Reduced normal force caused a reduction in lateral traction, which allowed the trailer to swing to the left in the right-hand curve.

Truck semi-trailer position at wheel lift on road surface showing lines of constant elevation.

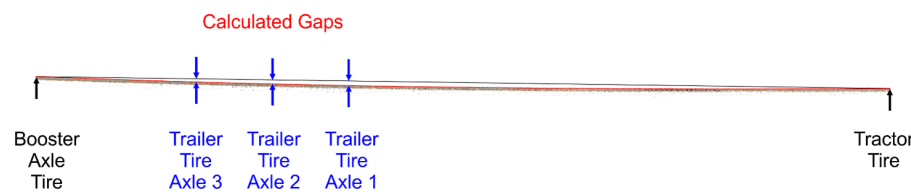
Figure 11

Gap analysis at area with loss of trailer tire friction.

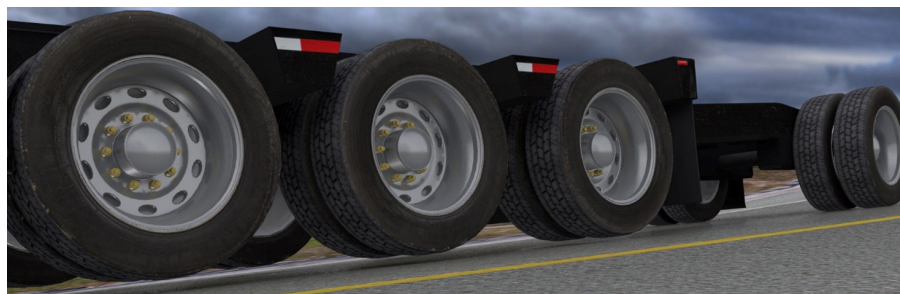
Figure 12

Trailer wheel lift with booster axle loading before suspension droop.

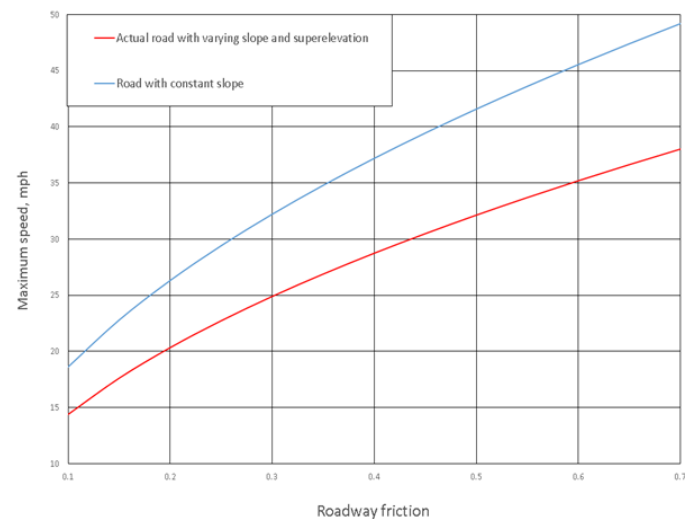
The maximum critical speed for the tractor-trailer at the onset of trailer slide-out as a function of roadway friction is shown in **Figure 15**. Two geometric scenarios are shown: the actual road geometry with varying slope

Figure 15
Maximum speed without trailer slide-out.

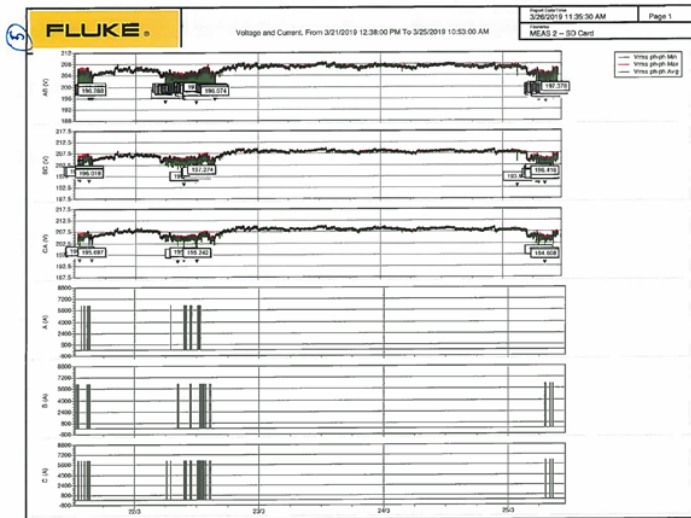
Figure 3

1. *First hypothesis:* Although the buyer's electrician tested and reported normal readings that should not cause problems with equipment, the author's first hypothesis was that equipment failure was due to a fault in the three-phase power distribution. **Figure 3** on page 24 shows amplitude versus time plots of voltages and currents of the three phases. Plots of voltage and current on the neutral wire, referred to as ground, are not included. (Power quality testers, including three phases plus neutral, were available in March of 2019.) The current plots show current spikes of more than

No problems with three hot-phase voltages appear in this voltage power quality plot.

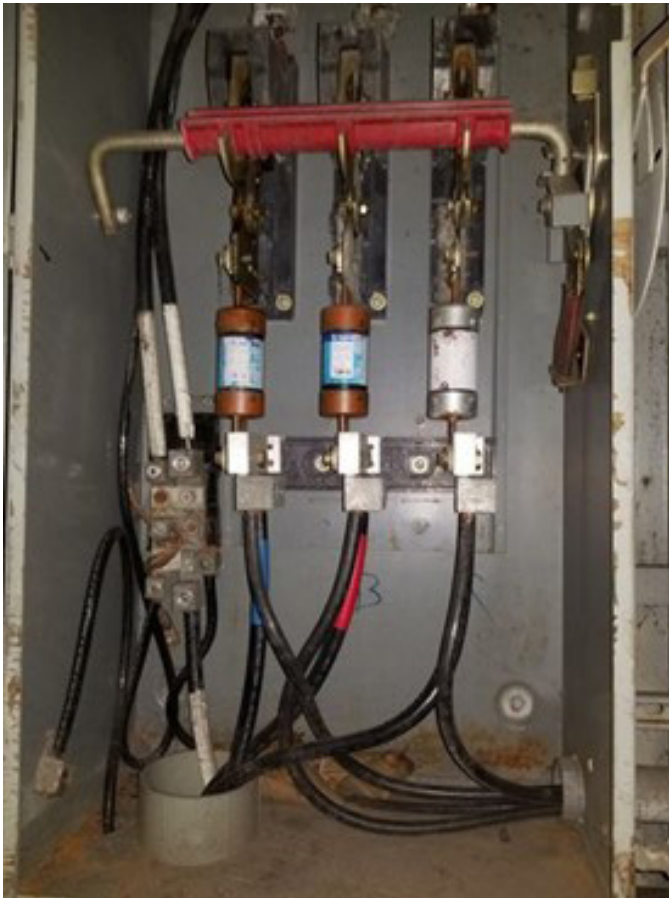
Figure 5

Panel 1, showing proper configuration of three fuses and neutral-to-ground bonding point.

Earth grounding is established by a grounding rod penetrating the foundation into the earth as shown in **Figure 6** (pointed out by the author's foot). This earth-ground is bonded to the node shown in **Figure 5**.

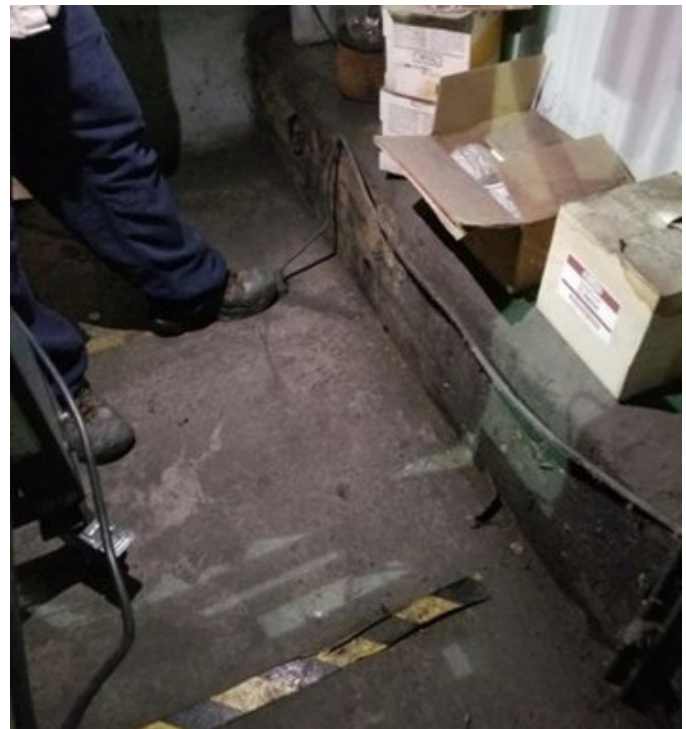
Figure 6

Service ground is established by a steel rod penetrating the foundation into the earth.

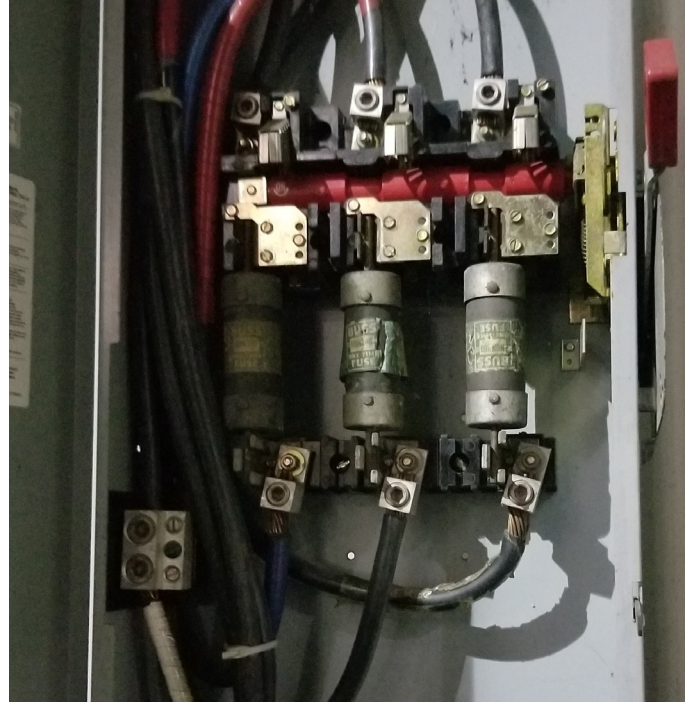
Panel 2 is mounted on the same exterior wall, a few meters from Panel 1. Panel 2, shown in **Figure 7**, limits the available current to 200A. Three hot phases, neutral, and ground wires can be seen. As is proper, neutral and ground are isolated from each other by insulating fittings. This isolation and the bonding between the cabinet of Panel 2 and ground can be seen more readily in **Figure 8**.

Figure 8
Close-up showing neutral isolated from ground within Panel 2.

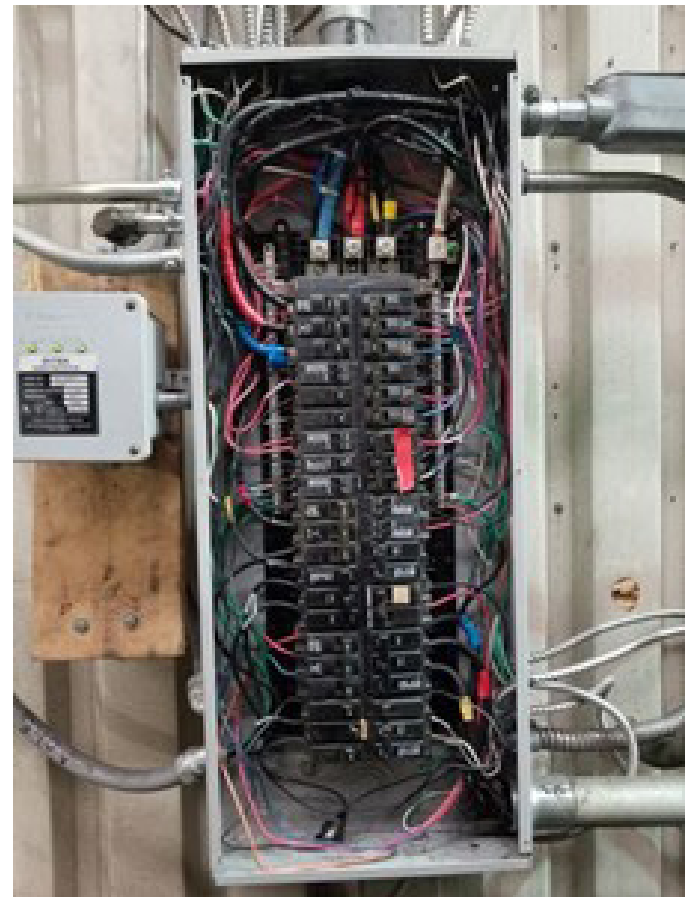
Figure 9
Interior view of Panel 3.

Panel 3 is the first panel upstream from the equipment and is shown on the upper right of **Figure 11** (on page 28). Panel 3 supplies power to the two chargers for the

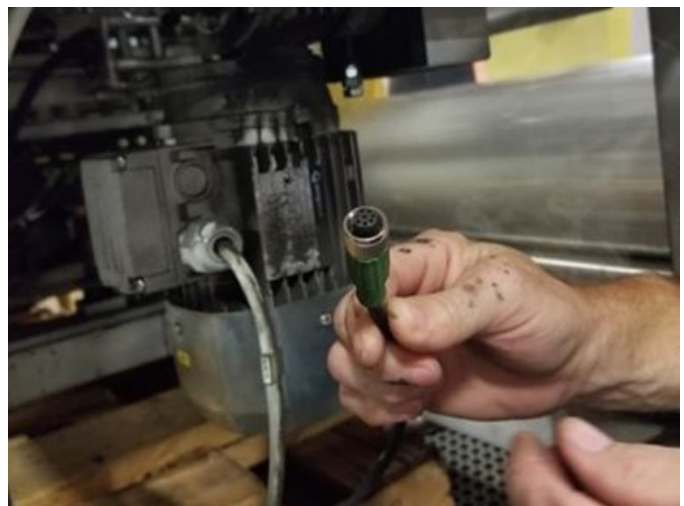
Figure 13
Opposite end of the cable of **Figure 10** where it attaches to the microprocessor.

The opposite end of the green cable connector is shown in **Figure 13**, along with the connecting fixture to the microprocessor. Cable and connector include shielding. Outside of connector is connected to shield and makes electrical contact with the encoder housing. Shielded point to point connectivity to grounded metal housings provides protection from ESD and RFI damage. The author observed similar proper grounding and shielding techniques throughout the equipment, making hypotheses

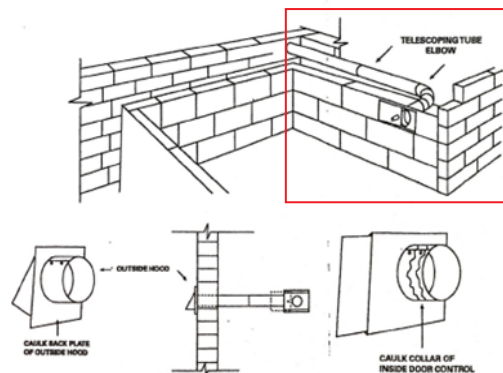
Figure 5

An annotated excerpt from the combustion air kit manufacturer's installation instructions. A steel telescoping horizontal hard duct (tube) is provided with the kit. Note the requirement that the make-up combustion air discharge into the firebox be installed "as far forward as possible and in the third course of firebrick." Note also the multiple instructions not to use combustibles in the construction of the ducting.

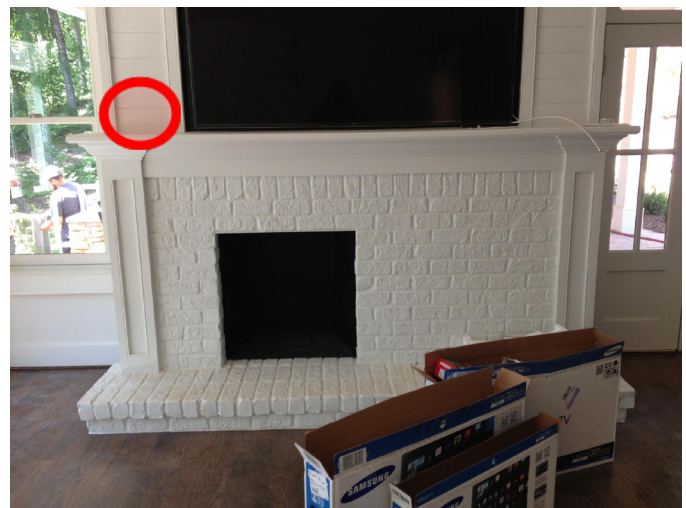
Figure 7

Pre-fire photograph of incident fireplace unit. The circle indicates the area where the witness first observed fire burning through the wall.

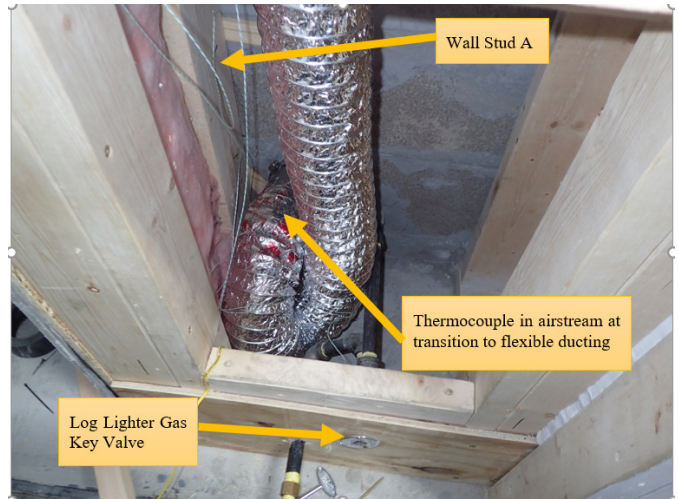
Figure 10

A view into the chase cavity on the left-hand side of the firebox. The rear wall jogged or recessed inward into the chase on the left-hand side. The wall stud, identified as “A,” also in **Figure 9**, was placed in direct contact with the firebox and wood wedges inserted in the gaps where thermocouples were located.

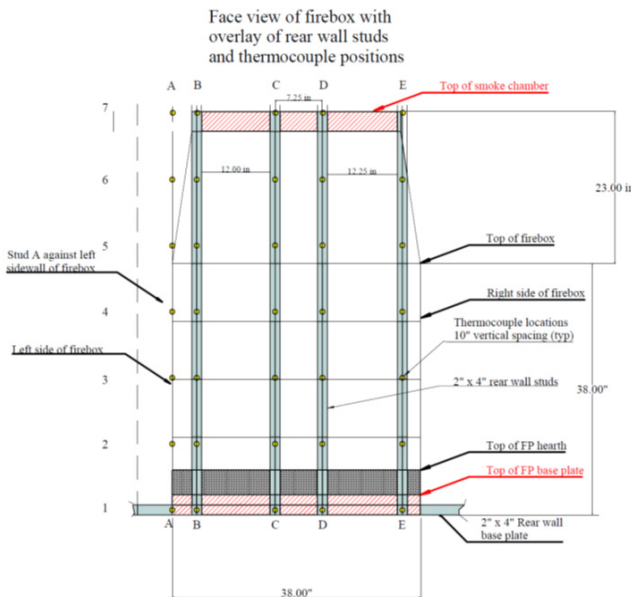
Figure 9

Thermocouple locations on the rear chase wall and interior left side jog wall extension stud. The view is from the front of the firebox looking at the studs behind the firebox. The horizontal lines represent the joints in the masonry firebox and smoke dome construction.

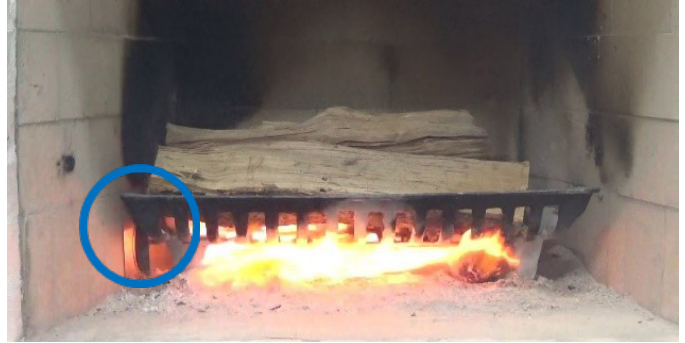
Figure 12e

Continued flash fire propagation right to left toward register door. Door, circled, partially open.

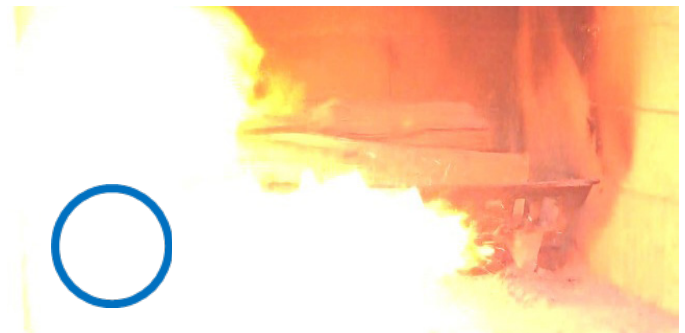
Figure 12f

Flash fire impingement on the left-hand side of the firebox and door when accumulated gas is ignited.

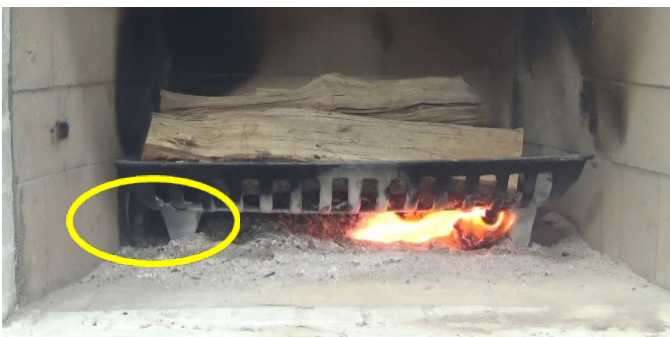
Figure 12d

Flash fire ignites on the right-hand-side and propagates rapidly to the left beneath the firewood.

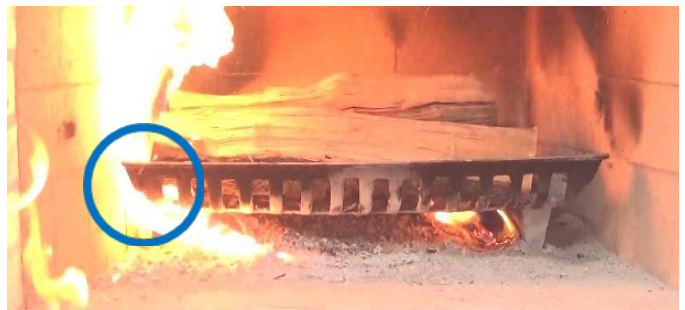
Figure 12h

Asymmetric flames from the log lighter and horizontal deflection to the left side of the firebox and onto the register door. Near flash fire end.

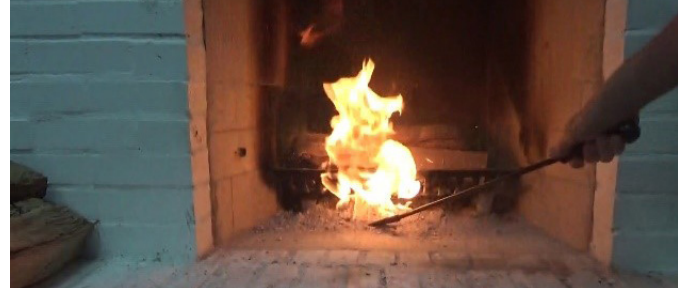
Figure 12j

2. Ash tends to enter and block off portions around the perimeter of the pan style log lighter cap plate where gas would otherwise normally escape and then burn. As a result of this blockage, sometimes no gas discharges around large sections of the perimeter top cap plate while the unblocked portions of the cap plate discharge the full amount of gas (asymmetric discharge of propane gas). See **Figure 8(q)** for symmetric discharge and burning of gas from the log lighter.

Ash cleaned out of the log lighter ports to create a more even distribution of gas and flames.

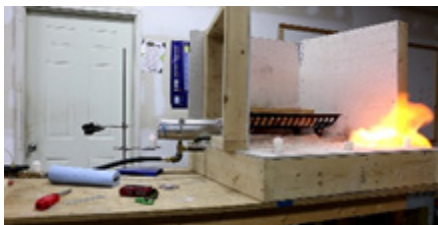
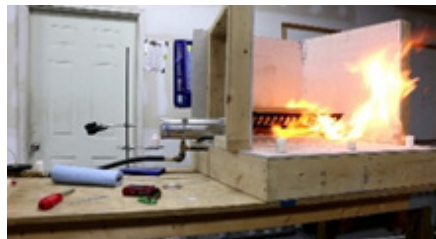
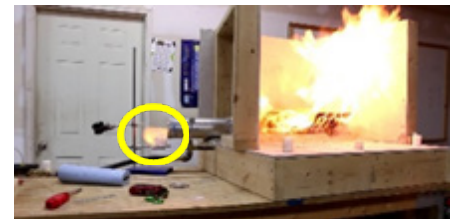
Propagation through ductwork and into the firebox (left to right).

Figures 15(a) through **15(c)** depict an initiating flash fire generated when “trenched” ashes allowed gas to migrate into the rigid ducting and reach the lower flammability limit (LFL) at the point the flexible ducting would have been connected. The combustion air discharge register door was open only approximately 1/2 inch.

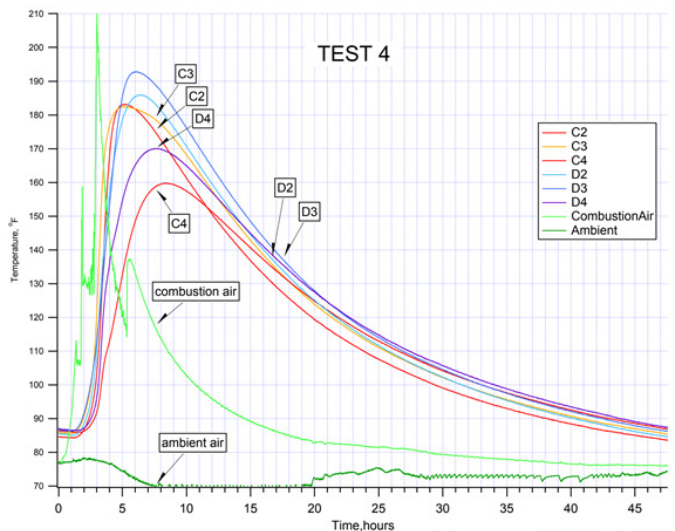
Figure 18

The maximum temperature reached during test 4 on the exterior wall of the firebox in contact with the wood was approximately 193°F, occurring 6 hours after the initiation of the test. The software was set to depict the graphs of all thermocouple points that exceeded 150°F. Temperatures briefly exceeded 450°F in the combustion air ducting during the flash fire illustrated in **Figure 12**; however, the temperature point was removed to maintain graph scale and clarity. For the most part, flames and embers were intentionally kept away from the combustion air door, but occasionally burning wood fell near the door and temperatures in the duct work elevated.

Time-temperature curves for test 4. The combustion air duct door was partially open during the testing.

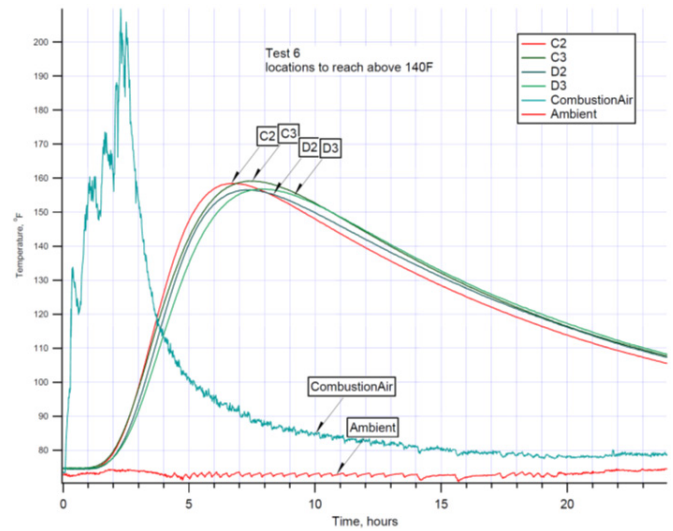
Figure 19

Time-temperature curves for test 6, baseline test most approximating use conditions of the fireplace. The combustion air duct door was partially open during testing. Maximum temperatures of the firebox wall remained below 160°F.

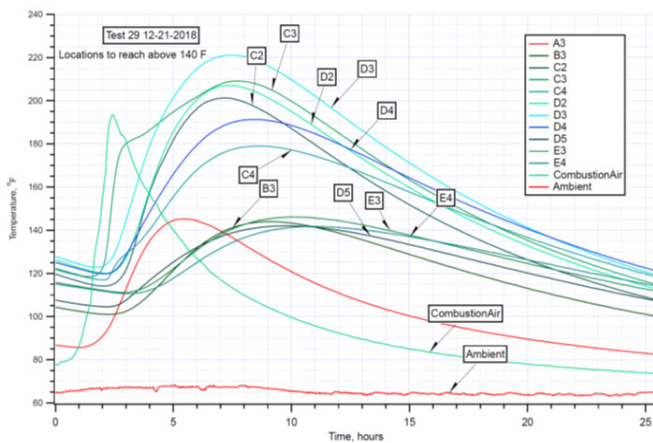
Figure 20

Therefore, to develop conservative results, multiple series of tests were run “back-to-back” (i.e., assuming a fire of similar size and duration was burned in the fireplace consecutively every 24 hours) — sometimes two to three days in a row. **Figure 20** depicts testing results from one set of back-to-back testing over a three-day period. Even with the back-to-back testing, maximum temperatures did not exceed 222°F. In these tests, it was observed that the heat transfer to other portions within the large masonry fireplace mass begin to increase (i.e., more thermocouple points begin to appear on the graphs) as the heat is more uniformly distributed within the firebox masonry.

Results of back-to-back testing over three consecutive days. Note that the incident fireplace was only used once or twice each week (the home had five other fireplaces).

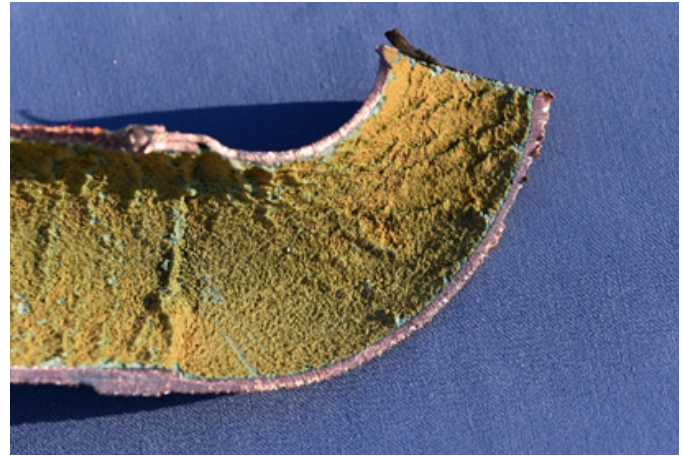
Figure 1

Copper is a soft and reasonably reactive material. When used in water reticulation systems, it typically develops a protective coating either through the formation of copper oxide or copper carbonate films or a layer of minerals precipitated from the water being carried by the pipe. In essence, the copper becomes the mechanical support for a contact surface that is not metallic copper (**Figure 1**).

Copper pipe after 30 years of service with an internal coating.

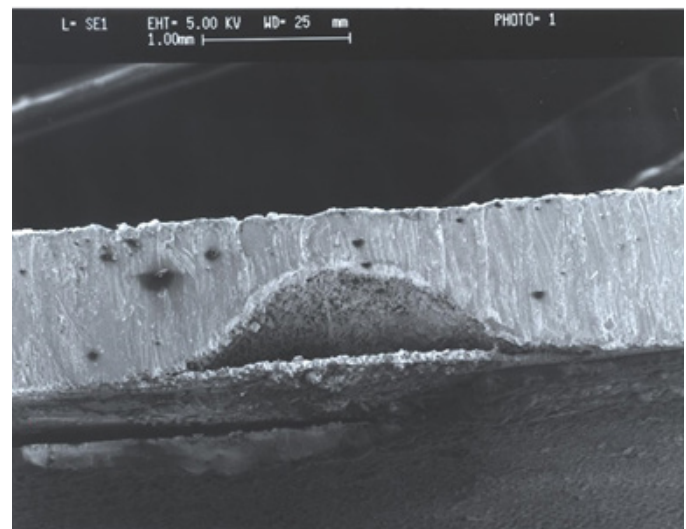
Type I pitting is rarely (if ever) seen in current installations. This is because the root cause was identified as being a thin carbon film left on the inside of the pipe during the manufacturing process as a result of oxidation of drawing lubricants^{12,13} (**Figure 2**). This film was generally imperfect, and accelerated electrochemical pitting took place at breaks in the film. This happened in cold water,

Figure 2
Scanning electron micrograph of a Type I pit.

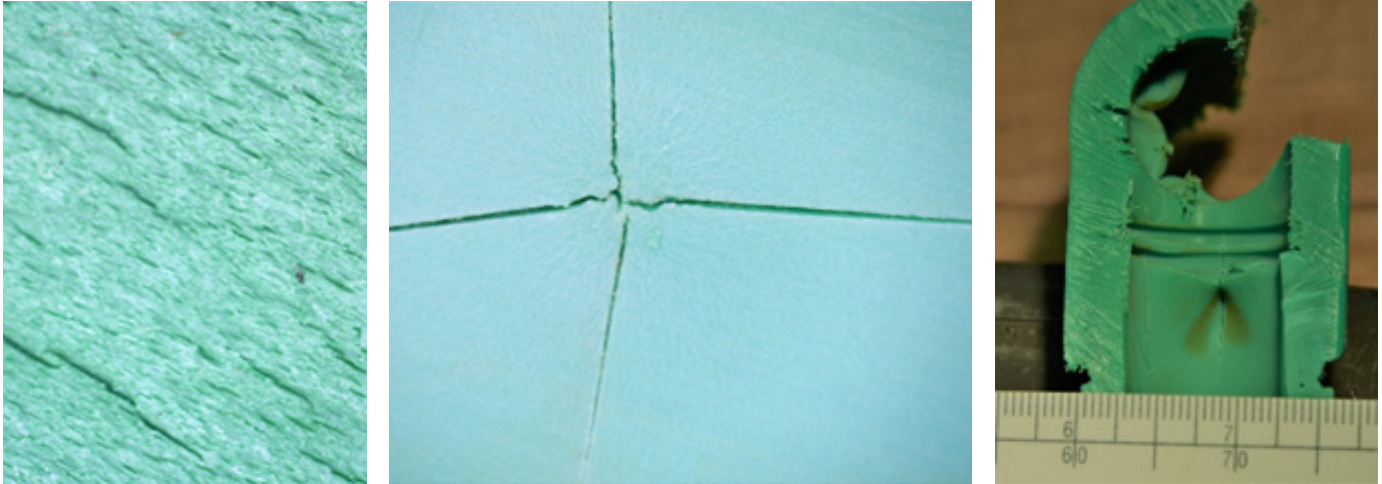
Figure 6

One common factor in both these types of failure is a water temperature above 65°C, but the nature of the failure obviously is different in different materials. Some failures as observed in polypropylene random copolymer are related to stress or joints that appear to have been moved during fabrication while the joint is still hot and occur in both hot and cold services (**Figure 6**, on page 58).

Typical failures in PPR piping in hot and cold systems. Left: internal surfacing cracking; center: cracking from point stress; right: cracking from poorly formed joints.

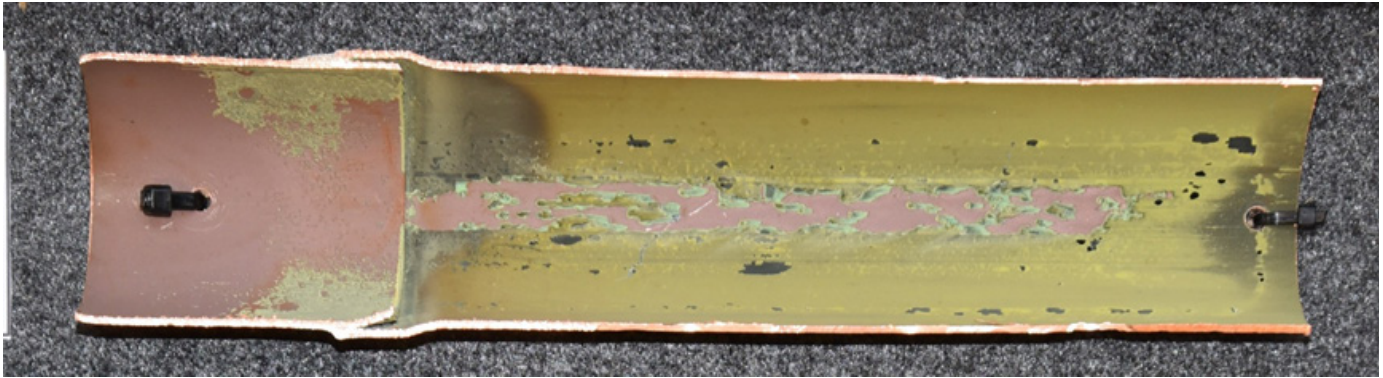
Figure 9

Hot water above 65°C is an aggressive material with a high capacity to damage copper through erosion, particularly as a result of cavitation, which can be originated by poor joints (**Figure 7**) or partially closed valves used for flow control (**Figure 8**). It can also erode apparently smooth surfaces most likely starting at a small surface imperfection³ (**Figure 9**, on page 60).

Left-hand end general material removal from surface with gross erosion extending from a burr measured at 0.1 mm high at the joint coupled with a poorly formed joint. Flow left to right. (Bend in joint at bottom was caused when the section was cut.)

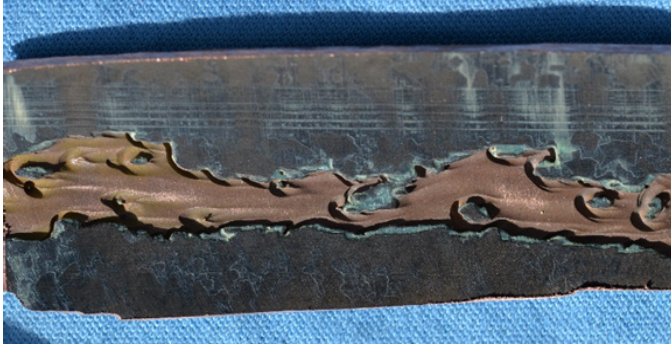
Figure 11

Gross material erosion. Flow from left to right cut from a section of pipe about 3 meters (10 feet) long.

horseshoe shape (**Figure 11**). The direction of flow can be identified using the mnemonic that horses walk upstream. It may be difficult to find an origination for this kind of erosion, which can extend for significant distances along the inside surface of the pipe.

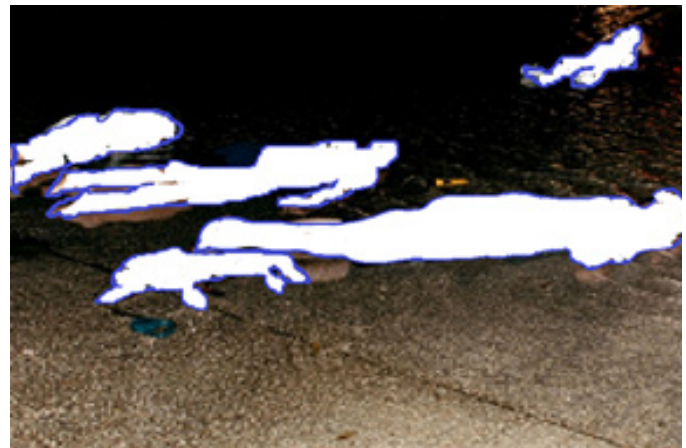
Figure 1

Location of victims observed in the puddle of water after electrocution.

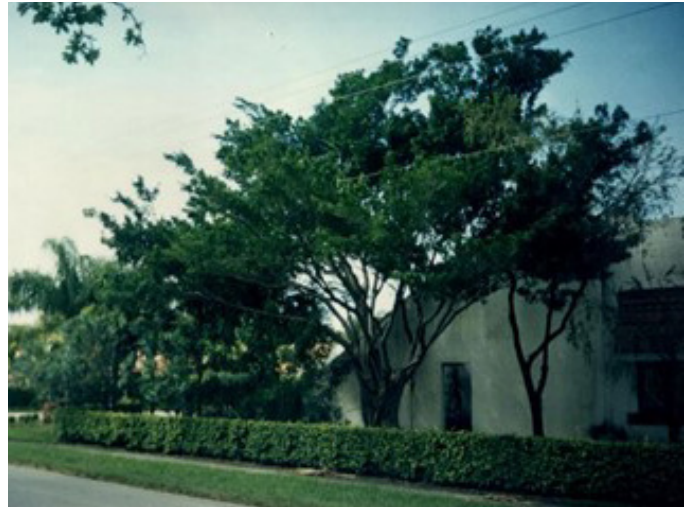
Figure 3

Neutral conductor in the Ficus tree after the incident.

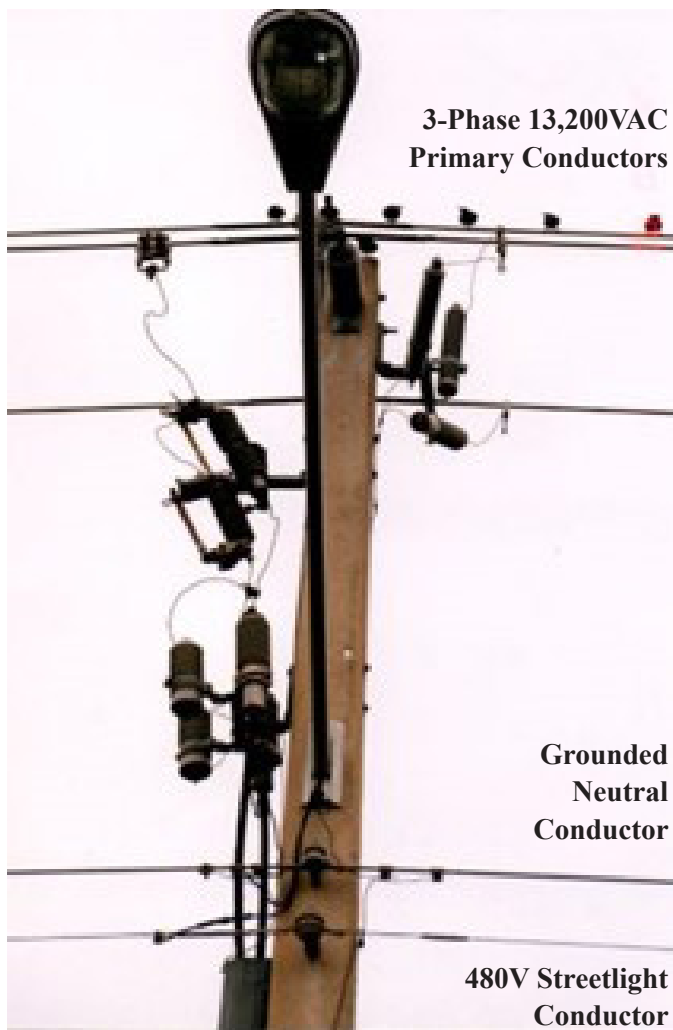
Figure 2

north side of the street. A neutral conductor (3/0AWG AAAC) was underbuilt. The #4 AWG AAAC streetlight conductor was mounted 1 foot below the neutral at each concrete pole (**Figure 2**).

Streetlight conductor configuration.

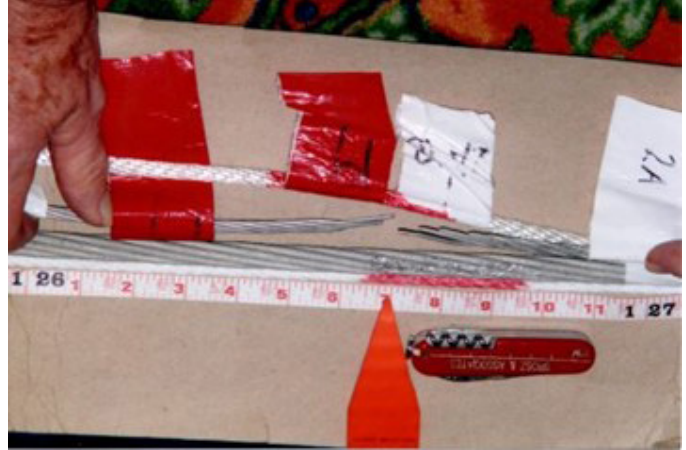
Figure 9

Severed streetlight conductor.

- a. Close visual and optical examination of the neutral and streetlight conductor revealed a short circuit occurred between the two at the 126-foot location and at other locations. The seven strands (7 x 0.0843 inches) of the #4 AWG streetlight conductor were melted and severed (**Figure 9**). The larger neutral conductor was only one of its seven 0.1672-inch strands severed (**Figure 6**).

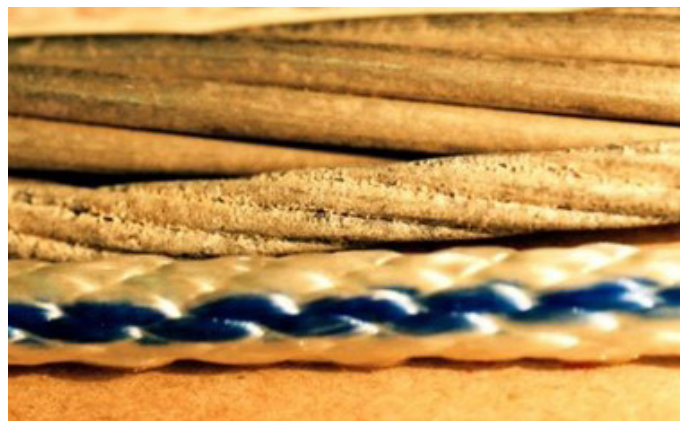
Figure 11

Rope copy of conductor with vegetation contact markings.

- b. On the severed conductor, evidence of long-term contact with vegetation (**Figure 11**) resulted in a form of corrosion. The survey was conducted six years after the event and tree trimming.

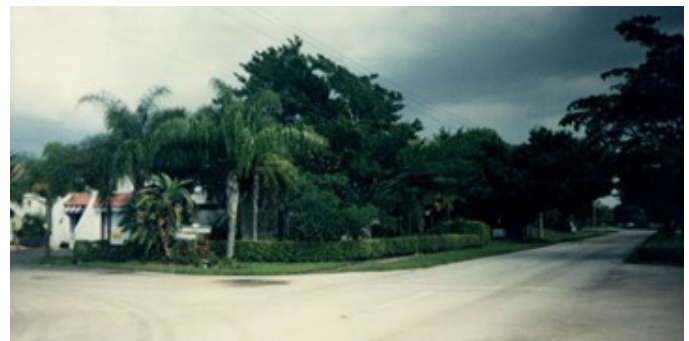
Figure 12

- c. New shoots emanating from the Ficus tree trimming cuts were observed. The diameter of the cuts ranged from 3 to 6 inches, corroborating the extent of branches in contact and in the vicinity of the open conductor. Production of documents revealed trimming had not occurred for at least six years prior to the electrocution. The tree

- d. The primary cause factor for the short-circuit event was due to the lack of vegetation maintenance. The vegetation was not appropriately managed in maintaining a 6-foot clearance between powerlines and trees. According to the utility standards, appropriate vegetation management requires to maintain a clearance of 6 feet between power lines and trees⁵. This distance was not met and was a large factor in causing the short-circuit event.
- e. Short circuits caused by conductive flying objects were ruled out due to the lack of flying conductive objects found, seen, or reported. Furthermore, the momentary contact would not be long enough to produce the damage observed.
- f. Sustained contact with branches alone at 480VAC would not draw sufficient current to produce the arcing damage observed — only corrosion evidence is attributed.

Ficus branches below neutral 3/0 and #4 streetlight conductor (removed) following the incident and prior to trimming.

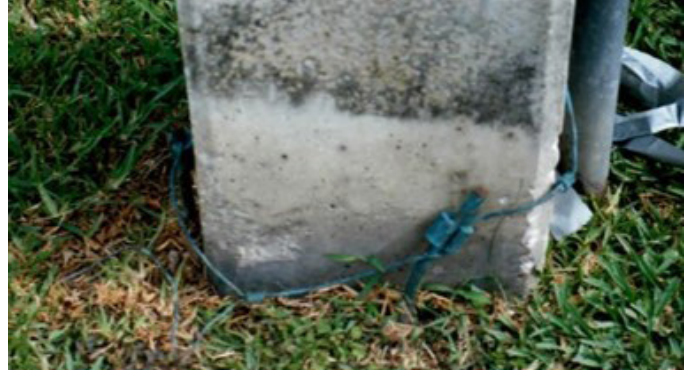
Figure 13

Ground rod at the base of the transformer pole.
