Journal of the  
**National**  
**Academy** OF  
**Forensic**  
**Engineers**<sup>®</sup>

Vol. 39 No. 1 June 2022

‡ FE Analysis and Visual Presentation Methodology of Mechanical Systems .....	1
<i>By David A. Danaher, PE, DFE (NAFE 703F) and Sean M. McDonough, PE (NAFE 1146M)</i>	
‡ Forensic Engineering Research and Testing of Building Copper Tube Water Piping System Freeze Failures.....	13
<i>By Joseph G. Leane, PE, DFE (NAFE 524F)</i>	
+ FE Use of Arc Mapping/Arc Fault Circuit Analysis in a Residential Kitchen Fire Investigation .....	29
<i>By Jason McPherson, PE (NAFE 852M)</i>	
§ Forensic Engineering Investigation of a High-Voltage Transmission Line Anchor Shackle Failure .....	35
<i>By Daniel P. Couture, PEng, DFE (NAFE 951S)</i>	
+ Resolving Schedule Delay Claims with Forensic Analysis .....	47
<i>By Michael D. Stall, PE, DFE (NAFE 955M)</i>

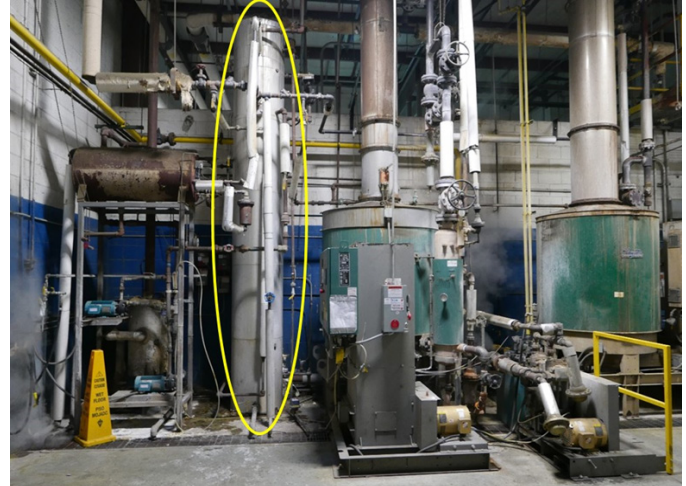
The incident, which occurred in April 2017, involved a storage tank that stored steam condensate, which was used in a commercial manufacturing process. The tank measured 30 inches in diameter and 17.5 feet tall and weighed approximately 2,000 pounds. At the time of the incident, the tank contained approximately 510 gallons of condensed steam at a temperature of 330°F and pressure of 100 psig<sup>4</sup>. The tank, which is referred to as a "semi-closed receiver" or SCR, received surplus steam from the plant, and allowed additional hot water makeup from an external reservoir with a vent to the environment. **Figure 1** shows an exemplar tank highlighted with a yellow circle.

**Figure 1**  
Exemplar SCR highlighted by the yellow circle  
(photograph taken by Kineticcorp).

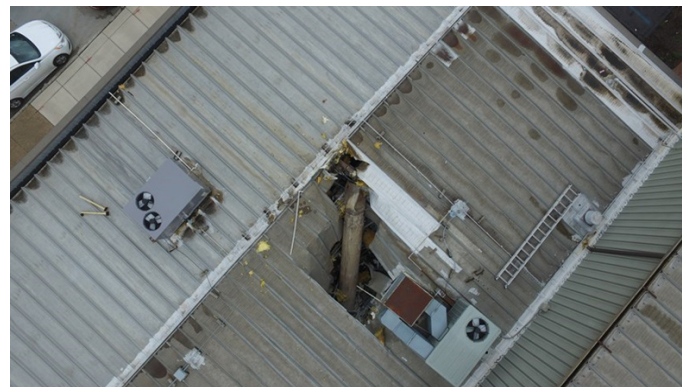
At the time of the incident, the bottom cap of the tank failed, allowing the pressurized water in it to flash instantaneously into steam. The volume of steam produced was approximately 75 times that of the water volume of the tank<sup>4</sup>. The amount of energy instantaneously released was equivalent to 350 pounds of TNT, which was mainly directed in rocketing the tank through the roof of the building and propelling it 425 feet into the air. The tank traveled in a parabolic trajectory for more than 10 seconds and landed 520 feet laterally away from its original location at a speed of approximately 120 mph at impact<sup>4</sup>. The tank crashed through the roof of a neighboring commercial building and fatally injured three individuals. **Figure 2** shows the final resting location of the SCR tank in the commercial building.

**Figure 2**  
Resting location of the SCR tank through  
the roof of the commercial building<sup>4</sup>.

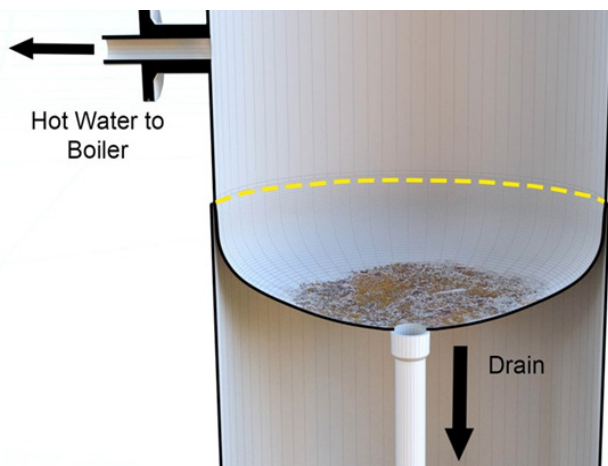
**Figure 5**

The yellow line shows where the skirt was cut to access the bottom cap (image produced by Kineticcorp).

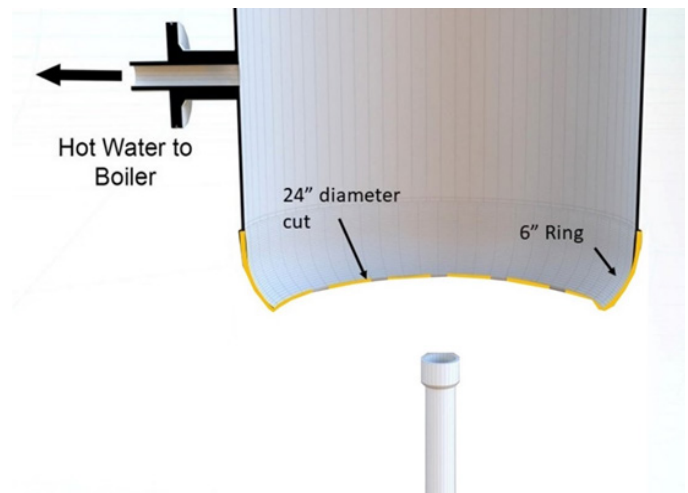
**Figure 6**

24-inch diameter section removed from bottom cap with the original 6-inch ring of cap remaining (image produced by Kineticcorp).

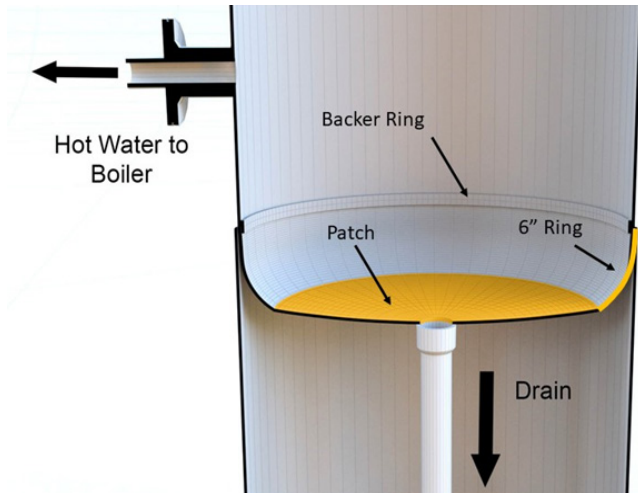
**Figure 7**  
Backer ring, 6-inch ring and repair patch  
(image produced by Kineticcorp).

The new patch was then welded to the remaining 6-inch ring from the original ellipsoidal cap, and a hole was cut in the patch where the drain was then welded in place. The repaired bottom cap and the skirt were then reattached to the tank of the SCR using a 1-inch-wide and 0.25-inch-thick backing ring behind the weld. **Figure 7** shows the backing ring, 6-inch ring, and patch after the repair.

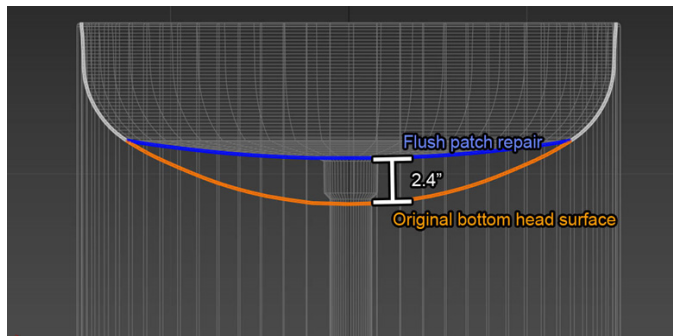
Although the reduction in the thickness due to corrosion of the original 6-inch bottom cap was the ultimate cause of the failure, the shape and design of the 24-inch patch also played a role. When the patch was installed, the size was sufficient to cover the removed bottom section; however, the shape did not match the original ellipsoidal profile. **Figure 12** shows the shape of the bottom cap with the repaired patch piece compared to the original bottom cap. As can be seen in **Figure 13**, the patch piece is much flatter compared to the original ellipsoidal-shaped bottom cap with the maximum deviation of 2.4 inches measured at the apex.

**Figure 12**  
Comparison of the flat patch piece to the original ellipsoidal bottom cap (image produced by Kineticcorp).

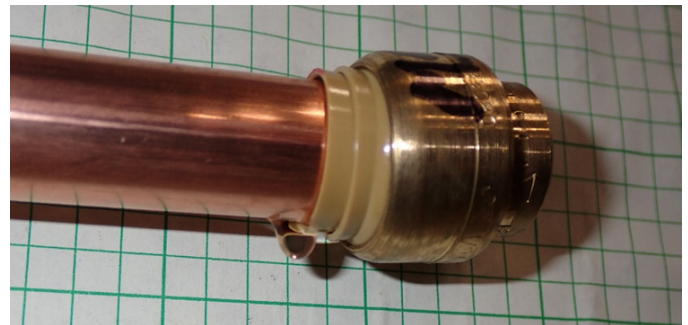
**Figure 12**

*Group 5 tests:* Push-to-connect caps were fully pressed onto the ends of copper tube so there was full engagement. The caps began to drip water at an average pressure of 1,029 p.s.i. (**Figure 12**). Failure pressure readings from different trial runs were within 30 percent of each other. Some movement of the caps on the tube was observed. In later tests, the caps were installed on copper tube and frozen solid (**Figure 13**). During those tests, the metal outer caps were pushed off the tube by the expanding ice. However, the inner plastic components remained on the tube.

Photo of a push-to-connect cap dislocated on copper tube.

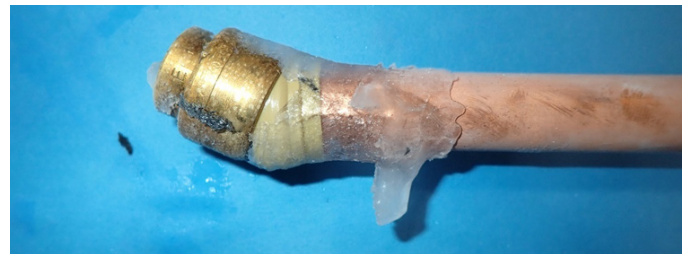
**Figure 13**

Photo of a push-to-connect cap separated from frozen solid copper tube.

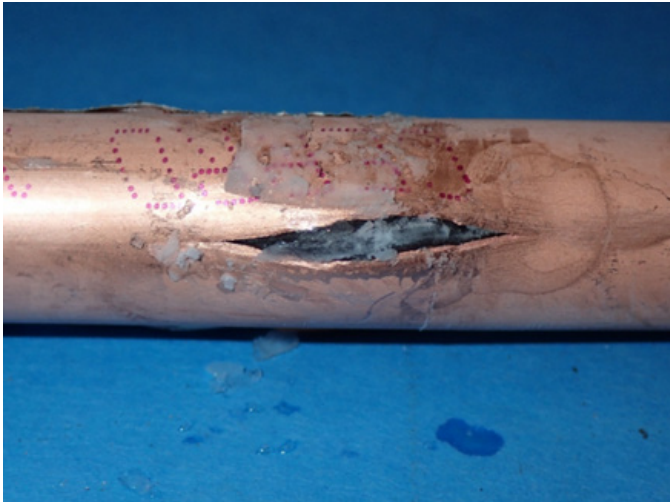
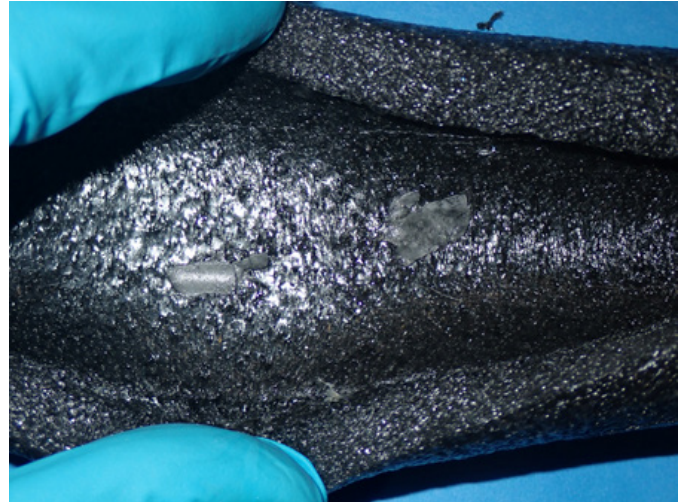
**Figure 20**

During trial runs, the horizontal legs ruptured generally near the middle in longitudinal hoop stress type

Photographs of ice that formed in the annular space between the tube and insulation.

failures (**Figure 20**). A thin layer of ice was observed to have formed on the outer surface of the tube and the inner surface of the insulation at the rupture, indicating liquid water had flowed out of the rupture and into that annular space where it froze.

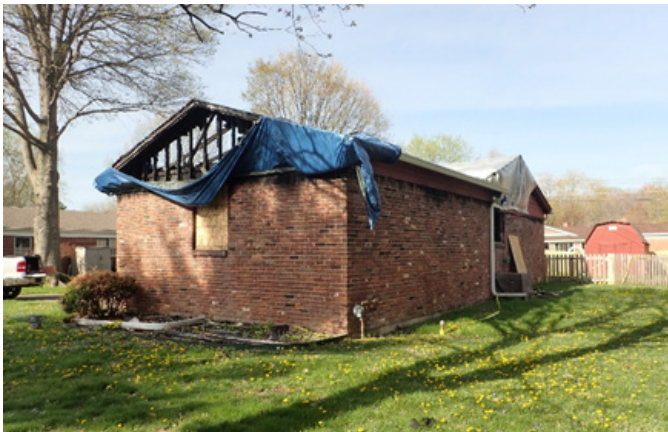
**Figure 1**

Exterior photograph of the residential structure.

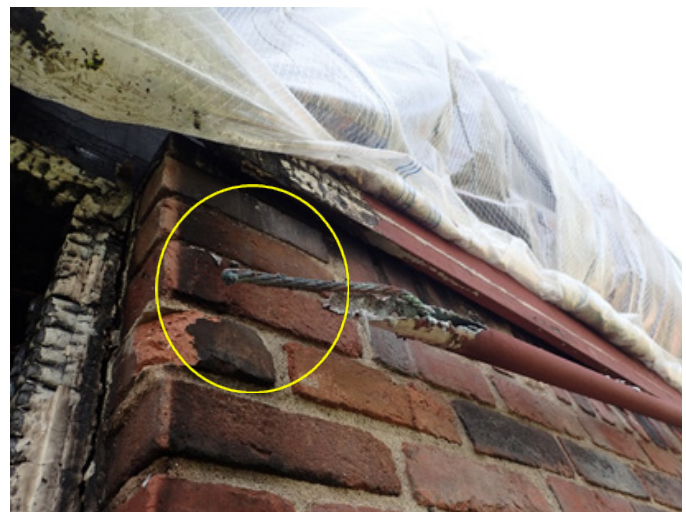
**Figure 4**

During the electrical survey, it was noted that an arc site was present on the service entrance conductors in the area of the west side of the kitchen window (**Figure 4**). This was the sole site in this area, meaning it was the only site on this section of the circuit. This provided the following information:

- The utility service consisted of enough available fault current to result in an arcing event that would leave physical damage to circuit conductors.
- At the time the wife utilized the garage vehicle door keypad to open the door, the fire had not yet breached the kitchen window and caused the service to fault.
- The west side of the kitchen window was the location where the fire first breached the kitchen window and service entrance.

Arc site found on service conductors.

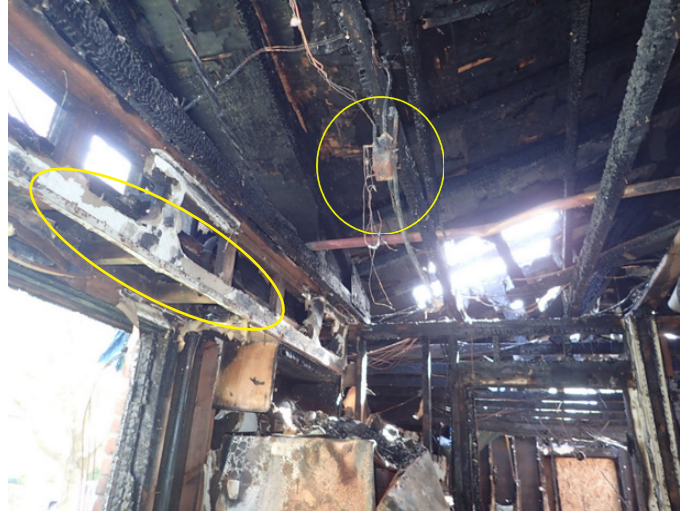
**Figure 5**

The question of whether the origin could be at or near the coffee maker was posed. If this was the case, then the principles of fire dynamics would dictate that the first location of the fluorescent light fixture/range hood circuit affected by fire would be either at the fluorescent light fixture located above the sink or the ceiling-mounted light fixture. Examination of the wiring related to the light fixtures revealed no arc sites within the fixture wiring or the portion of the branch-circuit conductors that would be an

Ceiling light junction box in relation to over-sink light fixture.

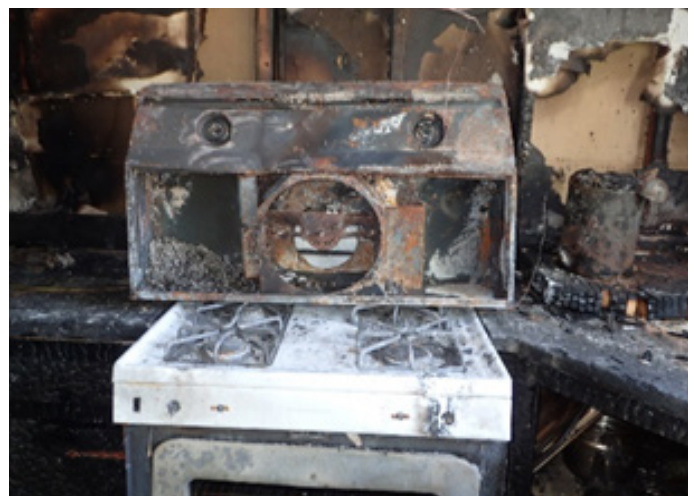
**Figure 6**

Range hood.

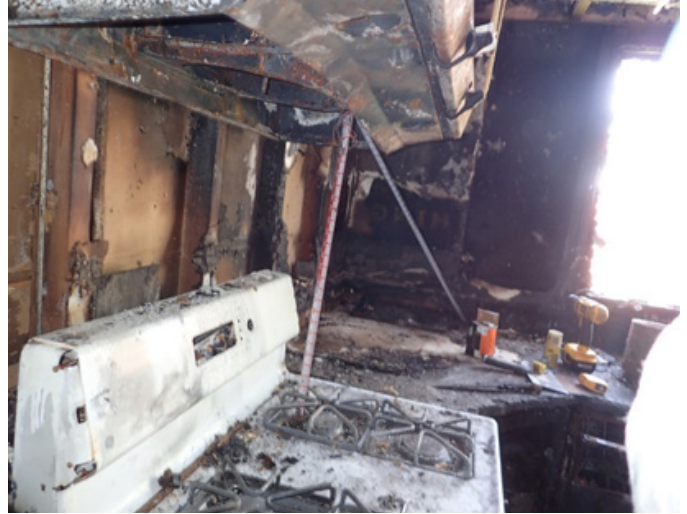
**Figure 8**  
Reconstructing the range hood.

Remains of melted aluminum mesh were found on top of the right front burner grate (**Figure 8**). It was first thought that the remains consisted of the remains of aluminum filters from the range hood. By reconstructing the range hood position — and then using documentation techniques to determine if the filter material would drop onto the front burners or not — investigators determined this would not be the case (**Figure 9**).

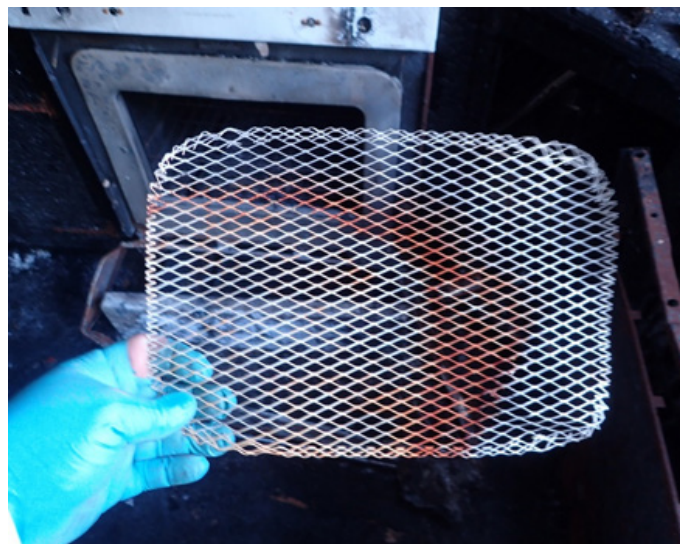
**Figure 10**  
Exemplar mesh screen.

The wife was interviewed again regarding the use of aluminum mesh screens for cooking. She indicated that the husband liked to cook jalapeno peppers stuffed with cream cheese and wrapped with bacon on the grill, using a small aluminum mesh screen. She did not recall seeing the husband ever use the stove for that purpose. The kitchen area was searched, and additional aluminum mesh screens of the type that the husband would use were found (**Figure 10**). When compared with the remains found on the right

front burner grate, they matched.

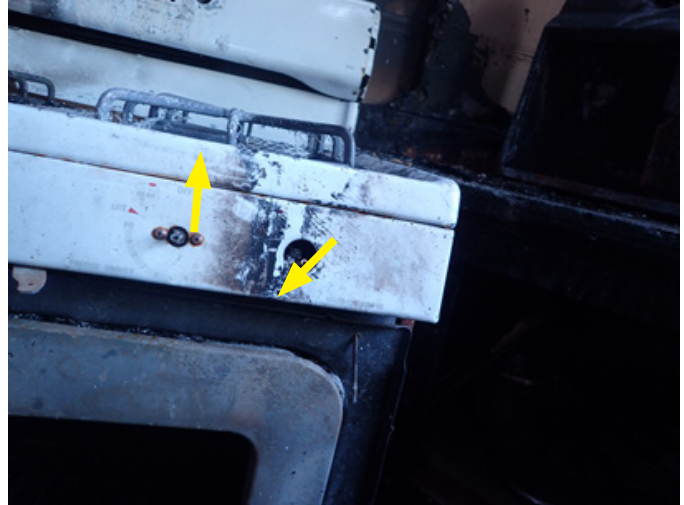
**Figure 12**

The cooktop was raised so the gas valve positions could be compared. It was determined that the right-front gas valve was slightly dislodged from its installed position (**Figure 11**). Further comparing it with the remaining three gas valves revealed that when the gas valve was rotated back to its installed position, the gas valve stem would still have been in a position other than OFF. It was estimated that the burner was at a medium-high setting (**Figure 12**).

Based on the available data, it was determined that at some point the husband started cooking and fell asleep with the stove on with foodstuffs on the right front burner grate.

Estimated setting of the right-front burner control stem.

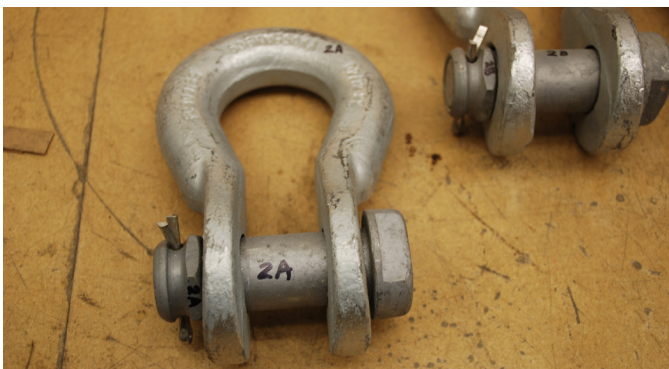
**Figure 1**  
Typical Number 9 anchor shackle with clevis pin.

of the shackle, splitting evenly at the eyes by the contact from the clevis pin. By inspection, the cross-sectional area at the midpoint is therefore at the maximum tensile stress when the insulator assembly is loaded in service. Number 9 shackles have a nominal rating of 440 kiloNewtons (kN). The load divided by the cross-sectional area defines the tensile stress in the arms. The position of the broken shackle on the tower is depicted in **Figure 3**.

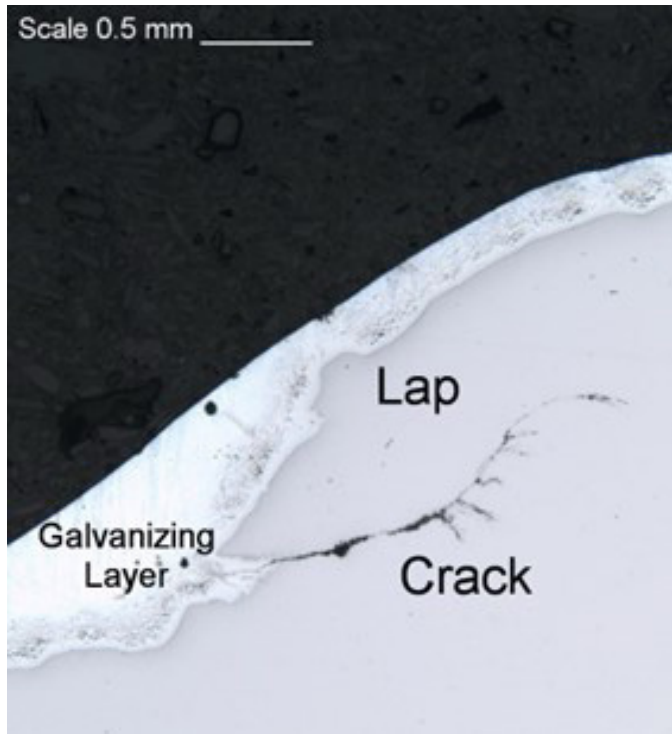
**Figure 12**

The essence of the Company B working hypothesis was that these forging laps, coincidental with a trimming line (Figures 11 and 12), had created the critical crack size necessary for the crack to propagate through the arm under cold weather service conditions at Fracture 1 area shown in Figure 8. The forensic engineers concurred with the first part of the hypothesis, but disagreed that the service conditions were necessarily contributory, based on prior fracture mechanics and failure analysis experience. The low alloy 41Cr4 (5140) steel has a ductile/brittle transition temperature near -100°C (-148°F), and tempered martensite does not undergo this transition. The cold weather effect hypothesis was tested with a factorially designed series of experiments developed by the forensic engineers to quantify the effect of service temperature.

Magnified view of the crack in the trimming area.

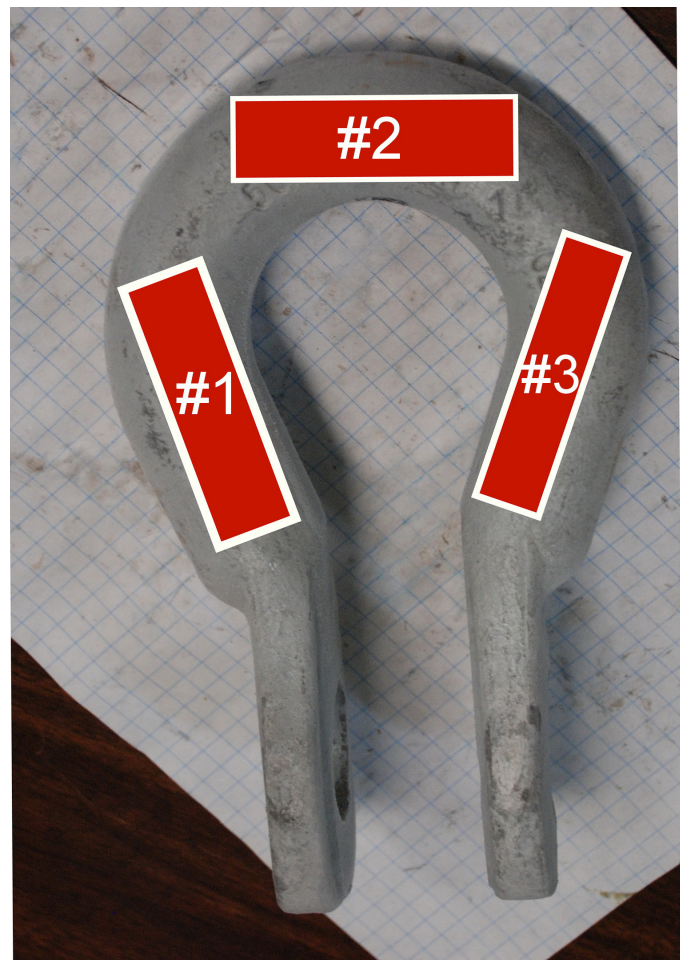
**Figure 13**

The variation appeared to be related to the location of the samples, taken from one of three places in the body of the shackle shown in **Figure 13**, with those in #2 central position testing significantly lower and not meeting the acceptance criteria. These are not the area where the shackle failed adjacent to the clevis pin hole, shown in

Locations of typical Charpy tests for Company C.

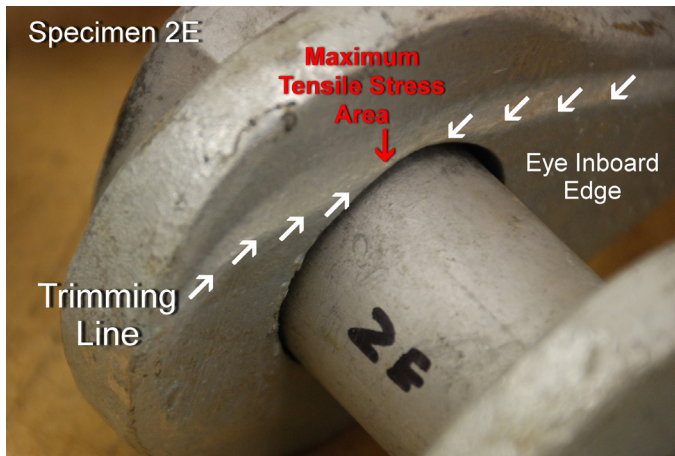
**Figure 20**

The poor intersection of the trimming line on Specimen 2E.

To illustrate the trimming issue, **Figures 20** and **21** show the trimming line meeting the edge of the eye on specimens 2E and 2H.

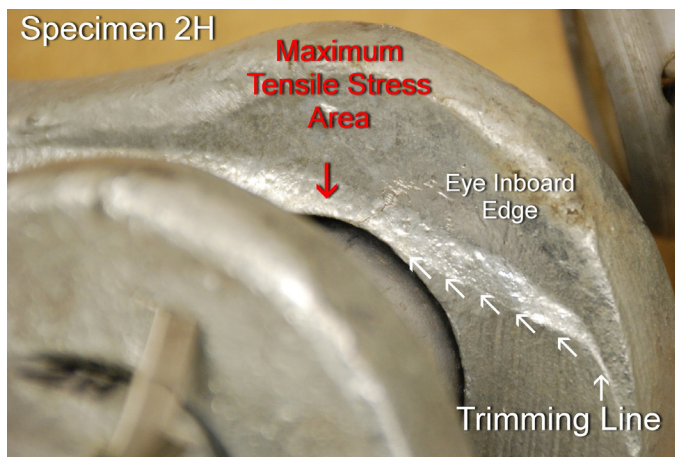
**Figure 21**

Example of poor trimming line intersection on Specimen 2H.

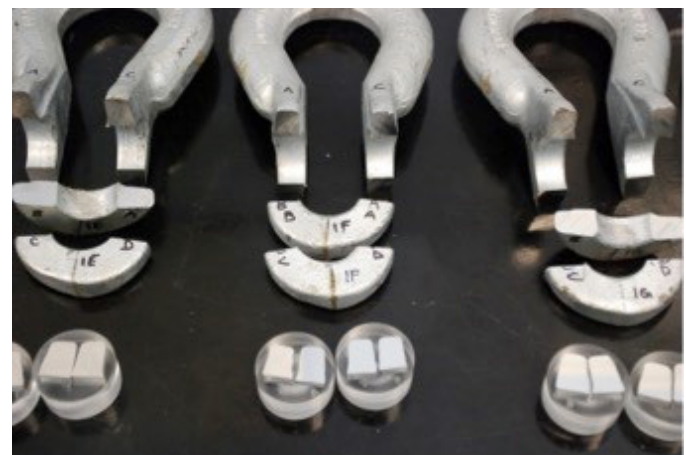
**Figure 22**

At Company E, the group of 10 shackles were sectioned in a manner similar to the European laboratory, at the midpoint of the eye (**Figure 22**), to inspect the critical area for the presence of lap defects arising from the post-forging trimming process.

Of 40 cross-sectional specimens from 10 shackles, eight were enumerated with laps in the plane of center of the eye, with two laps near the critical area 5 mm from

Specimens cut and polished for metallographic assessment of the critical area.

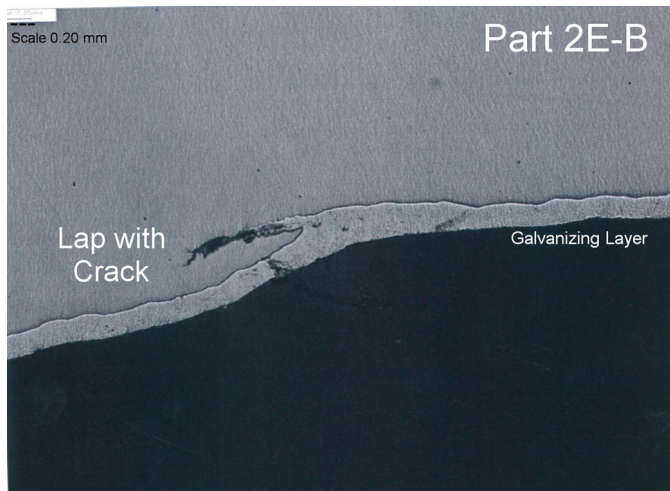
**Figure 29**

Polished cross-section showing the lap with crack on Part 2E-B.

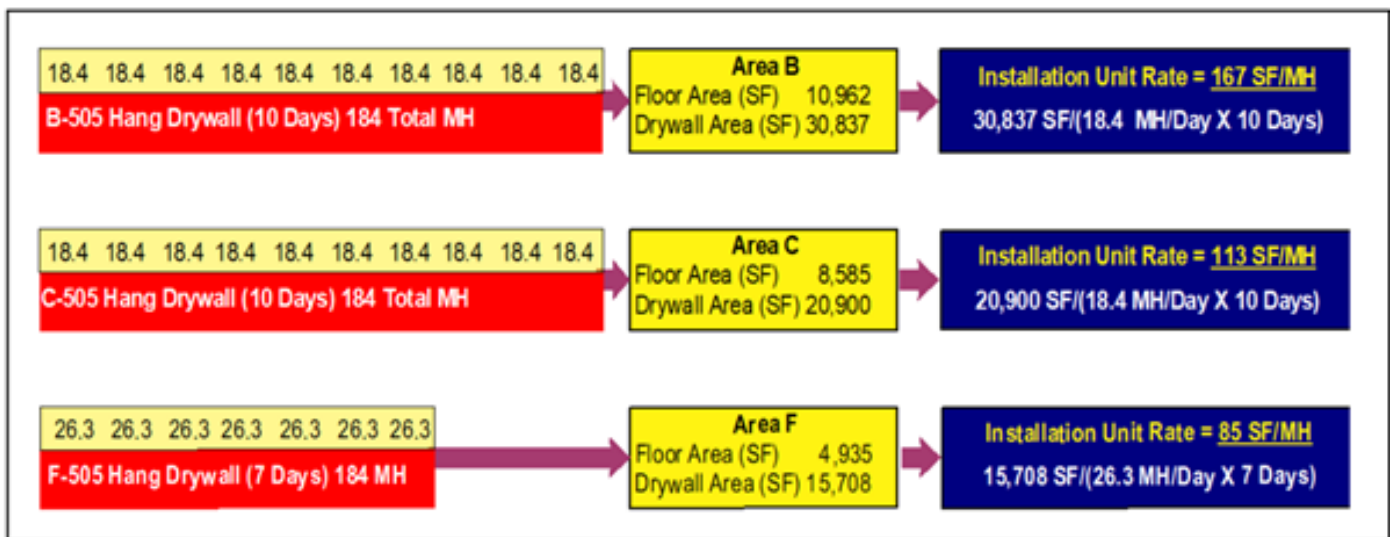
Figure 10 shows the same three activities that were illustrated in Figure 9 with the addition of the drywall quantities by area in the middle yellow boxes and the calculated unit installation rate in the blue boxes.

Figure 10 Evaluation of native file exposes widely divergent installation unit rates.

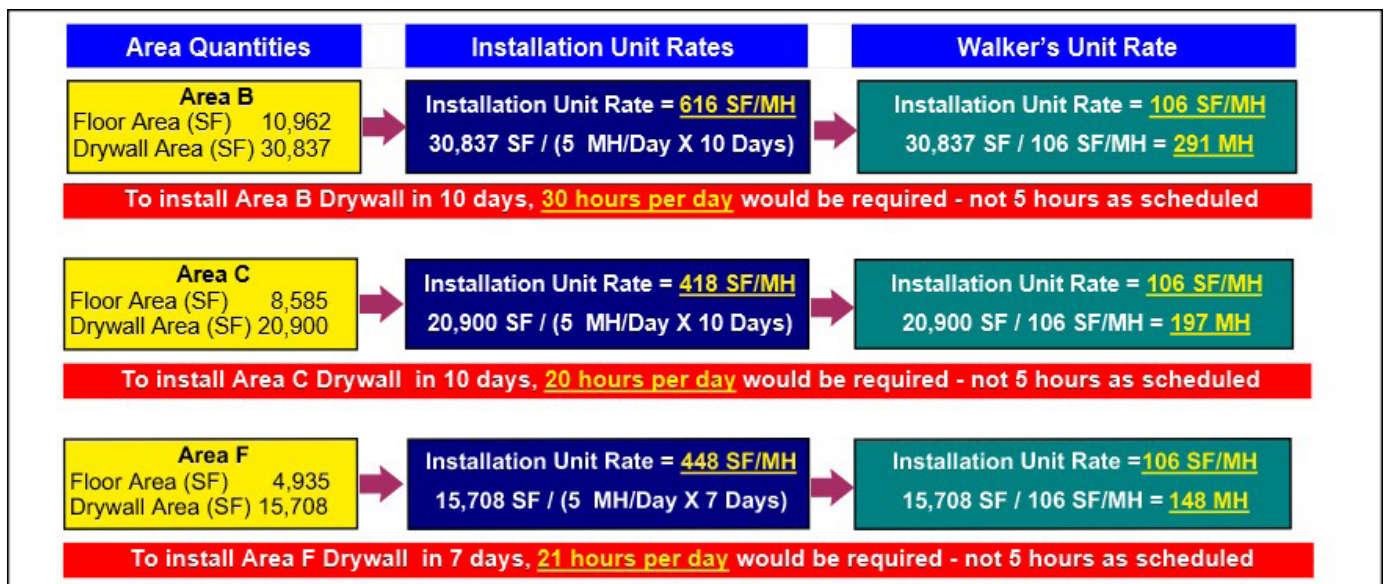
Figure 11 shows results of the quantities, resources, and unit rate evaluation compared to the Walker's Building Estimator's Reference Book, 26th Edition, drywall installation unit rate of 106 square feet per man-hour. It demonstrates how the contractor's resource loading has provided activity durations that are not realistic and cannot be attained. In Area B, for example, the scheduled unit rate of 616 square feet per man-hour is unrealistic and

Figure 11 Poor scheduling practices result in unrealistic durations.

unattainable. With a more reasonable unit rate of 106 SF per man-hour, the resources required would be 30 hours per day rather than the 5 hours per day that was scheduled. The other two examples are similar in that they show the work cannot be accomplished as scheduled.

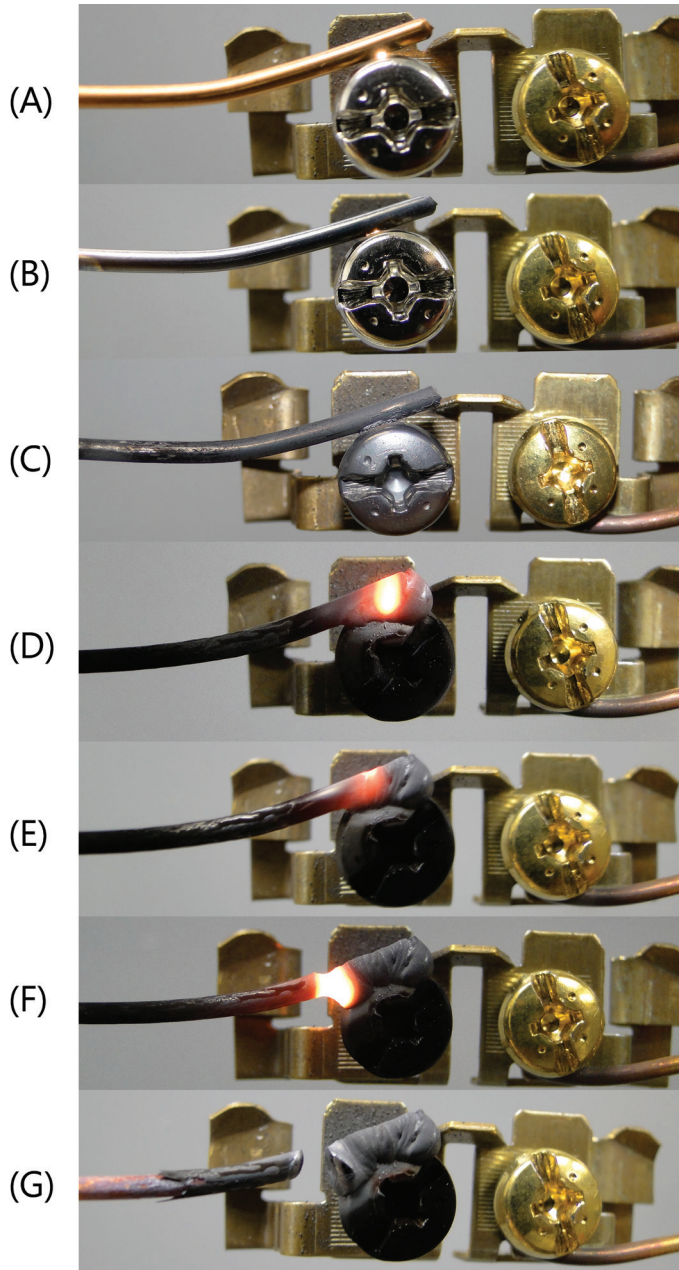
**Figure 2**  
Common sequence of overheating for a loose connection between copper and steel, such as an improperly tightened wire on a receptacle screw terminal.

**Figure 2(E)** shows the molten pool wandering at a later stage. More of the wire and screw have been converted into oxide due to the molten pool. For the copper-to-steel connections studied at 12 amps, more of the copper wire was converted to oxide compared to the iron from the screw. In addition, it took between 10 and 100 hours of runtime to reach the stage shown in (F).

**Figure 2(F)** shows the molten pool, which is only supported by surface tension in this stage, but still conducting

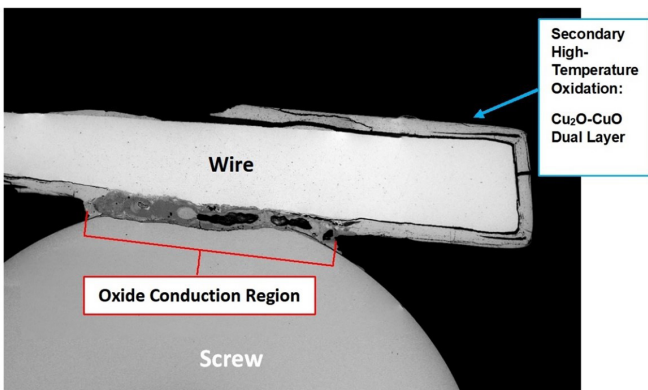
Mounted and polished cross-section<sup>2</sup> showing the overheating interface between a loose wire making contact with a steel screw. Evidence of the worm is not always found in a cross-section because it is only a single two-dimensional slice — the worm can be in a different location.

The scanning electron microscope (SEM) image in **Figure 3** shows a mounted and polished longitudinal cross-section through a sample in a state comparable to **Figure 2(C)**, where the oxide nugget is about the size of a grain of rice. This image was taken with a backscattered electron detector (BSE), which produces a grayscale contrast based primarily on the local atomic weight of the sample regions. Higher atomic weight results in lighter shades, and lower atomic weight will have darker shades. The copper wire is the brightest; the dark background is the epoxy mounting material. The red arrow points to the formerly liquid oxide nugget between the wire and screw, and the blue arrow points to the secondary high-temperature oxide growth layer. This sample was stopped after 107 hours of overheating.

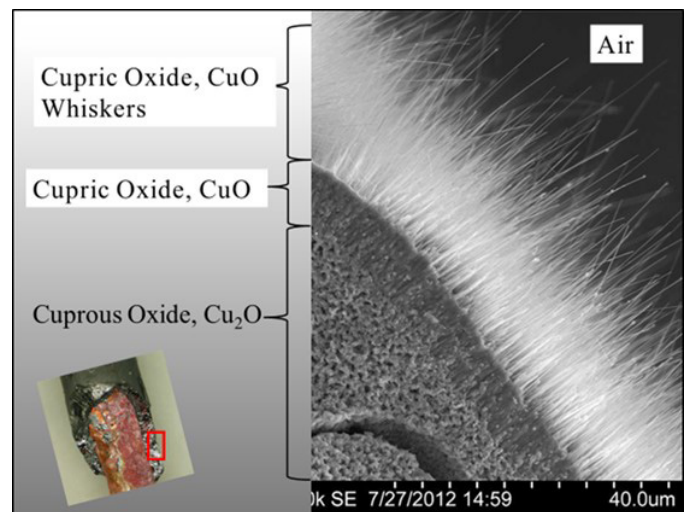
**Figure 4** shows the secondary high-temperature oxidation of a copper wire in greater detail. This image is an unmounted cross-section of the oxide layers after some of it fractured away. The oxide is a dual layer composed of Cu<sub>2</sub>O grown at the Cu metal interface, and CuO grows on top of the Cu<sub>2</sub>O. The ratio of Cu<sub>2</sub>O to CuO thickness is dependent on temperature<sup>6</sup>. The CuO grows into the atmosphere as whiskers, which would resemble something like a winding staircase on the atomic level. The whiskers then coalesce into a polycrystalline CuO layer with the Cu<sub>2</sub>O underneath. For the time and temperatures of the Cu-Cu

SEM image showing the dual copper oxide scale plus the whisker morphology of the outer layer after high temperature growth<sup>2</sup>.

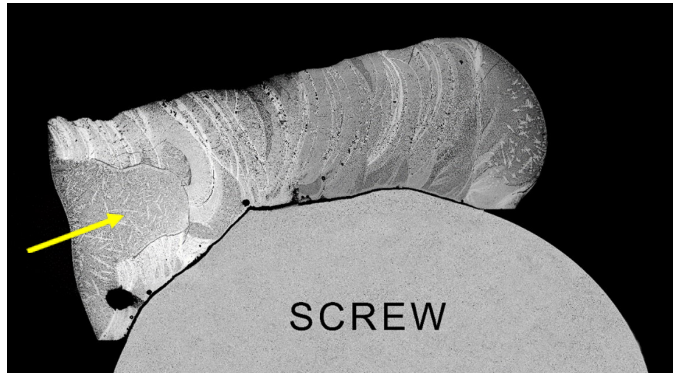
**Figure 5**

An as-polished metallurgical cross section<sup>2</sup> of an OPC remnant from a connection between a 14-gauge copper wire and a steel screw as shown in **Figure 2**. All parts of the wire in the vicinity of the screw have been part of the molten oxide worm at some point, and the region that was molten immediately prior to the connection melting open is the bell-shaped feature on the left-hand side (as indicated by the yellow arrow).

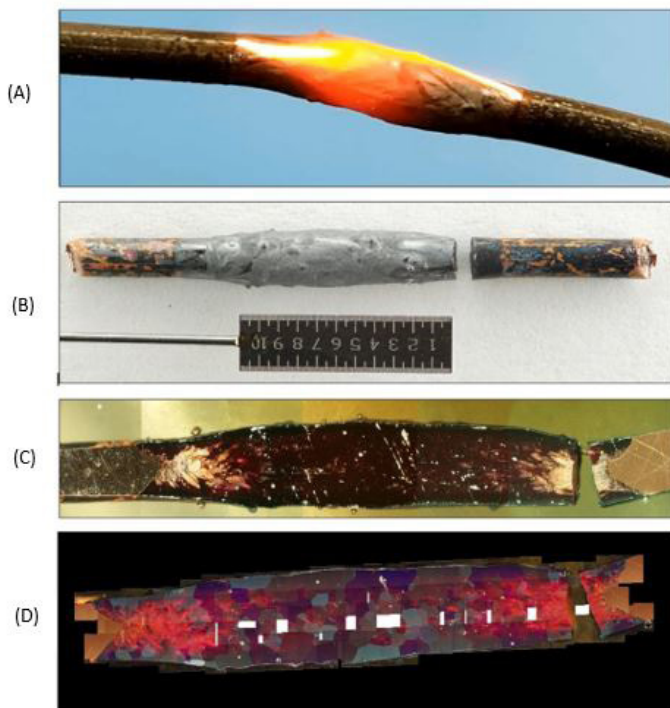
**Figure 6**

A Cu-Cu OPC showing (A) the worm and oxide nugget growth after a period of overheating, (B) remnants after shutting the circuit off, (C) as-polished cross section of the connection with incident lighting under the stereo microscope, and (D) composite image of photos taken with the metallurgical microscope using crossed polarizing filters<sup>3</sup>.

**Figure 6(C)** shows the same sample mounted and polished longitudinally, viewed under the stereo microscope.

**Figure 6(D)** is a composite image of more than 100 long-exposure photos taken through the metallurgical microscope using completely crossed polarizing filters and stitched together afterward. The exposure time for each photograph was approximately 30 seconds. With completely crossed polarizers, the field of view when framing these shots is completely dark. The filters are not perfect materials (or perfectly crossed), so some light gets through, resulting in the images shown. The white areas in the image compilation were missed areas because it was difficult to know where the shot was before taking it.

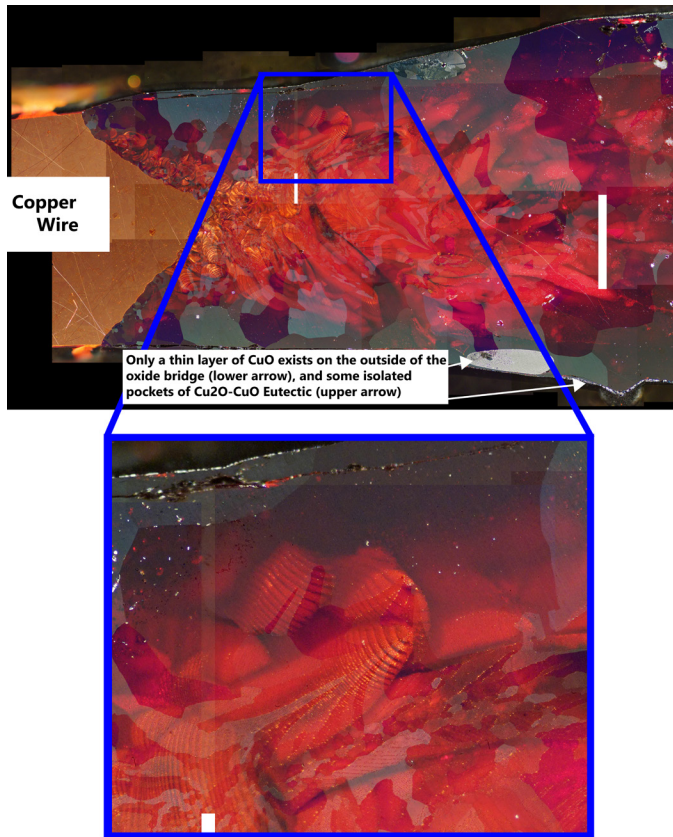
Images from **Figure 6(D)** at higher digital zoom. There is a thin outer layer of CuO and some pockets of Cu<sub>2</sub>O-CuO eutectic, as indicated by the white arrows. The segmented morphology of the worm microstructure is apparent<sup>3</sup>.

**Figure 7** shows the left-hand region from **Figure 6(D)** at a higher magnification. The microstructure of the worm can be seen; it actually represents many past locations of the worm. One aspect to reiterate is that Cu<sub>2</sub>O is semitransparent, and using crossed polarizing filters allows features below the plane of polish to be observed — so some areas inside the material can be seen. It is also important to note that only a thin layer of CuO is found on the outside of the nugget, except for a few small pockets containing Cu<sub>2</sub>O-CuO eutectic. This is also consistent with the dual layer discussed earlier. The cross-section is useful because if only energy dispersive spectroscopy (EDS) were to be performed non-destructively on the surface of the nugget, one could come to the incorrect conclusion that the whole nugget is composed of CuO.

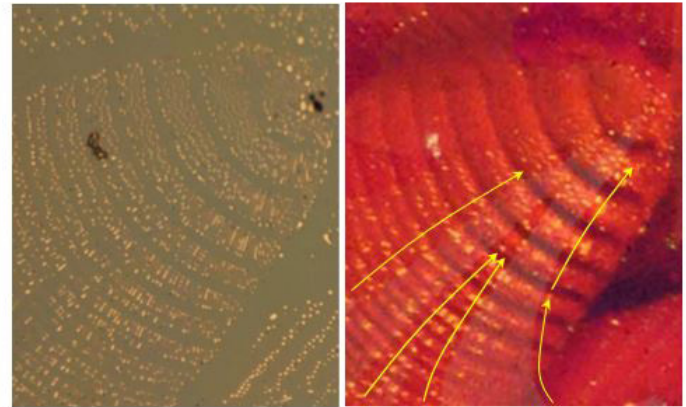
Image of the worm microstructure with normal brightfield reflected illumination under the metallurgical microscope (left); the copper globules are peach colored, and the Cu<sub>2</sub>O matrix is gray and opaque. Same region of the worm under crossed polarizing filters with long camera exposure time (right); the copper globules are gold colored, and the Cu<sub>2</sub>O matrix is red and translucent, which shows additional copper globules below the surface and surface macro grain morphology (as shown by the yellow arrows)<sup>3</sup>.

**Figure 8** shows a comparison of the worm microstructure with different illumination techniques under the metallurgical microscope. One interesting aspect of this microstructure is that it displays banding and segmentation similar to an earthworm. The cause for this morphology deserves more research. While the glowing oxide worm from the outside looks visually similar for many OPCs between different materials (including both AC and DC currents), the microstructure of the worms in the plurality of scenarios has yet to be studied in greater detail and deserves more research.

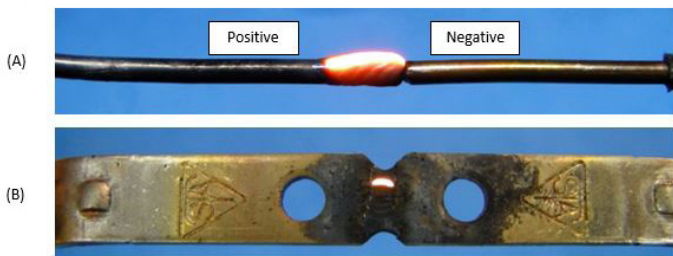
**Figure 11**

**Figure 11 (A)** shows an OPC with 12-volt DC with an overheating connection running 6 amps of current

(A) shows a DC OPC where the liquid conducting worm only consumes the positive electrode. (B) shows a brass-to-brass OPC where the worm is shown to behave similarly to the other experiments. Metallurgical cross-sections of similar samples are documented in “Poor Electrical Connections: Physical Features, Materials Characterization, and Newly Identified Characteristic Traits, Before and After a Fire.”

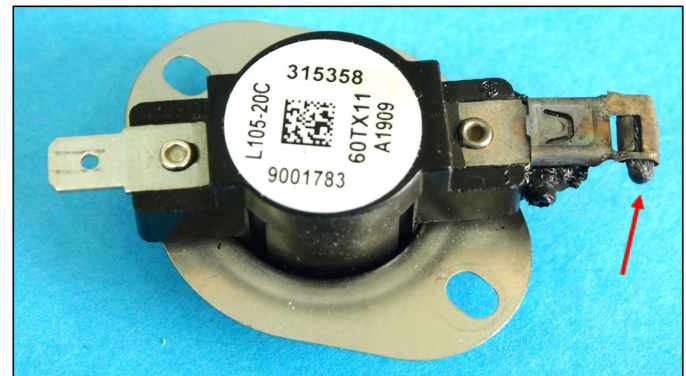
**Figure 12**

This case involves a thermal cut out (TCO) switch from a commercial cooking range. The subject TCO, as shown in **Figure 12**, was presented to this author’s laboratory by the range appliance manufacturer for a failure analysis. The subject TCO was part of a range that was being field tested under the control of the manufacturer. The range had been in service for approximately 10 months prior to the failure of the TCO crimp terminal connection. The current through the subject TCO is 20 amps during normal operation when both range heating elements are

Subject TCO with overheated terminal crimp on the right-hand side. The TCO manufacturer markings have been blurred out.

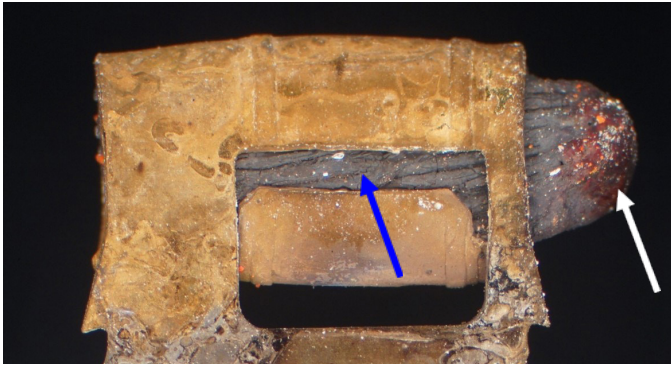
**Figure 13**  
Digital image taken through the stereo microscope with crossed polarizing filters.

on. There is some melting and thermal decomposition of the plastic insulation materials close to the terminal, but no other surrounding materials ignited before the subject OPC melted open at the region indicated by the red arrow.

**Figure 13** shows a stereo microscope image of the subject crimp connection between the brass terminal and a stranded copper wire. This image was taken with crossed polarizing filters and the region where the stranded wire melted open is red colored, as indicated by the white arrow. The red color under crossed polarizing filters is consistent with  $Cu_2O$  (cuprous oxide), which is semi-transparent and red colored under polarizing filters<sup>11</sup>. Also apparent is a gap in the crimp barrel, as indicated by the blue arrow.

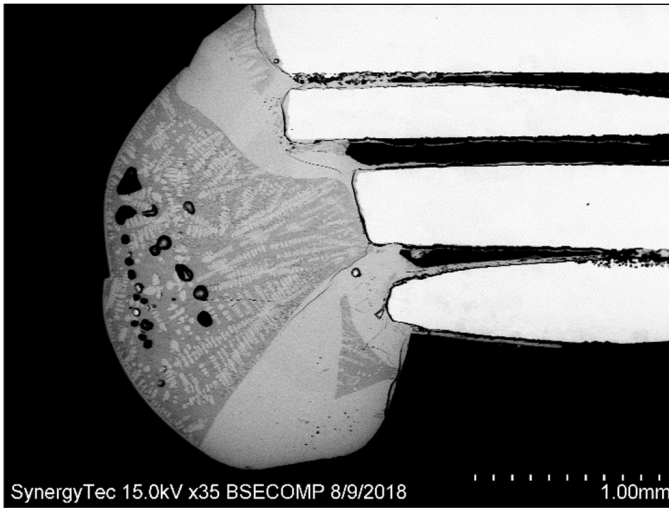
Above is an as-polished cross section<sup>3</sup> of a sample produced in the lab between copper electrodes with an AC current (2 amps for 20 minutes, then 13 amps for 20 minutes until the connection melted open).

**Figure 16** shows a polished cross-section of a solidified oxide mass from an experiment performed on a copper-to-copper OPC produced in the lab<sup>3</sup>. This sample ran with a current of 2 amps for 20 minutes (after which the circuit current was switched to 13 amps for 20 minutes), and the OPC proceeded to melt open. The last oxide liquid to solidify can be seen coming from one strand. It is expected the melted open cross-section (as shown in **Figure 11**) would display similar features if examined in similar detail.

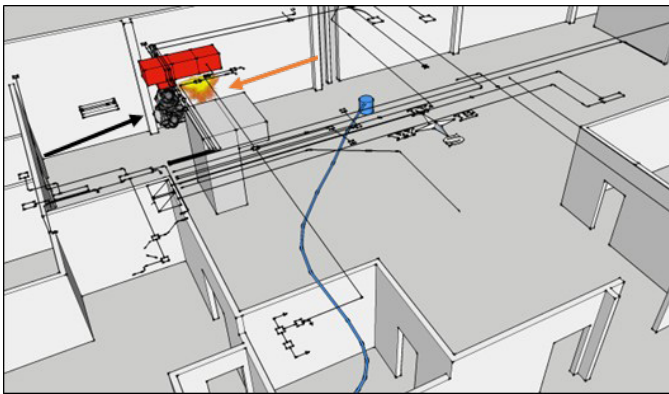
A model of the room where the fire took place. The blue wiring is the security camera and wiring; the red item is the furnace where the fire was first discovered. The furnace is above a drop ceiling.

**Figure 17** shows the location of where the first smoke and fire was observed by workers on the production line, as indicated by the black and orange arrows, respectively. The smoke was observed coming out of a return vent, and the first fire was seen about 7 feet from the return vent.

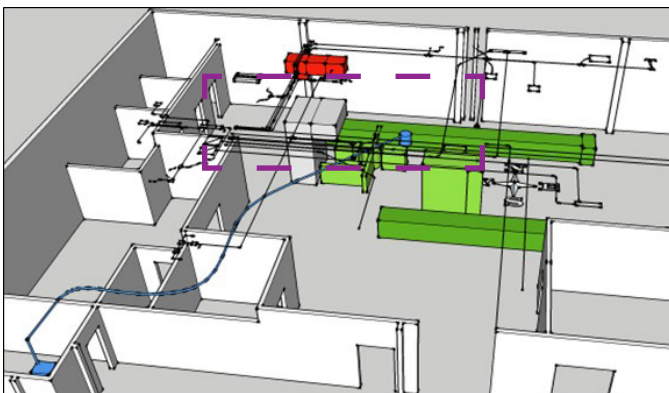
Macro view of the area identified by the plaintiffs as the origin, indicated by the dashed purple box.

**Figure 18** shows a more zoomed out view of the subject structure compared to **Figure 17**. The production line in the room of fire origin is shown in green. The furnace where the first smoke and fire were observed is shown in red. This furnace was installed above a drop ceiling. The components shown in blue are a camera in the upper right, the power supply panel with the transformer is in the lower left, and the camera wiring is in between. The

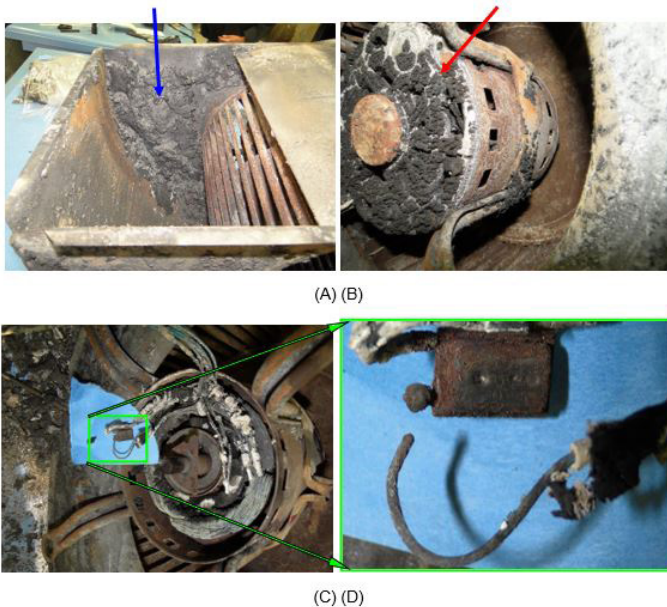
**Figure 19** shows four images from the subsequent examination of the furnace. (A) shows the furnace fan discharge with a thick layer of burnt flour deposits, as indicated by the blue arrow. (B) shows more burnt flour deposits on the end-bell of the motor for the furnace air handling fan, as indicated by the red arrow. (C) shows an image after the fan motor end-bell was removed, and (D) shows an enlarged view of the thermal protector switch, which exhibited a formerly molten bead consistent with an OPC and a solidified oxide that melted open. The stranded wire, which was previously crimped into the steel thermal protector body, also displayed localized melting consistent with an OPC.

(A) shows caked-on flour deposits inside the blower volute, as indicated by the blue arrow. The witness who first spotted flames identified a location close to this component. (B) shows the motor end bell, which is caked with flour deposits. This is where the cooling fan within the motor housing draws in air to cool the motor. (C) is the thermal protector with the overheated connection, and (D) is a close-up of the melted open connection.

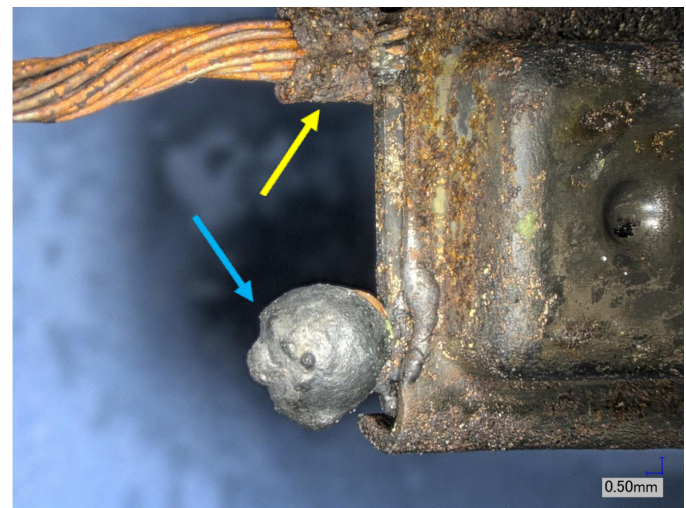
**Figure 20** shows a close-up stereo microscope image of the formerly molten mass on the end of the subject motor thermal protector switch, as indicated by the blue arrow. This thermal protector employs a steel casing that carries the circuit current between the crimp connections and the interior contacts as well as the crimp connections. The other crimp connector is shown by the yellow arrow. Both of the subject crimp connectors are a copper to steel connection.

The blue arrow points to an oxide mass resulting from an OPC on the subject switch.
