Journal of the
National
Academy OF
Forensic
Engineers[®]

* Forensic Engineering Experience with Electrically Ignited Fires	1
<i>By Roger L. Boyell, P.E. (NAFE 696F)</i>	
* Forensic Engineering Analysis of an Emergency Bridge Replacement Project	9
<i>By Paul G. Swanson, P.E. (NAFE 653S)</i>

* Generalized Deformation and Total Velocity Change Analysis with Missing Vehicle Stiffness Coefficients; G-DaTAAV™	15
<i>By Jerry S. Ogden, P.E. (NAFE 561F)</i>

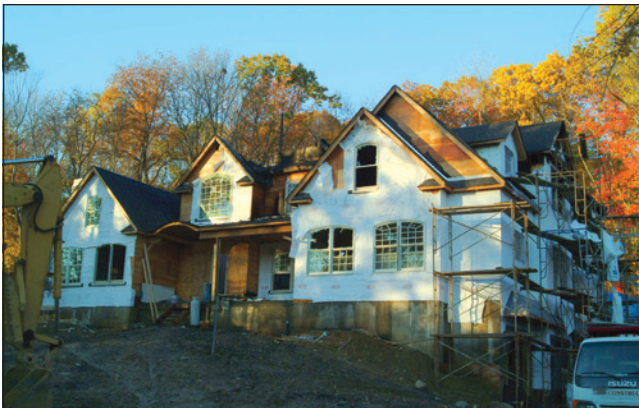
Figure 1

House under construction at the time of the fire.

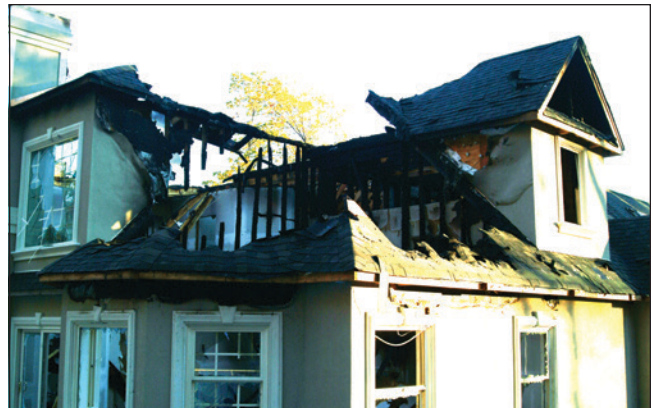
Figure 2

Fire inside broke through the roof.

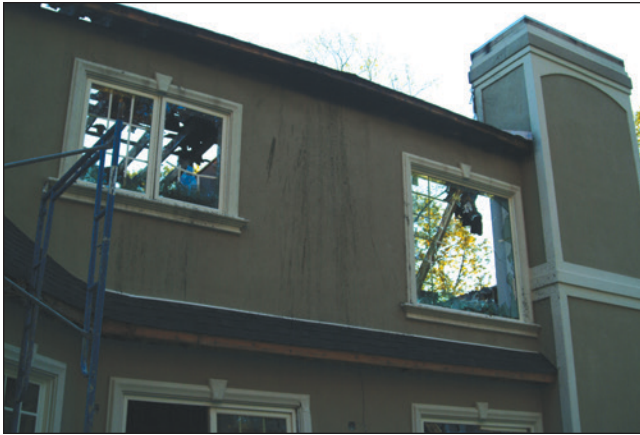
Figure 3
Interior heavily damaged.

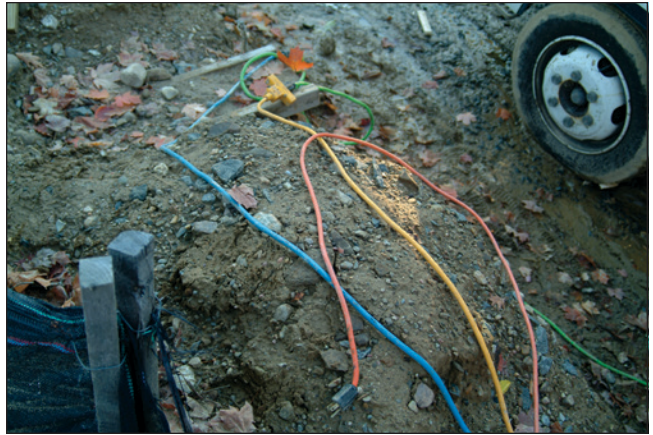
Figure 4
Various contractors' extension cords.

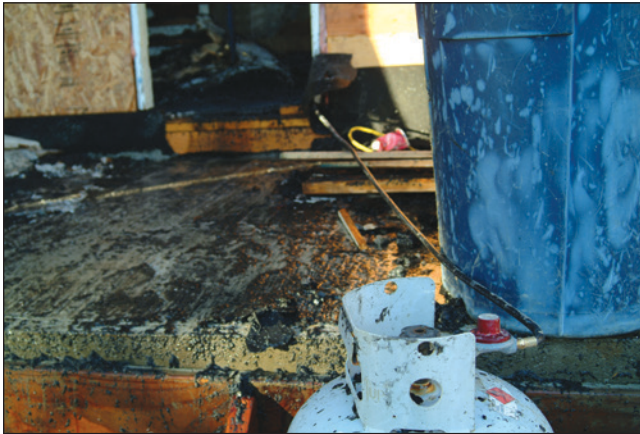
Figure 5
Propane tank and hoses.

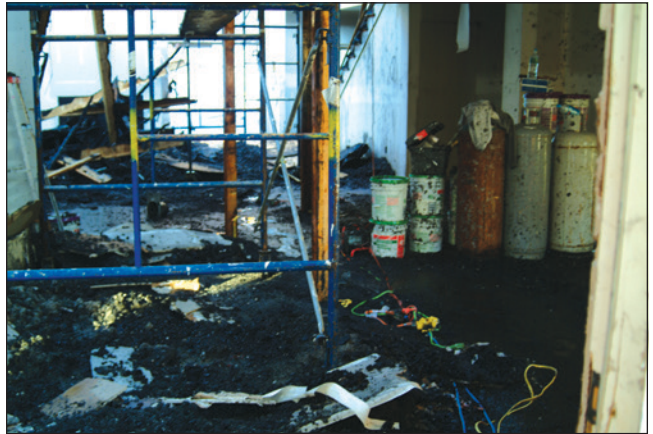
The investigators took note of the cans of paint and bottles of propane (**Figure 6**) stored at the site, observing the route of the fire (**Figure 7**) as it climbed through the roof. Interest centered, in particular, on one orange extension cord that wound through the

Figure 6
Paint cans and propane tanks.

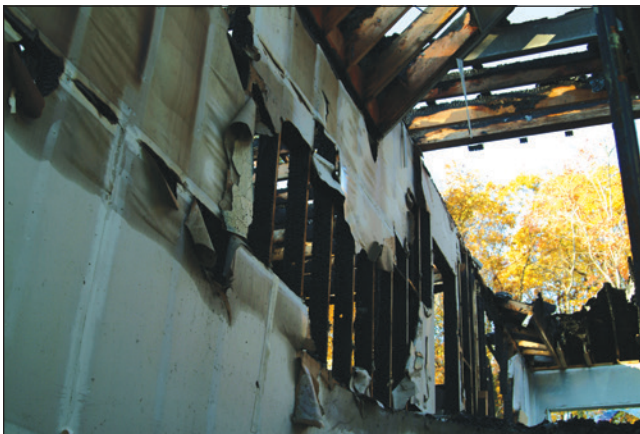
Figure 7
Fire damage from ground floor through roof.

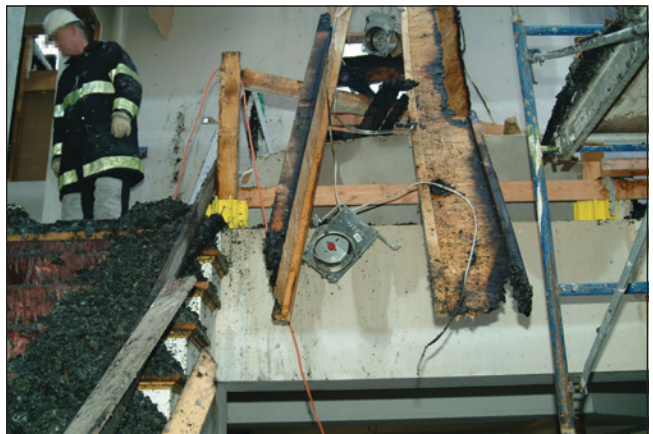
Figure 8
Orange extension cord of particular interest.

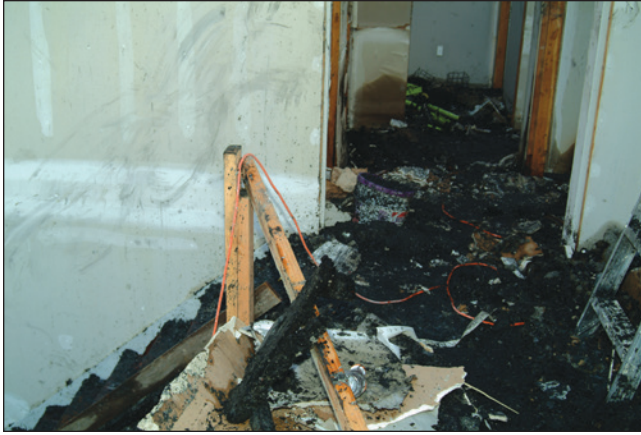
structure (**Figure 8**) and into an area exhibiting heavy fire damage (**Figure 9**).

Figure 9
Extension cord leading into area of heavy damage.

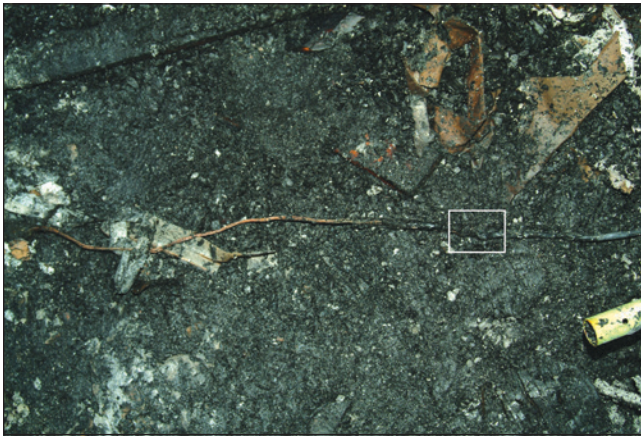
The orange jacket of the extension cord had been burned away near a plug-and-socket junction with a black power cord (lower right of **Figure 10**). The junction was encrusted with debris (right side of **Figure**

Figure 11
Plug-and-socket junction encrusted with debris.

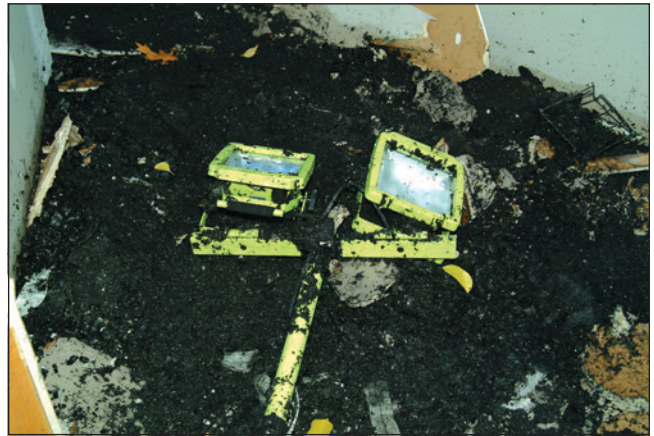
11), and the power cord was found to originate from a dual-head halogen work light (**Figure 12**), which later was found to draw 1,000 watts of power.

Figure 12
Work light that was plugged into the extension cord.

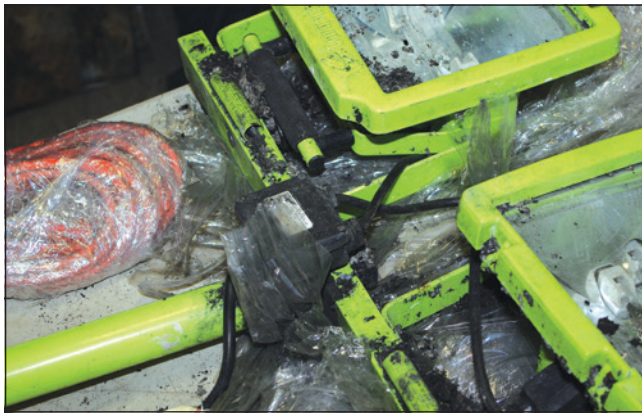
Eventually, the physical evidence was to be made available for examination. When the big day came, the extension cord and work light were unwrapped (Figure 14), and the first peek at the allegedly burned electrical junction (Figure 15) showed it to be intact and unburned. The debris that encrusted the junction seemingly protected it from damage during the fire. Engineers retained by the accused contractor opined that this physical evidence indicated the contractor's electrical equipment was not responsible for the fire.

Figure 14
Evidence when first opened for examination.

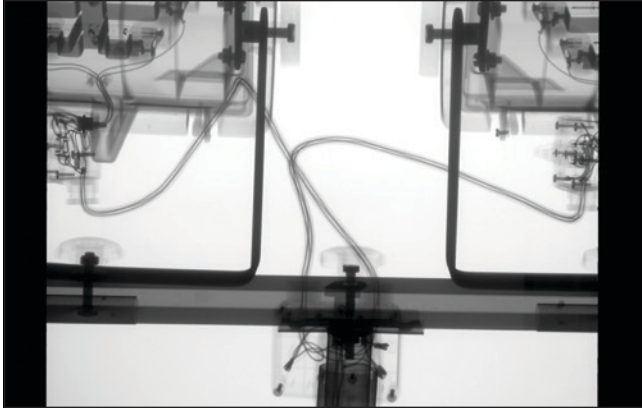
Figure 18

and could not have been the cause of the fire. In addition, when examined under X-ray, the work light (Figure 18) and the far end (plug) of the extension cord (Figure 19) showed no electrical damage. Two more years transpired due to more expert reports, addendums, explanations, affidavits, and lawyers' correspondence about the matter. Finally, the initial investigator agreed under deposition cross-examination that his interpretation of the floor pattern may have been in error.

X-ray of work light showing no electrical abnormality.

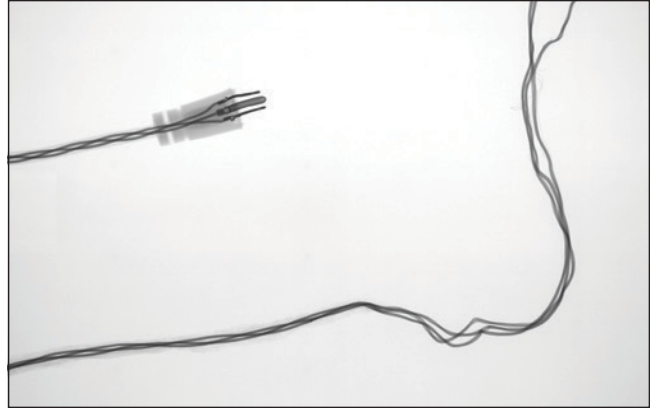
Figure 19

Extension cord plug also showing no electrical abnormality.

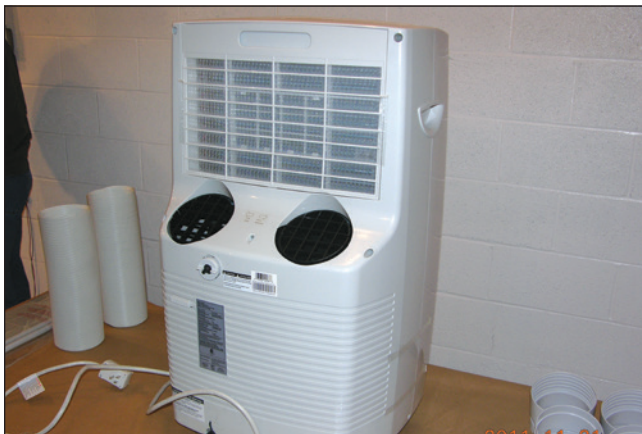
Figure 22

Exemplar of room air conditioner.

With this portable air conditioner (see exemplar in **Figure 22**), room air is blown through the evaporator coils at the top, and outside air is circulated through the interior by plastic ducts that run to an adjacent window. The molded plastic case can be removed to show the internal construction (**Figure 23**).

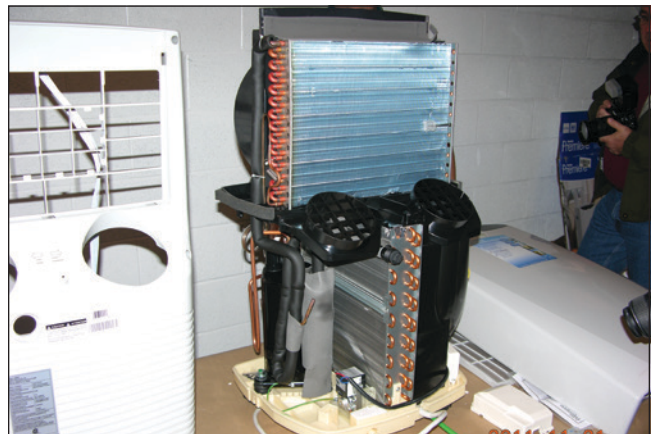
Figure 23

Interior of exemplar unit.

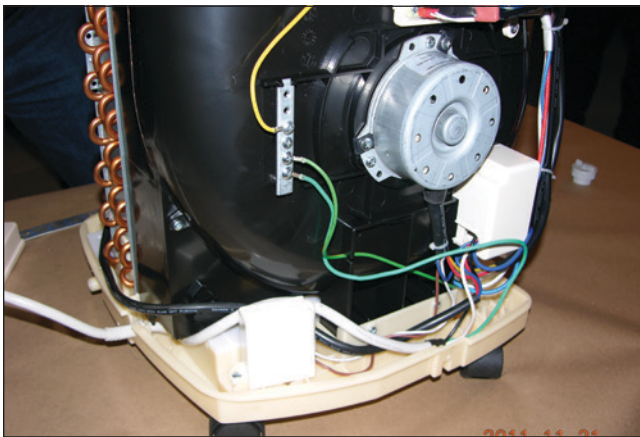
The exemplar exhibits electrical wiring, a compressor motor, and fan motors (**Figure 24**), all of which can be compared with the evidence unit to locate the presumed defect or malfunction. Upon investigation, such comparison revealed that the bottom of the evidence unit was surprisingly intact (**Figure 25**), considering that the fire was said to have begun there.

Figure 24
Fan motor and electrical wiring.

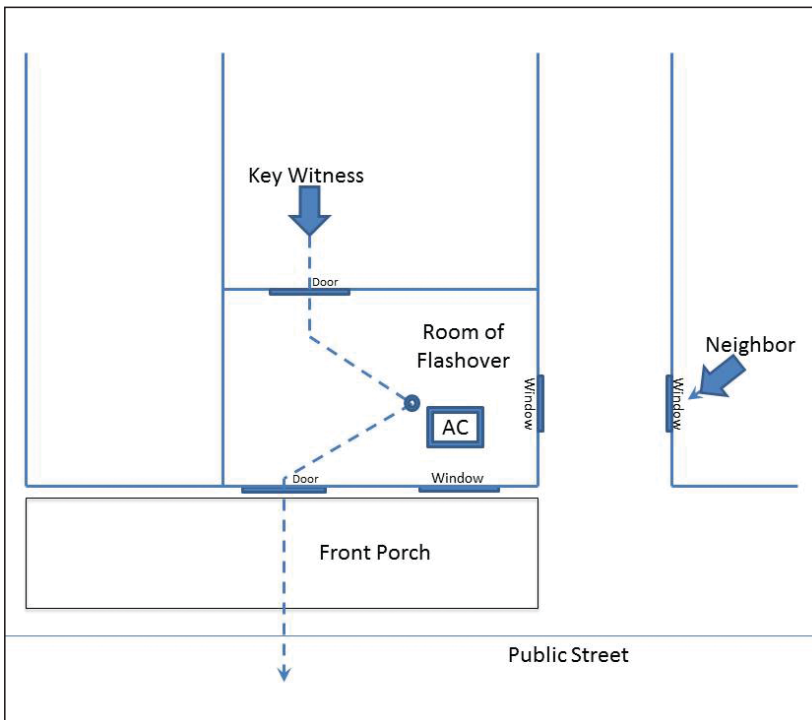
Figure 29

Information was pieced together from many witnesses. Everyone said the fire started near the front corner of the house. The layout of the premises is shown in **Figure 29**. The portable room air conditioner had been running to cool the room. The unit obtained its intake and exhaust from the front window.

The key witness said he entered the room and walked to the air conditioner as shown in **Figure 29**, seeing the flame begin there. Before he could do anything, the unit became engulfed in flames, and he ran out the front door to the street.

Layout of the house showing witness path.

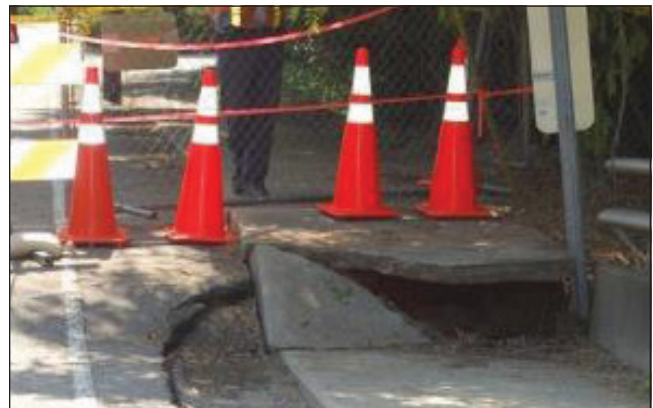
Figure 2

Settlement resulting from soil erosion at the bridge abutment.

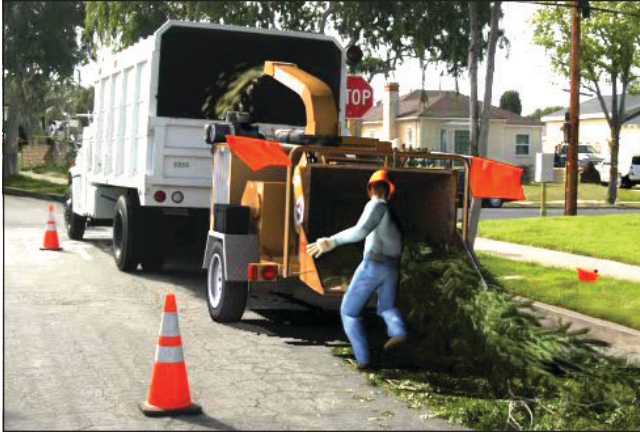
Figure 2

Based on the witnesses' statements and biomechanical evaluation of the operator injury pattern, as the operator was feeding branches into the chipper, his right hand or arm apparently became caught or entangled, which pulled him into the infeed chute, the feed wheel, and then the cutting drum containing the blades. The victim died in this very gruesome incident (see **Figure 2** and **Figure 3**).

Wood chipper with the towing truck.

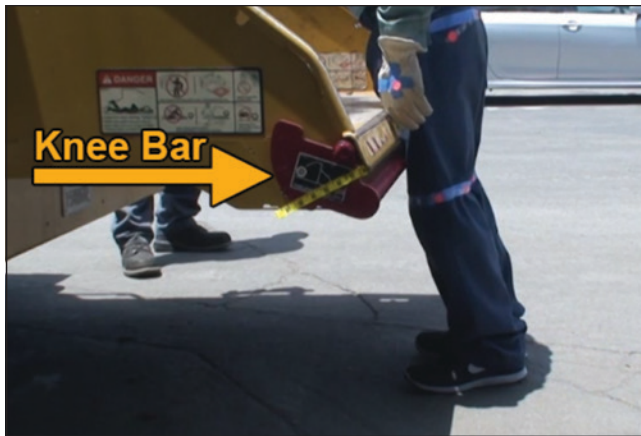
Figure 4

Had a knee bar been present on the subject machine, as it should have been to provide safety protection to operators, the operator’s body (particularly his upper leg and knee) would have activated the knee bar before any part of his body came in contact with the feed wheel (**Figure 4**).

Wood chipper with knee bar and surrogate testing.

Because of the ineffectiveness of the control bar and warnings and instructions in preventing this incident, this engineer evaluated other safety devices that could have prevented this incident. One effective safety device is a “knee bar” depicted in **Figure 4**. A knee bar is a passive safety device, located across the horizontal opening of the infeed chute/tray and is activated by a caught or entangled operator whose knees come in contact with the bar. The bar, pushed passively by the knees, activates the infeed reverse motion and prevents the operator from being pulled into the infeed chute.

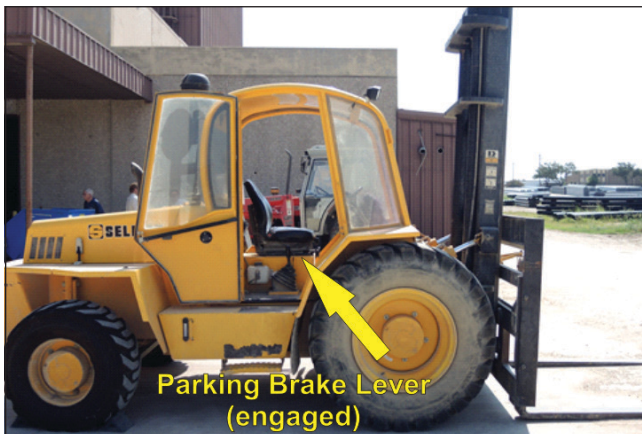
Figure 7

Subject forklift showing parking brake lever.

After the incident, the Occupational Safety and Health Administration (OSHA) performed an investigation of the subject forklift. OSHA issued a citation to the employer for failing to chock the wheels of a powered industrial truck while parked on an incline (see **Figure 7**).

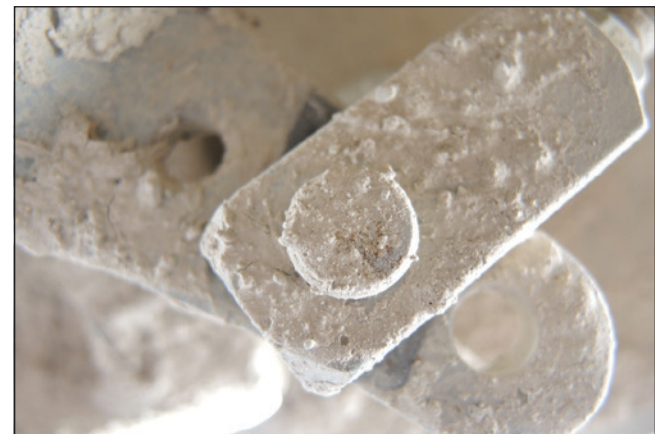
Figure 8

After the incident, this engineer inspected the braking system and found a lot of caked-on dirt and debris on the outside of the caliper housing and linkage system (**Figure 8**), indicating that the parking brake system components had not been serviced in a long time — possibly years. In addition, the operator’s manual preventive maintenance schedule stated that the parking brake pads must be checked and replaced, as necessary, every 300 hours. However, the heavy wear on the movable parking brake pad and the employer’s maintenance records indicated that the subject forklift’s brake pads had never been replaced in its five-year history and approximately 6,900 hours of service. Therefore, the employer failed to follow the manufacturer operator’s manual preventive maintenance schedule regarding checking and replacing the parking brake pad every 300 hours, as necessary.

Caked dirt located over parking brake linkage components.

In addition, the parking brake was tested by this engineer on the incident site (1.2 percent slope), and it was found that with the parking brake engaged, the forklift began to roll down the incline. Furthermore, review of the ANSI/ASME B56.6 *Safety Standards for Rough Terrain Forklift Trucks* was conducted to determine if the subject forklift's parking brake was defective. Section 8.8.1 of the standard states:

The subject forklift's parking brake was not able to hold on an incline of no more than 1.2 percent, which was substantially lower than the holding requirement of 15 percent outlined in ANSI B56.6. Therefore, this engineer determined that the parking brake was defective at the time of the inspection.

This engineer also conducted testing of braking performance of the forklift and determined that after the parking brake was adjusted per the instructions in the operator's manual, the forklift's parking brake functioned properly. Therefore, had the employer followed the parking brake adjustment procedure described in the forklift's operational manual prior to the incident, the parking brake would have been in proper working condition, and the incident would not have occurred.

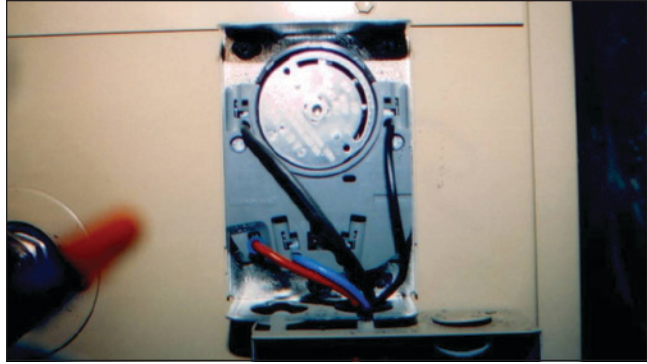
Figure 9

Several furnace components were damaged as a result of the fire, including the circulating fan and high temperature control (as seen in **Figure 9**). As a result, pre-fire operability of the furnace could not be determined.

Fan limit and high temperature control into the furnace.

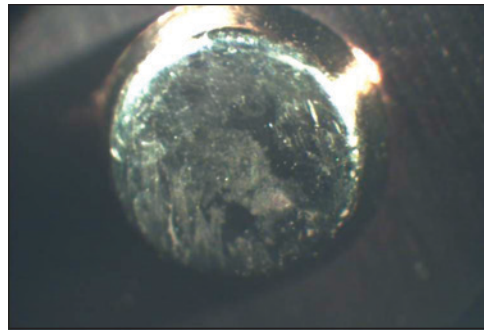
Figure 10

Upon examining the contacts, as viewed in **Figure 10**, there was no evidence of any past electrical activity. Accordingly, it did not appear that the high limit control was wired into the control circuit that would have shut the oil burner down in the event of a high temperature.

High limit control shows no electrical activity.

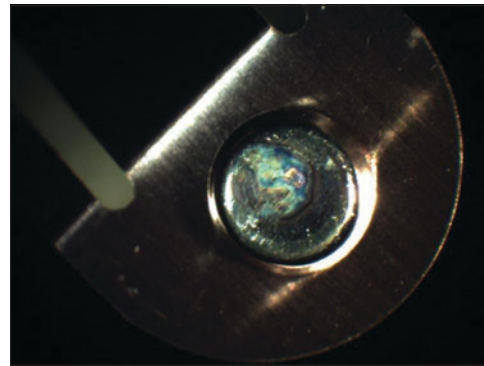
Figure 11

Arcing found on contact of high limit switch that was properly wired into circuit. Compare to contact shown in Figure 10.

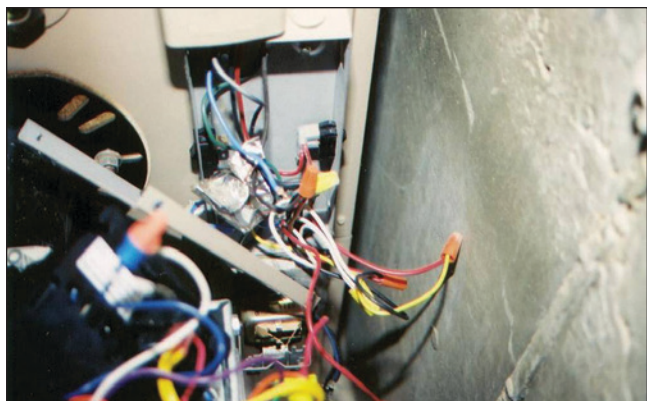
Figure 12

With the hypothesis apparently confirmed, the next challenge was to determine whether the high limit control was indeed not wired into the circuit, and (if possible) to identify the party responsible for the error in wiring — be that the installer or the manufacturer. The furnace wiring is depicted in **Figure 12**.

Furnace wiring.

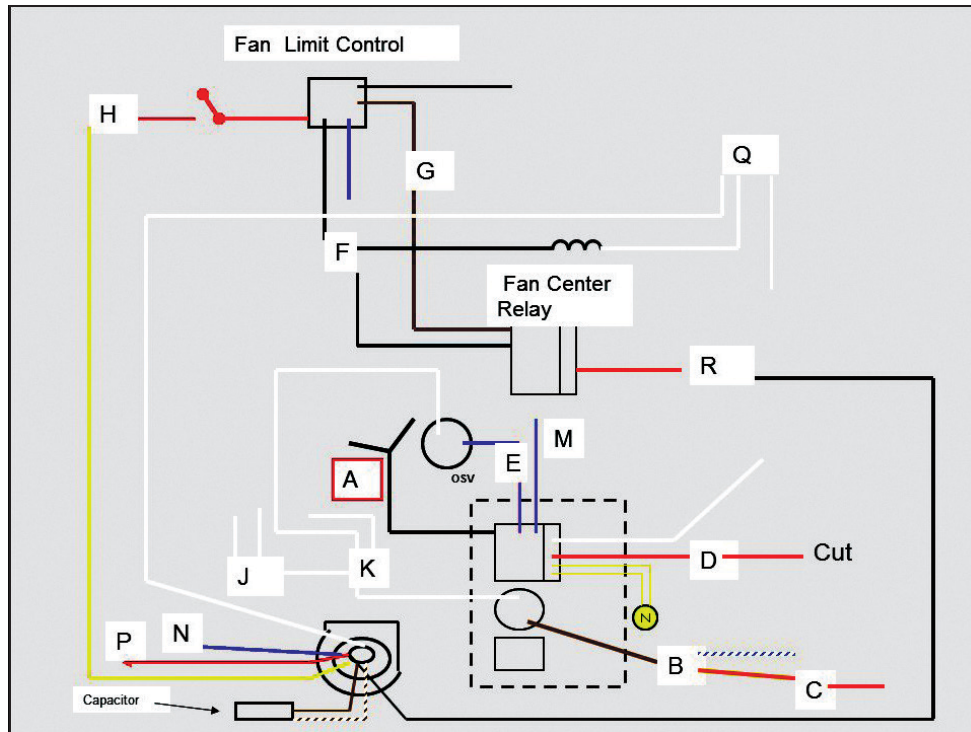
Figure 13
As-built wiring of disassembled furnace.

Although the furnace had much of its wiring detached and removed when it was detached from the system ductwork and electrical service by the initial contractors, a detailed "as-built" wiring circuit diagram of the existing wires was created (via inspection) and is shown in **Figure 13**.

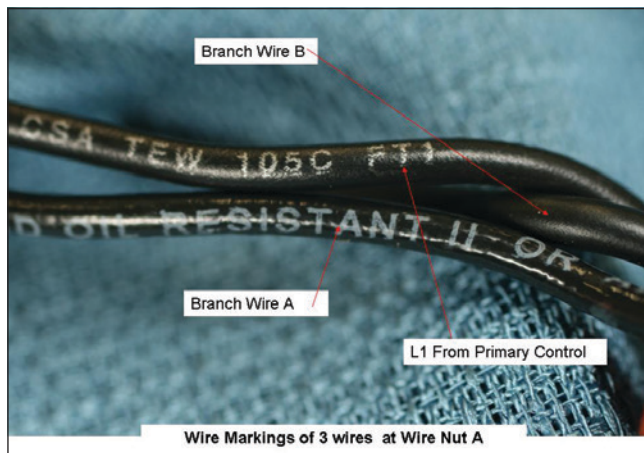
Figure 17
Wire markings of three wires at wire nut A.

During examination of the identified wire that was a deviation from the manufacturer’s wiring (**Figure 17**), the following wire characteristics were identified:

Junction A A Strand	Junction A B Strand	36 Inch Limit L1 Wire
No. Strands	19 - 20	26	24
Coated?	Yes	No	No
Markings	"Markings" Gasoline and oil resistant II or AWM 600 Volt	None	CSA TEW 600V 105C FTLL 3995 - - - AWM 1015 OR 1230 600V

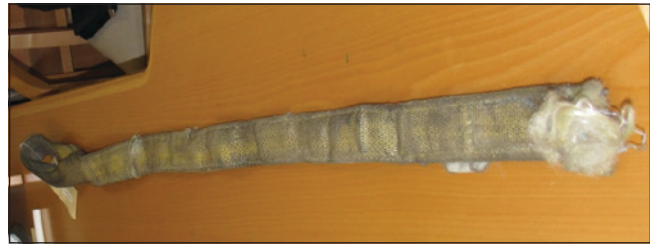
Figure 5

A similar inspection was done on the All_Lift slings. Besides the structural damage to slings, the findings were unremarkable, including the comparative fading of several of the retrieved sections. The Ex_Lift sling did not show any clear visual signs of UV degradation as claimed by the city's building department report.

Ex_Lift sling section retrieved after crane incident.

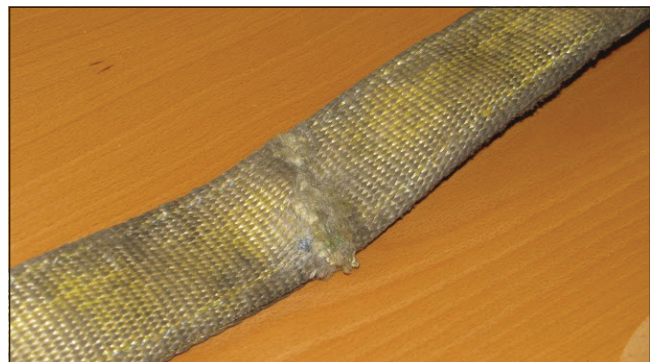
Figure 8

Abrasion contact mark on the sling face.

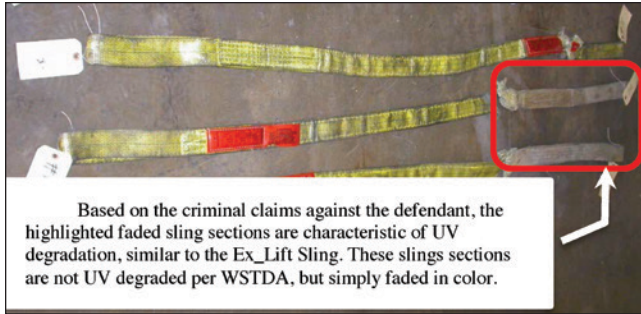
An inspection of two of the All_Lift sling sections, 2A and 4A, showed similar characteristics to the Ex_Lift sling — color fading, which could have resulted from exposure to water followed by drying. See **Figure 11** through **Figure 13** (items labeled 7A and #11). Of particular interest were two sections of the sling that were faded. Had the larger matching sections not been retrieved, would the inspectors also conclude UV degradation? Bleaching condition of the sling rather than color fading is one measure of UV degradation. To conclude that the two highlighted sections were UV degraded, the other factors would need to be present, including increased stiffness, brittleness, and abrasion. Of course, the obvious fact that the slings were new at the time of the incident excludes the UV findings.

Based on the criminal claims against the defendant, the highlighted faded sling sections are characteristic of UV degradation, similar to the Ex_Lift Sling. These slings sections are not UV degraded per WSTDA, but simply faded in color.

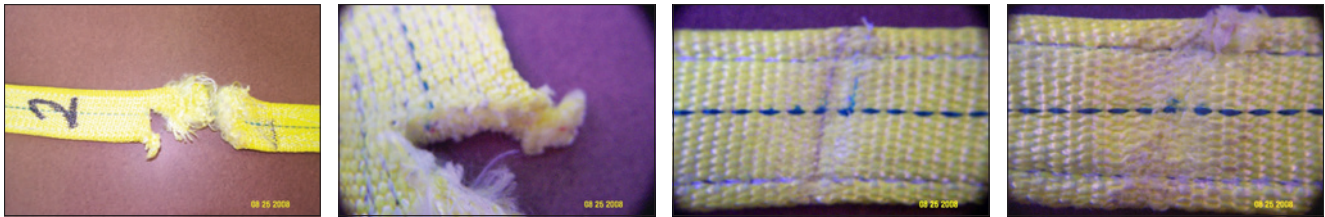
Figure 24

Pictures of the sheared or abraded surfaces of All_Lift Sling #2 test. Note no visible signs of melting on the surfaces.

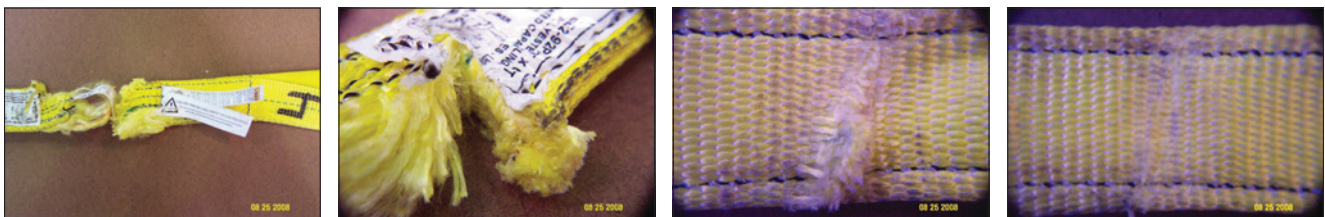
Figure 25

Pictures of the sheared and abraded surfaces of Ex_Lift sling #4 test. Note no visible signs of melting on the surfaces.

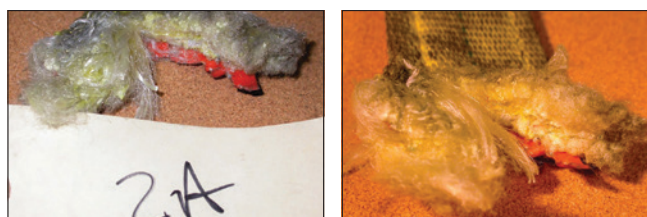
Figure 26

In the inspection of the sling designated 2A melted fibers were easily visible, as shown in **Figure 26**. None of the tests conducted on behalf of the regulatory agency showed any level of melted fibers on the sheared ends.

All_Lift Sling 2A sheared surface showing some melted fibers as well as frayed fibers that are a result of tensile failure.

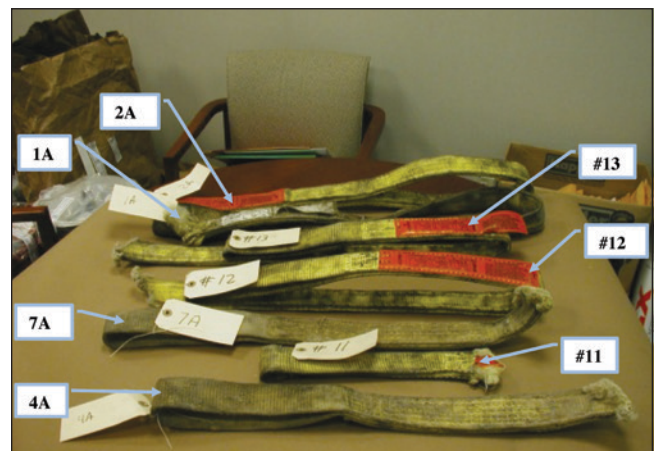
In **Figure 31**, All_Lift sling section 2A is suspended from the collapsed tower. This section combines with All_Lift section 11 to form a complete sling. Note: This sling was the only All_Lift to have been damaged at the red identification tag. In **Figure 32**, sling #12 and #13 identification tags are intact and undamaged.

Figure 32
Sling sections retrieved from the incident site. A total of seven sections were retrieved. The Ex_Lift sling 1A, All_Lift slings 2A, 4A, 7A, #11, #12, & #13 tagged and labeled.

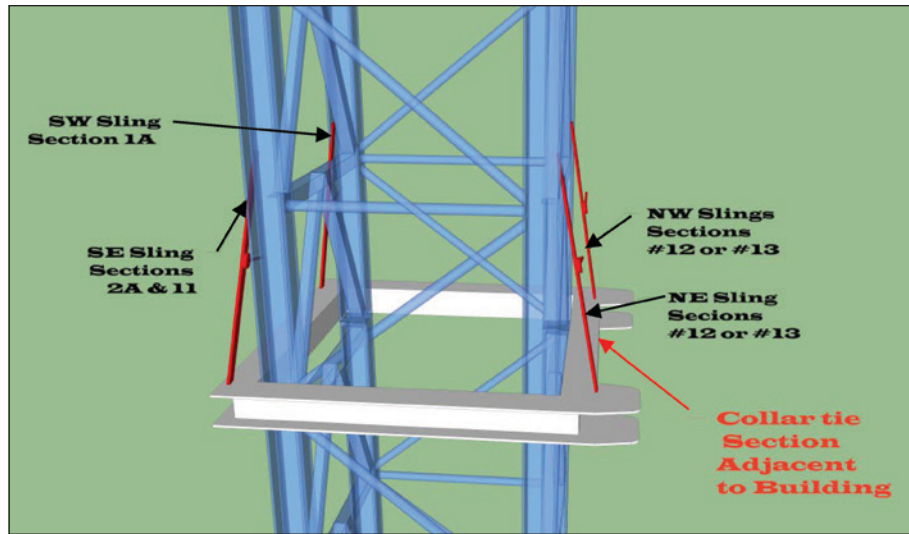
Figure 33
Diagrammatic representation of a section of the crane tower, the collar tie, and sling-lever hoist combination used to rig the collar tie.

The remaining sling sections #12, #13, 4A and 7A are located on the north side of the crane tower closest to the building to which the crane was attached. In other words, these sling sections were rigged to the collar tie and crane tower closest to the building. The sling section arrangements are shown in **Figure 33** and **Figure 34**.

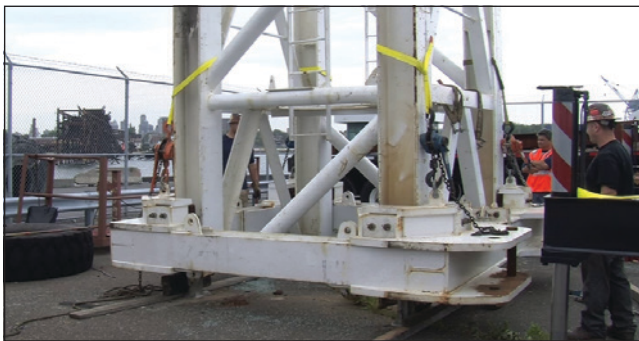
Collar tie test in progress.

Figure 46 shows the completed assembly of rigging and collar tie suspended for approximately 40 minutes to match the elapsed time to failure of the actual setup on the day of the incident. The elapsed time contradicts regulatory agency conclusions that once the collar tie is rigged, the continuous elongation of the polyester slings would require adjustment, hence making synthetic slings incorrect for this rigging operation — no violation of Hooke’s law here.

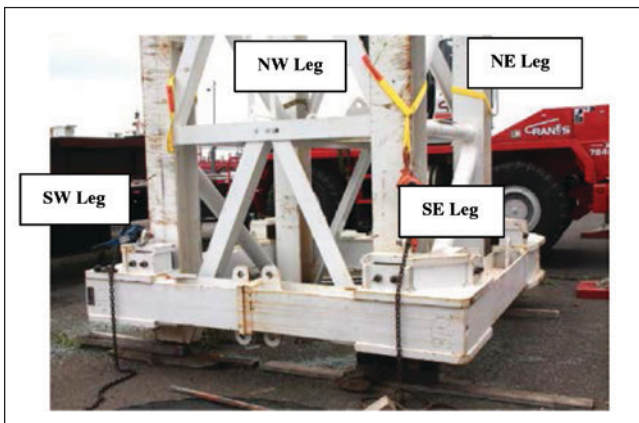
Collar tie suspended from three slings with the SW sling disconnected.

Figure 47 shows the disconnected sling at the SW leg of crane tower. The removal of this sling from the collar tie corresponds to the sling that allegedly failed first, resulting in the failure of the remaining three slings followed by crane collapse. This configuration results in the slings (Ex_Lift sling and All_Lift sling) adjacent to the disconnected slings carrying close to 90% of the collar tie load. This test condition was sustained for more than 20 minutes. The sling directly opposite of the disconnected sling carries a few hundred pounds to balance the collar tie. Based on the geometry of the collar tie, the center of gravity is toward the mobile crane in the background of Figure 45.

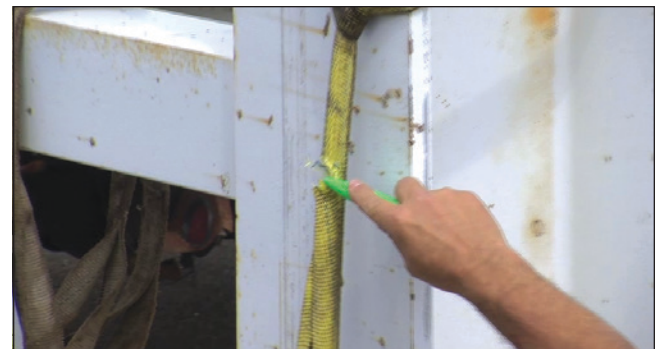
Figure 48

Loaded sling being weakened by cutting.

The Ex_Lift sling shown in **Figure 48** and **Figure 49** was cut more than 50% of its width (the double blue tread along the width of the sling is regarded as the sling's center line) using a utility knife. The collar tie remained suspended in equilibrium after more than 20 minutes.

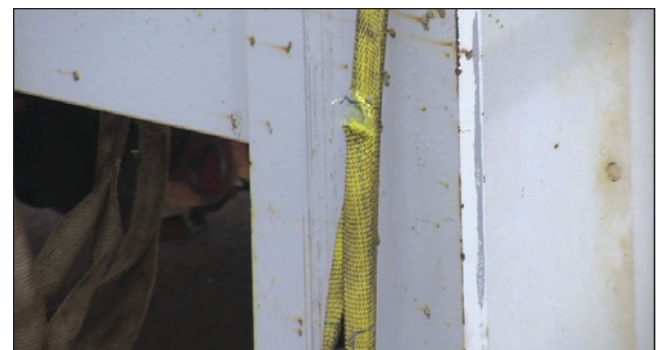
Figure 49

Weakened sling was cut beyond half its width, weakening more than 50%.

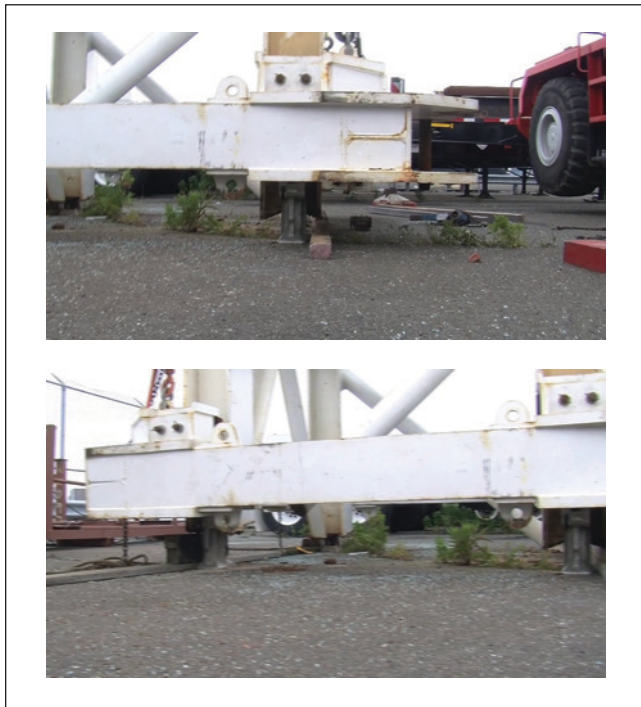
Figure 50

Ground clearance is maintained during the static tests using four sling and subsequent three slings.

During the tests performed on the sling, collar tie, and tower, the clearance between the rigged collar tie and the ground was maintained, as shown in **Figure 50**. The clearance between the ground and the collar tie was estimated to be between 14 to 18 inches. Maintaining clearance between the ground and collar tie was essential to ensure the four slings were carrying the total weight of the collar tie. The situation was continuously monitored during each phase of the test.

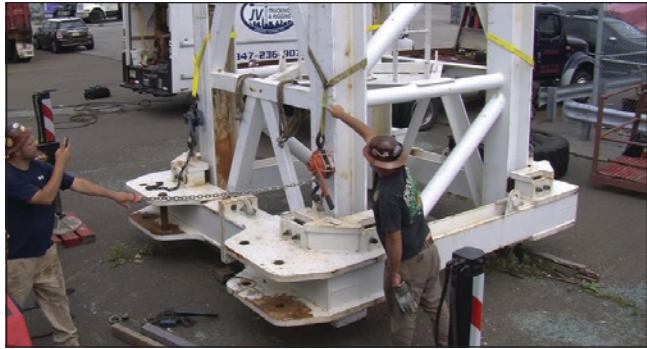
Figure 51

Shock load being applied to the collar tie rigging.

The sling cut, as shown in **Figure 51**, resulted in a dynamic load to the entire system of remaining slings. Additionally, the northwest corner of the collar tie dropped some 8.5 inches, remaining clear above the ground as shown in **Figure 52**. This equilibrium condition was sustained for more than 15 minutes. During the 15 minutes of equilibrium, the remaining slings showed no further elongation.

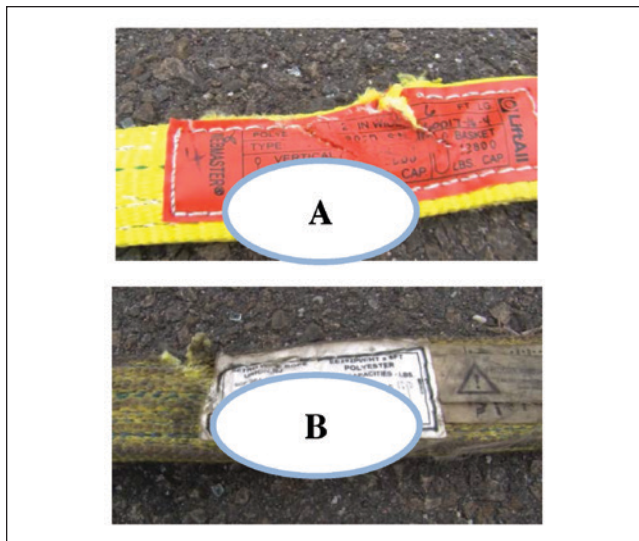
Figure 53

utility knife. The All_Lift sling A, as shown in **Figure 53**, adjacent to the Ex_Lift sling B, is on the heavier end of the collar tie. This sling experienced the worst damage of all the slings. This result is expected because the All_Lift sling is one of the two slings carrying the total load of the collar tie. This sling carried about 55% of the total weight of the collar tie after the shock load — it should be noted that shock loads increase loads shared by the slings conservatively by an order of magnitude of 2, minimally.

The following five pictures show the damage to the slings that resulted from the dynamic test. The cuts are less than 50% of the sling width. The damage to the slings was a result of the slings being placed in the notch. The Ex_Lift sling damage in the three-ply area was restricted to shear.

Damage sustained by tested slings. No ultimate slings' failure occurred after one sling was completely cut.

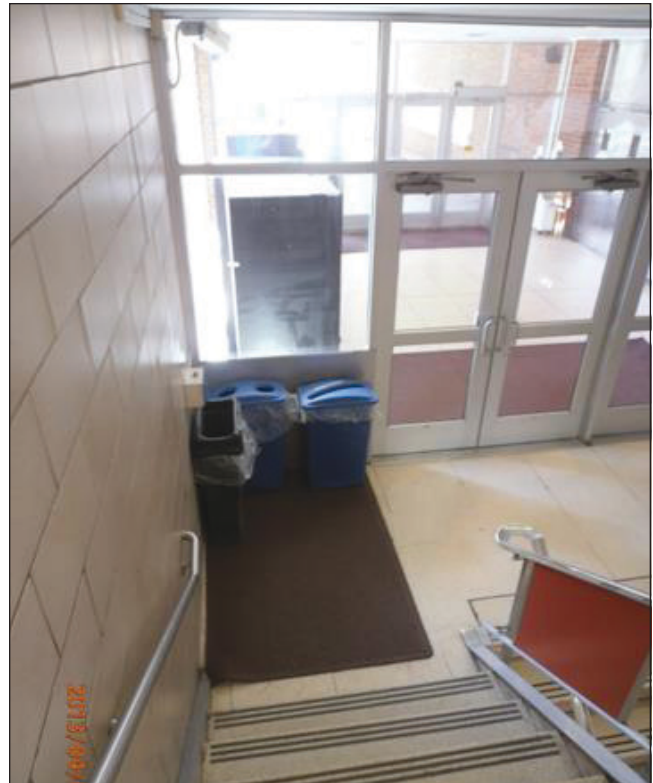
Figure 1

The photo shows the view of the stairs, landing, exit doors, and glass panel that was impacted by the plaintiff as he was descending the stairs. The trash containers were not in front of the glass panel at the time of incident. The photograph was taken at the time of the inspection; therefore, the panel had been repaired.

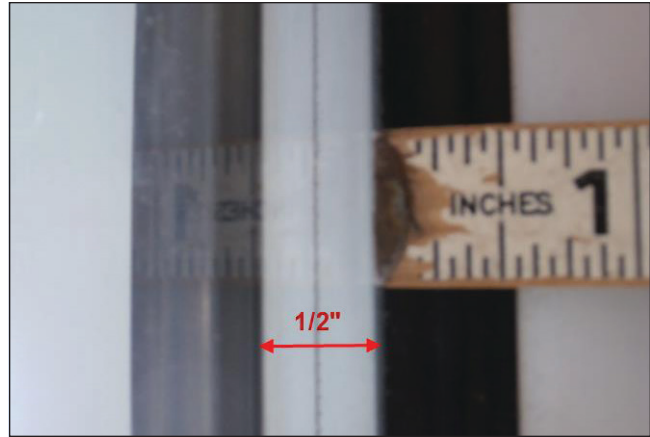
Figure 3

The glass panel consisted of two ¼-inch-thick panels sandwiched together, as shown in **Figure 3**, which was adjacent to the exit doorway. The panel on the other exit doorway was the original glass, and the author was able to measure the thickness as well as the unsupported height and width of the panel. The glass panel appeared to be substantially fixed and supported around all edges of the panel, but the window frame could not be disassembled to ascertain the specific mounting and weather sealing method used. The analysis assumption was that the glass panel would behave as a membrane because the thickness relative to the shortest dimension was large — approximately 90 to 1, which is above the threshold of 80 to 1 for membrane analysis¹. The analysis assumed that the membrane was flexible and infinitely thin, of uniform material and thickness, and that it would elastically stretch uniformly in all directions when deflected. Hence, if it failed, it would fail in tension^{1,2}. The impact load was considered to be perpendicular to the plate surface. Testing of the pushing strength was estimated to be approximately 15% of the male's weight. Based on the plaintiff's weight of 180 pounds, that pushing force equals 27 pounds of force³. Another source of arm strength estimated 37 pounds of force⁴. Based on the average for the arm pushing force against the panel on sources, the author used 32 pounds of force

The photograph represents the measurement taken of the thickness of the sandwiched glass panels of ¼ inch each. The panel was the original installed glass panel similar to the one that the plaintiff impacted.

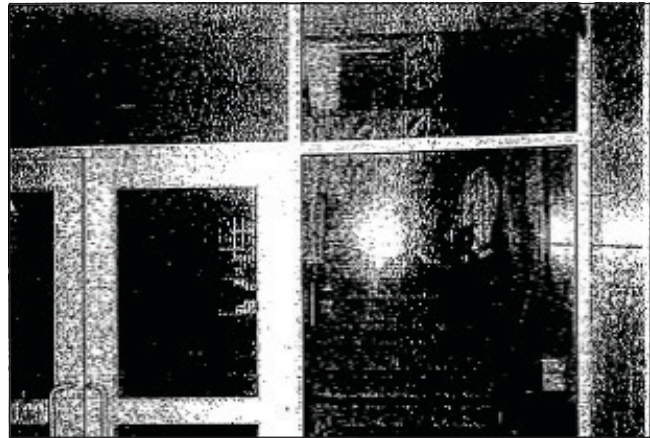
Figure 4

The poor photographic reproduction shows the glass panel as viewed from the outer lobby entrance. The shards of glass still remaining in the frame can be barely observed.
