Journal of the
National
Academy OF
Forensic
Engineers[®]

Vol. 39 No. 2 December 2022

FE Investigation into Manufacturing- and Design-Related Issues Contributing to the Failure of a Climbing Treestand

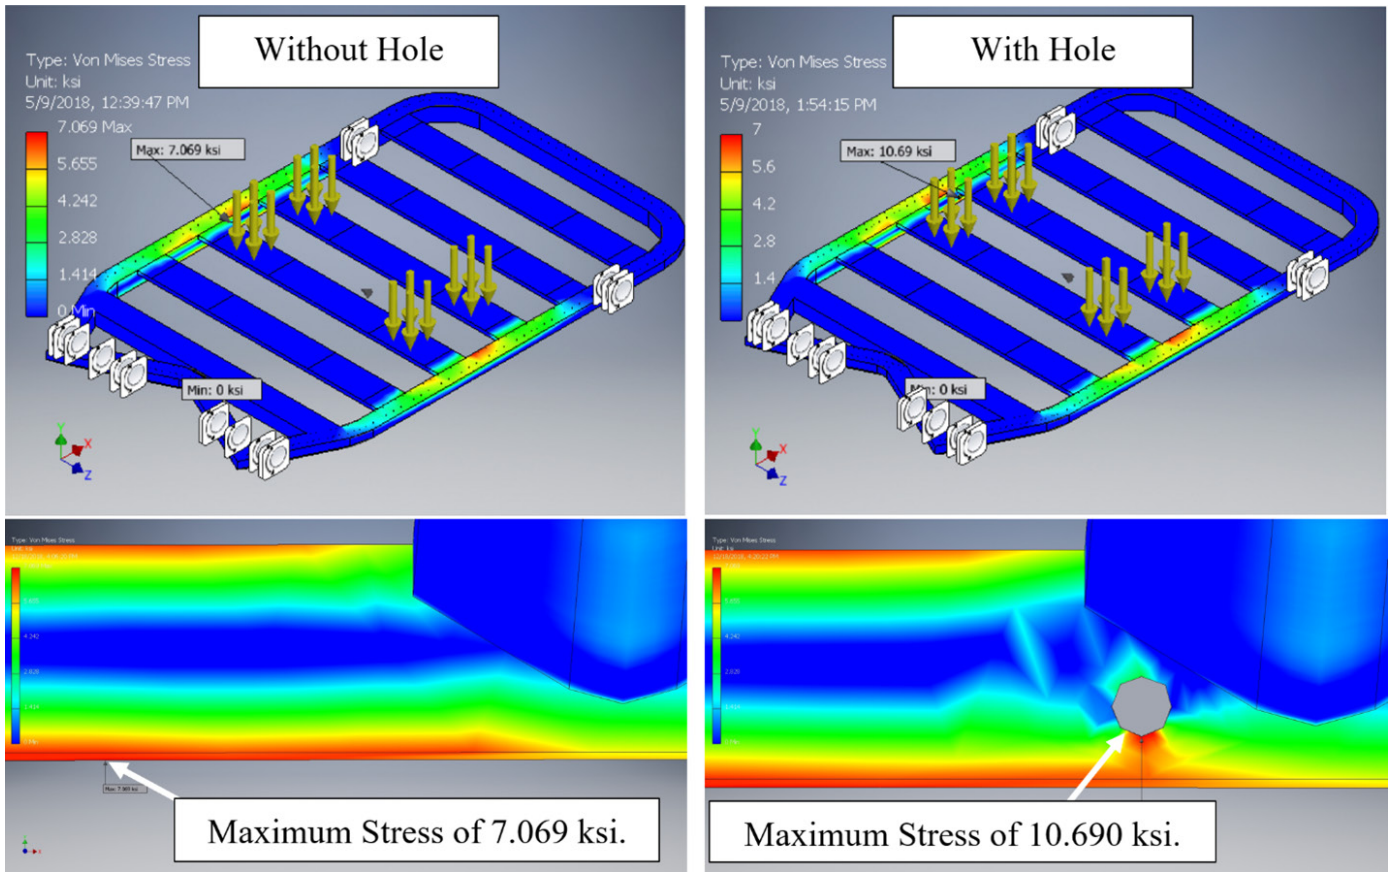
Figure 7

FEA analysis results comparing the Von Mises stresses of the frame railing with (right) and without (left) the discovered hole.

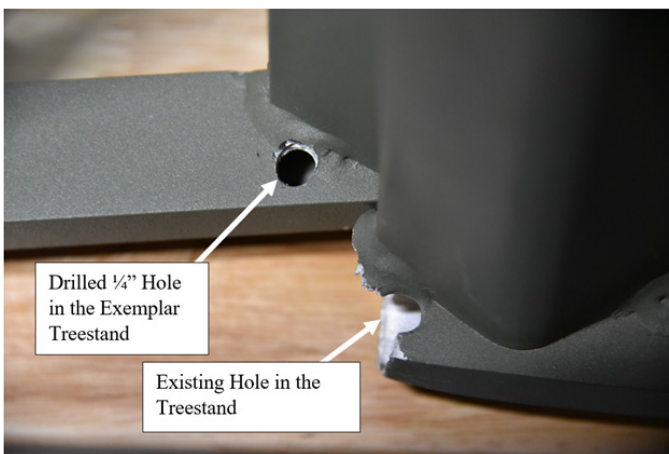
Figure 8

Photograph of hole drilled in exemplar next to manufacturing-induced hole.

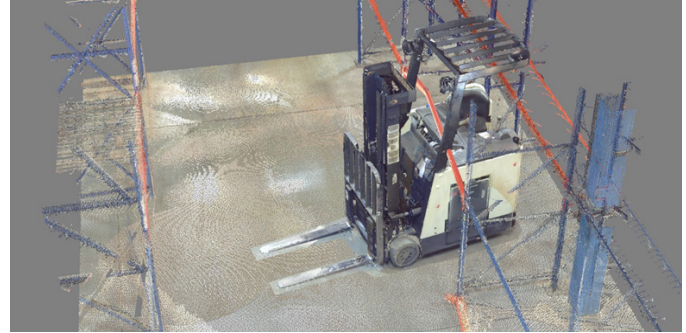
Figure 3

3D graphic of a rack beam that had intruded into a stand-up forklift's occupant compartment.

A horizontal intrusion incident involving a stand-up forklift and a storage rack that resulted in serious injury was investigated and reconstructed (**Figure 1, 2, 3, and 4**). The horizontal rack beam, which had intruded into the forklift and crushed the operator, was 96 inches long with a C-channel profile that was 3 inches tall, 1.4 inches wide, and ¼ inches thick. The beam was made out of A992 steel. The forklift involved in the incident was not originally equipped with a third corner post but was equipped with the fourth corner extension. However, the third corner post was offered by Manufacturer A as an optional feature when the forklift was originally sold. As part of the incident reconstruction, it was determined that the forklift (with no load) traveled into the rack at a speed of up to 6.1 mph.

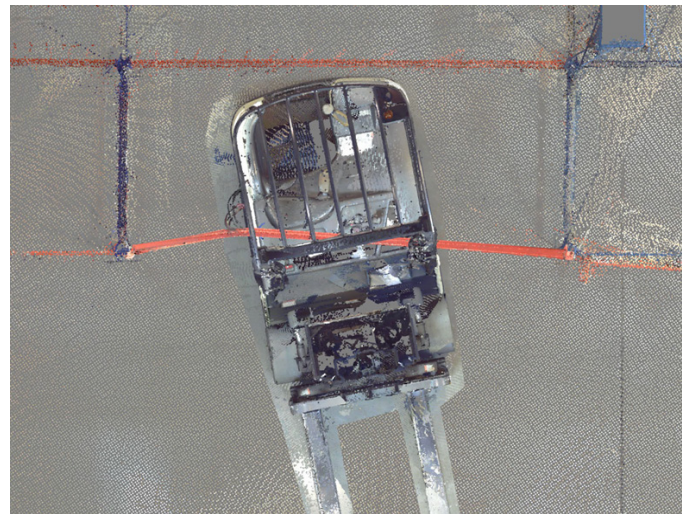
Figure 4

3D graphic of a rack beam that had intruded into a stand-up forklift's occupant compartment (from a top-down view).

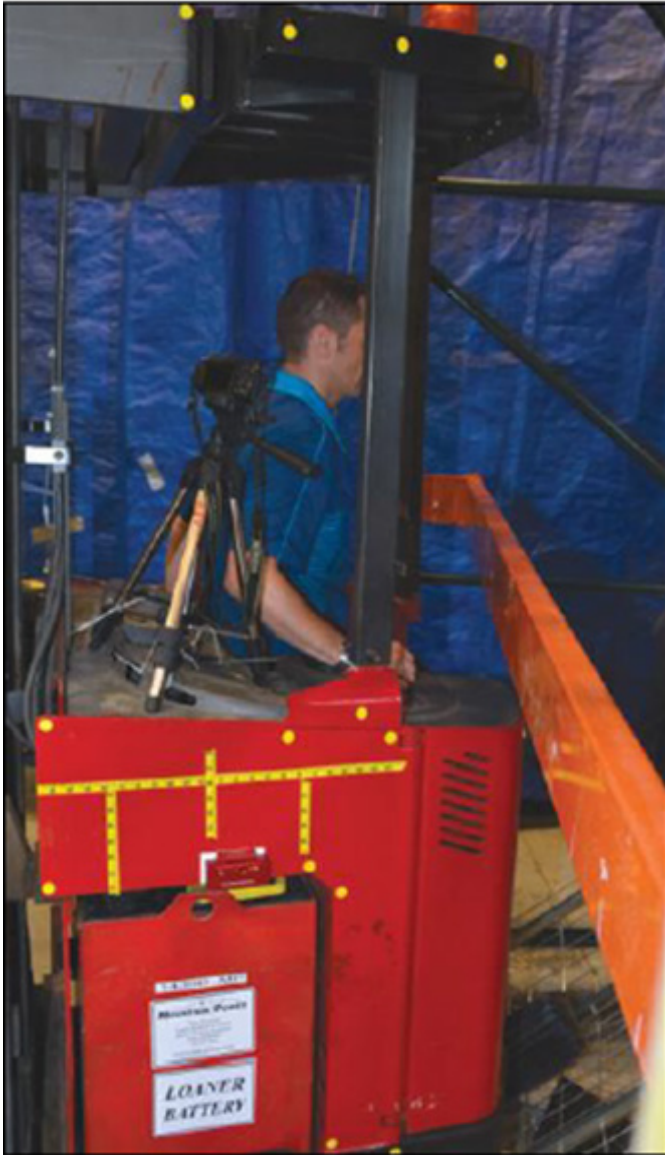
Figure 12

During the tests, both posts contacted a horizontal beam, with the fourth corner post contacting the beam first because the position of the post on the forklift was a few inches further rearward than the third corner post. The test results showed the maximum permanent deformation of the posts was 0.229 inches — a fraction of the 3.9-inch maximum allowed by the B56.1 standard (a factor of safety of approximately 17 in these type of collisions). Further, the test results showed there was up to 9.5 inches of deformation to the impacted rack beam or significantly more than the deformation to the post (**Figure 12** and **Figure 13**).

Photograph showing the results of the physical testing performed from the 2015 study³.

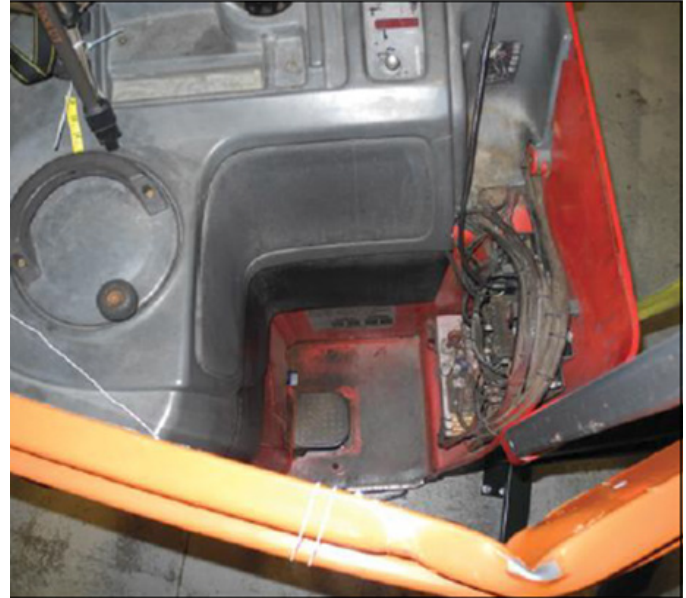
Figure 13

Photograph showing the results of the physical testing performed from the 2015 study (view showing the operator compartment and the deformed beam)³.

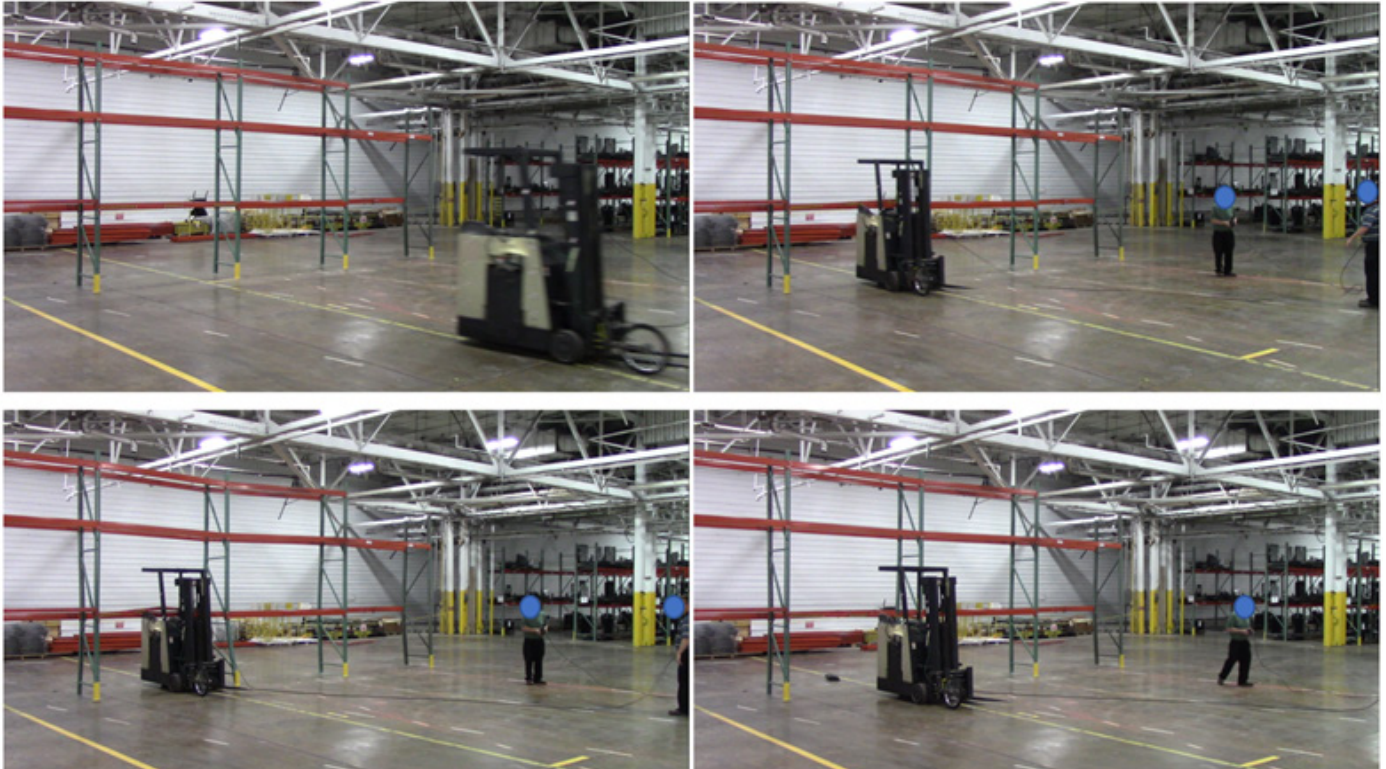
Figure 14

As part of the investigation, the manufacturer of the forklift performed testing with a surrogate stand-up forklift that was equipped with a third corner post. Based on the manufacturer's specifications, the third corner post was a 49-inch-long steel tube with a circular cross section profile with an outer diameter of 2.5 inches and a wall thickness of 0.31 inches. The third corner post was made from 1018 carbon steel. The manufacturer performed impact testing with racking systems that were like the one involved in the case. The manufacturer performed its test with an impact speed of approximately 6 mph (**Figure 14** and **Figure 15**).

Screenshots from Manufacturer A's testing of a forklift striking a racking system at 6 mph, before impact (top left), at impact (top right), the forklift's maximum intrusion into the rack (bottom left), and the forklift at rest (bottom right).

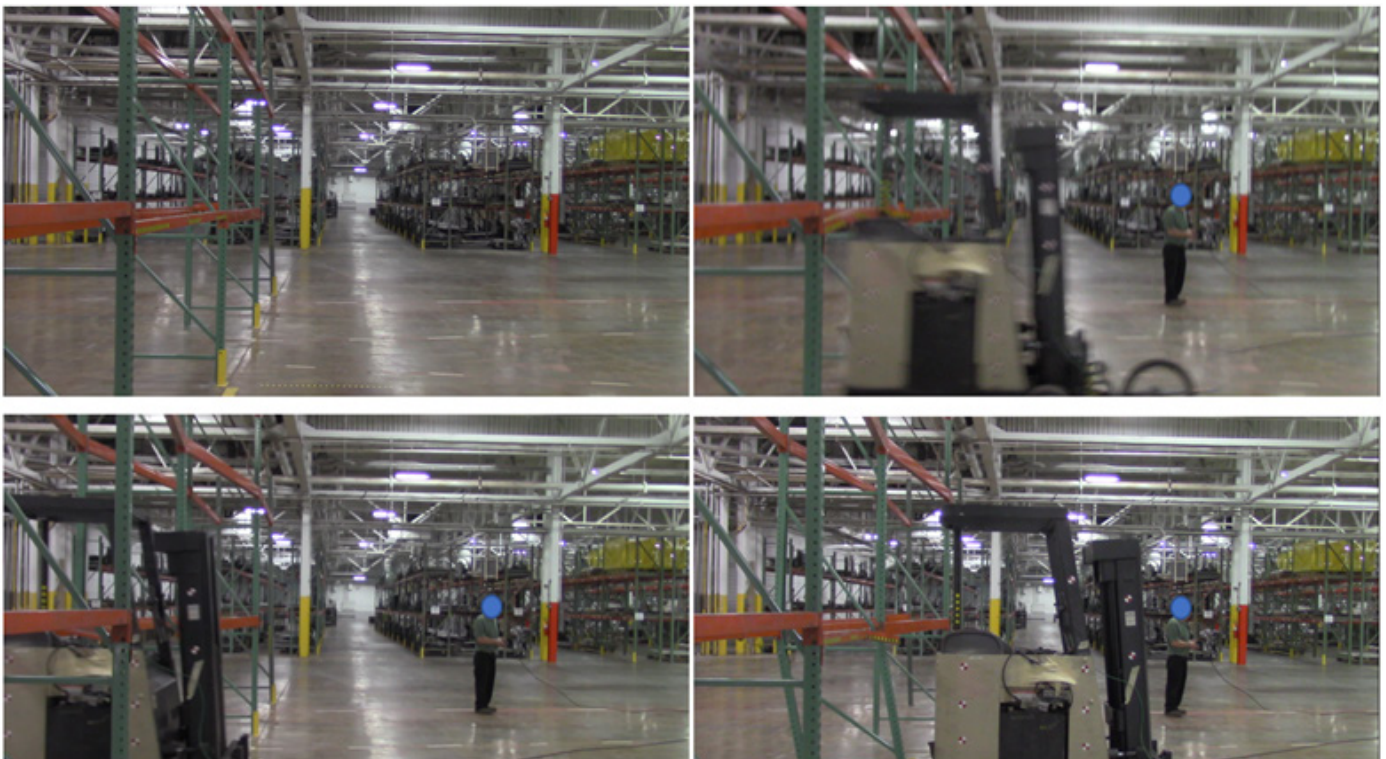
Figure 15

Screenshots from Manufacturer A's testing of a forklift striking a racking system at 6 mph, same test as shown from **Figure 14** but from a side view. Screenshots showing before impact (top left), at impact (top right), the forklift's maximum intrusion into the rack (bottom left), and the forklift at rest (bottom right).

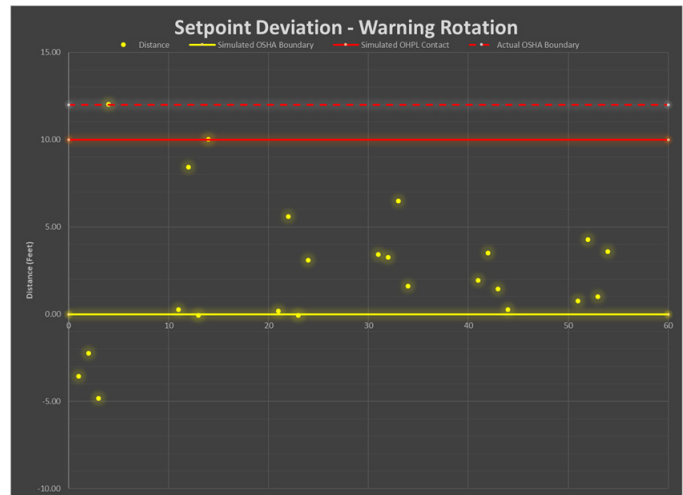
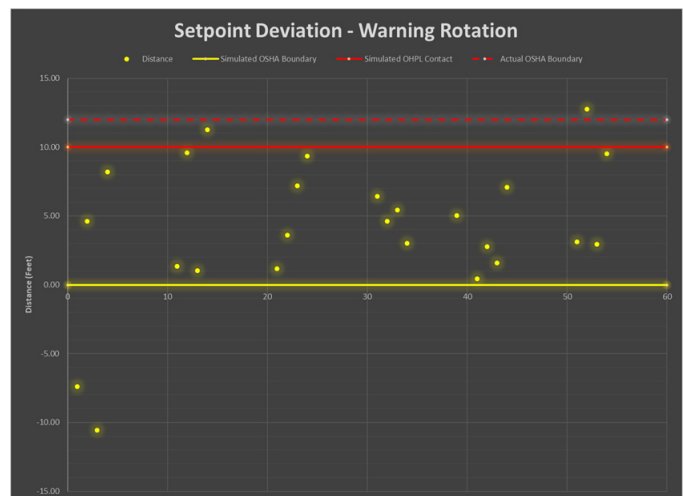
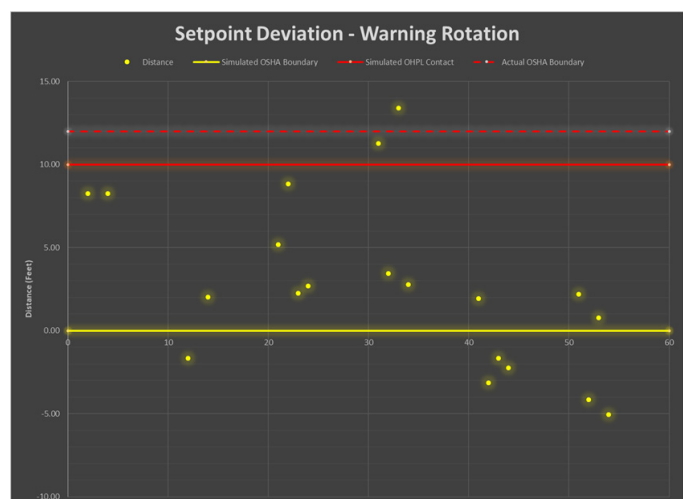
Figure 5
PWD2 deviation from setpoint (warning rotations at Station1A).

Figure 6
PWD2 deviation from setpoint (warning rotations at Station2).

Figure 7
PWD2 deviation from setpoint (warning rotations at Station3).

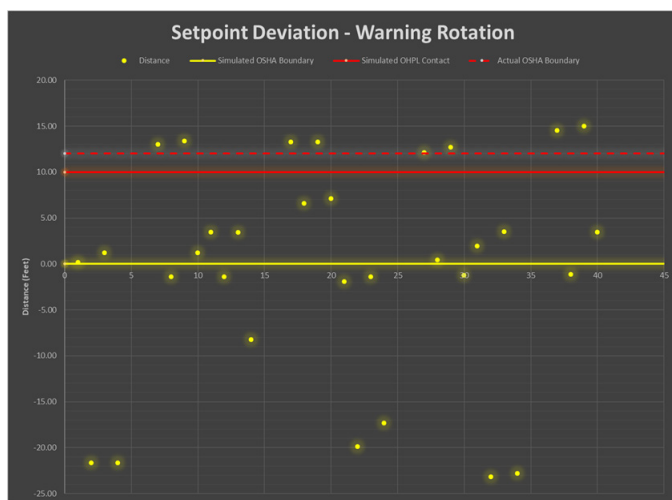
Figure 8

Half of the PWD2 setpoints for Station4 were set on the right side of the subject MEWP; the other half were set on the left side of the subject MEWP. PWD2 deviation from the setpoint (simulated OSHA boundary) for all the warning rotations can be seen in **Figure 8**. The PWD2 warning rotation alarm farthest from the setpoint, prior to

the setpoint location, occurred at 23.2 feet. The warning rotation alarm farthest from the setpoint (past the setpoint location) occurred at 15 feet. There was substantial variation in the PWD2 responses for the warning rotations. The variation was also substantial for the danger rotations (not shown).

PWD2 deviation from setpoint (warning rotations on Station4).

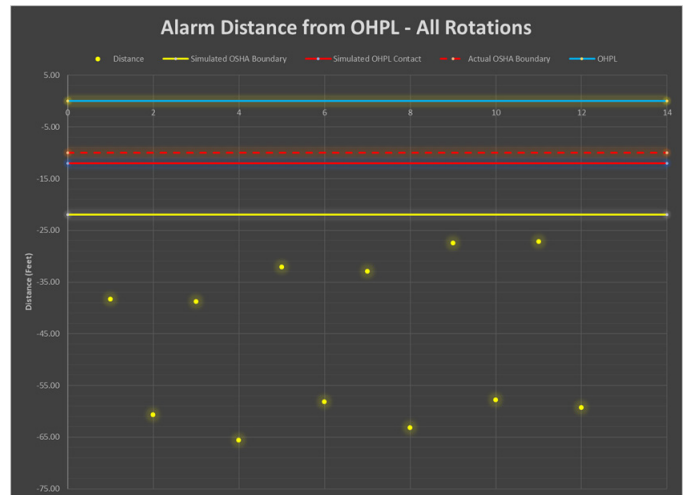
Figure 9

PWD1 alarmed at distances between 27 to 66 feet from the OHPL at the various platform heights. The closest (to the OHPL) alarm occurred at 27.3 feet and the farthest (from the OHPL) at 65.6 feet. Only the electric field sensor alarmed. No alarms from the magnetic field sensor occurred during any of the rotations. The alarm distances with respect to the OHPLs can be seen in **Figure 9**.

PWD1 alarm distance from OHPLs at Station4.

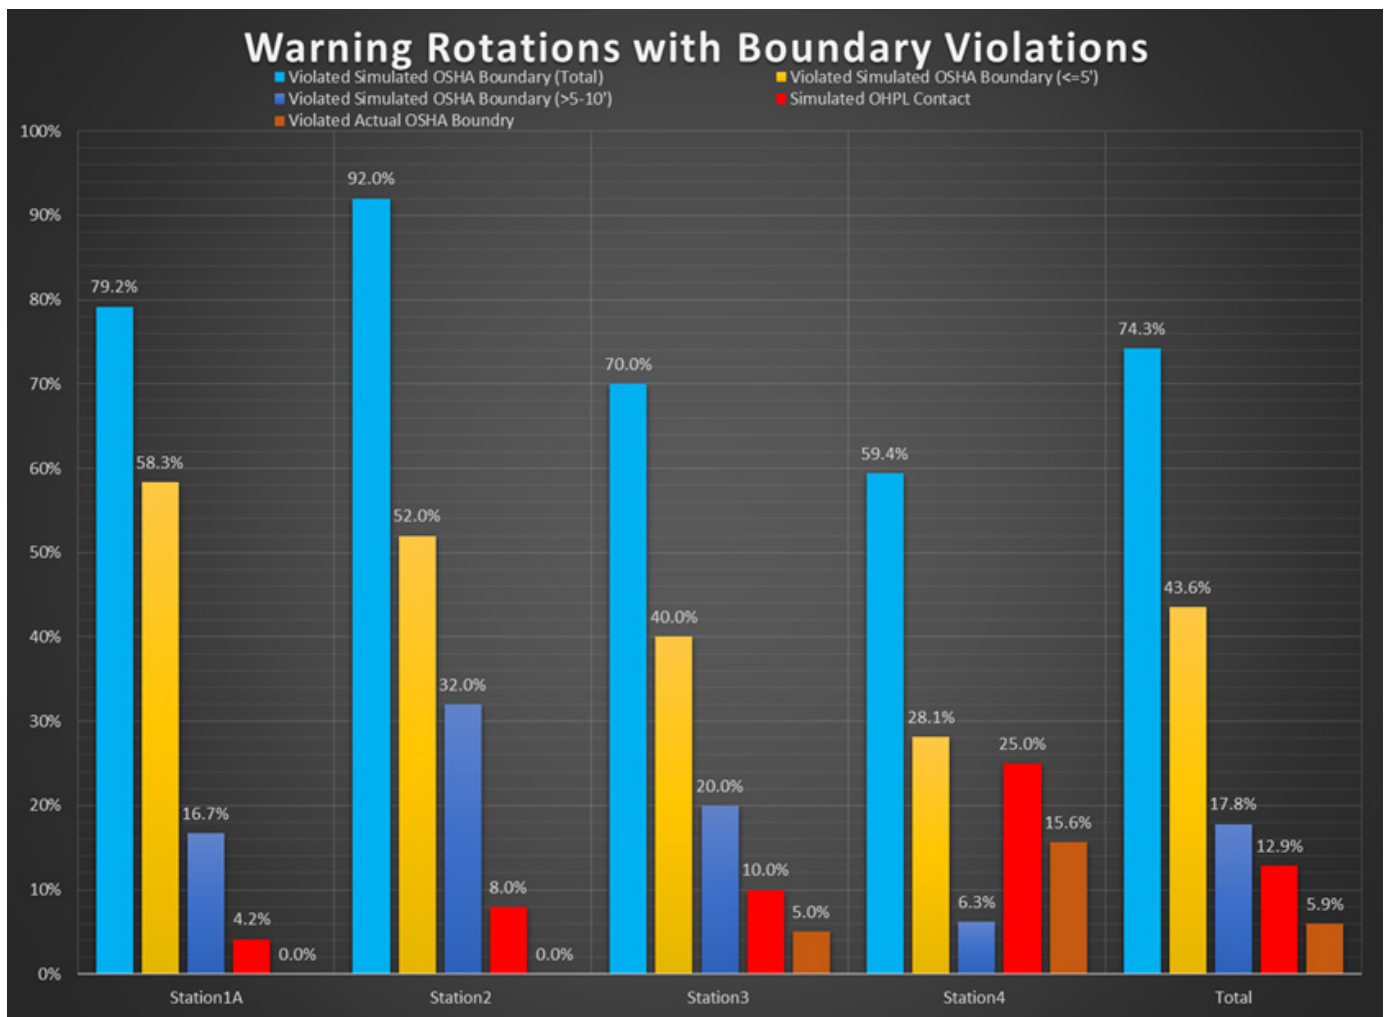
PWD2 boundary violations are shown in **Figure 10**. Only boundary violations that occurred for warning rotations are shown. Boundary violations for danger rotations were more numerous.

Figure 10
Percentage of PWD2 warning rotations with boundary violations.

The severity of harm incurred from contacting an OHPL is immediate and tragic, almost assuredly resulting in damage to property, personal injury, and/or death. PWD2 allowed violation of the simulated OSHA boundary on 74.3% of the total rotations without initiating a warning alarm. PWD2 allowed violation of the simulated OSHA boundary on 92.0% of the rotations at Station2, without initiating a warning alarm. PWD2 allowed simulated OHPL contact on 12.9% of the total rotations without initiating a warning alarm. PWD2 allowed simulated OHPL contact on 25.0% of the rotations at Station4, without initiating a warning alarm.

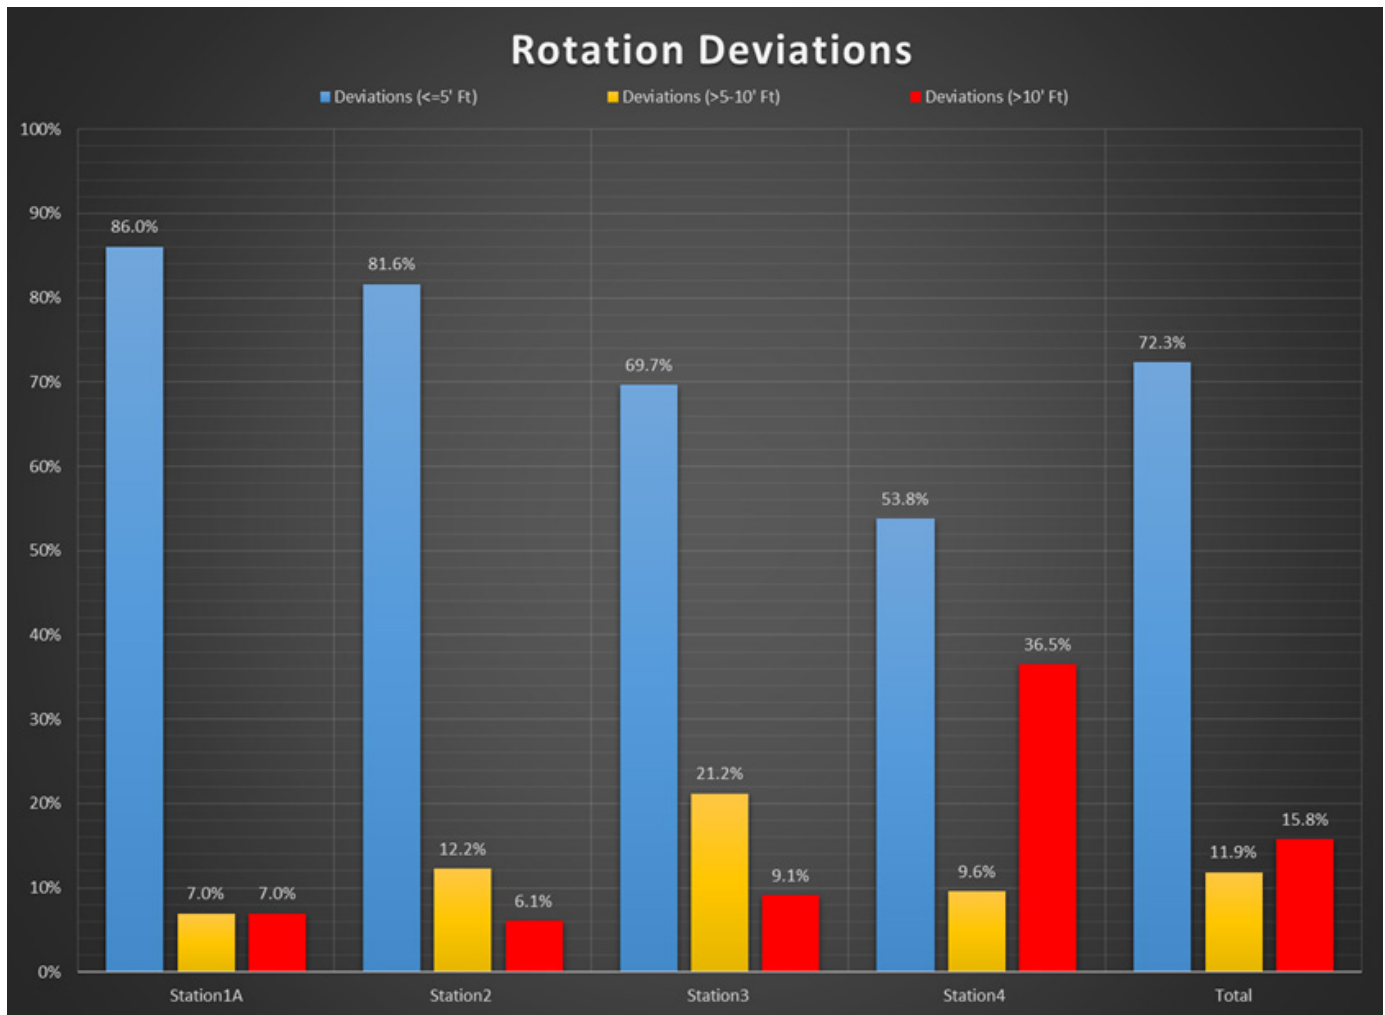
A rotation deviation was defined as the difference (in feet) between the alarm distance on one MEWP rotation and the alarm distance on another MEWP rotation. To better understand the nature of the variability of alarm distance experienced during the test, several PWD2 rotation deviations were examined. The comparison was not exhaustive, and other rotation comparisons could be made. Rotation deviations for PWD2 are shown in **Figure 11**.

Figure 11
PWD2 rotation deviations.

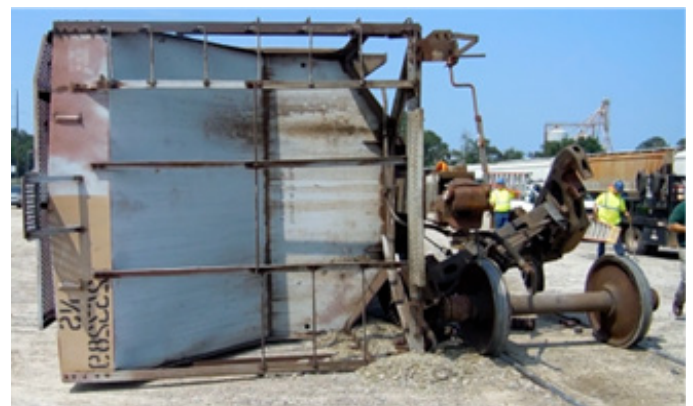
Figure 1

Rail car derailed from the tangent track (left); another view of the derailed rail car (right).

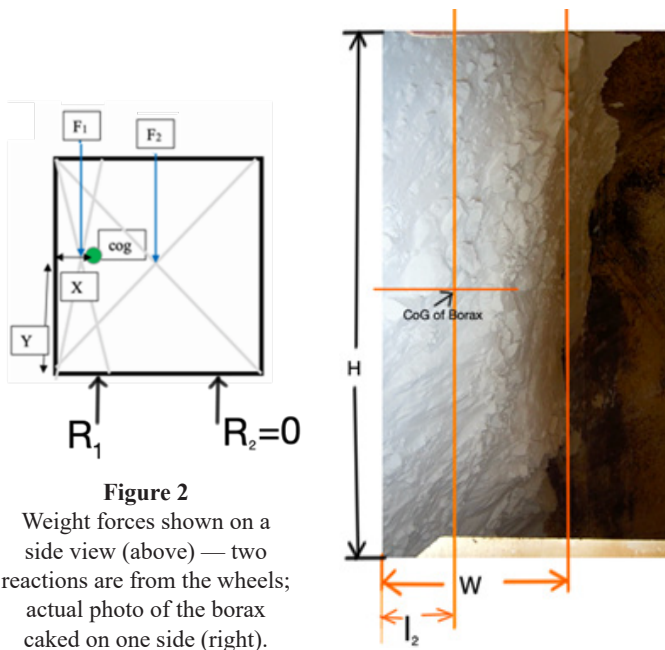
Figure 2
Weight forces shown on a side view (above) — two reactions are from the wheels; actual photo of the borax caked on one side (right).

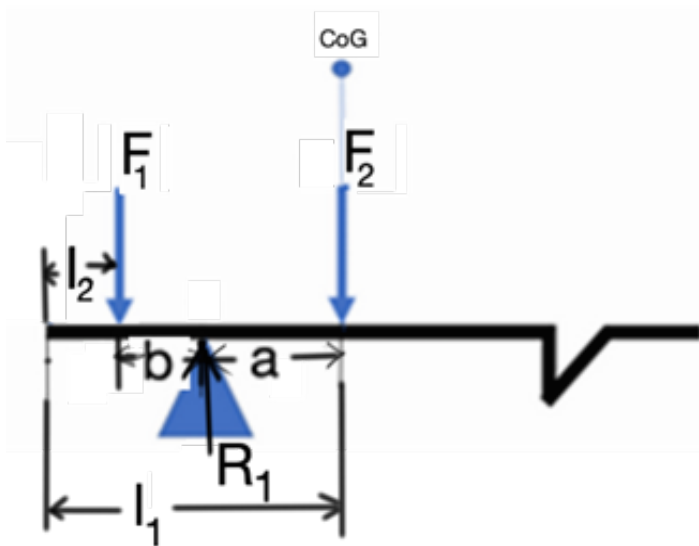
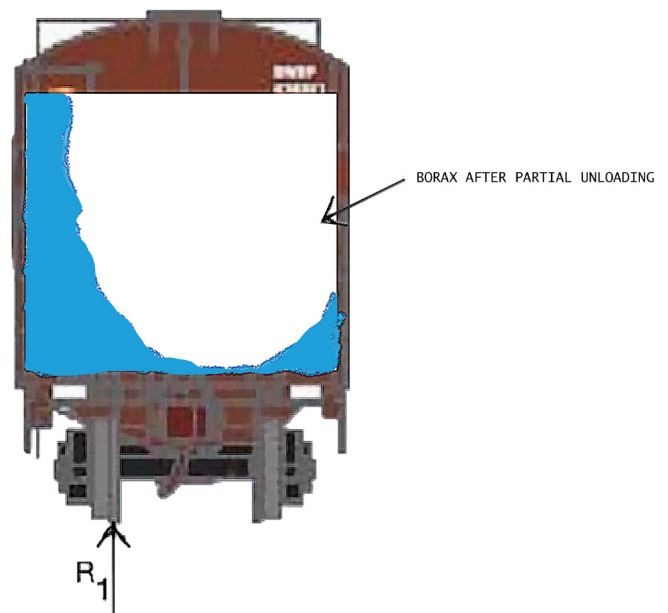
The pivot point of the rail car is the location of wheel-to-rail contact. The tipping angle was found to be 26.3° . The rail car was pulled in place by the railroad locomotive while it was fully loaded. It was emptied by transfer station workers using an unloader placed under the car at the drop chute. The unloader conveyed borax up to drop in the dump trucks. Unloaders had shakers to help loose material in the rail car, so it fell freely into the unloader. The shaker on this device was not working.

Figure 3
Moments calculations with moment arms.

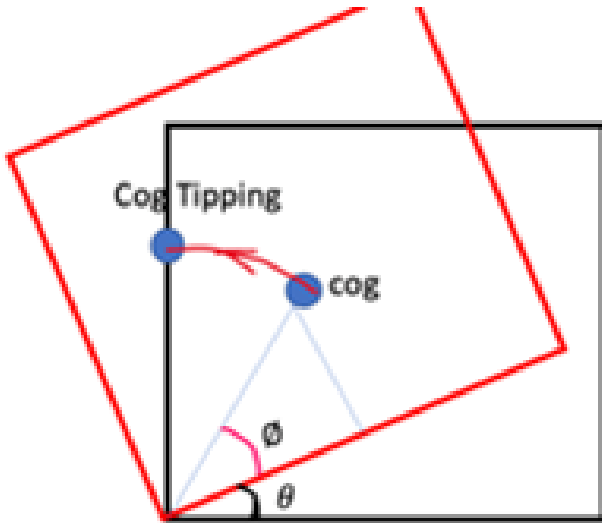
Figure 4
Lean angle calculations.

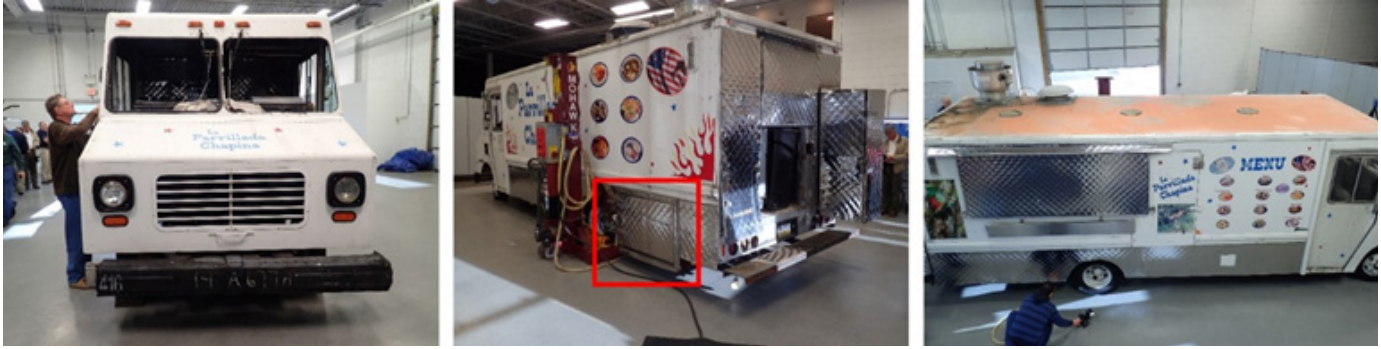
Figure 13

The front (left), driver (middle), and passenger (right) sides of the food truck.

The post-incident appearance of the food truck is illustrated in **Figure 13**. The windshield was missing from its frame. The truck was equipped with a generator located inside a cabinet near the back on the driver's side. Metal on the front and rear sides of the generator cabinet were pushed to the front. The exterior diamond plate on the rear of the truck, which formed the back wall of the left cabinet, had a dent or impact mark about 2 feet 10 inches above the bumper. Reconstruction of the left cabinet, which was framed using square metal tubing covered with diamond plate, is shown in **Figure 14**. The exterior diamond plate on the rear wall of the truck enclosed the back of the cylinder cabinet. The cabinet exhibited signs of forces from the inside acting in an outward direction.

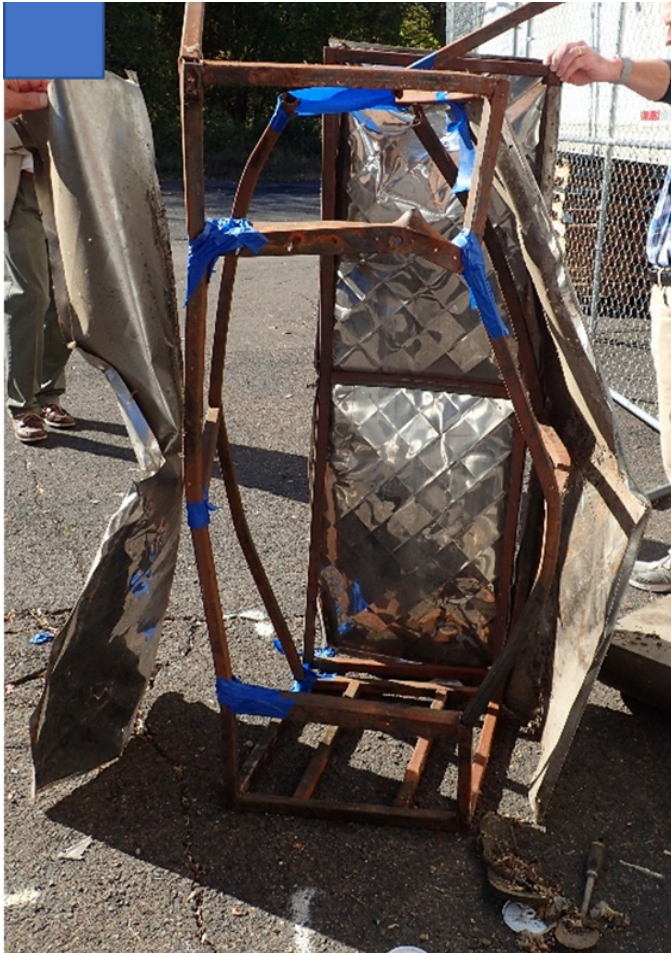
Figure 14
Reconstruction of the left cabinet.

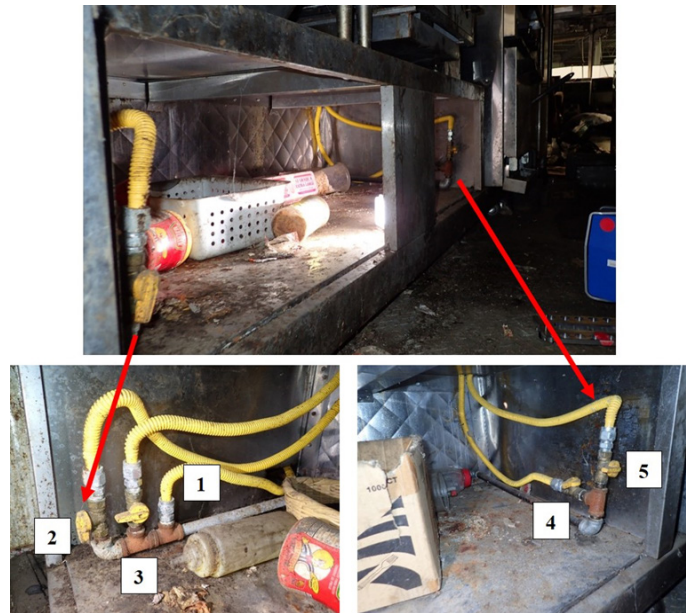
Figure 18

The images show the as-found positions of the manifold valves after the incident.

The four manifold valves supplying gas to the appliances on the left side were found in the following positions (see **Figure 18**): flat top griddle (2) open, charbroiler (3) closed, vertical broiler (4) closed, and range (5) closed.

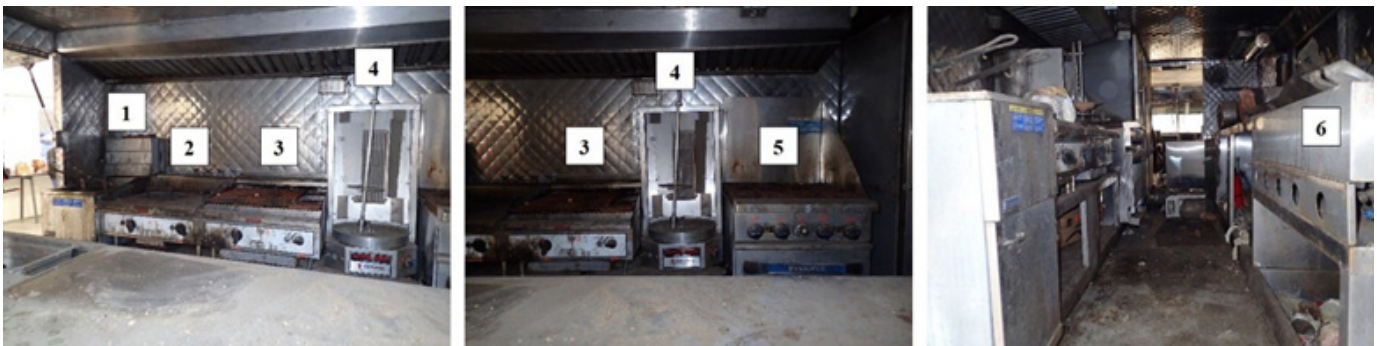
Figure 19

The five appliances on the left side and the one appliance on the right side of the food truck after the explosion are shown in **Figure 19**. The appliance information and as-found valve positions for each appliance are detailed in **Figure 20** (the valves for each appliance were assigned a number). For example, the left valve on the griddle was labeled as “2L,” the left rear valve on the cooktop of the range was labeled “5LR,” and the oven control was labeled “5O.”

Post-explosion images of the six gas appliances inside the food truck, which included a deep fat fryer (1), griddle (2), charbroiler, (3), vertical broiler (4), range (5), and steam table (6).

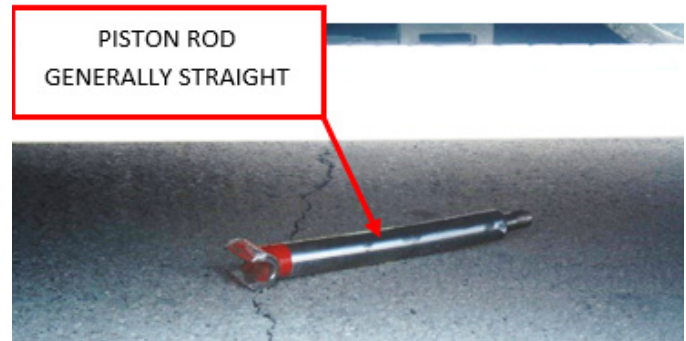
Figure 5 show the piston head and piston rod after the failure. As shown, the piston head did not show any significant deformation, and the piston rod was generally straight.

Figure 5
Piston rod after incident.

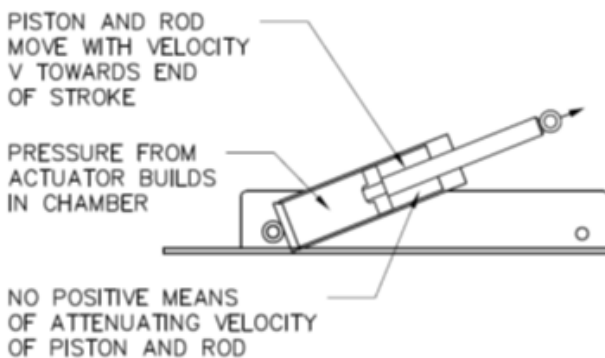
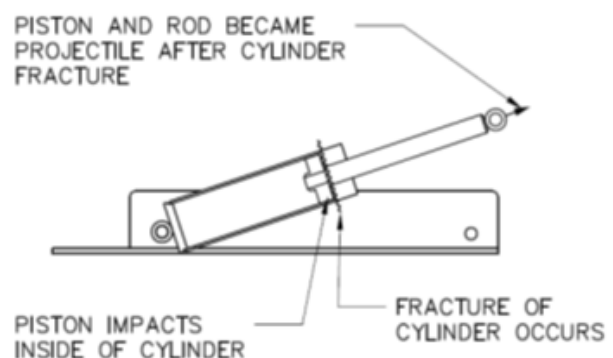
The design of the cylinder did not have a damping mechanism to attenuate the impact of the piston head and piston rod. The kinetic energy of the piston head and piston rod was absorbed by impact with the cylinder end cap. The hypothesis tested in this investigation was whether the piston and rod were moving with sufficient velocity such that their kinetic energy was adequate to result in a rupture of the cylinder as shown in **Figure 6**. The piston rod also

Figure 6
Impact of piston and rod on cylinder end cap. (Note: There was no positive connection — just a C-type clamp around the pin. The pin broke through the frame at its point of supports.)

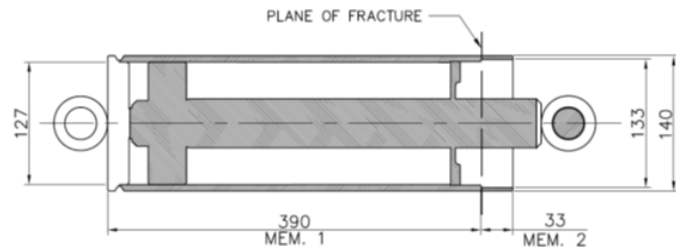
Figure 17 shows a cross-section of the cylinder. The plane of fracture was located at the cylinder’s end cap. The cylinder end cap was threaded onto the cylinder body, resulting in a smaller thickness than the cylinder wall. The equivalent spring method⁷ was used to estimate the energy required for yielding and rupture of Member 2, taking into account the deformation in Member 1. Examinations of the piston did not reveal any significant deformation.

Figure 17
Cross-section of cylinder showing member identification.
shown in **Figure 18**.

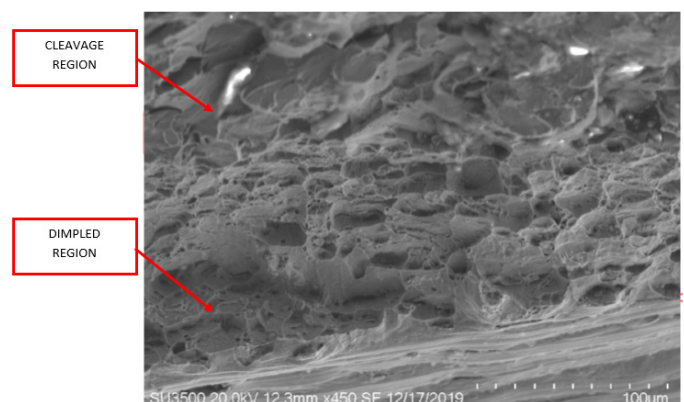
Figure 20

There was also some evidence of accompanying ductile fracture near the inner and outer diameters of the end cap, as shown in **Figure 20**. There was no evidence of striations, beach marks, or corrosion damage observed in the SEM examination.

Dimpling near inner diameter.

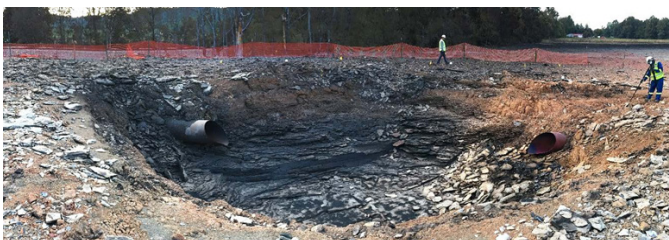
An incident occurred involving a section of a vintage natural gas pipeline in the United States that unexpectedly ruptured, resulting in one fatality, destruction of 30 acres of the surrounding area, hospitalization of six people, and the evacuation of more than 75 residents (**Figure 2** and **Figure 3**). The families of those affected filed suit against the owners of the pipeline, pursuing legal theories of recovery based on negligence and gross negligence.

Crater left by the pipeline explosion⁴.

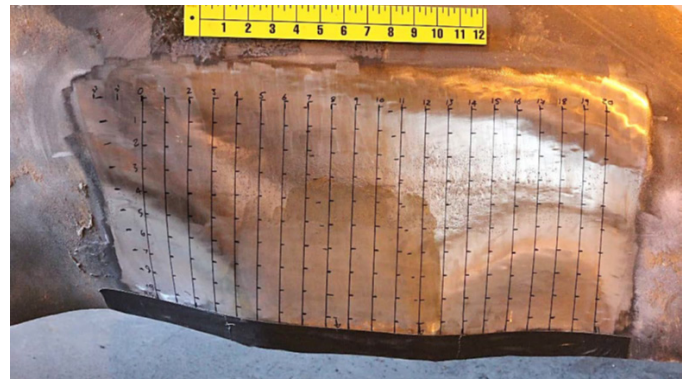
The surface of the pipeline segment near the failure origin was ground, polished, and etched to create a grid for the measurement of hardness variation within this area (**Figure 8**). The etched surface revealed a darker region (**Figure 9**) near the failure origin where higher hardness values were measured as compared to areas away from the failure origin (**Figure 10**).

Figure 8
Hardness grid on a polished and etched surface of the pipeline near the failure origin⁴.

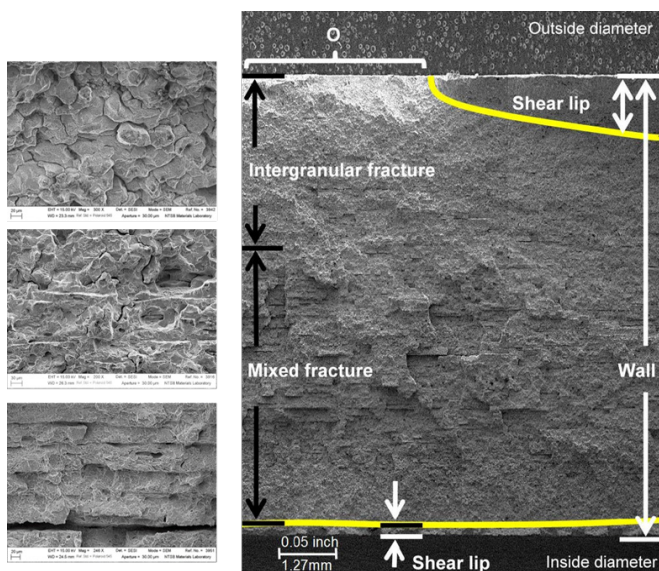
Figure 11

SEM image of the fracture surface at the fracture origin, displaying regions of intergranular and mixed mode fracture⁴.

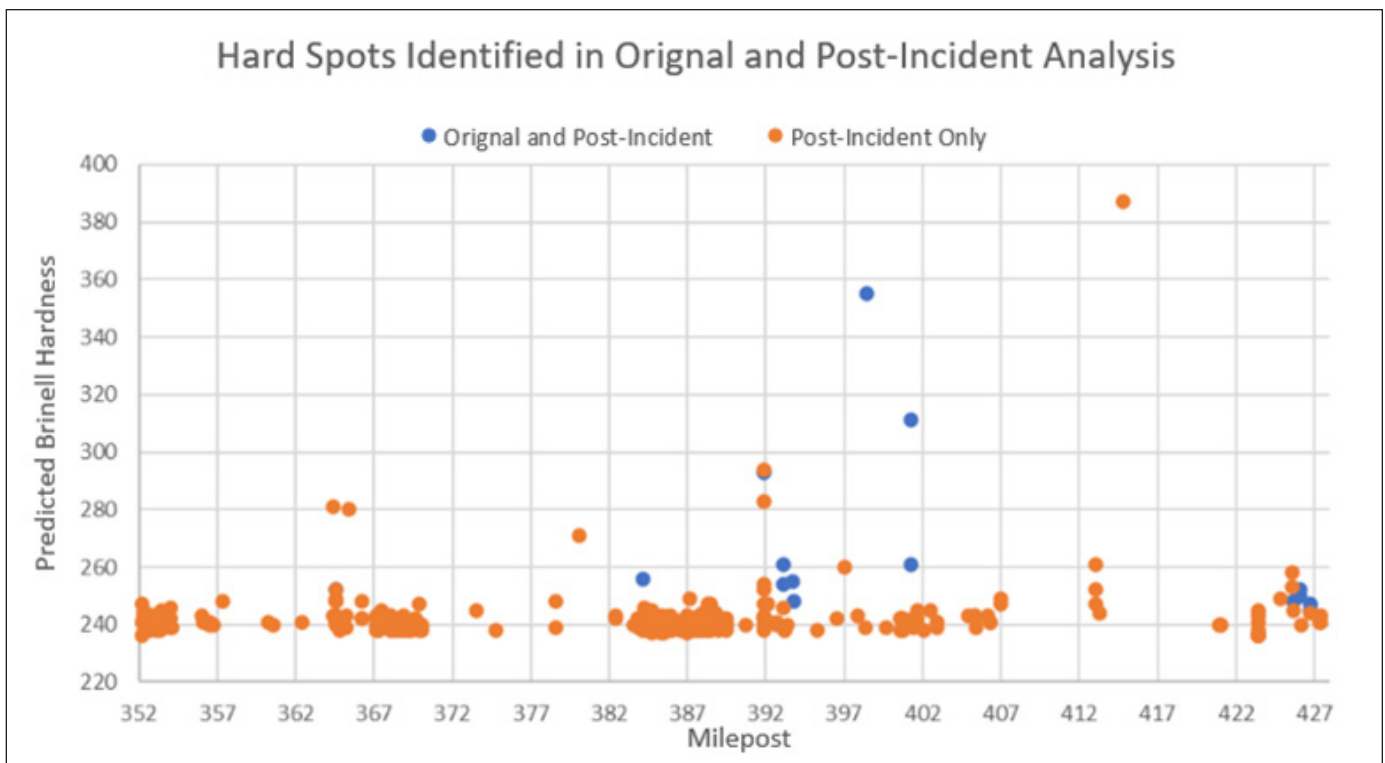
Following the incident, the pipeline inspection company performed a re-analysis of its original data from the inspection performed eight years before the incident. This re-analysis utilized an improved version of the company’s analysis software, which now incorporated AI instead of human operators to identify potential hard spots. As shown in **Figure 12**, this re-analysis revealed a total of 441 hard spots (compared to only 16 that were originally identified), nine of which were located within the same section of pipe that ruptured and one that was located at the failure origin.

Figure 12
Comparison of hard spots identified in the original and post-incident analysis.

program¹⁴.” As the pipeline at issue was a vintage pipe with a known susceptibility to hard spots, the pipeline owners should have instituted an inspection interval well below the maximum stated interval of seven years in order to account for the increased risk of hard spots presented. Had the pipeline owners run ILI multiple times as required by federal regulations, they would have — in all probability — caught 99% of the defects present in the pipeline, and the incident may likely have been prevented.

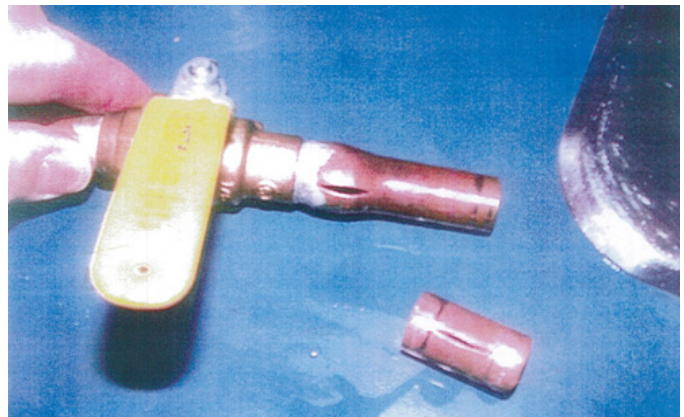
Figure 3
The two longitudinal splits in water supply pipes.

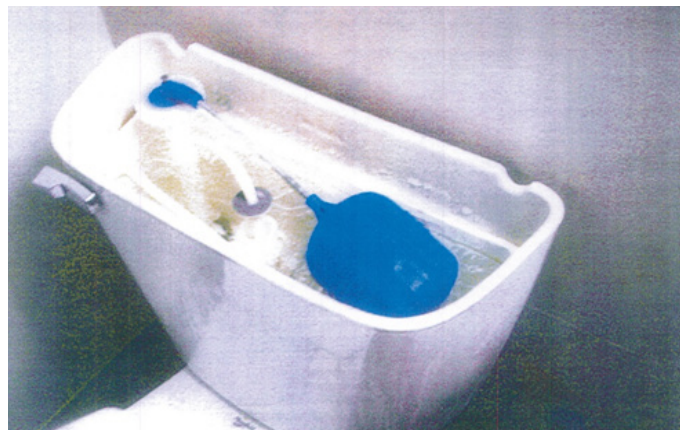
Figure 4
One of two toilet tanks with ice formation.

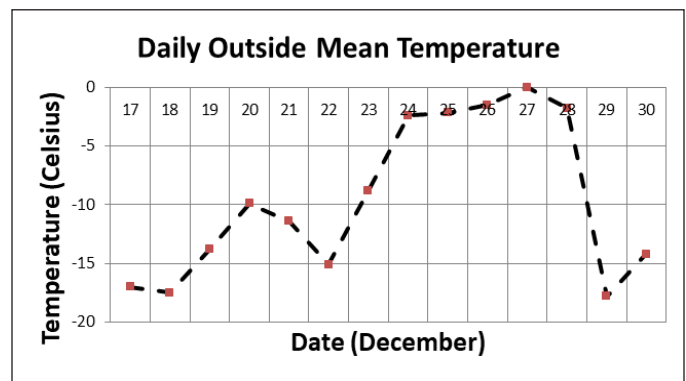
Figure 6

Daily outside mean temperature from Environment Canada, December 2009.

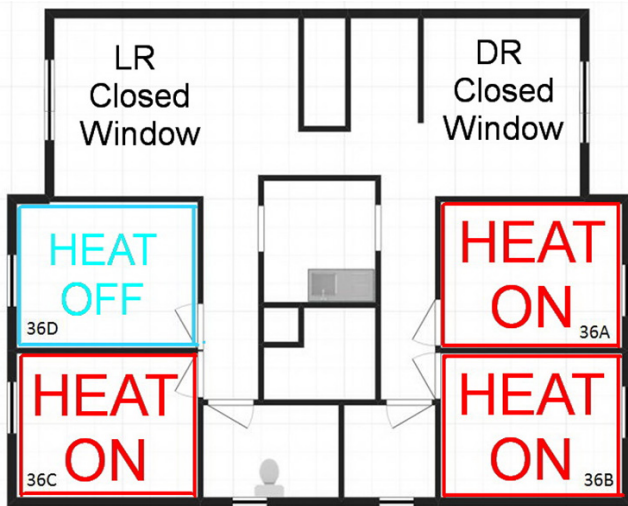
Figure 8

Case 1 suite diagram – heat source off in 36D.

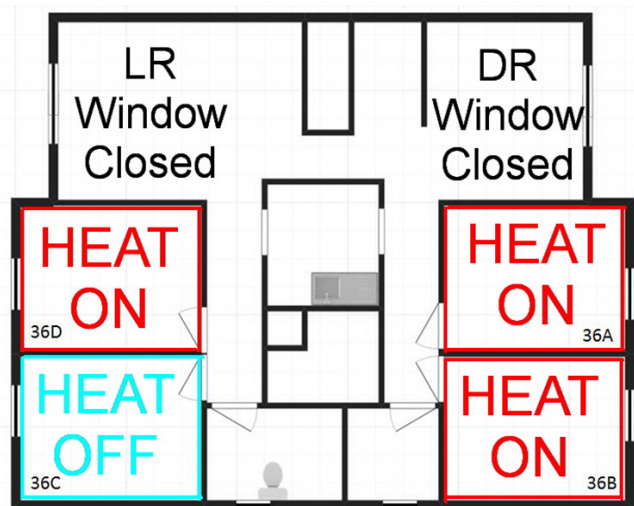
Figure 9

Case 2 Summary: The main room begins to cool as soon as the heat source in Room 36C is interrupted, in a 39 HDD situation. The deficit of 821W (2,800 BTU/h) is less significant than that of Case 1, in part because there would be a smaller area of higher conductance wall involved.

Case 2 suite diagram – heat source off in 36C.

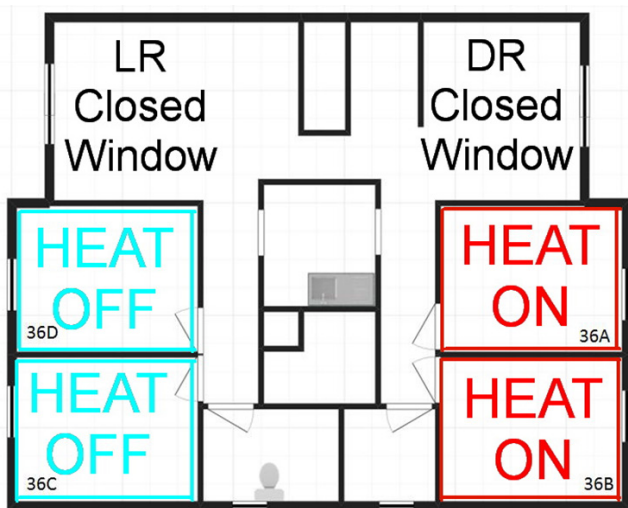
Figure 10

Case 3 Summary: The main room begins to cool as soon as the heat sources in Rooms 36C and 36D are interrupted in a 39 HDD situation. The deficit of 2,104W (7,200 BTU/h) is smaller than that of Case 1, but larger than that of Case 2, due to the different areas of higher conductance wall in the calculations.

Case 3 suite diagram — heat sources off in both 36C and 36D.

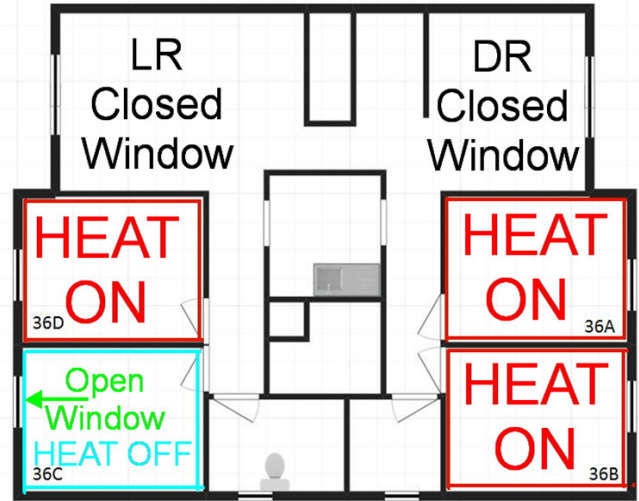
Figure 11

The corner Room 36C allegedly had its window open and baseboard heater off (**Figure 11**) from December 19 through December 30, and this was examined in Case 4. For example, using equation (5) assuming 10% window opening with a velocity 1.14 m/s (3.74 ft/s), with a volume of 72 L/s (152 cubic feet per minute) calculates a convection loss of 3,210W (11,000 BTU/h) for an HDD of 35.8 on December 29th. When combined with the through-wall heat loss of 1,175W (4,000 BTU/h), the net heat loss value for the suite was 4,294W (14,600 BTU/h). The equivalent air changes per hour for Room 36C was 11.3 on that date.

Case 4 suite diagram — window open and heat source off in 36C.
