Journal of the
National
Academy OF
Forensic
Engineers[®]

Vol. 39 No. 2 December 2022

FE Investigation into Manufacturing- and Design-Related Issues Contributing to the Failure of a Climbing Treestand

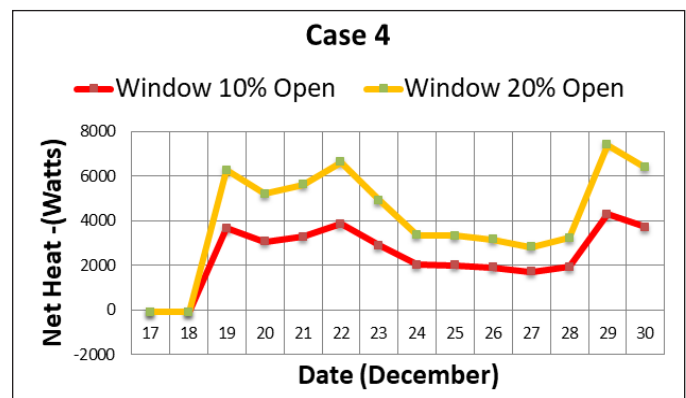
Figure 12

Case 4 Summary: Room 36C begins to cool as soon as the heat source is interrupted and the window is opened, as calculated on a daily basis beginning on December 19, and shown in **Figure 12**. The additional heat loss is about three and a half times larger, and the situation would lead to a disruption of the suite heating dynamics — since between 1,700 and 4,300W (5,800 to 14,600 BTU/h) are required to keep the room at 18°C (64.4°F). This deficit means that the room will cool quickly to the exterior temperature and then track this with a lag. The effect of the percentage opening (10% or 20%) is seen in the cooling trend magnitude.

Net heat loss trend by date for Case 4 conditions: window open and heat source off in 36C.

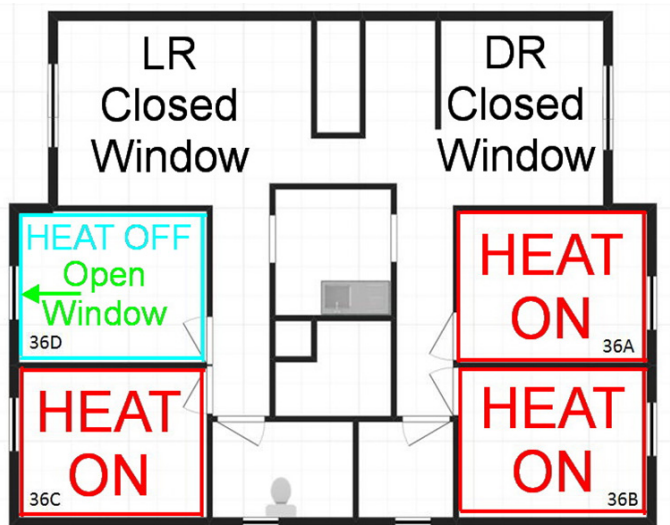
Figure 13

for the equilibration process that begins on three sides: – two walls adjoining the main room and the third adjoining Room 36C (Figure 13). The baseboard heater copes well up to and including December 23.

Case 5 suite diagram — window open and heat source off in 36D.

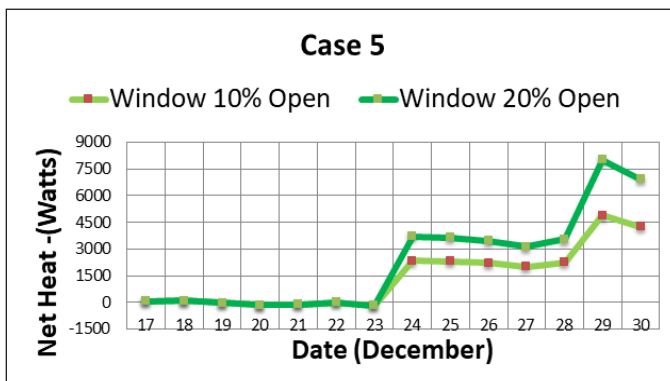
Figure 14

Net heat loss trend by date for Case 5 conditions: window open and heat off in 36D beginning December 24.

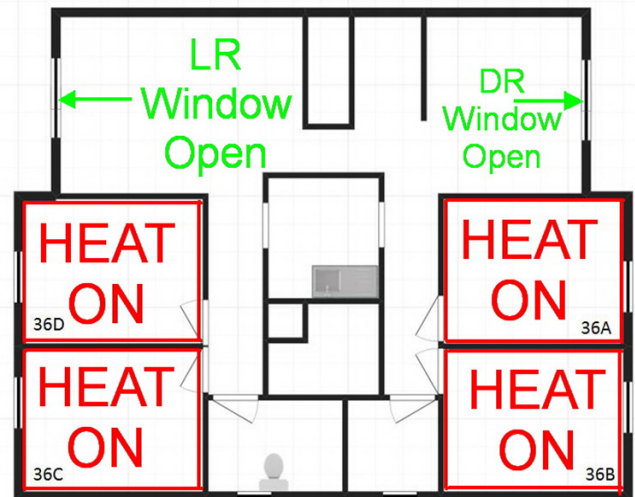
Figure 15

Case 6 mimics having two large windows open while the occupants continue to heat the premises, beginning December 24 (Figure 15). Of course, the immediate effect is that the two baseboard thermostatically controlled heaters in these rooms move to ‘ON’ setting and remain there.

Case 6 suite diagram — windows open in living room and dining room.

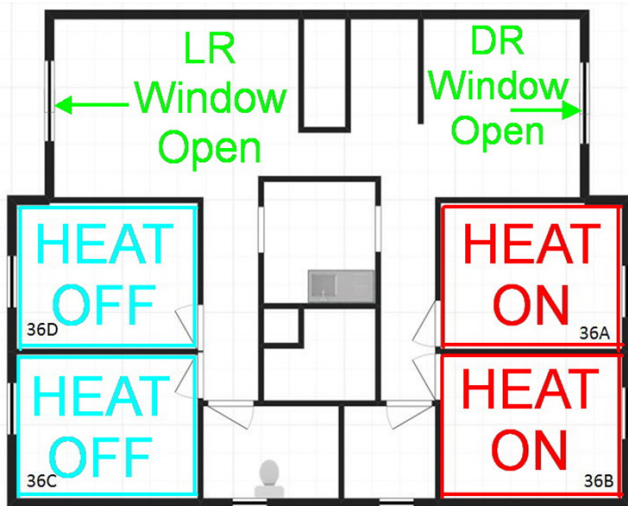
Figure 16

Case 7 follows the set-up of Case 6 except that the elements in Rooms 36C and 36D are turned off, but their windows are kept closed (Figure 16). Only when the windows are opened does the heat deficit go well beyond the suite’s heating system 6,100W (20,800 BTU/h) heating capability with about four air changes per hour. A comparison of these cases is shown in Figure 17.

Case 7 Summary: Removing the heating elements makes the situation dramatically worse in the first few days. The results are similar to Case 6 with a large heat deficit as soon as the windows are opened on December 24. Between 3,000 and 16,200W (10,200 and 55,250

Case 7 suite diagram — heat source off in both 36C and 36D, windows open in living room and dining room.

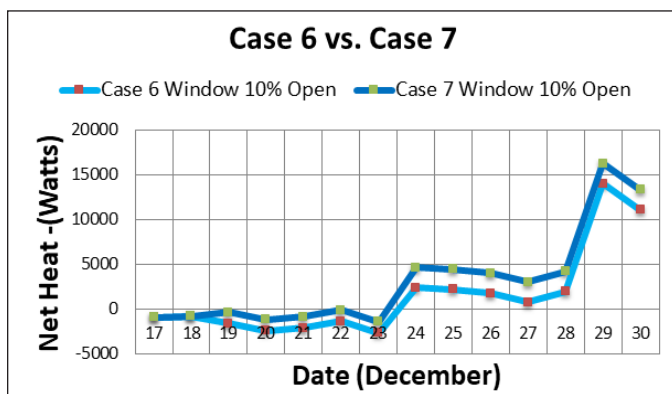
Figure 17

Comparison of net heat loss trends by date for Cases 6 and 7, living room and dining room windows 10% open.

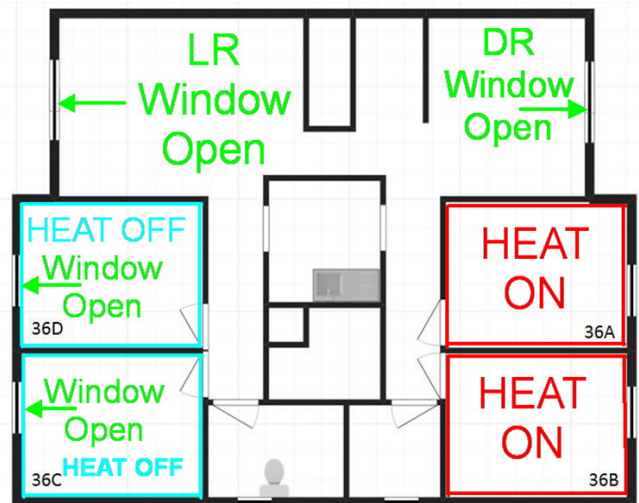
Figure 18

Case 8 Summary: The suite began to cool as soon as Charlie opened his window and turned off the heat in Room 36C on December 19 (see Figure 18), instilling a heating deficit range of 700 to 2,300W (2,400 to 7,840 BTU/h) for the whole suite, depending on the HDD value. The heating deficit was exacerbated on December 24 by the opening of the windows in 36D by Dave and the living room and dining room by Dave and Bob as well as the interruption of the baseboard heater in Dave’s room. The suite temperature then equilibrated with the outside after December 24, rendering the suite pipes susceptible to freezing on December 28 (when the temperature dropped to -21°C or -6°F) because the water in the pipes started from a cold temperature other than 18°C (64.4°F), as would be expected in a heated suite.

Case 8 unit diagram — heat source off in both 36C and 36D, windows open in 36D, 36C, living room and dining room.

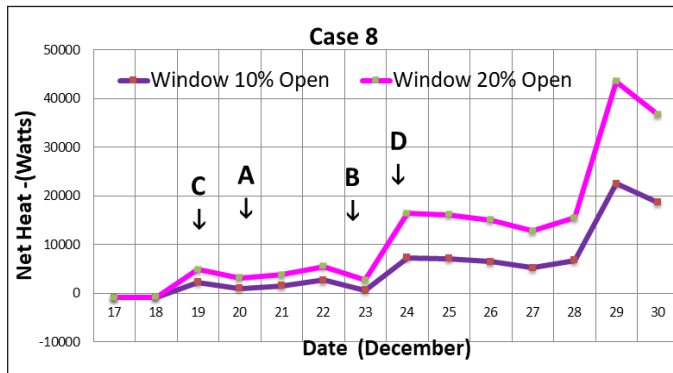
four sets of windows to 10% positions on December 24. The chart in **Figure 19** reveals that the suite was in a heating deficit condition from the first day, December 19, that the window of Room 36C was opened 10%, its baseboard heater turned off, and the volume of air in the suite was changing about once per hour.

Graph of Case 8 showing the net heat flow by date with heat off in Room 36C and 36D; windows at 10% or 20% open in living room, dining room, Room 36D and Room 36C. Departure dates are labelled by resident initial and arrow.

Figure 19 reveals that the suite was in a heating deficit condition from the first day (December 19) that the window of Room 36C (Charlie's) was opened 10%, and its baseboard heater turned off. Case 8 represents the reported configuration discovered with the water escape.

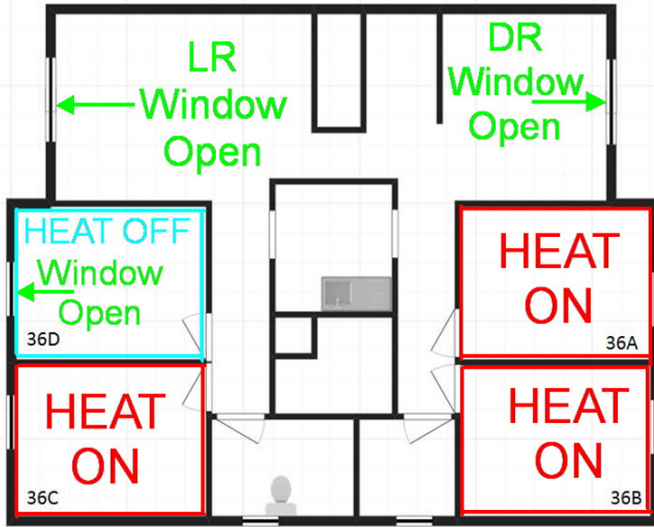
Figure 20

Case 9 of the model was created to assess this statement, and the configuration is shown in **Figure 20**. With just the heating element added on, the net heat deficit for the suite occurs on December 29, and had a value of 665W (2,270 BTU/h) loss, not typically enough to freeze the pipes in a day. The closing of the window shifts the first net heat loss value to 5,000W on December 24 (**Figure 21**), considerably less than the 7,300W (24,900 BTU/h) seen in our Case 8. The maximum heat deficit becomes 18,500W (63,000 BTU/h) on December 29, compared to 22,500W (76,700 BTU/h) in Case 8.

Case 9 suite diagram — heat source off in 36D, windows open in 36D, living room and dining room.

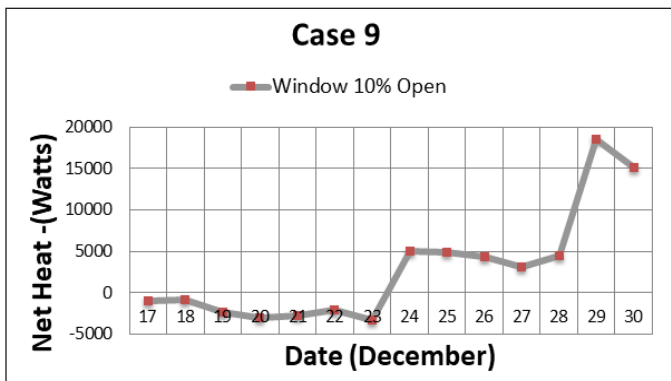
Figure 21

Net heat trend by date with Case 9 conditions: Heat off in Room 36D; Room 36D, living room and dining room with windows 10% open.
