Journal of the
National
Academy OF
Forensic
Engineers[®]

Vol. 40 No. 1 June 2023

Forensic Analysis of a CNC Lathe Window Guard Failure

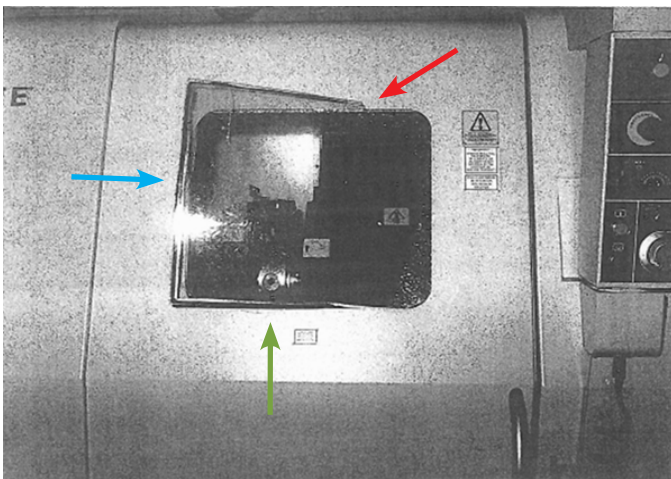
Figure 1

bowed outward with a hinge-like crease in the center, and the workpiece chuck is visible at the lower center of the window. The angled red arrow in **Figure 1** is included to show that the surviving polymer window pane is slightly bigger in width and height as compared to the overlapping viewing aperture. The vertical green arrow of **Figure 1** shows the position of the workpiece chuck. The horizontal blue arrow of **Figure 1** indicates where the workpiece grazed the inner steel door window frame and dented the sheet metal. A higher quality color image of the damaged door and window assembly is shown in **Figure 2** with the door detached from the lathe enclosure. This photograph shows the door's interior side. The horizontal blue arrow shows the witness mark of the workpiece against the now-bent inner window frame, which corresponds to the arrow shown in **Figure 1**. The cylindrical workpiece grazed and damaged the steel window periphery as it struck the window substantially off window center.

Exterior photograph of the mounted lathe door with the outward-side polymer window pane bent and folded outward.

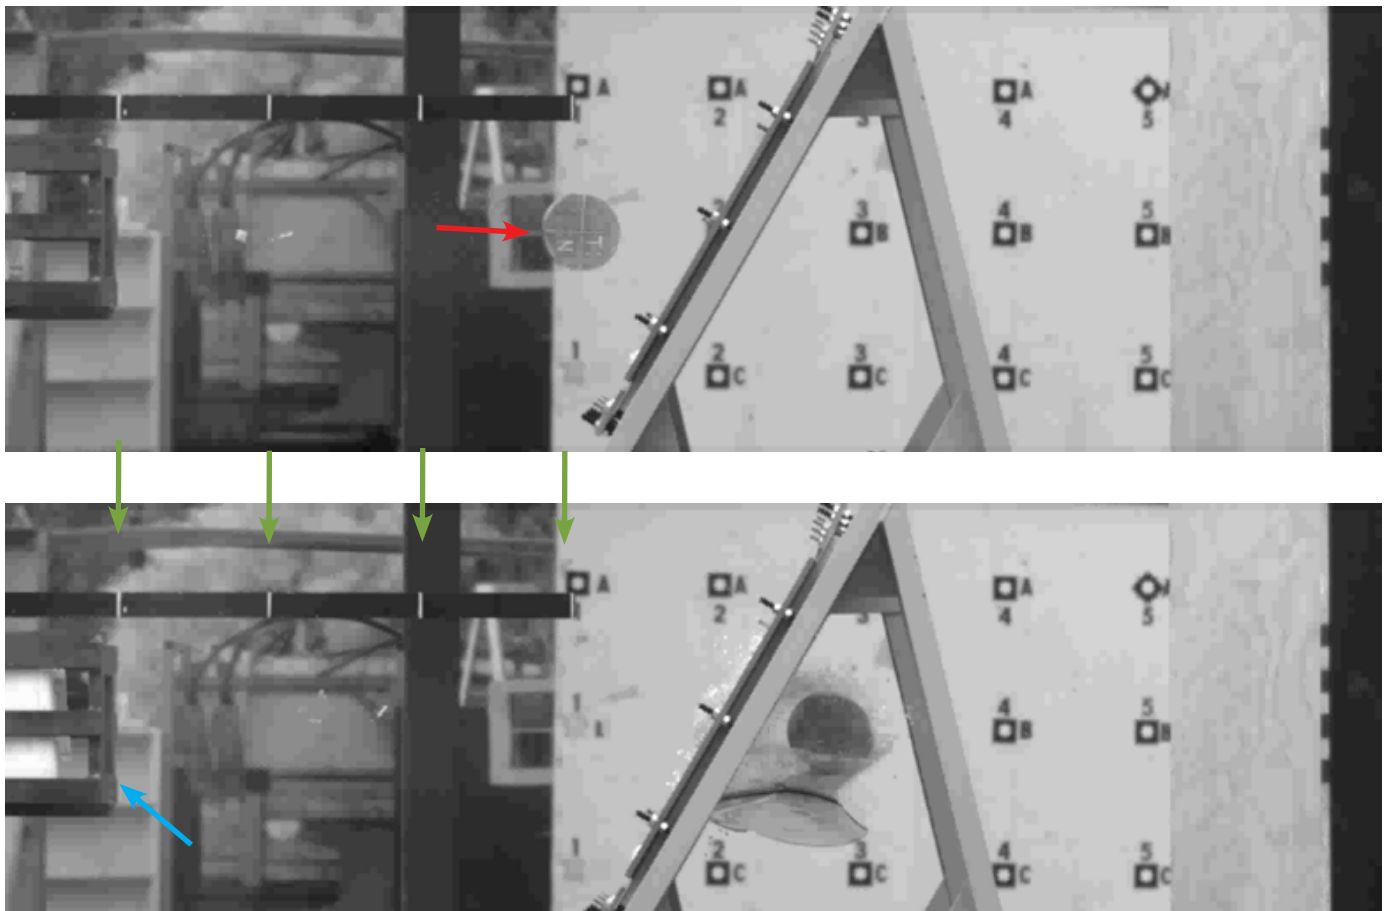
Figure 5

Test 1 — the projectile between the launcher and the inclined test door (top); post window penetration (bottom).

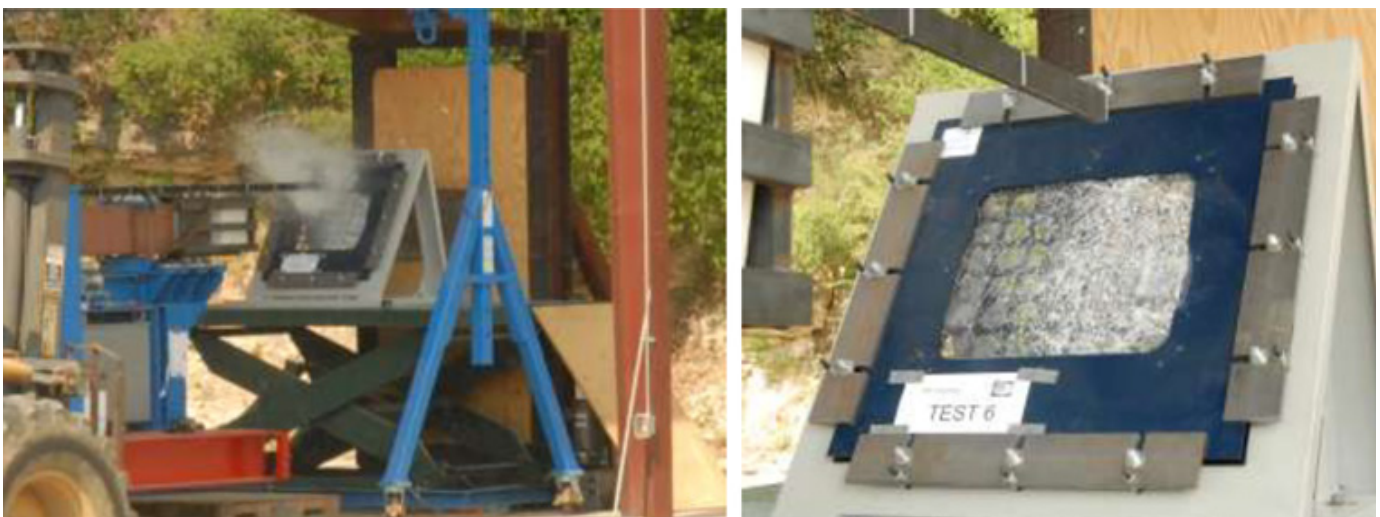
Figure 12

Test 6 – “Maximum Protection” CNC lathe window using muntin bars at exterior surface.

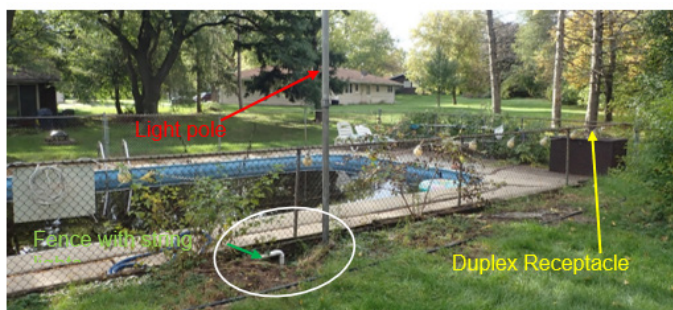
Figure 13

The author found a hole in the lawn where there were individual visibly exposed wires (with colored insulation) as 7 in. of the underground conduit had disintegrated due to corrosion as seen in the white ellipse in **Figure 13**. Plus, there were many unanswered questions about the detailed actions of the man and other site anomalies, which caused the team to only do a non-destructive brief broad survey of the electrical characteristics over a large physical area.

Pool layout and hole in lawn (see white ellipse).

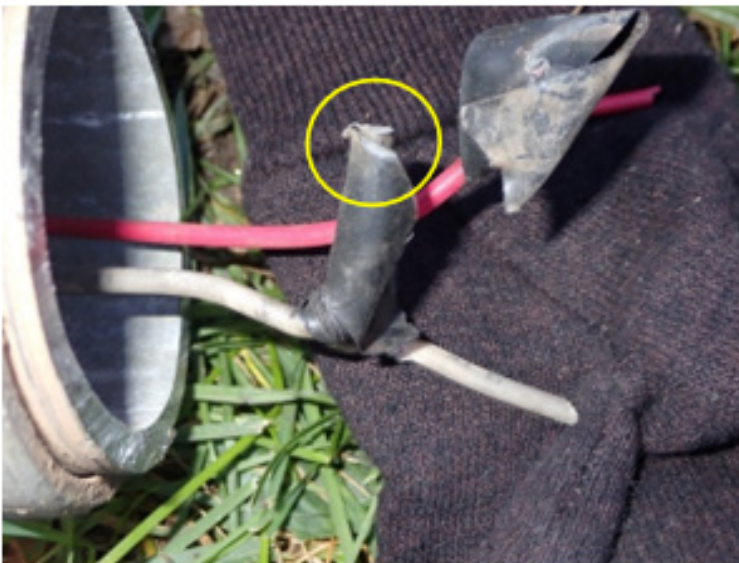
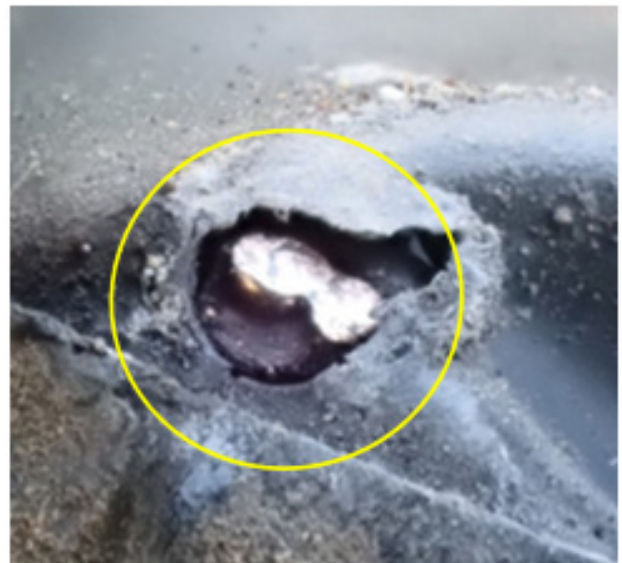
Figure 15 illustrates two photos that show a portion of the internal wiring for the light pole that had splices with electrical tape for insulation. It was found that a bare copper wire had worn through the tape (as seen in the yellow circles), and the copper wire was able to touch the inside of the light pole to energize the metallic light pole with 102VAC.

1. The causes of the electrocution in this incident were both of the following conditions occurring simultaneously:
 - a. A failure in the electrical system of the light

Internal wiring for the light pole with a bare copper wire protruding through a worn hole in electrical tape.

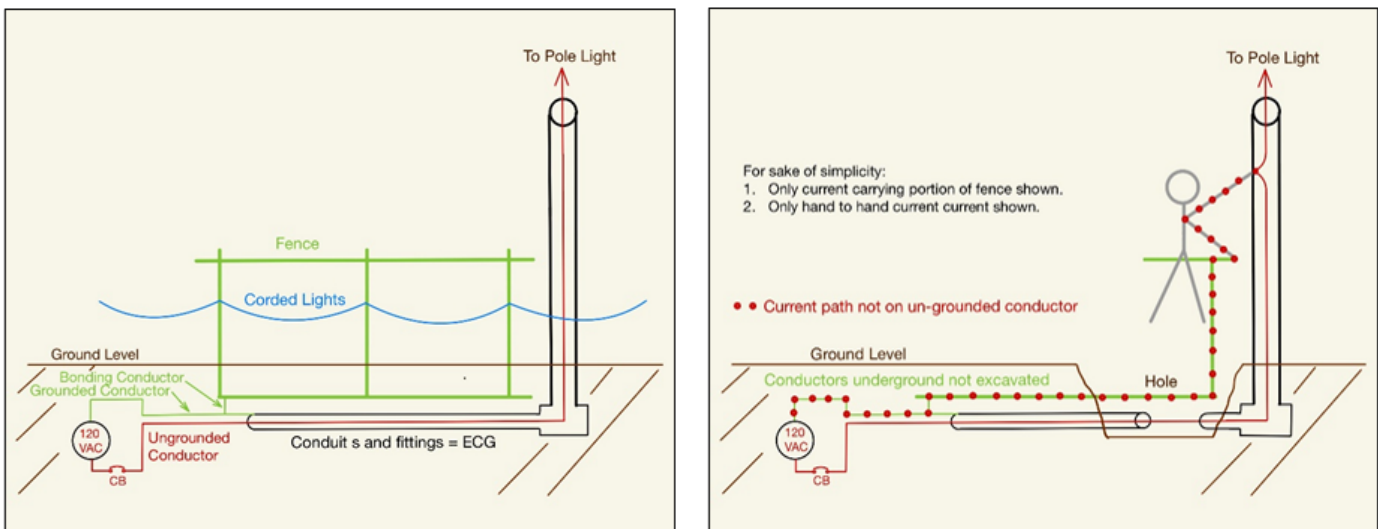
For clarity’s sake, **Figure 16** shows two diagrams of the pertinent pool circuit components. The left-hand diagram shows the circuits as they should have existed under prevailing codes and standards such that a short circuit to the light pole could be carried to ground by continuously connected conduits as EGCs. The right-hand diagram shows the pool circuits as they were in the incident where the conduits were not continuous, eliminating this as a current path and creating the causal hazard.

Figure 16
Two diagrams — reasonably safe circuits on the left; hazardous circuits on the right.

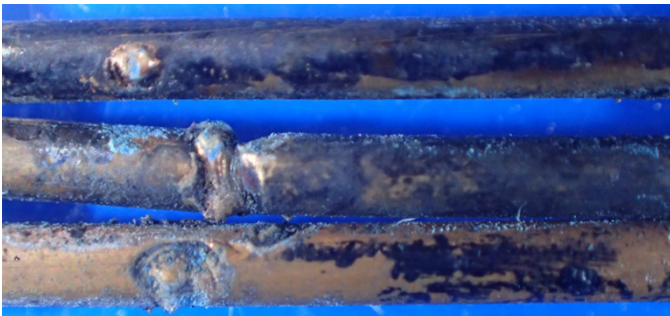
Figure 4
Example of electrical conductor arc melting damage²⁶.

When the heat of the fire is sufficient to compromise the electrical insulation of an electrically energized (with sufficient available fault current) non-metallic cable, a fault or short circuit (arcing melting event) often occurs between the energized and/or earth (grounded or grounding) conductors. The arc melt site features are formed from an electrical arcing event and subjectively identified by localized electrical arcing damage, generally identified on electrical conductors and equipment in the form of beads and/or notches (**Figure 4**).

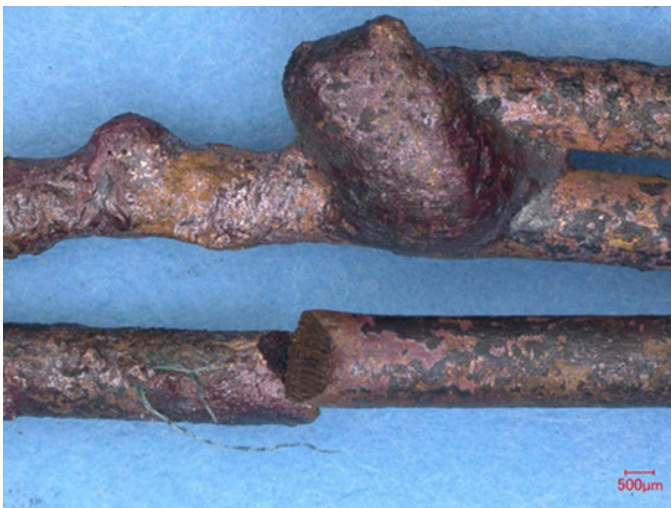
Figure 5
Example of electrical conductor fire melting damage²⁶.

Fire melt site features will generally form during fire and heat attack that exceeds the melting temperature of electrically conductive materials, such as aluminum, zinc, copper, or steel. Conductor melt sites (recognized as fire-melting damage) are generally identified in the form of gross melting and/or globule features (**Figure 5**). They may exhibit, in part, a non-uniform surface and shape, no clear lines of demarcation at the damage site, irregular melting features in and around the damage site, manufactured tool markings melted away from the damage site, and non-uniform porosity within the damage site.

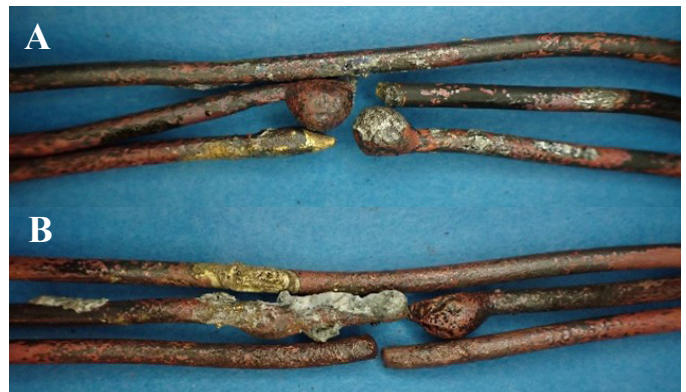
Figure 6
Examples of electrical conductor fire melting damage (alloying). Fire melting copper and aluminum (A) and fire melting copper and zinc fire (B)²⁶.

Alloying sites (mixed metal) are generally recognized as a fire-melting feature that occurs by the mixing or alloying of dissimilar materials at elevated temperatures, causing melting at the damage site. The effect may occur due to electrical equipment, components, and wiring of different materials (such as copper, aluminum, lead, tin, and zinc) coming in contact during the course of a fire. Alloying sites may exhibit features similar in appearance to fire melt sites. The alloying site may have a brass and/or silver color appearance (**Figure 6**). Alloying sites are commonly mischaracterized as eutectic melting.

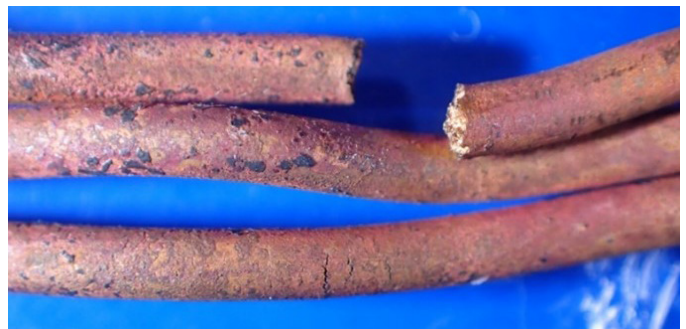
Figure 7
Example of electrical conductor mechanical damage²⁶.

Mechanical damage sites are generally recognized by fractured, impact, cracked, cut, sheared, stretched, or other damage from a mechanical action at the damage site (**Figure 7**). Mechanical damage can occur prior to the incident event or due to the excavation process involved in a scene investigation. Examples of this type of damage include: gouging/scraping of wires during installation or subsequent construction tasks; structural collapse causing conductors to stretch or break; or cutting by a tool.

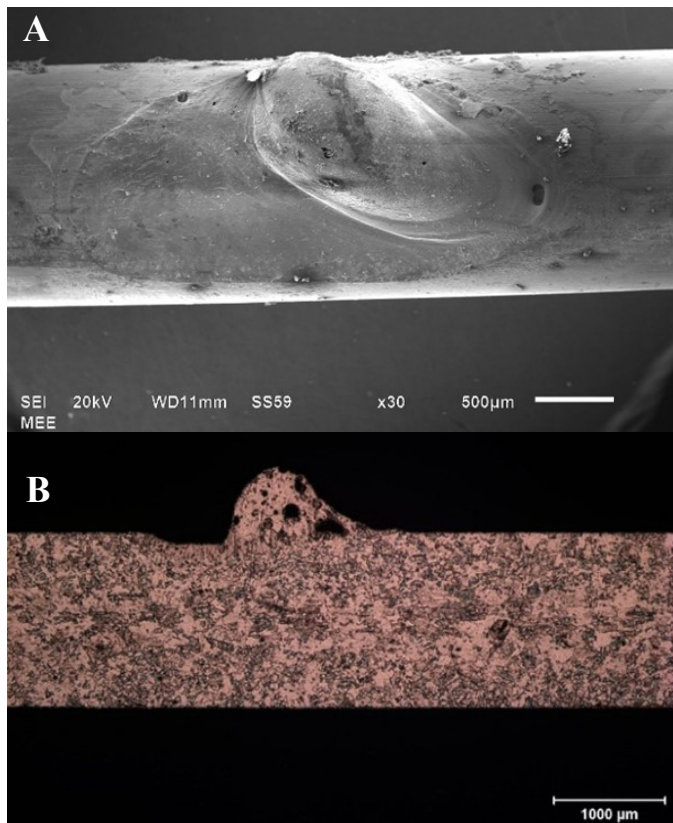
Figure 8

examination and analysis can be performed by implementing advanced methods. Additional examinations may involve laboratory analysis utilizing a scanning electron microscope (SEM) and/or by dissecting and examining the interior of the damage site to perform internal microstructure analysis (Figure 8 and Figure 9).

(A) Example of SEM arc melt surface features and (B) internal arc melt microstructure²⁹.

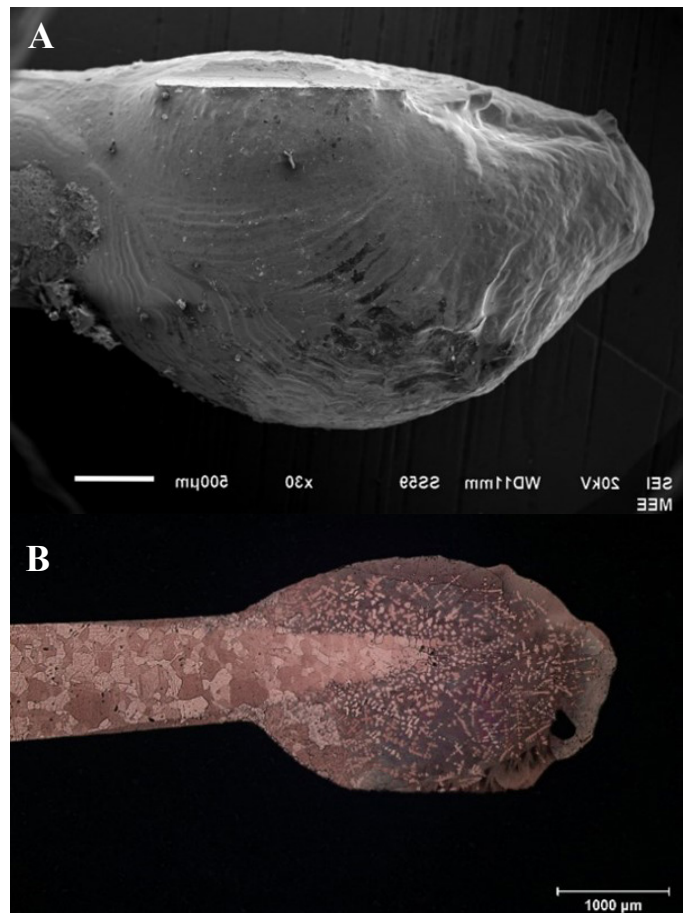
Figure 9

(A) Example of SEM fire melt surface features and (B) internal fire melt microstructure²⁹.

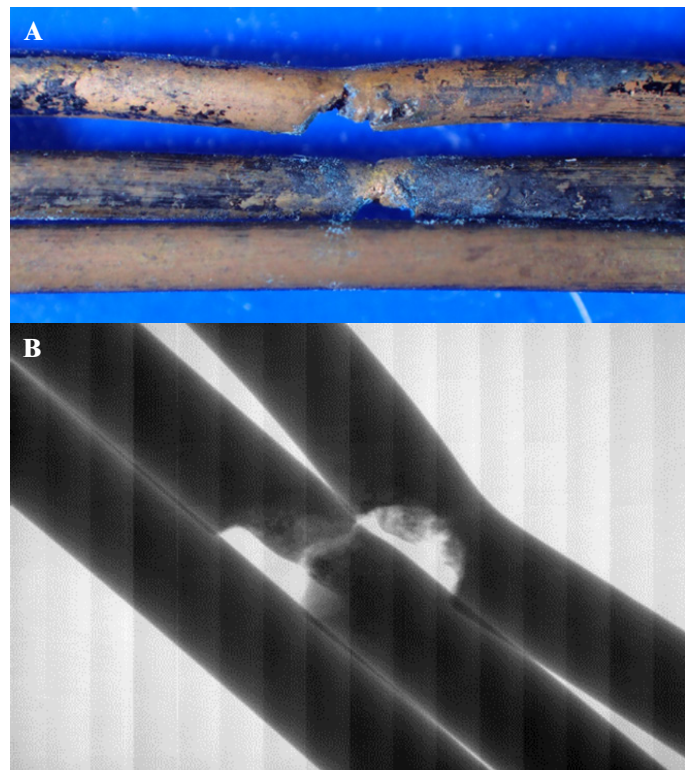
Figure 14

Thermal imagery, ultrasonic testing, and X-ray methodologies were considered. Initial X-ray examination revealed the most promise for damage site identification. X-ray examination of North American #14 AWG (1.6 mm) and United Kingdom (UK) copper, 1.0 mm² (1.1 mm) and 2.5 mm² (1.7 mm), "Twin and Earth" cabling revealed distinguishable features when compared to known artifacts or phantoms. Localized melting features, clear lines of demarcation, and uniform porosity were observed within an arc melt site (**Figure 14**).

(A) Arc melting surface features and (B) X-ray digital radiograph²⁶.

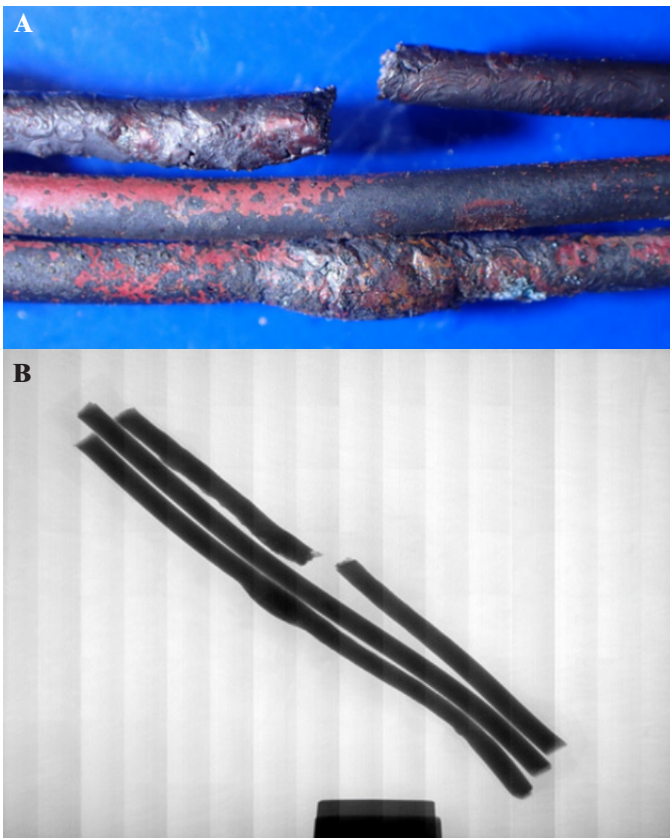
Figure 15

In Buc's analysis of arc melt sites, Buc described this feature as a persistent porosity within the arc site³⁰. In contrast, fire melt sites revealed irregular melted globules or balls with non-uniform or non-persistent porosity (**Figure 15**). Mechanical damage sites revealed sharp lines of mechanical damage demarcation and no porosity (**Figure 16**). These experiments were repeated with the same identifiable, distinguishing features.

(A) Fire melting surface features and (B) X-ray digital radiograph²⁶.

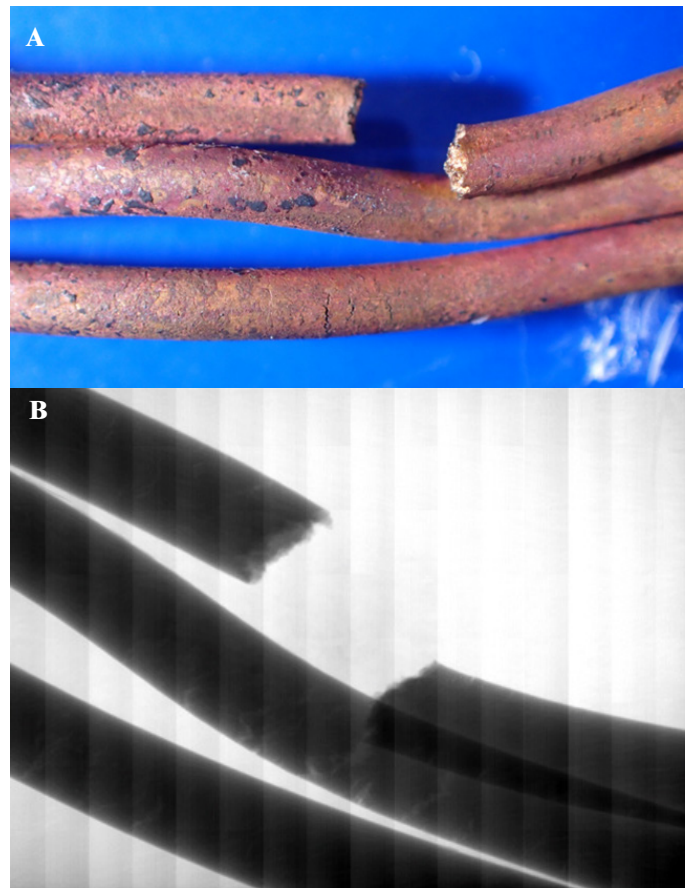
Figure 16

(A) Mechanical damage surface features and (B) X-ray digital radiograph²⁶.

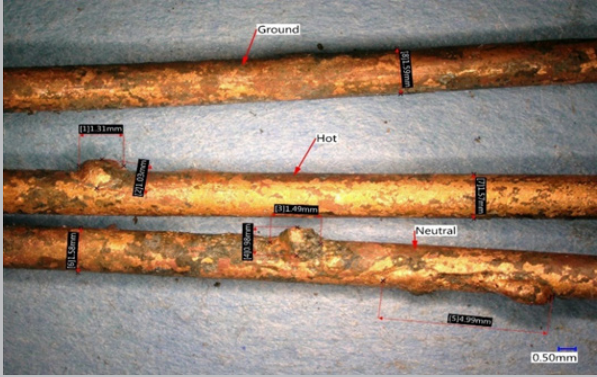
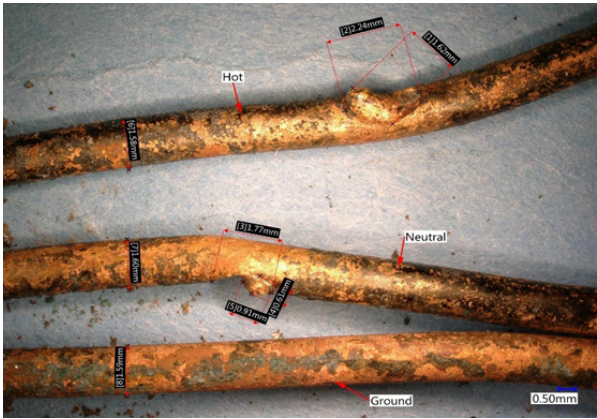
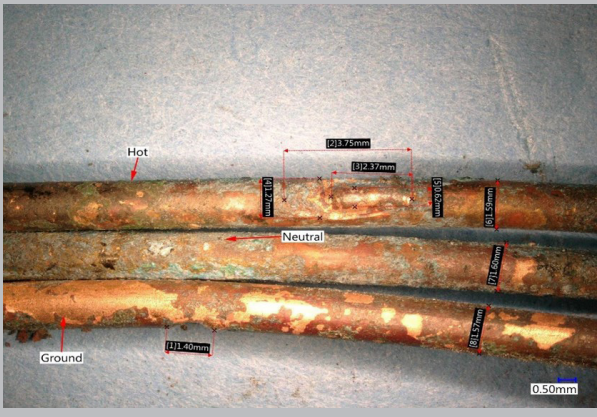
Figure 7
Representative samples of series one – FLETC arc-melted artifacts²⁷.

Localized melting features, clear lines of demarcation, and uniform porosity were observed within arc melt sites. Electrical arc-melt features generated had melted copper

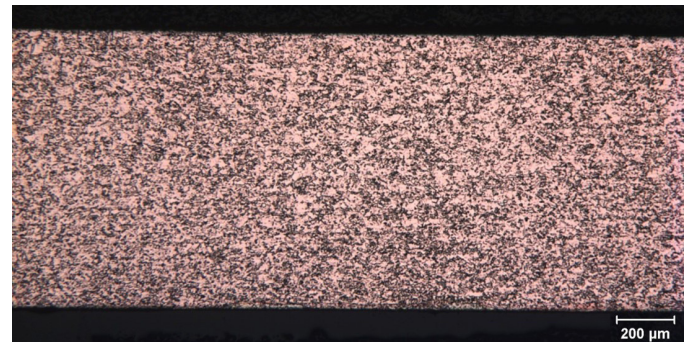
Figure 16

of drawing copper into wire³⁸. Copper wire for electrical purposes is commonly supplied in the annealed condition, which has a fine, equiaxed (i.e., non-elongated) grain structure. A representative example of the typical microstructure for a commercially available copper wire is shown in **Figure 16**.

Typical material microstructure for a copper conductor as-manufactured (longitudinal section view)²⁷.

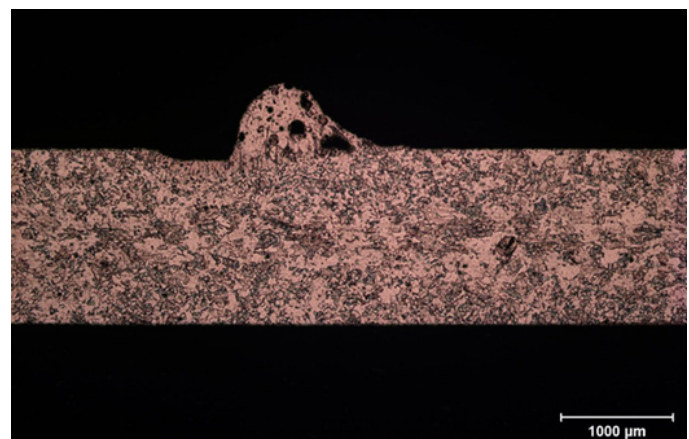
Figure 18

Light micrograph of a metallographically prepared specimen showing localized columnar grains, internal porosity, and a sharp boundary between the resolidified material and unaffected bulk material grain structure²⁷.

of a material⁴⁰. However, due to its destructive nature, it should be the last step in the characterization process. Since metallographic specimen preparation involves preparing a cross section through the conductor material to be studied, a primary benefit is that the internal structure of the material can be characterized. Once a metallographic section is prepared, the surface is chemically etched to reveal the grain structure and examined by light microscopy and/or SEM/EDS (**Figure 18**).

As discussed previously, melted and resolidified material will typically have a dendritic or columnar structure (unless there has been sufficient subsequent heating to recrystallize the material). Again, a clearly delineated boundary between the resolidified material and the bulk material and/or a lack of other indications of high temperature exposure for the damaged conductor is strong evidence of an extremely localized and rapid heating event (e.g., an electrical arc).

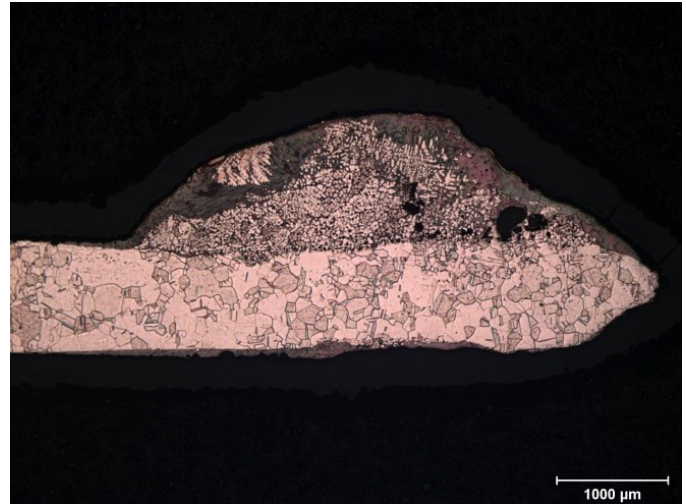
Figure 19

Light micrograph of a metallographically prepared specimen showing an irregular conductor profile, non-uniform melting, a more gradual transition between melted material and the bulk structure as well as a widespread enlarged grain structure²⁷.

non-localized heating that can be expected from the heat of a fire. Somewhat localized or gross changes in the fine-grained texture of the bulk material (e.g., grain growth) indicate prolonged exposure to elevated temperatures (**Figure 19**). The specific features observed, as well as their location, orientation, and/or coincidence with other artifacts, can be used to make a more conclusive determination of the conditions that resulted in the damage to the conductor.

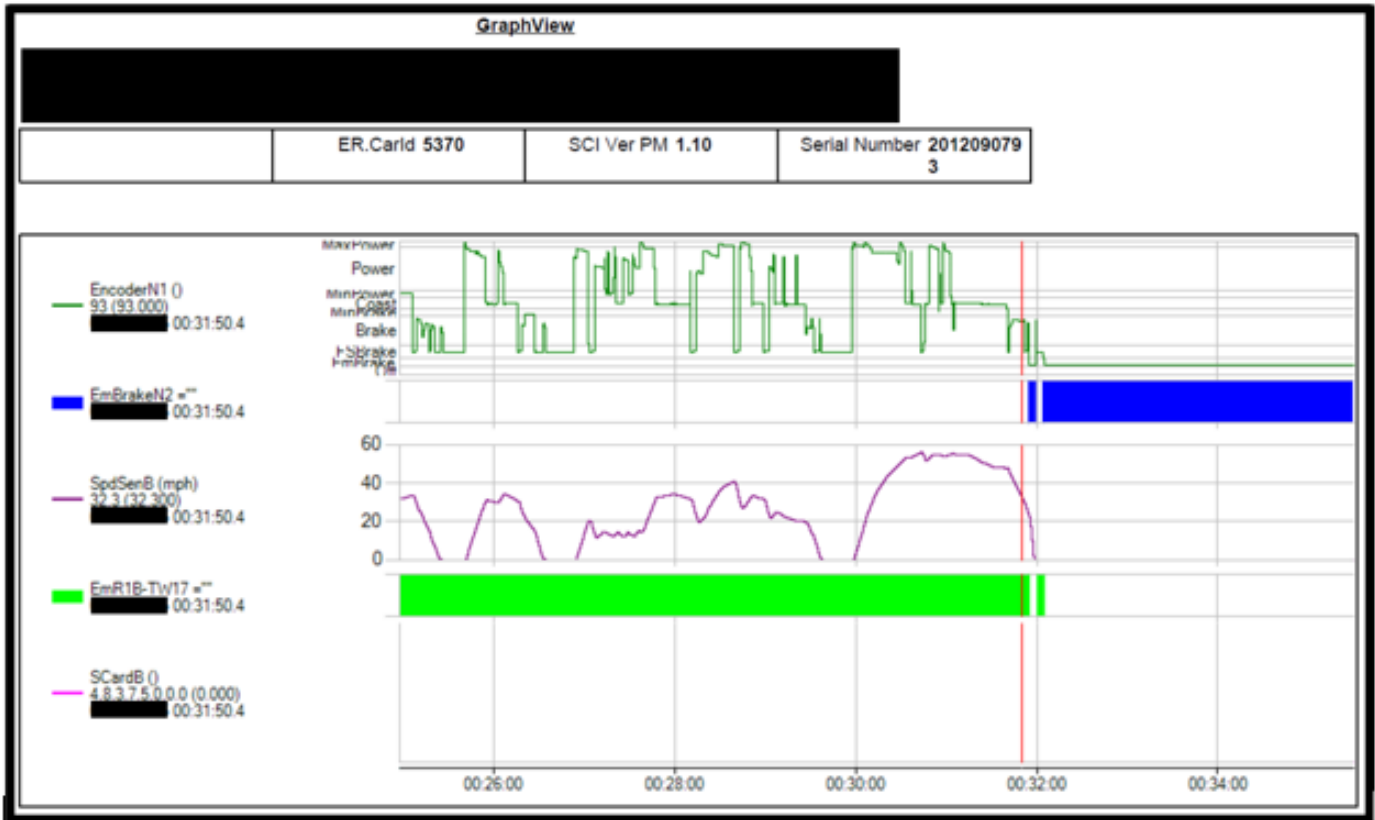
Figure 1

The original screenshot of the graphs that were generated from data recorded by the train’s event data recorder at the time of the incident. The graph data traces include the train’s speed profile (purple curve), the train’s acceleration/service brake input position (dark green curve and light green bar) and the application of the train’s emergency brakes (blue bar) as a function of time in minutes.

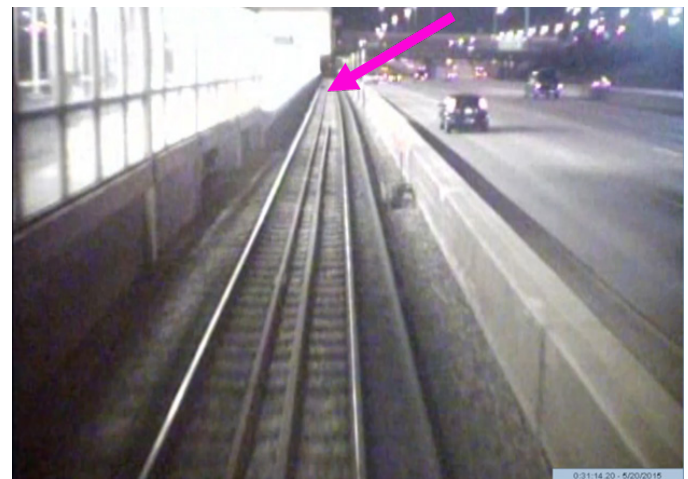
Figure 3

Another screenshot from the footage recorded from the front camera of the train at the time of the incident, showing the train approaching the station’s passenger loading platform. The magenta arrow was added to show the position of the pedestrian lying on the train tracks.

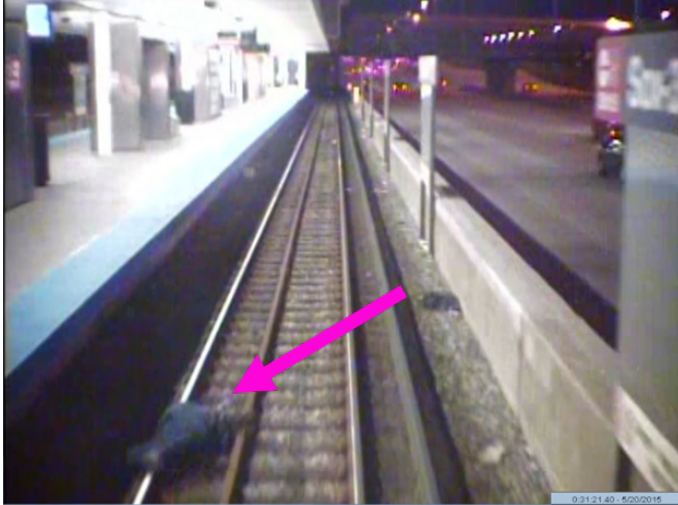
Figure 4

Another screenshot from the footage recorded from the front camera of the train at the time of the incident, showing the pedestrian lying on the train tracks. This was the last frame in which the pedestrian was visible before the train collided with him. The magenta arrow was added to show the position of the pedestrian lying on the train tracks.

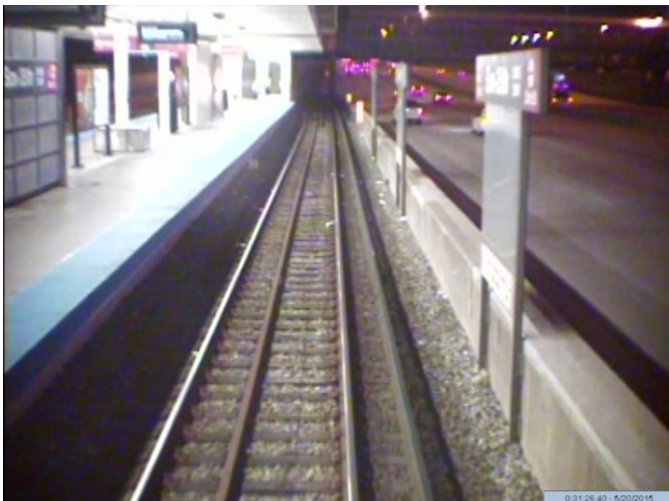
Figure 5

Another screenshot from the footage recorded from the front camera of the train at the time of the incident, showing when the train came to a stop after colliding with the pedestrian.

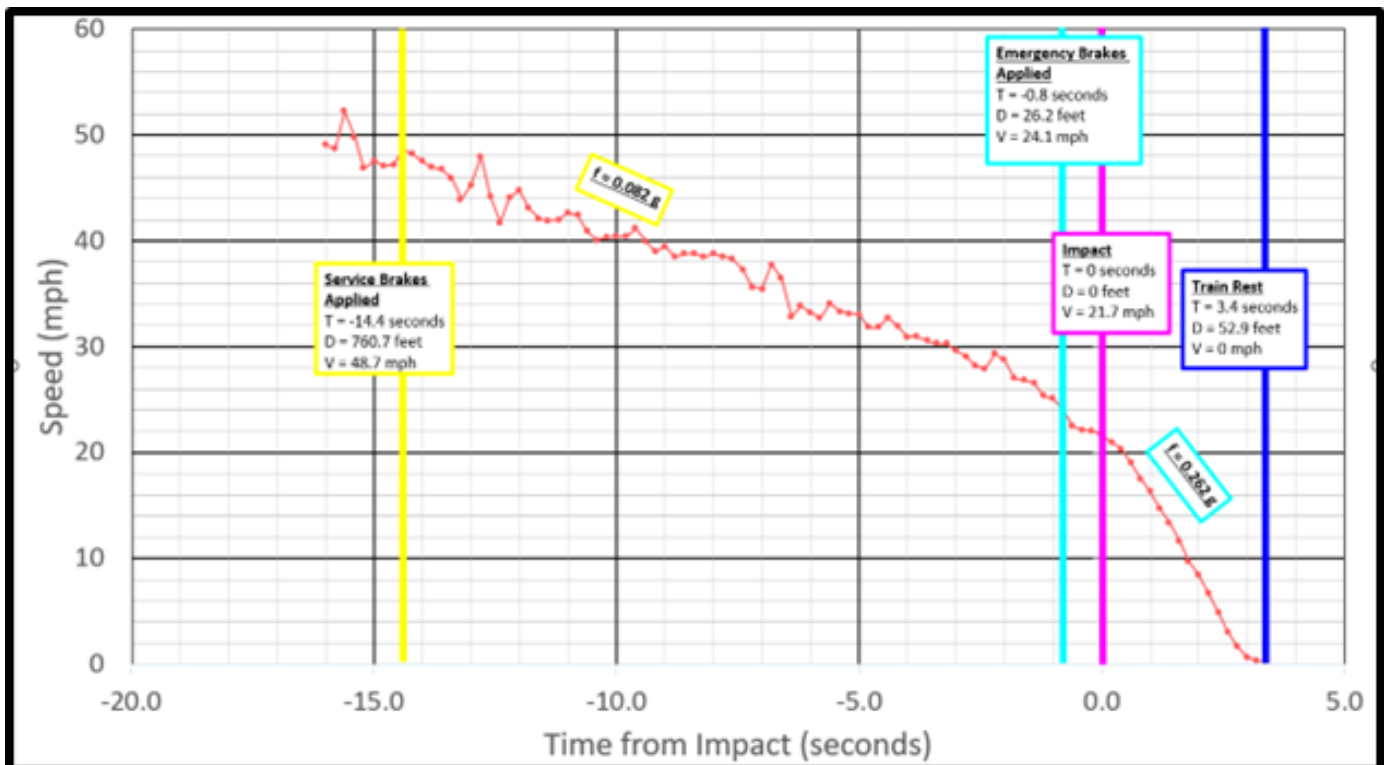
Figure 14

At approximately 0.8 seconds before the train collided with the pedestrian, the train decelerated at a much higher rate until it was brought to a complete stop at approximately 3.4 seconds (or 53 feet) after impact. The deceleration rate in the above time frame was approximately 5.7 miles per hour per second (or 0.26 g), which is well above the maximum rate the service brakes could provide and just below the emergency brake's specified maximum theoretical deceleration rate of 6.3 miles per hour per second (or 0.29 g). Therefore, the above analysis showed the emergency brakes were not engaged until approximately 0.8 seconds before the train collided with the pedestrian — or when the train was approximately 26 ft from the pedestrian (see **Figure 14**).

The train's speed profile determined through the matchmoving analysis with callouts showing when the train's service and emergency brakes were engaged in relation to the point of impact with the pedestrian.

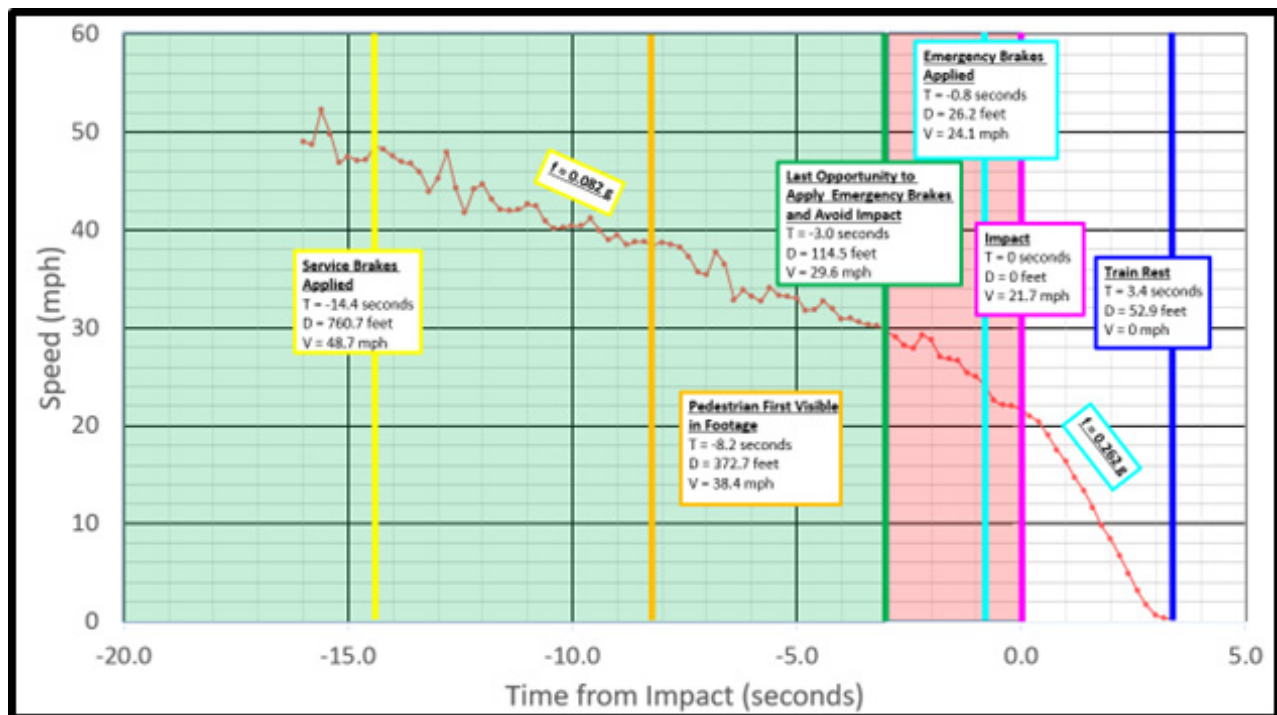
Figure 17

The calculation was performed at every video frame to determine the distance the train would need to decelerate to a stop and to avoid impacting the pedestrian. Based on the above calculations, the authors determined the emergency brakes would need to engage when the train was at least 3.0 seconds from impact (or at least 114 ft from the pedestrian) to avoid the impact. The train was traveling approximately 30 mph at this time (Figure 17).

The train’s speed profile determined through the matchmoving analysis with callouts showing when the pedestrian was first visible in the footage and the points in time the impact was avoidable (green) and unavoidable (red) had the emergency brakes been engaged at that time.

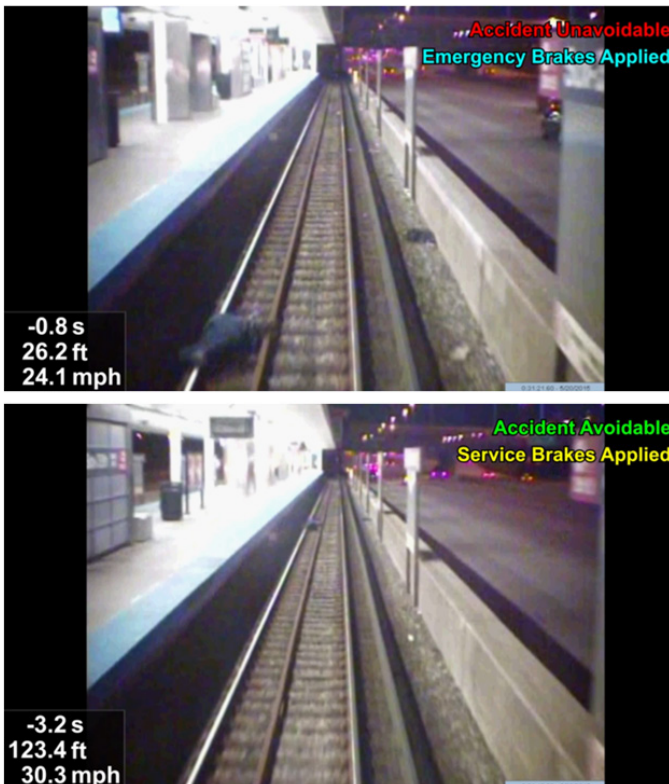
Figure 18

The authors then overlaid the train's speed, time to impact, distance to impact, type of braking system applied, and whether the collision would have been avoidable had the emergency brakes been engaged sooner at each frame in the video. Below are screenshots showing when the emergency brakes were applied and what points in the footage the collision was avoidable had the emergency brakes been engaged sooner (**Figure 18**).

Screenshots of footage recorded from the front of the train at the time of the incident with the train's speed, time to impact, distance to impact, which braking system was applied, and whether the collision would have been avoidable at that moment in time. These screenshots show the moment that the operator applied the emergency brakes during the incident (top) and when the collision was avoidable — had the emergency brakes engaged sooner (bottom).

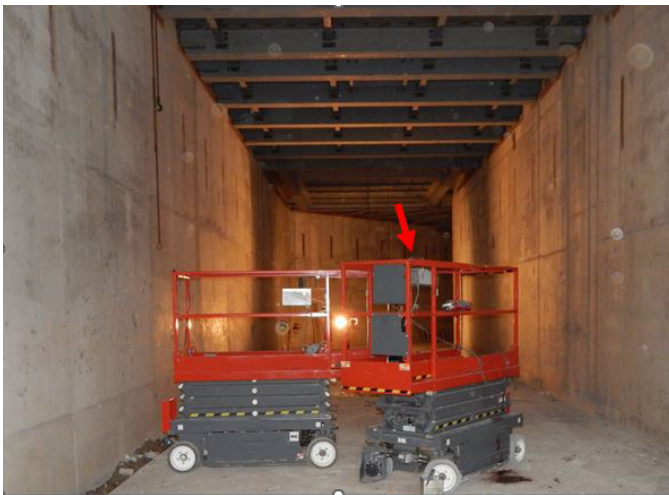
Figure 1

Photo from the incident scene showing the subject scissor lift (red arrow), the other lift used in rescuing the victim, and the overhead beams involved in entrapping the victim.

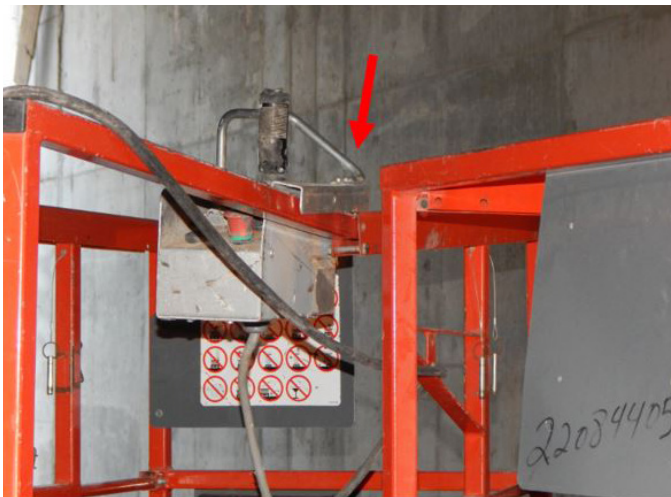
Figure 2

Photo from the accident scene, showing the control console of the subject scissor lift mounted on the top rail. The rail of a second scissor lift, used in an attempt to rescue the victim, is in the foreground. The top rail of the subject scissor lift is bent downward from the force exerted between the scissor lift rail, the victim, and an overhead beam.

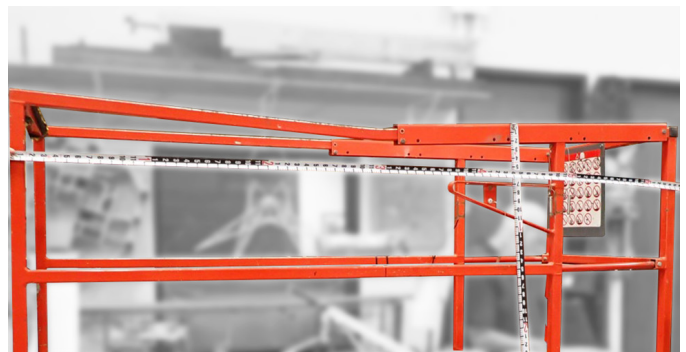
Figure 3

Photo from inspection of the lift several months after the accident. The top rail was bent downward where the victim was entrapped between the rail and an overhead beam.

bend the top rail and fracture the victim's skull. The effect of the motor or battery failures discovered at later inspections would have made the lift unable to raise, preventing the incident. Thus, the condition of the motor could not have contributed to the incident.

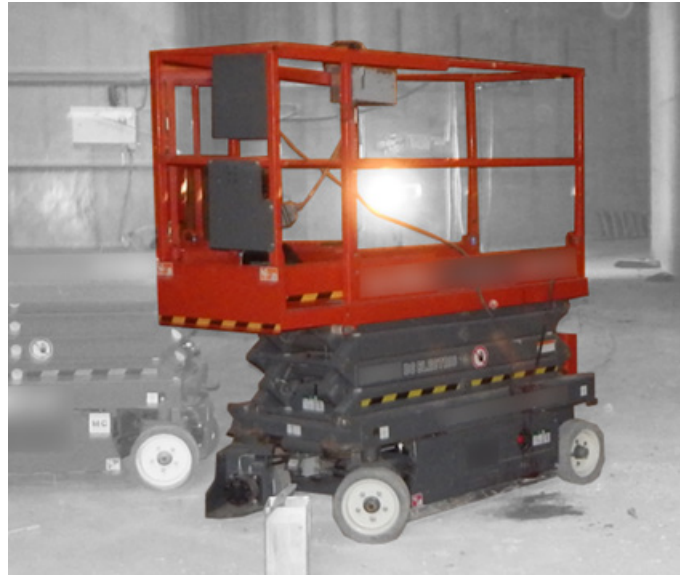
Figure 4

Photographs from the incident scene showed the subject scissor lift's front wheels were steered to the right (**Figure 4**). At the time of the accident, the lift was able to steer to the right. However, during functional testing, the incident control box was unable to steer the wheels to the right. This indicated an intermittent malfunction, of the lift's steering mechanism. An intermittent malfunction was consistent with the victim's colleague referring to "hesitation" and other (non-specific) control malfunctions prior to the incident.

Photograph of the incident scene taken shortly after the incident, showing the subject lift's wheels turned to the right.

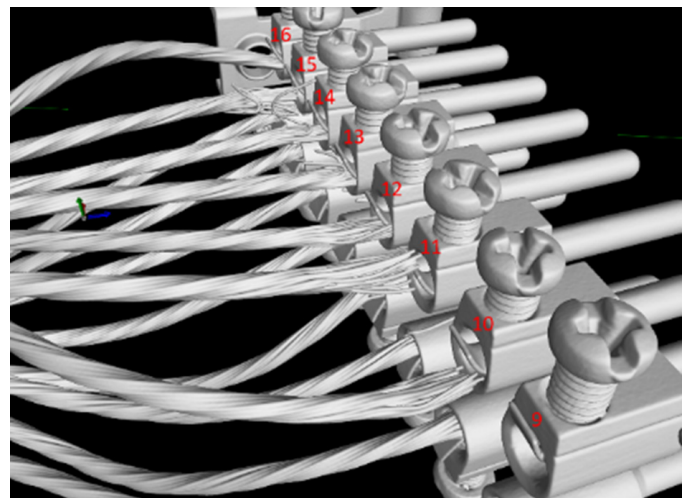
Figure 7

Side view of a 3D CT scan of the subject platform control console cable connector. Numbers in red have been added to identify individual pins. Pins 10 through 15 exhibited varying degrees of being withdrawn from the screw terminals.

The reduced clamping force in the affected screw terminals would have made it easier for the wire to be pulled out from the terminal. Additionally, pin 14 was still partially inserted into the terminal, even though pin 13 and pin 15 on either side of it were more withdrawn from their respective terminals (**Figure 8**). If the sole cause of the withdrawal of the wires from the terminals was an excessive force, then one wire would not be expected to remain connected while the wires on either side failed. The fact that only some of the wires were withdrawn from the terminals indicates that those wires were not as firmly secured as the others in the connector.

Some, but not all, of the wires inside the connector in the subject platform control console pulled out of the screw terminals used in the cable connector (**Figure 6** and **Figure 7**). The screw terminals in pins 10, 11, and 15 had wires that withdrew completely, and pins 12, 13, and 14 were partially withdrawn. These pins did not provide adequate strain relief to hold their wires in place, but the other screw terminals successfully retained their wires. Pins 10 through 15 were not properly secured to the connector. If they were properly secured, then the connections between the cable and connector (the cable gland and the screw terminals) should have been stronger than the cable and its wires. When a properly secured connector fails, the cable and/or the wires fail rather than the strain relief. No such breakage or damage was visible in the 2D radiographs, CT scans, or physical inspection.

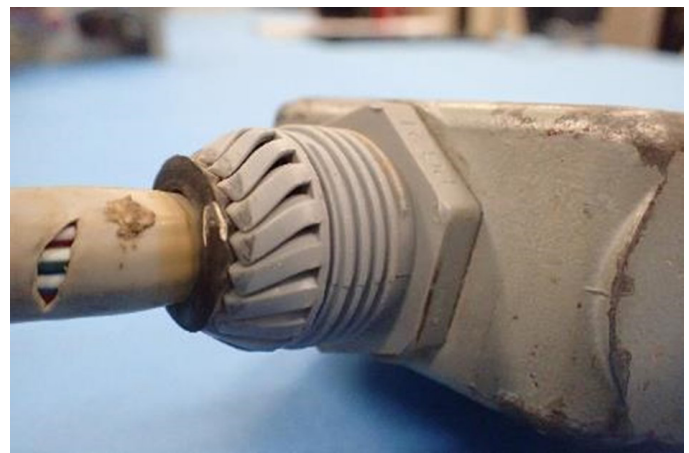
Figure 9

After nondestructive radiography, the cable gland connector on the control console plug was disassembled. The cable exhibited evidence of tension on the cable, such as movement of the cable within the gland and a tear in the outer insulation.

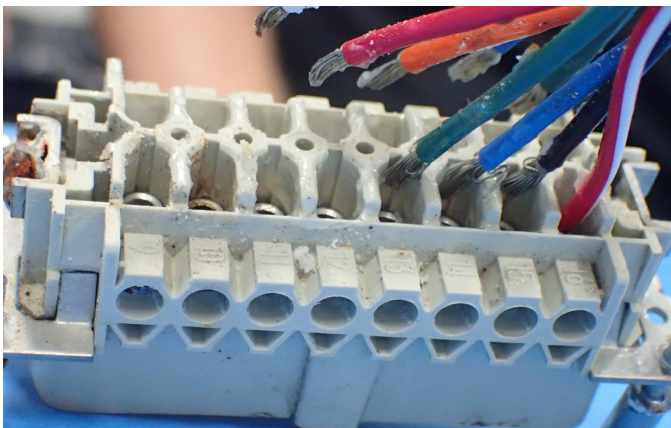
Figure 10

After nondestructive radioactivity, the cable terminal block was disassembled. The wires in terminals 1 through 8 were removed by backing out the screws on each terminal. Upon backing out the screw for terminal 8, the wires in terminal 10 through 15 slipped out of their respective terminals without applying tension to the wire or backing out the terminal screws.

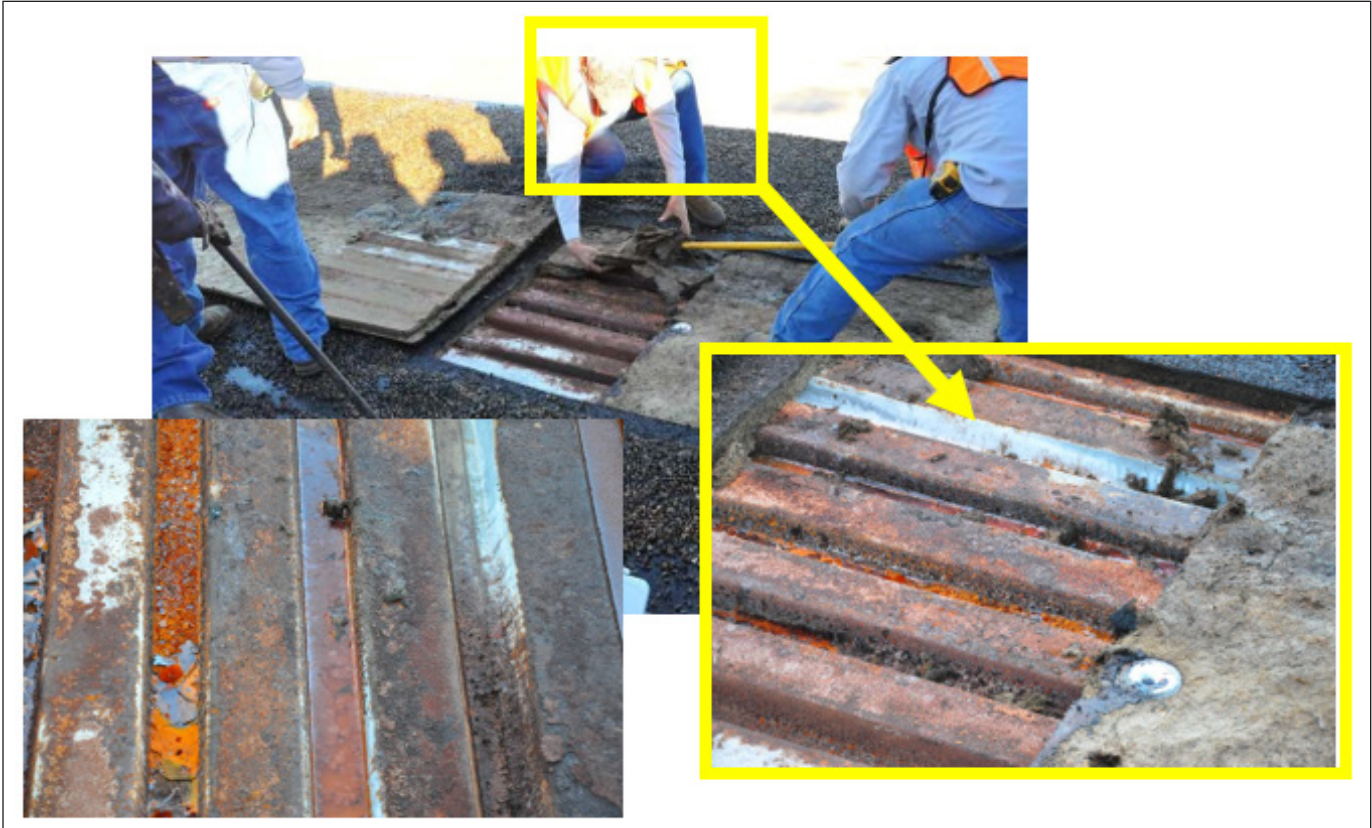
Figure 3

To evaluate the substrate, contractors engaged by the plaintiff systematically removed areas as large as 4 feet (ft) by 8 ft (roof cores) in 31 locations. In performing each roof core, after the roof membrane was removed, the insulation was observed and then removed to expose the underlying steel deck. With the removal of each layer, experts observed, photographed, and sampled the materials. Observed conditions at most (but not all) roof cores included damage to the roofing membrane, corroded steel decks, and water saturated fiberboard (**Figure 3**).

Corrosion of the structural steel roof deck exposed by removal of roofing membrane and fiberboard insulation during destructive testing. Note standing liquid and prevalence of corrosion in the ribs of the steel deck.
