Journal of the
National
Academy OF
Forensic
Engineers[®]

Vol. 40 No. 1 June 2023

Forensic Analysis of a CNC Lathe Window Guard Failure

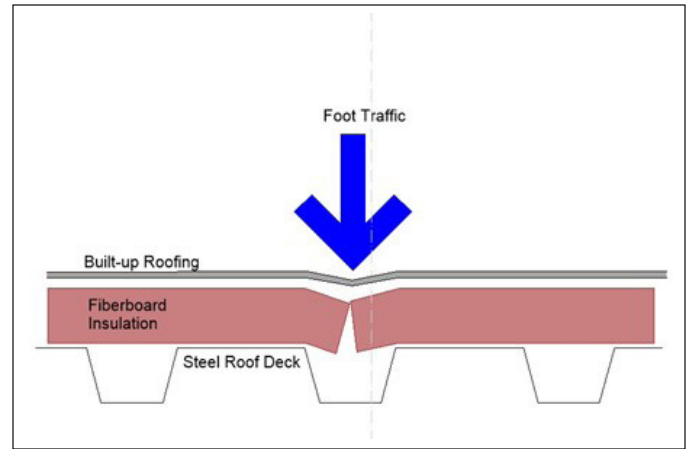
Figure 8

may have deflected the unsupported ends of the boards and damaged the roof membrane (**Figure 8**). It was still unexplained, however, why more roof failures occurred near the edges of the north and south perimeter of the building, why the steel deck corroded beneath undamaged roof membrane, and why some steel deck was not corroded. Once the roof membrane fractures, water can penetrate the roof membrane through those fractures. However, the presence of corrosion where no roof membrane damage occurred suggests that water entered the

Illustration of the mechanism by which foot traffic damages unsupported joints that abut over the rib of the structural steel deck.

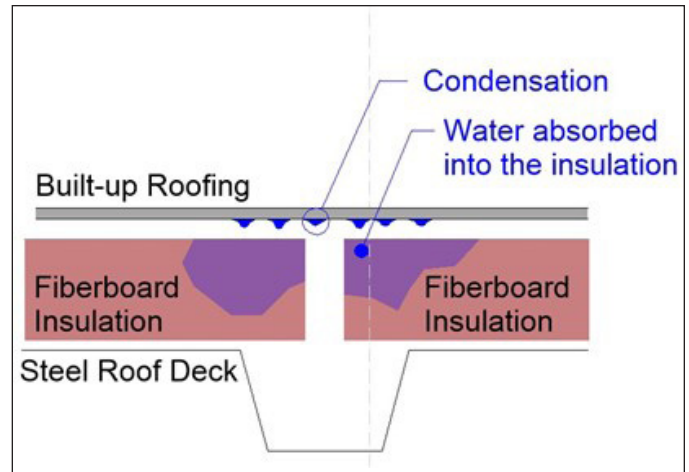
Figure 9

For example, in the Southern coastal region of the United States, during the winter daytime temperatures average 40°F to 50°F, and nighttime temperatures regularly drop to 30°F to 40°F¹¹. Formation of condensation in this manner occurs due to seasonal or nightly drop in temperature¹². Exposed to ambient temperatures, during the evening, the temperature of the roof membrane can fall below the dew point of air trapped in the roof assembly. February 11, 2010 represented typical noontime conditions during winter in the Houston. During the day when the interior of the warehouse is exposed to outdoor conditions due open dock doors, daytime temperatures were in the low 40s, the relative humidity was 93 percent, and the dewpoint temperature was 37°F to 39°F. At night, the ambient temperature fell to 37°F, below the dewpoint of air infiltrated from the exterior during the day. Not only is the roof membrane

Illustration of the mechanism by which moist air condenses within the roof assembly.

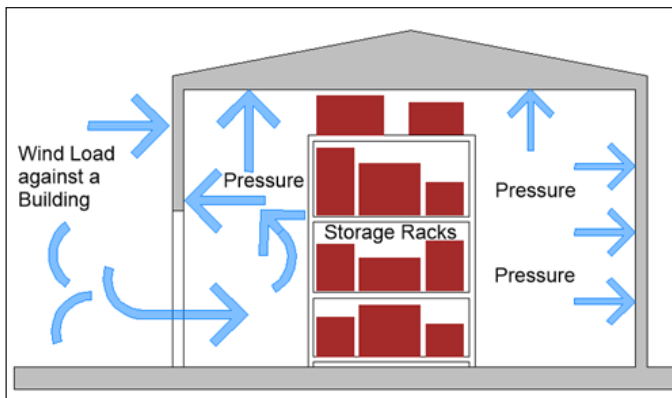
Figure 10

Wind-induced pressure in the building due to wind load on one face resulting in higher air pressure at the perimeter of the building next to the opening through which the wind enters the building.

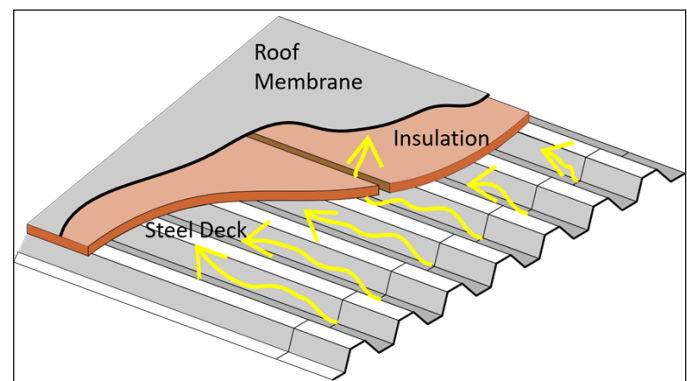
Figure 11

The interstitial space between the steel roof deck and the roof membrane has a series of voids created by the ribs of the steel deck and joints between the fiberboard panels¹⁸. The pathway for air to migrate from the warehouse into the roof assembly is through the laps and other openings in the steel deck (**Figure 11**). As air pressure fluctuates, air migrates into and out of the roof assembly from the warehouse through the openings in the steel deck. Air is pushed into the interstitial space of the roof assembly as air pressure in the warehouse increases and leaves the interstitial space as the air pressure in the warehouse decreases. On buildings covered with a mechanically attached single-ply membrane roof, the membrane will lift as wind blows across the roof surface, creating negative pressure in the interstitial space of the roof assembly. This acts as a bellows and pulls air into the interstitial roof space (**Figure 12**).

Illustration of the path of air infiltrating the structural steel deck and the fiberboard insulation.

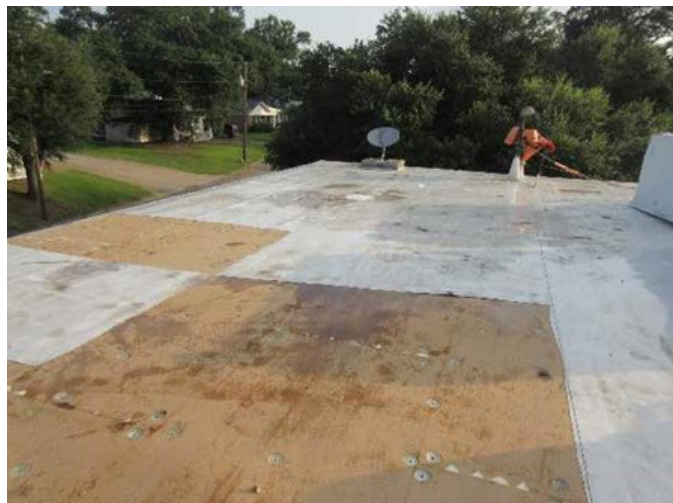
Figure 13

The exposed insulation revealed moisture concentrated around fastener penetrations and along the seams of the insulation panels (**Figure 13** and **14**), reminiscent of observations in the subject warehouse case. The subject building in this case has apartment units heated/cooled using PTAC wall

Removal of a TPO roof from polyisocyanurate insulation board. Notice the dark areas indicating moisture due to condensation.
