Journal of the
National

DOI: 10.51501/jotnafe.v40i2

| φ Factors to Consider in Developing Conceptual Scopes of Repair for Common Low-Slope Roofing Assemblies | 11 |
| υ Investigation and Root Cause Analysis of Transformer Metering Destruction by Arc Flash | 33 |

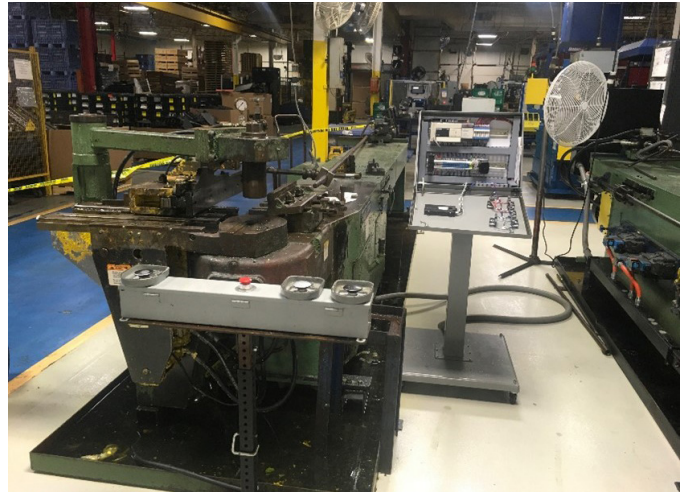
Figure 2
Automated hydraulic rotary tubing bender.

related to a partial amputation workplace injury involving an automated hydraulic rotary bending machine that was utilized to bend metal tubing. **Figure 2** shows the automated hydraulic rotary bending machine that was involved in the accident.

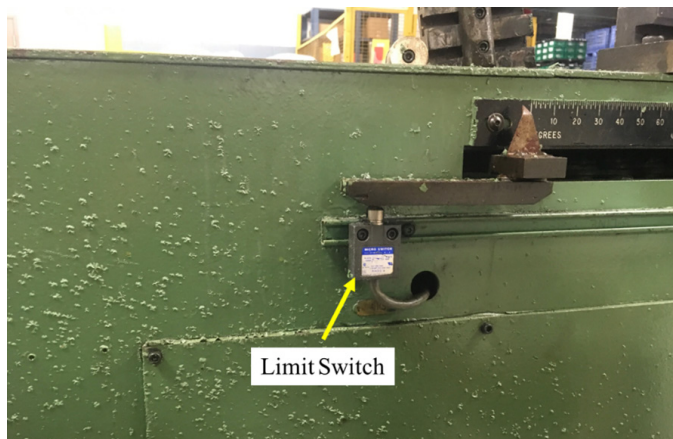
A field service technician from the machine manufacturer performed a separate investigation of the incident. Subsequently, a service report was written. The report indicated that there were three scenarios that would result in an unexpected start. The report indicated that the personal injury was simply the result of a mis-adjustment of the bend arm home limit switch in **Figure 6**. Subsequent to the injury, an updated version of the programmable logic controller software was implemented that was intended to address this issue.

Figure 6
Limit switch alleged to be misadjusted.

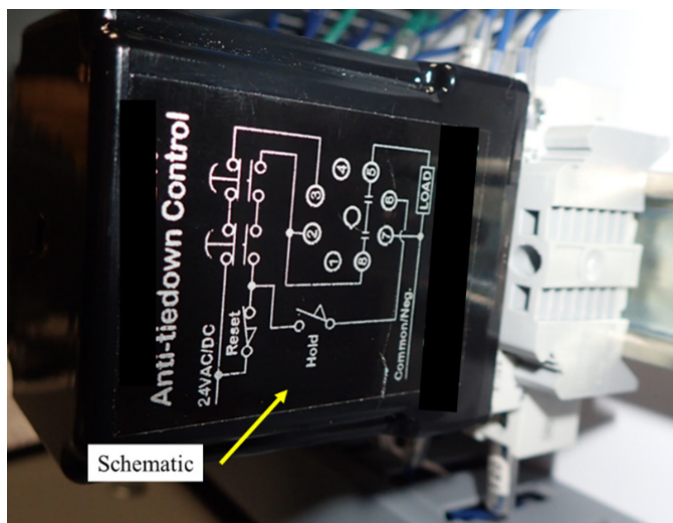
Figure 7
Anti tie-down module.

Figure 7 shows the anti-tiedown safety interface module (SIM) that was used to interface the two forward cycle pushbuttons with the control system. The two pushbuttons were wired into the SIM. According to the manufacturer’s documentation (**Figure 8**), the output contacts of the SIM were supposed to be hard-wired to a load, which represents the hazardous machine motions. However, in this instance, the SIM contacts were wired directly to a PLC input.

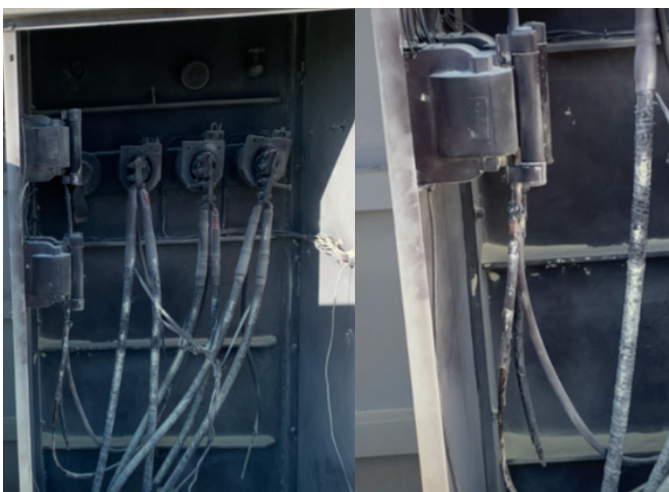
Figure 2
Post-event photos.

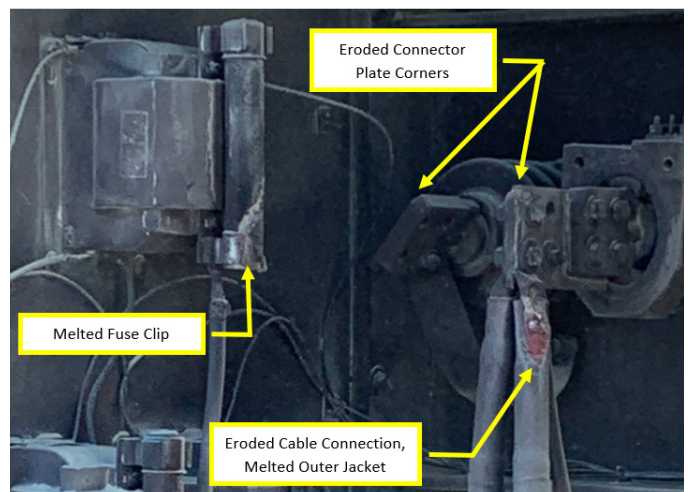
Figure 3 shows the arc erosion of the large copper connector plates, erosion and melting of one cable end, and destruction of the VT “A” fuse clip. The loss of copper (erosion) at corners and edges is characteristic of arc endpoints: highly localized hot spots vaporized conductor material wherever arcs originated. Insulation in the nearby area melted due to the heat radiated from these arcs.

Figure 3
Arc erosion of connectors and cables.

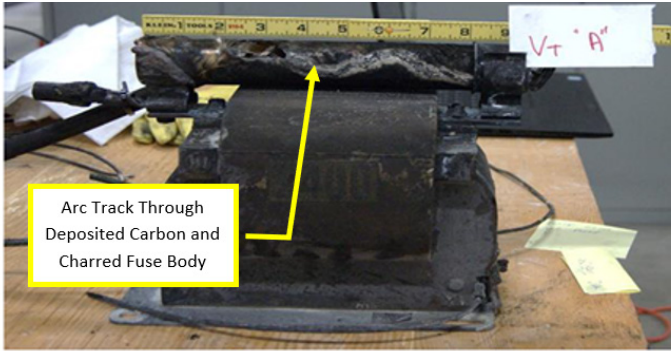
Figure 4 shows destruction of the “A” phase VT fuse due to textbook “arcing through char”^{6,7} — a phenomenon

Post-event VT with arc tracking across destroyed fuse.

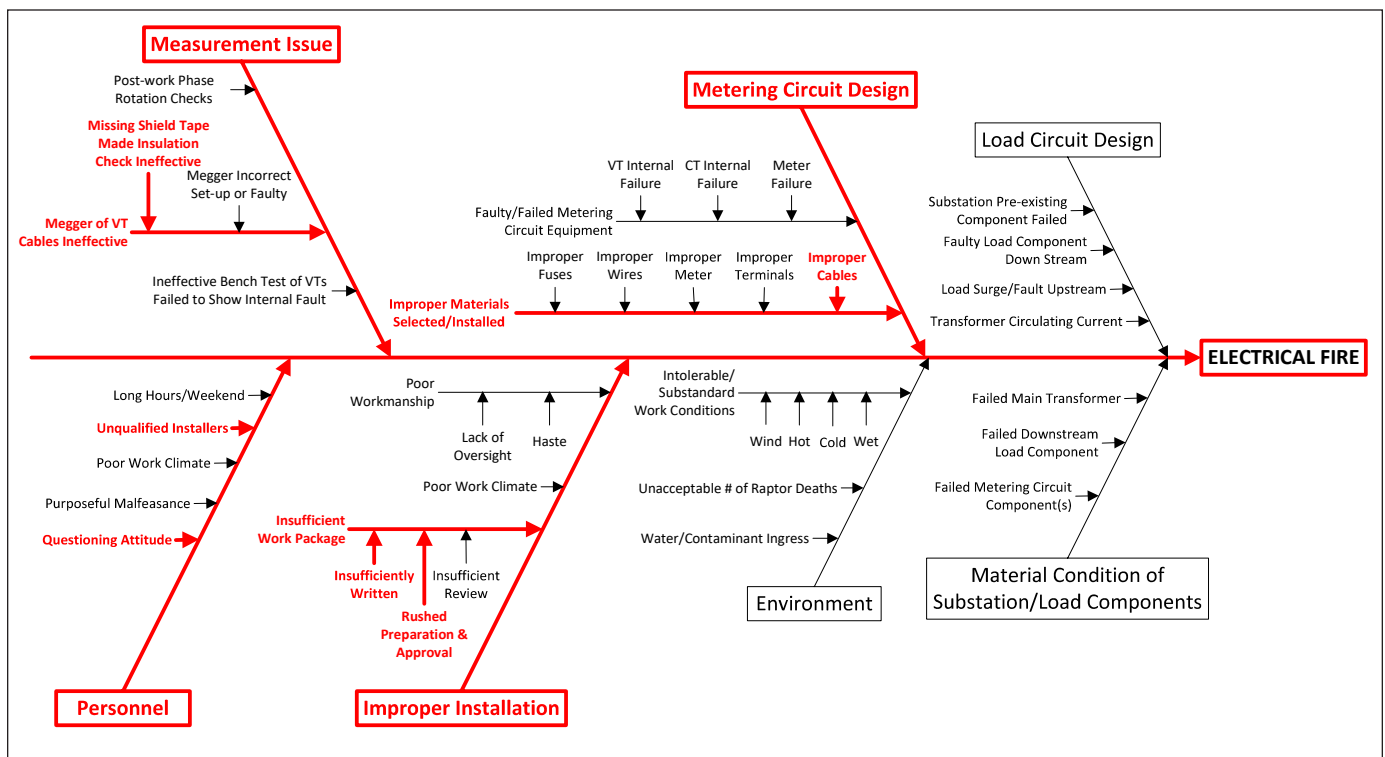
While the physical reconstruction of the debris was key to understanding the physics of “what” happened, careful dissection of the client’s organizational dynamics was central to identifying direct causal and contributory factors explaining “why” it happened. The forensic team found several ingrained institutional issues. These issues are included in an Ishikawa “fishbone” diagram^{16,17}, as shown in Figure 9 and in the details following. Out of the full set of factors identified, the items and paths highlighted in red were those the team found to be most-likely

Figure 9
Ishikawa diagram.

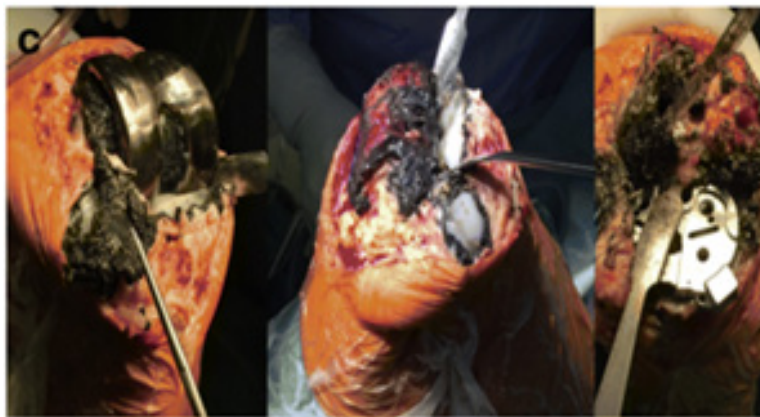
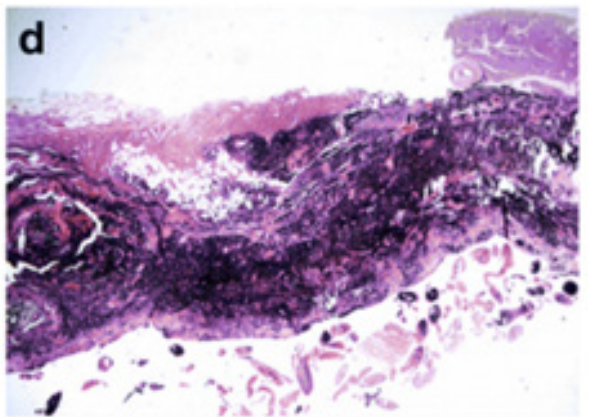
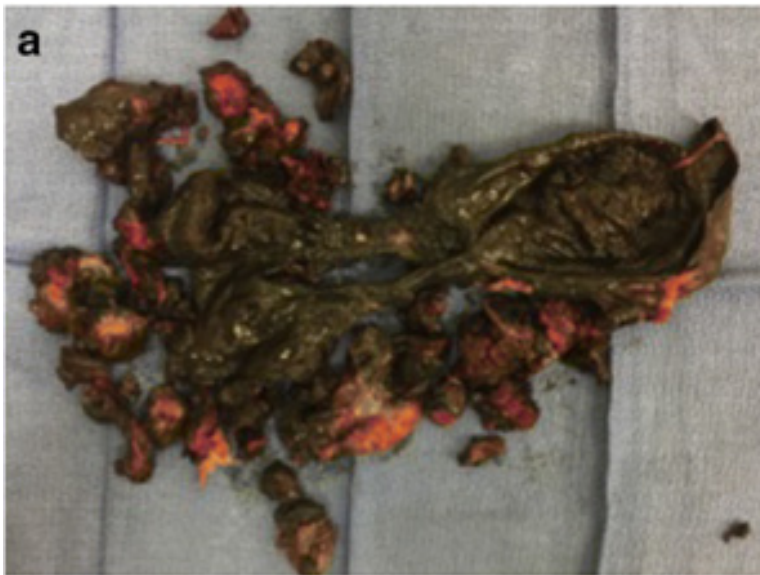
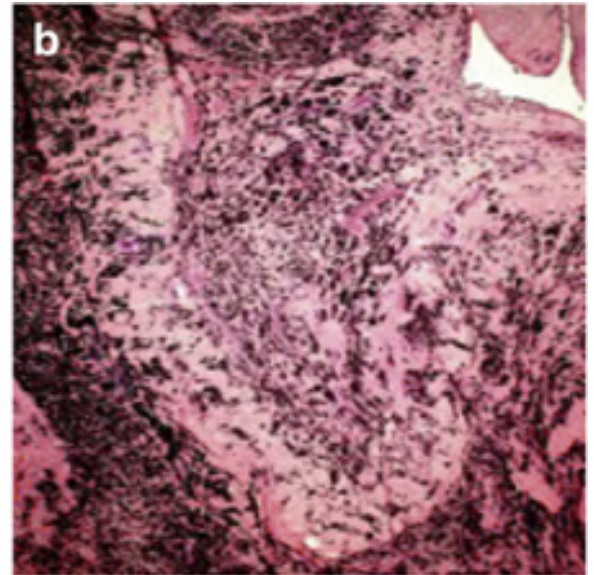
Figure 8

Explanted pseudotumor (a), microscopic view of pseudotumor tissue (b), black staining of tissue around an MoM implant (c), and microscopic photo of stained tissue (d)¹⁷.

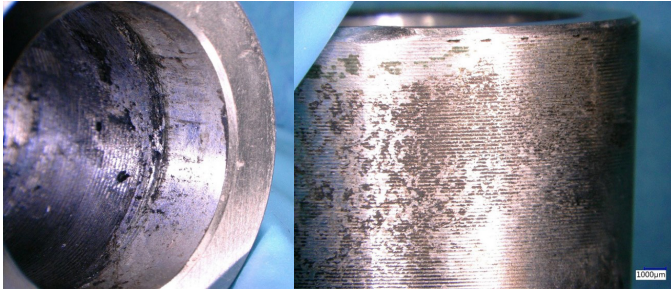
Figure 10

Images of the taper sleeve from one of the retrieved devices, displaying black corrosion features and imprinted lines.

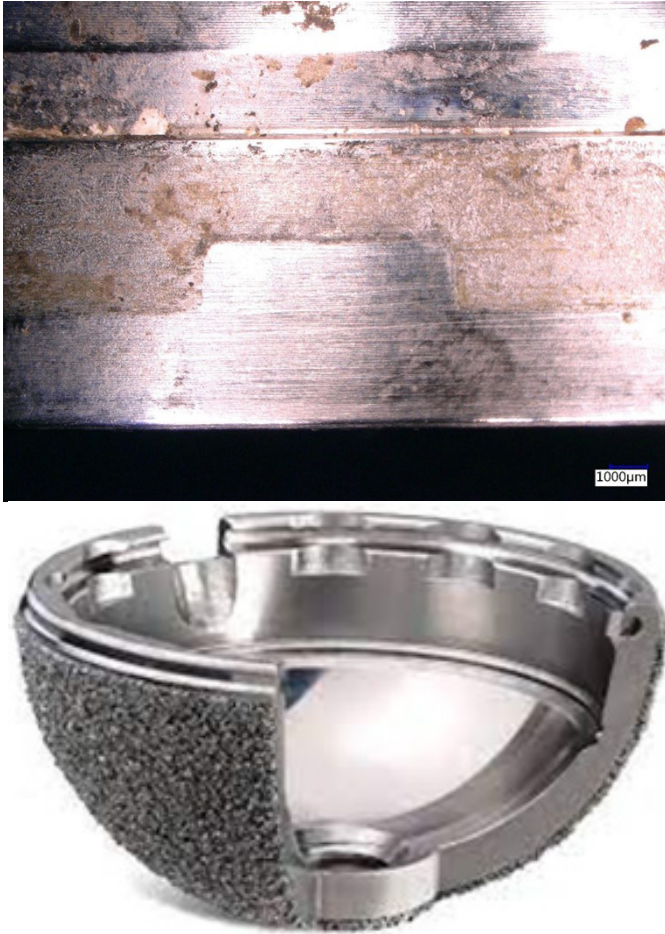
Figure 12

Image of the imprinting marks left behind on the outer surface of the metal liner (top) and a Ti6Al4V shell similar to the one it was connected to, displaying similarly sized rectangular teeth (bottom).

Modular MoM THA devices that utilized metal liners presented yet another modular interface for MACC to occur. As shown by the square teeth-shaped imprinting marks, there were portions of the liners that were directly mated to the shell with the imprinting marks left behind by the areas that were not directly mated as a result of the square gaps in the shell. The micromotion that took place between the metal liner and shell further generated the release of metal ions into the recipients bodies⁴⁸. More recently, dual mobility components consisting of a polyethylene liner, mated between a metal liner and femoral head, have been noted to suffer from elevated metal ions as a result of the coupling between the CoCrMo liner and Ti6Al4V shell. This adds further support for the conclusion that the use of metal liners significantly increased the level of metal ions in a recipient's body^{49,50}.

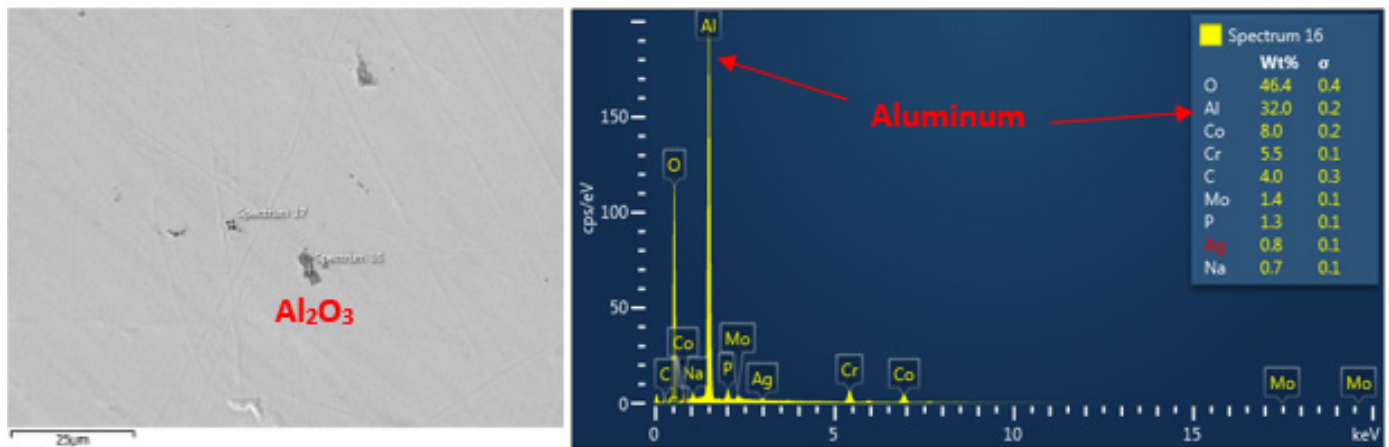
Figure 23

SEM image (left) and EDS results (right) showing high concentration of aluminum and oxygen, indicative of the presence of a micron-sized particle consisting primarily of aluminum and oxygen.

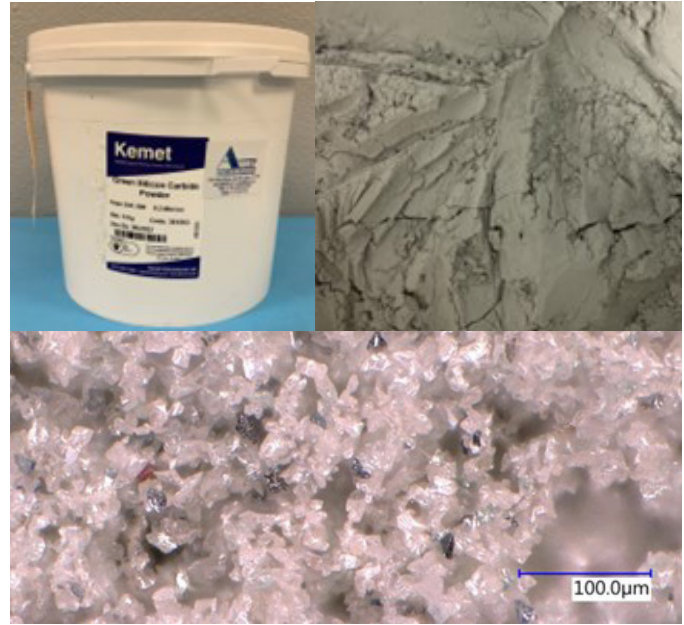
Figure 25

Photographs of the Kemet green silicon carbide powder container (top left) and the silicon carbide powder (top right) and image of silicon carbide particles taken with a digital microscope under 500x magnification (bottom).

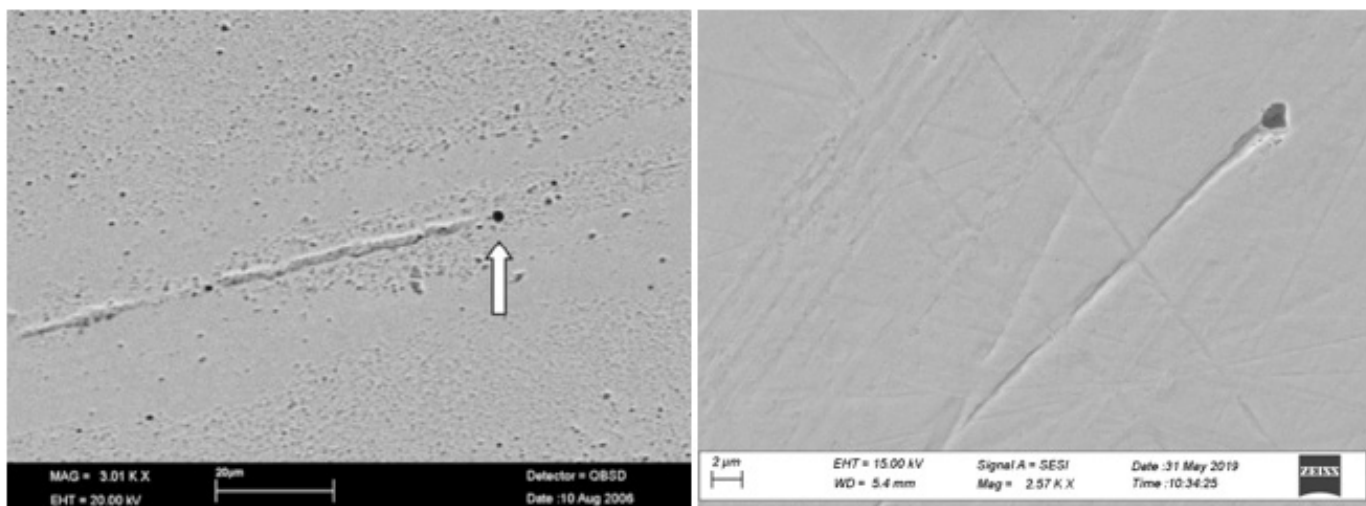
Figure 28

SEM image showing a figure from a study with “scratch originating from alumina filled pit ([white] arrow)” (left) and SEM image from the subject modular S&N femoral head with a similar scratch or furrow adjacent to the pit (right), which exhibited high levels of aluminum (Al) and oxygen (O) consistent with aluminum oxide (Al_2O_3), another polishing agent used during the polishing step of manufacturing.

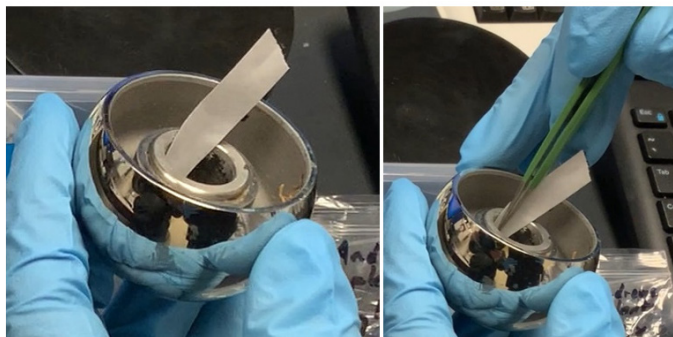
Figure 32
Images showing the process utilized to extract corrosion debris from the interior surface of the taper sleeve.

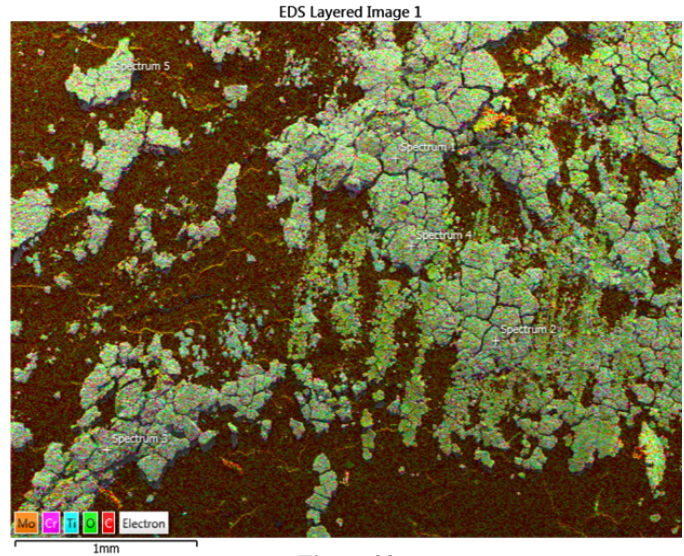
Figure 33
EDS map of the debris collected from the interior surface of the subject taper sleeve.

Based on the EDS maps and percent weight of these elements at various analysis points, it was concluded that, on a more-likely-than-not basis, the debris recovered from the interior surface of this taper sleeve primarily consisted of chromium, molybdenum, and titanium corrosion products produced as a result of MACC.

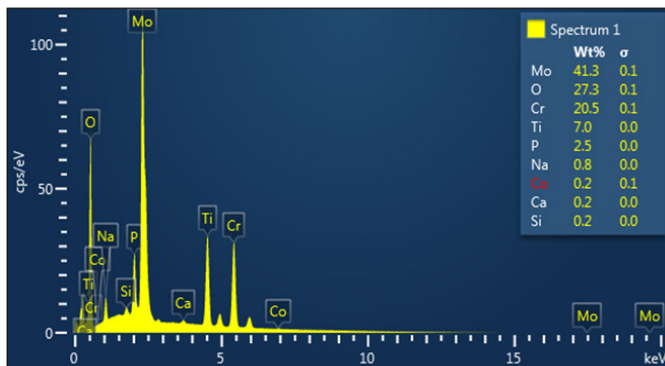
Figure 35

SEM and EDS analysis of the recovered corrosion debris revealed the presence of chromium, molybdenum, titanium, and oxygen (**Figures 33 through 35**).

EDS results from the debris collected from the interior surface of the subject taper sleeve.

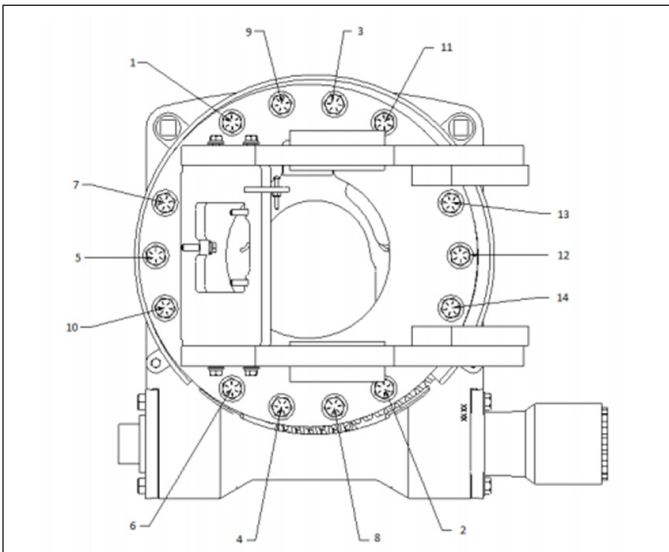
Figure 4

Diagram of the crane pedestal with each of the 14 bolts labeled with numbers 1 through 14. Note that bolts 7, 5, and 10 are located on the far side (rear) of the pedestal.

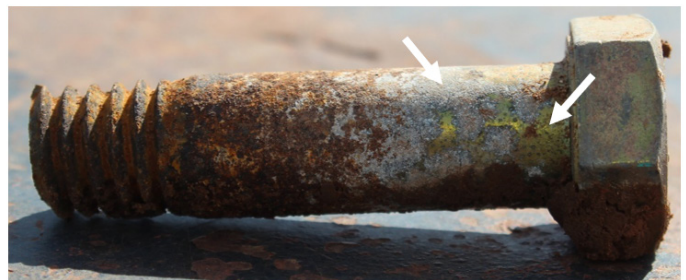
Figure 5

zinc on their heads, and a number of the bolts displayed significant depletion of this coating on the bolt shank and threads (**Figure 5**). It is likely that the yellow zinc coating was depleted from the bolt heads over a long period of exposure to water or other corrosive mediums while these same corrosive mediums stagnated in the notches and bolt holes, allowing for the coating on the body of the bolt to

Heavily oxidized (rusty) surface of bolt #9, displaying iron oxide and traces of the chromate and zinc galvanic coating (highlighted by the white arrows).

be removed and result in the corrosion of the bolt shank and threads. While a small amount of corrosion was noted on the fracture surfaces of some of the bolts (**Figures 6 and 7**), comparison with extensive corrosion noted on the exterior surface of the bolts (**Figure 5**) indicates that this corrosion likely occurred following the failure as the fracture surface was exposed to four days of snowfall before the bolts were retrieved during the authors' inspection.

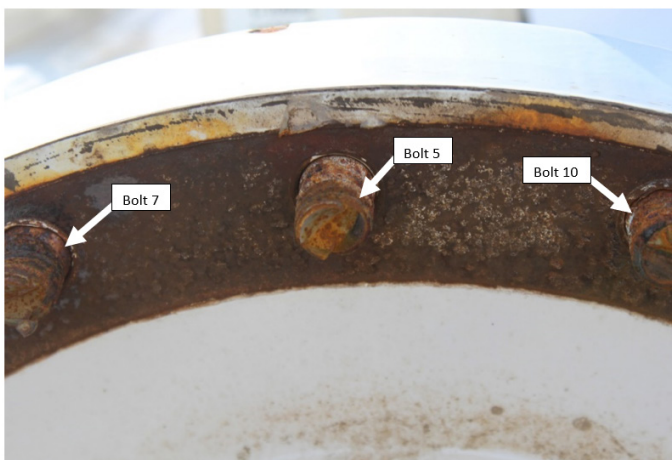
Figure 7

Bolts 7, 5, and 10 — still in their bores at the time of inspection. Note the severity of corrosion.

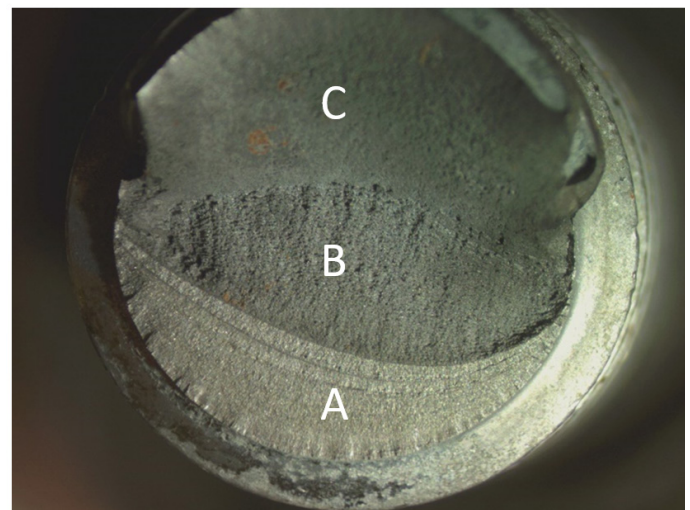
Figure 8

particularly low cycle fatigue), and finally a region (C) indicative of fast fracture through an inclined fracture plane (shear lip), as shown in **Figure 8**.

Fracture regions observed in a typical failed bolt fracture surface: A (fatigue beach marks), B (low-cycle crack arrest marks), and C (final sudden fracture).

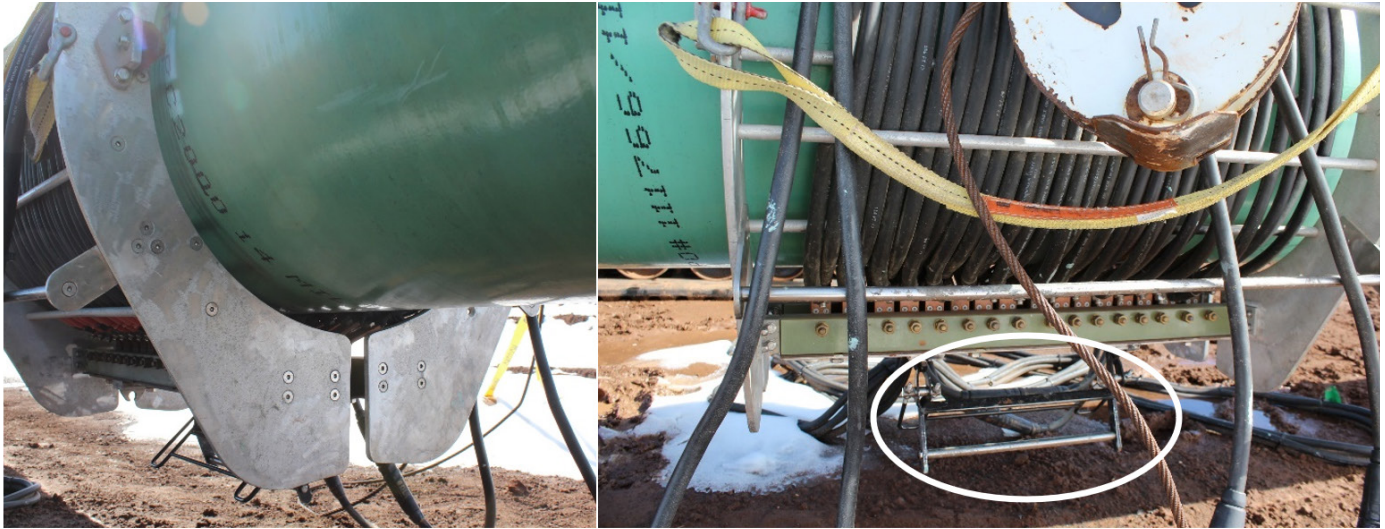
Figure 10

The heat ring being lifted by the crane boom was reported to have weighed between 400 and 500 pounds, significantly below (12% to 14%) the maximum load capacity of the crane as specified by the crane's load chart for the specific crane boom length and orientation at the time of failure. These heating rings are designed to drop down over a pipe and close around the pipe via a light clamp at the bottom of the pipe, as shown in **Figure 10**.

According to a report by the crane manufacturer as well as the manufacturer of the heating ring, this clamp was not designed to carry any loads. The clamp on the

Images of the heating ring, displaying no apparent signs of damage to the ring itself or the securement clamp (circled in white).

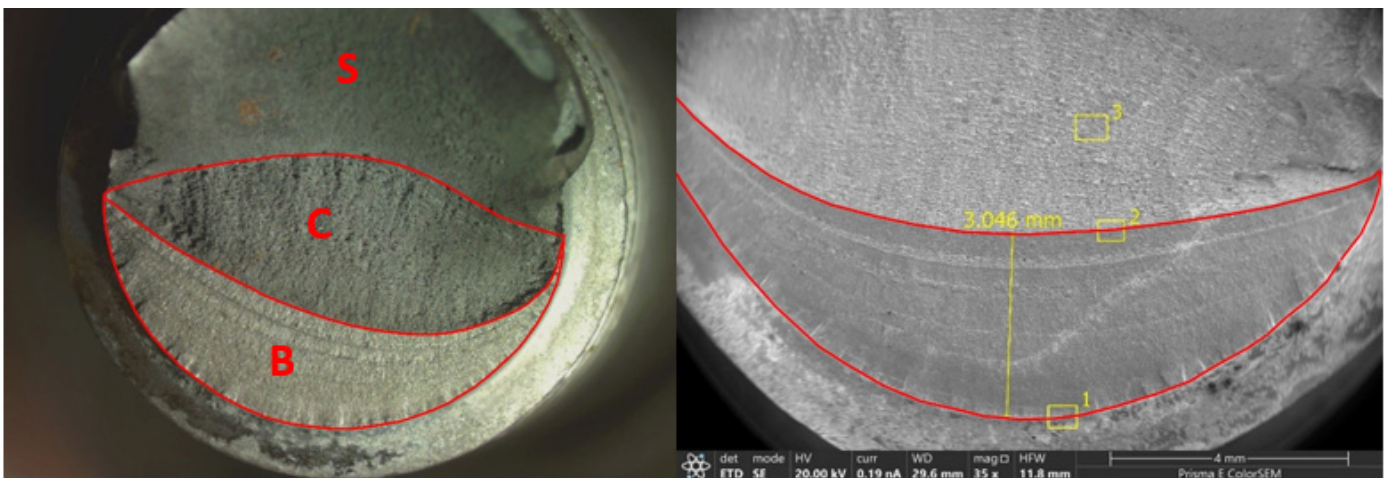
Figure 11

Fracture surface of Bolt #6, displaying three distinct regions. The presence of beach marks (B), parallel crack arrest marks (C), and a shear lip (S), are noted on the figure (left). A closer view of the beach marks and the parallel crack arrest marks are shown in the image to the right.

cross sections are shown in **Figures 11** through **15**. Features indicative of fatigue, such as beach marks (B), crack arrest marks (C), and ratchet marks (R), are marked on the first two sets of images. The remaining bolts were noted to exhibit large regions of parallel crack arrest marks and a lack of beach marks or patterns indicative of pure cleavage (**Figures 16** and **17**). These pronounced marks are due to the quicker fatigue fracture progression as a result of higher stresses experienced.

Figures 11 through **17** show that many of the bolts experienced regions of fatigue failure as evidenced by classi-

cal witness marks such as beach marks and ratchet marks. Some of these bolts also displayed the presence of long-term fatigue failure, evidenced by the presence of beach marks having highly differentiable corrosion texture (**Figures 14** and **15**). The combined presence of classical beach marks with highly differentiable corrosion bands suggest stress corrosion cracking as a mechanism that contributed to the failure of the subject bolts. The fracture surfaces observed on the 14 bolts also proved to be similar in nature to those that have been reported in literature^{7,8} (**Figure 18**). Based upon this evidence, fatigue failure was identified as the primary mode of failure of the subject bolts.

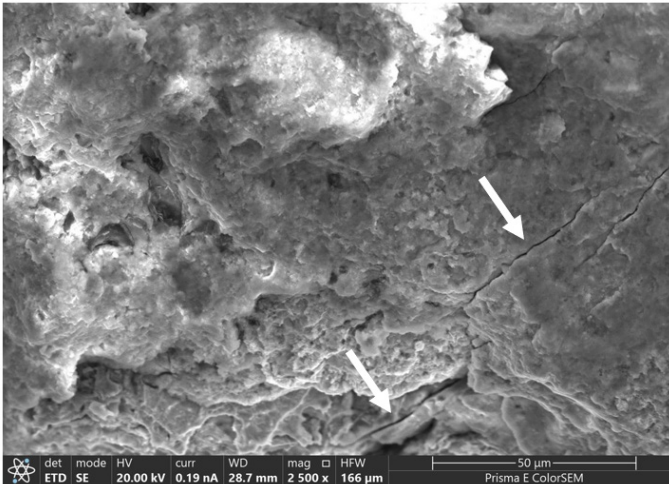
Figure 19

As the subject bolts were found to have hardness values of 39 HRC and were electroplated, hydrogen embrittlement was investigated as a potential factor contributing to the fatigue failure at issue. SEM of the failed bolts identified signs of stair-step cracking and intergranular fracture characteristics with pitting of exposed grains, a telltale sign of hydrogen embrittlement and stress corrosion cracking (**Figures 19 and 20**).

An SEM image of Bolt 10, showing fracture occurring along the grains of the material as well as the presence of stair step cracking along the grains of the material (white arrows).

The failure analysis team concluded that hydrogen embrittlement was likely to have occurred during the manufacturing of these bolts and that the in-service corrosion of the bolt coating while in service provided another source of hydrogen exposure, allowing for additional embrittlement to occur. The team recommended that the manufacturer change the bolts that were utilized on these cranes, utilize lubricant, and inspect the bolts regularly/replace them if they showed signs of corrosion.

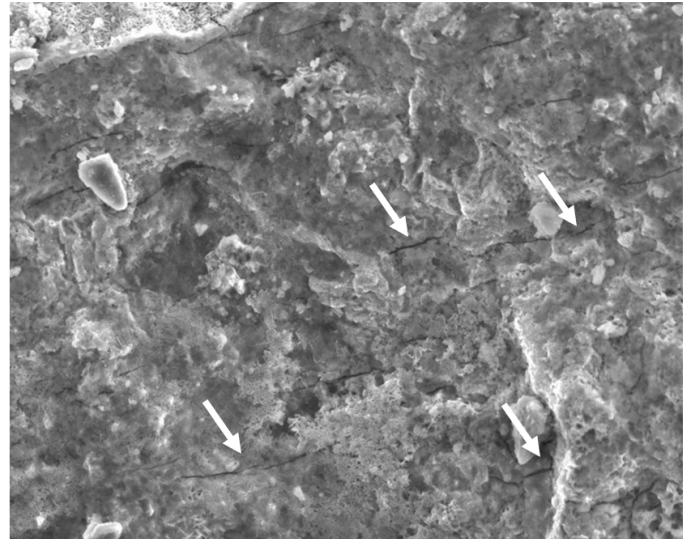
Figure 20

An SEM image of Bolt 5, displaying quasi-cleavage indicative of mixed inter and transgranular fracture.

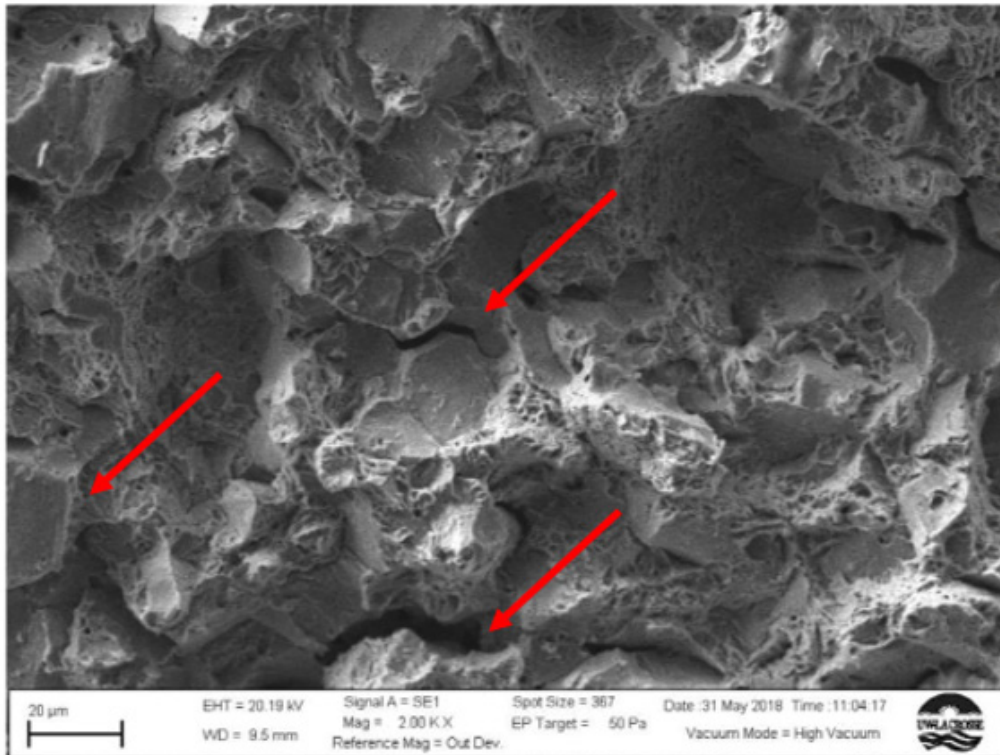
Location 2

Another one of the cranes produced by the crane manufacturer was noted to have experienced failure in March of 2018, around a year after it was first assembled. As was the case with the previously mentioned incident, all of the 14 bolts on this crane were the same Grade 8 steel fasteners utilized in the subject crane. SEM analysis revealed extensive intergranular and quasi-cleavage fracture morphology typical in bolts subjected to hydrogen embrittlement (**Figure 21**).

This images shows:

- Intergranular fracture
- Secondary cracking
- Ductile tearing on grain facets
- Microvoid coalescence

Intergranular fracture features on the failed bolts from the 2018 incident, indicating embrittlement took place.
