Journal of the
National
Academy OF
Forensic
Engineers[®]

Vol. 41 No. 2 December 2024

Forensic Engineering Analysis of a Residential Fire Caused by an Open Neutral

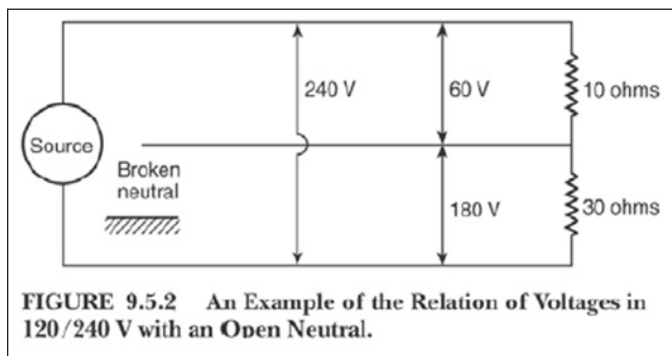
Figure 8

Per Section 9.5.2 of NFPA 921-2017, “[a]n electrical installation with an open neutral conductor will not have a fixed 120V between each hot leg and the neutral. There will still be 240V between the two legs, but instead of the voltages of the two legs being fixed at 120V to neutral each, they may vary to some other values that add up to 240V (**Figure 8**). All 120V circuits connected to the open neutral conductor will be affected. The actual voltages in the legs will depend on the loads on the two legs at any particular time. For example, the voltages might be 60 and 180 as in Figure 9.5.2. The higher voltage can overheat or burn out some equipment, and the lower voltage can damage some electronic equipment. Occupants may have seen incandescent lights that were too bright or too dim or appliances that overheated or malfunctioned in some way. A floating neutral condition is not dependent on proper grounding of the service. Removing the grounding electrode connection does not cause an open neutral”.

Figure 9.5.2 from NFPA 921-2017.

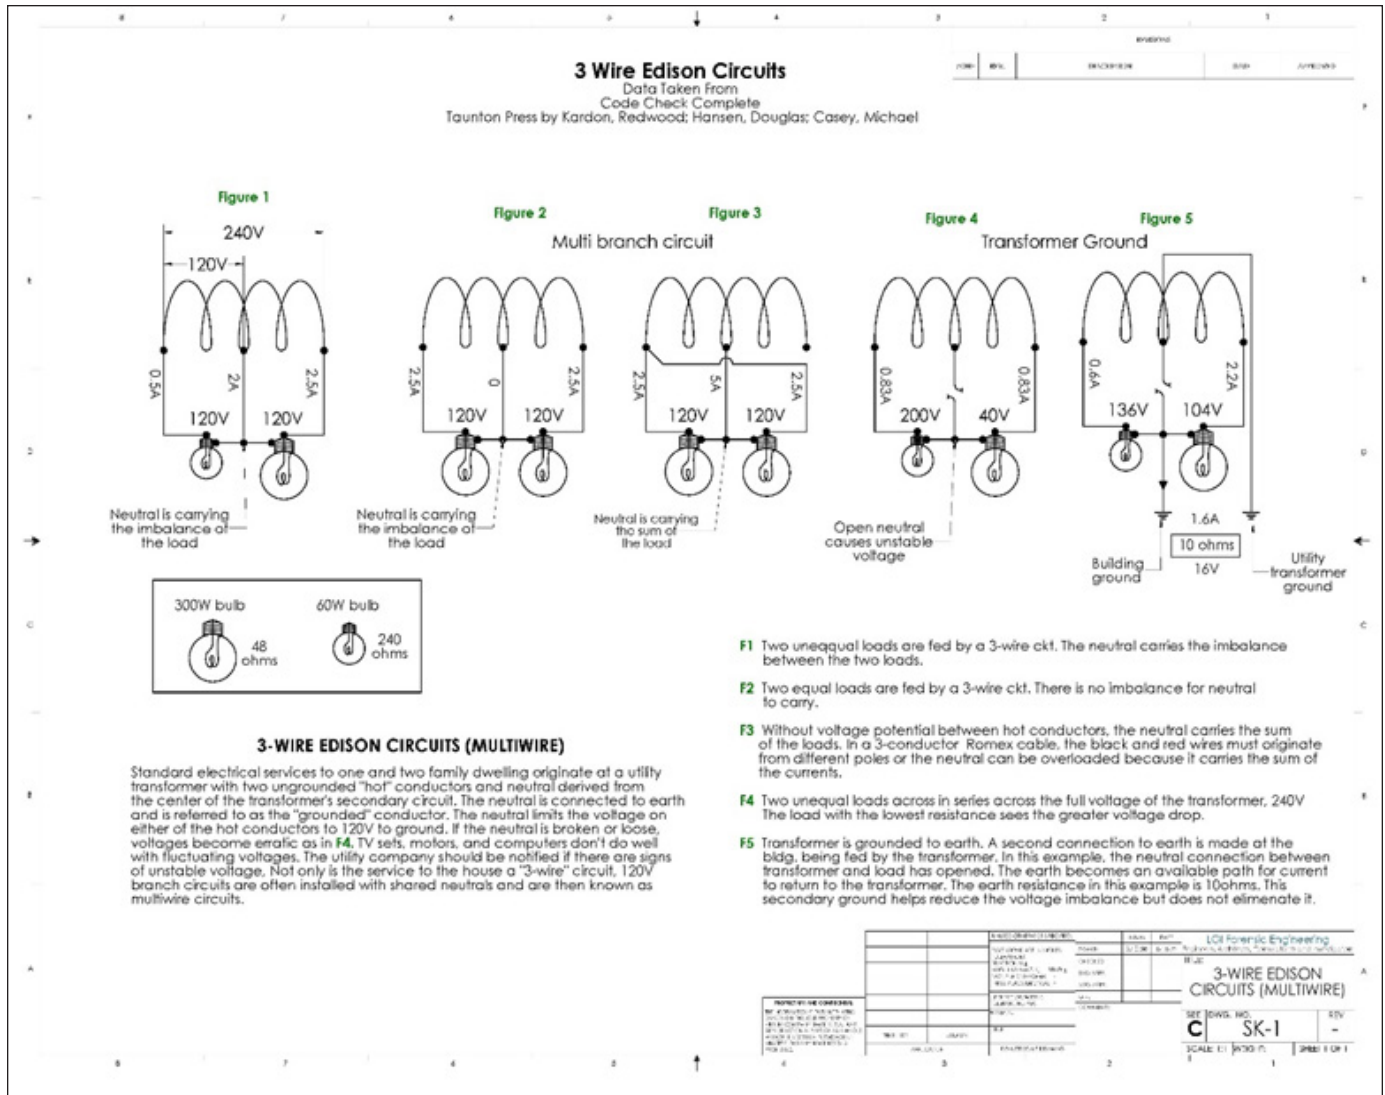
In a multiwire circuit, such as the case at this property, the neutral conductor carries the load imbalance. **Figure 9**, showing a three-wire circuit, has been supplied to assist in the explanation of an open neutral. As shown in Figure 1 of **Figure 9**, the neutral conductor is designed to carry the imbalance of the two loads. In this example, there is one load requiring 0.5A on one phase, while the load on the second phase is drawing 2.5A. The difference of the two currents, 2A, will flow back to the transformer and into the service supply. When the loads are balanced (a very

A higher-wattage device will have a lower resistance than a lower-wattage device. In an open neutral condition, the smaller wattage device will see the larger voltage drop. In Figure 4 of **Figure 9**, the 60W bulb will be very bright because its voltage drop is five times greater than the voltage drop across the 300W bulb.

Figure 9
A sketch showing a three-wire Edison circuit (multiwire).

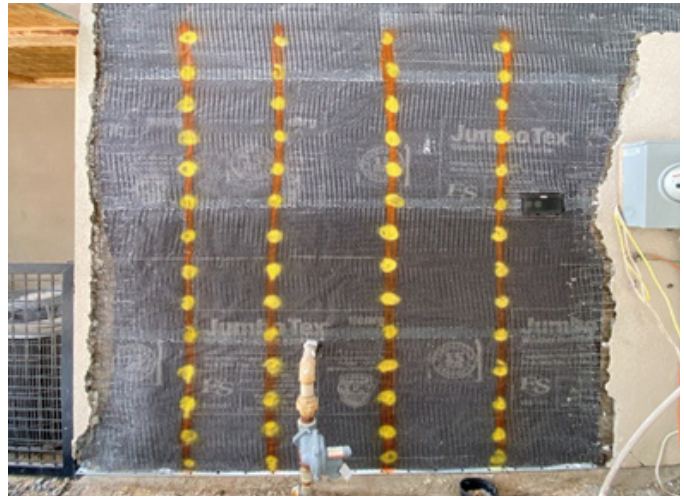
Figure 2

The installation of metal lath utilizing fasteners that align with wood framing members (wall studs) is illustrated in **Figure 2**.

Installation of lath fasteners (yellow dots) aligned with underlying framing members (vertical red lines).

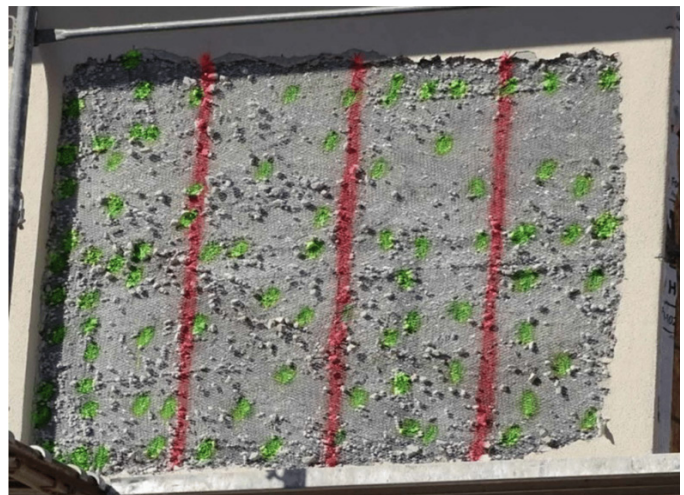
Figure 3

In some parts of the United States, it is a common construction practice to attach the metal lath directly to wood structural sheathing panels, such as plywood or oriented strand board (OSB), with staples spaced at approximately 6 inches on center each way without any regard for the alignment of fasteners with underlying wood framing members (wall studs) as illustrated in **Figure 3**. Without any analysis, the aforementioned practice is often asserted to be a construction deficiency by some simply because the placement of fasteners does not strictly comply with the exact prescriptive specifications of the IRC; however, it should be noted that Section R703.7.1 of the 2021 IRC also provides an option to attach the metal lath “as otherwise approved”².

Installation of lath fasteners (green dots) without regard to alignment with underlying framing members (vertical red lines).

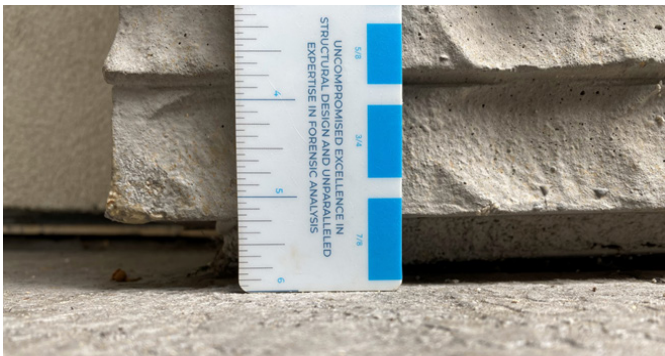
Figure 6

In the event that cement plaster (stucco) veneer is installed with a clearance of less than 2 inches to an underlying monolithic foundation surface (e.g., porch, patio), the as-built condition should be further evaluated to determine whether the as-built condition is capable of performing the intended function. If the cement plaster (stucco) veneer is installed with sufficient clearance to provide adequate drainage for the moisture management system and protect the veneer/wall assembly from contact by surficial water and/or ground movement (½ of an inch is considered sufficient for similar cladding systems) — and the veneer does not exhibit any salient signs of excessive cracking and/or

Adhered masonry veneer installed with not less than ½ of an inch of clearance to the foundation.

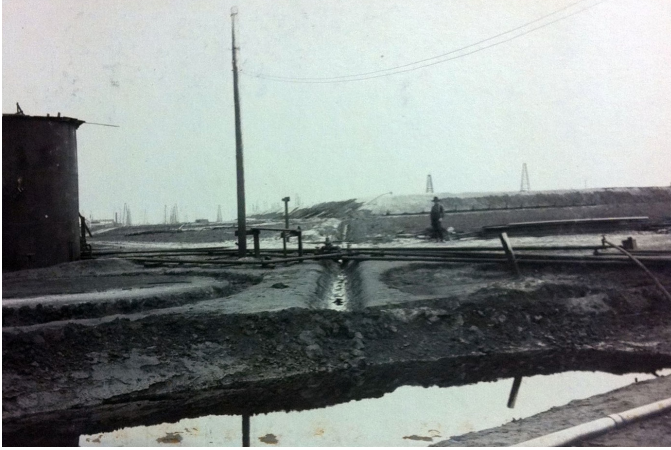
Figure 2

Seepage losses varied due to construction methods, soil types, and oil characteristics. Wooden-lined tanks built on clay soils tamped by mules or machines had lower loss rates than tanks constructed solely from plowing dirt to the depth of the underlying clay and pushing it to the outside to create impounding levees²⁰. Oil seeps were commonly observed through levee walls and on the ground adjacent to the tanks^{21,22}. As oil was a valuable commodity, tank owners attempted to recapture as much of the seeped oil as possible by building ditches or moats around the perimeters of their tanks and using pick-up pumps to return oil to the reservoirs (**Figure 2**).

Photograph looking northeast on the Houssiere-Latreille property of earthen and steel oil tanks with pipelines, collection ditches, and pick-up pumps. For scale, a man stands in front of an earthen oil storage tank. Its containment levee is taller than the man. Wooden oil derricks on Houssiere-Latreille property are visible in the background²³. See **Figure 5** for a plan view of this location on the Hervey map.

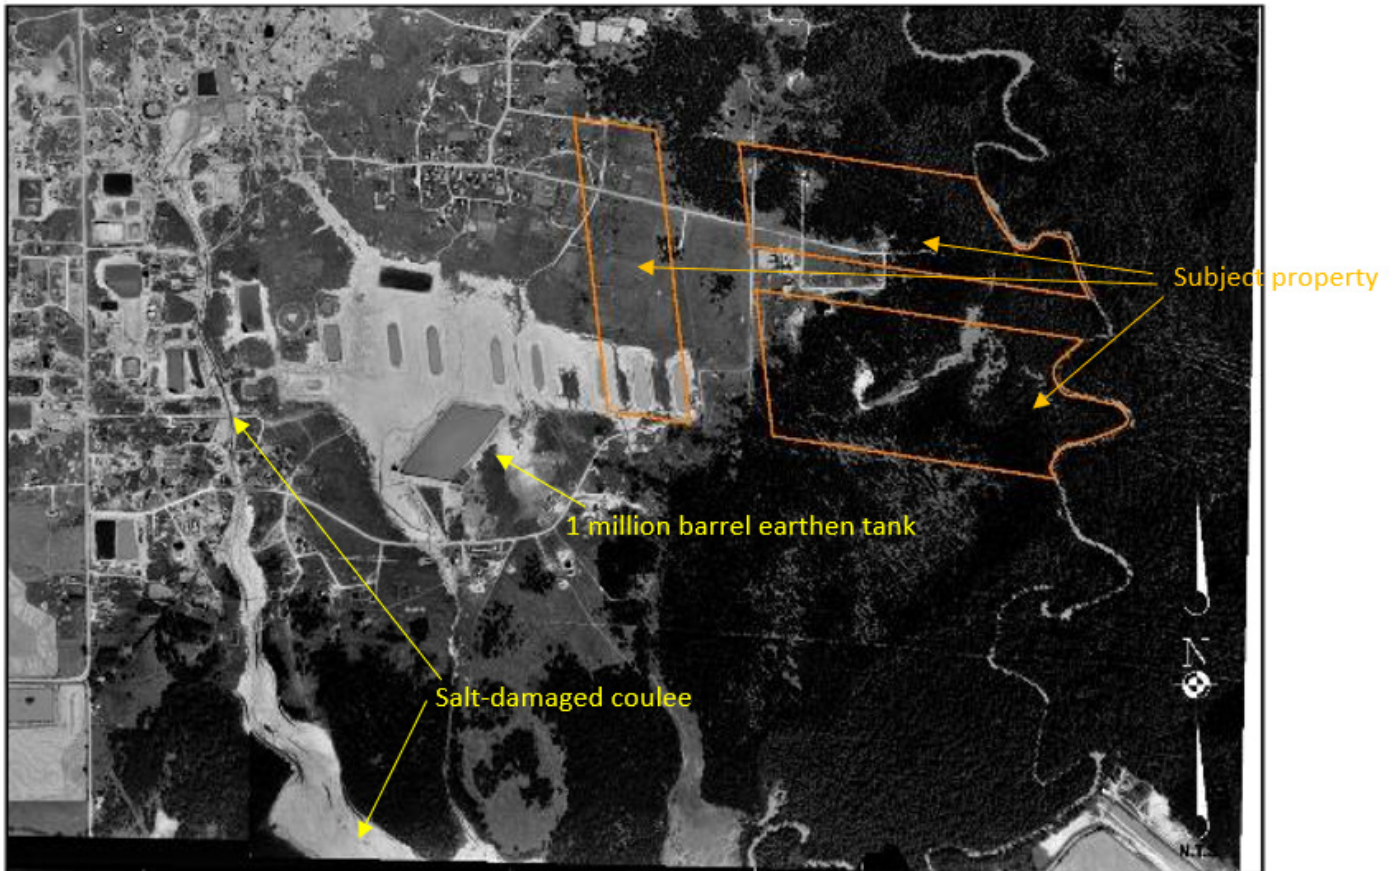
Figure 3

Between the smaller, immediate-need well storage pits and the larger, longer-term collection earthen tanks, the Jennings Oil Field became dotted with open pits resembling oil lakes, visible in aerial photographs as late as the 1950s (**Figure 3**). In **Figure 3** and subsequent figures, the outlined areas mark the boundaries of the plaintiffs’ properties at issue in this case.

Photograph of the three properties of interest outlined in orange in Section 47 and of Jennings Oil Field in 1953. Massive earthen storage tanks are obvious on the Houssiere-Latreille and surrounding properties. Bayou Des Cannes is on the eastern edge of the subject property. The salt-damaged coulee from the center of Jennings Field is in the southwestern portion of the photograph²⁴. The outlines of the three properties of interest will also appear on subsequent images.

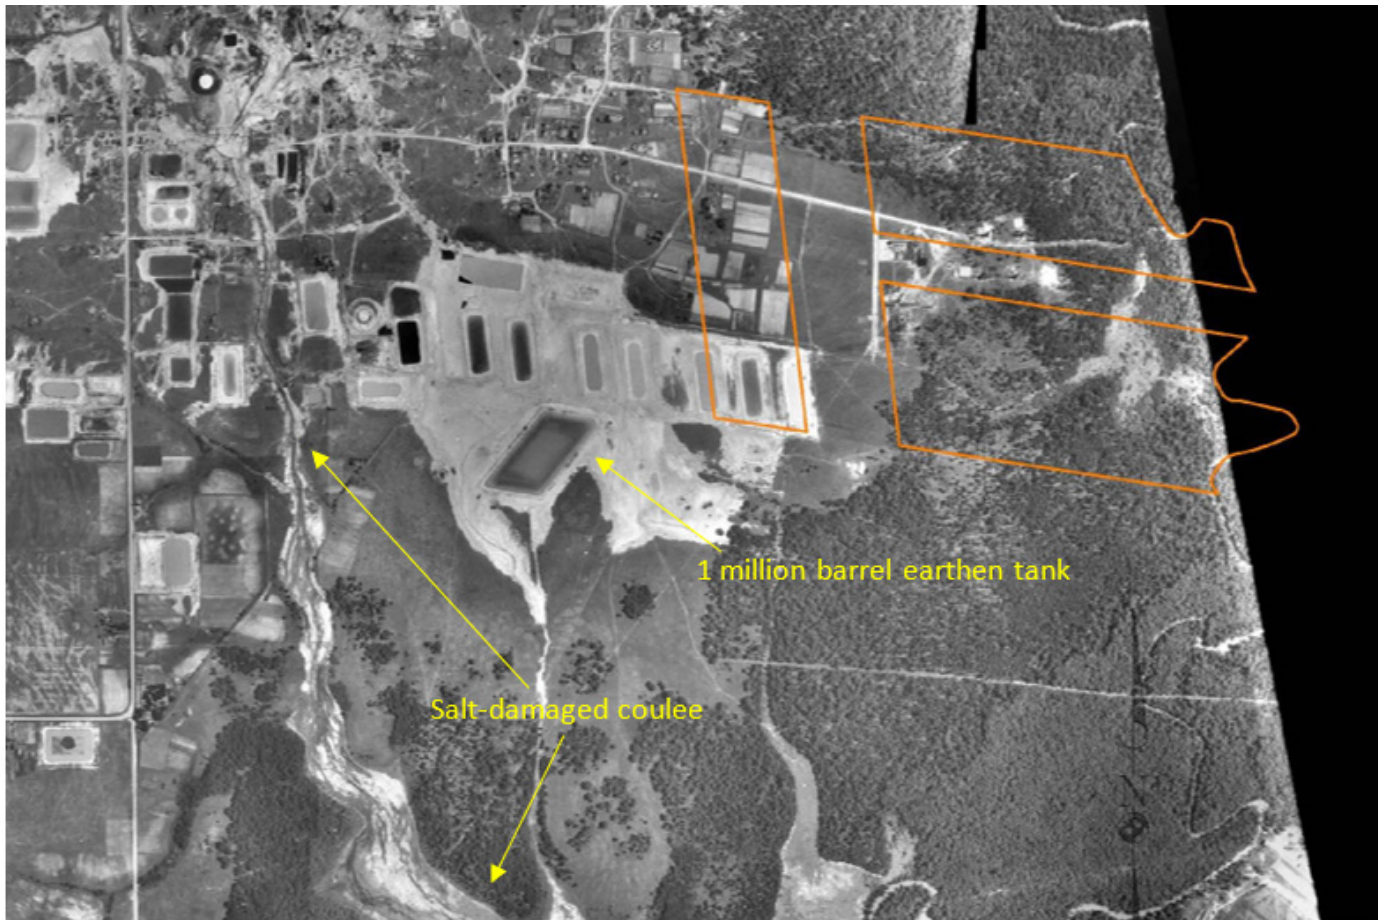
Figure 4

In **Figure 4**, two water bodies border Section 47 of the Jennings Oil Field: Bayou Des Cannes to the east and the central drainage coulee to the west. Even though the photograph does not contain topographic data, the “water flows downhill,” or down elevation gradient, understanding of hydrology informs the forensic hydrologist that higher elevations are present between those two water bodies. The central coulee is a low elevation linear feature in this landscape — surface water flows into it. The central coulee drains downstream (downhill) to Bayou Des Cannes, an even lower elevation linear feature. Also, natural ditches and bayous typically increase in width as they flow downstream due to additional runoff they receive and transport along their paths to their discharge points in larger water bodies. In between low elevations natural drainage channels higher points of elevation must exist³⁷.

Vegetation differences evidenced in **Figure 4** also indicate elevation differences, thus, hydrology and drainage directions. Vegetation on land closer to natural water bodies is dense with tree canopies; vegetation farther away (uphill) is dense with prairie grasses (or rice). Upland

The earliest photograph of the three properties of interest dates to 1933³⁹. The light-colored area in the center of the photograph illustrates vegetation removal as part of safe operational practices around open crude oil storage tanks. Light-colored meandering shapes along natural drainage pathways illustrate salt deposits or salt scarring of the land by produced water.

the central area of **Figure 4** is likely a combination of vegetation removal for safety and salt deposits from produced water. The easiest method to distinguish salt scarring from produced water runoff and contaminant transport is to analyze the shapes of the light areas farthest from the earthen tanks. A non-geometric, naturally meandering pattern strongly suggests salt scarring from overland flow of produced water versus vegetation loss by design. The salt water follows the natural (or altered) drainage patterns determined by topography. Produced water has a higher density than fresh water, so it moves as a stratified layer along the bottom of the drainage ditch and under the fresh water precipitation. Also, salt in produced water does not evaporate with the water. Thus, the lightest colors in **Figure 4** present in meandering patterns along drainage paths are more likely to be salt deposits (scarring) than vegetation removal.

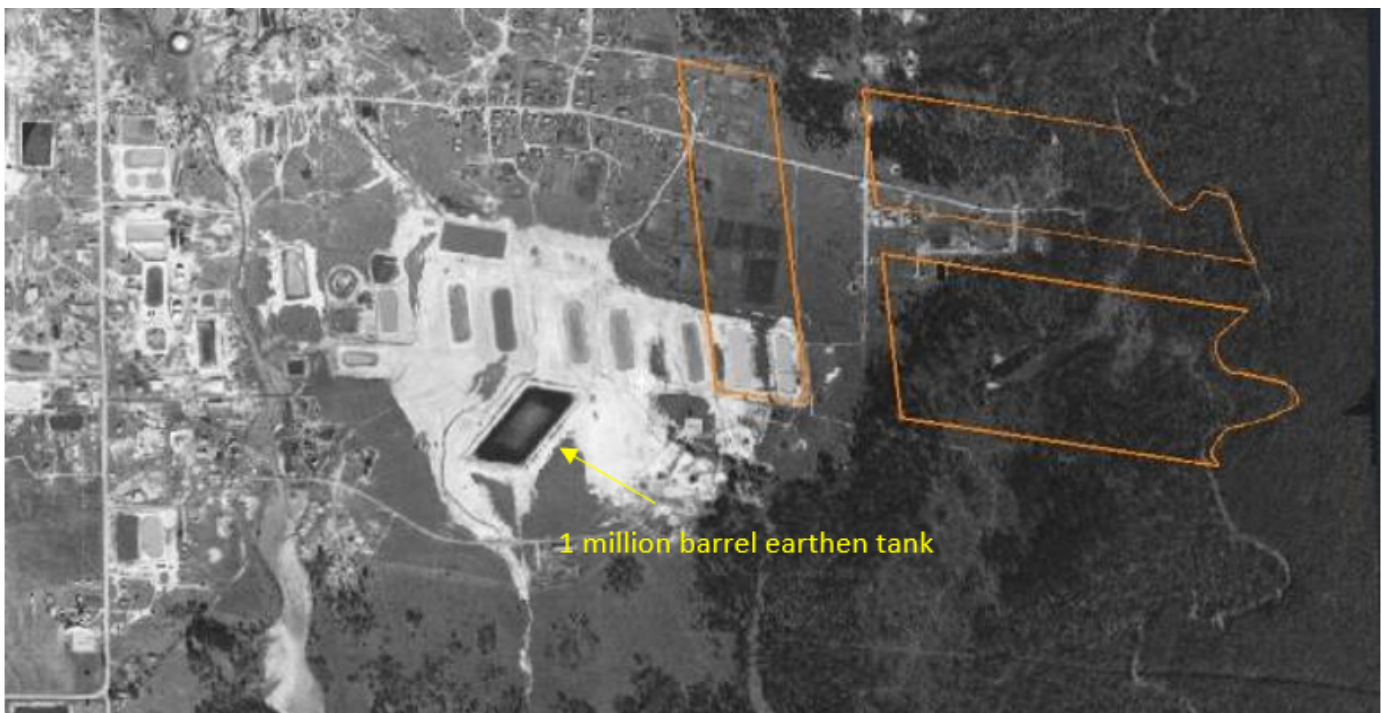
Figure 6

The time-series analysis approach requires applying the techniques used to analyze **Figure 4** to subsequent chronological photographs. Comparing the 1933 aerial photograph (**Figure 4**) to the 1940 aerial photograph (**Figure 6**), the 1940 image shows vegetation returning to the western fringes and in the northwestern portion of the wooded area⁴⁰. Land to the south of the salt-scarred coulee is less vegetated than in 1933. The area around the large

A 1940 aerial photograph of the subject property and surrounding area⁴⁰. Comparing this photograph to the 1933 photograph as part of a time-series analysis illustrates changes on the land surface. When performing the FE analysis, it is important to determine the date of the photographs to account for seasonal changes with respect to water levels and vegetation growth.

earthen tanks appears to be slightly re-vegetated. The tank on the northern edge of the southern portion of the subject property appears to drain to the edge of the sparse vegetation through a small ditch. This tank was likely used to store salt water until it could be discharged during the regulated months between September and March, and the ditch

encouraged produced water ponding, leading to salt scarring shown in the 1940 photograph (**Figure 6**)⁴¹.

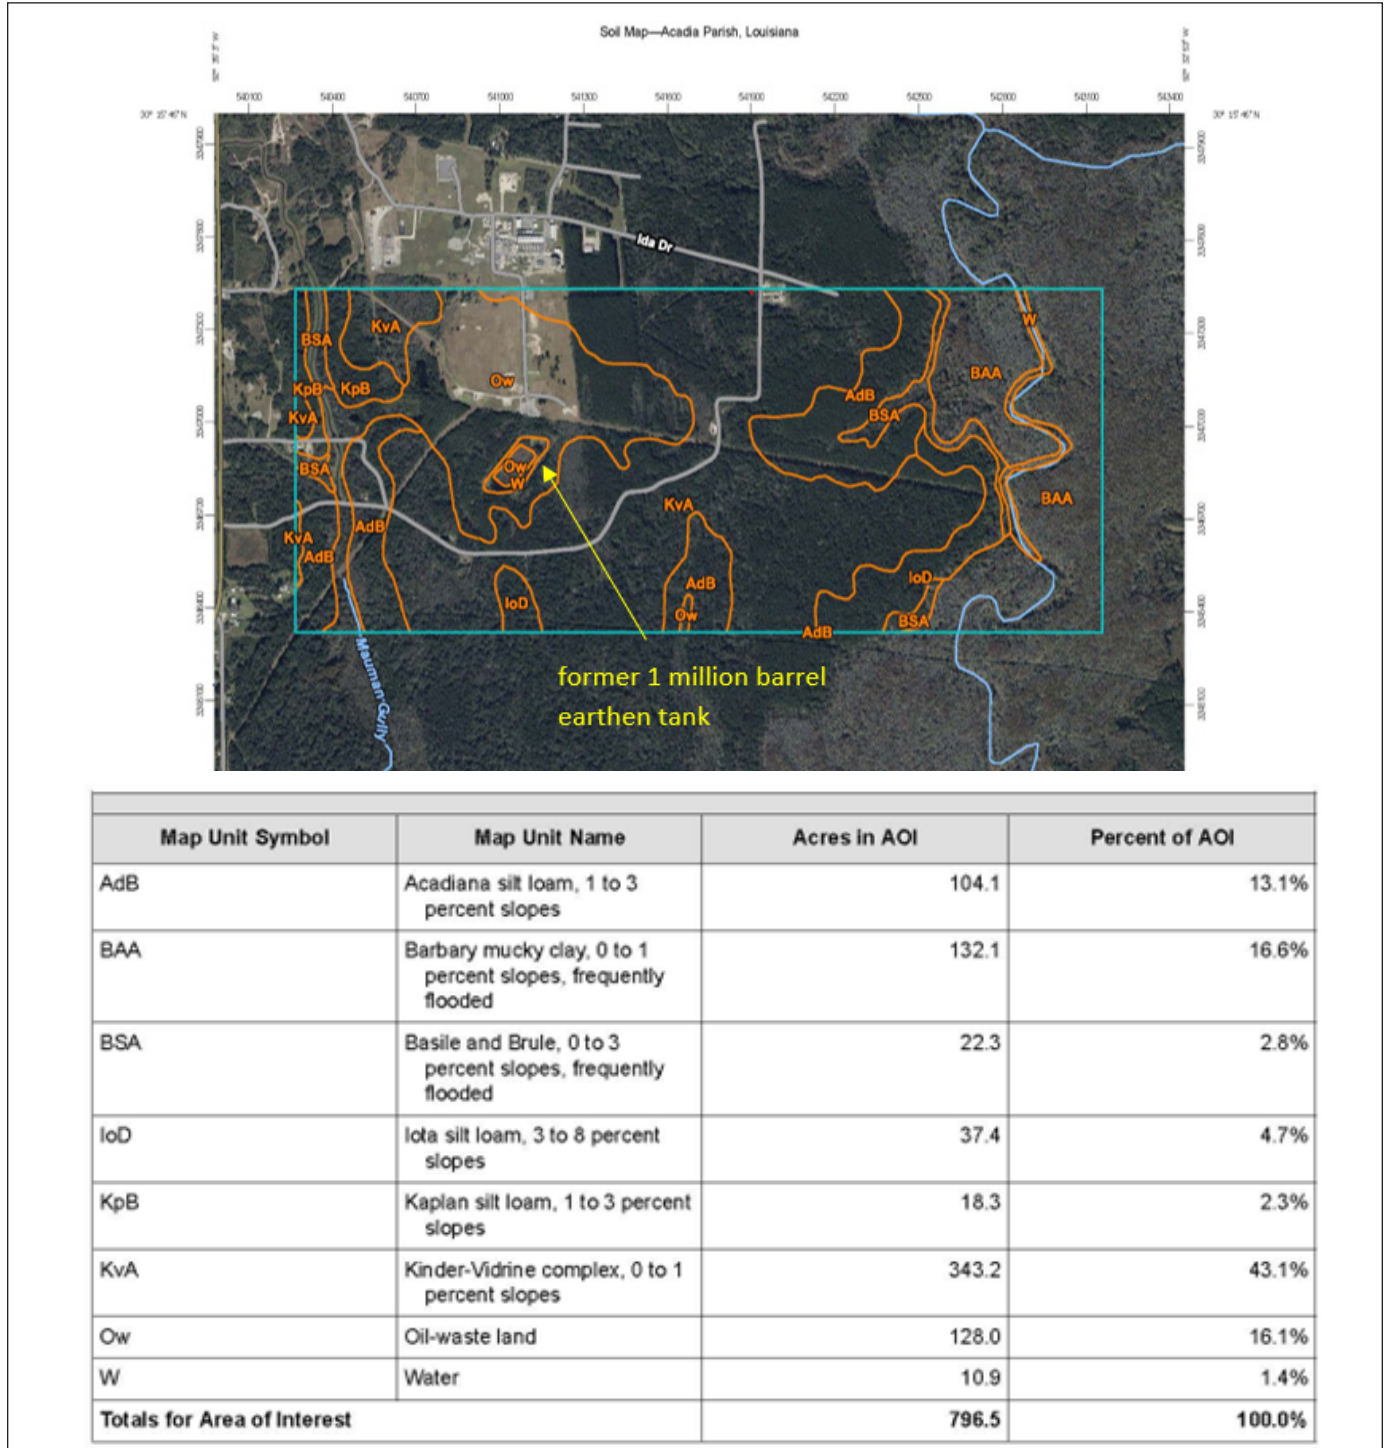
Figure 7

likely directed the discharge to minimize the impact of the overland flow of the salt water. Support for this conclusion comes from undisturbed soil types in the subject area. Silty loam soils on the subject property facilitated drainage toward Bayou Des Cannes while the frequently flooded Basile and Brule soils adjacent to Bayou Des Cannes (Figure 7)

Present-day soil survey on the subject properties and surrounding land⁴¹. For areas unaltered by oil field operations, present-day data informs past hydrology and drainage patterns on the subject land. Interestingly, the 1 million barrel earthen tank just south of the plaintiffs’ properties presently map as oil-waste land and water — the remaining tank infrastructure continues to hold water.

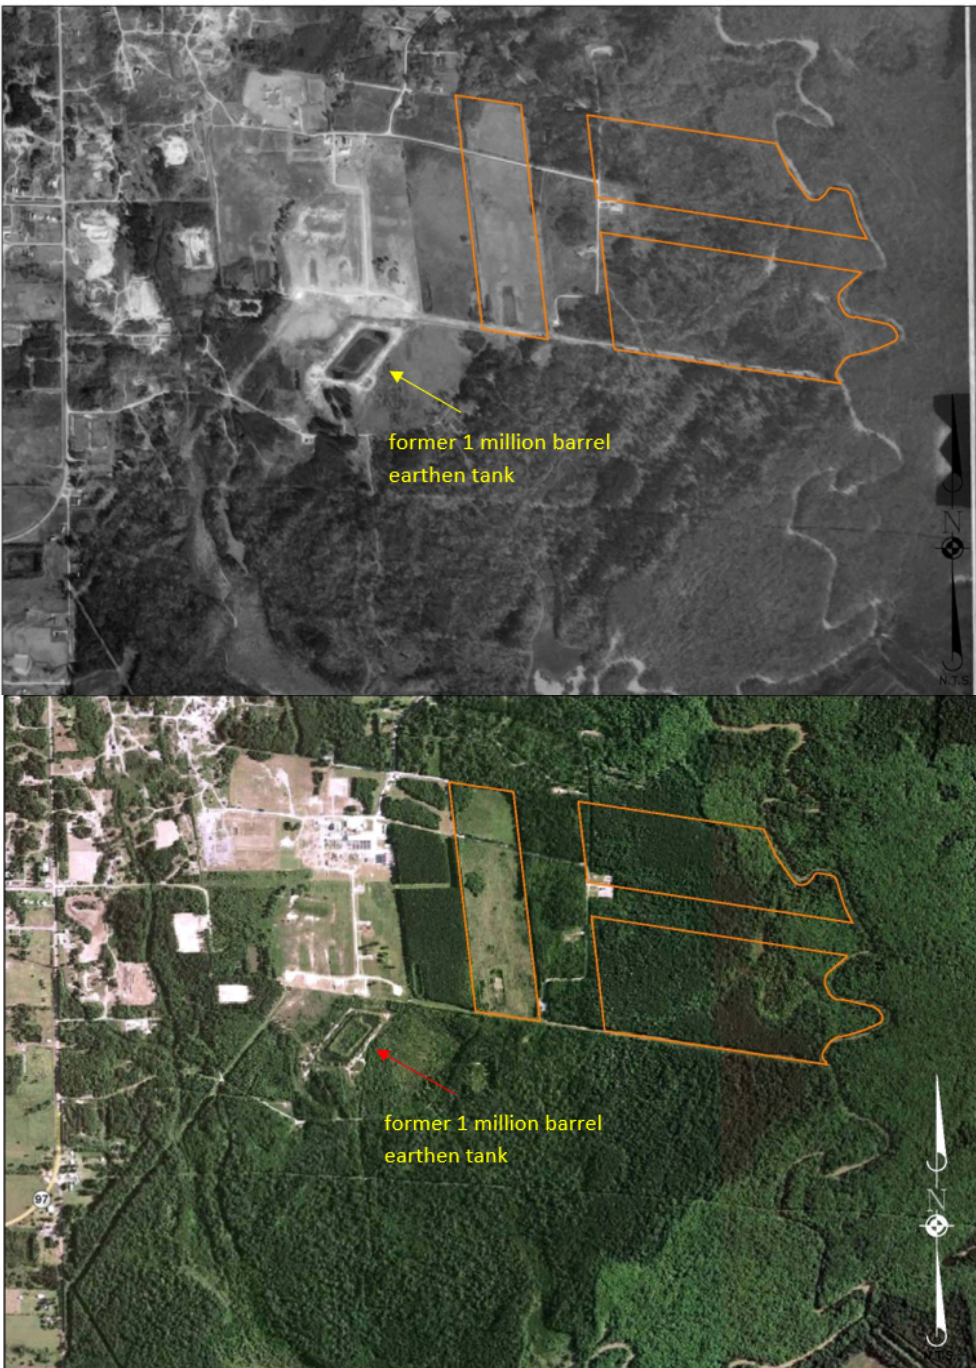
Figure 8

1995 (top)⁴² and 2009⁴³ (bottom) aerial photographs of the subject property and surrounding area. The Jennings Oil Field experienced immense recovery from 1995 to 2009 with the closure of earthen storage tanks and revegetation in previously denuded areas.

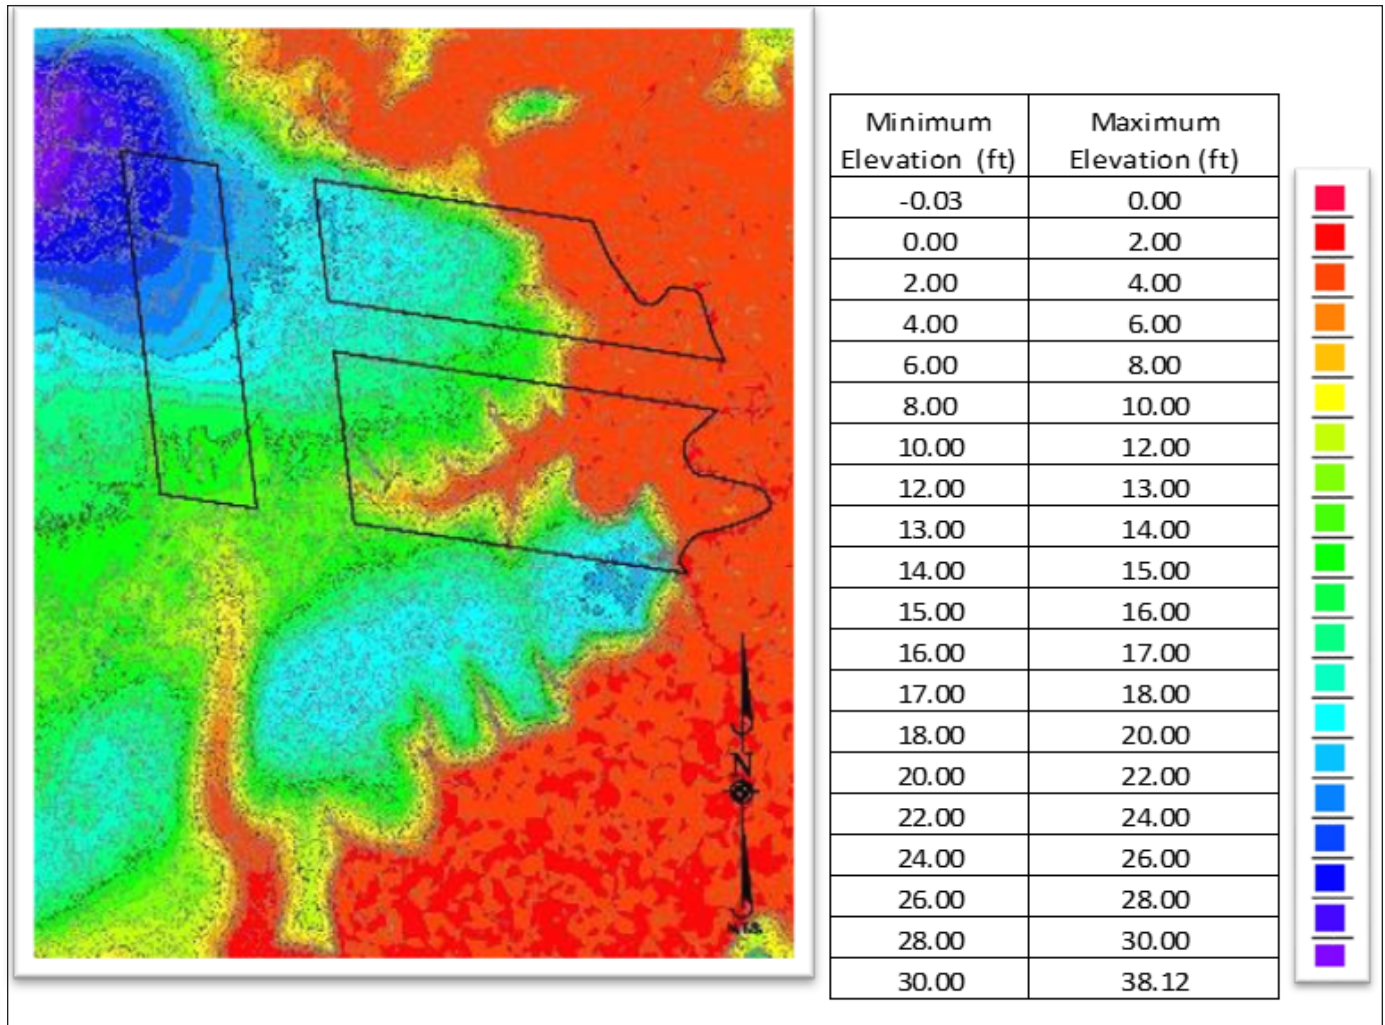
Figure 9

LiDAR map of the subject property shows that it is at lower elevations than surrounding property. The three properties of interest are outlined in black. The salt dome on which most of the 1930s drilling took place is located in the northwestern corner of the map (purple and blue round shape). Surface water flowed to and across the subject property from higher, adjacent elevations, transporting oil field wastes to Bayou Des Cannes and other lower lying areas⁴⁴.

property is the surface water runoff collection point for only a small portion of the subject property. As illustrated in **Figure 9**, based on elevation gradient, the western part of the subject property drains predominantly to the south, consistent with Hervey’s description in the McFarlain case. The northern part of the property drains predominantly to the east into Bayou Des Cannes, again based on elevation gradient. Therefore, the southeastern part of the subject property is, for the most part, the only contributing drainage area to that coulee.

Land south of the subject property (on the northeastern corner of Section 40) is the dominant surface water runoff source for the coulee on the subject property due to its higher elevations. The LiDAR map in **Figure 9** shows a higher elevation in blue in that northeastern corner of

Section 40. Based on topographic analysis with the highest elevations delineating the drainage watersheds, approximately half of that area in blue drains north into the coulee on the subject property, and approximately half drains south into Bayou Des Cannes. Thus, the area designated as the “salt water discharge impact area” by plaintiffs’ experts predominantly receives surface water runoff, historically including salt water and oil from the oil fields — from the property south of the subject property.

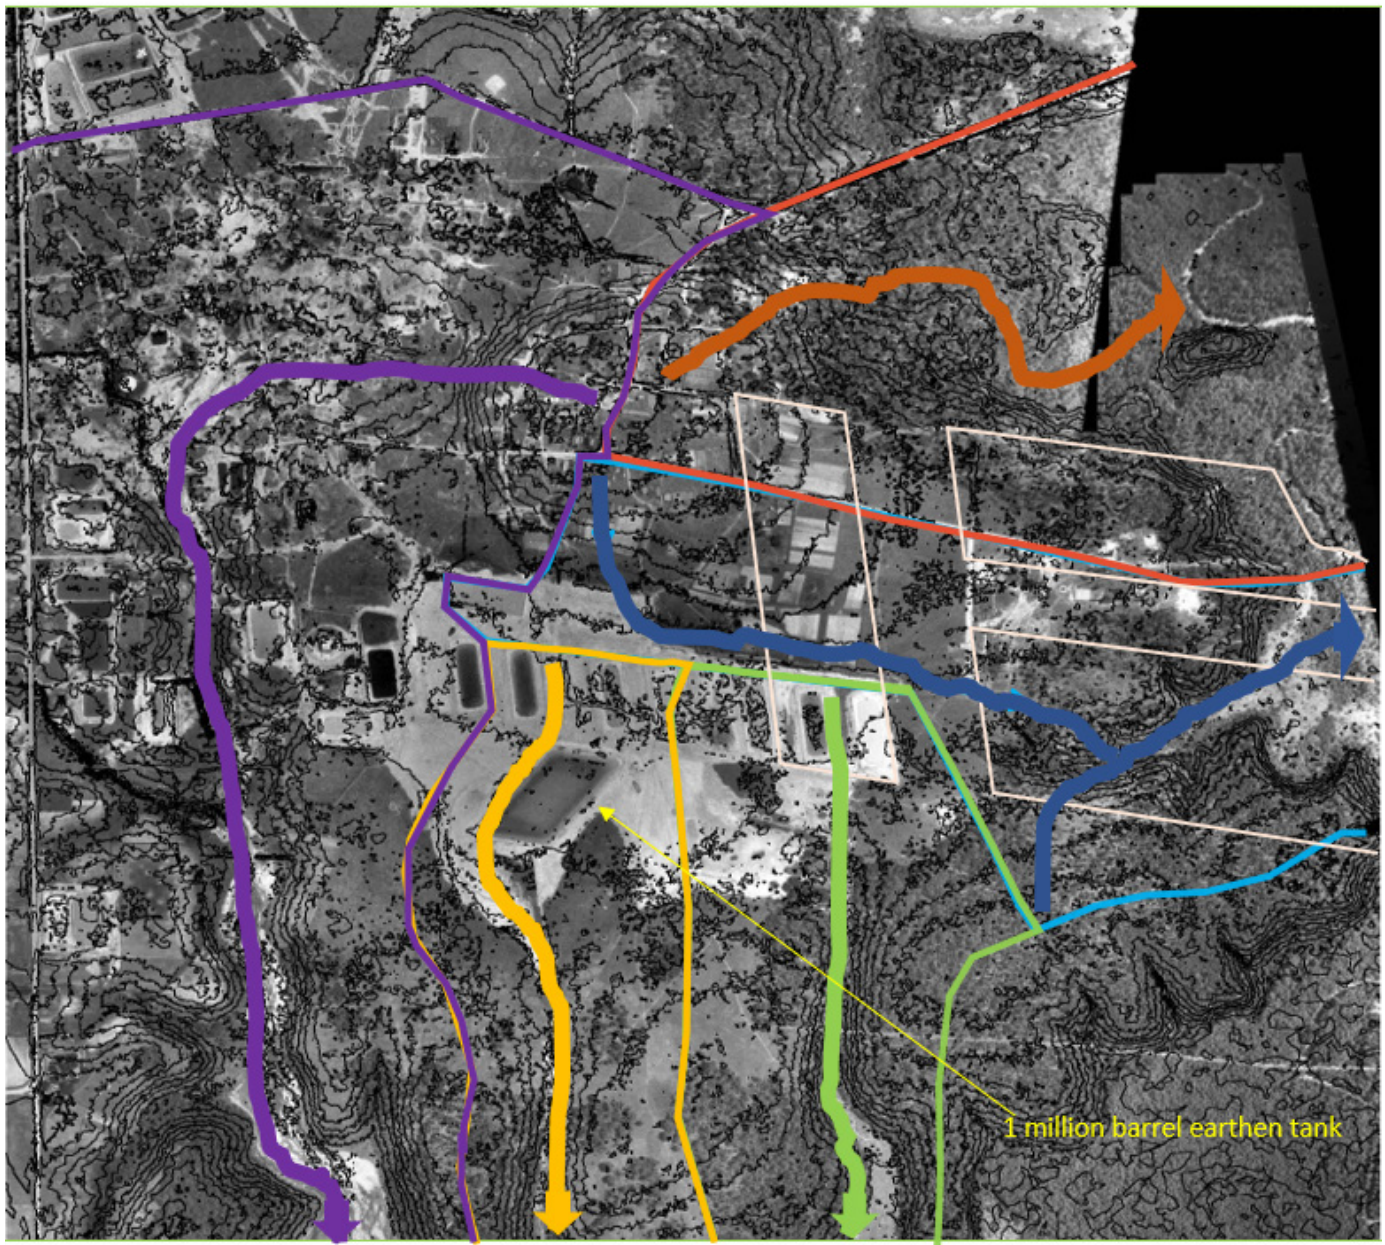
Figure 10 also illustrates altered natural drainage patterns resulting from oil field infrastructure. The gold-outlined drainage subcatchment in the south-central area of the photograph outlines the diverted overland flow path water must take between and around large earthen storage tanks. The green-outlined drainage subcatchment

LiDAR elevations⁴⁴ overlaid on the 1953 aerial photograph²⁴ with thick lines and arrows to illustrate overland flow directions. Each color is a separate drainage subcatchment based on higher elevations around its perimeter. Forensic hydrologic analysis refuted plaintiffs' claim of salt water scarring on their property by the defendant's action when combining elevation and property boundary data with a historical aerial photograph.

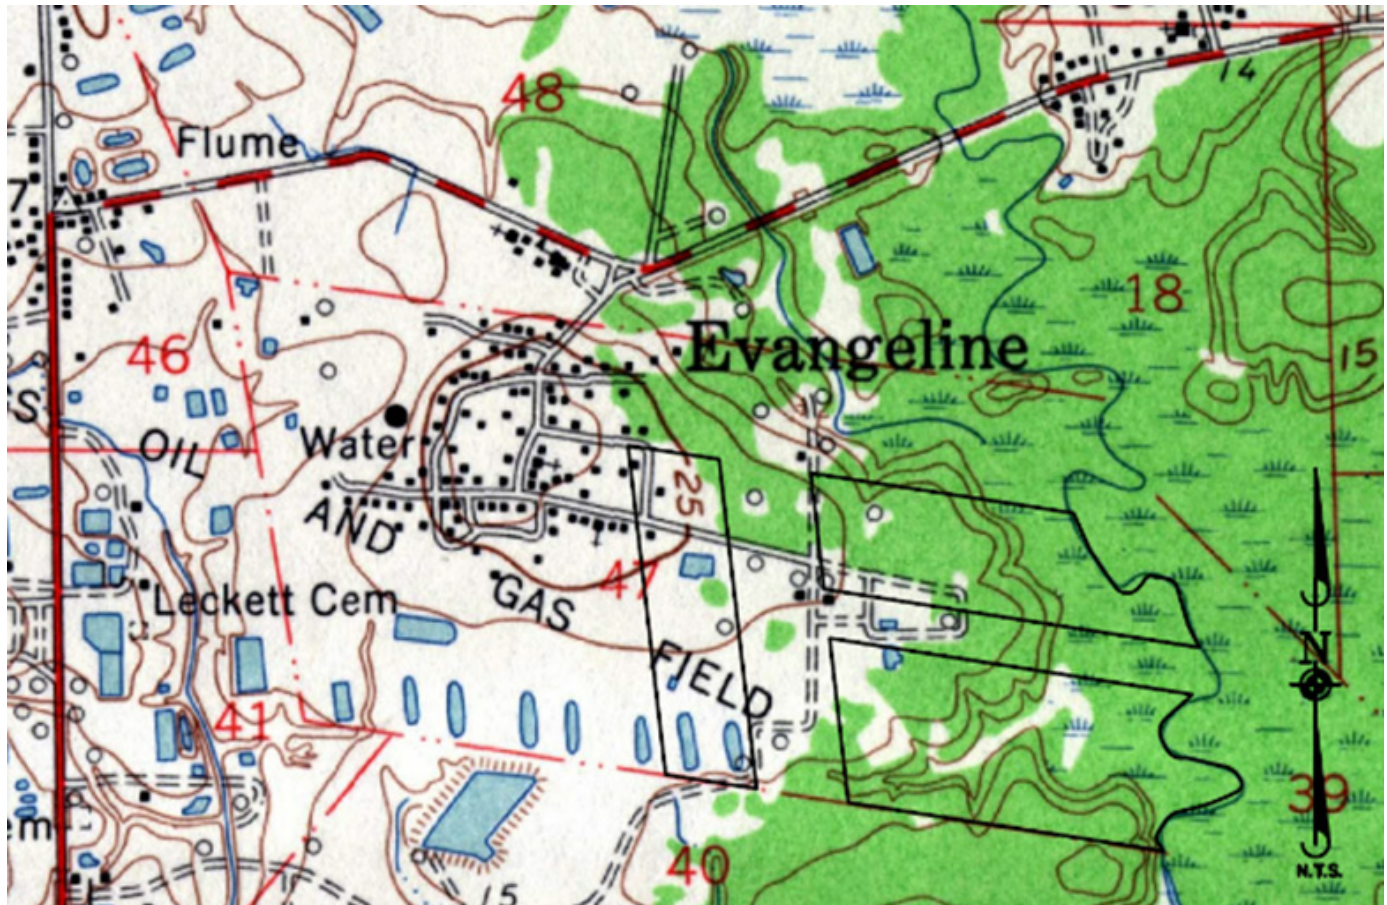
Figure 11

elongated white area at the same location as the "salt water discharge impact area" (Figure 11)⁴⁶. Based on the contour lines, the area that drains through this arm of Bayou Des Cannes is limited to that including and immediately surrounding the southeastern portion of the subject property. The northeastern portion of the property flows to the northeast and east, and the western portion of the subject property shows a predominantly southern flow direction.

A 1960 U.S. Geological Survey topographic map of the subject property and surrounding area⁴⁶. LiDAR data collected 50 years later exhibit flow patterns and altered drainage paths consistent with oil field operations mapped in 1907.

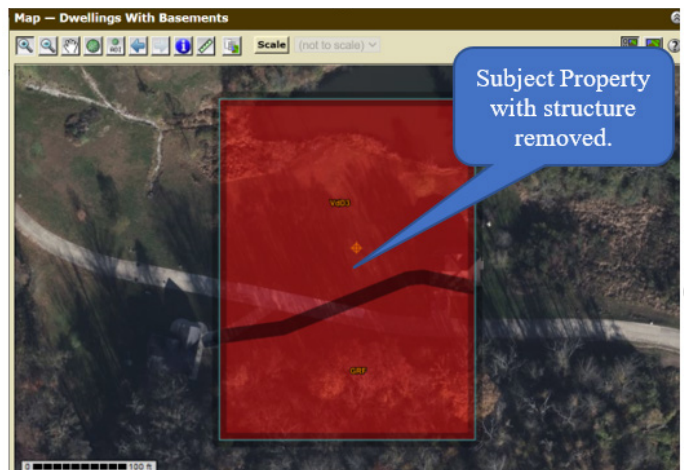
Figure 4

This review revealed that the site soils were of the Gilpin-Upshur (GRF) complex and Vandalia (VdD3) soil series that are fine-grained, well-drained soils with high plasticity indices and low strength and liquid limits on steep slopes (**Figure 4**)⁶. Gilpin-Upshur soils are clay loams, and Vandalia soils are loamy clays that each have high shrink-swell or linear extensibility characteristics. These soils are common on hillsides in the geographic region of the home and have a propensity for absorbing and retaining water that weakens the interior soil strength while increasing unit mass until failure as a debris flow-type landslide. The site was thus situated in a defined debris flow area. This activity should have been reviewed and the foundation/site conditions designed and constructed around the peril.

NRCS Web Soil Survey of soils on and around the subject parcel, “Soil Slippage Potential” hazard class “High” (red). (U.S. Department of Agriculture, NRCS Web Soil Survey)

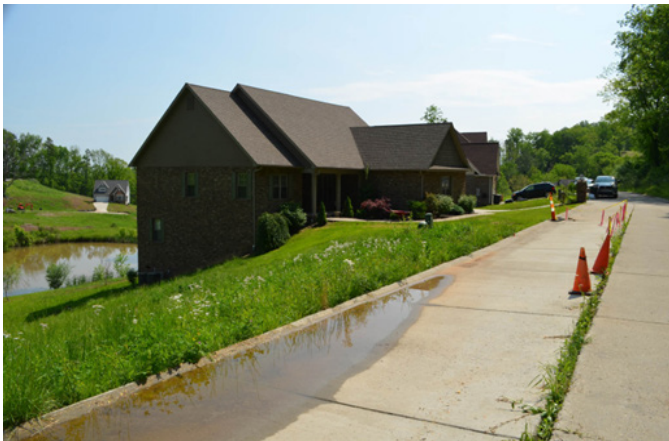
Figure 5

Wood platform framing techniques were used in constructing the home's structure. Due to the approximate 18-foot to 20-foot drop in elevation relief from the front street to back of the home, the walkout basement level floor system was constructed on a crawl space foundation with a platform framed floor system (**Figure 5**). The front basement (crawl-space) foundation wall utilized 12-inch concrete unit masonry on a poured concrete footing. Veneer masonry techniques were used to apply the brick exterior and construct the left and right basement walls. The crawl space floor was covered with a polyethylene vapor barrier.

Elevation relief from street to rear of home was approximately 20 feet along left side.

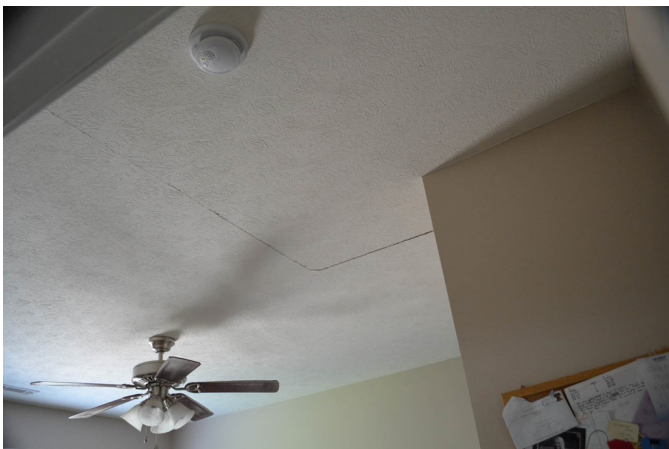
Figure 6

Ceiling of bedroom at right end of the structure with gapping between joints in the drywall field; joints had been previously repaired post-construction.

Cracking was observed in the drywall surfaces of the main level, particularly at the intersection of wall and ceiling surfaces, but occurred at most drywall joints in rooms on the right side of the structure (**Figure 6**). Walls extending left-to-right in the room were displaced rearward approximately $\frac{3}{4}$ inch at the base with drywall corner tape detached and stretched diagonally. The rear sashes of the front right bedroom's twinned window were broken out and filled with board insulation (**Figure 7**). Review of the window's exterior exhibited rearward displacement of the framed wall with an increased gap between aluminum frame at the front edge of 2 inches. The rear window frame jamb was distressed and distorted as the first level framing platform was forced rearward past the right side brick veneer.

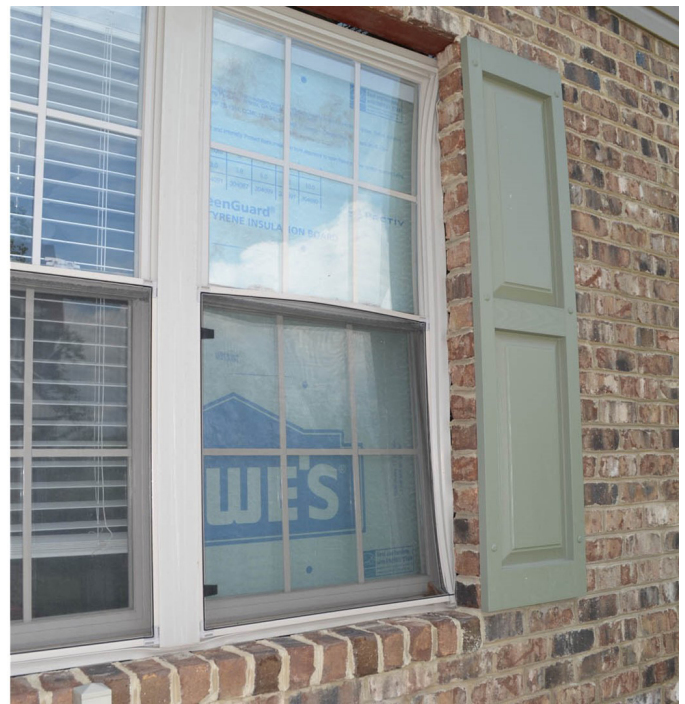
Figure 7

Right bedroom window jamb rolled beneath the right-side brick masonry veneer, buckled window screen and board insulation filling the sash space as protection against glass breakage.

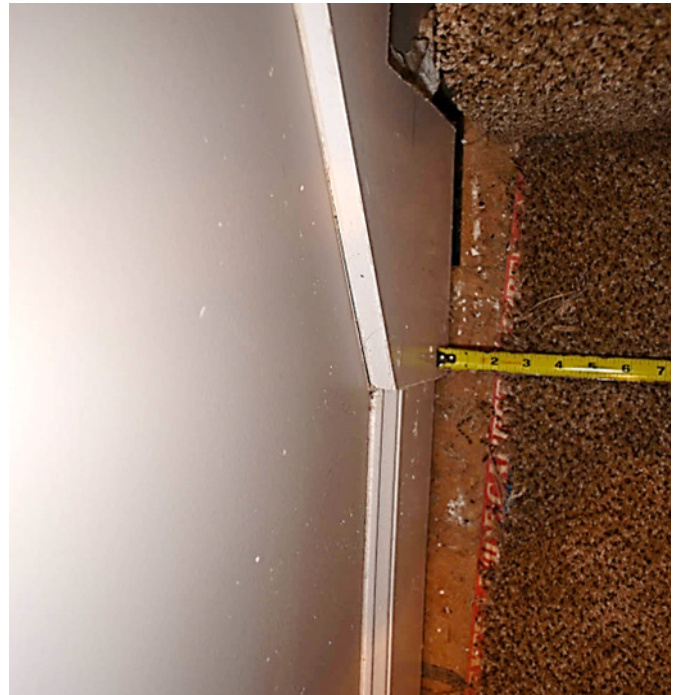
Figure 9

The basement stair treads and risers connected the basement and main floor along the front basement wall. The front basement wall also provided foundation support for the rear garage wall. The stairway was twisted with an approximate 2-inch gap along the front foundation wall near the base (**Figure 9**). Though the garage foundation walls provided limited passive resistance to the active

Lower stairway landing at the front foundation wall with an approximate 2-inch gap.

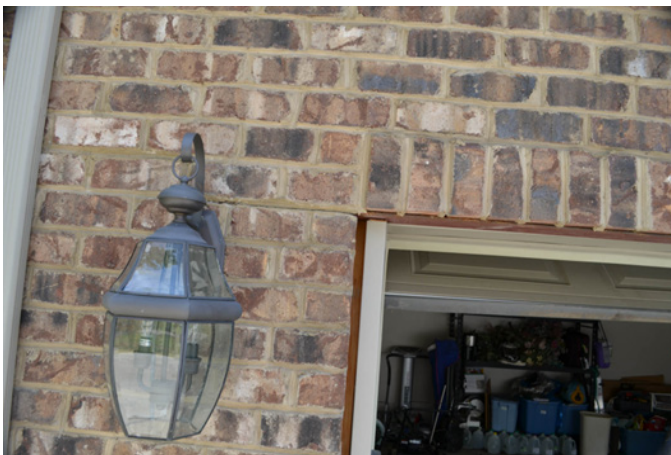
Figure 14

walls (**Figure 13**). The gap at the garage door entrance increased from the rear jamb to the front jamb, indicating that the right-side masonry of the structure was somewhat restricted from movement as compared to the wood framing (**Figure 14**).

Front garage door jamb separation from brick masonry veneer because first level framing system was being forced rearward by connection to the front foundation wall.

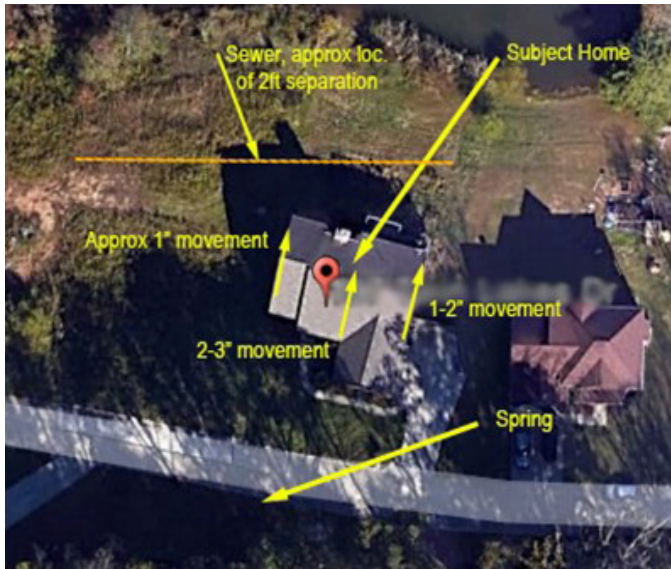
Figure 16

Water from the spring upgradient from the subject structure provided constant water flow that had three cumulative consequences: increased the unit density of the restrained soil behind the foundation wall; reduced the internal friction of the soil structure; and increased hydrostatic pressure bearing on the front foundation wall. The home was not only forced rearward on its foundation but also rotated about the driveway retaining wall, generally at the right side based on the tapered gap between the garage floor slab and driveway slab (viewed north to south). Estimated movement by the structure was approximately 1 inch along the left side wall, approximately 3 to 4 inches of movement at the central region of the basement floor system, and 2 to 3 inches of movement rearward along the right side wall (**Figure 16**).

Site plan showing spring, street and lake in relation to structure and movement observations.
(Aerial imagery from Map West Virginia, mapwv.gov)
