Journal of the  
**National**  
**Academy** OF  
**Forensic**  
**Engineers**<sup>®</sup>

Vol. 42 No. 1 June 2025

<b>‡ Forensic Deformation Analysis of a Farm Clevis Using Photographs and Exemplar Tests</b> .....	1
<i>By Michael Stichter, PhD, PE, DFE (NAFE 1162M) and Wade Lanning, PhD</i>	
<b>ø FE Analysis of a Modular Fireplace Fire with an Improperly Constructed Hearth Extension</b> .....	11
<i>By Jerry R. Tindal, PE (NAFE 642S)</i>	
<b>‡ Forensic Analysis of an Elevated Pool Vault</b> .....	33
<i>By Brian C. Eubanks, PE, DFE (NAFE 962S), Garrett T. Ryan, PE, DFE (NAFE 1125M), and Derek T. Patoskie, PE (NAFE 1312A)</i>	
<b>υ Failure of a Climbing Treestand Due to Corrosion and Selective Leaching of Cable’s Galvanic Layer: Failure Analysis and Experimental Study</b> .....	45
<i>By Olin Parker (NAFE 1334A), Jahan Rasty, PhD, PE (NAFE 768S), and Matthew Mills, PE (NAFE 1199A)</i>	
<b>ø Using Ground Penetrating Radar Techniques in Forensic Structural Engineers</b> .....	67
<i>By Chakradhar Gondi, PE (NAFE #1329A), J. Vincent Barnes III, PE, and Michael J. Wightman</i>

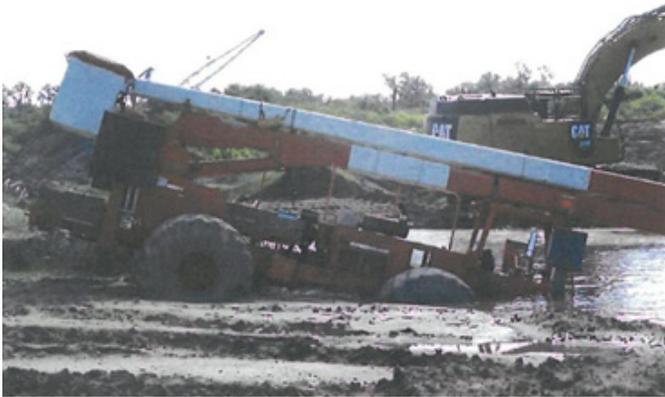
**Figure 1**

The MSHA citation included photographs of the mired equipment.

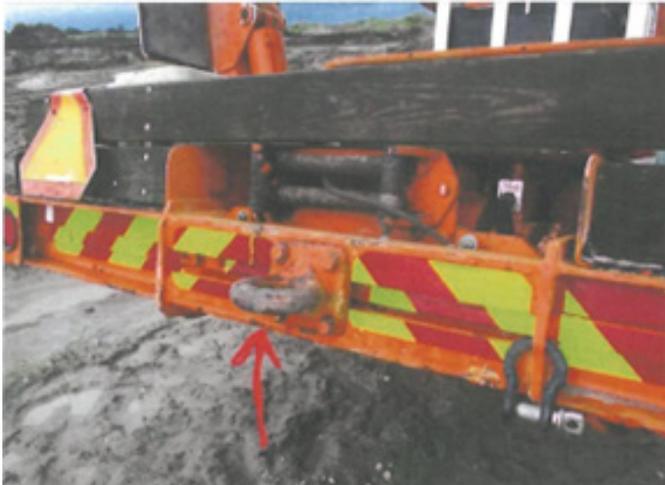
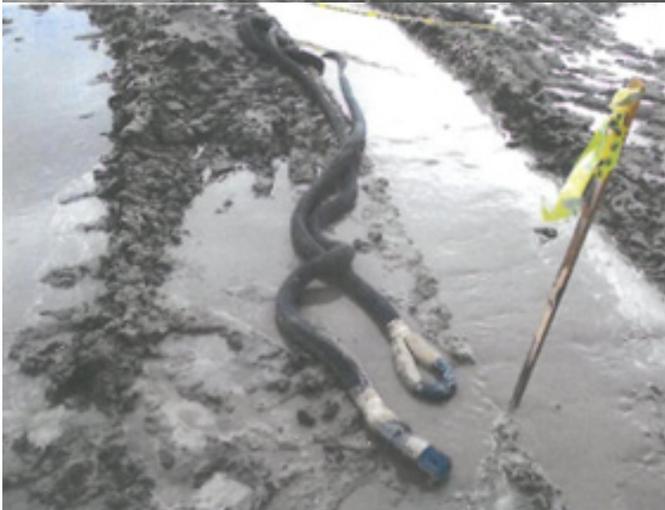
**Figure 2**

The MSHA citation included photographs of the hitch where the clevis was connected to the mired equipment (top) and the rope used to attempt to recover the mired equipment (bottom).

The difference in deformation is due to the difference in how those forces were applied. The more extensively deformed clevis was connected with its pin passing through a ring-shaped hitch on the mired vehicle (**Figure 2**), while

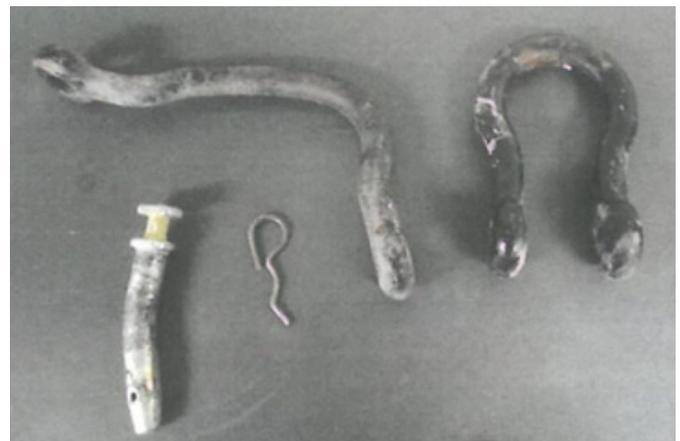
**Figure 4**

The MSHA citation included a photograph of the clevis and pin that were connected to the mired equipment (left) and the clevis that was connected to the bulldozer (right).

Differences among the deformations exhibited by different clevises were most likely due to the distribution of external forces acting upon the clevises. There were two clevises in use at the time of the accident — one connected to the bulldozer and one connected to the mired vehicle (**Figure 4**). Even though the clevises were identical to one another and were subjected to the same total amount of force, the clevis connected to the bulldozer exhibited only slight spreading of its ears; it was significantly less deformed than the clevis connected to the mired vehicle.

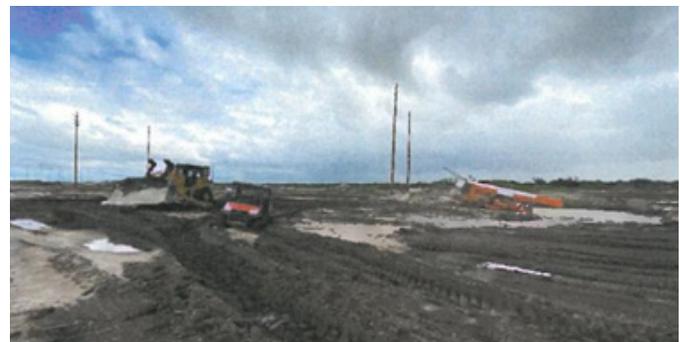
**Figure 5**

Photograph of the accident scene included in the contractor incident report. The mired equipment is mired in the mud on the right, and the CAT D8T bulldozer is positioned on the left of the image with a side-by-side UTV positioned in the foreground between the bulldozer and the mired equipment.

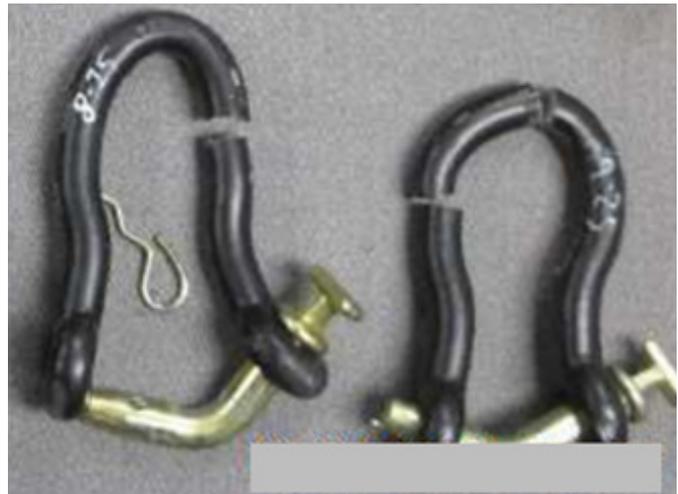
**Figure 9**

Exemplar clevises that were tested slightly off-axis (slight side-loading).

The MSHA-tested shackles that were in-line or only slightly side-loaded (longitudinal loading) all had bent pins (**Figure 8** and **Figure 9**), and failed at more than twice the shackle's load rating. Bending of the pins indicates a three-point loading condition that existed before the pin disengaged from the clevis ears. Most likely, the maximum force during the test was at the yield point of the pin, which was loaded in three-point bending with relatively short moment arms.

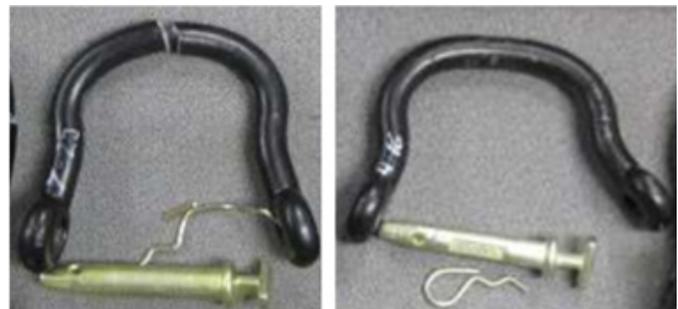
**Figure 10**

Exemplar clevises that were tested with severe side-loading.

The side-loaded exemplar clevises — where the clevis ears were oriented transverse (90°) to the applied tensile force as shown in **Figure 11** — are straightforward to interpret. The tensile forces would be parallel or near-parallel to the pin in extreme side loading, which would result in minimal load transfer through the pin, limited to the shear strength of the cotter pin and friction between the pin and clevis ears. The pin in the side-loaded clevises exhibited no deformation because in side-loading, the pin never experienced a bending stress in excess of its yield strength. The bow of the clevis would transmit the majority of the force exerted by the tow rope and mired equipment. Thus, the bow was the part that exhibited deformation in the extreme side-loading case. The lateral offset

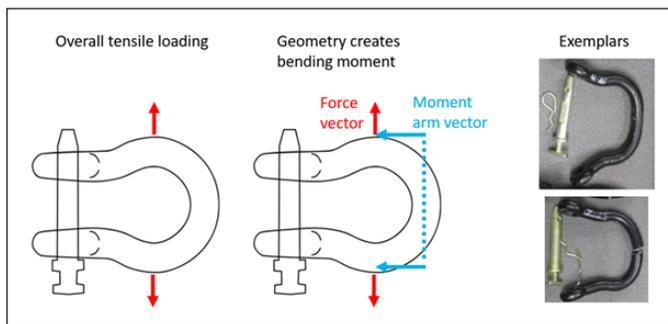
**Figure 12**

between the loading axis and the load-bearing clevis bow would produce a bending moment (**Figure 12**) that would cause the bow to open up when it deformed, which is what the authors observed in testing the exemplar, side-loaded clevises.

In transverse tensile loading, 90° (side loading), the overall loading condition is tensile (left). Because load transfer is primarily through the clevis bow, which is offset from the tensile axis, the bow is in bending (center). Thus, the exemplars tested in side loading exhibited bending of the bow and the ears spread apart (right).

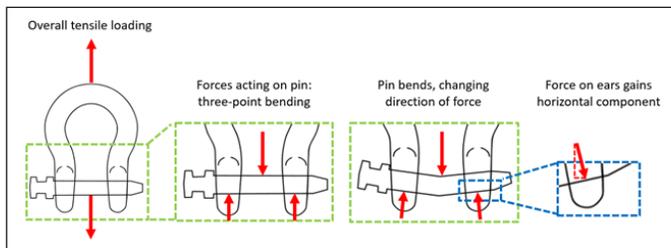
Figure 14

and the horizontal component would have caused the clevis ears to spread apart (Figure 14). Bending of the pin would also have exerted a bending moment on the ears, which would also have caused the ears to spread apart.

Longitudinal tensile loading on the clevis resulted in three-point bending of the pin. Bending deformation of the pin resulted in a horizontal force spreading the ears of the clevis apart.

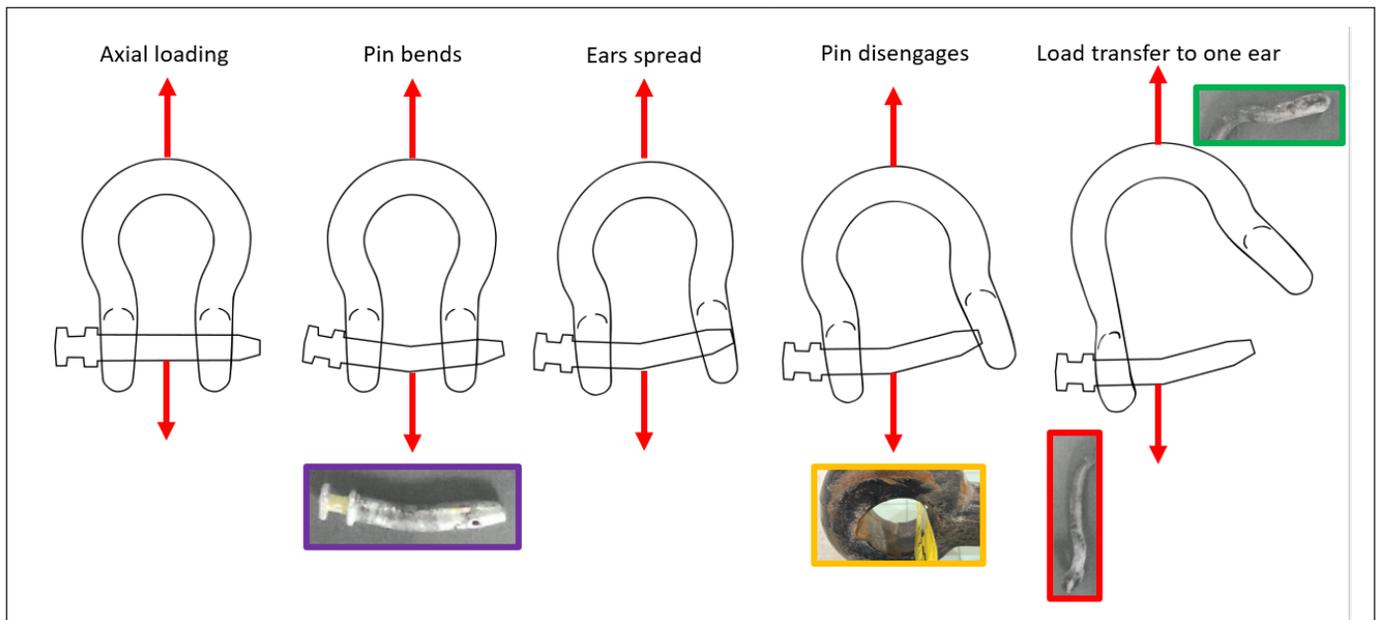
Figure 15

From photographs, it appeared that shearing of the cotter pin did not induce enough stress on the ear to cause visible deformation. The tip of the pin sliding out of the eye created the contact damage present on the inside of one ear (Figure 13B). Before the pin disengaged, both sides of the clevis bow and both ears would be under load — and, to the extent they deformed, would be symmetrical. After the pin disengaged, only the side of the shackle that retained the pin would be under load, and deformation would no longer be symmetrical (Figure 15).

The shackle deformed until the pin disengaged from one ear, creating localized deformation inside the ear.

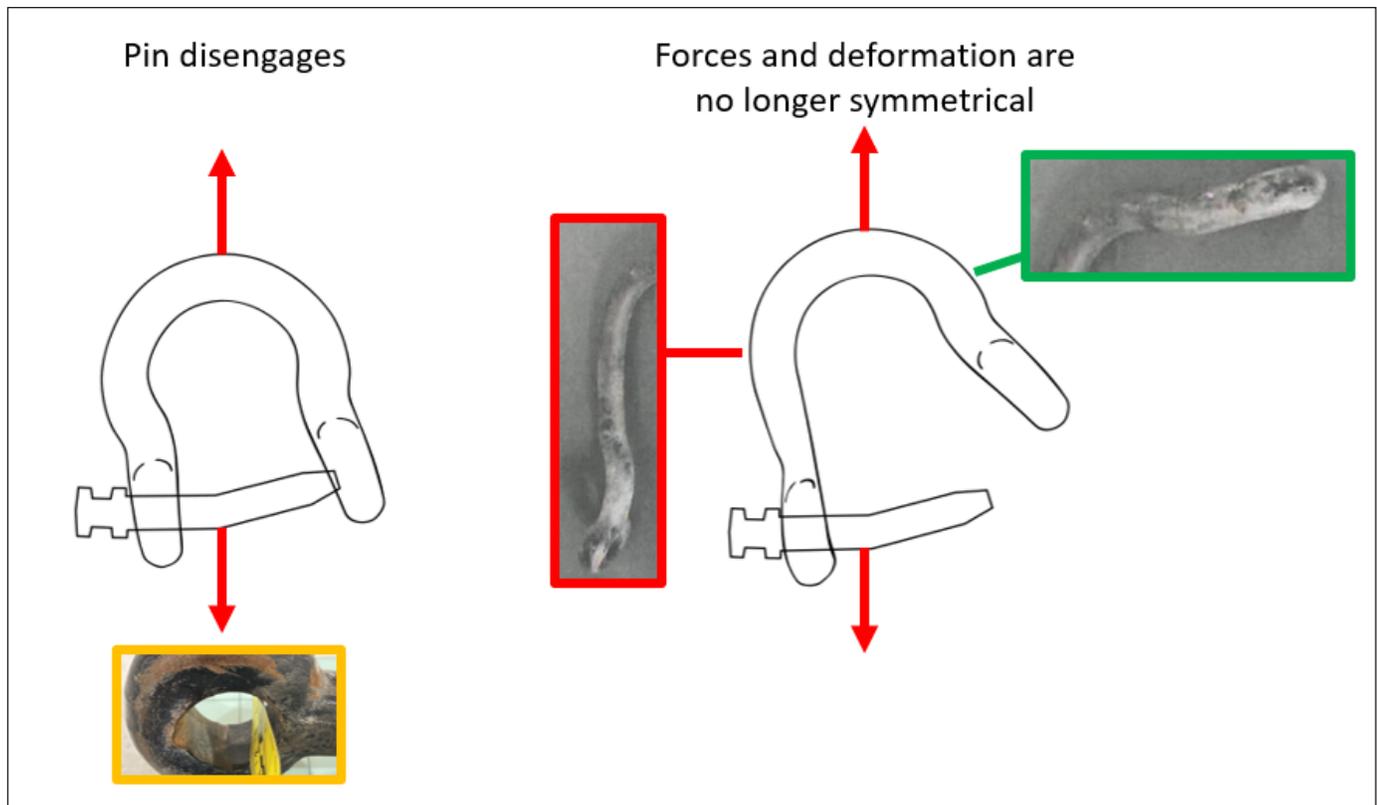
**Figure 16**

Once the pin disengaged from one ear of the shackle, that ear would no longer participate in load transfer and would no longer deform (Figure 16). This is why the relatively undeformed side of the shackle was on the same

Once the pin disengaged from one ear, deformation would no longer be symmetrical. Thus, the left side of the shackle, which remained connected to the pin, deformed significantly more than the right side, which disengaged from the pin first.

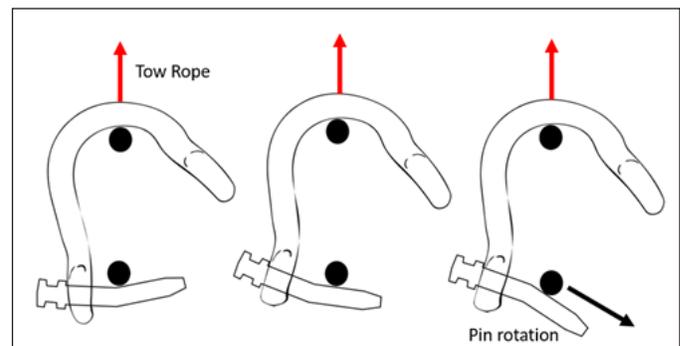
**Figure 17**

side as the ear with the contact damage — because that ear disconnected from the pin first. All load transfer would be through the other ear, which would continue to deform (**Figure 13C**). Deformation would continue to change the angle of the pin relative to the tensile direction, up until the point where the pin was able to slide out of its connection point to the mired equipment (**Figure 17**). This is why the other leg was more severely deformed, and went from its original curved shape to nearly straight. Deformation of the left side of the shackle bow continued until the shackle slid off of its connection point to the mired vehicle (**Figure 17**).

Deformation would continue until the angle of the pin allowed it to slide off of its connection point to the mired equipment.

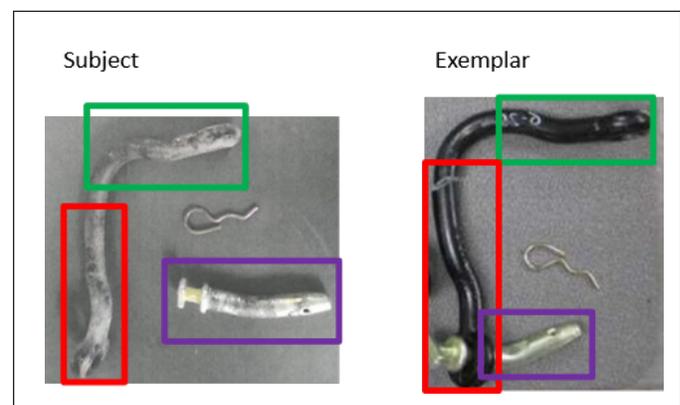
**Figure 18**

The subject clevis also had a bent pin, and the ear that retained the pin was significantly more deformed than the other ear (**Figure 7** and **Figure 13**). Similarities between post-failure conditions of the subject clevis and one of the exemplars (**Figure 18**) indicated that they followed a similar series of deformation steps. Thus, the subject clevis failed by the same sequence of deformation and load transfer as the exemplars — and with similar forces in excess of the clevis' rating. The MSHA was correct to cite the mine operator for using the clevis above its rating.

The most significant difference between the exemplar and subject clevises (**Figure 18**) was that the exemplars fractured. This fracture may be due to the testing equipment used with the exemplars. The quasi-static test conducted by MSHA involved less dynamic loading, and therefore less likelihood that the clevis could disconnect from the load frame in the manner that the subject clevis disconnected from the mired vehicle. Thus, the MSHA exemplar continued to be loaded until final fracture, while the subject clevis disconnected from the mired vehicle before it could fracture.

Similarities between the subject clevis and exemplar clevis indicate that they followed a similar sequence of deformation steps and that the subject clevis failed at a similar force to the exemplar clevis.

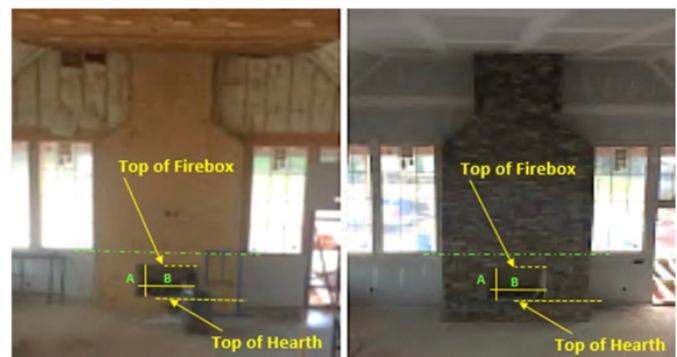
**Figure 13**

The A and B lines approximately define the rectangular firebox opening and illustrate the very close proximity of the OSB to the opening edges. A/B (and other) ratios within the two photographs are equivalent. The light green dash-dot line across the windowsills provides a frame of reference to the top of the firebox. The Radius Throat Front (RTF) block (previously referenced in **Figure 10**) of the firebox begins at the top edge of the firebox opening and runs vertically up  $9\frac{3}{16}$  inches toward the green dash-dot line. As seen in **Figure 10** and again in **Figure 14**, the RTF block forms a trapezoid shape (front face) with interlocking side blocks. The RTF block is clearly covered by the OSB depicted in **Figure 13**. OSB also extends over to the sides of the firebox near the opening edge. The area near the top of the hearth, extending down to the floor and running across the width of the firebox, is clearly

Annotations added to the photographs of Figure 12.

covered by OSB in the left-side image and then the masonry hearth extension in the right-side image.

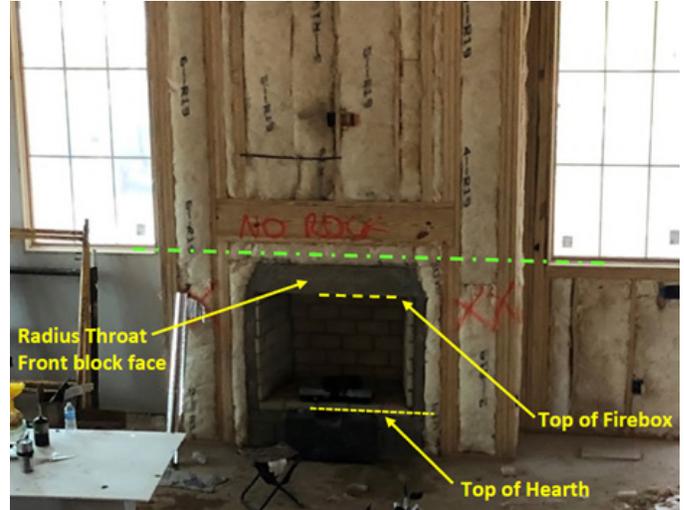
**Figure 14**  
An annotated photograph of the living room fireplace prior to OSB and stone veneer enclosure.

As previously observed in **Figures 10** and **14**, fiberglass batt insulation was installed in the air clearance spaces between the firebox and the wall framing in violation of the manufacturer’s installation instructions. The instructions state that (in multiple locations of the manual) no insulation is to be placed in the air clearance spaces around the fireplace. Insulating air clearance spaces around the perimeter of the firebox will result in higher operating temperatures of those faces and, in particular, any combustibles in (improper) contact with or in close proximity to them.

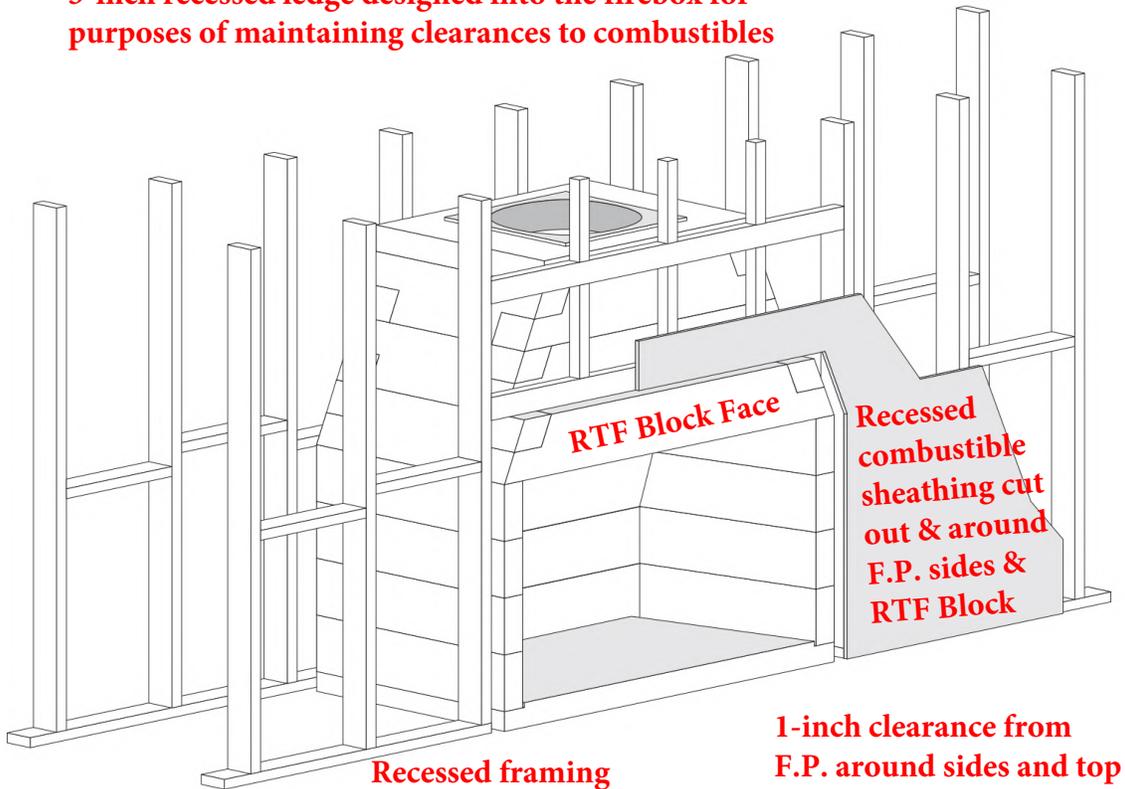
**3-inch recessed ledge designed into the firebox for purposes of maintaining clearances to combustibles**

**Figure 15**  
An excerpted and annotated view of an isometric drawing and the instructions above the drawing from the manufacturer’s installation instructions.

illustrating and describing the fireplace design for framing and combustible sheathing installation around the firebox for the purposes of maintaining required clearances to combustibles. The fireplace is designed with a 3-inch ledge over the top of the RTF block to allow framing and combustible sheathing to be recessed and brought flush with the front vertical face of the firebox. For the case in question, OSB was installed across the face of the RTF block as well as the faces of the sides of the firebox and base plate. The OSB further projected beyond the vertical face of the firebox opening, creating a “trim” around the opening. **Figure 16** is another excerpted and annotated drawing from the manufacturer’s installation instructions that depicts the proper construction around the firebox above the opening to maintain clearances to combustibles.

The OSB should not be in contact with any portion of the face of the RTF block (in this case, the OSB covers approximately 8 vertical inches of the face and runs across the entire width of the block). Instead, the OSB should be above the top of the RTF block with a minimum of 1-inch vertical clearance. Furthermore, the OSB should not project beyond the vertical face of the RTF block, as such projection creates a combustible trim above the face opening of the firebox. Based on the manufacturer’s installation instructions, such trim projection would require a minimum

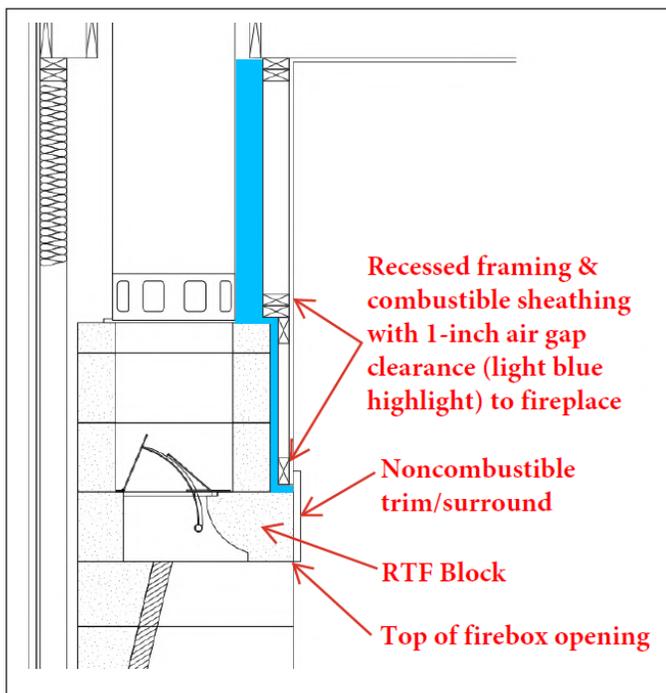
**Figure 16**

An excerpted and annotated profile drawing from the manufacturer’s installation instructions pertaining to the combustible framing and sheathing around the top of the firebox. Note also the required cooling air spaces which are annotated in blue.

of 12 inches clearance. Covering such projecting trim with mortar and/or stone veneer does not render it noncombustible and does not prevent exposure to the substantial heat emanating from the top of the firebox opening; it merely conceals it, creating a hidden fire hazard.

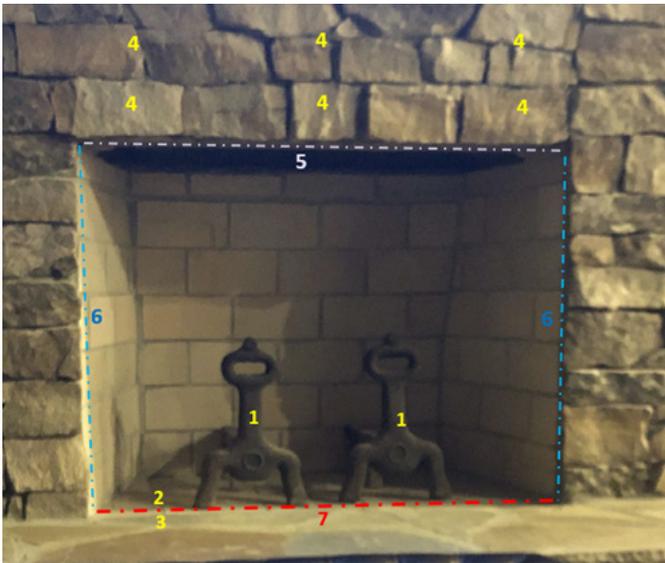
**Figure 17**

A view of the finished fireplace opening and hearth extension in front of the fireplace. Notes: 1) andirons (used to support logs during fireplace use); 2) fireplace hearth (note proximity of mortar joint 7, red dash-dot line); 3) fireplace (flush) hearth extension; 4) stone/mortar covering OSB running across and in direct contact with the face of the RTF block and with air/clearance spaces above the RTF block packed with fiberglass insulation; 5) mortar joint covering the edge of the OSB sheathing projecting beyond and around the perimeter face of the fireplace opening (trim projection); and sandwiched between the stone veneer and the RTF block face along the top of the firebox opening; 6) mortar joint covering the edge of the OSB sheathing projecting beyond and around the perimeter face of the fireplace opening on the sides (trim projection) and sandwiched between the stone veneer and firebox side faces. Blue dash-dot line. The OSB is also in direct contact with the vertical front face of the firebox sidewall; and 7) mortar joint covering the edge of the OSB sheathing projecting beyond and around the perimeter face of the fireplace opening and sandwiched between the hearth and hearth extension. Red dash-dot line. Subject to intense radiant, conduction and convection heat transfer processes during operation of the fireplace.

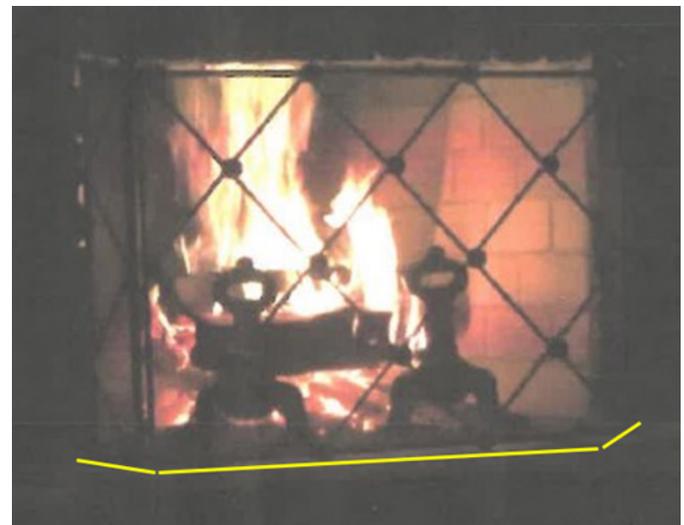
**Figure 18**

A view of the subject fireplace in use (on a different occasion) sometime prior to the incident. Note the spark screen forms a trapezoid projection (yellow outline) out into the hearth extension. Also note the hot burning coals and ash accumulating beneath the burning logs and andirons on the hearth surface.

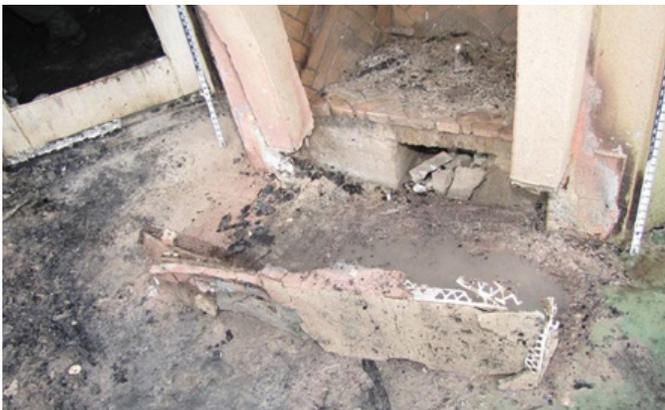
**Figure 19**

Prior Case #4. A view of the fireplace during excavation and reconstruction at the fire scene.

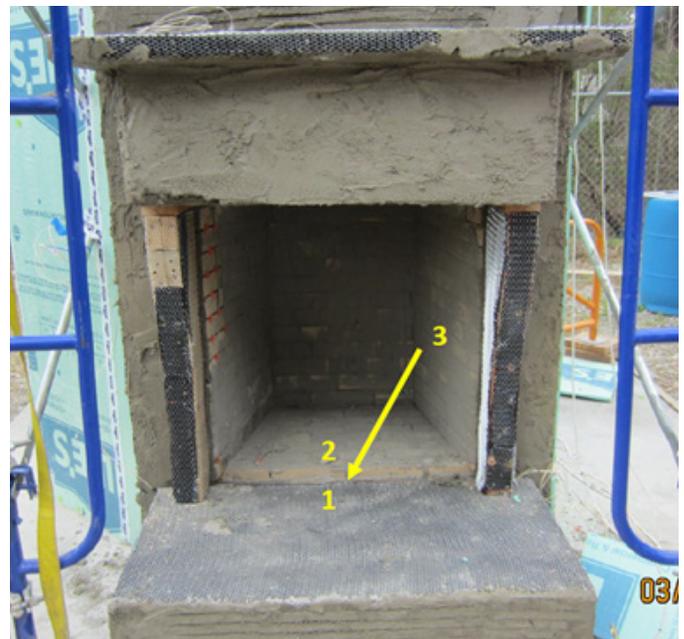
**Figure 20**

Prior Case #4. A view of the fireplace, chase, and hearth extension during laboratory reconstruction (per data from the fire investigators scene exam) and instrumentation prior to covering the hearth extension and surround with masonry. Notes: 1) wood framed hearth extension covered with plywood, felt paper and metal lathe prior to covering with masonry mortar; 2) hearth refractory; and 3) joint between hearth and hearth extension.

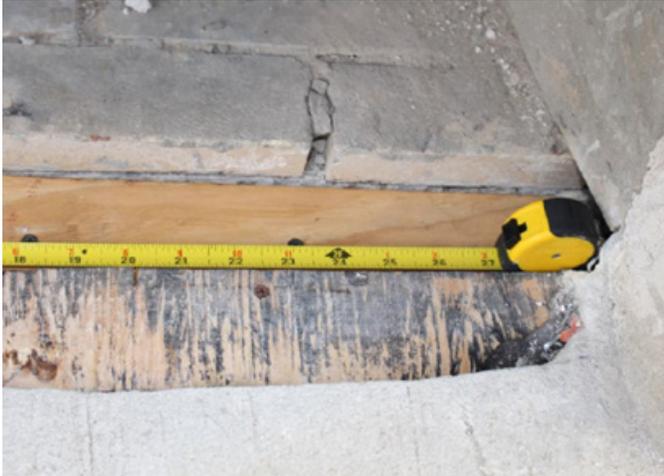
**Figure 21**

Prior Case #4. Joint between the hearth and hearth extension (fitted with new wood after a prior test run) prior to thermocouple instrumentation, filling and covering with masonry. The wood framing is beneath the hearth refractory brick surface (approximately 1.5 inches) and in contact with the base plate. The joint as well as the surface of the hearth extension were filled and covered with masonry to make it flush with the hearth.

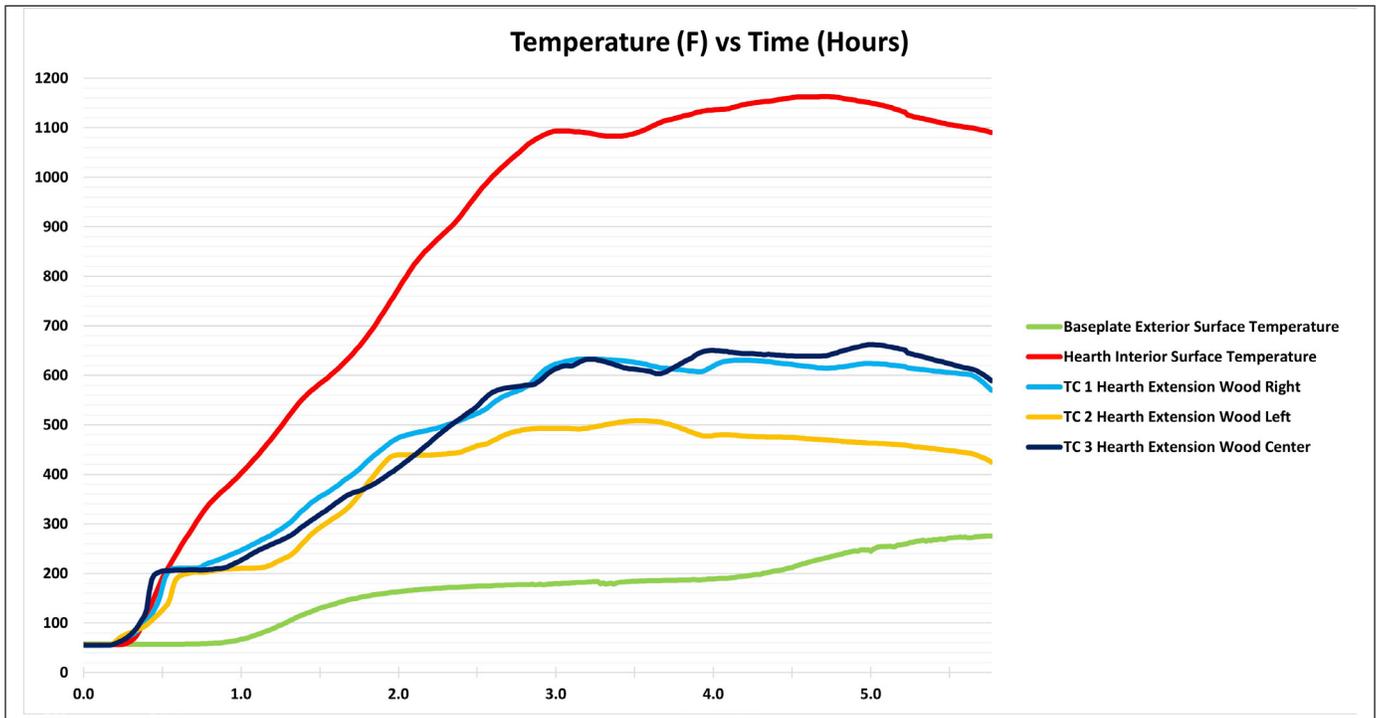
**Figure 22**

Prior Case #4. Data plot of thermocouple temperatures on the wood approximately 1.5 inches below the mortar joint between the hearth and the hearth extension. Also included are the hearth interior surface temperature and the exterior bottom surface of the base plate.

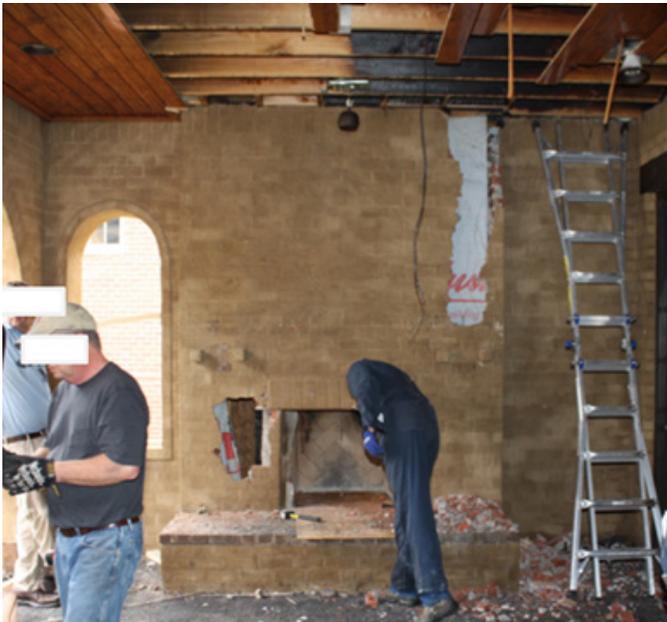
**Figure 23**

Prior Case #5. A view of the modular fireplace during delayering of the brick veneer.

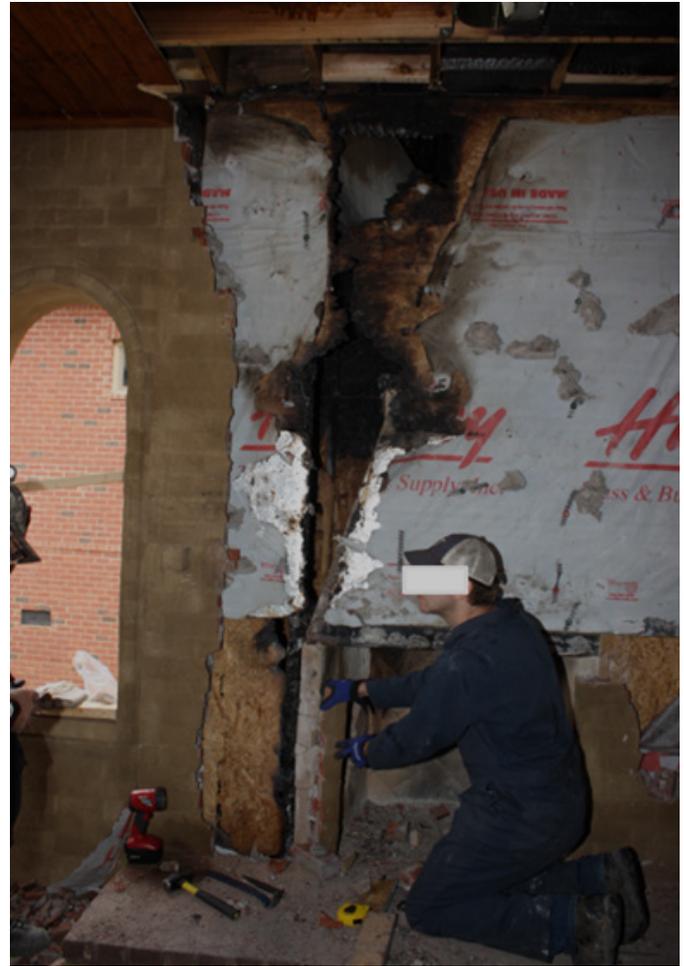
**Figure 24**

Prior Case #5. Another view of the fireplace during progressive delayering. Fire spread from near the base of the fireplace and up the wall and into the attic.

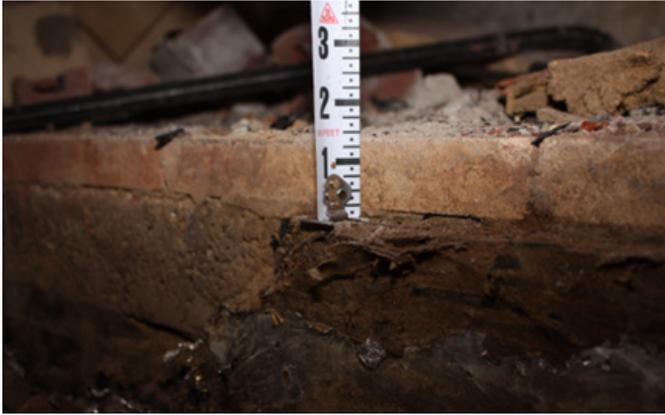
**Figure 26**

Fire investigators and engineers (including the author) examined the scene and delayered the fireplace brick veneer. It was concluded that the fire originated within the OSB sandwiched between the fireplace base plate (beneath the hearth) and the masonry hearth extension. The OSB was ignited via smoldering ignition. Once sufficient degradation occurred to the embedded OSB structure and sufficient oxygen pathways were available, the smoldering fire transitioned to flaming combustion and spread into the chase enclosure, vertically up the interior of the chase, and then into the rest of the home. As a result, the home was completely destroyed.

Prior Case #5. The OSB had been installed approximately 1.5 inches below the surface of the hearth.

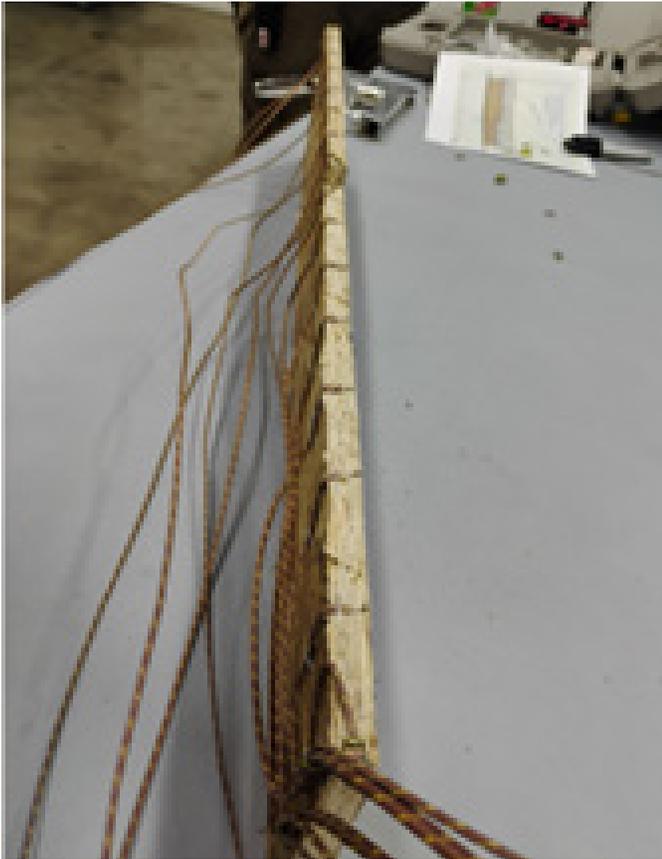
**Figure 27**

A view of the thermocouple instrumented stepped OSB sheathing installed in the joint between the hearth and hearth extension.

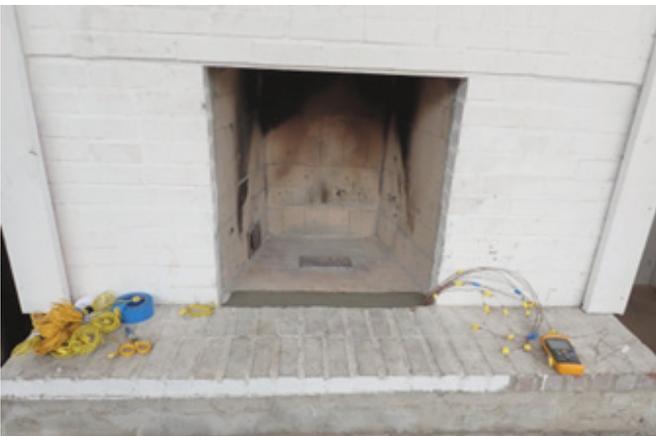
**Figure 28**

A view of the thermocouple instrumented joint between the hearth and the hearth extension after installation of the OSB.

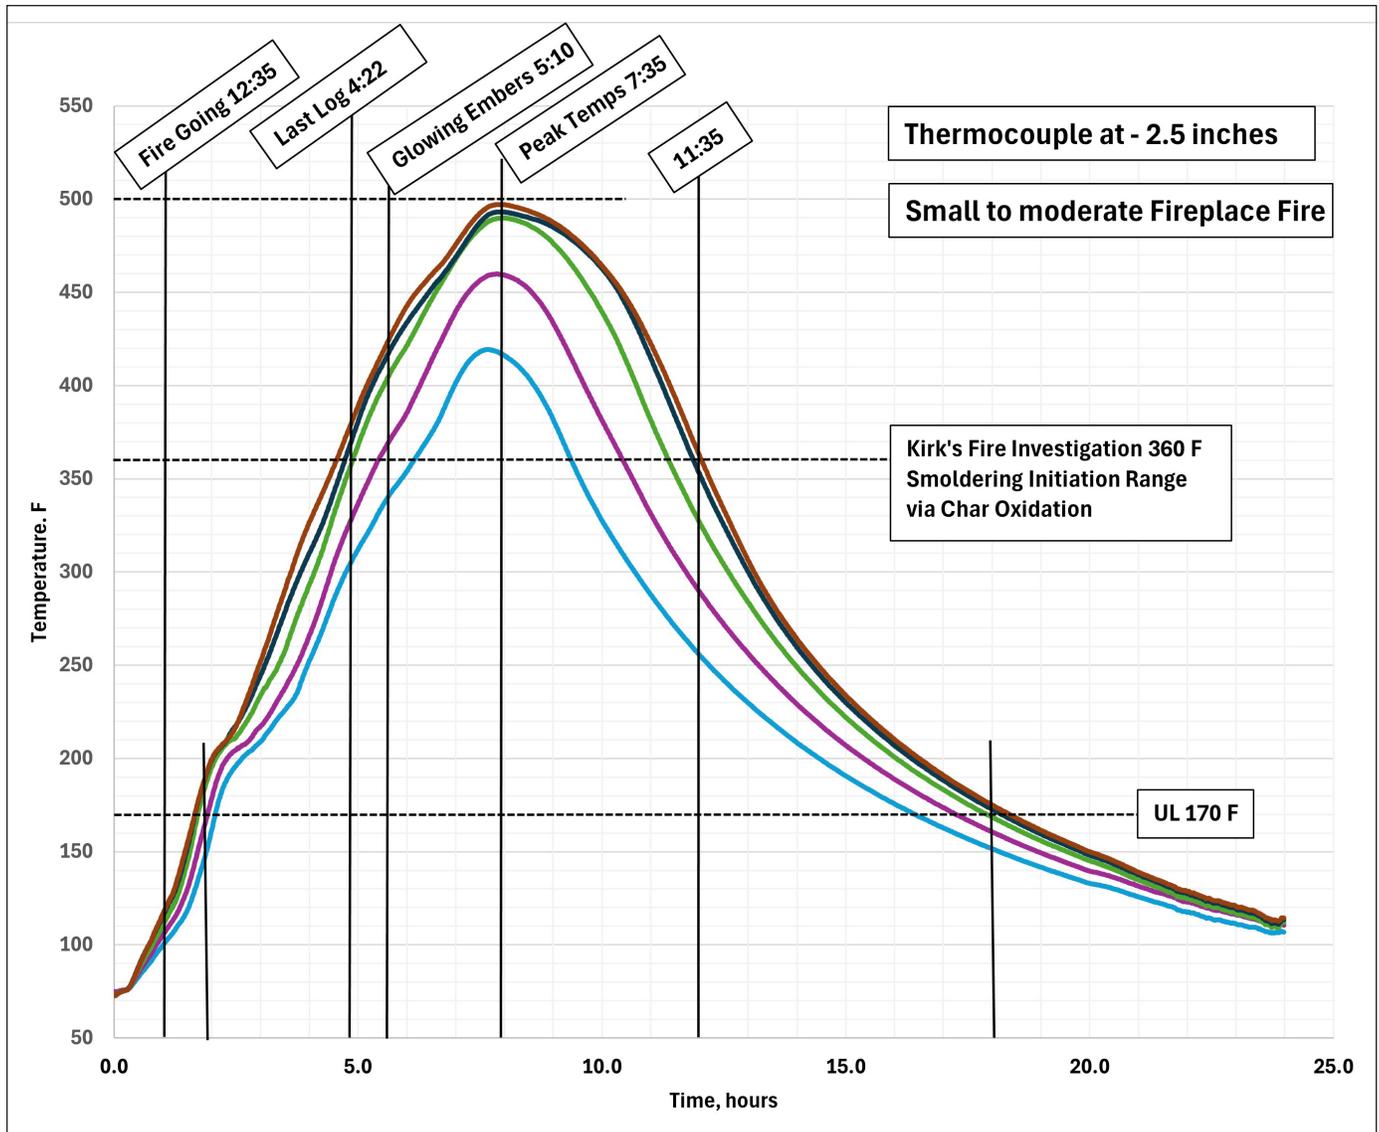
Figure 31

A view of thermocouple data at 2.5 inches depth from Test 1.

Temperatures in the demonstration testing reached 460°F/500°F (3 inch / 2.5 inch) in test one and 475°F/508°F (3 inch / 2.5 inch) in test two. Temperatures at 1.5-in depths would therefore be even higher for the testing undertaken utilizing a small to moderate fire and controlling large ember and log collapse migration onto the joint. The temperatures obtained reached and exceeded common

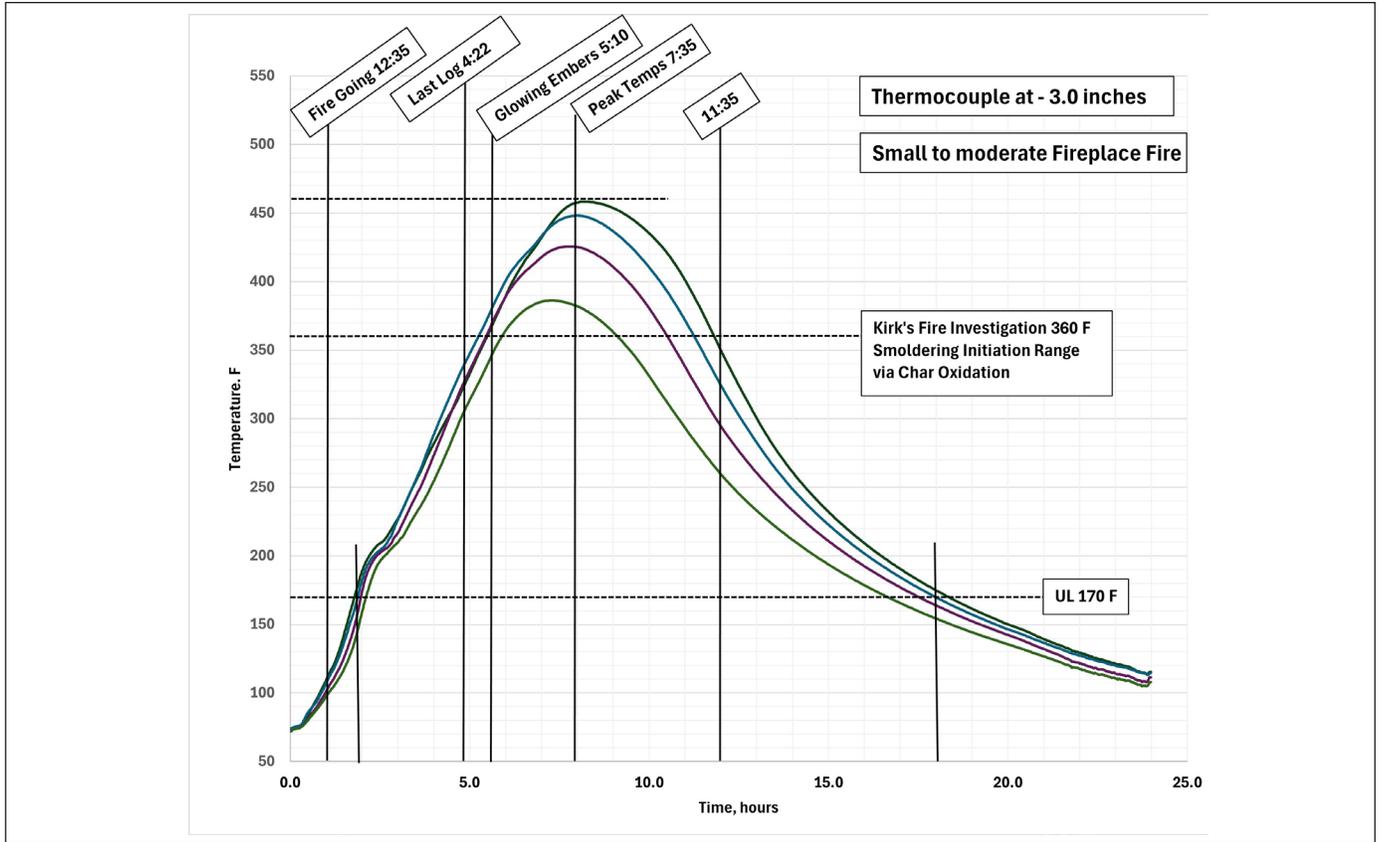
Figure 32  
A view of thermocouple data at 3.0 inches depth from Test 1.

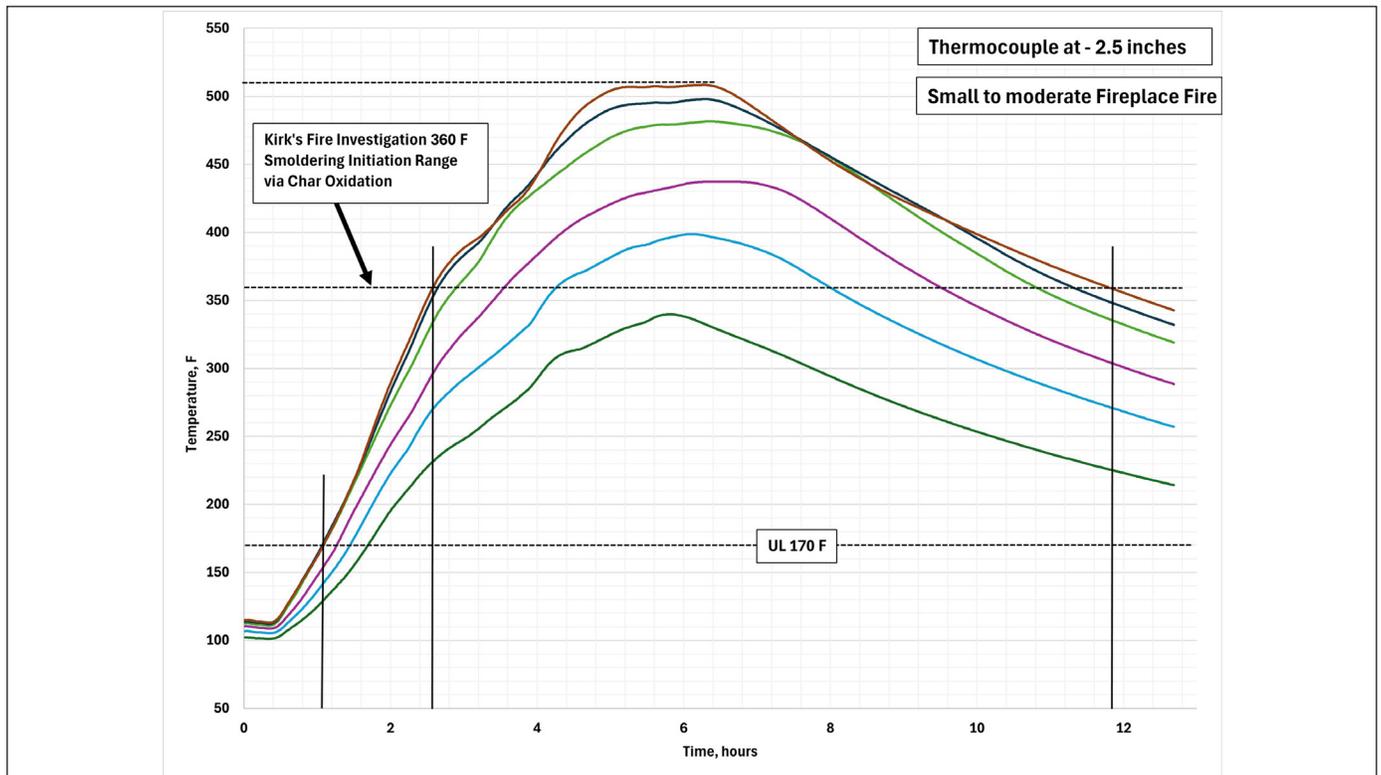
Figure 33  
A view of thermocouple data at 2.5 inches depth from Test 2.

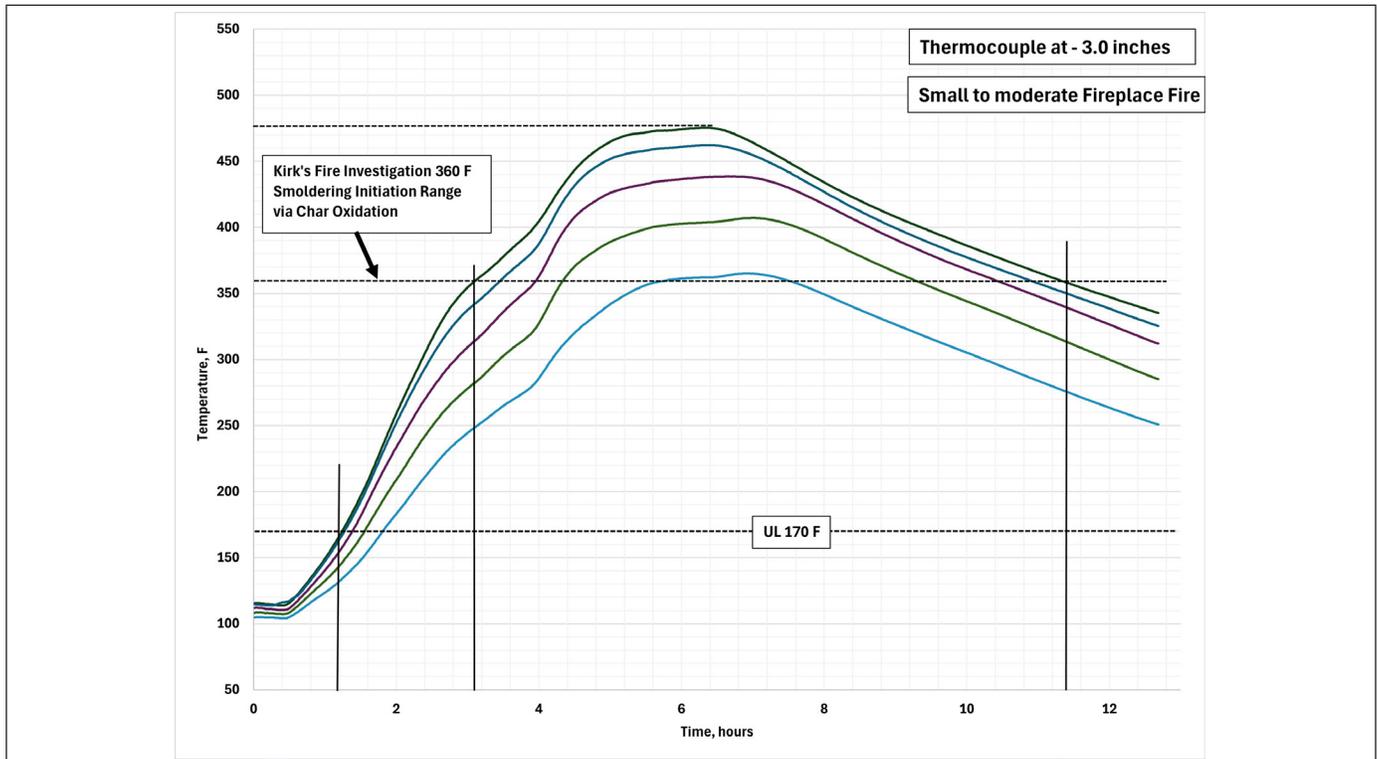
**Figure 34**  
A view of thermocouple data at 3.0 inches depth from Test 2.

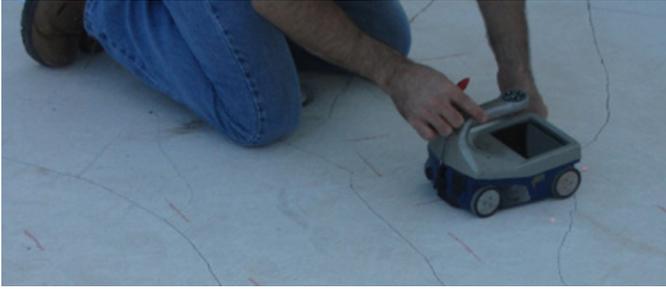
**Figure 4**

GPR survey performed on the floor of the pool shell.

GPR surveys were performed within the pool structure to evaluate the placement of steel reinforcement within the floor and walls of the pool shell, as illustrated in **Figure 4**. The GPR surveys performed on the floor of the pool shell did not detect any salient signs of steel reinforcement; however, it should be noted that the presence of cracks and/or moisture may have limited the effectiveness of the surveys<sup>2</sup>. A GPR survey performed on one wall of the pool shell detected the presence of steel reinforcement spaced at approximately 12 inches on center horizontally and vertically. The same GPR survey also indicated an average gunite/shotcrete cover of approximately 3½ inches (horizontal bars) to 3¾ inches (vertical bars). A GPR survey performed on another wall of the pool shell detected the presence of steel reinforcement spaced at approximately 9 to 14 inches on center vertically and approximately 12 inches on center horizontally. The same GPR survey also indicated an average gunite/shotcrete cover of approximately 5¼ inches (horizontal bars) to 5¾ inches (vertical bars).

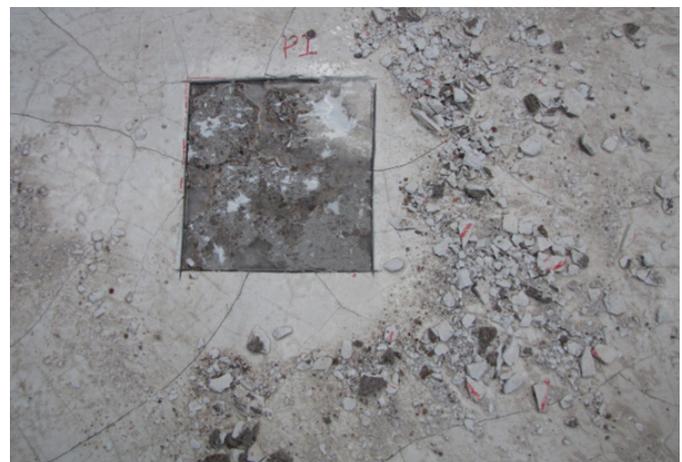
**Figure 5**

Selective demolition was performed within the pool shell, as illustrated in **Figure 5**, in order to determine whether the cracks observed in the plaster lining continued into the gunite/shotcrete and to verify the locations of the steel reinforcement indicated in the previous GPR surveys. An exploratory opening located near the central portion of the pool shell extended into the gunite/shotcrete, and it was intended to locate the steel reinforcement in the floor of the pool shell; however, no steel reinforcement was encountered at this location.

Selective demolition performed within the horizontal floor surface of the pool shell.
