Journal of the  
**National**  
**Academy** OF  
**Forensic**  
**Engineers**<sup>®</sup>

Vol. 42 No. 1 June 2025

<b>‡ Forensic Deformation Analysis of a Farm Clevis Using Photographs and Exemplar Tests</b> .....	1
<i>By Michael Stichter, PhD, PE, DFE (NAFE 1162M) and Wade Lanning, PhD</i>	
<b>ø FE Analysis of a Modular Fireplace Fire with an Improperly Constructed Hearth Extension</b> .....	11
<i>By Jerry R. Tindal, PE (NAFE 642S)</i>	
<b>‡ Forensic Analysis of an Elevated Pool Vault</b> .....	33
<i>By Brian C. Eubanks, PE, DFE (NAFE 962S), Garrett T. Ryan, PE, DFE (NAFE 1125M), and Derek T. Patoskie, PE (NAFE 1312A)</i>	
<b>υ Failure of a Climbing Treestand Due to Corrosion and Selective Leaching of Cable’s Galvanic Layer: Failure Analysis and Experimental Study</b> .....	45
<i>By Olin Parker (NAFE 1334A), Jahan Rasty, PhD, PE (NAFE 768S), and Matthew Mills, PE (NAFE 1199A)</i>	
<b>ø Using Ground Penetrating Radar Techniques in Forensic Structural Engineers</b> .....	67
<i>By Chakradhar Gondi, PE (NAFE #1329A), J. Vincent Barnes III, PE, and Michael J. Wightman</i>

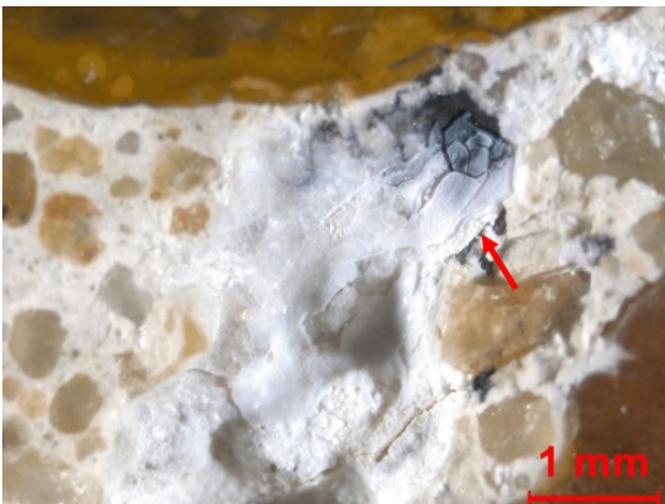
**Figure 6**

As previously stated, most of the cracks observed in the plaster lining of the pool appeared to exhibit a pattern consistent with craze cracks or map cracks, which is consistent with distress patterns causally related to ASR. As a result, the authors determined that the distress observed in the plaster lining and gunite/shotcrete of the pool shell was causally related to ASR. In addition, the distress related to ASR was exacerbated by construction deficiencies associated with the thickness of the pool shell and the depth of gunite/shotcrete cover over the reinforcement steel, which likely increased the volume of reactive materials available for ASR to occur and located the tensile reinforcement

Desiccated alkali-silica gel adjacent to a chert aggregate viewed under microscope.

Based upon the magnitude of distress causally related to ASR within the pool shell — in conjunction with the likelihood for such distress to continue — it was recommended by the authors, as well as various other consulting firms (including the owner's consultant), that the pool shell be removed and replaced.

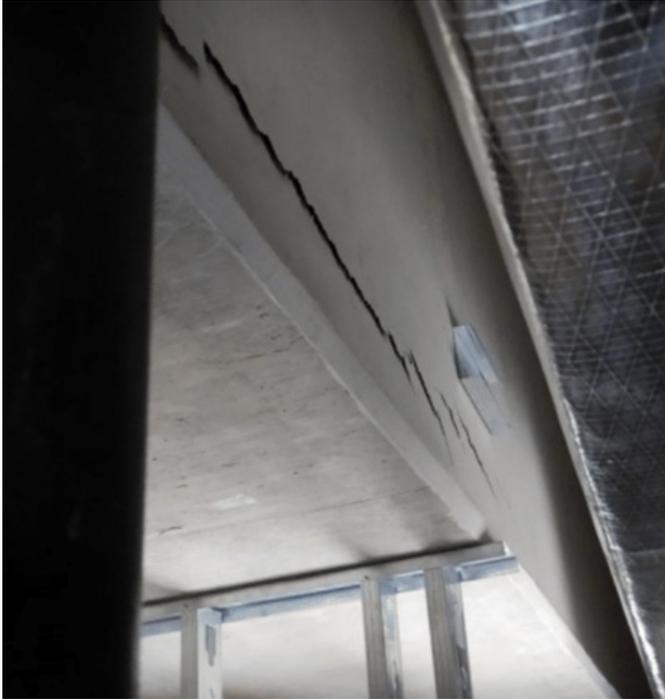
**Figure 7**

During demolition of the pool shell, cracks were observed at various locations in the concrete support structure underlying the pool shell. Of particular concern was a horizontal crack that exhibited lateral displacement located in the outside face of the vault wall near the abutment of the vault wall and the vault floor as shown in **Figure 7**.

Horizontal crack exhibiting lateral displacement near the abutment of the vault wall and the vault floor.

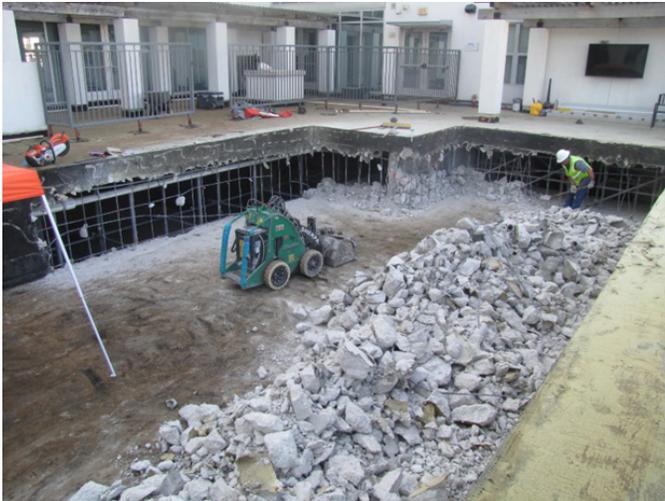
**Figure 8**

As a result, all consultants collectively agreed that selective demolition was warranted in isolated areas of interest, and the demolition would progress as necessary until the as-built construction of the pool vault could be determined with a reasonable degree of certainty to allow for structural analyses of the as-built structure. Ultimately, the selective demolition progressed until it was determined that corner bars/hooks were omitted from the as-built structure. Independent structural analyses performed by each consultant, considering the omission of corner bars/hooks, indicated that the concrete pool vault was not structurally adequate to support the required design loads of the superstructure, and the concrete pool vault was subsequently demolished in its entirety, as illustrated in **Figure 8**.

Selective demolition of the pool vault.

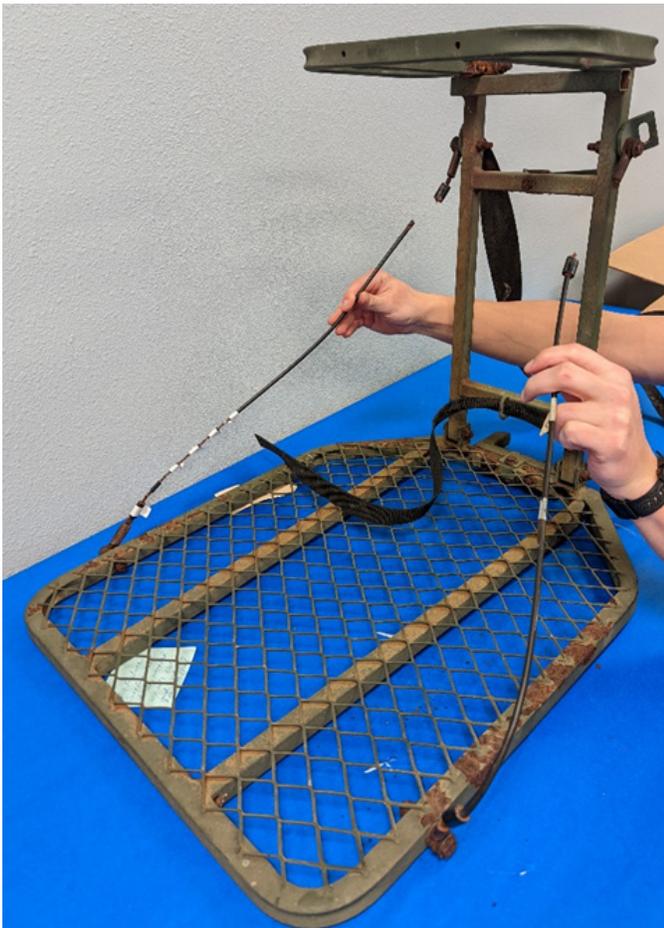
**Figure 1**

Image of the subject treestand taken by the authors.

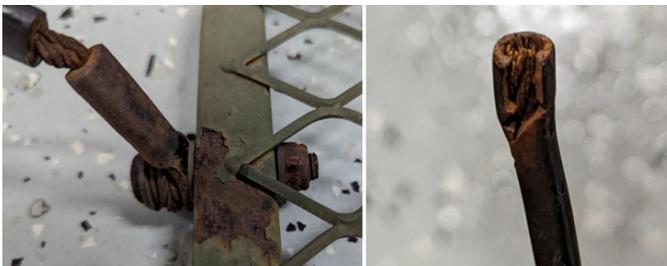
**Figure 6**

Signs overload on the left-cable eyelet attached to the foot platform and signs of brittle failure of the polymer coating.

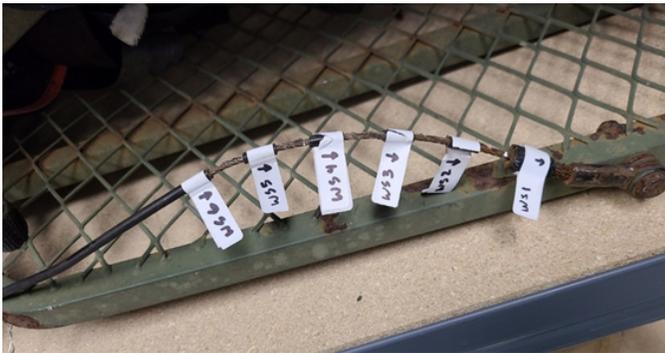
**Figure 11**

Limited sectioning of the subject cable’s black polymer coating to expose wire stands and to measure zinc content in the cable.

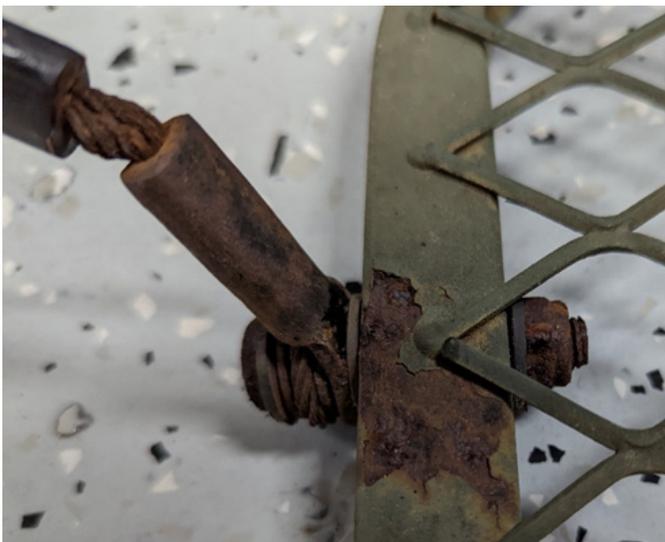
**Figure 12**

The cables on the subject treestand were bolted onto the foot platform through the cable eyelets (**Figure 12**). Although three plastic washers were used to separate the bolt, eyelet, and foot platform, an electrical connection was still present between the bolt threads and edge of the

Connection between the foot platform and left-cable eyelet on the subject treestand.

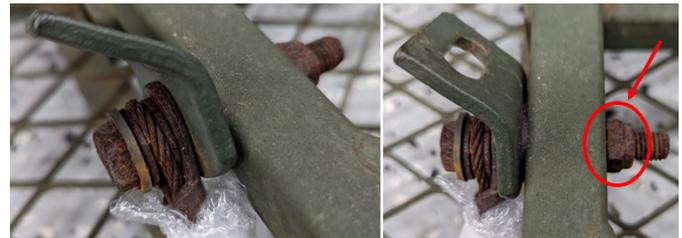
**Figure 13**

The bolts connecting the cable eyelets to the vertical support of the treestand have 55 mm of thread — around 10 mm longer than the bolts used on the foot platform, which provides more surface area for corrosion to occur on and accelerate the depletion of the cable’s zinc coating. It can also be seen that a bracket intended for use with the tree strap is affixed to these bolts. While washers are present at this connection as well, there is no washer separating the bolt nut and vertical support (**Figure 13**). This results in an enhanced electrical connection between the treestand and galvanized cable, further accelerating zinc depletion. It is likely that the increased corrosion of these nearby components caused more rapid dealloying of the galvanized steel cables, which resulted in the cables failing near their attachments to the vertical support where the cable’s degradation and loss of nominal strength was greatest.

Connection between the vertical support and left-cable eyelet on the subject treestand, displaying the direct coupling of the nut and frame.

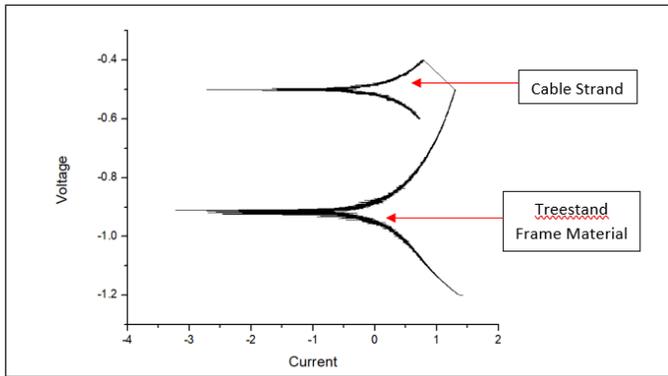
**Figure 25**

The potential and corresponding current were plotted and converted to a Tafel plot from which the galvanic potential, corrosion current, and Tafel constants were extracted (**Figure 25**). The corrosion currents for the galvanized steel cable by itself and the cable galvanically connected to the treestand were then converted to corrosion rates via Faraday’s Law, as given in ASTM G102.

Tafel plots extracts for treestand frame material and cable strand.

Cyclic Volt Corrosion Rate		
	Corrosion Current ( $\mu\text{A}/\text{cm}^2$ )	Equivalent radius reduction in mm per year	Coupled vs. Uncoupled % Increase
Coupled Treestand and Galvanized cable	105.4	1.5789	175%
Uncoupled Galvanized cable	38.34	0.5744

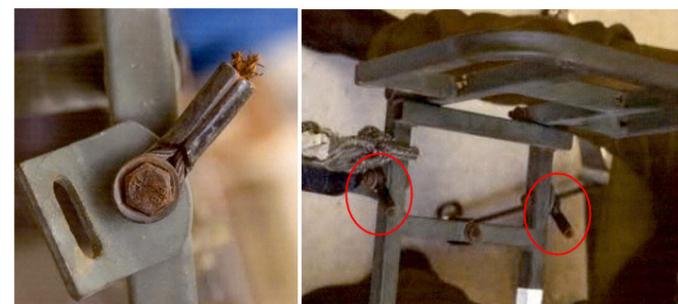
**Figure 29**

Discovery documentation revealed a number of previous incidents similar to the one that occurred in the subject incident (i.e., involving failure of the company’s treestands due to cable corrosion). In the first of these similar incidents, failure was observed in the segment between the right-cable eyelet and copper crimp near the vertical support. However, in the case being investigated here, the left-cable and right-cable both failed in the segment between the crimp and cable eyelet (Figure 29).

Failures observed on the treestand of the first similar incident with both failures occurring between the eyelet and crimp.

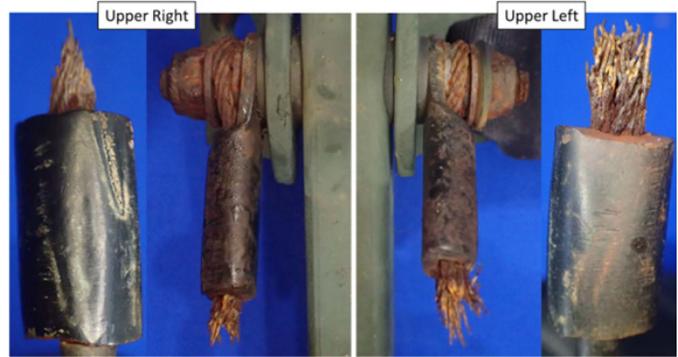
**Figure 31**

In the third similar incident, both the right and left cables failed just below the eyelet affixed to the vertical support. The bolts on this section were attached backward with the nut directly adjacent to the eyelets (**Figure 31**). As in other cases, the important factor to note is the fact that the thicker cross-section of the cables failed before the thinner cross-section below the crimp indicates that the segment between the crimp and eyelet experienced severe degradation of its strength due to corrosion as a result of galvanic coupling between the cable, copper crimp, and treestand frame. Fraying of the cables similar to the previous incident was observed (**Figures 32 and 33**). This fraying and the elongated strands suggest the occurrence of ductile overload.

Locations of failure observed on treestand in the third similar incident.

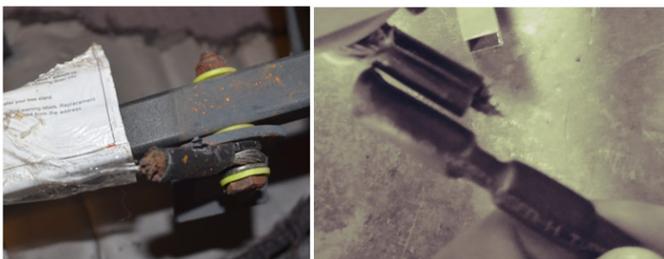
The fourth similar incident involved a newer model of the manufacturer’s treestand. As shown in **Figure 34**, newer models of the manufacturer’s treestands come with a thermoplastic coating over the cables. This coating, however, is loosely attached and allows water to easily seep and become trapped on the inside, corroding the cable. At the same time, the coating prevents users from observing the degradation state of the cables.

**Figure 34**  
Failed cables the fourth similar incident.

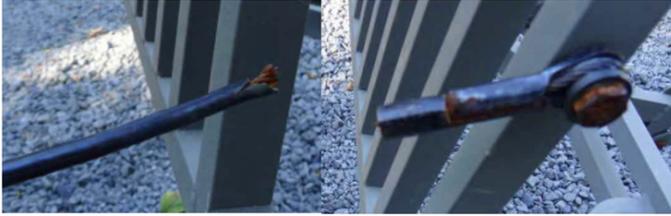
**Figure 36**

The failed cable on the climber treestand fractured between the copper crimp and plastic coating, showing the same design as the subject cable in the subject case.

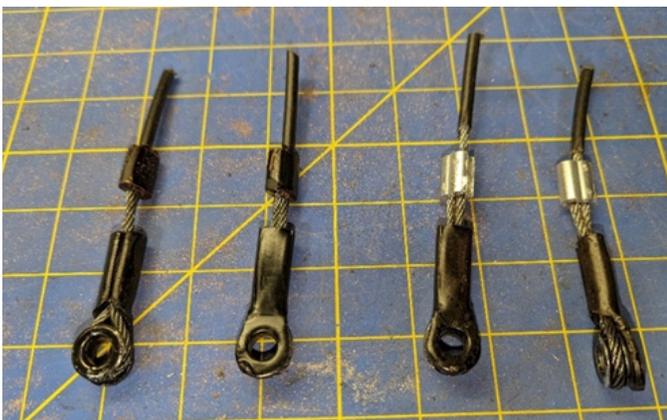
**Figure 39**

As previously noted, the usage of a copper crimp on the subject cable increased corrosion by a considerable amount. It was determined that aluminum was an alternative crimping material the manufacturer could have used, as it is relatively easy to form and is already extensively used in crimping applications. In order to determine how the usage of an aluminum crimp would have affected the corrosion rate of the galvanized steel cables, additional accelerated immersion corrosion testing was conducted.

The copper (right two) and aluminum (left two) crimp samples.

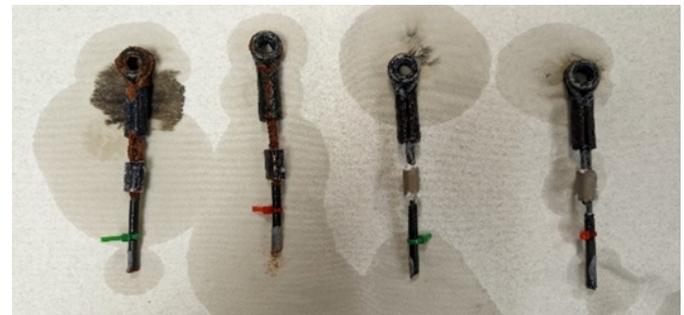
**Figure 40**

and replaced with a commonly available aluminum crimp of a similar size. These samples were then weighed and immersed in 1.025 specific gravity salt water (typical seawater) for 14 days. As shown in Figure 40, visual observation alone shows that the cables with the copper crimp corroded significantly more.

Corrosion present on the copper (right two) and aluminum (left two) crimp samples after 28 days of immersion.

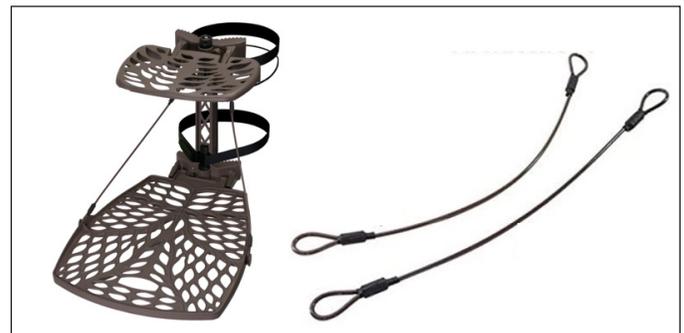
**Figure 41**

Various competitor treestands displayed an alternative cable attachment method, which allows the cables to be coated in a plastic sheath that prevents contact with air or water, cutting off one of the required conditions for corrosion to occur. While it is possible that this coating could degrade over time, constructing it out of UV-resistant materials would greatly reduce the likelihood of this occurring. The plastic sheath could also be made out of a semi-transparent material, which would allow users to see the cable corroding should water find a way in (Figure 41).

Competitor treestand displaying fully coated cables and an alternative attachment mechanism.

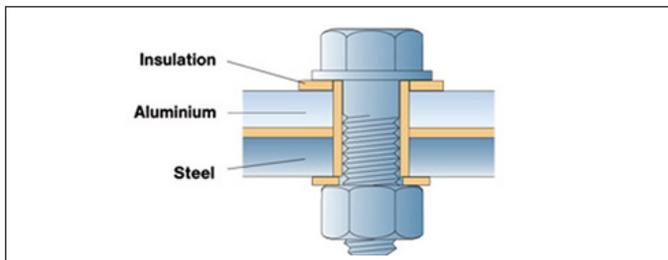
**Figure 43**

A potential design that could be used to prevent contact between the bolts and treestand.

Another method that could be utilized to prevent a galvanic connection between the treestand cable and frame would be to insulate the bolt holes (Figure 43). All of the design alterations discussed above are technically and economically feasible, and their implementation would have greatly increased the lifespan of the subject cable, preventing the incident from happening at the time it did. Although no projected corrosion time could be determined due to lack of any observed corrosion, it is likely that incident would likely have been postponed by at least bifold the amount of time the plaintiff had been using the treestand — by which time it would be reasonable to assume the plaintiff would have thrown away the treestand due to the degradation elsewhere on its frame.

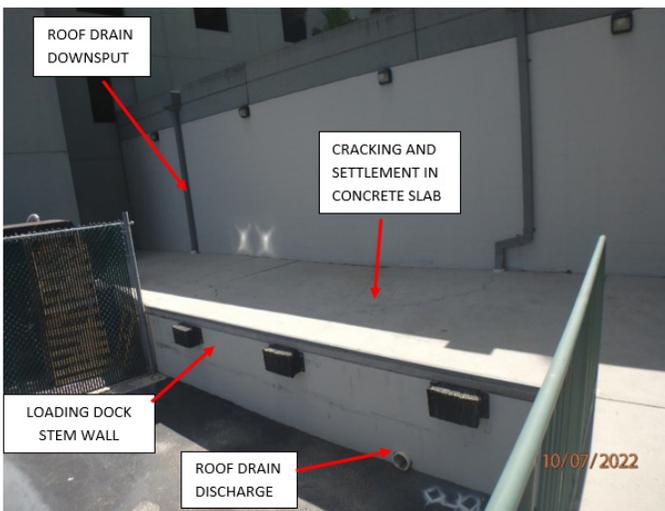
**Figure 3**  
Loading dock area.

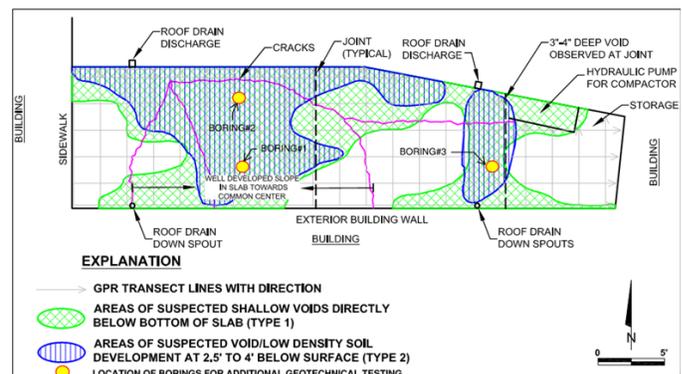
**Figure 6**  
Site map showing results of GPR investigation.

The results of the geophysical investigation are presented in **Figures 6, 7, and 8**. Based on the GPR results, the authors identified two types of anomalous subsurface conditions. Type 1 anomalies are suspected shallow voids directly below the bottom of the slab. For the majority of the anomaly areas, these voids appear to be less than 0.25 inches in height. However, in some areas, they could be up to 3 to 4 inches in height — as was observed at the northern end of the slab joint in the eastern portion of the site. Type 2 anomalies are characterized by a localized increase in the amplitude of the GPR signal response at a depth range of 2.5 to 4 ft bls. Examples of the GPR data collected across each of the Type 1 and Type 2 anomaly areas are provided in **Figure 7** and **Figure 8**. The coloration of the interpreted voids in **Figures 7 and 8** was produced by the equipment software, which offers options for selecting

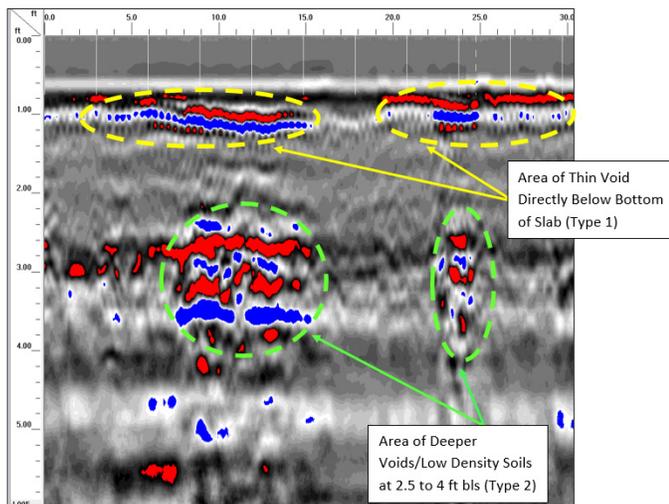
**Figure 7**

GPR data collected with 900 Mhz antenna.

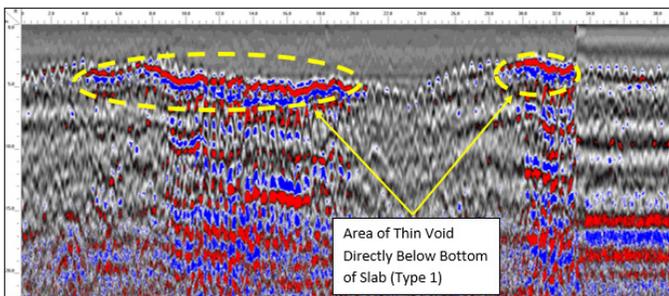
**Figure 8**

GPR data collected with 2.6 GHz antenna.

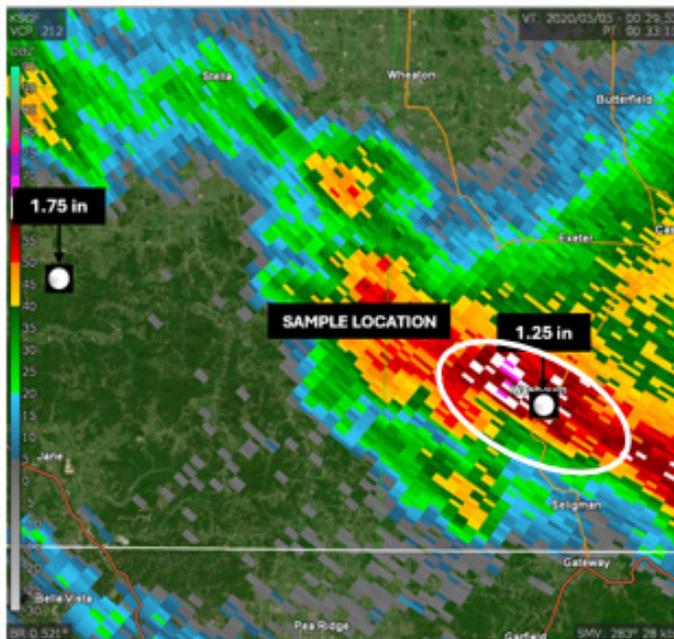
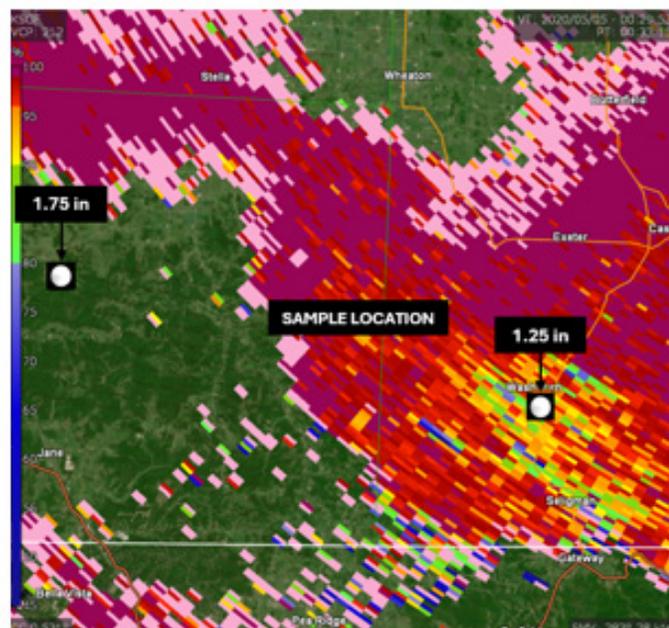
**Figure 17**

As the storm began to move over the area of the secondary storm report, radar readings continued to indicate the hail potential within the storm (**Figure 17**). However, for this location, the hail indicators were less impressive than they were when they moved over the sample location — this is noted by a decreased reflectivity maximum and slightly less defined region of co-located lowered CC values.

Reflectivity and correlation coefficient reading for secondary location (7:33 p.m. CDT).
