Journal of the
National
Academy of
Forensic
Engineers[®]

Vol. 42 No. 2 December 2025

Discerning Wind-Related Damage to Residential Roofs

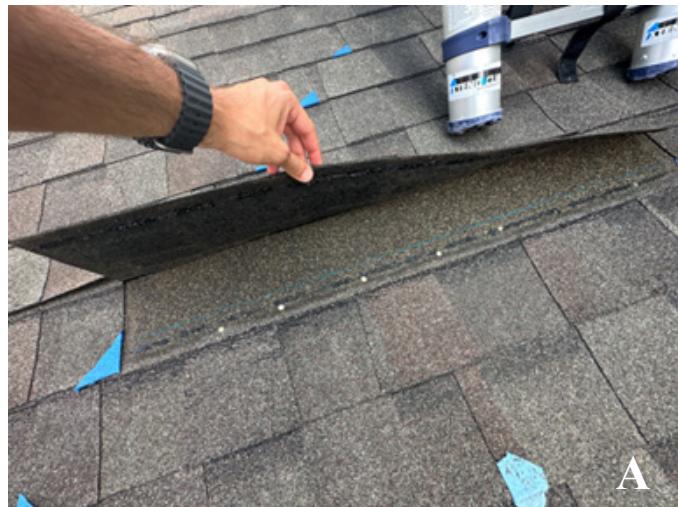
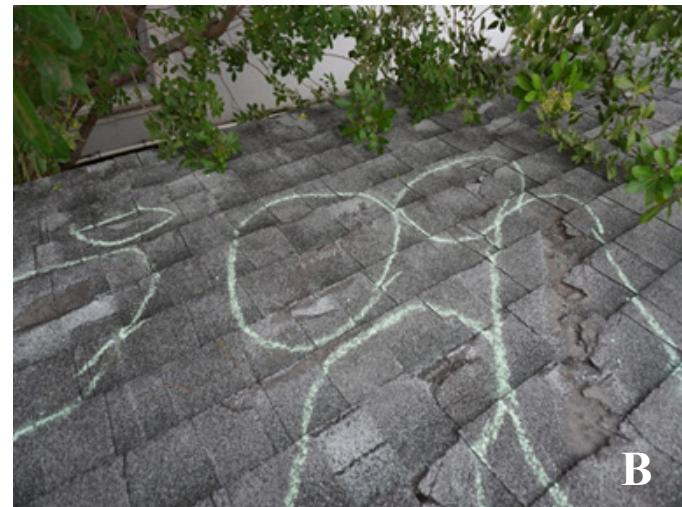
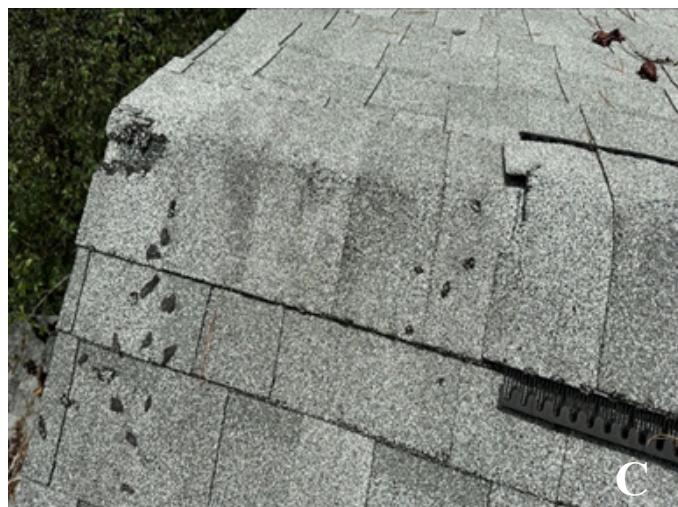
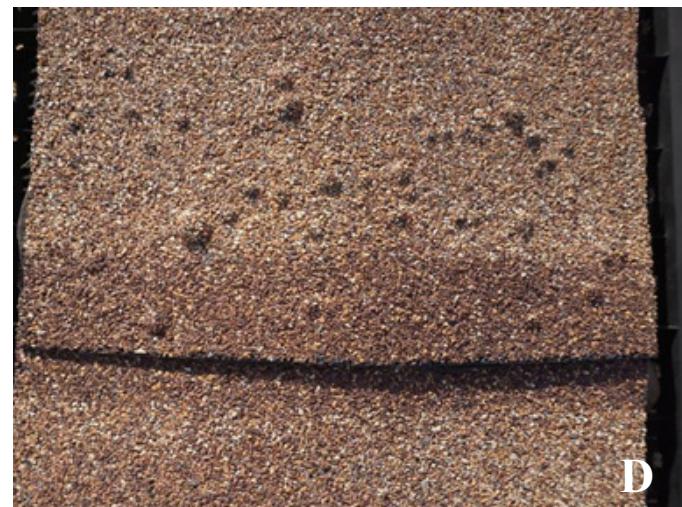
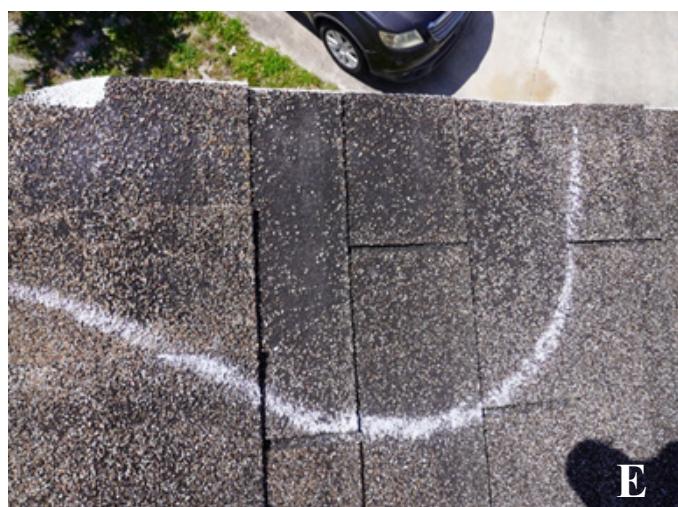
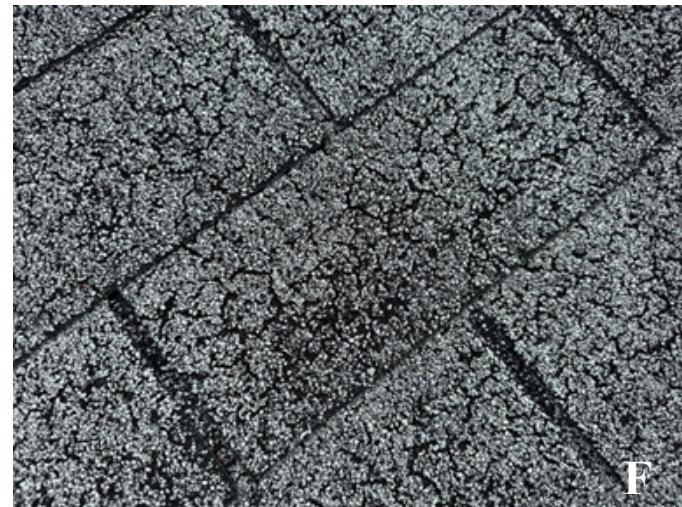
Figure 5

reinforcement mat may degrade to the point where the mat can no longer withstand thermal stresses, leading to splitting.

Koonts (1990)⁵² further attributes this failure to insufficient tensile strength of the mat, which, when combined with the shear forces acting on the sealant strip, results in

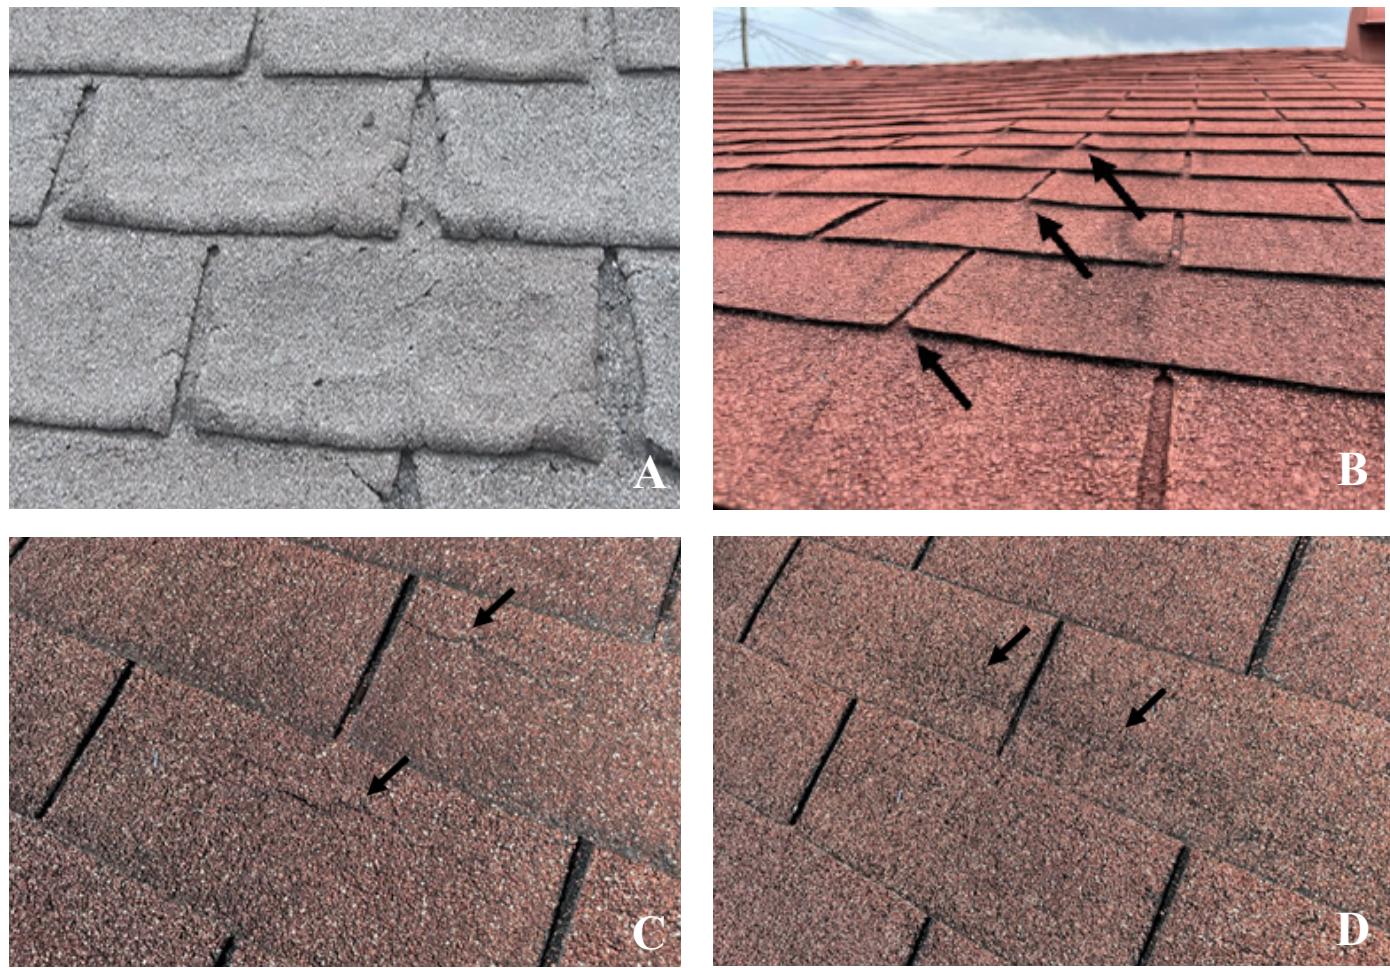
Figure 6

Nonwind-related damage: a) clawing, b) cupping (or curling), c) random thermal splitting, and d) horizontal thermal splitting.

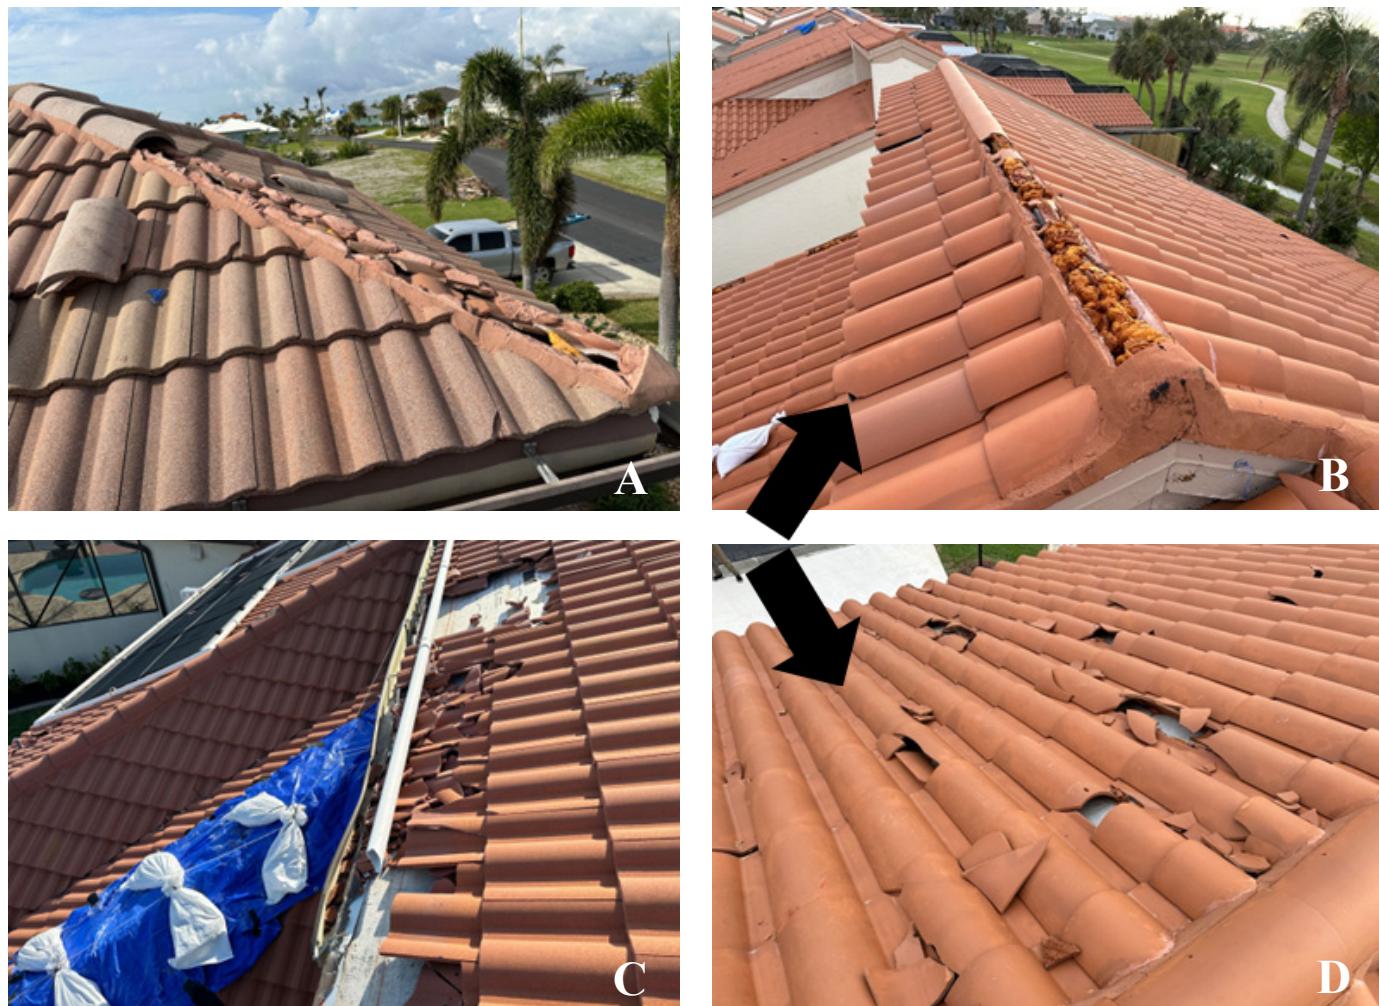
Figure 8

Beyond the hazards posed by flying tiles, the impact of such debris on intact roofing systems can be severe. According to a previous research investigation, projectile impacts on tiled roofs often result in localized cracking or shattering of the impacted tiles (**Figure 8**). However, the damage extends beyond the point of impact; loss of tiles due to projectile strikes can lead to breaches in the roof covering that promote wind infiltration beneath adjacent tiles, thereby escalating the overall damage through progressive failure⁶⁸. Comparative testing between concrete and clay tiles revealed key performance differences: concrete tiles exhibited 39% greater resistance to impact forces than clay tiles⁶⁷. Moreover, concrete tiles tended to break in larger, more localized pieces, particularly when bonded with mortar, absorbing the impact energy. In contrast, clay tiles tended to shatter extensively, creating larger areas of failure around the impact zone⁶⁸.

Wind-related damage: a) uplifting of hip cap tiles, b) uplifting of ridge cap tiles, c) impact with windborne debris, d) fractures from impact with windborne debris (black arrows indicate oncoming wind direction on the date of loss).

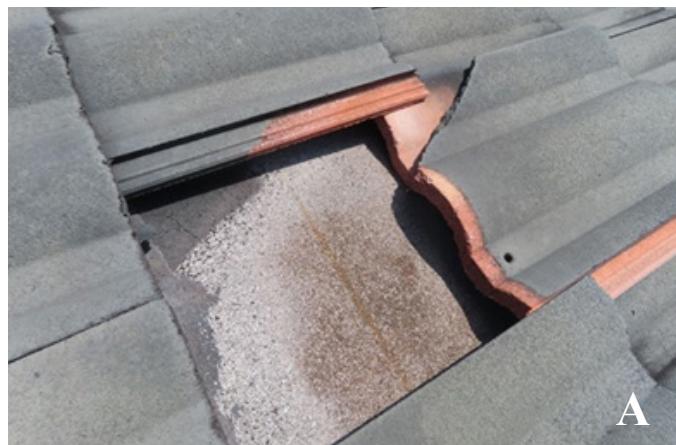
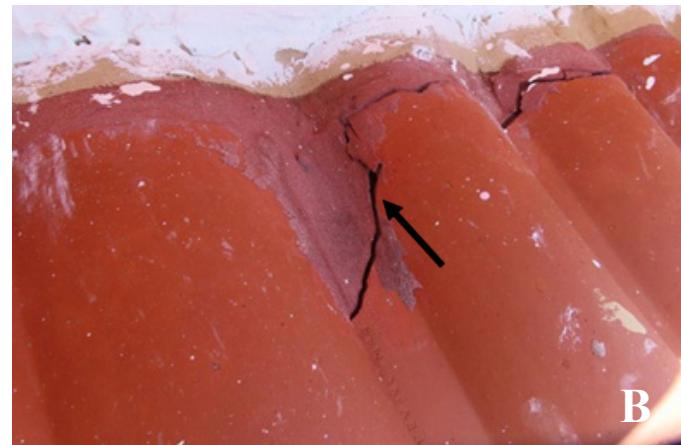
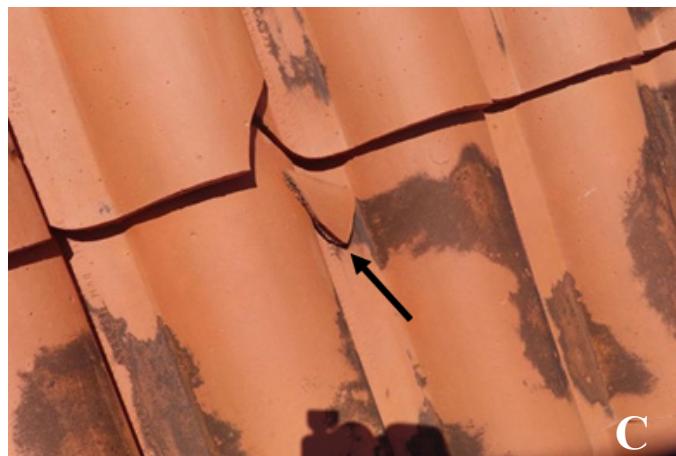
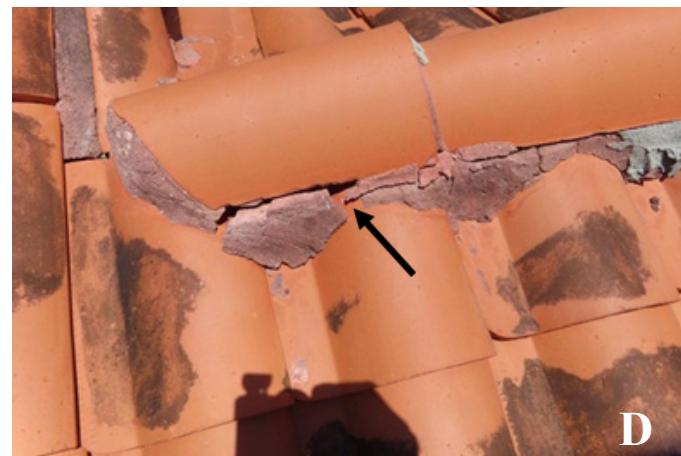
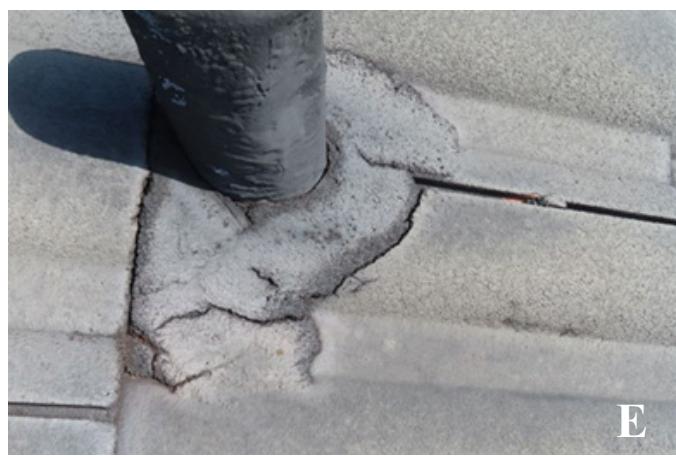
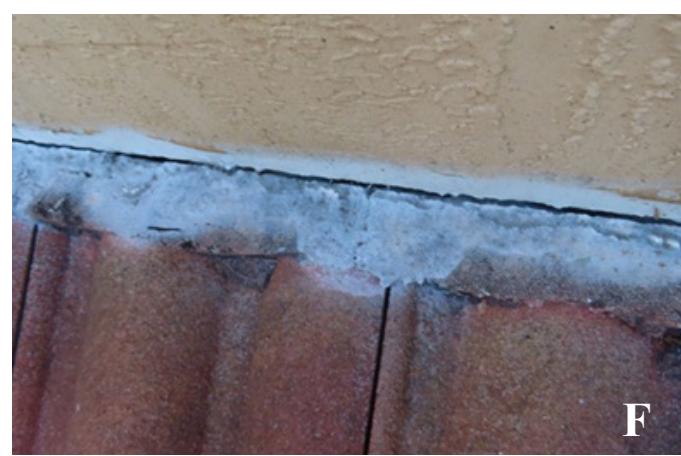
Figure 9

deficiencies introduce localized stress concentrations, reduce mechanical interlock, and create voids or misalignments that may lead to premature tile cracking or slippage under normal thermal or mechanical loads⁶⁹ (**Figure 9**).

Additionally, improper installation includes nail heads that are installed flush with the tile surface restraining the

tiles from any movement. Such practices lead to premature linear cracking of the tiles at the nail penetration location. Improper installation also renders the tiles susceptible to flutter/chatter during repeated windstorm events, which loosens the fasteners further, abrade the underlayment and exposes the roof underlayment to moisture intrusion. The loosening of these fasteners aggravates the tile

ing of the mix lead to premature cracking of the mortar (Figure 9).

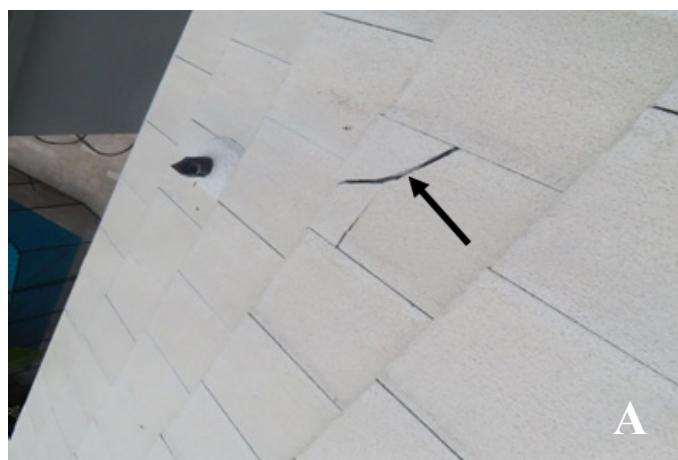
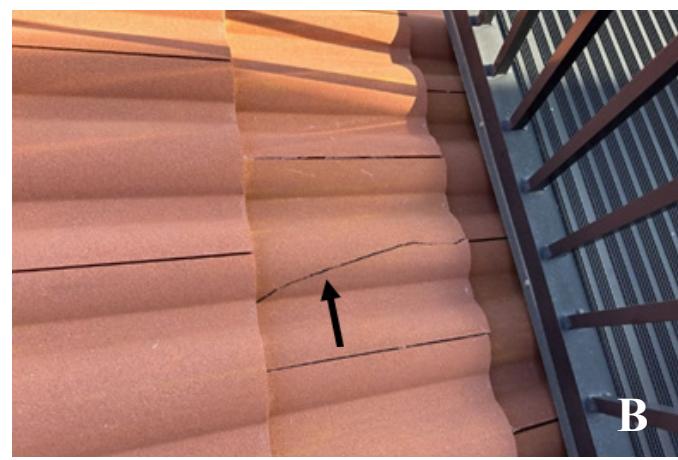
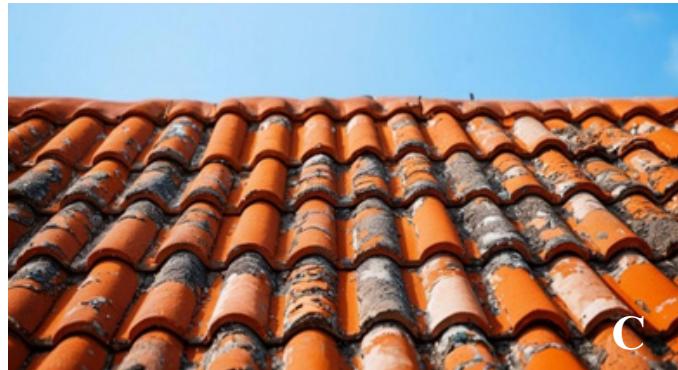
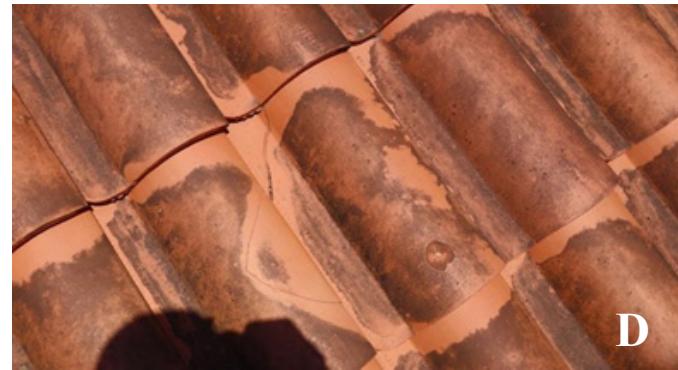
Figure 10

Impact damage is a leading cause of nonwind-related failure in tiled roofing systems. This includes localized cracking from foot traffic, impacts from overhanging branches, and tool or ladder contact during maintenance activities. Such cracks are typically irregular and located in walkways, valley intersections, or under satellite dish mounts^{69,76}. Concrete tiles, though more resilient than clay, are still susceptible to cracking or chipping at unsupported corners when subjected to concentrated loads emanating from foot traffic and mechanical impact⁷⁰ (Figure 10).

Footfall damage to roof tiles is typically evidenced by a linear nature of the cracks and lack of radial cracks emanating from point of impact to broken tile surfaces. Broken tile pieces typically remain in place or are slightly displaced downward, depending on the age of the fracture itself. As such, broken tile fragments that remained in place are evidence that the cracking was not caused by wind, as strong wind would have removed the cracked portion from its original position.

Moss, algae, and lichen growth can degrade both clay and concrete tile surfaces. These organisms retain moisture against the tile, encouraging efflorescence and biological etching over time. Root systems from lichens and mosses can expand existing microcracks and lead to mechanical tile displacement^{77,78}. Furthermore, animal activity, such as droppings, often damages the surface of the tile, resulting in gradual deterioration and discoloration of tiles⁷¹ (Figure 10).

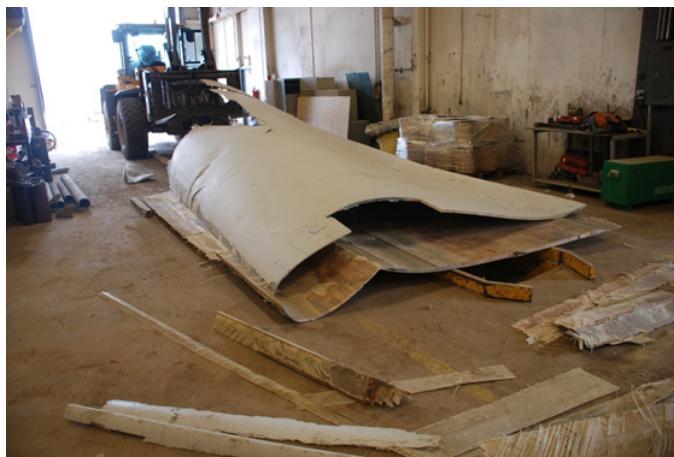
**Figure 8**

Parts of a wind-turbine blade set down for inspection and cataloging.

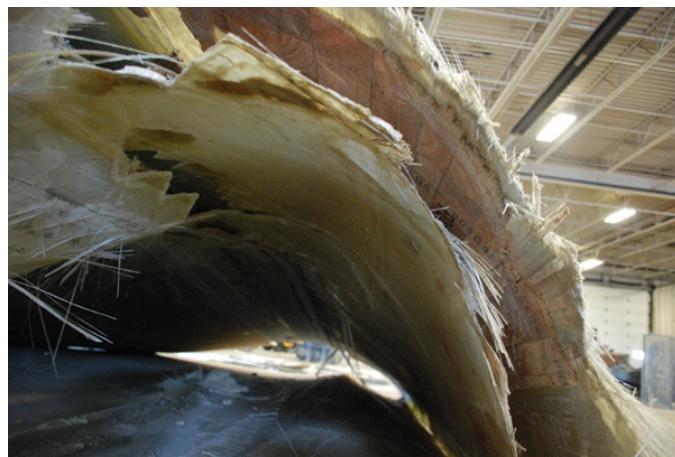
**Figure 9**

Wind-turbine blade fracture surface.

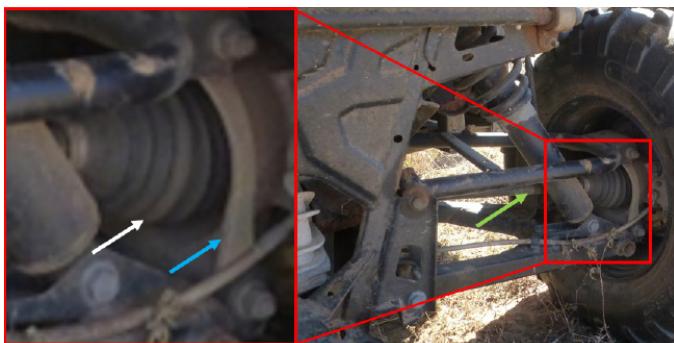
Figure 1

Right rear wheel assembly showing drive axle with normal CV boot indicative of axle shaft and joint rotating in tandem. Green arrow = axle main shaft; white arrow = right axle; and blue arrow = bearing carrier.

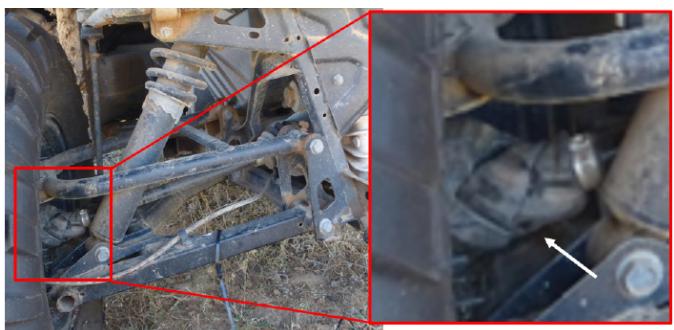
Figure 2

Left rear wheel assembly showing twisted CV boot indicative of axle shaft and joint turning independently. White arrow = twisted CV joint boot.

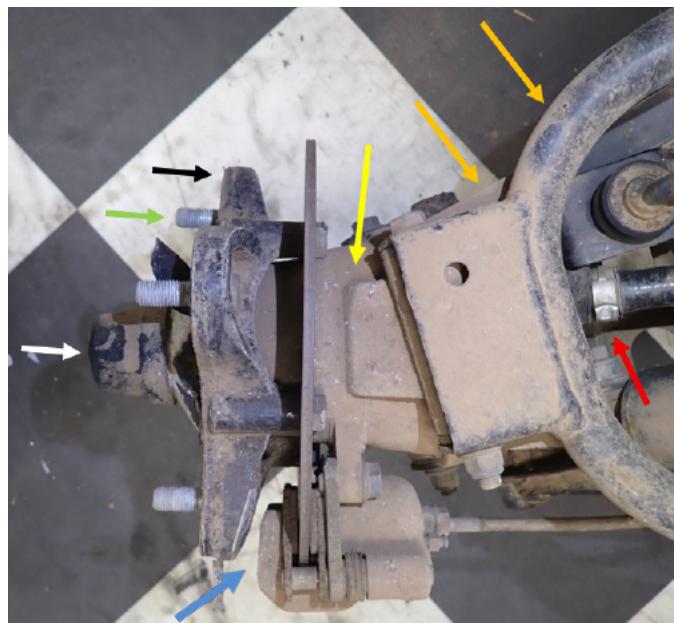
Figure 3

Left rear drive assembly, overhead view, tire and wheel dismounted. White arrow = grease cap; green arrow = lug stud; black arrow = hub; yellow arrow = bearing carrier; blue arrow = brake shoe assembly; orange arrows = A-arms; and red arrow = half shaft showing black axle, CV joint polymer boot, and mounting clip.

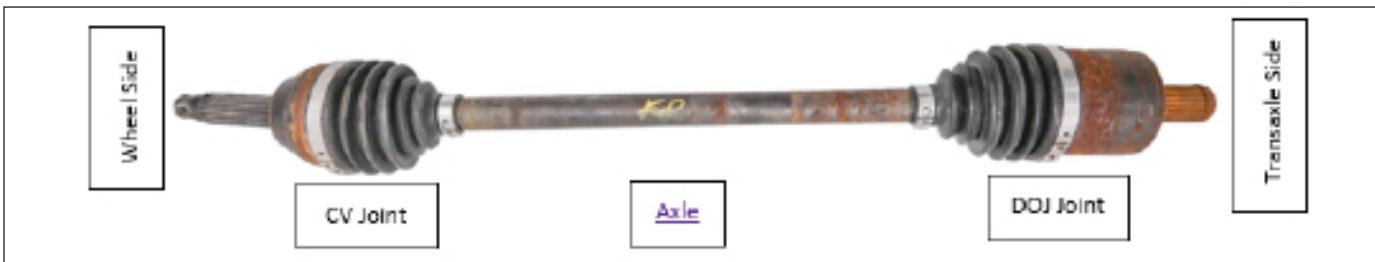
Figure 4

Exemplar half-shaft assembly for the incident UTV oriented with the outboard driving splined end at left and inboard driven splined end at right.

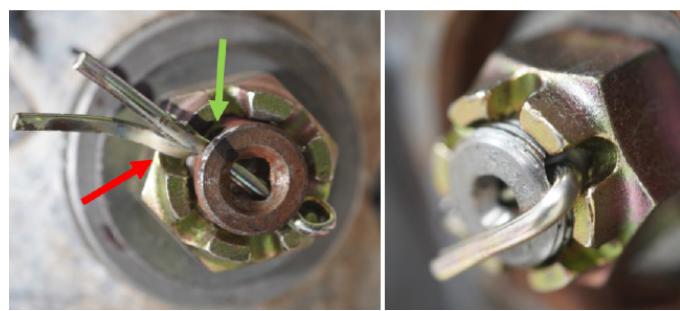
Figure 7

Notice how the right rear cotter pin through-hole in the threaded axle stub aligns with the castellated nut slot, while the left rear transverse axle stub cotter pin hole does not align properly with the cotter pin recess. The left rear

Left rear axle cotter pin showing post-installation misalignment of the axle cross hole and castellated nut slot (left). Right rear axle cotter pin showing undisturbed factory-installed alignment (right).

cotter pin segment in the foreground aligns with the axle transverse hole (green arrow), while the cotter pin segment in the background aligns with the castellated nut slot (red arrow); the head of the left cotter pin is also deformed. This is consistent with the threaded driving axle stub turning $\sim 10^\circ$ clockwise relative to the castellated nut after the cotter pin had been installed. Like the chipped wheel fracture surface shown in **Figure 6**, this is an indication that the axle and wheel damage occurred while the vehicle was in motion.

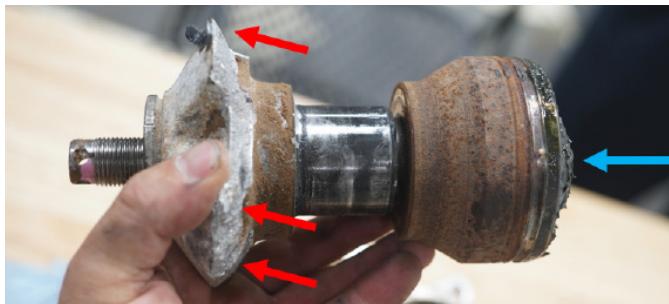
Figure 8

The burnished regions on both sides of the mating conical cast aluminum wheel hub fracture surfaces are from high points rubbing against each other (see **Figures 8** and **9**, red arrows). Also shown with a yellow arrow in **Figure 9** is the polished precision cylindrical interface surface for the wheel bearing; the blue arrow shows the splined internal recess for interaction with the driving end of the axle assembly, which is the outer race "bell housing" of the CV joint.

The physical evidence of burnishing is consistent with

Left rear-threaded axle stub, aluminum wheel hub fragment, bearing, CV joint outer bell. Red arrows indicate representative burnished surfaces; blue arrow shows the installation point of the fractured main axle shaft.

the fracture occurring during travel of the vehicle. There was also major abrasion damage to the disc brake assembly, consistent with the left rear wheel hub wobbling as it rotated. The largely axially symmetric conical wheel hub fracture surface is consistent with a centered inboard to outboard axial force being applied to the wheel hub, rather than a bending moment being applied by a local rim strike. Other than shape and post-fracture damage observations, no detailed fractography was performed on the cast aluminum wheel hub, since there was no macro evidence of a fatigue break at the aluminum hub. The wheel bearing at the center of **Figure 8** between the CV joint outer race at right and the fractured wheel hub at left spun freely. Consequently, it was not further examined.

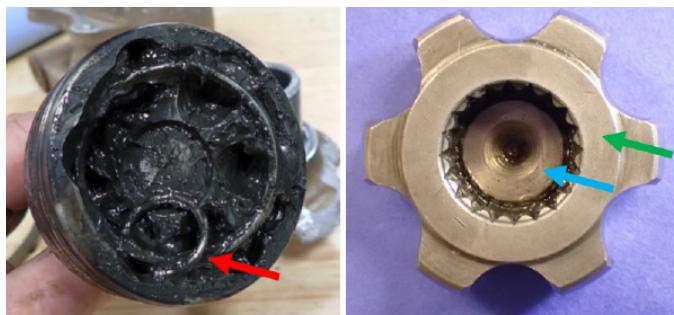
The left rear CV joint, detached from the wheel assembly and with the damaged flexible rubber boot removed, is shown from the inboard side in **Figure 10** (left). Although covered with grease, many details are apparent. From exterior to interior is the bell housing (outer race), the cage, the inner race with six cavities for hardened steel ball bearings with the balls removed, the retaining circlip near the bottom, and the fractured stub of the left rear drive axle in the center. **Figure 10** (right) shows the degreased inner race from the outboard side and the axle stub in the splined inner recess, which is not properly positioned fully outboard.

Left: Inboard view of CV joint bell housing showing fractured end of the main axle shaft and retaining circlip (red arrow). Right: Outboard view of degreased inner race; the stub end of the main axle is inappropriately inboard as the outboard face of the axle shaft (blue arrow) should be above flush of the outboard face of the inner race (green arrow).

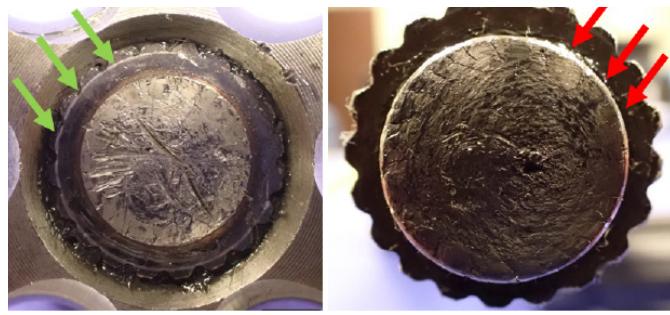
Figure 11 shows that the fatigue break occurred at the end of the main axle shaft at the outboard side of the circlip groove nearest the inner race. The fracture surface developed at the region of greatest axle bending moment and minimum cross section. The entire axial width of the circlip groove was present on the longer inboard axle shaft fragment (**Figure 11**, right). As a rotating cylindrical member, the fatigue crack progressed semi-uniformly planar to the shaft axis from outside to inside. This also ensured rotary compressive loading of the circlip as the axle shaft and the end past the groove became misaligned; a light in color witness mark of this compression is visible in **Figure 11** (left) — see green arrows.

The arc-like impressions on the main face of the outboard main shaft fragment are consistent with the interfacing rim of the detached inboard axle shaft pressing against the outboard stub during rotation, producing the fracture of the aluminum wheel hub with an inboard to outboard force. The light-colored groove end perimeter in **Figure 11** (right, red arrows) is no longer sharp but presents an

Left: Inboard end of CV inner race and fractured axle end showing a circlip compression mark and multiple arc-shaped impressions from the detached axle main shaft. Right: Outboard side of fractured axle shaft showing classic topographic macro features of fatigue fracture.

irregular beveled interface of the groove wall at the fracture surface. This was caused by cold work compression of this inboard edge against the outboard axle stub center segment during vehicle travel. The fracture surface on the inboard axle shaft fragment is better preserved for macro features of fatigue (**Figure 11**, right). Notable features include³⁻⁵:

- A. The overall planar fracture surface that is perpendicular to the shaft axis.
- B. The ratchet marks that initiated the planar crack perpendicular to the shaft axis once the axle shaft had backed off sufficiently for the circlip groove to be exposed past the splined region;
- C. Radial spaced arc-like markings of crack progression from exterior to interior; and
- D. An identifiable point of final fracture near the shaft centerline. These macro features were plainly visible with low power optical microscopy and did not require scanning electron microscope (SEM) examination.

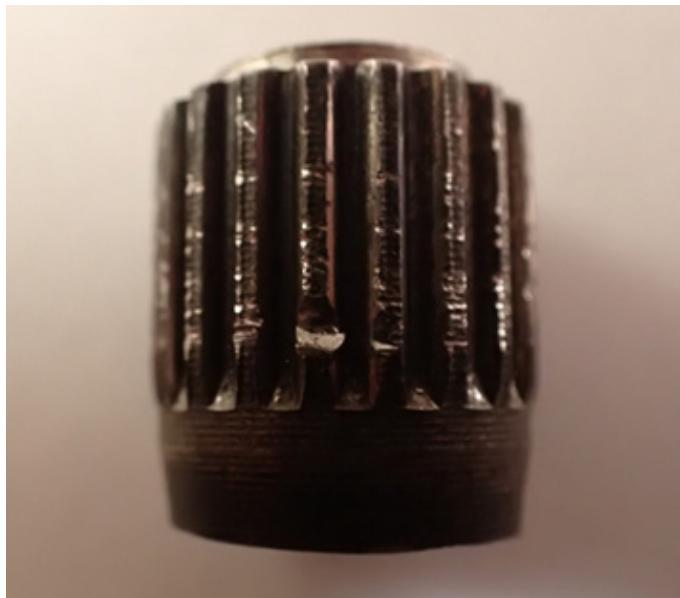
Figure 12

Witness marks about the circlip were consistent with the axle main shaft having been inserted some distance into the inner race, but these marks could not confirm that the main shaft had been fully inserted with circlip expansion at the factory during half shaft assembly. On the main splined surface of the axle were circumferential compression marks documenting bending loading on the axle as the end moved incrementally inboard relative to the CV joint inner race (**Figure 12**). These marks strongly indicate that the shaft was, at least, nearly fully inserted — though perhaps not fully inserted — which would be one potential failure mode mechanism of the shaft backing out. The axle

Sawn-off end of main axle stub, which fractured at circlip groove (top), showing circumferential compression marks developed while it backed out of the mating splines of the inner race.

fragment shown in **Figure 12** is the profile view of the segment shown in **Figure 11** at right.

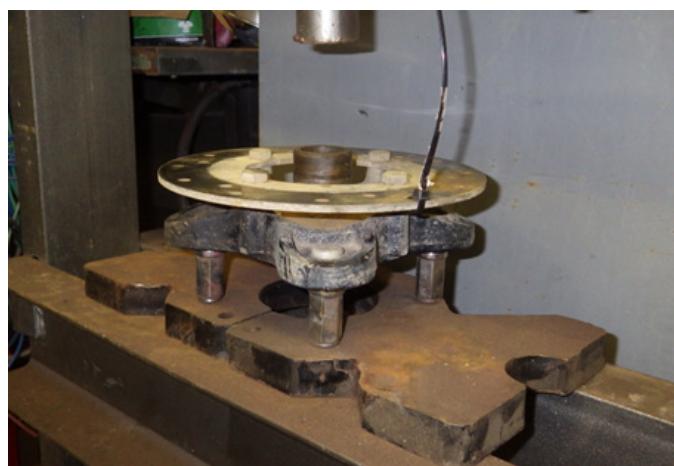
were purchased from an on-line salvage retailer and axially loaded using a manual arbor press to develop a concentrated active load on one side and a diffuse reactive load on the other, thus producing outside-in and inside-out loading fracture (**Figure 13**). Note the wheel studs and brake disc attached to the black aluminum wheel hub.

Figure 13
Exemplar wheel hub and arbor press used to apply a concentrated inboard force against the wheel hub.

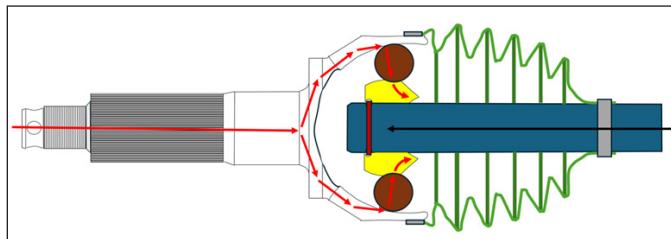
In this diagram, the components mating to the CV joint end of the half shaft are not shown. What is shown is the driving outer race “bell” end, the ball bearings as brown spheres, the inner race in yellow, the main axle in blue, the retaining circlip in red, the flexible rubber boot in green, and the boot clips in gray. The red arrows show the impact force that could potentially be transmitted to the axle, which is resisted by the black arrow that is traceable to the inboard mounting end of the axle assembly at the transaxle. The combined impact force (red) will tend to move the inner race (yellow) toward the right, while the

Figure 15
Free body diagram of wheel force from outboard to inboard against the axle.

resisting force will tend to move the axle and circlip to the left. This would act to seat the outboard end of the main axle shaft to the CV joint inner race — not to overcome the fixation of the circlip and move the main axle shaft inboard. Thus, a conceptual free body diagram of an inboard directed wheel strike loading path further indicates that a substantial wheel strike would not cause the damage observed in the incident overturned UTV.

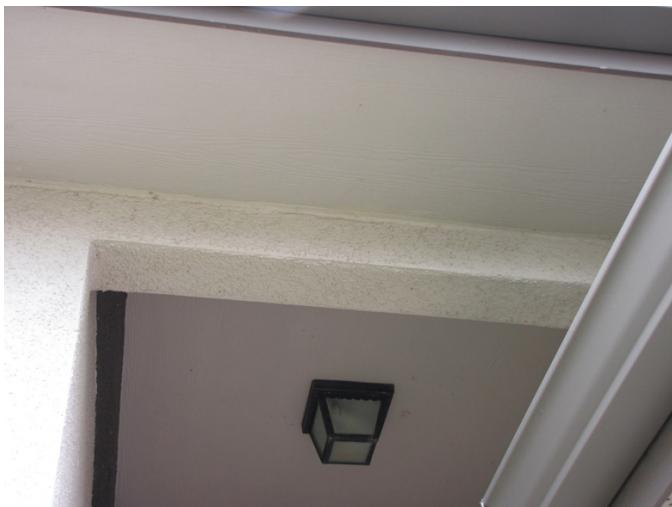
Figure 3

A forensic investigation should consider other factors such as roof cover and/or weather exposure. For example, if the roof projects beyond the exterior wall/header plane for a horizontal distance greater than the vertical height of the wall/header area above the vertical-to-horizontal transition in the veneer (as shown in **Figure 3**), the investigator

Example of a vertical-to-horizontal transition at a covered location.

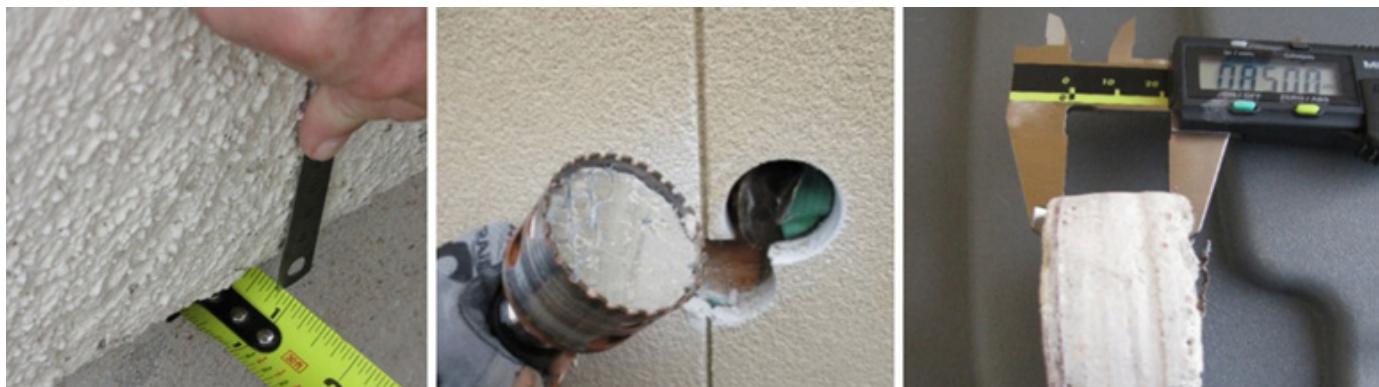
Figure 4

Example of non-intrusive (left) and intrusive (center and right) cement plaster veneer thickness measurements.

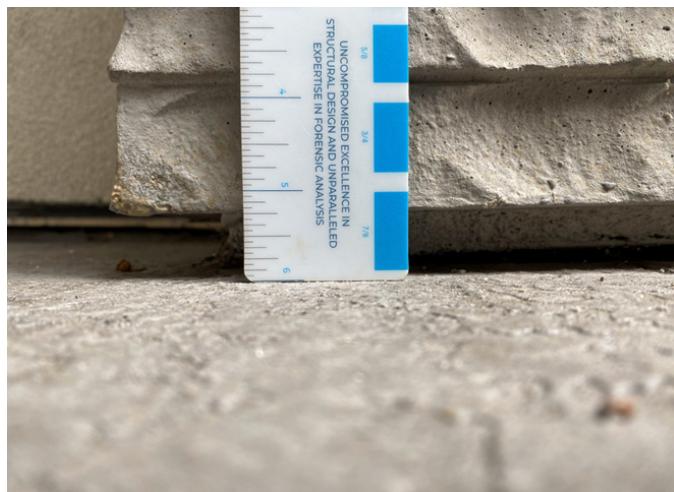
Figure 5

Section R703.12.1 of the 2024 IRC specifies that adhered masonry veneer shall be installed a minimum of 4 inches above the earth and a minimum of 2 inches above paved areas — similar to the aforementioned prescriptive specifications for cement plaster veneer. However, unlike the prescriptive specifications for cement plaster veneer, Section R703.12.1 of the 2024 IRC also explicitly specifies that adhered masonry veneer shall be installed a minimum of ½ of an inch above exterior walking surfaces that are supported by the same foundation as the exterior wall (e.g., porch, patio), as illustrated in **Figure 5**.

Adhered masonry veneer installed with not less than $\frac{1}{2}$ of an inch of clearance to the foundation.

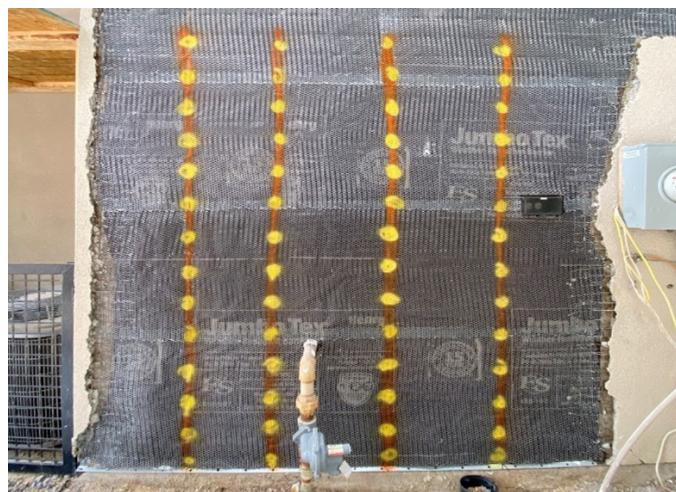
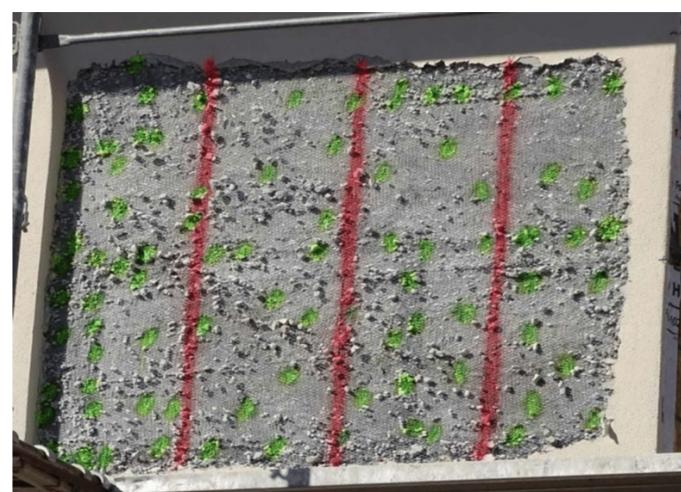
Figure 6

Installation of lath fasteners with (left) and without (right) regard to alignment with underlying framing members.

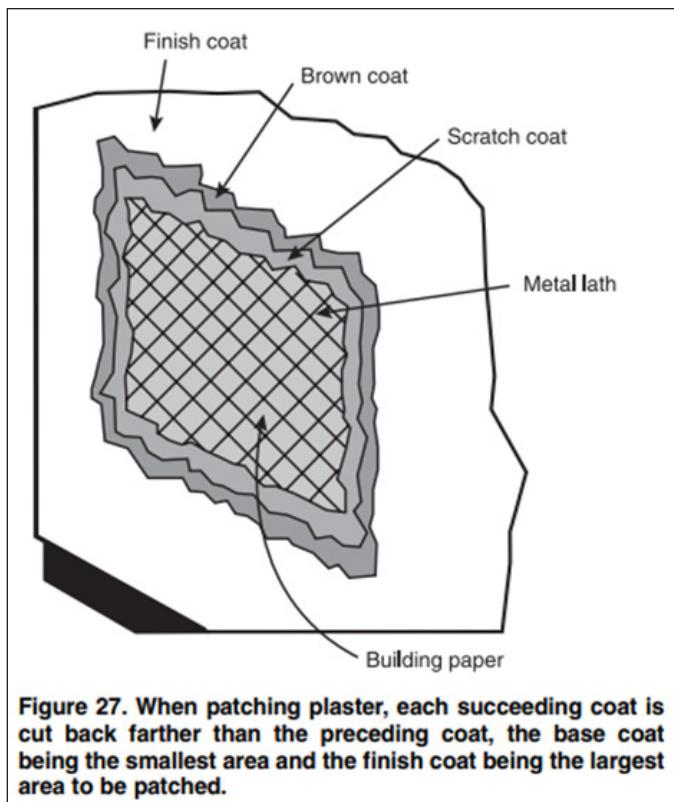
Figure 27 from the Portland Cement Plaster/Stucco Manual by the PCA¹⁵.

Apply patching materials in thin consecutive layers, troweling each layer until firm, and continue applying thin layers until the base-coat plaster has been replaced (Figure 27). The finish-coat plaster then can be applied and textured to match the surrounding plaster.

Figure 27 from the aforementioned document is shown as **Figure 7**, which depicts the recommended preparation of existing cement plaster veneer to receive a new patch¹⁵.

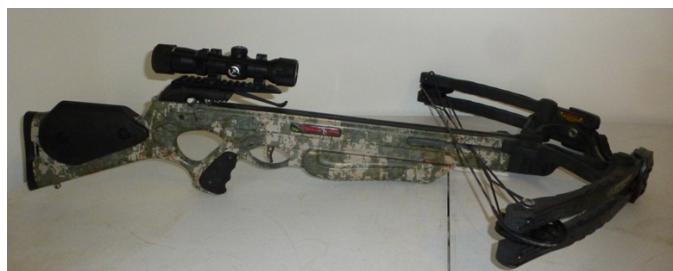
In the initial unintended discharge incident, the owner acquired the crossbow in new but non-standard condition, as depicted in **Figure 3**. The crossbow, which was assembled from factory components, lacked a serial number sticker, indicating that it was neither sold through wholesale nor retail channels. Instead, it was privately sold by an employee of the local crossbow factory to an acquaintance. This modern crossbow, constructed from synthetic materials, belongs to an earlier design generation compared to the model shown in **Figure 1**. It was assembled circa 2017 and features an optical sight, a rudimentary anti-dry fire (ADF) mechanism (components that prevent cocked bowstring discharge in the absence of an arrow), cams (rotating wheels at the outboard position of the limbs), and power cables crossing beneath the barrel (the axial "flight rail" of the crossbow).

Figure 3
Case Study 1 incident crossbow assembled circa 2017.

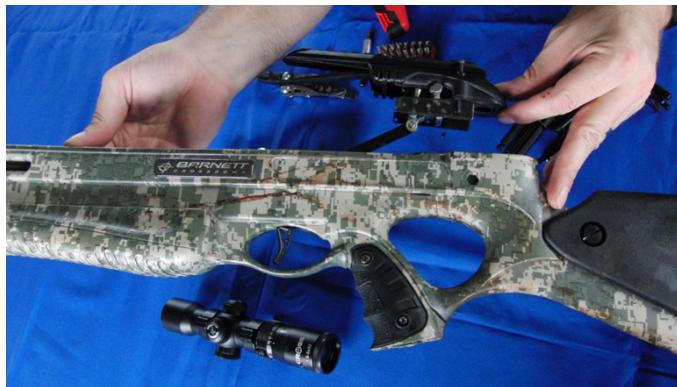
Figure 4

An inspection of the crossbow was performed, including removal of the trigger mechanism, as shown in **Figure 4**. Similar to the crossbow trigger mechanism previously

Incident crossbow showing removal of trigger mechanism and scope mount with draw bar leading to trigger shoe.

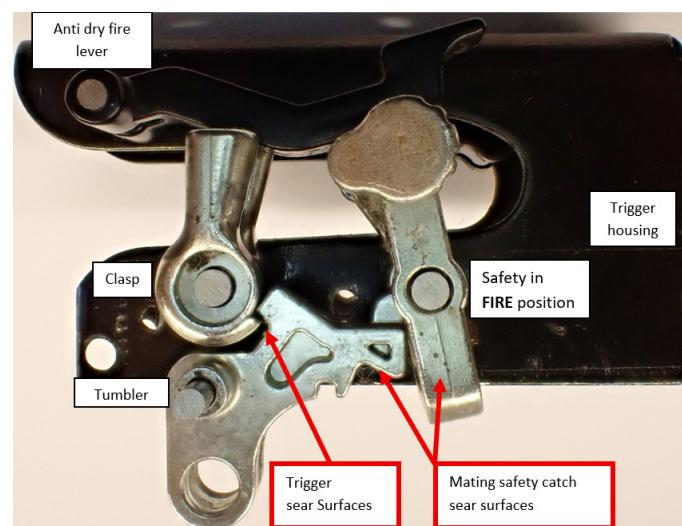
Figure 6

The trigger mechanism components and their axles were removed from the stamped steel box housing, and longer gage pins were inserted into the component axle holes from the left side to facilitate a positional layout of the major moving components, as shown in **Figure 6**. The multiple torsion springs, which bias individual component motion, are not shown. The biasing springs rotate the anti-dry fire (ADF) lever DOWN, the clasp VERTICAL, the tumbler ENGAGED (as shown, fully counter-clockwise), and the safety fixed either fully forward or backward as a detent. In **Figure 6**, the sear surface of the tumbler is in the engaged position — such that the clasp cannot rotate forward counter-clockwise into its released position.

Incident crossbow trigger mechanism with internal components and axles removed with the four major components affixed to the left exterior side of the housing and the trigger bar removed from the sear.

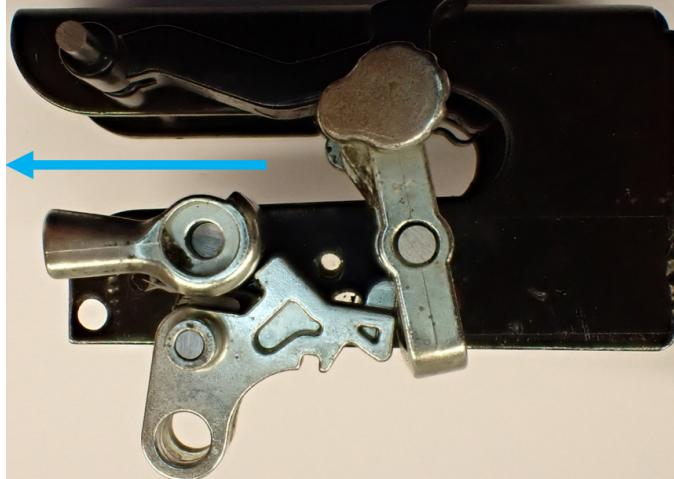
**Figure 8**

Figure 8 shows the trigger mechanism components as they are positioned at the moment of firing. The ADF lever had been moved up by the presence of the arrow. The safety was then moved forward to the FIRE position. The draw bar pulled the tumbler such that it rotated clockwise, disengaging the tumbler's sear surface from the mating surface of the clasp. The unconstrained clasp rotated ~90° counter-clockwise and released the bowstring and arrow, which rapidly moved forward (left) as represented by the blue arrow.

Incident crossbow trigger mechanism showing discharge position.

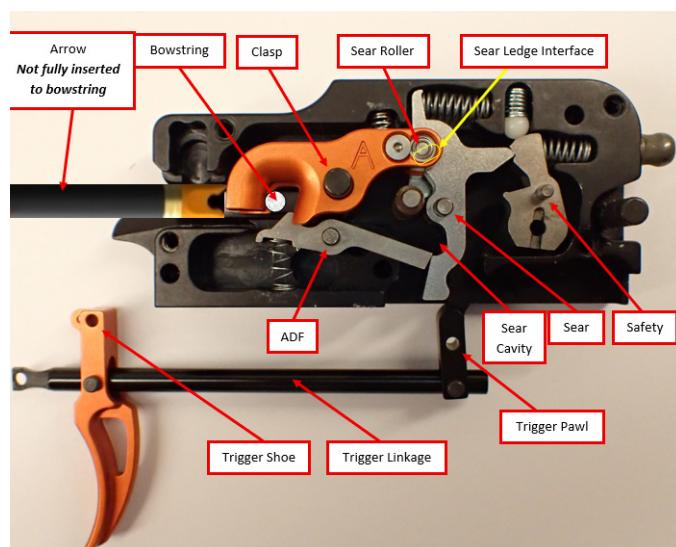
Figure 12
Photograph of the generation 1 trigger mechanism in the cocked but unloaded position.

Figure 12 illustrates the dismounted and partially disassembled “generation 1” (that is, originally marketed) trigger mechanism of the Ravin R9 and R15 crossbows, which are detailed in the associated patent¹⁶. To enhance visibility of key components, the left cover of the trigger housing has been removed. For clarity, a digital representation of an arrow stub equipped with an orange post-recall nock and a circular depiction of the bowstring cross-section, held by the clasp, have been superimposed. Red arrows, used to label component nomenclature, indicate the rotational axes of the respective parts where applicable. A yellow rectangle highlights the concealed sear ledge interface, which must disengage to enable crossbow discharge. The arrow retention actuator and its forward coil spring (located ahead of the clasp) have been omitted, as has the trigger shoe return spring, typically anchored at the forward holes of the trigger shoe and trigger linkage.

When the crossbow is cocked, the clasp is in the down position, and it retains the tensioned bowstring until the sear disengages, releasing the clasp, bowstring, and arrow. As depicted in **Figure 12**, the clasp is prevented from rotating to the open position by the sear’s interfacing sear ledge surface. The clasp’s sear roller, a cylindrical hardened steel pin, is transversely mounted within the clasp and supported by sealed ball bearings on both sides. The trigger mechanism of **Figure 12** is shown with the safety in the SAFE position, locking the sear against clockwise rotation. Additionally, the ADF lever blocks sear rotation in this illustration, as the digitally inserted arrow has not been fully inserted rearward to push down the ADF lever’s leading nose (see green arrow in **Figure 13**, which shows the trigger mechanism in the discharged configuration). For the sear to release the clasp, two conditions must be met: the user must rotate the safety to the FIRE position, and the ADF lever must be rotated counterclockwise by the full insertion of an arrow. After firing, the clasp moves

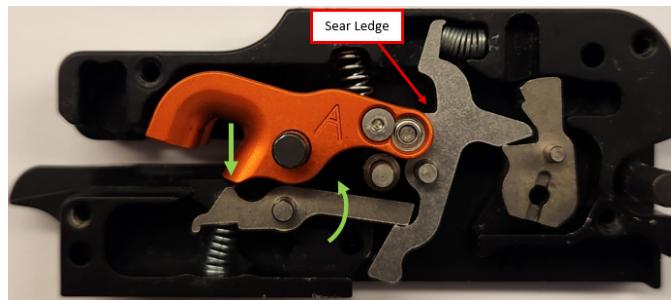
Figure 13

Photograph of the generation 1 trigger mechanism in the discharged position with the ADF lever inside of the sear cavity and the green arrows indicating the direction of ADF travel to disengage the ADF and allow sear rotation.

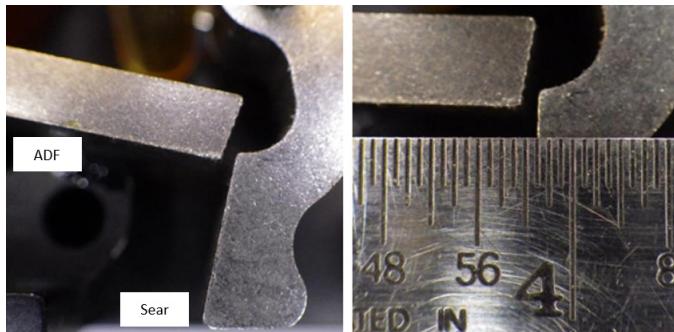
Figure 14

Photographs of the generation 1 ADF and sear in the intermediate position with the ADF trailing edge not completely clearing the entrance to the sear cavity.

gap between the ADF endform and the sear. This gap is objectionable; it allows the sear to rotate enough to assume an unsafe and unstable position.

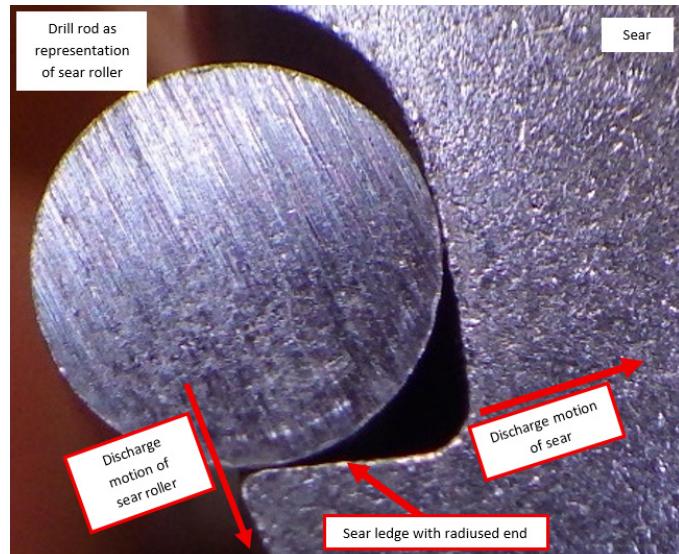
4. The archer's trigger finger pulls the trigger shoe, causing the front surface of the trigger pawl to press against the back surface of the sear and rotate it slightly, taking up the gap between the sear and the ADF lever. As the ADF lever is only partially aligned with the sear cavity's entrance, it prevents the sear from fully rotating. As a result, the sear roller shifts beyond the supporting point on the sear ledge (Figure 15), exerting considerable force and prying the sear toward the discharged position. The red arrows in Figure 15 highlight the insufficient support of the clasp's sear roller by the sear ledge, indicating a design error.

Drill rod in the same diameter as the sear roller resting on the sear ledge, showing that the contacting point of the cylinder is incrementally past the point of edge radius initiation with red arrows representing discharge motion direction.

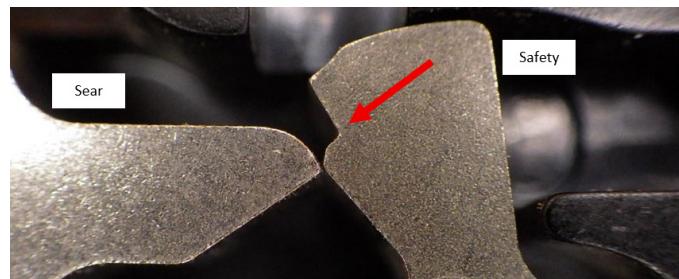
Figure 16

the safety button rearward (away from the discharge end). However, the internal safety mechanism only partially moves and becomes fixed in an unstable intermediate position — unable to fully engage beneath the sear's horn (Figure 16). The sear obstructs the safety's path, preventing proper engagement.

Generation 1 sear in the intermediate position at left and the safety at right in the FALSE SAFE position, with the red arrow showing both the direction of motion of the safety against the sear and the unengaged safety ledge.
