Journal of the
National
Academy of
Forensic
Engineers[®]

Vol. 42 No. 2 December 2025

Discerning Wind-Related Damage to Residential Roofs

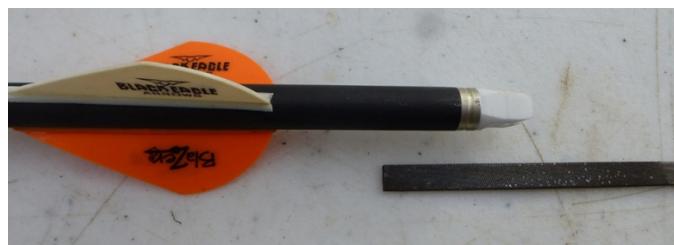
Figure 17

To validate the mechanistic feasibility of the incident sequence, crossbows involved in user injuries were individually tested using modified arrow nocks. These modifications enabled a cock/load/trigger pull sequence with the ADF lever positioned at various angles. Specifically, the bottom surfaces of polymer nocks were incrementally filed to reduce the ADF lever's rotation when an arrow was fully inserted. Minimal filing had a negligible impact on the ADF lever's rotation, whereas extensive filing prevented arrow discharge by entirely restricting the sear's rotation. The objective was to identify an "intermediate" degree of filing that replicated the conditions leading to user injuries and to document the crossbow's characteristics when this intermediate condition manifested, as shown in **Figure 17**.

Jeweler's file and Ravin crossbow filed nock on the side with the index vane — the bottom surface of the arrow when inserted into the trigger pack.

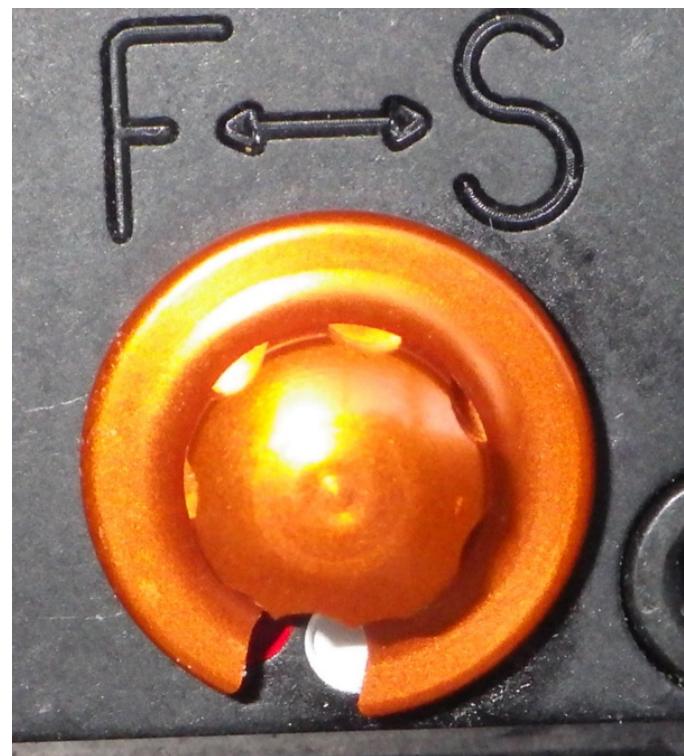
Figure 18

clicking sound when the trigger shoe was pulled, signifying the internal unstable re-arrangement of components, but no arrow discharge. This indicating sound was not recognized by unsophisticated archers who had no knowledge of trigger mechanism defect. When the safety button was pushed forward during filed nock testing, the safety position indicator window reliably indicated that the crossbow was neither set to SAFE nor to FIRE (**Figure 18**). This subtle indicator of the crossbow's intermediate position was also not recognized by the users.

Ravin R9 crossbow safety showing the intermediate FALSE SAFE position with half of the SAFE white dot showing and half of the red FIRE dot showing.

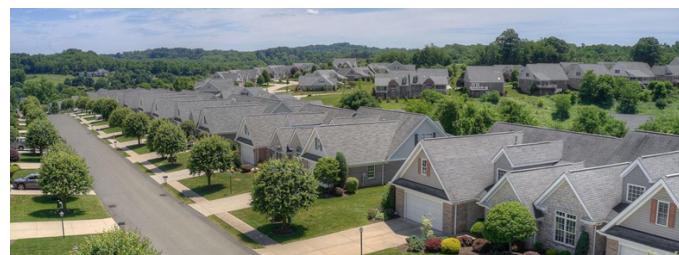
Figure 8
General view of subject site topography.

structures began in 2001 (starting at the bottom of a steep hill and working up). A photograph of the site, illustrating the site topography, is included in **Figure 8**.

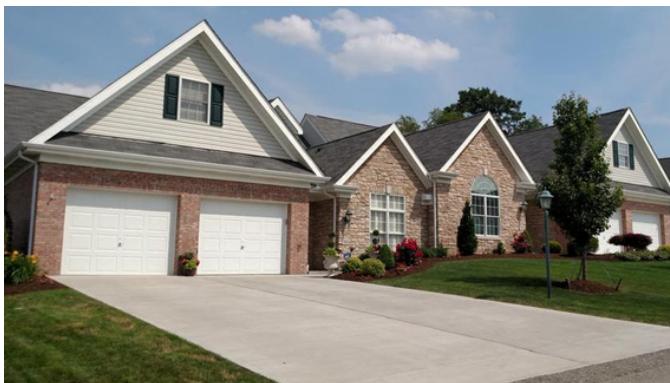
was no visible distress and/or rotation to the basement wall. According to county records, the residential structure in question was among the first to be built in the development. The subject residence has a front-entrance garage, with the dwelling area to the side and rear. A photograph of the subject unit is included in **Figure 9**.

Figure 9
Front elevation of the subject unit.

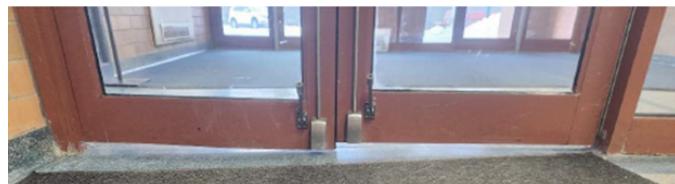
It was reported that adjustments had been made to the entry doors in order to remain functional. Based on measurements of modifications to the front entry doors, the center of the vestibule floor appeared to have moved upward approximately 2 inches since original construction (Figure 12).

Figure 12
Photograph of the front entry doors.
