Journal of the  
**National**  
**Academy** OF  
**Forensic**  
**Engineers**<sup>®</sup>

Vol. 42 No. 2 December 2025

# Discerning Wind-Related Damage to Residential Roofs

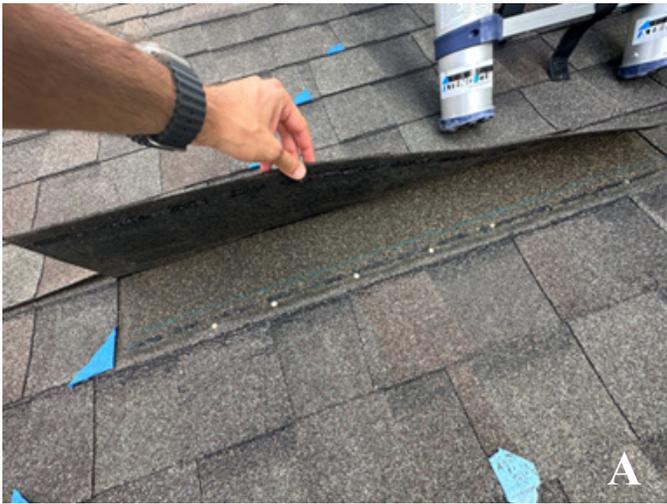
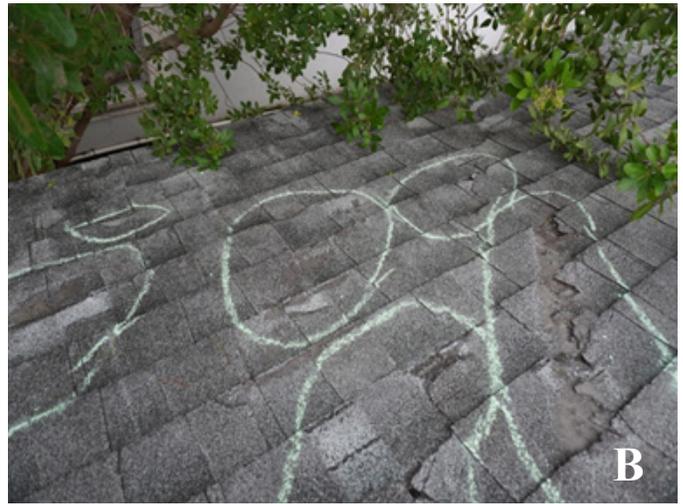
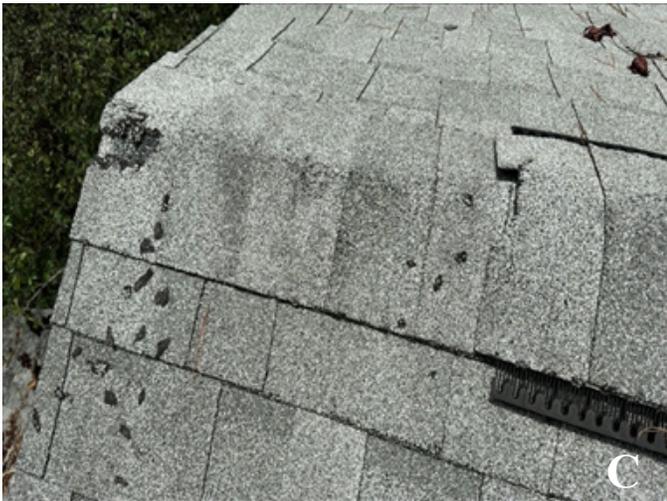
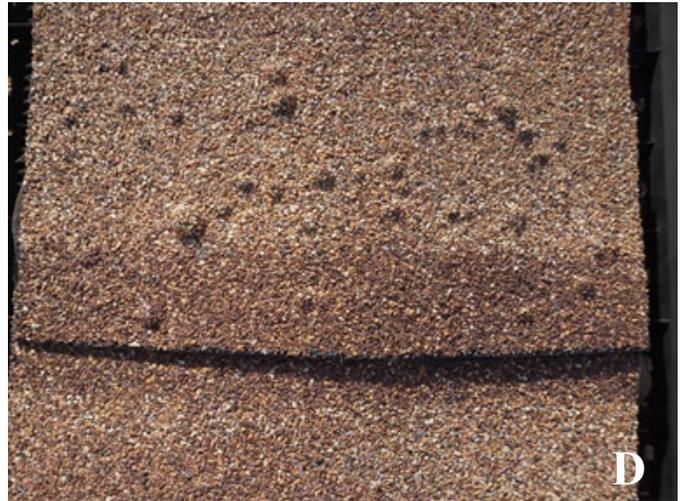
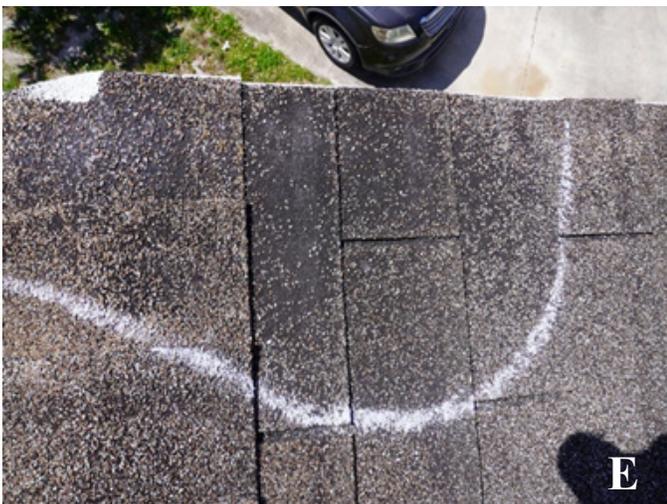
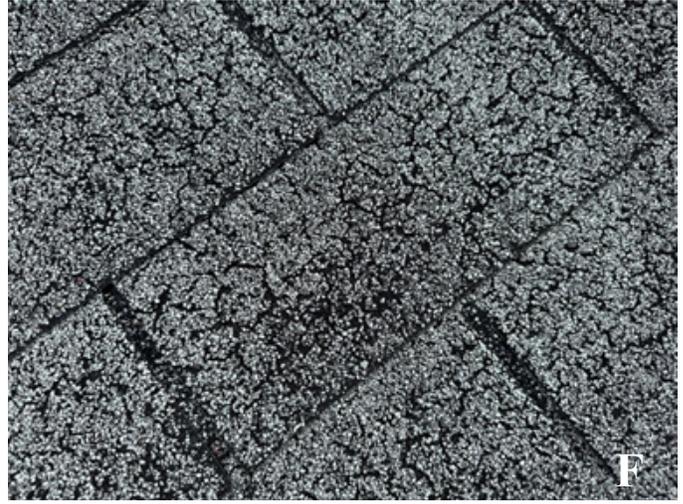
Figure 5

Nonwind-related damage: a) debonding, b) tree abrasion, c) animal activity, d) blistering, e) granular loss, and f) alligatoring.

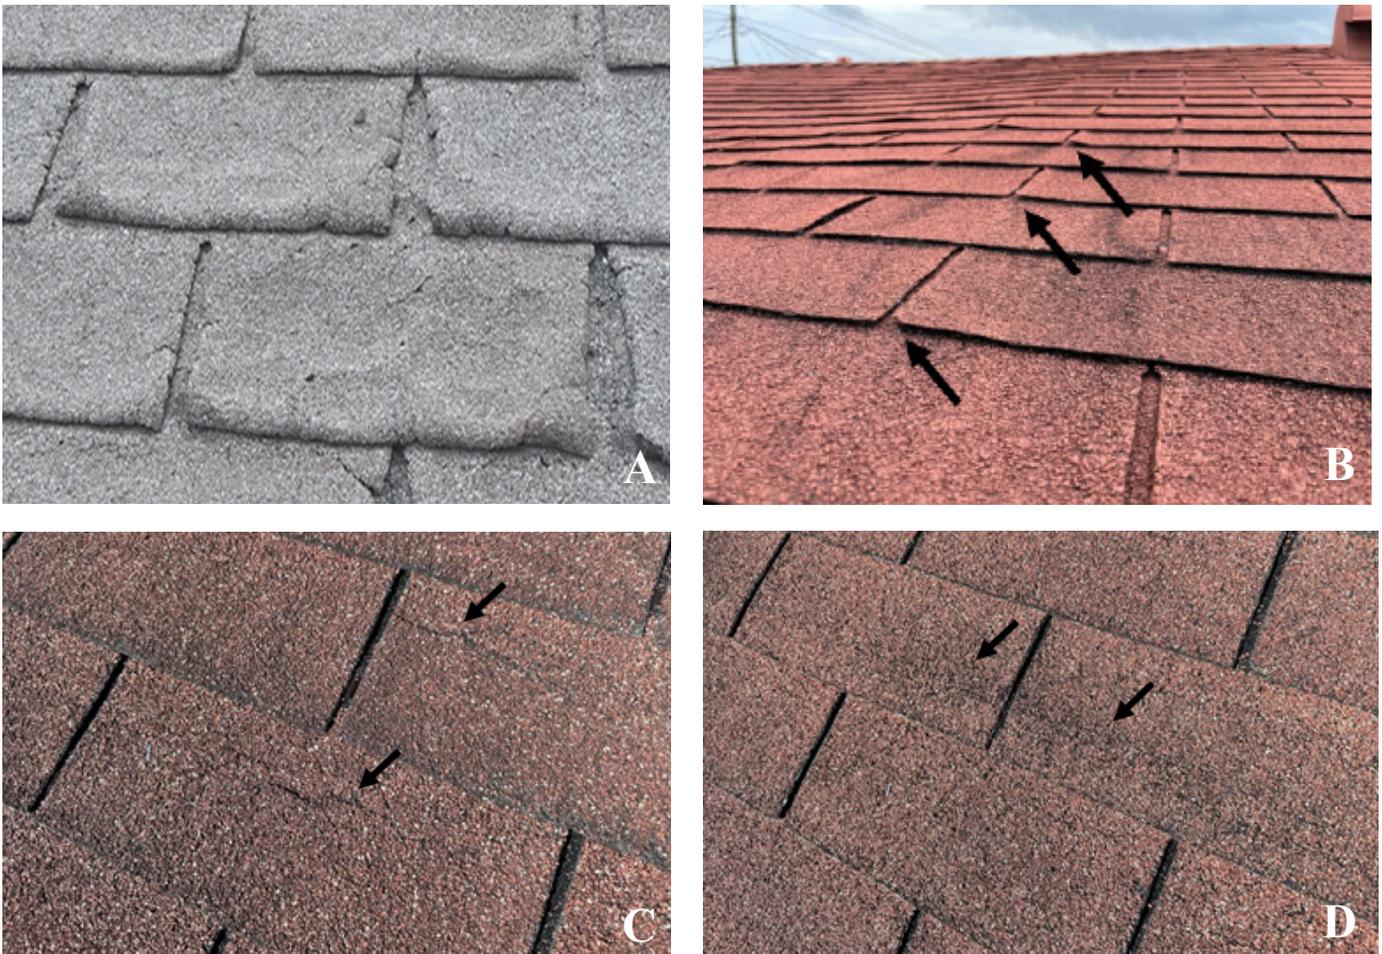
**Figure 6**

Nonwind-related damage: a) clawing, b) cupping (or curling), c) random thermal splitting, and d) horizontal thermal splitting.

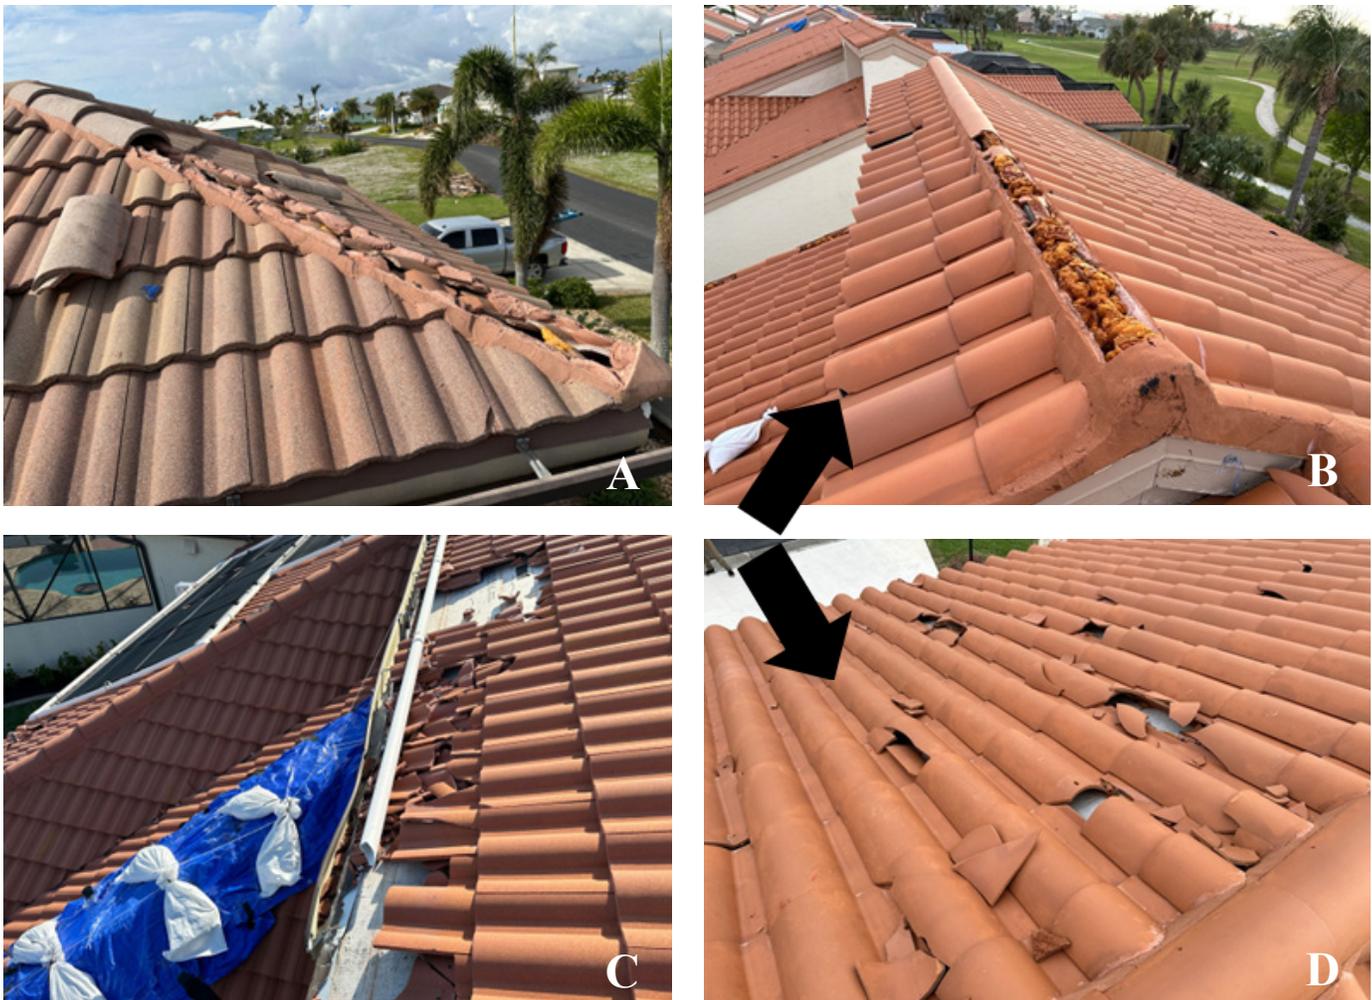
**Figure 8**

Beyond the hazards posed by flying tiles, the impact of such debris on intact roofing systems can be severe. According to a previous research investigation, projectile impacts on tiled roofs often result in localized cracking or shattering of the impacted tiles (**Figure 8**). However, the damage extends beyond the point of impact; loss of tiles due to projectile strikes can lead to breaches in the roof covering that promote wind infiltration beneath adjacent tiles, thereby escalating the overall damage through progressive failure<sup>68</sup>. Comparative testing between concrete and clay tiles revealed key performance differences: concrete tiles exhibited 39% greater resistance to impact forces than clay tiles<sup>67</sup>. Moreover, concrete tiles tended to break in larger, more localized pieces, particularly when bonded with mortar, absorbing the impact energy. In contrast, clay tiles tended to shatter extensively, creating larger areas of failure around the impact zone<sup>68</sup>.

Wind-related damage: a) uplifting of hip cap tiles, b) uplifting of ridge cap tiles, c) impact with windborne debris, d) fractures from impact with windborne debris (black arrows indicate oncoming wind direction on the date of loss).

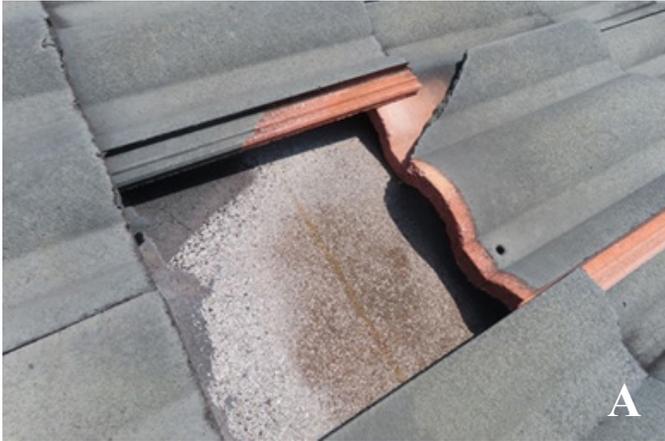
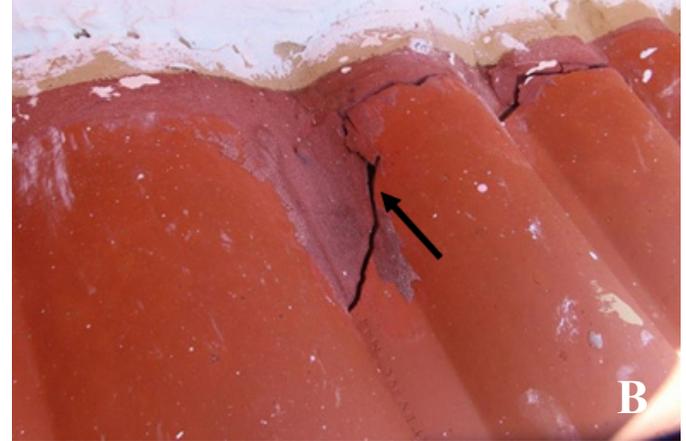
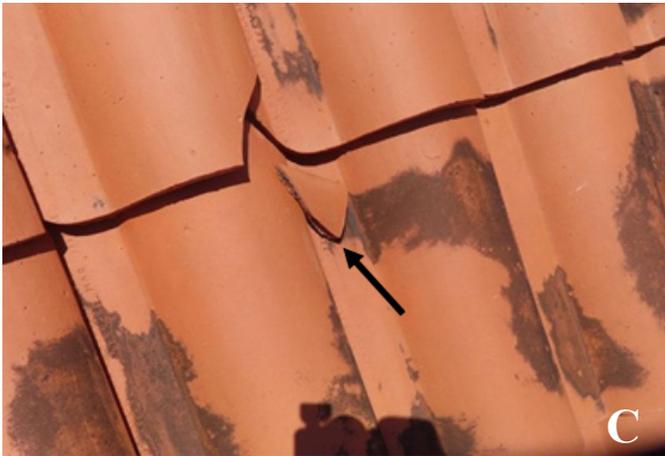
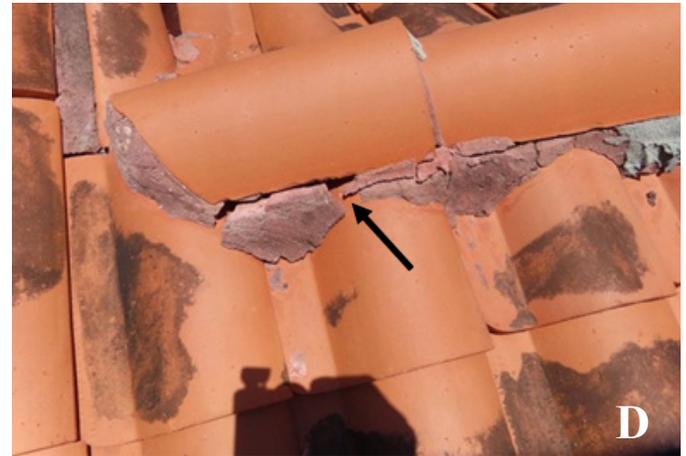
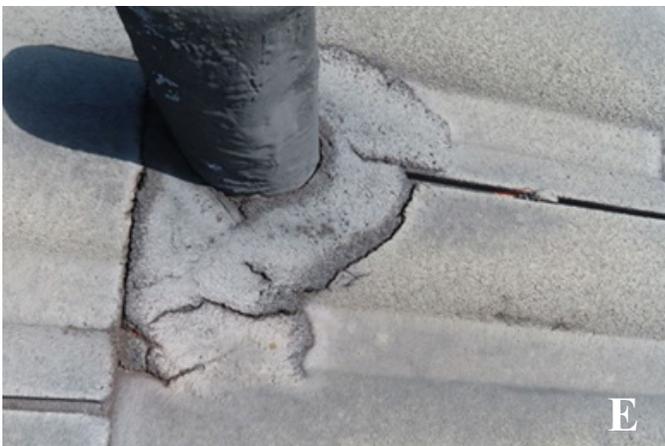
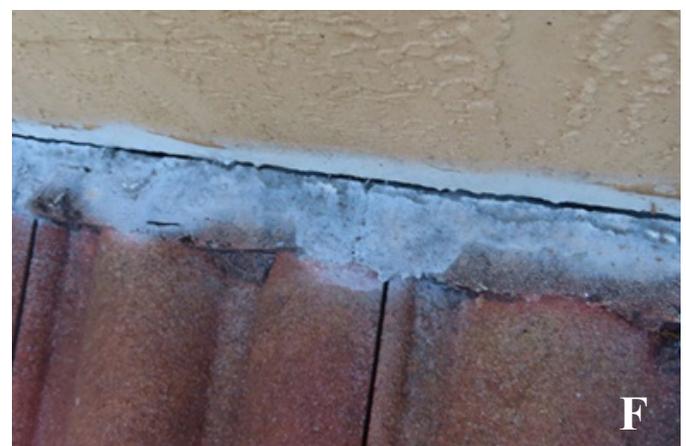
**Figure 9**

deficiencies introduce localized stress concentrations, reduce mechanical interlock, and create voids or misalignments that may lead to premature tile cracking or slippage under normal thermal or mechanical loads<sup>69</sup> (**Figure 9**).

Nonwind-related damage: a) downward shifted tile due to missing fastener, b) improperly sized tile and poor alignment, c) corner chipped tile, d) premature cracking and chipping of mortar, e) cracked mortar around a plumbing vent, f) cracked mortar at roof-to-wall interface.

ing of the mix lead to premature cracking of the mortar (**Figure 9**).

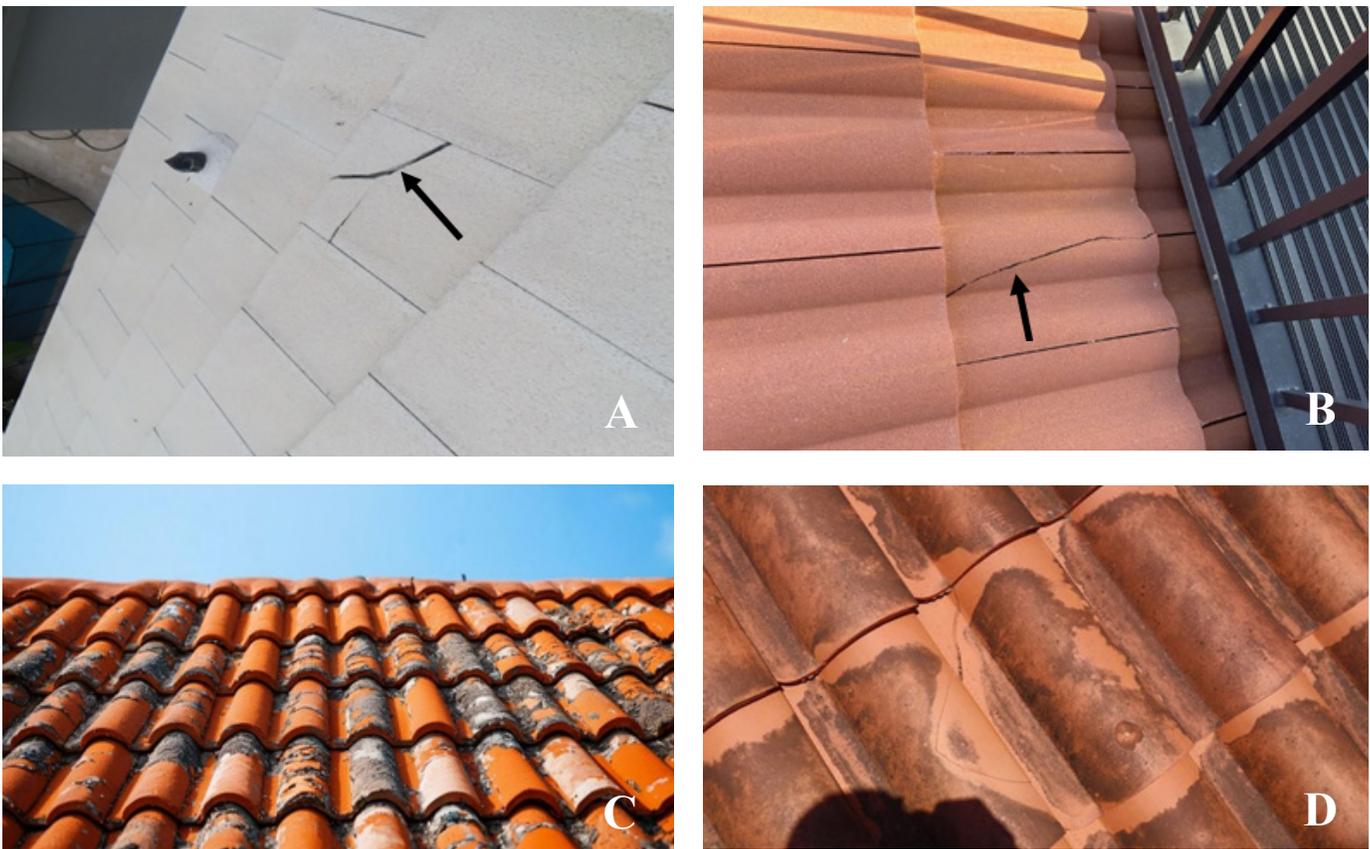
**Figure 10**

Impact damage is a leading cause of nonwind-related failure in tiled roofing systems. This includes localized cracking from foot traffic, impacts from overhanging branches, and tool or ladder contact during maintenance activities. Such cracks are typically irregular and located in walkways, valley intersections, or under satellite dish mounts<sup>69,76</sup>. Concrete tiles, though more resilient than clay, are still susceptible to cracking or chipping at unsupported corners when subjected to concentrated loads emanating from foot traffic and mechanical impact<sup>70</sup> (**Figure 10**).

Footfall damage to roof tiles is typically evidenced by a linear nature of the cracks and lack of radial cracks emanating from point of impact to broken tile surfaces. Broken tile pieces typically remain in place or are slightly displaced downward, depending on the age of the fracture itself. As such, broken tile fragments that remained in place are evidence that the cracking was not caused by wind, as strong wind would have removed the cracked portion from its original position.

Nonwind-related damage: a) footfall damage, b) fractured tile due to foot traffic, c) algae accumulation, d) mildew growth.

Moss, algae, and lichen growth can degrade both clay and concrete tile surfaces. These organisms retain moisture against the tile, encouraging efflorescence and biological etching over time. Root systems from lichens and mosses can expand existing microcracks and lead to mechanical tile displacement<sup>77,78</sup>. Furthermore, animal activity, such as droppings, often damages the surface of the tile, resulting in gradual deterioration and discoloration of tiles<sup>71</sup> (Figure 10).

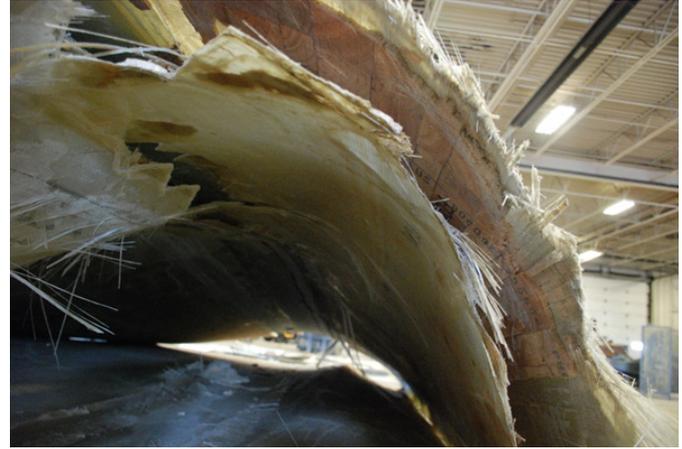
**Figure 9**

Wind-turbine blade fracture surface.

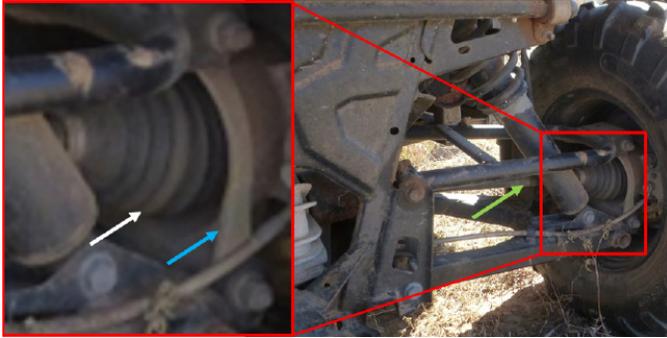
**Figure 1**

Right rear wheel assembly showing drive axle with normal CV boot indicative of axle shaft and joint rotating in tandem. Green arrow = axle main shaft; white arrow = right axle; and blue arrow = bearing carrier.

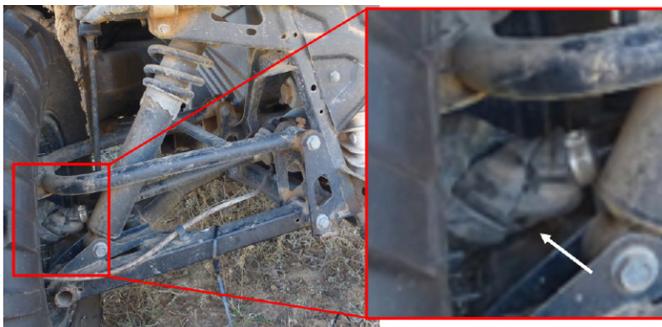
**Figure 2** shows the damaged left axle with a distorted CV boot at the outboard position. The twisted outboard CV boot, indicative of an axle fracture and the axle shaft rotating independently of the CV joint, is highlighted with a white arrow.

Left rear wheel assembly showing twisted CV boot indicative of axle shaft and joint turning independently. White arrow = twisted CV joint boot.

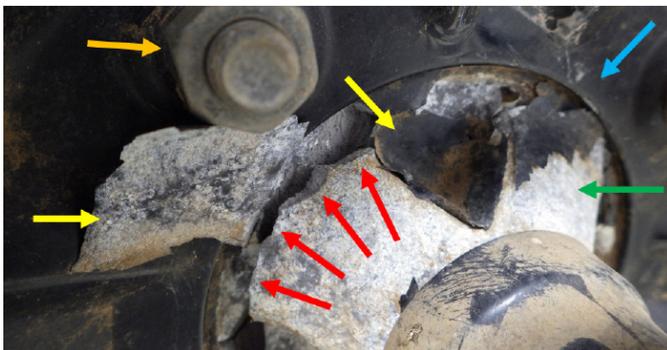
**Figure 6**

Close-up of left rear wheel assembly showing the black painted steel wheel (blue arrow) that is secured by four threaded lugs and nuts (orange arrow), aluminum wheel hub (green arrow), spalling black factory paint to include a detached large flake at left (yellow arrows), and the circumferential hub crack with edge chipping (red arrows).

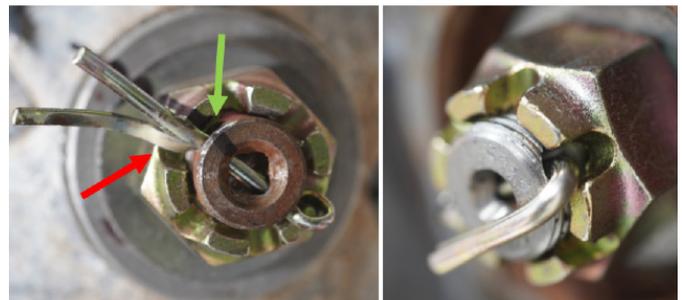
**Figure 7**

Notice how the right rear cotter pin through-hole in the threaded axle stub aligns with the castellated nut slot, while the left rear transverse axle stub cotter pin hole does not align properly with the cotter pin recess. The left rear

Left rear axle cotter pin showing post-installation misalignment of the axle cross hole and castellated nut slot (left). Right rear axle cotter pin showing undisturbed factory-installed alignment (right).

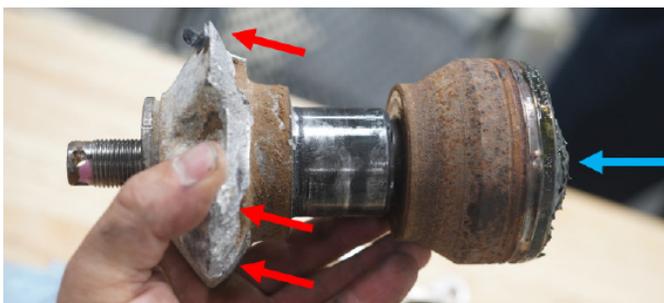
The burnished regions on both sides of the mating conical cast aluminum wheel hub fracture surfaces are from high points rubbing against each other (see **Figures 8 and 9**, red arrows). Also shown with a yellow arrow in **Figure 9** is the polished precision cylindrical interface surface for the wheel bearing; the blue arrow shows the splined internal recess for interaction with the driving end of the axle assembly, which is the outer race "bell housing" of the CV joint.

The physical evidence of burnishing is consistent with

Left rear-threaded axle stub, aluminum wheel hub fragment, bearing, CV joint outer bell. Red arrows indicate representative burnished surfaces; blue arrow shows the installation point of the fractured main axle shaft.

the fracture occurring during travel of the vehicle. There was also major abrasion damage to the disc brake assembly, consistent with the left rear wheel hub wobbling as it rotated. The largely axially symmetric conical wheel hub fracture surface is consistent with a centered inboard to outboard axial force being applied to the wheel hub, rather than a bending moment being applied by a local rim strike. Other than shape and post-fracture damage observations, no detailed fractography was performed on the cast aluminum wheel hub, since there was no macro evidence of a fatigue break at the aluminum hub. The wheel bearing at the center of **Figure 8** between the CV joint outer race at right and the fractured wheel hub at left spun freely. Consequently, it was not further examined.

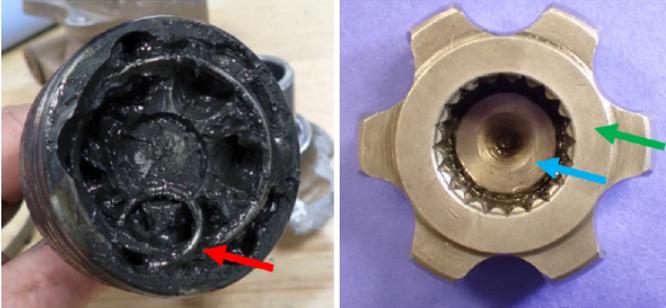
The left rear CV joint, detached from the wheel assembly and with the damaged flexible rubber boot removed, is shown from the inboard side in **Figure 10** (left). Although covered with grease, many details are apparent. From exterior to interior is the bell housing (outer race), the cage, the inner race with six cavities for hardened steel ball bearings with the balls removed, the retaining circlip near the bottom, and the fractured stub of the left rear drive axle in the center. **Figure 10** (right) shows the degreased inner race from the outboard side and the axle stub in the splined inner recess, which is not properly positioned fully outboard.

Left: Inboard view of CV joint bell housing showing fractured end of the main axle shaft and retaining circlip (red arrow).

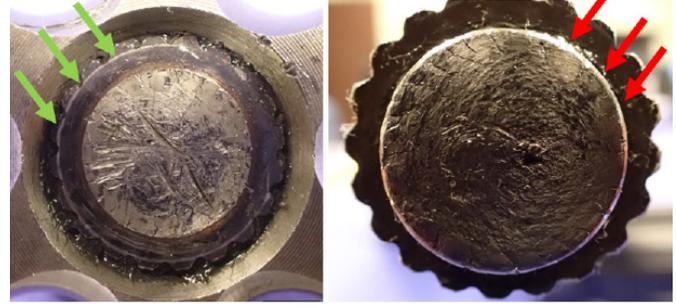
**Figure 11** shows that the fatigue break occurred at the end of the main axle shaft at the outboard side of the circlip groove nearest the inner race. The fracture surface developed at the region of greatest axle bending moment and minimum cross section. The entire axial width of the circlip groove was present on the longer inboard axle shaft fragment (**Figure 11**, right). As a rotating cylindrical member, the fatigue crack progressed semi-uniformly planar to the shaft axis from outside to inside. This also ensured rotary compressive loading of the circlip as the axle shaft and the end past the groove became misaligned; a light in color witness mark of this compression is visible in **Figure 11** (left) — see green arrows.

The arc-like impressions on the main face of the outboard main shaft fragment are consistent with the interfacing rim of the detached inboard axle shaft pressing against the outboard stub during rotation, producing the fracture of the aluminum wheel hub with an inboard to outboard force. The light-colored groove end perimeter in **Figure 11** (right, red arrows) is no longer sharp but presents an

Left: Inboard end of CV inner race and fractured axle end showing a circlip compression mark and multiple arc-shaped impressions from the detached axle main shaft. Right: Outboard side of fractured axle shaft showing classic topographic macro features of fatigue fracture.

irregular beveled interface of the groove wall at the fracture surface. This was caused by cold work compression of this inboard edge against the outboard axle stub center segment during vehicle travel. The fracture surface on the inboard axle shaft fragment is better preserved for macro features of fatigue (**Figure 11**, right). Notable features include<sup>3-5</sup>:

- A. The overall planar fracture surface that is perpendicular to the shaft axis.
- B. The ratchet marks that initiated the planar crack perpendicular to the shaft axis once the axle shaft had backed off sufficiently for the circlip groove to be exposed past the splined region;
- C. Radial spaced arc-like markings of crack progression from exterior to interior; and
- D. An identifiable point of final fracture near the shaft centerline. These macro features were plainly visible with low power optical microscopy and did not require scanning electron microscope (SEM) examination.

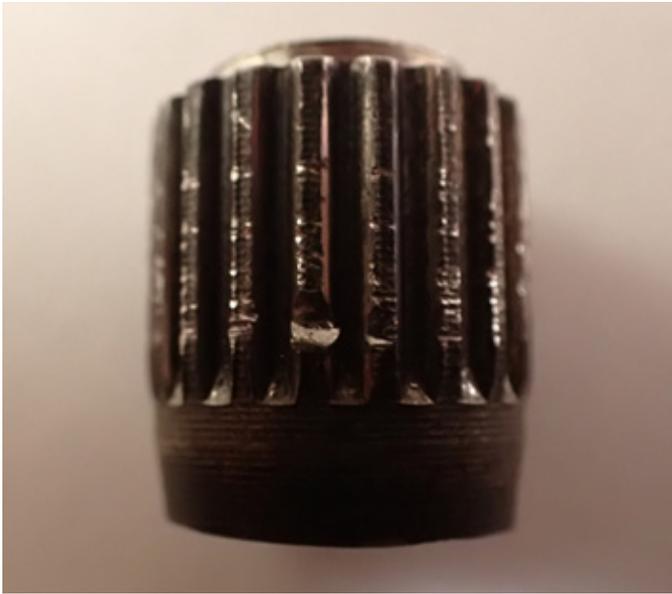
Witness marks about the circlip were consistent with the axle main shaft having been inserted some distance into the inner race, but these marks could not confirm that the main shaft had been fully inserted with circlip expansion at the factory during half shaft assembly. On the main splined surface of the axle were circumferential compression marks documenting bending loading on the axle as the end moved incrementally inboard relative to the CV joint inner race (**Figure 12**). These marks strongly indicate that the shaft was, at least, nearly fully inserted — though perhaps not fully inserted — which would be one potential failure mode mechanism of the shaft backing out. The axle

Sawn-off end of main axle stub, which fractured at circlip groove (top), showing circumferential compression marks developed while it backed out of the mating splines of the inner race.

fragment shown in **Figure 12** is the profile view of the segment shown in **Figure 11** at right.

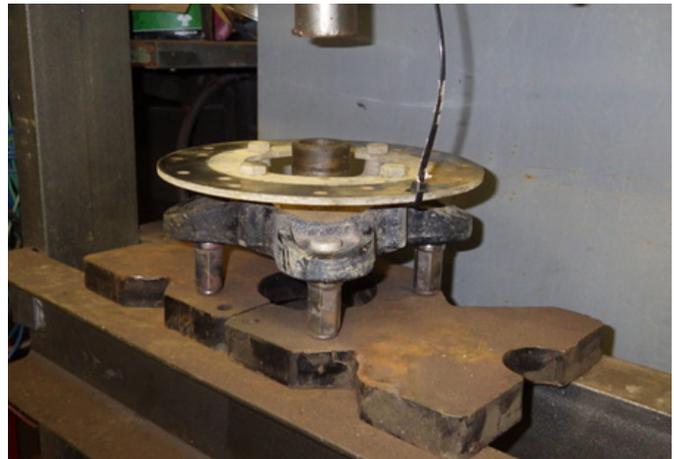
**Figure 13**

were purchased from an on-line salvage retailer and axially loaded using a manual arbor press to develop a concentrated active load on one side and a diffuse reactive load on the other, thus producing outside-in and inside-out loading fracture (**Figure 13**). Note the wheel studs and brake disc attached to the black aluminum wheel hub.

Exemplar wheel hub and arbor press used to apply a concentrated inboard force against the wheel hub.

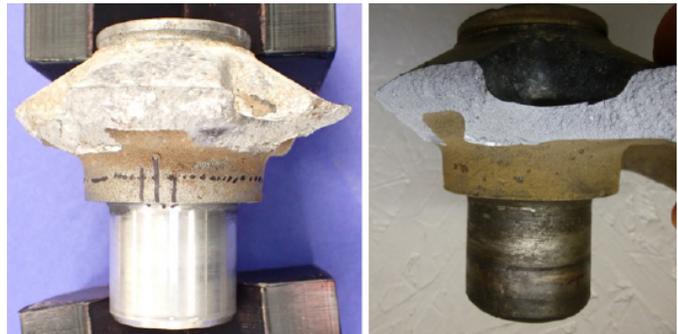
**Figure 14**

The general shape of the fracture surface from the in-board-to-outboard loading produced an angular wheel hub fracture surface, reasonably matching the incident wheel hub (**Figure 14**). While the incident hub was rotating at least 5 revolutions per second at the initiation of yaw and of loss of control, the fracture is a form of “Hertzian cone” in which the principal tensile stresses within the brittle material subjected to focal compressive loading ensures an angular, conical crack progression<sup>7</sup>. As an analogy to the instant fracture, a lead pellet that is discharged from an air rifle into common annealed window glass will produce an entry hole the same diameter as the pellet, a conical fracture downstream of impact through the glass thickness, and, finally, a larger damage diameter hole at the exit plane.

Incident wheel hub (left); Tested wheel hub given inside-to-outside loading (right).

The inboard concentrated load produced a conical fracture surface that diverged from inboard to outboard. The outboard concentrated load produced a conical fracture surface that diverged angularly from outboard to inboard.

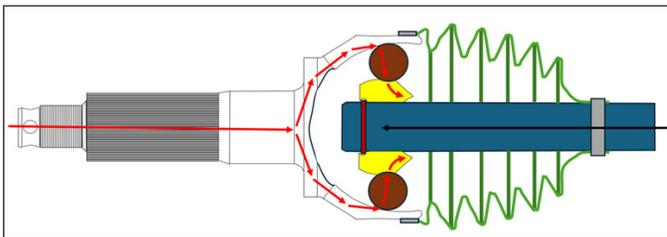
**Figure 15**

Pushing on a UTV tire or wheel inboard produces no compressive or tensile stress on the drive axle. This is easily seen when comparing two-wheel drive and four-wheel drive vehicles — in that the deletion of a drive axle does not require a change to the suspension, as the suspension resists the loading in all directions. Second, as a counterfactual thought experiment, suppose excessive slop existed in the mounts of the incident UTV A-arms that allowed the tires and wheels to objectionably move inboard and/or outboard. The half shaft could, in this hypothetical case, be loaded axially by a wheel strike. However, a wheel strike during barrel rollover would displace the wheel assembly inboard against the half shaft (**Figure 15**).

Free body diagram of wheel force from outboard to inboard against the axle.

resisting force will tend to move the axle and circlip to the left. This would act to seat the outboard end of the main axle shaft to the CV joint inner race — not to overcome the fixation of the circlip and move the main axle shaft inboard. Thus, a conceptual free body diagram of an inboard directed wheel strike loading path further indicates that a substantial wheel strike would not cause the damage observed in the incident overturned UTV.

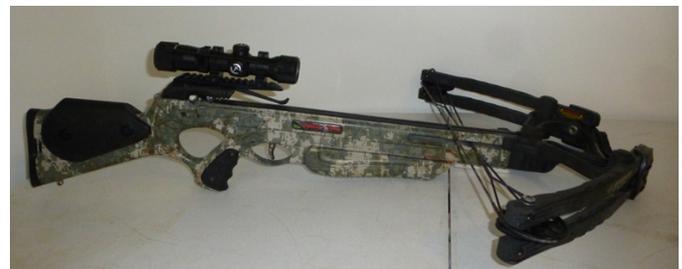
**Figure 3**

According to the user's testimony, he had taken his crossbow hunting for the first time, and he was hunting deer from elevation. The crossbow was cocked but not loaded with an arrow, with the safety at least partially engaged. He rested his right hand on the crossbow flight rail, and no part of his body was touching the trigger. The crossbow discharged, and the bowstring sliced through his hand, severing his middle finger. Subsequent investigation showed that there had been multiple reported OSIs (other similar incidents) of this crossbow inadvertently discharging and causing user injury. These reports were found in warranty claims, internet archery discussion forums, and litigation.

Case Study 1 incident crossbow assembled circa 2017.

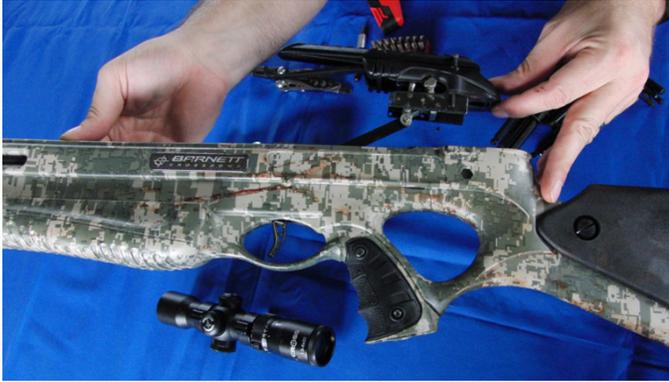
**Figure 4**

An inspection of the crossbow was performed, including removal of the trigger mechanism, as shown in **Figure 4**. Similar to the crossbow trigger mechanism previously

Incident crossbow showing removal of trigger mechanism and scope mount with draw bar leading to trigger shoe.

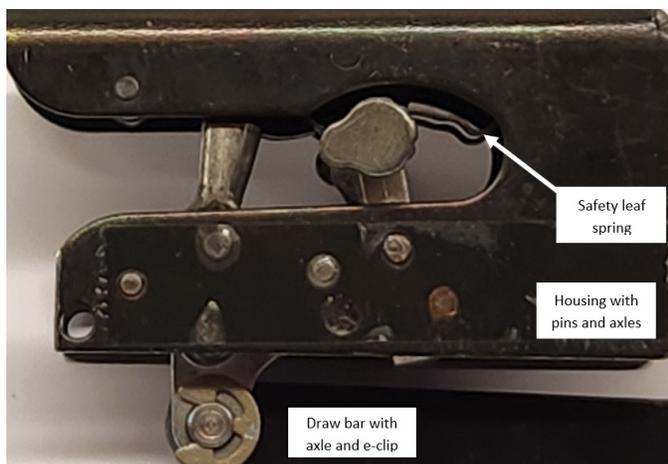
**Figure 5** shows the trigger mechanism removed from the crossbow stock with the trigger draw bar rotated backward. The basically rectangular stamped steel housing is perforated to mount transverse pins that act as axles, torsional spring posts, and component stops. An internal-stamped steel leaf spring near the top of the housing is

Incident crossbow trigger mechanism, ready, with the safety in the FIRE position with trigger draw bar folded ~180° rearward.

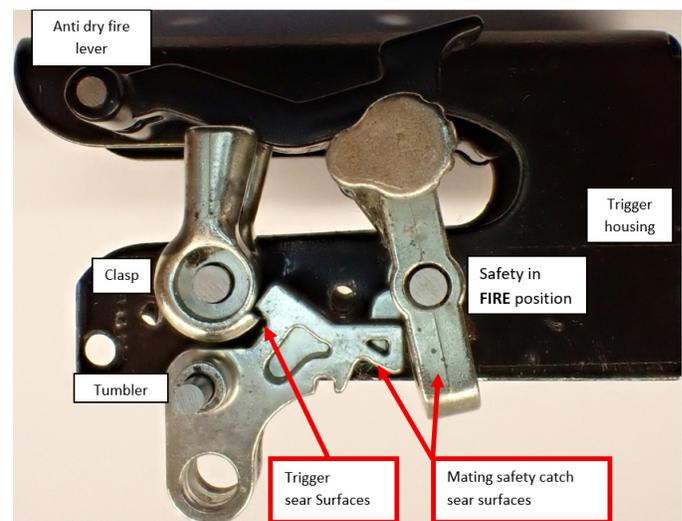
**Figure 6**

The trigger mechanism components and their axles were removed from the stamped steel box housing, and longer gage pins were inserted into the component axle holes from the left side to facilitate a positional layout of the major moving components, as shown in **Figure 6**. The multiple torsion springs, which bias individual component motion, are not shown. The biasing springs rotate the anti-dry fire (ADF) lever DOWN, the clasp VERTICAL, the tumbler ENGAGED (as shown, fully counter-clockwise), and the safety fixed either fully forward or backward as a detent. In **Figure 6**, the sear surface of the tumbler is in the engaged position — such that the clasp cannot rotate forward counter-clockwise into its released position.

Incident crossbow trigger mechanism with internal components and axles removed with the four major components affixed to the left exterior side of the housing and the trigger bar removed from the sear.

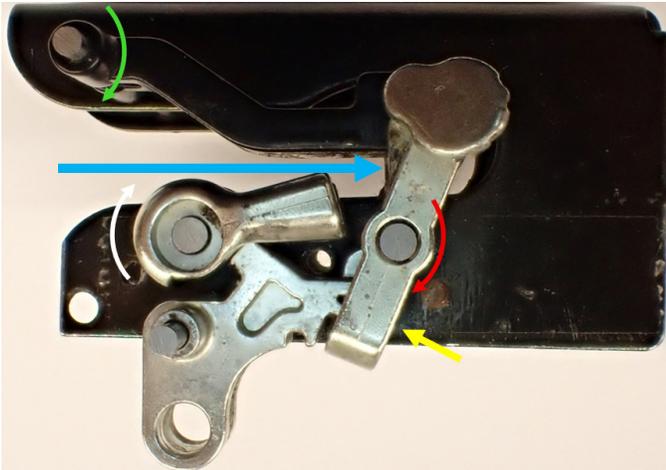
**Figure 7**

Incident crossbow trigger mechanism showing full draw position of bowstring represented by a blue arrow.

it from rotational motion. Also at full draw, the ADF rotates downward (green arrow). It will prevent the safety from rotating back to the FIRE position until the ADF is rotated back upward by the insertion of an arrow and nock onto the bowstring.

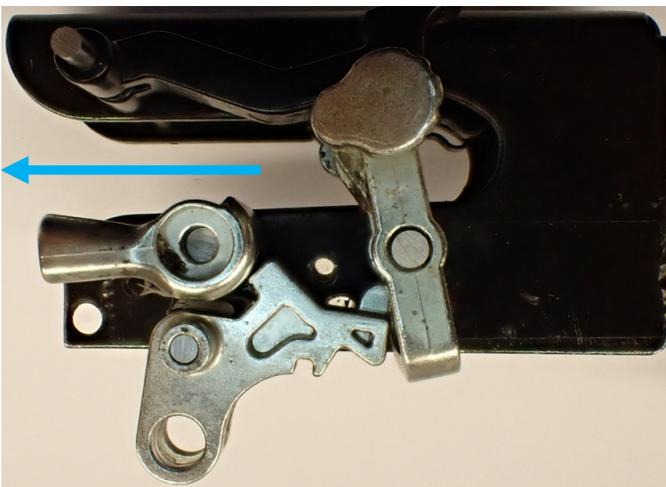
**Figure 8** shows the trigger mechanism components as they are positioned at the moment of firing. The ADF lever had been moved up by the presence of the arrow. The safety was then moved forward to the FIRE position. The draw bar pulled the tumbler such that it rotated clockwise, disengaging the tumbler’s sear surface from the mating surface of the clasp. The unconstrained clasp rotated ~90° counter-clockwise and released the bowstring and arrow, which rapidly moved forward (left) as represented by the blue arrow.

Incident crossbow trigger mechanism showing discharge position.

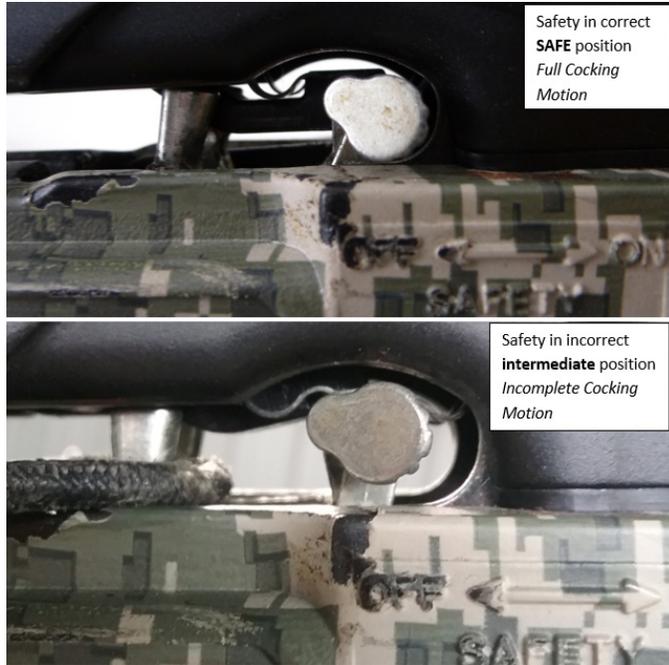
This is also shown with the components properly assembled in the crossbow. The top image of **Figure 10** shows the safety in the fully SAFE position without the bowstring present. Note that the ADF lever has moved downward, blocking forward motion of the safety if no arrow is loaded. The lower image of **Figure 10** shows the cocked crossbow with the bowstring and clasp in the proper position, but the ADF and the safety are not in the proper position. This miscocked condition was deliberately produced by a minimal rope cocking device pull for which the bowstring would index the clasp but not move the top of the safety lever fully rearward.

Based upon analysis and investigation of the incident crossbow, it was determined that this trigger design was sub-optimal. It was found that the ADF lever, while somewhat valuable, was not “active” in that the safety could be moved to FIRE after an arrow was loaded. Then if the arrow were removed, the safety would not automatically return to SAFE. In addition, the geometry of this mechanism was such that the bowstring could be deliberately or

Incident crossbow safety and ADF lever showing the proper position when drawn at top (bowstring not shown), and an incorrect intermediate position at bottom with the ADF not actuated and the tumbler not fully constrained, if at all.

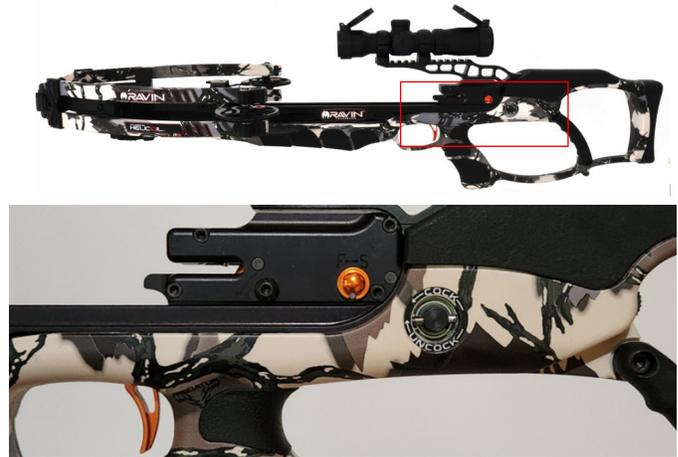
**Figure 11**

The second crossbow design evaluated in this study represents a significant technological advancement over the “value” crossbow model described in Case Study 1, despite their brief concurrent market presence. Introduced in 2016 by Ravin, a startup company founded to develop and market this design, this premium model features composite construction materials, relatively short power cables that do not cross under the barrel, and helical power cable journals facilitating a compact limb arrangement. Unlike many designs (e.g., Case Study 1 crossbow), this crossbow omits a foot stirrup as it incorporates an integrated crank cocking mechanism to draw the bowstring. This design also features an internal ADF trigger mechanism intended to allow the crossbow to only fire when an arrow nock is fully engaged to the center of the bowstring (Figure 11).

Photograph of the crossbow design of Case Study 2, Ravin R9 / R15 at top, along with a close-up of the trigger shoe and trigger pack at bottom.

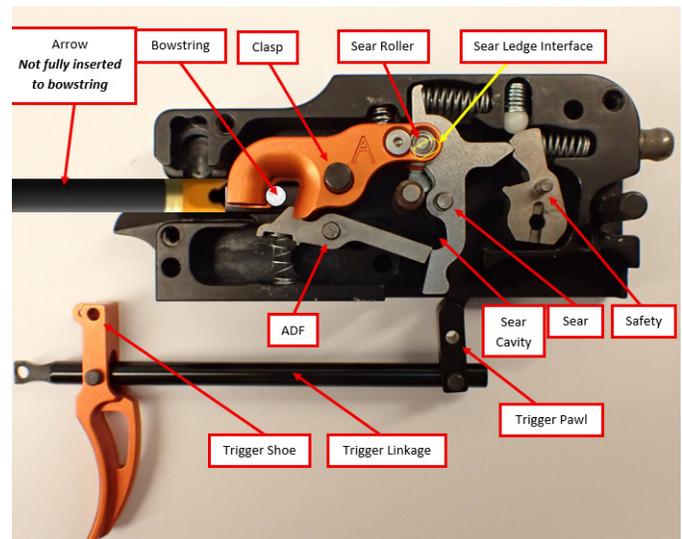
Photograph of the generation 1 trigger mechanism in the cocked but unloaded position.

**Figure 12** illustrates the dismounted and partially disassembled “generation 1” (that is, originally marketed) trigger mechanism of the Ravin R9 and R15 crossbows, which are detailed in the associated patent<sup>16</sup>. To enhance visibility of key components, the left cover of the trigger housing has been removed. For clarity, a digital representation of an arrow stub equipped with an orange post-recall nock and a circular depiction of the bowstring cross-section, held by the clasp, have been superimposed. Red arrows, used to label component nomenclature, indicate the rotational axes of the respective parts where applicable. A yellow rectangle highlights the concealed sear ledge interface, which must disengage to enable crossbow discharge. The arrow retention actuator and its forward coil spring (located ahead of the clasp) have been omitted, as has the trigger shoe return spring, typically anchored at the forward holes of the trigger shoe and trigger linkage.

When the crossbow is cocked, the clasp is in the down position, and it retains the tensioned bowstring until the sear disengages, releasing the clasp, bowstring, and arrow. As depicted in **Figure 12**, the clasp is prevented from rotating to the open position by the sear’s interfacing sear ledge surface. The clasp’s sear roller, a cylindrical hardened steel pin, is transversely mounted within the clasp and supported by sealed ball bearings on both sides. The trigger mechanism of **Figure 12** is shown with the safety in the SAFE position, locking the sear against clockwise rotation. Additionally, the ADF lever blocks sear rotation in this illustration, as the digitally inserted arrow has not been fully inserted rearward to push down the ADF lever’s leading nose (see green arrow in **Figure 13**, which shows the trigger mechanism in the discharged configuration). For the sear to release the clasp, two conditions must be met: the user must rotate the safety to the FIRE position, and the ADF lever must be rotated counterclockwise by the full insertion of an arrow. After firing, the clasp moves

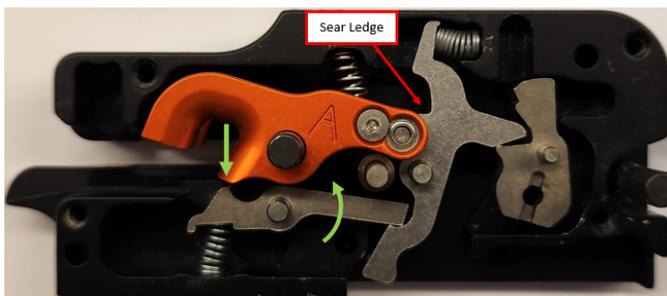
**Figure 13**

Photograph of the generation 1 trigger mechanism in the discharged position with the ADF lever inside of the sear cavity and the green arrows indicating the direction of ADF travel to disengage the ADF and allow sear rotation.

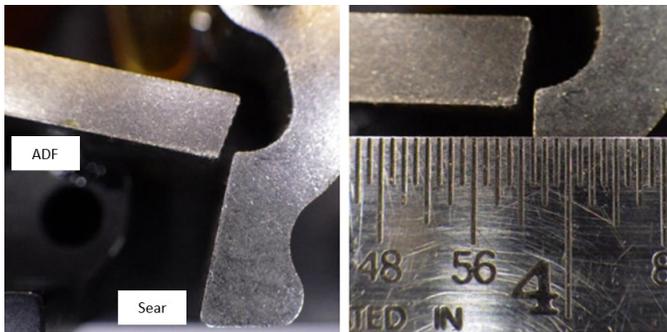
**Figure 14**

1. The archer cocks the crossbow using the integral crank mechanism, which automatically engages the physical blocking safety against the sear. The user interface button is below the safety rotation axle, so that the button moves backward to the SAFE position and displays a white dot, while the internal ledge, which is above the axis of rotation, moves forward and supports the sear.
2. The archer loads a factory arrow with its clip-on nock. The nock clicks and vibrates upon interaction with the bowstring, giving the user both tactile and audible feedback of success. The bottom surface of the arrow nock rotates the ADF lever from its fully engaged at-rest position, but not completely, putting it in a position that will prevent it from entering the sear cavity upon trigger pull. That is, the ADF is rotated into an intermediate position (**Figure 14**), with a prominent

Photographs of the generation 1 ADF and sear in the intermediate position with the ADF trailing edge not completely clearing the entrance to the sear cavity.

gap between the ADF endform and the sear. This gap is objectionable; it allows the sear to rotate enough to assume an unsafe and unstable position.

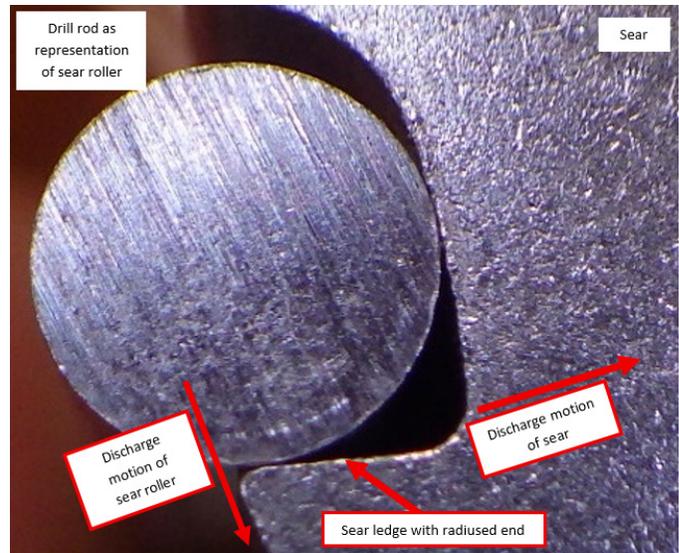
- The archer's trigger finger pulls the trigger shoe, causing the front surface of the trigger pawl to press against the back surface of the sear and rotate it slightly, taking up the gap between the sear and the ADF lever. As the ADF lever is only partially aligned with the sear cavity's entrance, it prevents the sear from fully rotating. As a result, the sear roller shifts beyond the supporting point on the sear ledge (**Figure 15**), exerting considerable force and prying the sear toward the discharged position. The red arrows in **Figure 15** highlight the insufficient support of the clasp's sear roller by the sear ledge, indicating a design error.

Drill rod in the same diameter as the sear roller resting on the sear ledge, showing that the contacting point of the cylinder is incrementally past the point of edge radius initiation with red arrows representing discharge motion direction.

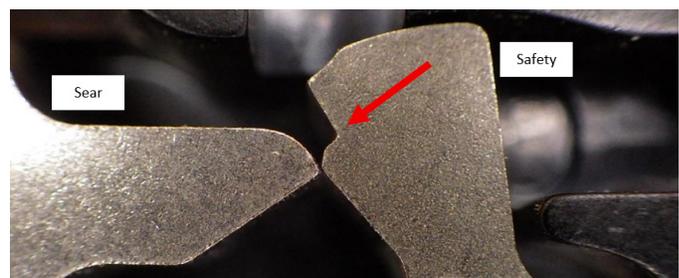
**Figure 16**

the safety button rearward (away from the discharge end). However, the internal safety mechanism only partially moves and becomes fixed in an unstable intermediate position — unable to fully engage beneath the sear's horn (**Figure 16**). The sear obstructs the safety's path, preventing proper engagement.

Generation 1 sear in the intermediate position at left and the safety at right in the FALSE SAFE position, with the red arrow showing both the direction of motion of the safety against the sear and the unengaged safety ledge.

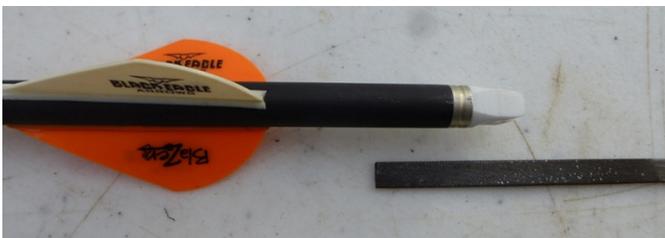
**Figure 17**

To validate the mechanistic feasibility of the incident sequence, crossbows involved in user injuries were individually tested using modified arrow nocks. These modifications enabled a cock/load/trigger pull sequence with the ADF lever positioned at various angles. Specifically, the bottom surfaces of polymer nocks were incrementally filed to reduce the ADF lever's rotation when an arrow was fully inserted. Minimal filing had a negligible impact on the ADF lever's rotation, whereas extensive filing prevented arrow discharge by entirely restricting the sear's rotation. The objective was to identify an "intermediate" degree of filing that replicated the conditions leading to user injuries and to document the crossbow's characteristics when this intermediate condition manifested, as shown in **Figure 17**.

Jeweler's file and Ravin crossbow filed nock on the side with the index vane — the bottom surface of the arrow when inserted into the trigger pack.

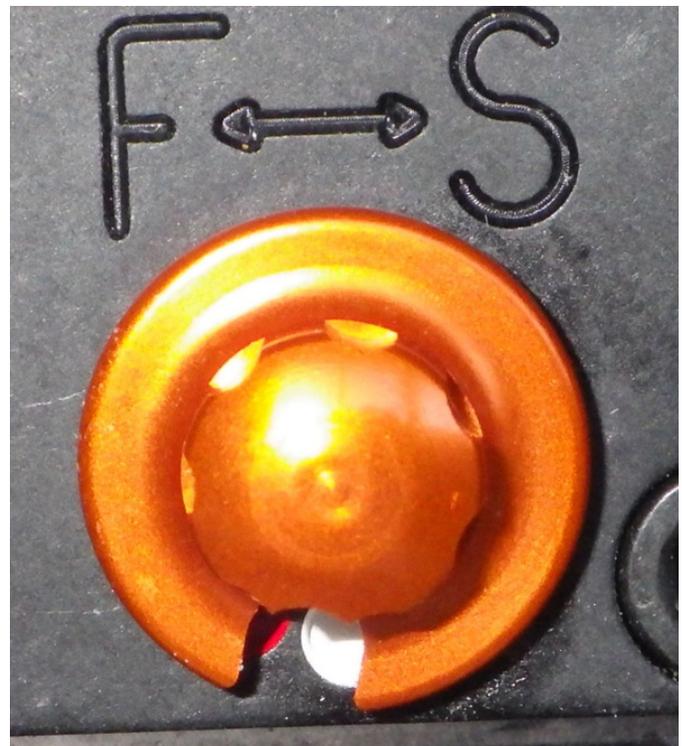
**Figure 18**

clicking sound when the trigger shoe was pulled, signifying the internal unstable re-arrangement of components, but no arrow discharge. This indicating sound was not recognized by unsophisticated archers who had no knowledge of trigger mechanism defect. When the safety button was pushed forward during filed nock testing, the safety position indicator window reliably indicated that the crossbow was neither set to SAFE nor to FIRE (**Figure 18**). This subtle indicator of the crossbow's intermediate position was also not recognized by the users.

Ravin R9 crossbow safety showing the intermediate FALSE SAFE position with half of the SAFE white dot showing and half of the red FIRE dot showing.
