Journal of the  
**National**  
**Academy** OF  
**Forensic**  
**Engineers**<sup>®</sup>

Vol. 42 No. 2 December 2025

# Discerning Wind-Related Damage to Residential Roofs

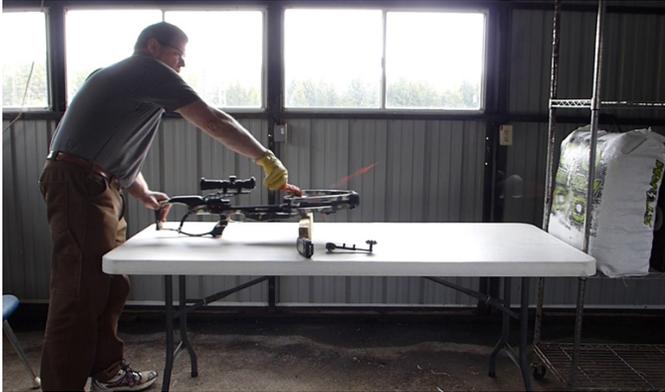
**Figure 19**

All crossbows tested in the intermediate position, with the safety mechanism set to the FALSE SAFE state, underwent further evaluation by re-seating the arrow shaft and nock into the trigger pack using a shaft-gripping implement. In every instance, this action resulted in immediate crossbow discharge (**Figure 19**).

Author deliberate re-seating of an arrow in an incident crossbow using an implement causing discharge without a finger on the trigger — notice the arrow vane which has dislodged as a result of the discharge.

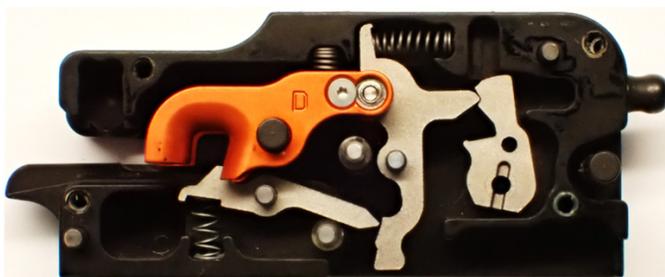
**Figure 20**

Photograph of the generation 2 trigger mechanism documenting geometric changes at ADF / sear interface amongst other improvements.

Laboratory testing of the incident crossbow trigger design substantiated the eyewitness accounts of the multiple injured users, confirming that their crossbows discharged unexpectedly during arrow re-seating. These incidents occurred under the following conditions: (A) after a misfire; (B) following re-engagement of the safety mechanism as outlined in the user manual; (C) without subsequent trigger activation; and (D) during the manual re-seating of the factory-supplied arrow. Changes were made to the ADF lever, sear, sear roller, and other components of the generation 1 trigger mechanism as a comprehensive upgrade, making the generation 2 trigger that has shown to be substantially more reliable.

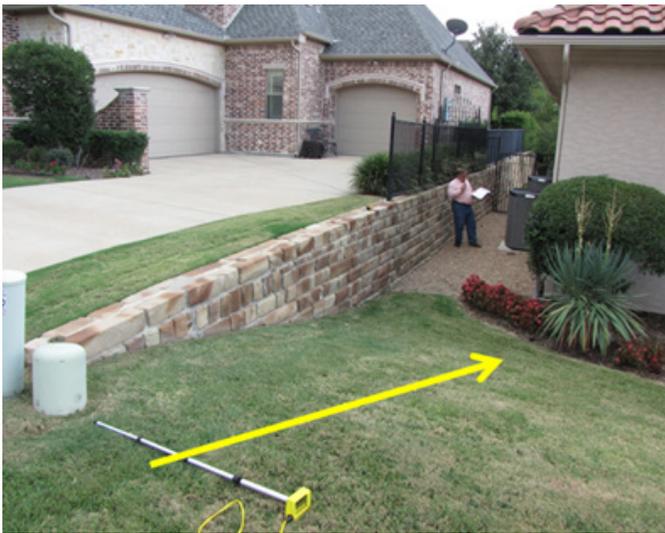
**Figure 6**

Photograph of drainage grades in northeast portion of the subject property.

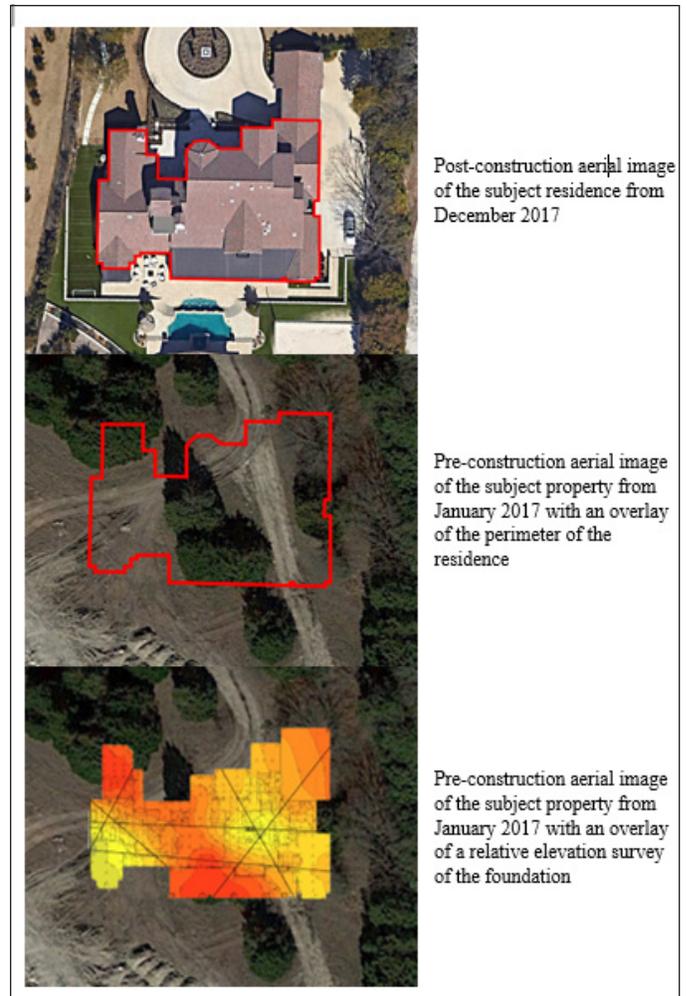
**Figure 7**

Pre-development and post-development aerial imagery with residence outline overlay and relative elevation survey overlay.

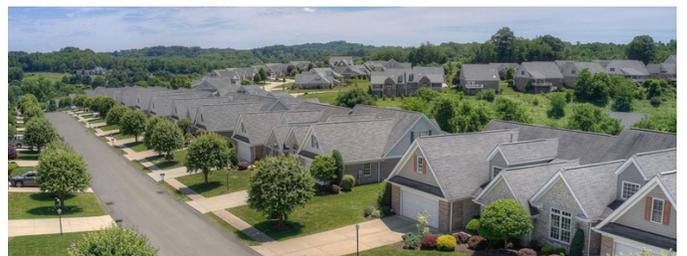
**Figure 8**

General view of subject site topography.

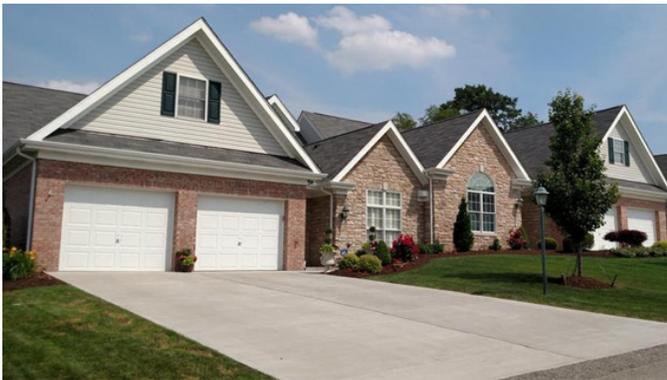
**Figure 9**  
Front elevation of the subject unit.

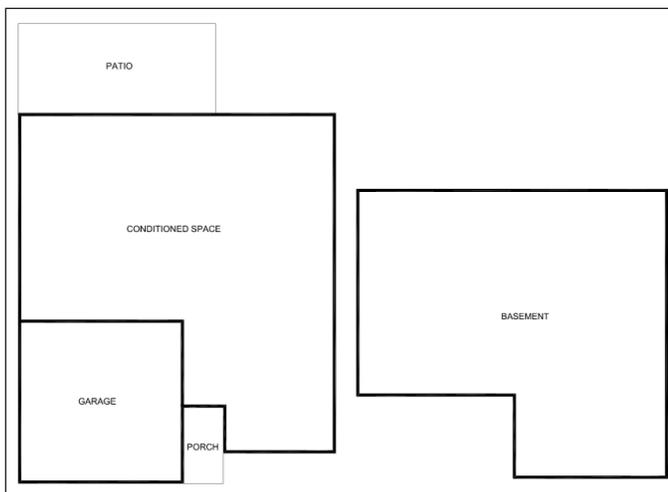
**Figure 10**  
Schematic of the main level (left) and the basement level (right).

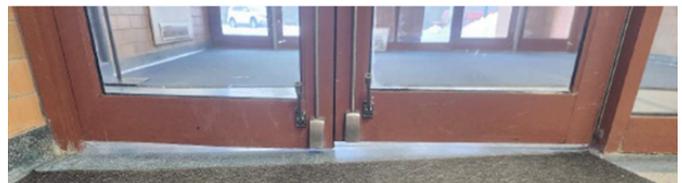
Figure 12

It was reported that adjustments had been made to the entry doors in order to remain functional. Based on measurements of modifications to the front entry doors, the center of the vestibule floor appeared to have moved upward approximately 2 inches since original construction (Figure 12).

Photograph of the front entry doors.

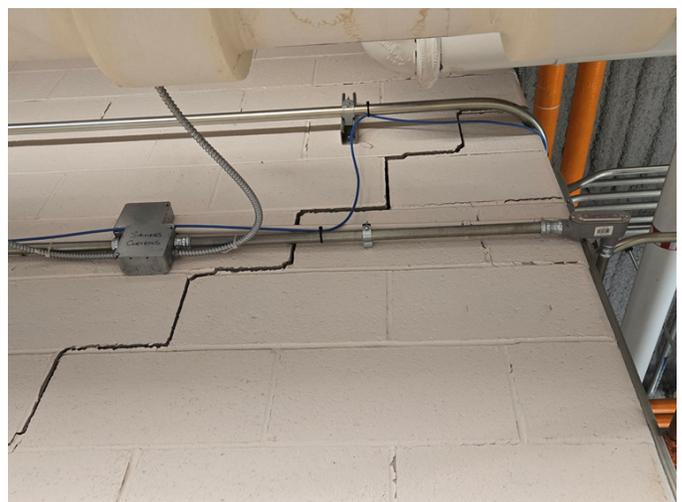
Figure 13

Distress to the walls, in the form of cracking and displacement, was observed in some masonry walls of the building, primarily within the electrical room (Figure 13). At the northernmost portion of the west masonry wall, a level-line was drawn across a vertical expansion joint on November 20, 2009. The masonry wall to the north is an exterior wall on a shallow spread footer, and the western wall is an interior, non-load-bearing CMU wall on the slab-on-grade. Since that level-line was drawn in 2009, the southern portion of the non-load bearing western wall has risen approximately 0.5 inch. Nearby stairstep cracking was later observed, and follow-up survey data gathered in this area indicated that the southern (interior) wall was rising at a greater rate than the eastern (interior) wall.

The footers, coupled with the weight of the exterior wall loads, appeared to be sufficient to resist expansive forces. Heaving was isolated to the slab-on-grade and non-load-bearing masonry walls, which suggested that expansive pyritic soils remained beneath many portions of

Photograph of cracking in masonry wall.
