Journal of the
National

Engineers[®]

Vol. 32 No. 2 December 2015

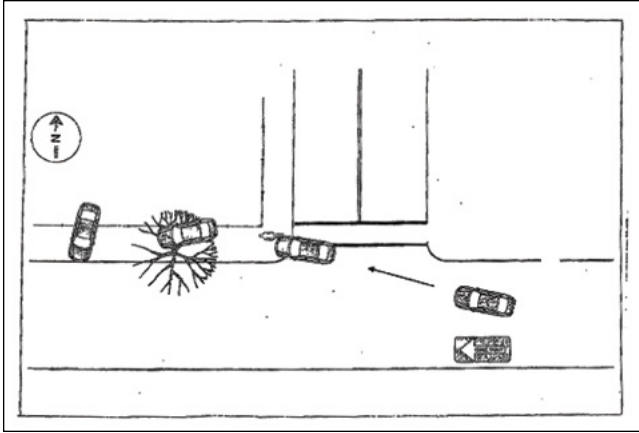
Figure 2

The sketch prepared by the prosecution accident reconstructionist is similar to the sketch in the police report in that it shows the deceased pedestrian being struck while standing on the sidewalk.

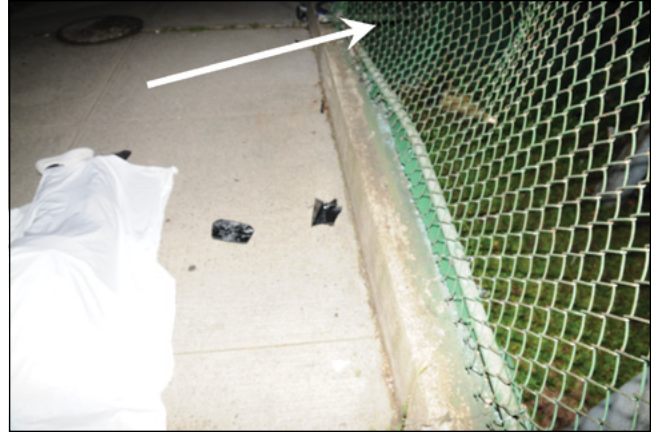
Figure 9

Pedestrian rest position. Notice the indentation of the chain-link fence where pedestrian struck as a result of her trajectory from the vehicle into the fence. The arrow shows the indentation into the chain-link fence.

Additionally, the pedestrian was not standing on the sidewalk when struck by the vehicle because there was not enough distance for her to be carried by the vehicle and strike the fence, as shown in **Figure 9**. The carry time of the pedestrian is approximately 200

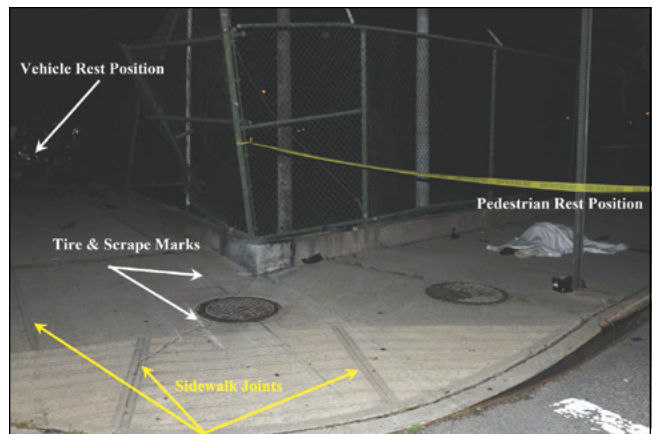
Figure 10

The photograph shows tire marks and scrapes (white arrows) where the vehicle mounted the sidewalk and sideswiped the fence. The yellow arrows depict the sidewalk joints. At this point in time, the vehicle was yawing; the fence sideswipe caused AE but no airbag deployment (ND).

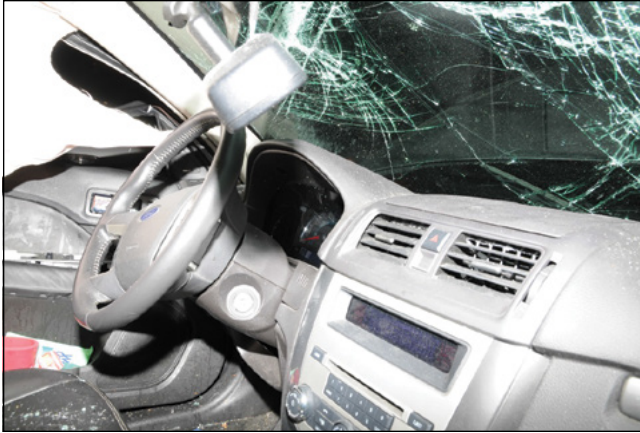
Figure 12

The interior of the vehicle shows that the front airbags were not deployed.

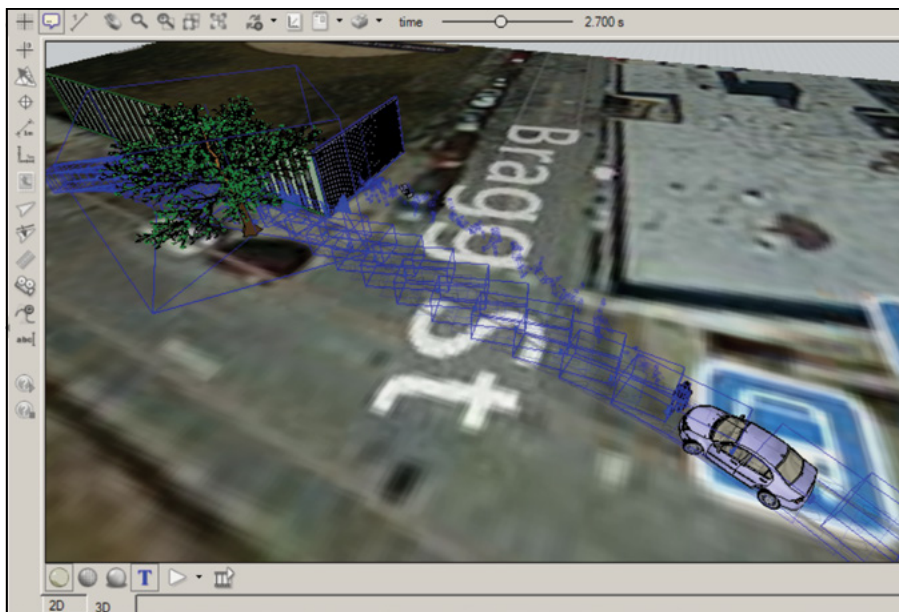
Figure 16

2.7 seconds into simulation corresponds to -2.3 seconds CDR. Pedestrian is in the roadway in front of bus stop. The image is taken from Virtual Crash simulation.

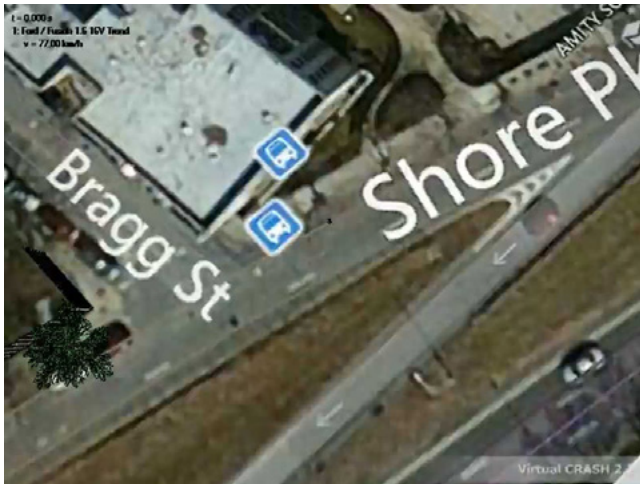
Figure 20

Above is the overview of the path of the vehicle along the service road. The vehicle strikes the pedestrian in the roadway near the bus stop. The pedestrian is projected into the chain-link fence and falls to the sidewalk. The vehicle continues into the tree and comes to rest at approximately its rest position as depicted in the photographs.

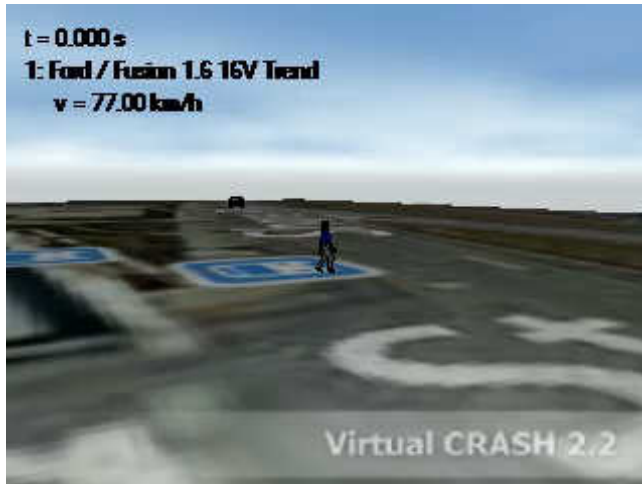
Figure 30

Video of pedestrian being struck in street near bus stop and projected into the fence.

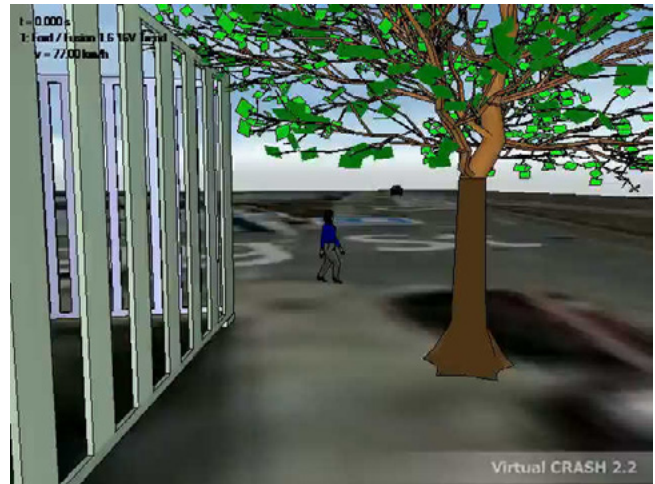
Figure 31

Video of pedestrian being struck on the northwest corner sidewalk as opined by the prosecution expert.

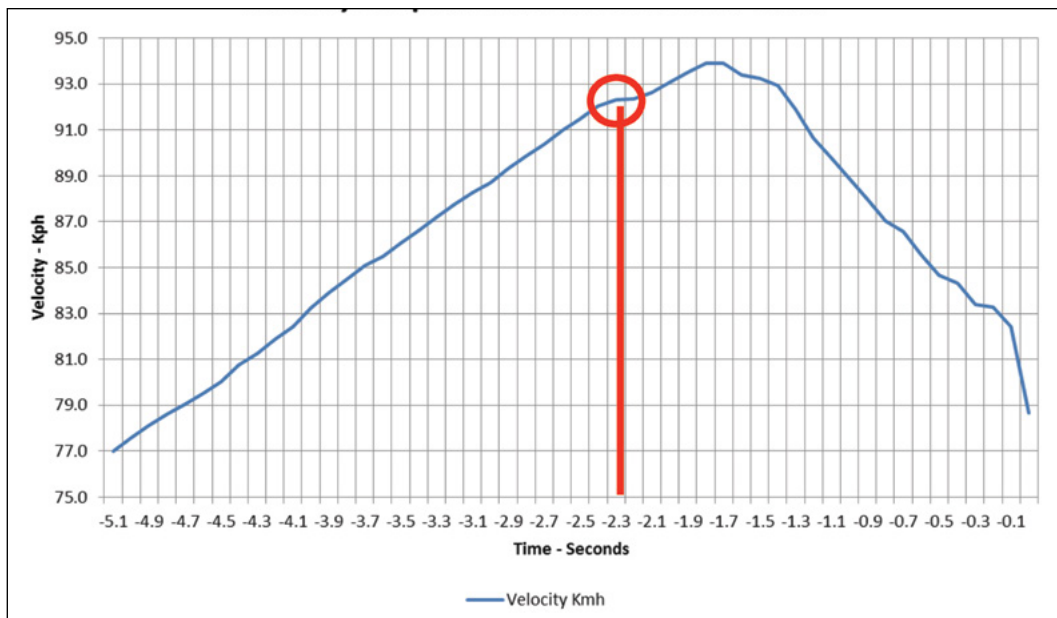
Figure 32

The problem with the author’s analysis is that the graph below, which is taken directly from the CDR data, shows a small change in velocity at 2.3 seconds — the estimated point of pedestrian impact (see **Figure 32**). The graph below, which is from the Virtual Crash pedestrian impact data, shows a distinct change in velocity at the same time.

The velocity of the vehicle (in kph) from the CDR download where the probable pedestrian hit coincides with the simulation by Virtual Crash as shown. Vehicle travels from left to right.

The probable cause of error is because the vehicle is at 100% throttle, which has a small effect on the change in velocity of the vehicle but a large effect on impacting the pedestrian.

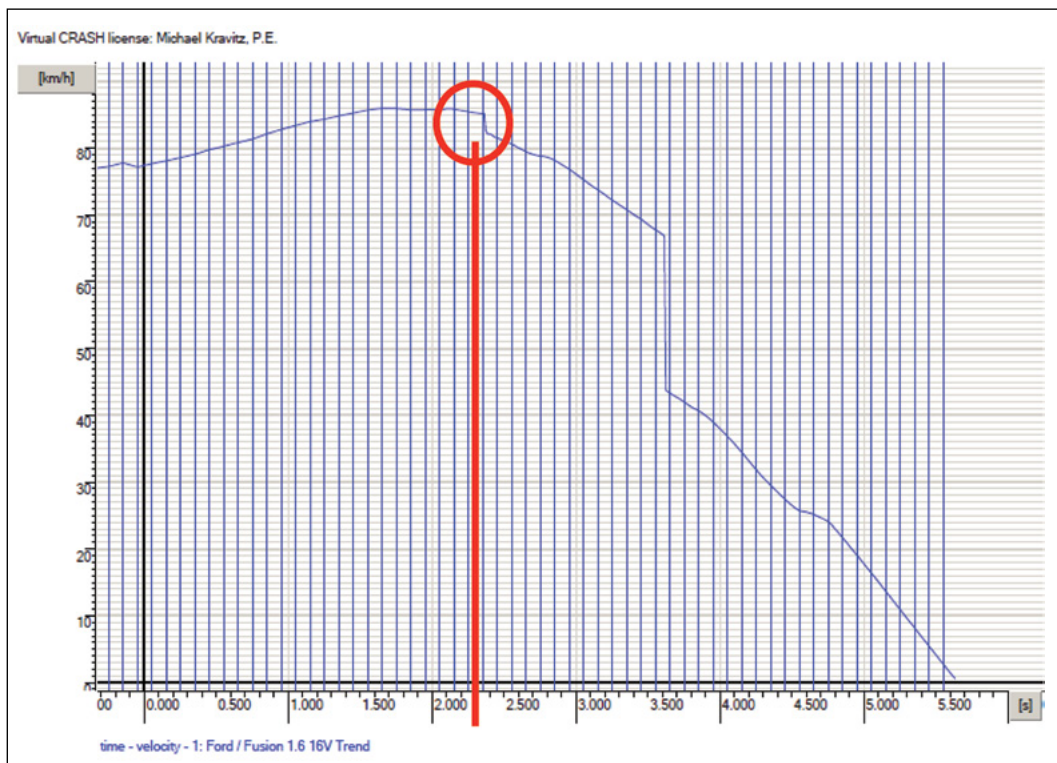
Figure 33

The Virtual Crash graph with the pedestrian hit shows a vertical drop in velocity (see **Figure 33**).

The graph above shows the pedestrian hit at about 2.3 seconds from the simulation of Virtual Crash. Notice the vertical drop indicated, which shows a change in velocity of the vehicle (traveling left to right).

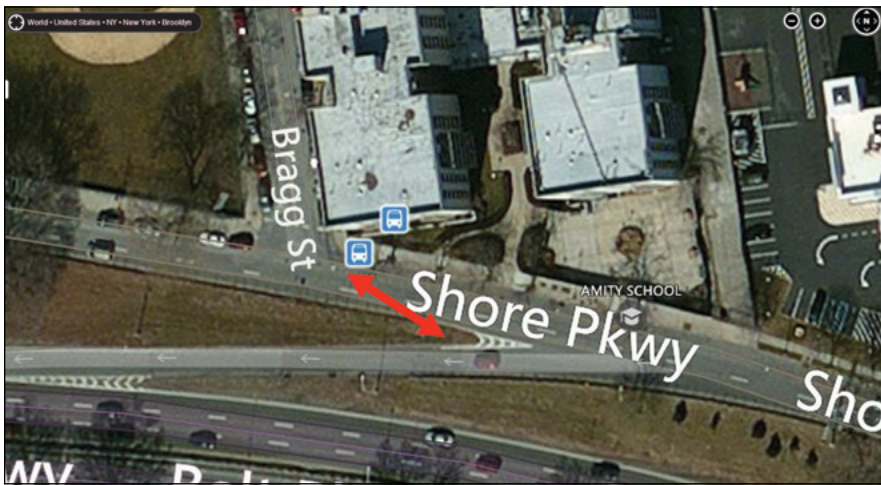
Figure 34

After sentencing, the author was informed of the negotiation between the prosecutor and defendant's attorney that resulted in the DWI plea. The defendant's attorney discovered that the pedestrian had a psychological illness, and it was noted in her records by her doctor that she wished to commit suicide by walking in front of a vehicle. She gave this statement to her psychiatrist 10 days prior to the accident. It was surmised by the defendant's attorney that she wanted to walk onto the service road that night. The on-ramp entrance to the parkway was a short distance from where she was struck, as indicated by the arrow (see **Figure 34**).

Image of pedestrian being struck in street near bus stop.

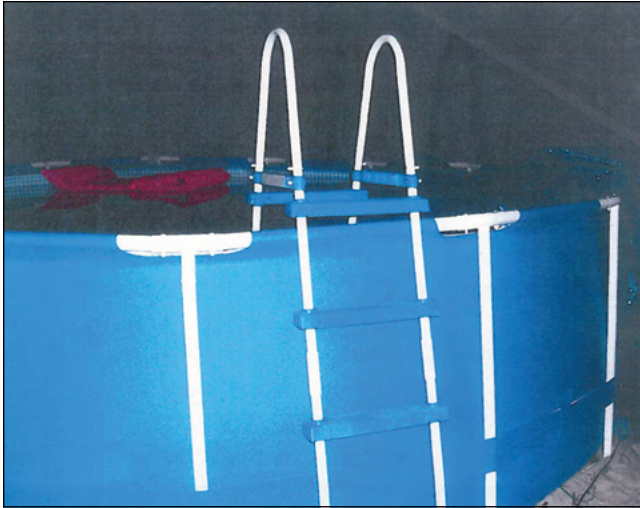
Figure 1

Above-ground swimming pool involved in the accident.

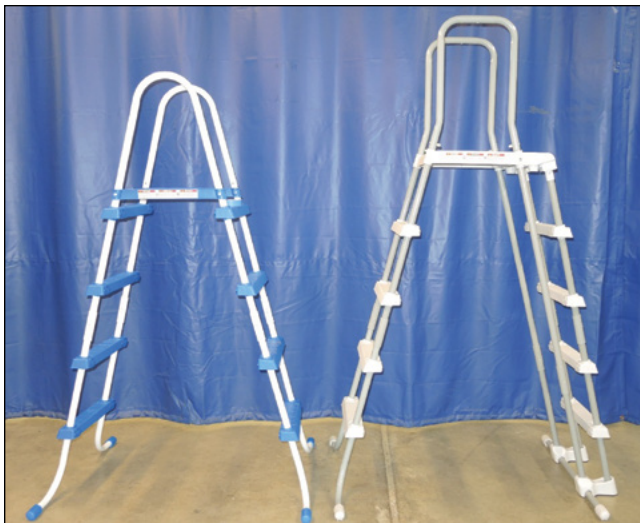
Figure 6

The manufacturer of the pool package involved in the subject incident also makes a "deluxe" A-frame ladder, but continues to sell A-frame ladders similar to the one involved in the submersion accident. Both ladders are depicted side by side in **Figure 6**.

Comparison between A-Frame ladder included with pool (left) and "deluxe" manufacturer ladder (right).

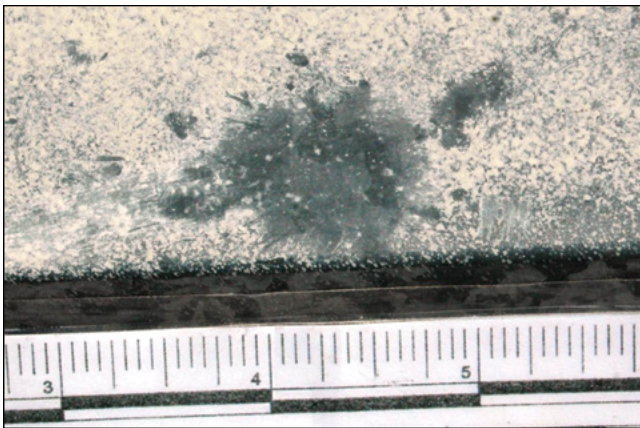
Figure 2

Spatter mark from hailstone impact (ruler demarcated in inches).

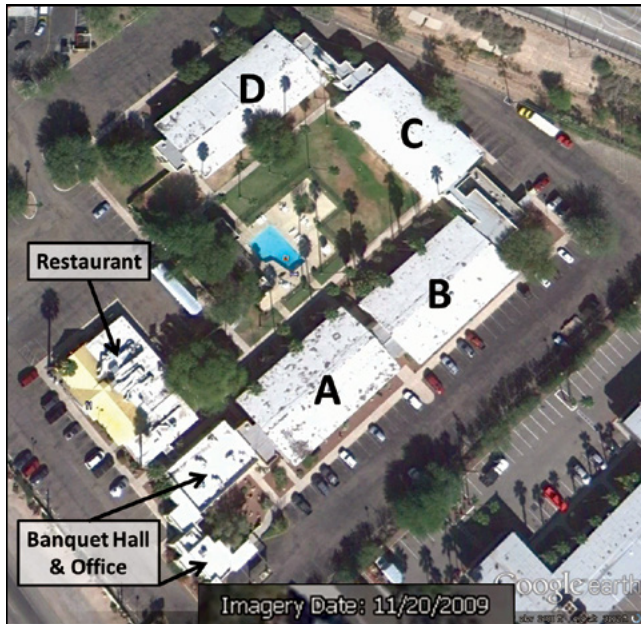
Figure 4

Image of roof from Nov. 20, 2009.

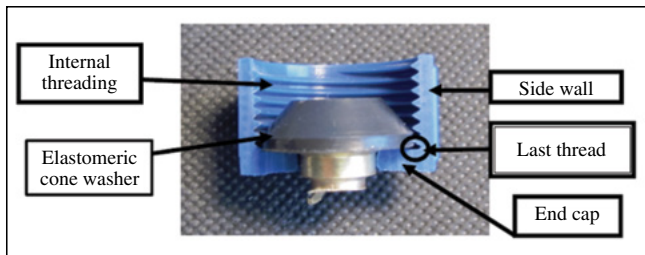
Figure 2
Cross-section of nut assembly.

Figure 2 is a photograph of a cross-sectioned nut showing the rubber cone washer and the end of the copper tube that form the water seal.

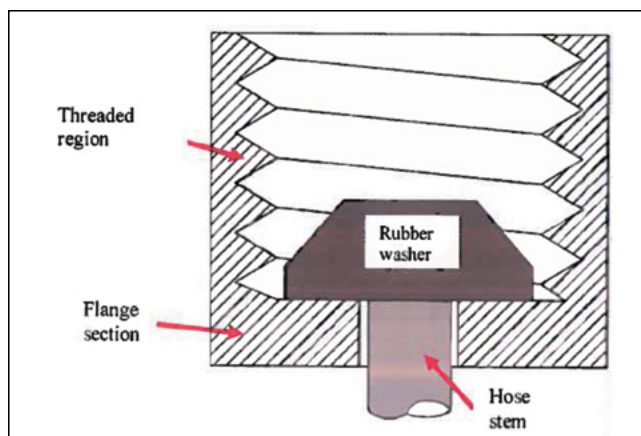
Figure 4

The counsel for the plaintiff claimed that the design of the nut was defective because the threads inside the nut formed a stress riser at the critical stress location, causing the nut to fracture when tightened. The sketch shown in **Figure 4** was produced by the plaintiff expert and was purported to accurately represent the nut design. Their expert cited plastic molding design guides that recommended against sharp corners and threads that end without tapering or rounding as design flaws.

Schematic used by plaintiff to characterize nut.

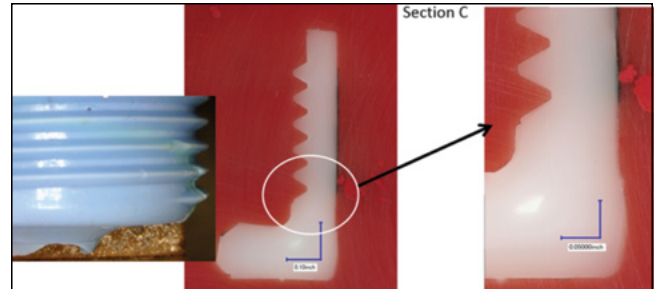
Figure 5

The actual design, as shown in **Figure 5**, clearly incorporates local radii and a tapered or “feathered” thread termination. However, it is difficult to visualize internal threads even when a cross-section is used. A more visually effective technique was developed by

using silicone RTV rubber to make a mold of the inside of the connector. As can be seen from **Figure 5**, the cast rubber replica provides a three-dimensional model of the thread profile. The RTV rubber castings provide a fast method of capturing and comparing thread profiles.

Cross-section of nut and RTV casting.

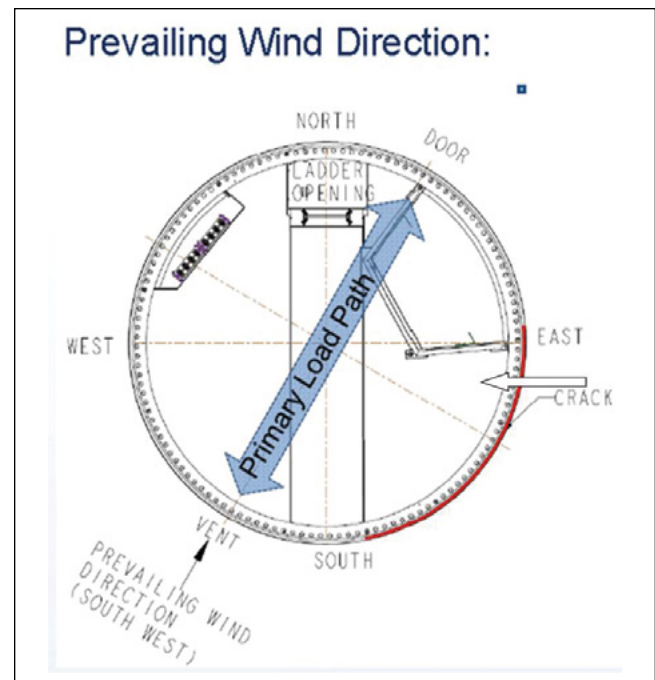
Figure 3
Location of crack with respect to wind direction.

the tower is also shown in **Figure 3**. **Figure 4** shows the crack in the tower before the section was removed and taken to the laboratory. The presence of iron oxide stains indicates that the crack existed in the steel for a considerable length of time before it was discovered, which could suggest that maintenance at the site was inadequate. The crack extended a total of 2,110 mm (83 inches) around the circumference.

As can be seen in **Figure 2** and **Figure 3**, the primary loading on the tower is from the southwest toward

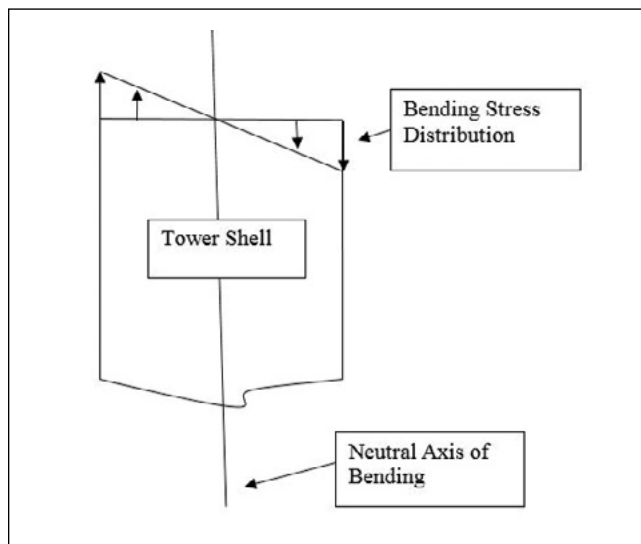
Figure 5
Bending stress distribution.

the northeast. Further, the primary direction wind load will result in a tensile load on the southwest side of the tower and compression on the northeast side. The bending stress distribution is shown in **Figure 5**. The crack is located almost exactly at the neutral axis of bending, where the bending stresses are very low. Further, the wind history indicated that site was almost never becalmed. A more or less constant wind would not produce reversed cyclic loading because the upwind side will always be in tension, and the downwind side would almost always remain in compression. Even more confounding, the weight of the tower shell above the crack plus the weight of the nacelle and blades provide a downward force at the crack location. This loading results in compressive stresses on the tower shell at the location of the crack. Virtually all cracks that result from cyclic loading involve a stress cycle in which there is a tensile stress component. In other words, some part of the loading cycle must result in a net tensile stress at the

origin of the crack face. Cracks in steel plates rarely, if ever, initiate in a location that is subjected only to cyclic compressive stresses.

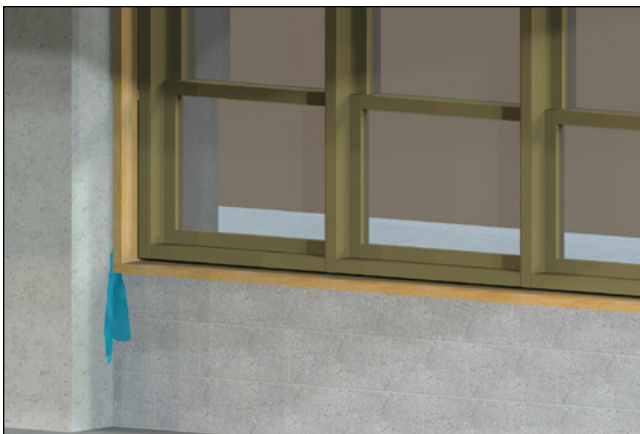
Figure 3

3-dimensional model used to demonstrate where leaks could be due to a gap between the window frames and the window rough opening. That gap was left open by design.

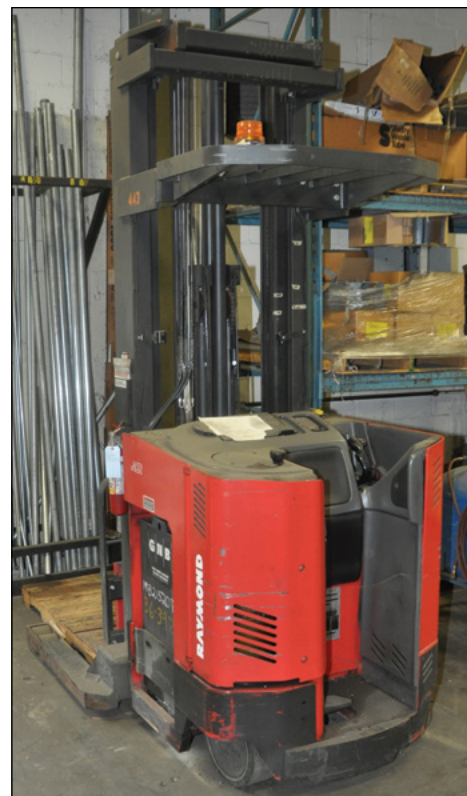
Figure 1

STAND-UP FORKLIFT: The forklift operator was using a narrow aisle, end-controlled forklift with a universal or fore/aft stance. The truck is equipped with a deep or double-reach pantograph (scissor) mechanism that can extend a pallet into a racking system either one or two slots deep. Nominal capacity of the forklift is 3,000 pounds; the manufacturer’s truck identification plate indicates that the truck can lift 3,000 pounds to a height of 246 inches (20.5 feet), and its capacity is reduced to 2,800 at a height of 252 inches (21 feet). The forklift has a triple-stage telescoping mast. The top speed of the forklift is 7.5 mph, but this can be electronically limited to a lower speed. The serial number indicates that the forklift was manufactured in 2007. A photograph of the forklift is shown in **Figure 1**.

Stand-up narrow aisle forklift.

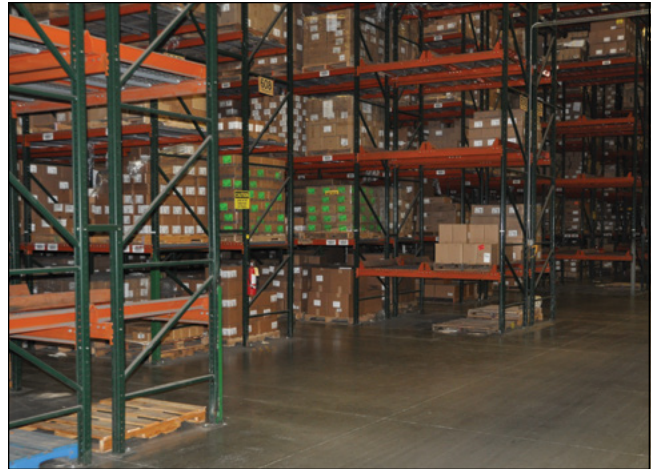
The horizontal beam that the forklift operator and the forklift collided with deformed approximately 2½ inches at a location about 80 inches from the left side of the beam and 28 inches from the right end of the beam. The rear beam, wire decking, and beam braces do not appear to have deformed in the collision. The vertical uprights did not deform or appear to sustain damage

Figure 2
Warehouse rack (modified after the incident).

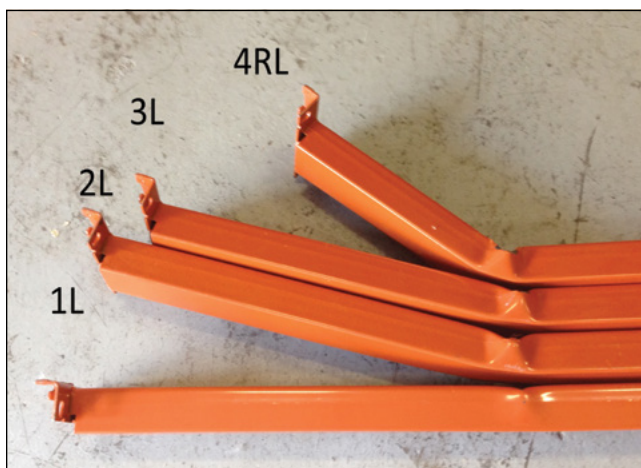
Figure 7

Deformed rack beams after testing.

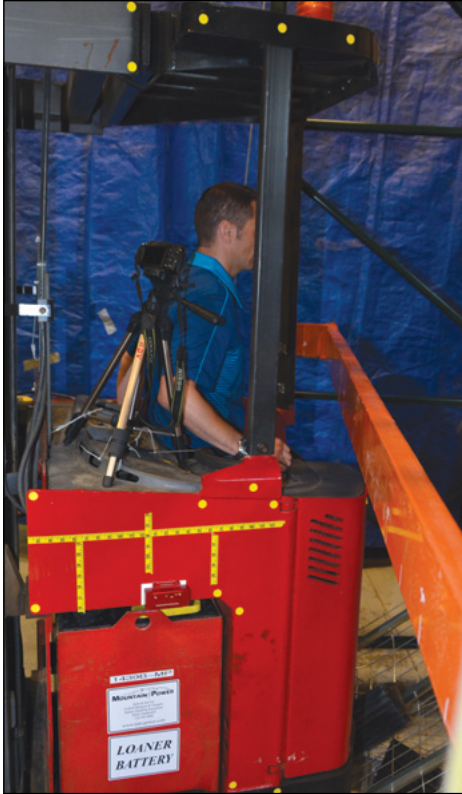
Figure 8

Of foremost importance, the testing performed as a part of this research further shows that the manufacturer's horizontal intrusion protection was effective at a speed of 3.4 mph with a full load. The protection would therefore be effective at higher speeds as well. Since the subject forklift involved in the incident was reportedly operating with a load of approximately 972 pounds, the load used in this testing exceeded the load in the incident. Further, the incident occurred at a speed lower than the maximum test speeds — and at a significantly lower amount of kinetic energy. Even at a higher load, higher impact speed, and higher kinetic energy, the rack beam was held outside of the operator compartment by the post guarding system. Since the rack beam did not significantly intrude in the operator compartment, the volume or space required by the operator was not compromised. **Figures 8 and 9** show that the operator compartment space was maintained during the fourth test at 3.4 mph. Therefore, it is clear that the manufacturer's horizontal intrusion protection system would have prevented the crushing injuries sustained by the operator.

Operator able to stand inside compartment after fourth test.

The majority of the stand-up forklifts currently available on the market have some form of horizontal intrusion protection. The subject manufacturer's counter-balance stand-up trucks and sit/stand model of a reach truck also incorporate some horizontal intrusion protection. Given that the majority of forklift manufacturers have adopted standard horizontal intrusion protection, the benefits or utility of the protection clearly outweigh any trade-offs associated with the horizontal intrusion protection. Therefore, it is the authors' recommendation that the permissive language within the ANSI B56.1 standard should be modified to "require horizontal intrusion protection."**

The authors also recommend that the performance requirements of the ANSI B56.1 standard be strengthened in regard to horizontal intrusion protection. The

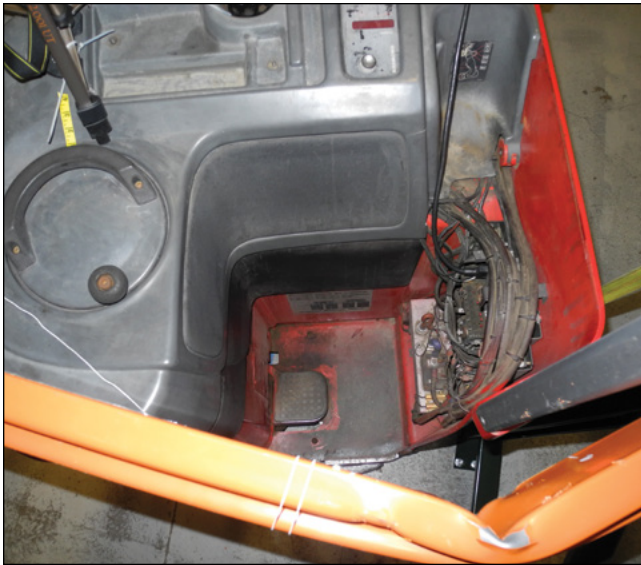
Figure 9

Deformed rack beams outside of operator compartment after the fourth 3.4-mph test.

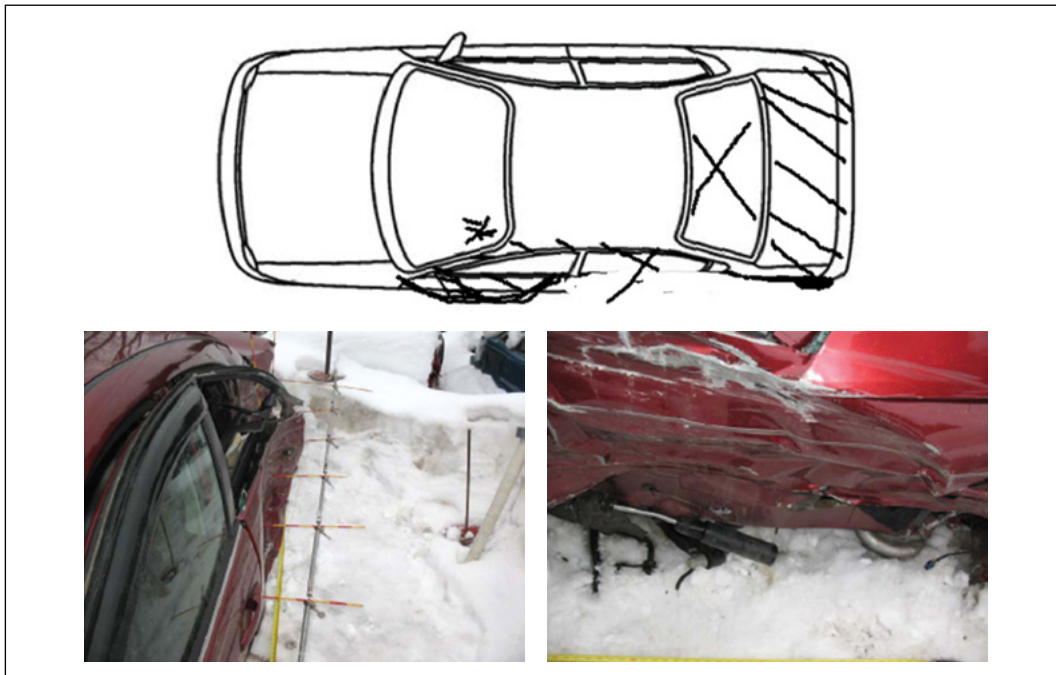
G6¹⁰. The following **Figures 8** and **9** from the NASS report detail the damages to the vehicles from the impact. Measurements of damage profiles as well as CDR downloads were also part of the NASS report.

Figure 8
Pontiac G6 damage diagram and sample photographs.

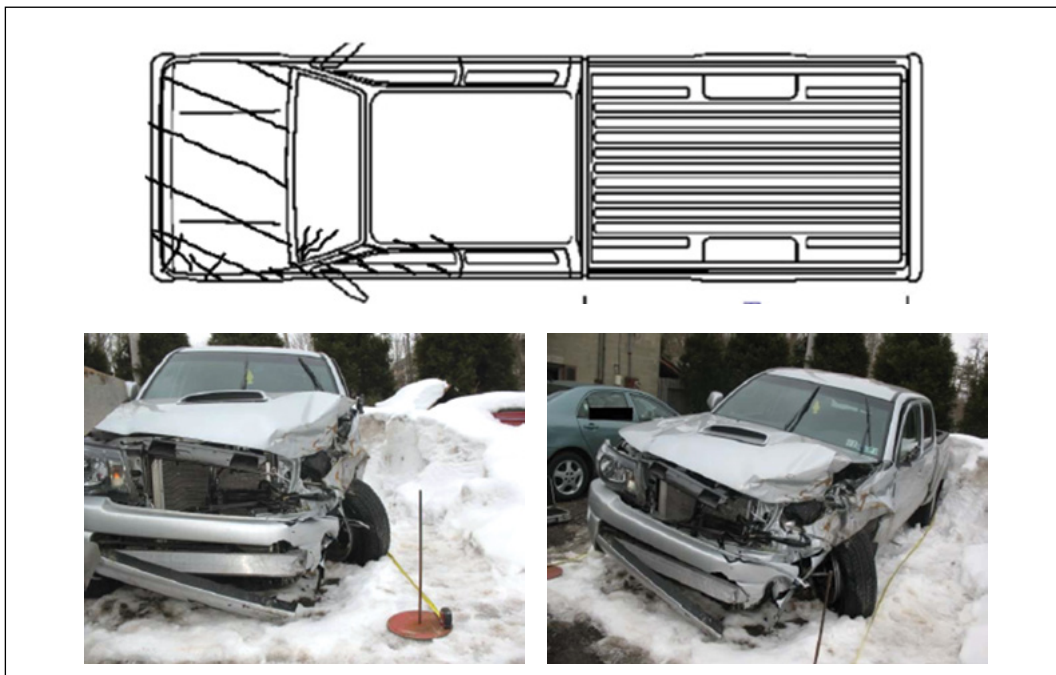
Figure 9
Toyota Tacoma damage diagram and sample photographs.
