Journal of the
National
Academy OF
Forensic
Engineers[®]

National Academy of Forensic Engineers®

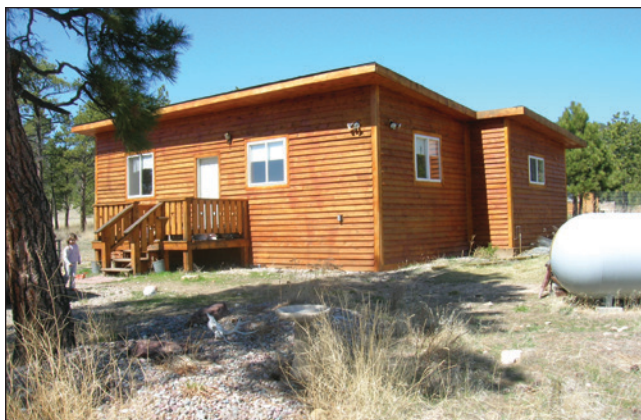
Figure 3
Family cabin about two years after the exposure.

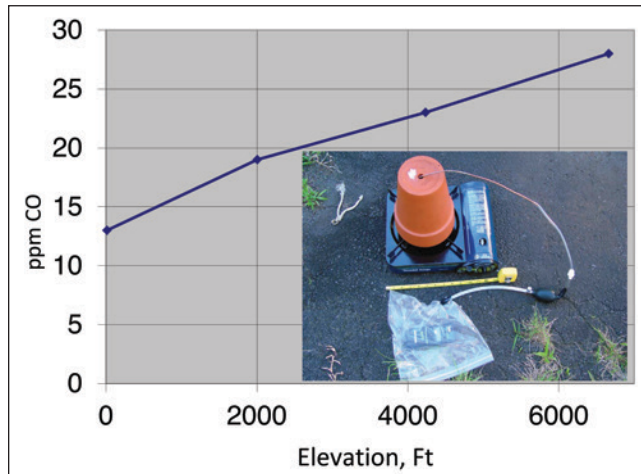
Figure 5

The methodology followed a field test developed by R. J. Karg and Associates⁵. This procedure was developed, reflecting the requirements for ANSI/CSA Z21.1-2012, *Household Cooking Gas Appliances*⁶. The stove was operated on high for ~5 minutes before collecting the sample so that a “steady-state” mixture would be realized. The combustion products were collected in a 9-inch flower pot, rather than a “hot pot” in the Karg protocol⁷. Combustion products were collected in a bag and analyzed with a standard CO monitor. The results were measurable — ranging from 13 to 28 ppm — and were repeatable, going up and down the mountain. The test setup and results are shown in **Figure 5**.

Test setup and chart, showing recorded CO values.

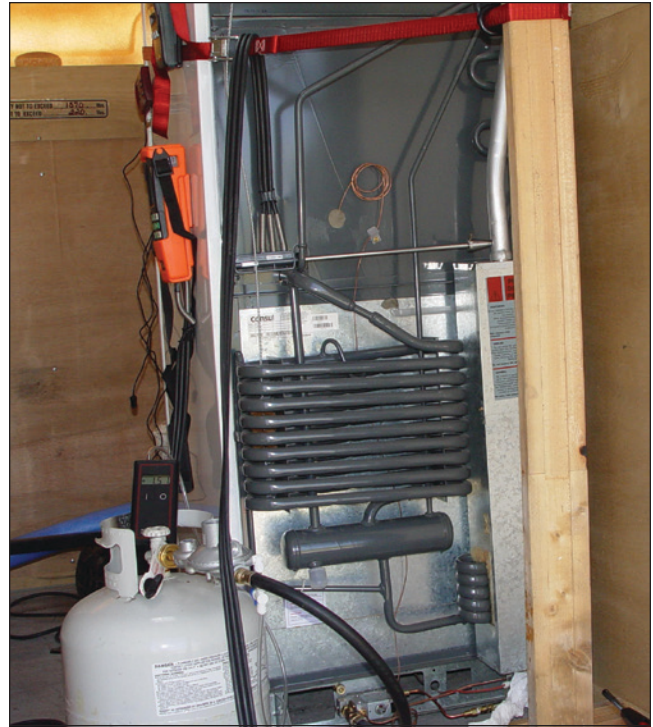
Figure 6

Tests were conducted at Texarkana, TX (~280 feet) and Clovis, NM (~4300 feet). Test variables included gas supply pressure and venturi obstruction. The high altitude tests added the high altitude orifice. Results of those tests are shown in Appendices A and B. At low altitude, the CO recorded was quite low until the venturi was fully obstructed. The tests at the higher altitude were higher but still nominal until the venturi was fully obstructed. **Figure 6** shows the rear of the refrigerator and test equipment.

Rear of refrigerator, sample location and test equipment.

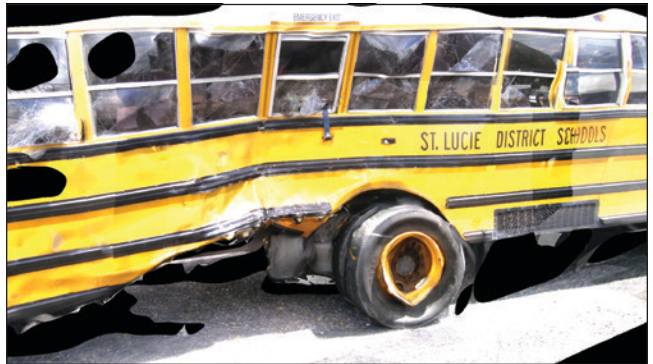
Figure 3

After plotting the physical evidence, the authors determined the impact configuration. First, photographs were taken around the perimeter of the school bus. Photogrammetry software (Photomodeler Scanner) was used to create a 3-dimensional model of the damaged school bus in virtual space (Figure 3). Further, the geometry of the semi-tractor was captured using a high-definition 3-D laser scanner, in which 3 million points of the semi-tractor were captured (Figure 4).

Point Cloud of exterior of subject school bus.

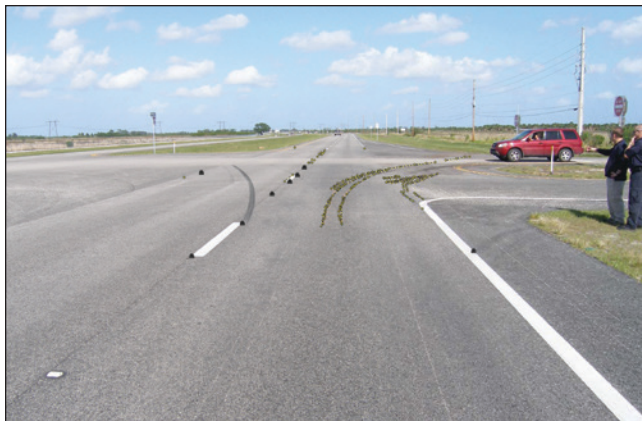
Figure 1

Reconstruction of the accident first involved plotting the physical evidence. The Florida Highway Patrol (FHP) surveyed the accident scene, which included several tire marks. The authors of this paper identified additional evidence on the roadway using scene photographs. After identifying the additional evidence, photogrammetry was performed using police photographs to identify the locations of the physical evidence (Figure 1). Figure 2 shows the evidence placed on a scaled diagram.

Photogrammetry of tire marks.

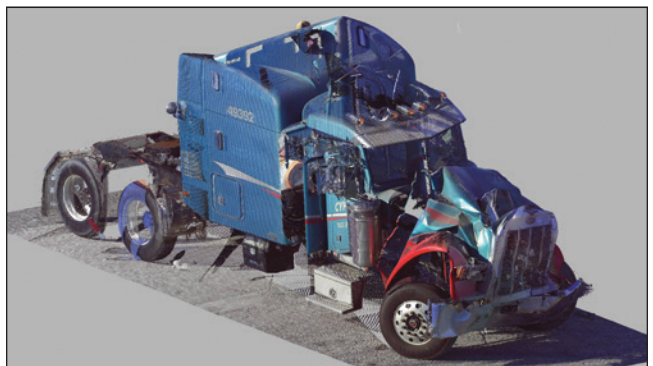
Figure 4

Point Cloud of exterior of subject semi.

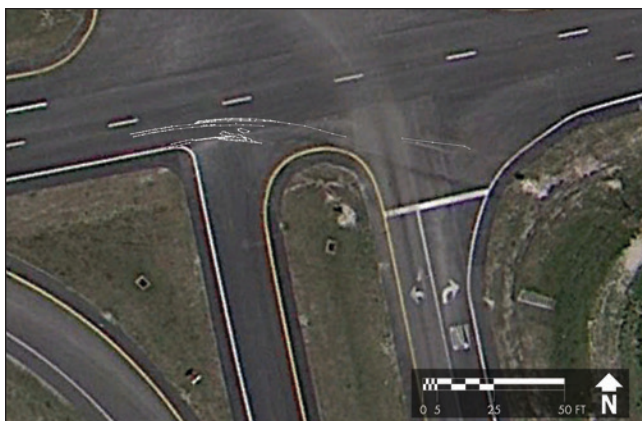
Figure 2

Physical evidence overlaid on aerial diagram.

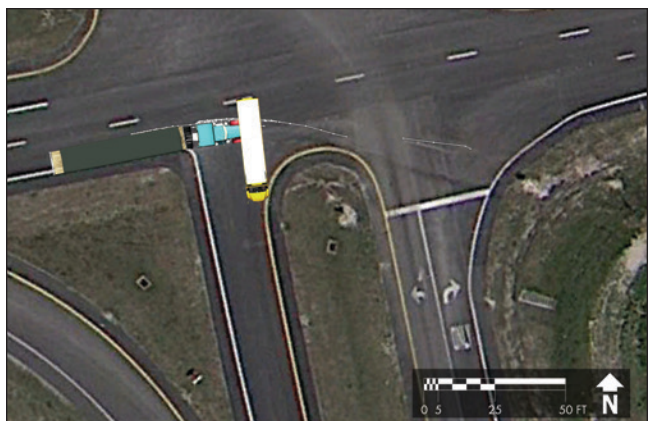
Figure 5

Impact configuration overlaid on physical evidence diagram.

Next, the virtual bus and semi-tractor models were aligned such that their crush profiles matched, thus establishing the impact configuration. The bus and semi-tractor impact configuration were then overlaid on top of the physical evidence diagram (**Figure 5**).

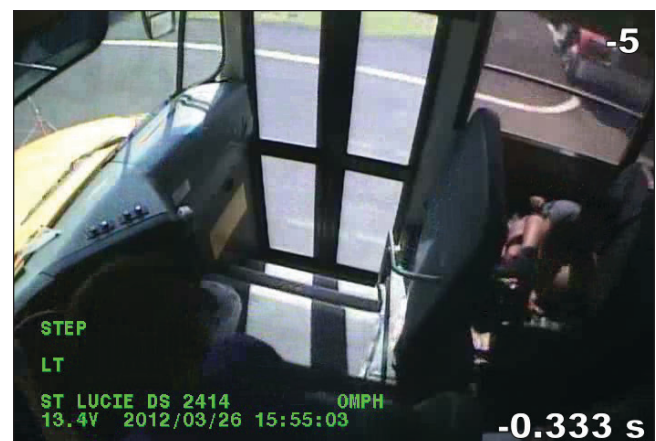
Figure 7

One of the onboard school bus cameras was pointed toward the steps of the bus recording at 15 frames per second. Five frames prior to noticeable movement due to impact, the semi came into frame near the southwest corner solid edge line of the roadway (**Figure 7**). Based on the frame rate, the semi came into frame between 0.26 and 0.33 seconds prior to impact. The impact configuration diagram shown in **Figure 5** was used to determine that the semi was 20.8 feet from the impact location between 0.26 and 0.33 seconds prior to impact.

Semi comes into view of bus camera five frames prior to impact.

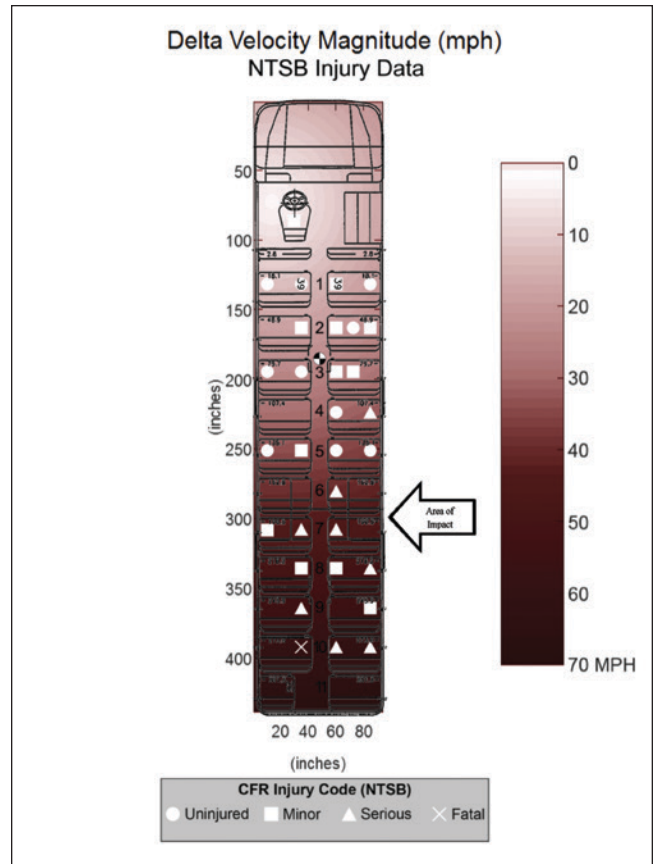
The authors also calculated (with the assistance of computing software) the magnitude of delta-V throughout the bus at seat level by applying equation (1) to thousands of points equally spaced at seat level height. The computing software was also used to create a color-coded diagram showing the delta-V throughout the bus at seat level. Further, the authors overlaid the NTSB occupant injury severity data over the color-coded delta-V diagram (**Figure 14**).

Figure 14 shows that the delta-V near the front of the bus was nearly 0 mph, whereas the delta-V increased approaching the rear of the bus with the rear of the school bus sustaining a delta-V near 70 mph. As expected, the general injury severity as categorized by the NTSB also increased toward the rear of the school bus. The significant variation in delta-V throughout the bus shows that the effects of rotation in offset collisions involving extended length passenger vehicles, such as buses or long vans, cannot be neglected.

Magnitude of delta-V and reported injury severity.

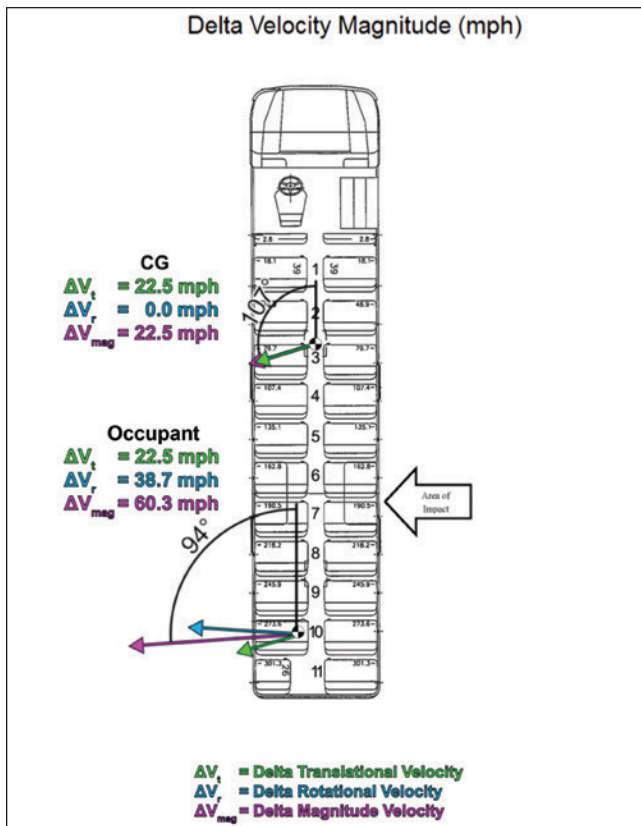
Figure 13 shows that the change in velocity of the center of gravity was only 22.5 mph whereas the change in velocity at the seating position of the fatally injured was significantly higher (60.3 mph). Therefore, the authors' hypothesis that the change in rotational velocity significantly affected the overall change in velocity at the seat location of the fatally injured was proven valid.

Summary of the velocity components of CG and seat of fatally injured occupant.

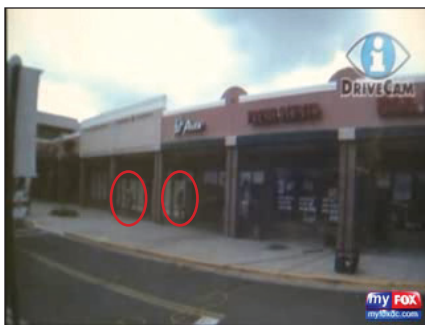
Figure 4

Firefighters making entry seconds before the explosion.

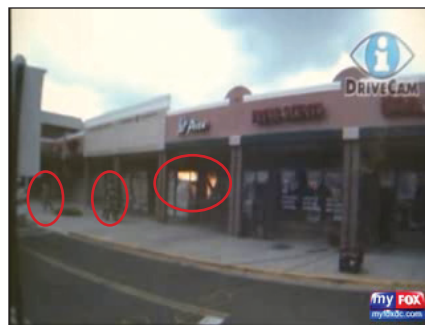
Figure 5

Additional firefighters approaching the front entry just as the explosion occurs. Note the expanding fireball through the glass window panes.

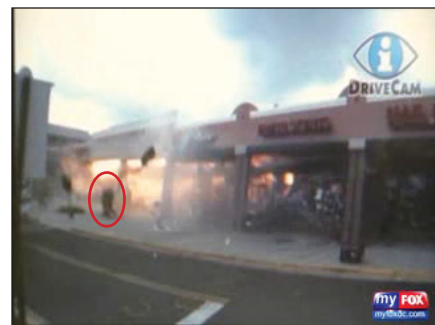
Figure 6

Explosion as viewed from the front of the building. Fireball venting through the front windows. Two of the firefighters are circled.

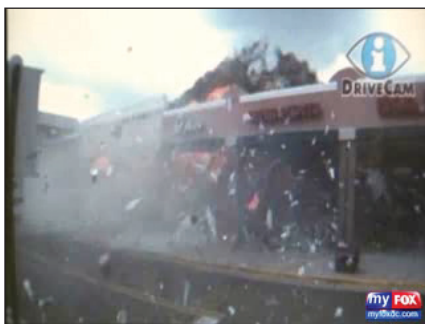
Figure 7

Explosion as viewed from the front of the building. Note displacement of the roof and subsequent venting of the fireball.

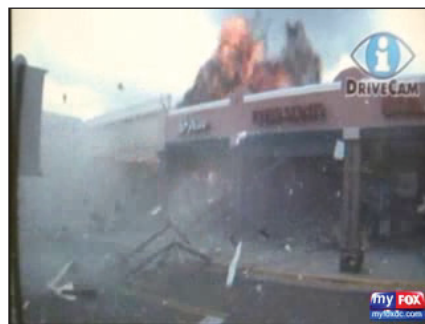
Figure 8

Fireball continuing to vent through the displaced roof.

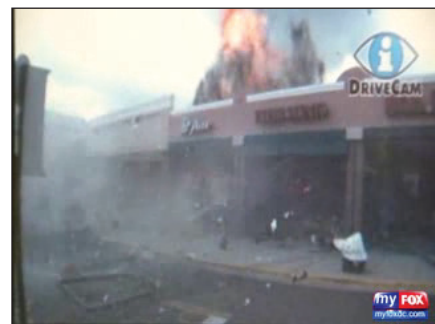
Figure 9

Fireball continuing to vent.

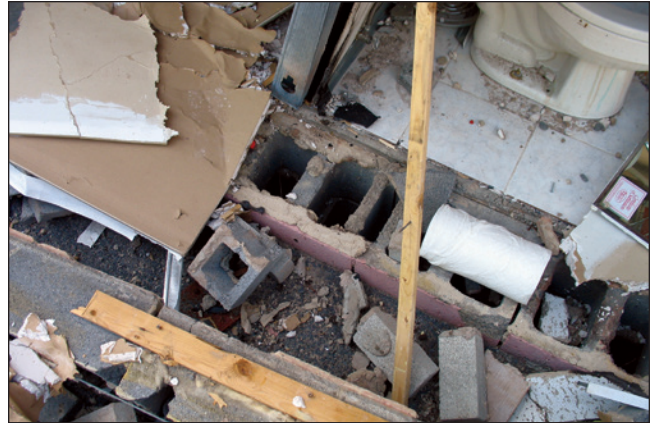
Figure 10

The natural gas flowed from leaks in the main, through the ground, and beneath the asphalt into the building via the electrical and plumbing conduits as well as through the hollow core CMU walls and openings/penetrations in the walls. The gas accumulated in

the building until it was ignited, at which point the explosion occurred. **Figures 10 through 13** depict some of the construction features of the building, which facilitated gas migration into the structure.

The asphalt surface behind the mall extends all the way to the exterior CMU wall of the structure.

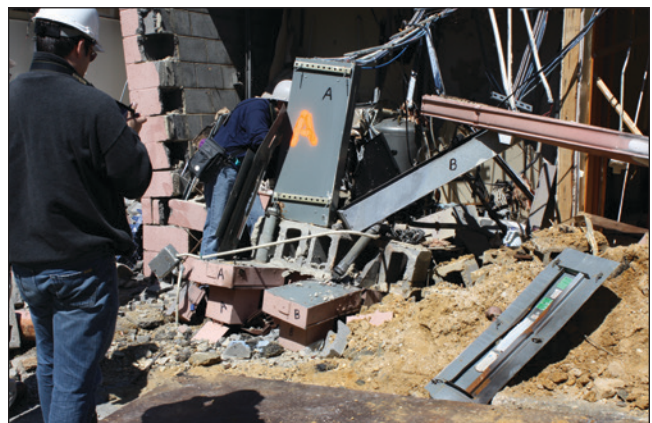
Figure 11

The hollow core CMU exterior walls extend into the ground well below the asphalt surface.

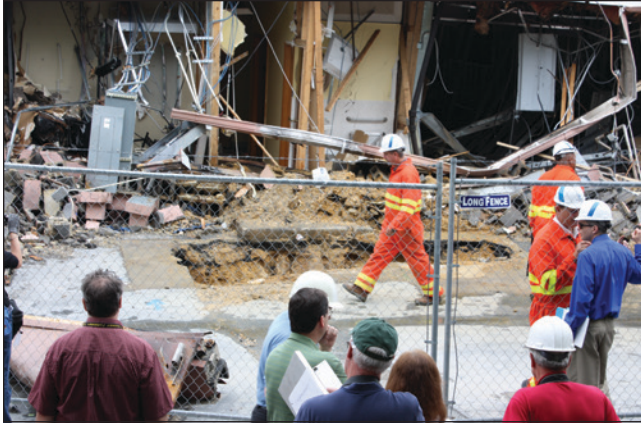
Figure 14

A joint inspection of the scene and the excavated pit area was performed at a later date with all parties of interest. Examination of the excavated area indicated that the 2-inch plastic gas main converged on and crossed in between multiple direct buried electrical power cables in the area behind the pizza shop. Measured clearances between the plastic gas main and the remains of the electrical power cables within the excavated pit in the general area of the crossover were as little as 3 inches. Several feet of the electrical cables in the area of the crossover had been destroyed by an electrical arcing event that preceded the explosion. The faulted power cables with subsequent gas line damage were consistent with the loss of electrical power followed by a gas smell shortly before the explosion. The power cables were installed in 1977, and the extensive heat produced from the catastrophic electrical faulting of several feet of the cables resulted in multiple burned, charred, and melted holes in the plastic gas main. Although the cause of the power cable failure was undetermined due to the extent of damage, such cable failures (as will be discussed later) are engineering-foreseeable events. **Figures 14** through **19** indicate the excavated area of where the gas pipe main leaked.

A view of the excavated area immediately behind the pizza shop.

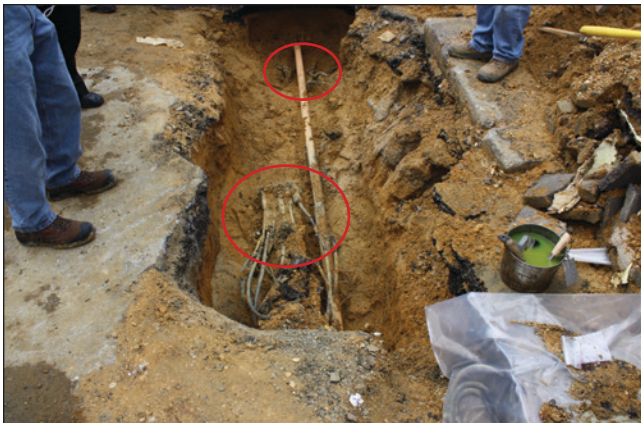
Figure 16

The gas line converged on and crossed in between a nest of multiple electrical power cables. The power cable remains were located on both sides of the gas main. The cable remains are circled.

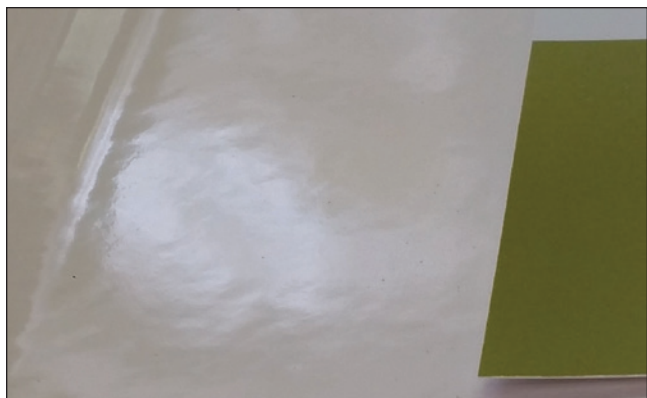
Given that one of the key goals of the comparative bathing surface testing was to eliminate non-textured surfaces, it is ironic that the F462 requirements have not prevented some bathtub manufacturers from making reportedly compliant bathtubs that have no apparent slip-resistance texture features (see **Figure 1**).

Figure 1
A new commercial “F462 compliant” porcelain enamel bathing surface with no visible texture features.

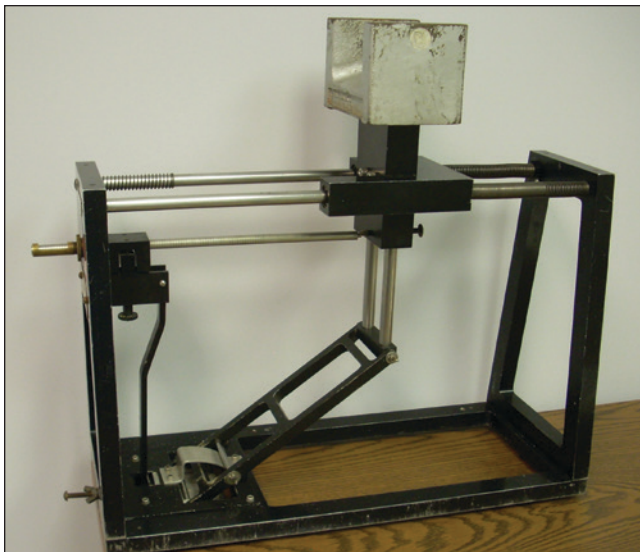
The Mark I's test measurement performance is susceptible to the device's internal friction; the design utilizes two sets of parallel stainless steel shafts upon which components slide (see **Figure 2**). As such, this design is sensitive to manufacturing dimensional tolerances and manufacturing consistency — yet the manufacturing drawings for the Mark I (which date from 1975) were created without a thorough tolerance analysis or the application of Geometric Dimensioning and Tolerancing (GD&T)⁸. The effect of unit-to-unit variability sources can be studied across a population of tribometer units, but there is no evidence this was done in the development of the Mark I. Further, to the authors' knowledge, there has never been a published reproducibility study conducted with the Mark I, though the need for one was highlighted back in 1977 in NBS 953⁹.

Figure 2
NBS-Brungraber Mark I tribometer.

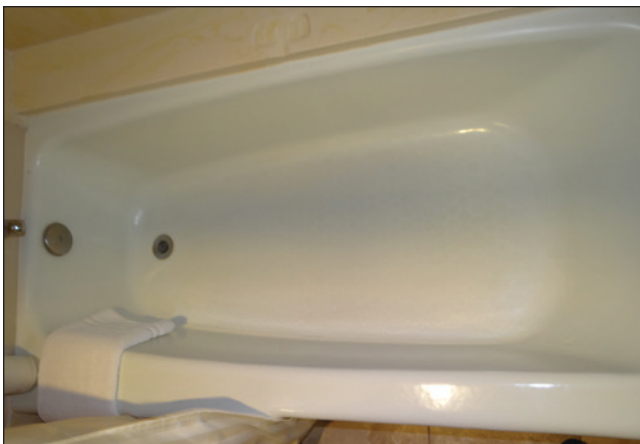
An inspection revealed a porcelain enamel-coated metal bathtub shown in **Figure 3**. According to the hotel manager (who had been at the property since 1986), the bathtub was likely original to the building's 1975-76 construction. The brand, model, and manufacturer's warranty information for the bathtub were unknown; destructive removal of the bathtub would not necessarily have provided this information.

Figure 3
Incident-involved bathtub.

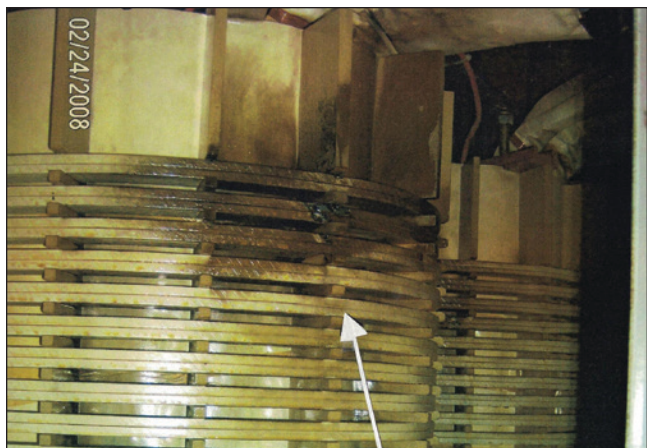
Figure 2
Transformer short circuit #1.

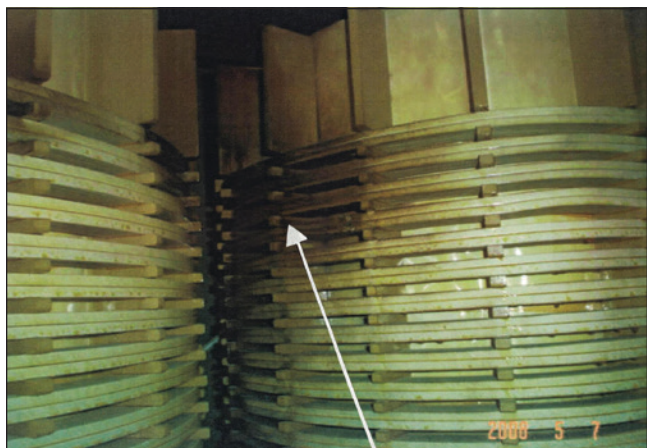
Figure 3
Transformer short circuit #2.

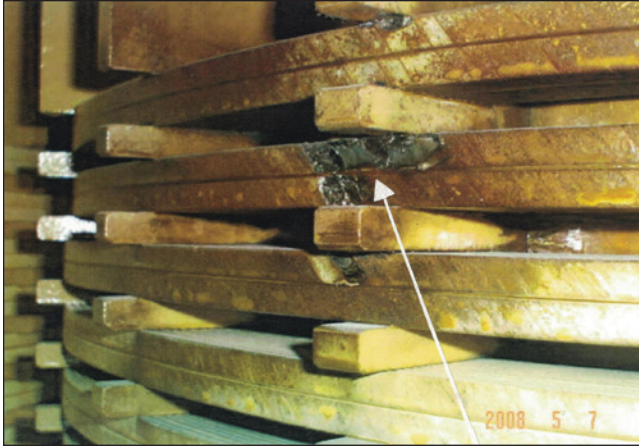
Figure 4
Transformer short circuit #1 close-up.

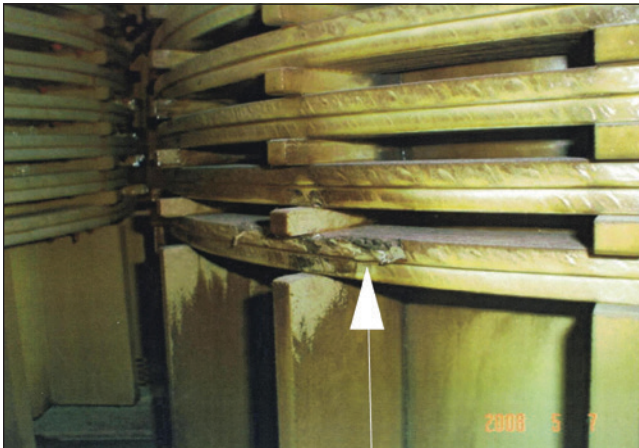
Figure 5
Transformer short circuit #2 close-up.

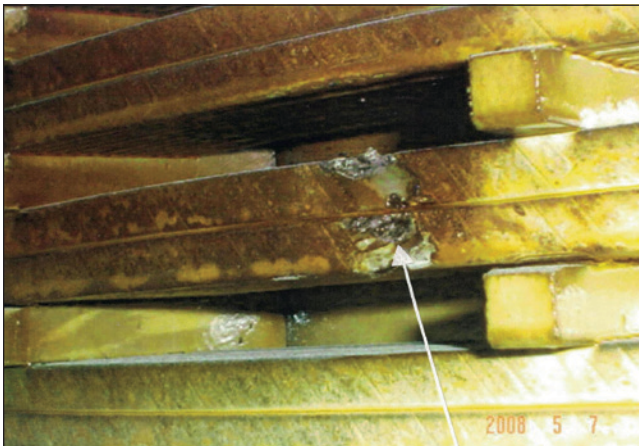
Figure 6
Transformer short circuit #3 close-up.

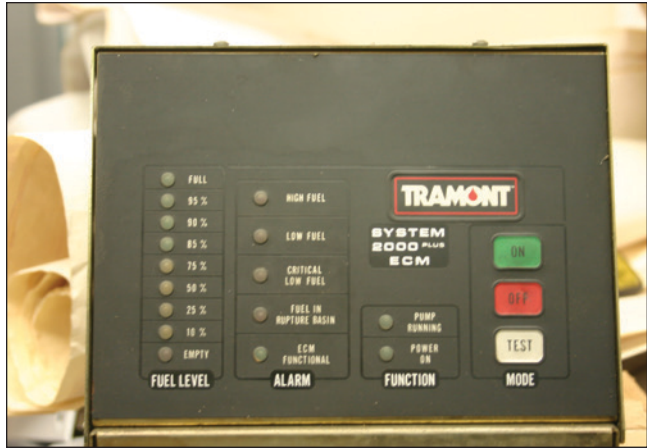
panels used the signals to process the information within these panels (see **Figures 11** and **12**). A signal was sent from these control panels to the emergency generator control panels located in the emergency generator room and to a remote alarm panel located in the lobby of the building.

Figure 11
Fuel day tank "A" control panel (front view).

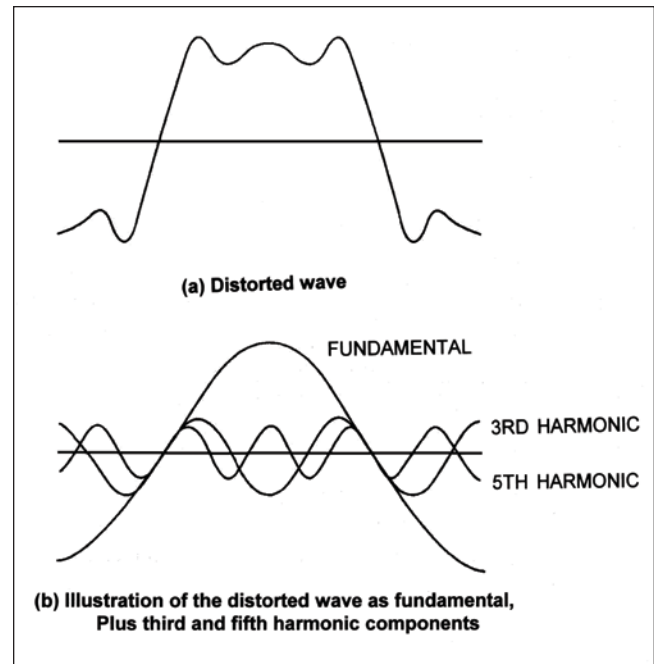
Figure 13

The effect of harmonics in the current and voltage waveforms shown in **Figure 13** were very similar to the results obtained from the power quality monitoring tests in the electrical distribution system in the building, which are shown in **Figures 14** and **15**.

Voltage or current waveforms with harmonic distortions. Upper waveform illustrates with total voltage or current waveform.

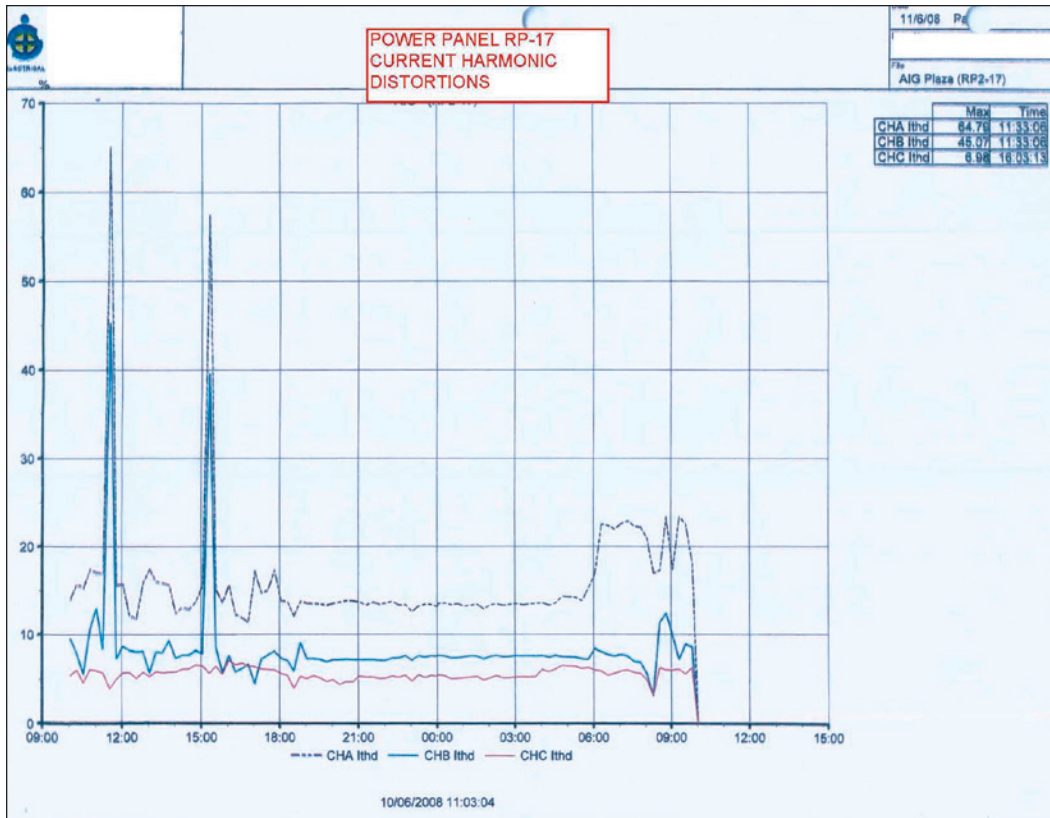
Figure 14
Power panel RP2-17 – current harmonic distortions.

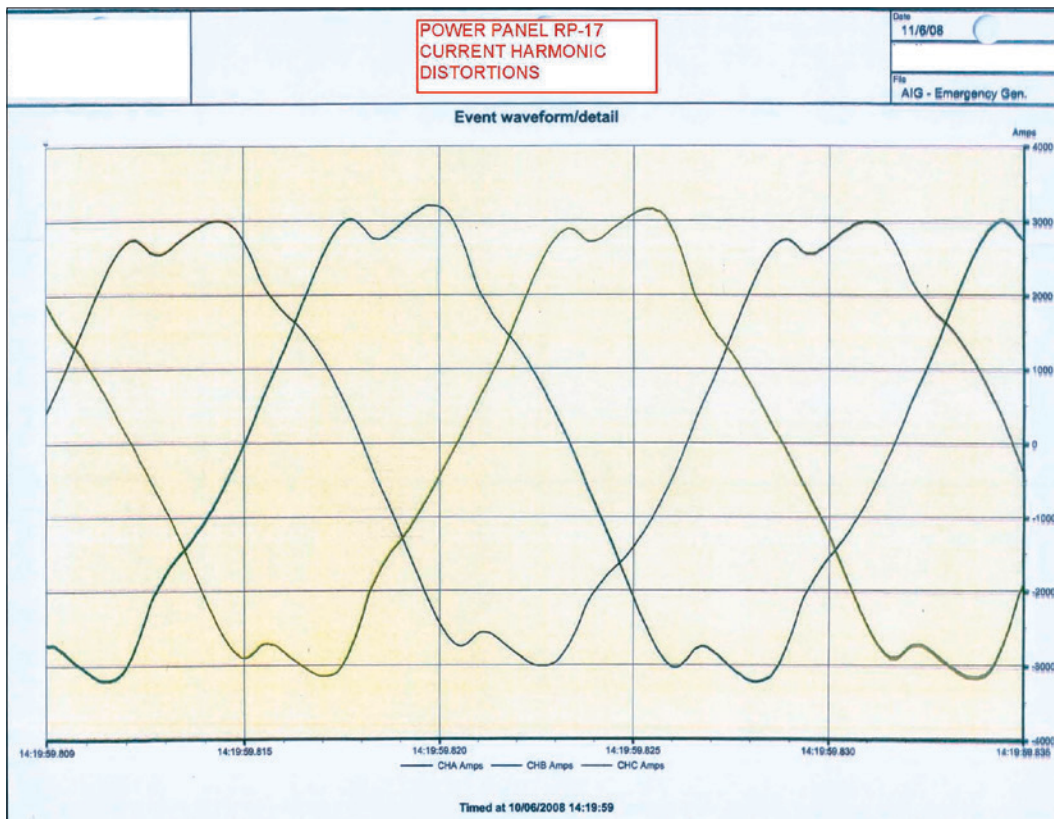
Figure 15
Power panel RP2-17 – sine wave current and voltage harmonic distortions.

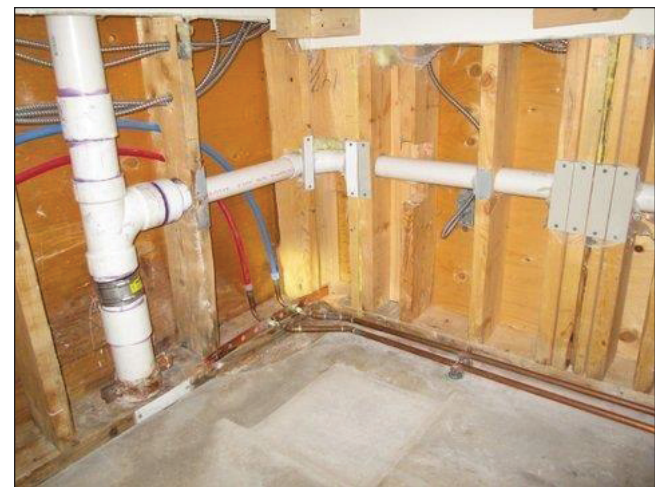
Figure 5
Kitchen walls removed, exposing piping.

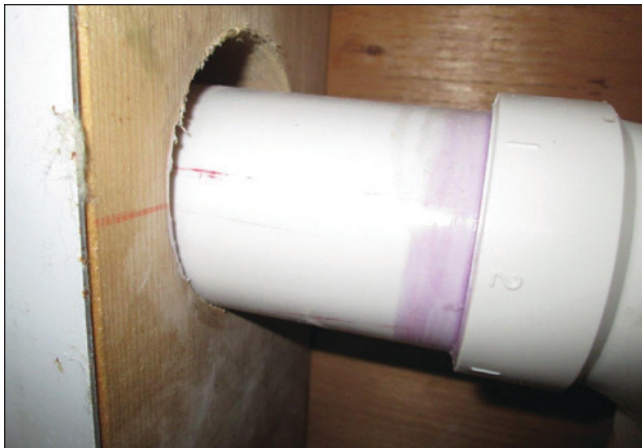
Kitchen wastewater was connected to the 4-inch main drain waste line by way of horizontal 2-inch PVC piping sections that passed through (and were restrained within) holes in framing members, significantly limiting vertical movement. (**Figure 7**).

Figure 7
Horizontal piping restrained within framing.

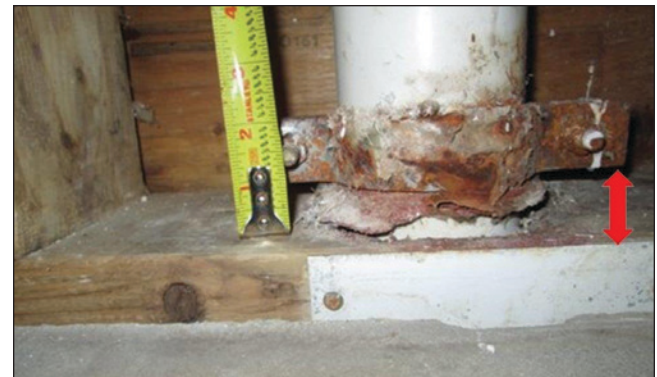
Although past piping repairs had already been performed, examination of the piping chase way and vent stack piping revealed that the piping was not resting on the riser clamps designed to secure a pipe against vertical downward movement and that the riser clamps were actually suspended off of the sill plates (**Figure 9**).

Figure 9
Riser clamp suspended above sill plate due to framing settling and pipe expansion on third floor of building.

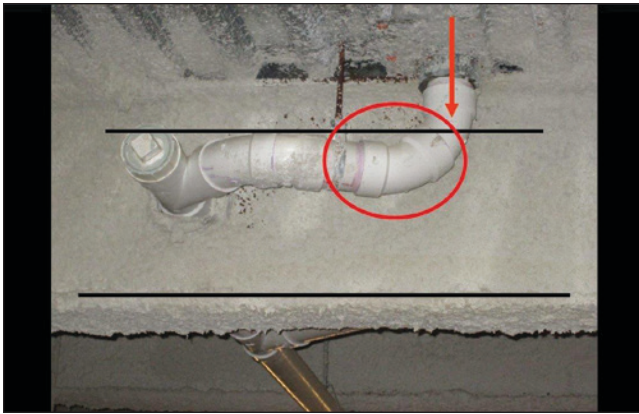
Figure 11

Additionally, the base of the stack systems, which were supported by a steel Milford hanger, was also deflected in a downward direction due to this one pipe support securing a major portion of the weight of the piping system (**Figure 11**).

Basement vent stack out of plumb due to excessive weight.

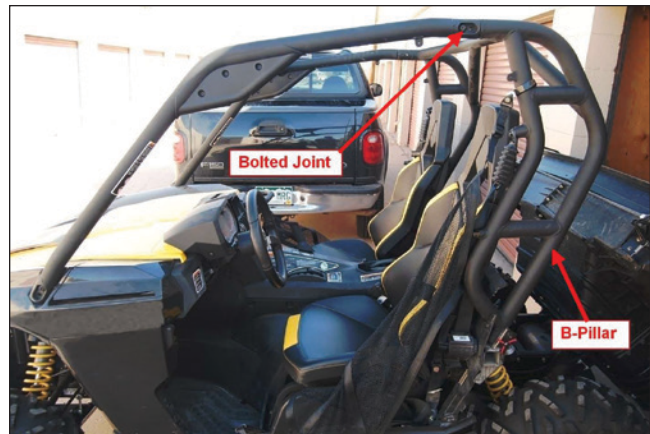
The longitudinal roll cage side header tubes between the A and B pillars include a bolted connection on each side. An optional plastic roof was installed on top of the roll cage in one case. An undamaged exemplar roll cage is seen in **Figure 1**.

Figure 1
Undamaged exemplar UTV roll cage.

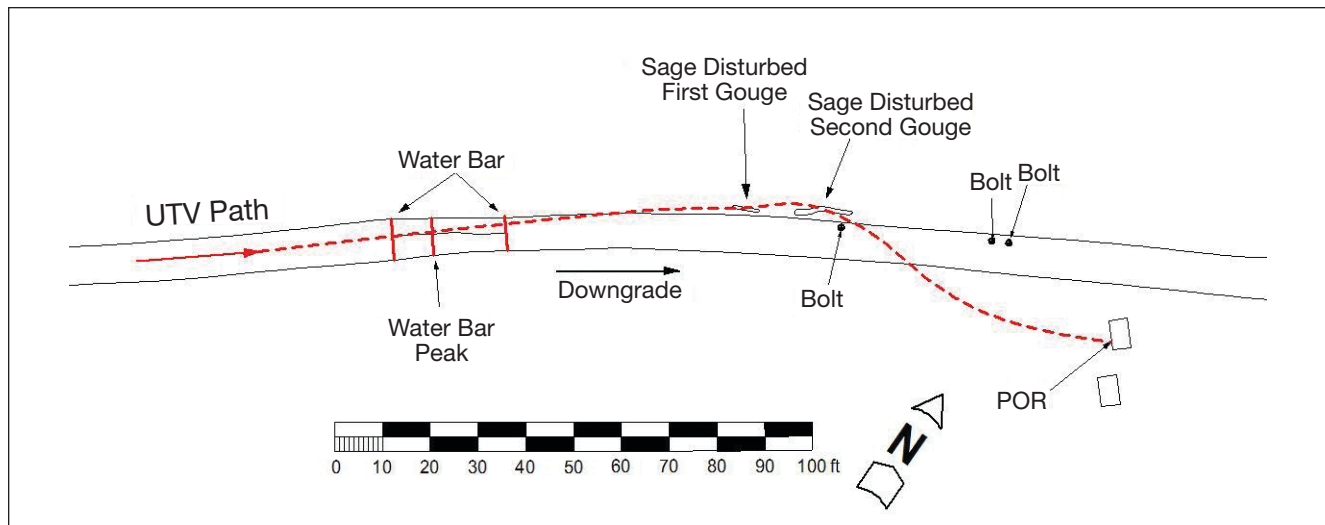
The road is relatively straight, approaching the water bar, and it curves slightly to the right downhill from the water bar. With respect to the plane of the road, the peak of the bump was approximately 1 foot high, and the entire bump was 8.4 feet long. A plan view of the accident scene is shown in **Figure 2**. Photographs of the accident site are shown in **Figures 3** and **4**.

Figure 2
Case A: Scale drawing of accident scene.

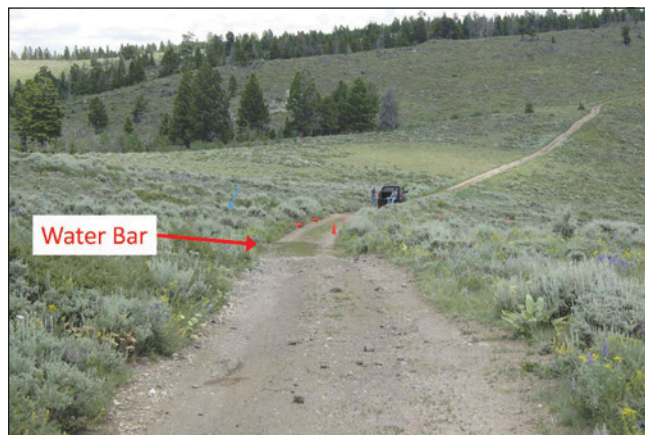
Figure 3
View of accident location, looking downhill in direction of UTV travel.

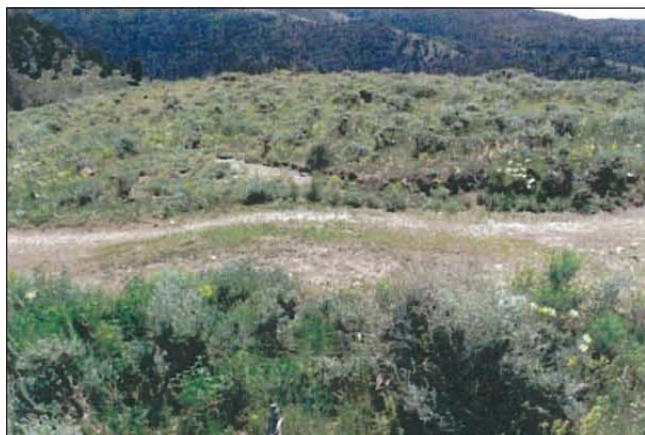
Figure 4
Side view of water bar. UTV traveled from right to left.

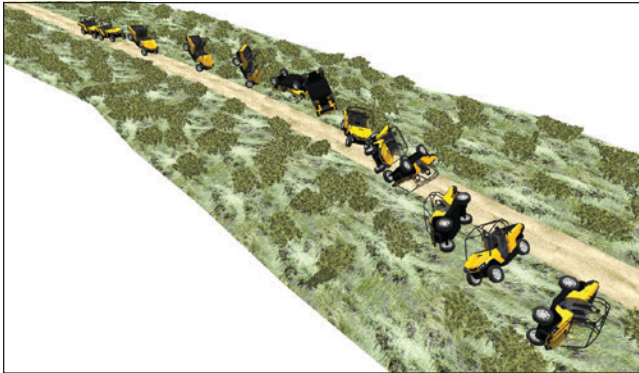
Figure 5

its wheels in a slightly clockwise orientation (i.e., rotated to face slightly toward the right). The UTV then swerved to the right and rolled over laterally with the driver's side leading. The vehicle rolled over laterally 1¼ times before coming to rest on the driver's side. The sequence of the rollover motion is shown in **Figures 5 through 7**.

Case A: Overall vehicle motion.

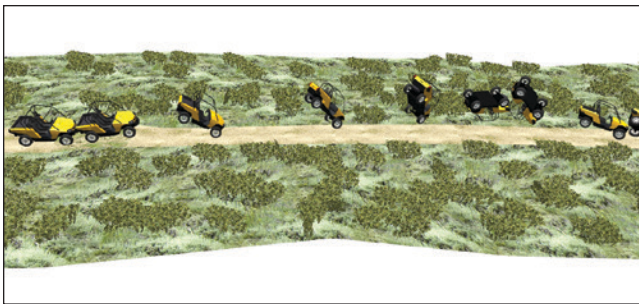
Figure 6

Case A: Initial pitchover motion.

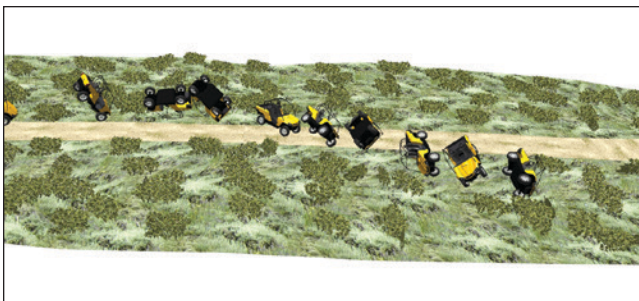
Figure 7

Case A: Final lateral rollover motion.

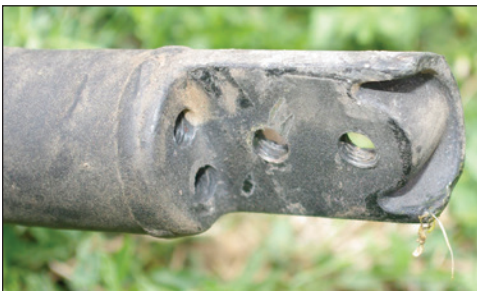
Figure 11

The roll cage collapsed at both B-pillars above the driver's head. The lateral roll cage cross member behind the driver's head buckled downward into a V-shape, and the B-pillars were deformed inward. The bolted connections in both side header tubes separated, and the bolts were found sheared in the bolt holes. Three of the four fractured bolt heads were found in the roadway. The fracture surfaces showed that the bolts failed in shear.

Case A: Failed bolted connection in side header tube.

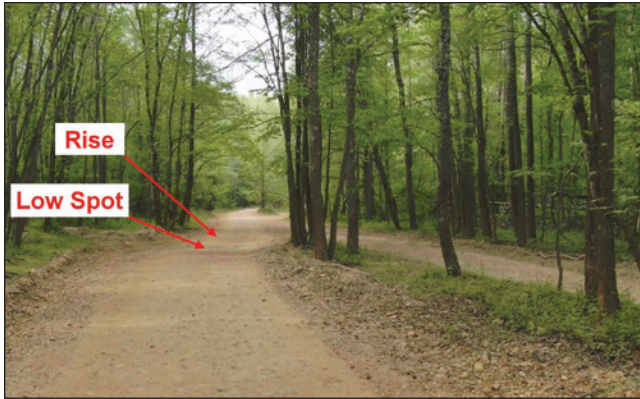
Scene Geometry: The trail is relatively flat throughout the rollover path. A shallow dip is present at a small drainage channel that enters the trail from the left. The entry to the dip descends very gradually over a distance of 25 to 30 feet. The profile transitions to a slight rise, leaving the low spot over a distance of 10 to 12 feet, with the final 7 feet at a 14 percent upgrade. Photos of the site are seen in **Figures 12 and 13**.

Figure 12
Case B: Accident site.

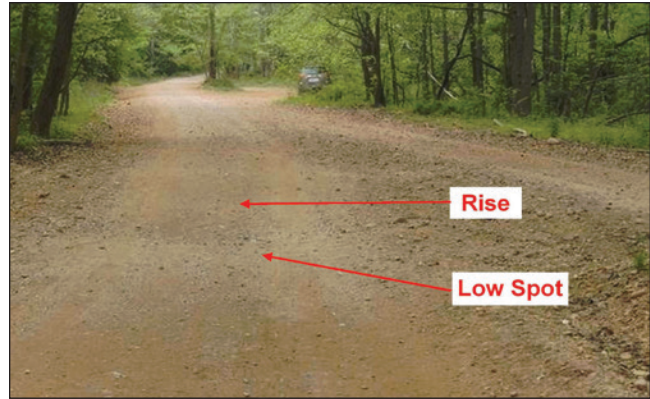
Figure 13
Case B: Accident site.

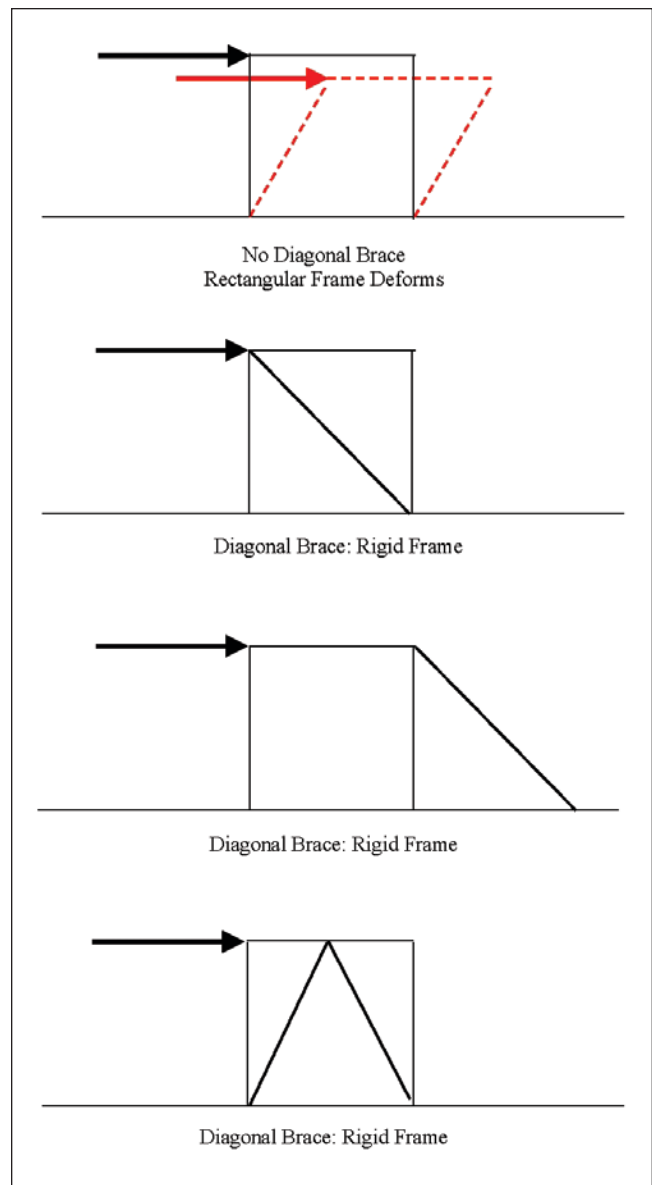
Figure 16

2. Roll Cage Geometry: The geometry of the roll cage is based on open-sided shapes, which are approximately rectangular with no diagonal bracing. A properly designed roll cage should be based on triangular trusses. Rectangular trusses can deform into parallelograms with relatively little resistance to deformation. Rectangular trusses are inherently much less rigid than triangular trusses. This concept is demonstrated graphically in **Figure 16**.

Schematic diagram of rectangular truss deformation vs. triangular truss stiffness.

Fundamental mechanical engineering design practice and numerous roll cage design standards require triangular trusses. This is accomplished with diagonal bracing. Diagonal braces can be included in a four-point mount design, or they can be added by utilizing six mounting points to the frame. Diagonal bracing is standard in roll cages designed for off-road racing vehicles where the probability of rollover is higher than in passenger cars. Longitudinal and lateral diagonal bracing should have been included in the UTV roll cage design. Fundamental engineering design principles should have been incorporated into the entire UTV design from the conceptual stage.

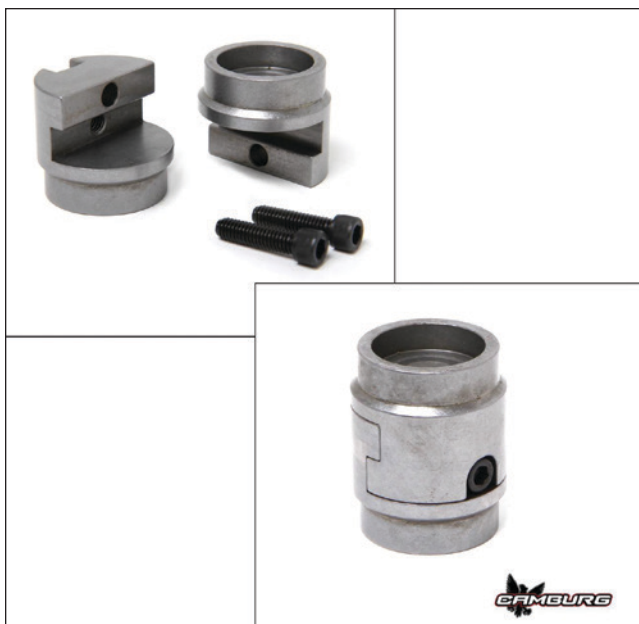
Figure 17

Camburg tube clamp

engineered products such as the Camburg Tube Clamp seen in **Figure 17**. In this design, if properly oriented, bending moments and resultant shear forces would be transferred through interlocking features and not through the bolts.

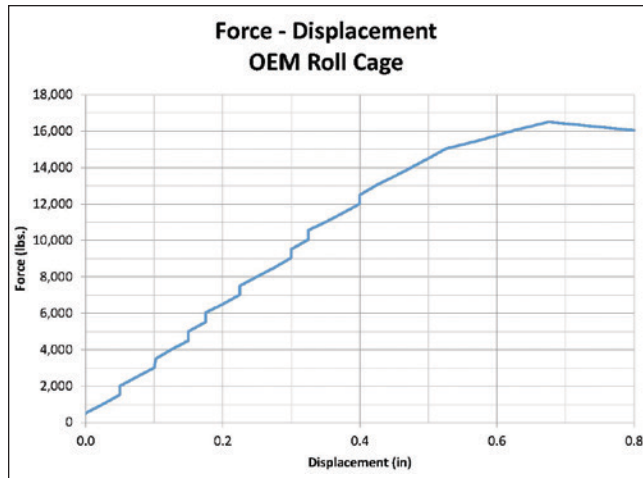
Figure 19

An exemplar roll cage was tested in a laboratory setting. The cage was bolted to a steel base plate, and a downward vertical load was applied across the lateral member at the B-pillars. As the cage was deformed vertically, load and displacement data was recorded until the vertical force peaked and then began to decline, indicating that the stress had exceeded the yield strength of the steel tubing. The roll cage failed due to buckling in the bends in the Z-shaped B-pillars.

The test setup is shown in **Figure 18**, and the load displacement data is shown in **Figure 19**. The B-pillars buckled at a vertical load of 16,510 pounds.

Load/displacement data from test shown in Figure 18.
Peak force was 16,510 pounds.

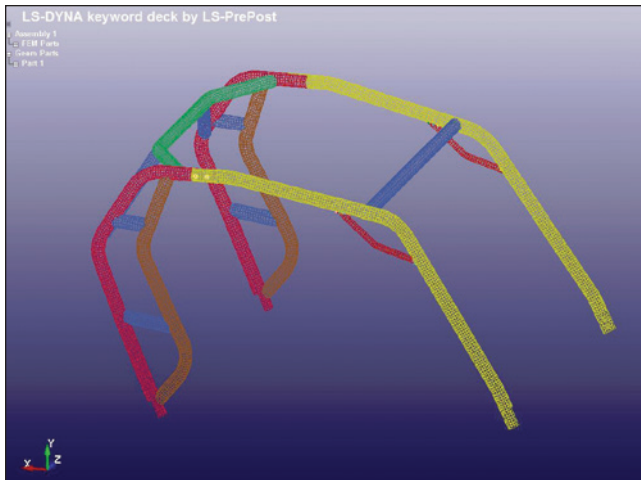
Figure 20

A graphical output from the FEA model is shown in **Figure 20**. The FEA model predicted a failure load of 17,200 pounds with a deflection of 0.5 inches compared to the laboratory test results of 16,500 pounds with a deflection of 0.675 inches. The FEA model had a somewhat stiffer initial response as shown by the steeper curve. Peak loading was about 4% greater than the measured physical peak cage load, and peak deformation of the model occurred with ~0.2 inch less deformation compared to the physically tested roll cage. The general shape and resulting peak load are very similar. **Figure 21** shows the data from the physical test and the output of the FEA model. Overall, the testing provided a reasonable validation of the FEA model.

LS-DYNA graphical output of roll cage model.

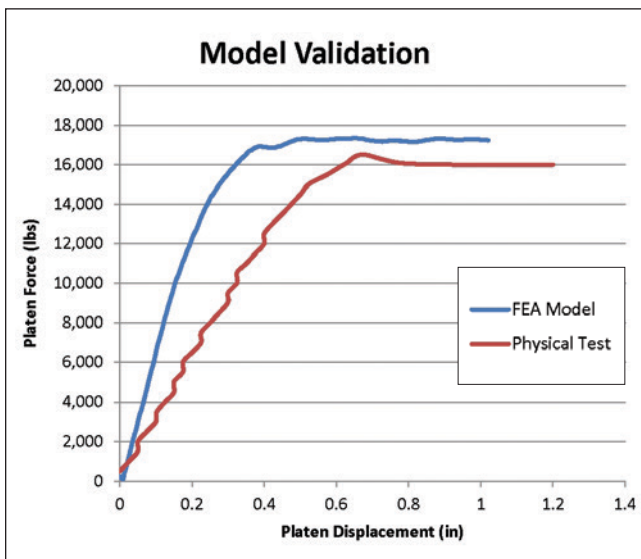
Figure 21

Validation of FEA model vs. laboratory test.

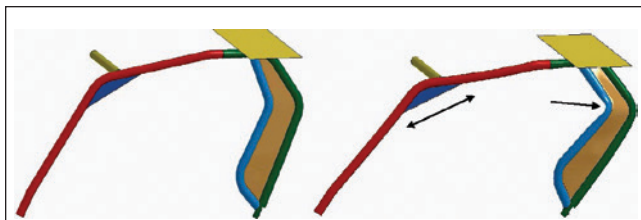
Graphic of conceptual alternative 1. Conceptual design shown in left panel. Resulting deformation shown in right panel.

Figure 22 shows the first alternative concept, which uses a 0.090-inch (2.3 mm)-thick steel web to fill in the area between the two B-pillar uprights in order to transfer shear loading between the uprights. As such, this concept deletes the two horizontal connecting tubes. The rear-most cage to chassis attachment

points are identical to the baseline model. The model is shown in the unloaded and heavily loaded states with 4 inches of deformation. Note the maximum distortion at the top bend of the rear cage forward upright. Also, note the straightening of the A-pillar / roof rail segment and minor rotation about the rear mount. The peak load of conceptual Alternative 1 measures 21,600 pounds at 0.5 inches of platen movement.

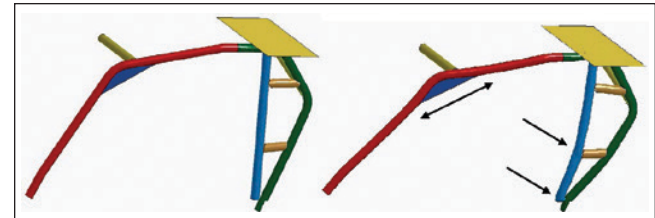
Graphic of conceptual alternative 2. Conceptual design shown in left panel. Resulting deformation shown in right panel. Z-shaped tube has been replaced by a straight vertical tube (see blue member).

Figure 23 shows the second alternative concept that uses a vertical tubular member in place of the original Z-shaped tube, eliminating the bends in the column. The bottom of the tube has been modeled as a fixed connection to the chassis. Thus, the fixation of the rear cage to the vehicle chassis has been strengthened by replacing the two fixed rear chassis connections with four fixed connections. This design concept is shown below in the unloaded and heavily loaded states with 4 inches of vertical deformation. The rear upright is not grossly distorted; the B-pillars rotated rearward about the mount with plastic deformation. The A-pillar / roof rail intersection straightened. The peak load of conceptual Alternative 2 measures 37,900 pounds at 2.0 inches of platen movement.

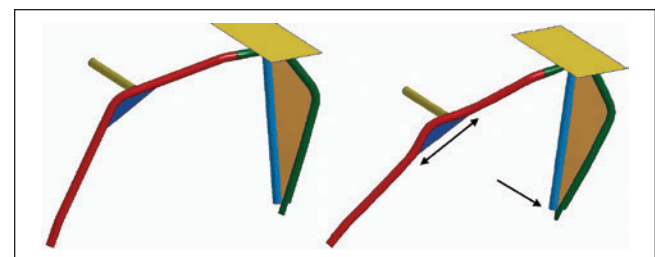
Graphic of conceptual alternative 3. Conceptual design shown in left panel. Resulting deformation shown in right panel.

Figure 24 shows the third alternative concept, which is a combination of concepts 1 and 2. The design
