Journal of the  
**National**  
**Academy** OF  
**Forensic**  
**Engineers**<sup>®</sup>

* <b>Effects of Evidence Spoliation on Forensic Engineering</b>	
<b>Analysis of Alleged Brake Servicing Defects . . . . .</b>	<b>13</b>
<i>By John Leffler, PE (NAFE 709S)</i>	
† <b>Forensic Engineering Analysis: Biomechanics is an Engineering Discipline . . . . .</b>	<b>23</b>
<i>By William E. Lee III, PhD, PE (NAFE 655S)</i>	
‡ <b>Forensic Engineering Tools and Analysis of</b>	
<b>Heavy Vehicle Event Data Recorders (HVEDRs) . . . . .</b>	<b>33</b>
<i>By Jerry S. Ogden, PhD, PE (NAFE 561F) and</i> <i>Mathew Martonovich, PE (NAFE 968M)</i>	
‡ <b>The Impact of the Lack of Marine and Rail Standards on the Transportation of</b>	
<b>Large Power Transformers . . . . .</b>	<b>51</b>
<i>By David Gillingham, P. Eng. (NAFE 935A)</i>	
‡ <b>Forensic Engineering Analysis of Fuel Usage and Thermostat Settings . . . . .</b>	<b>63</b>
<i>By John Certuse, PE (NAFE 708F)</i>	
‡ <b>Forensic Engineering Analyses of a Home Fire . . . . .</b>	<b>75</b>

# Effects of Evidence Spoliation on Forensic Engineering Analysis of Alleged Brake Servicing Defects

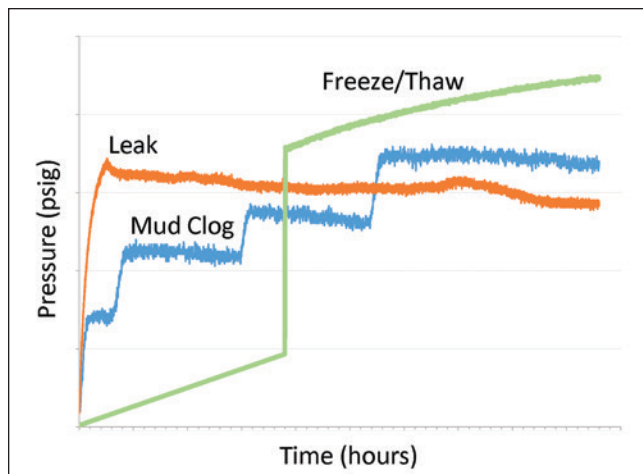
**Figure 3**  
Signature curves of erroneous data.

Similar to the pressure build-up signatures that have been identified, a series of signatures that identifies specific errors and anomalies based on their build-up curves has been defined by the author (**Figure 3**).

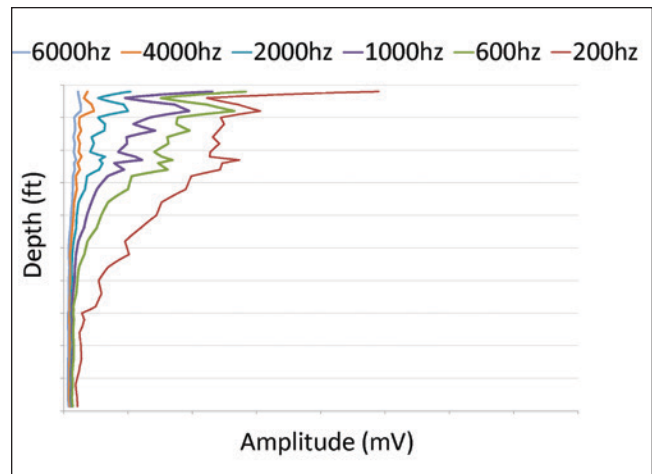
**Figure 6**  
Sample audio log indicating venting at the surface.

By utilizing audio logs during the well evaluation, operators can determine when flow is occurring, where the flow is originating, and where the flow is terminated. For example, if flow has been identified by increased amplitude over ambient noise originating at depths above the top of production casing cement and continuing to surface, it can be deduced that natural gas is entering the wellbore, traveling upward through the annular space and venting at the surface (**Figure 6**).

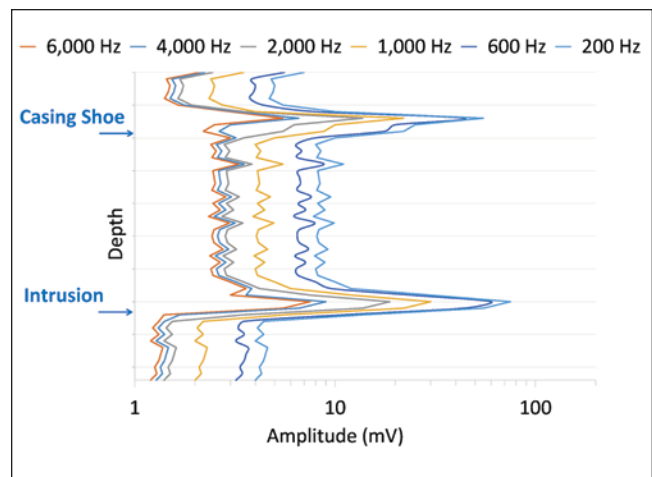
**Figure 7**  
Example audio log indicating intrusion and shallow migration.

An example of greater concern would be flow identified by increased amplitude over ambient noise at depth, continuing upward, and dissipating at some depth below the base of the next outer casing string (**Figure 7**). This scenario potentially suggests that natural gas flow is entering the wellbore and exiting at some other depth. Corrective actions should generally be pursued in this scenario.

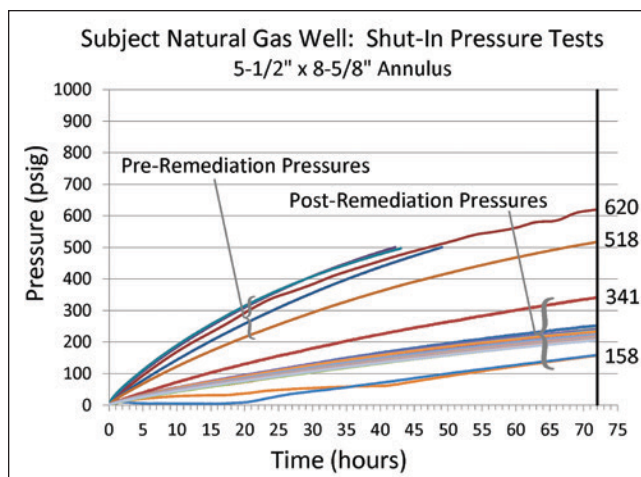
**Figure 8**

Post-remediation T/A logging of the subject gas well indicated that the remedial actions reduced natural gas migration in the annular space behind the production casing. Post-remediation shut-in pressure build-up testing indicated a 60% reduction in shut-in pressures as well as a declining trend in pressures. This decline indicates that the source is reduced, and the gas is depleting. Further, the shut-in pressure build-up curves indicated that with successive periods of controlled venting, shut-in build-up pressures will continue to decrease. Over successive months, shut-in build-up pressures were further reduced by 75%. These results suggest that natural gas that remained in proximity to the subject natural gas well was above the Marcellus and may have been artifact pressures on a depleting trend (**Figure 8**).

Graph of decreasing shut-in pressures after remediation.

Based on the results of mechanical integrity tests, the subject gas well was selected for remedial action to reduce the flow of natural gas in the wellbore outside of the production casing. Remedial efforts included the perforation of the 5½-inch production casing and remedial cementing behind the production casing.

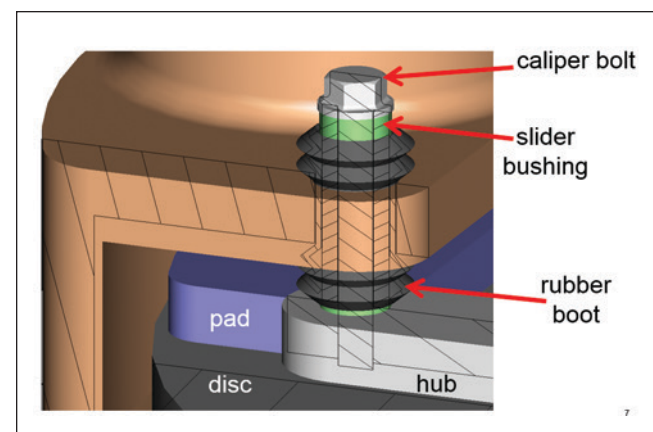
**Figure 3**

Close-up of caliper bolt area.

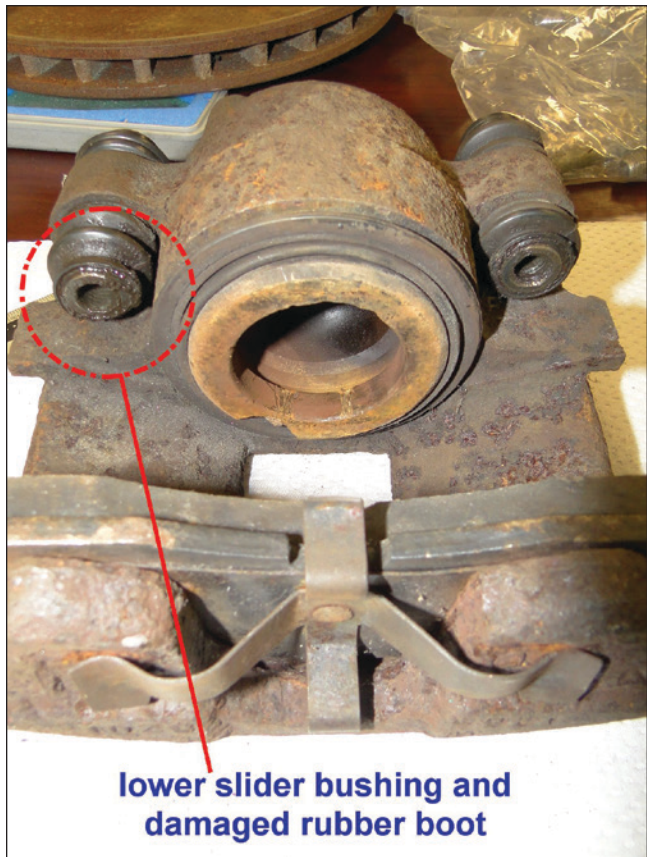
**Figure 5**  
Lower slider bushing and boot.

was judged to be that a floor jack was improperly placed on the bushing following manual retraction of the rubber boot. But such an action would be inconsistent with typical or effective shop practices. Regardless, the cause or time frame of this deformation remains unknown.

b. There was no evidence that mismatched components were used in this area of the subject minivan.

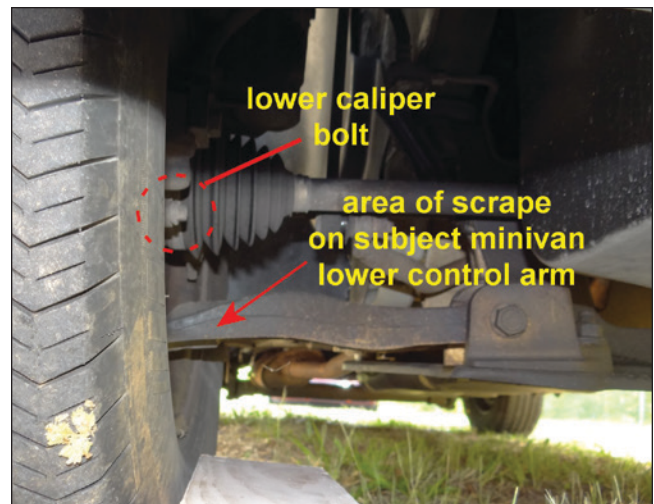
**Figure 9**  
Accessibility of lower caliper bolt to fork tips (exemplar).

d. The subject lower bolt also could have been deformed by some external force application unrelated to the dealership's servicing. For example, the vehicle had been stored at an auction yard for years following the incident. This auction yard (like many) moves vehicles around through the use of large wheel loaders equipped with long forks that the drivers basically shove under the vehicles to pick them up. **Figure 9** shows (on an exemplar minivan) how the lower caliper bolt could have been readily contacted by fork tips; additionally, there was a fresh scrape mark on the front

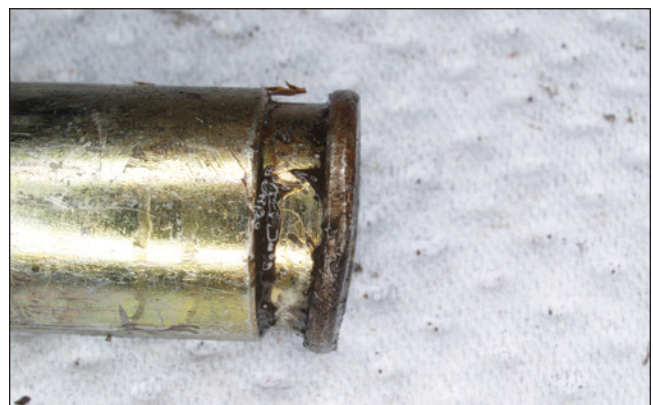
**Figure 10**  
Deformed end of lower slider bushing.

surface of the right front lower control arm (below and behind the lower caliper bolt) in photographs taken by the dealership's expert two months after the incident. Consistent with this scenario, it is also of note that not only the lower caliper bolt was deformed, but the face of that bolt's slider bushing (that contacts the suspension upright) also showed deformation consistent with a bending force being applied to the bolt (or bushing) while it was in place on the vehicle (**Figure 10**). It is not conclusively known, however, what the rotational orientation was of the bend in the bolt (and slider bushing) preceding their removal by the plaintiff's expert, as he had taken few photographs of the components during disassembly. Low-resolution zoomed-in portions of the few digital images taken by the plaintiff's expert appeared to show that the bolt was bent vertically up, but this was not conclusive.

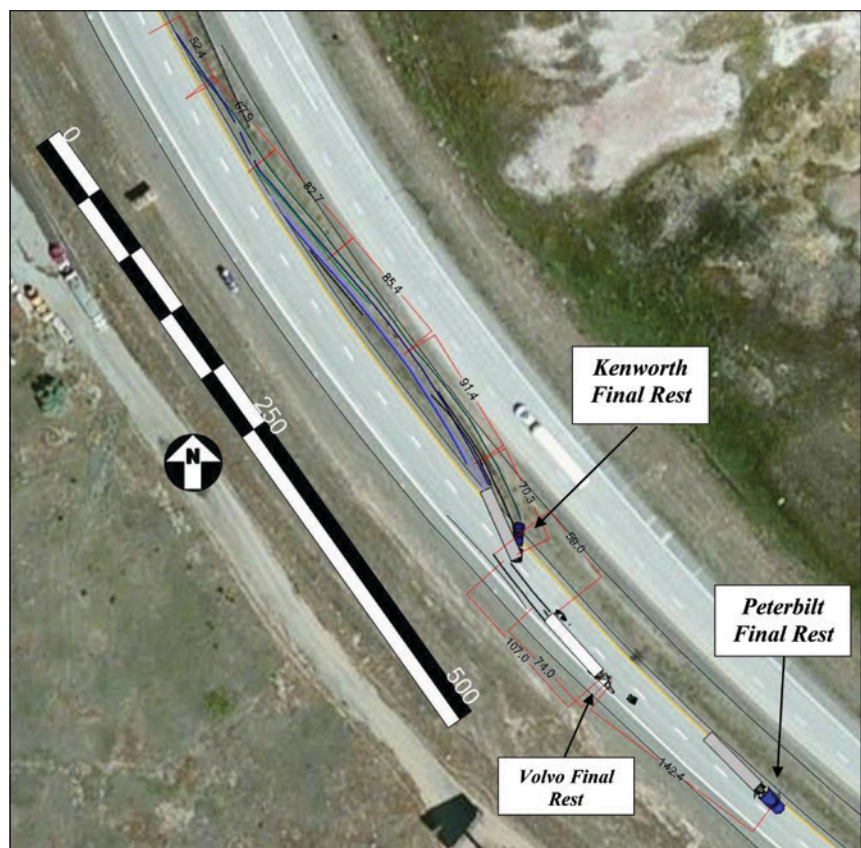
**Figure 9**  
Collision scene evidence.

The Kenworth was traveling within the inside (left) traffic lane of a stretch of four-lane-two-way interstate highway having a 75-mph posted regulatory speed limit and a brushed concrete surface. The roadway section was on the downgrade side of an extended crest vertical curve of approximately -3%. The roadway geometry also consisted of an approximate 2,000-foot radius horizontal curve to the left at the centerline of the travel lanes for the Kenworth's travel direction, having an approximate 7% super-elevation toward the outside edge of the roadway. **Figure 9** provides a diagram of the collision scene, documented evidence, and final rest locations of the three tractor/semi-trailer combinations.

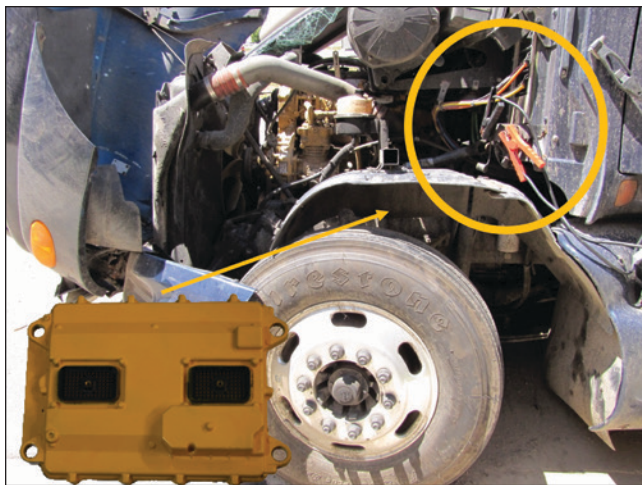
**Figure 10**  
Power supplied through main power terminal;  
location of HVEDR.

Emergency personnel cut the power supply cables from the service batteries of the Kenworth. However, the authors were able to provide power to the vehicle using a high-amperage jump box connected to the main power terminals located on the driver’s side firewall inside the engine compartment, as shown in **Figure 10**. The Kenworth Caterpillar engine was equipped with an ADEM IV generation Caterpillar HVEDR, located on the driver’s side of the engine block at frame rail height, also shown in **Figure 10**.

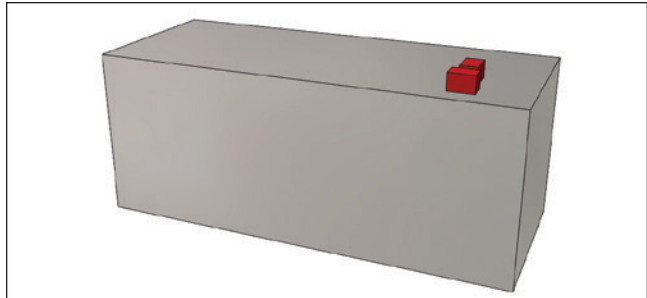
**Figure 4**  
Transformer showing location of impact recorders.

In the first event, Impact Recorder #1 (IR1) logged acceleration and duration values greater than the specified limits, while the same event logged by Impact

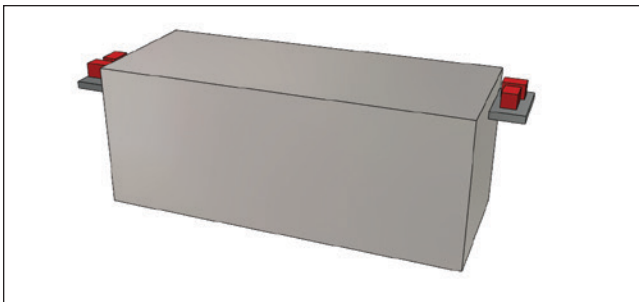
**Figure 9**

each end, as shown in **Figure 9**), with a third mounted directly on the railcar; however, the location and orientation of this one was not known. Once the transformer railcar was parked on a siding near the substation — and before the transformer was offloaded to the multi-axle transport vehicle — the manufacturer's representative downloaded and reviewed the impact recorder data, noting high levels of vibration. However, none of the recorders logged any significant impacts. Because of the high levels of vibration recorded by the impact recorder, the manufacturer put the rail transporter on notice for potential damages to the transformer, pending an internal inspection and electrical testing. The forensic engineer was mandated directly by the rail transporter. A marine surveyor also attended the site investigation along with the manufacturer's technician.

Transformer showing locations of impact recorders.

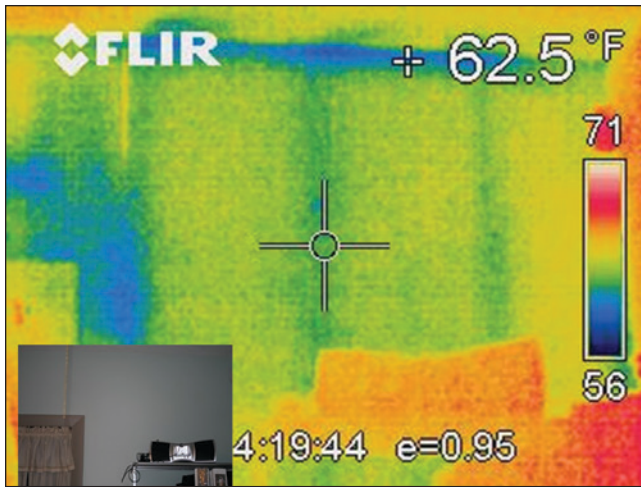
**Figure 9**

The fastening point of the pipe is also usually on the wooden framing members within the wall cavity. This locates the pipe in the coldest portion of the wall cavity, securing it to the fastening point with the least

thermal protection and in an area where the consistency of the insulation is likely at its lowest (**Figure 9**).

Thermal image of exterior wall shows poor insulation conditions at wooden frame areas. This is known as “thermal bridging.”

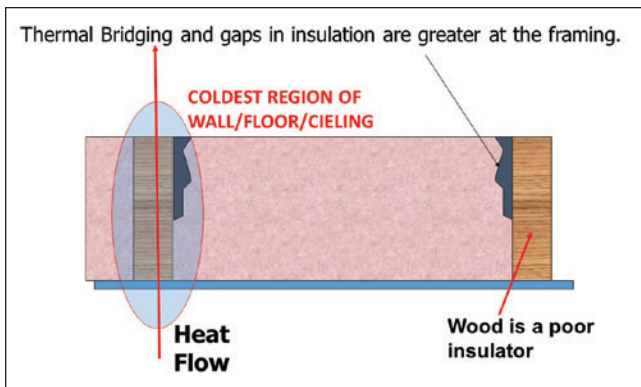
**Figure 10**

The poor insulation qualities of the wooden framing — as well as the tendency for air gaps to be present where the insulation meets the framing — all act together to undermine the thermal integrity of the wall system and increase the chances of freezing (**Figure 10**).

Thermal bridging is a combination of the poor insulating capability of wood and typical gaps where the insulation and framing meet.

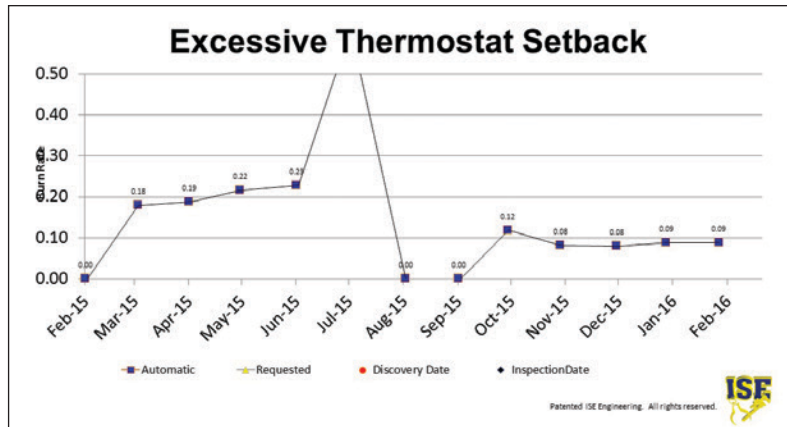
Figure 13

As seen in **Figure 13**, during a previous winter when the property was known to be occupied and no report of frozen pipes occurred, the consumption rate was 0.18 units of fuel per HDD, for a 5.5 K factor

Fuel usage burn rates (Y-axis) showing thermostat setback.

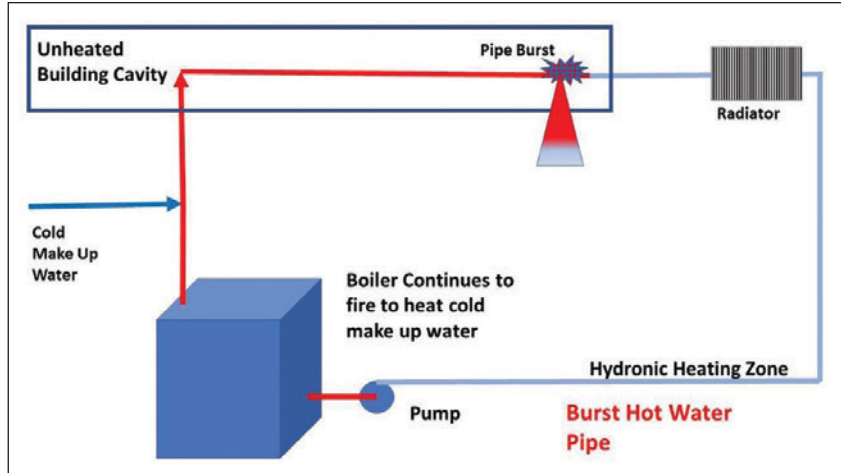
Figure 15

In **Figures 14** and **15**, both the fuel usage analysis graph and the system diagram show the effects of a hydronic heating system pipe break. The loss of heated water while being resupplied with cold make-up water causes accelerated fuel consumption.

Hydronic heating system pipe break results in accelerated fuel consumption.

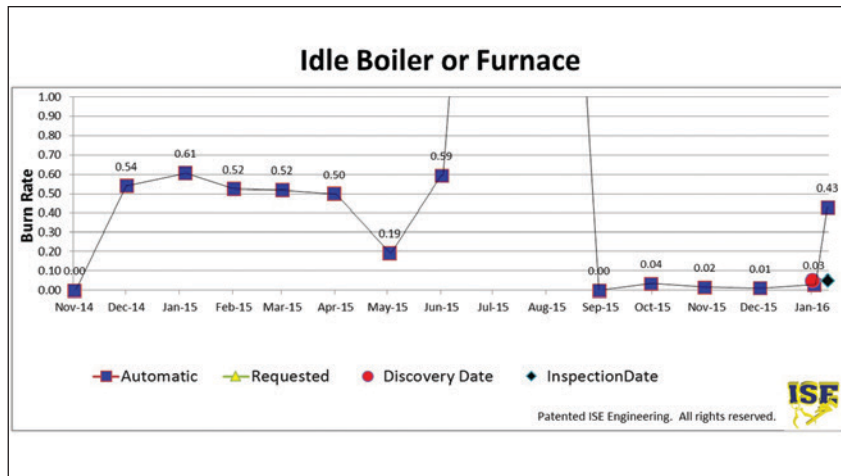
Figure 16

As seen in **Figure 16**, the fuel usage burn rates show the heating system capable of operating; however, the usage rates do not show that heat is being supplied to the building. This type of failure is indicative of the thermostats being turned off or some interruption of boiler hydronic water or furnace heated air flow.

Fuel usage burn rates showing idle boiler or furnace prior to failure.

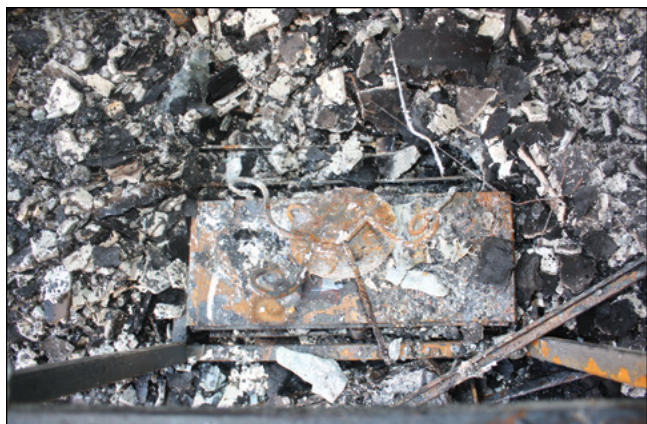
**Figure 3**  
Unattended candle remains within FD origin.

Four O&C investigations were performed, and the investigators had different opinions (**Figure 10**). The fire department investigator (#1) opined that the origin was in the northeast corner of the living room, and the unattended candle was the cause (ignition source). As mentioned, the first O&C investigator of the landlord

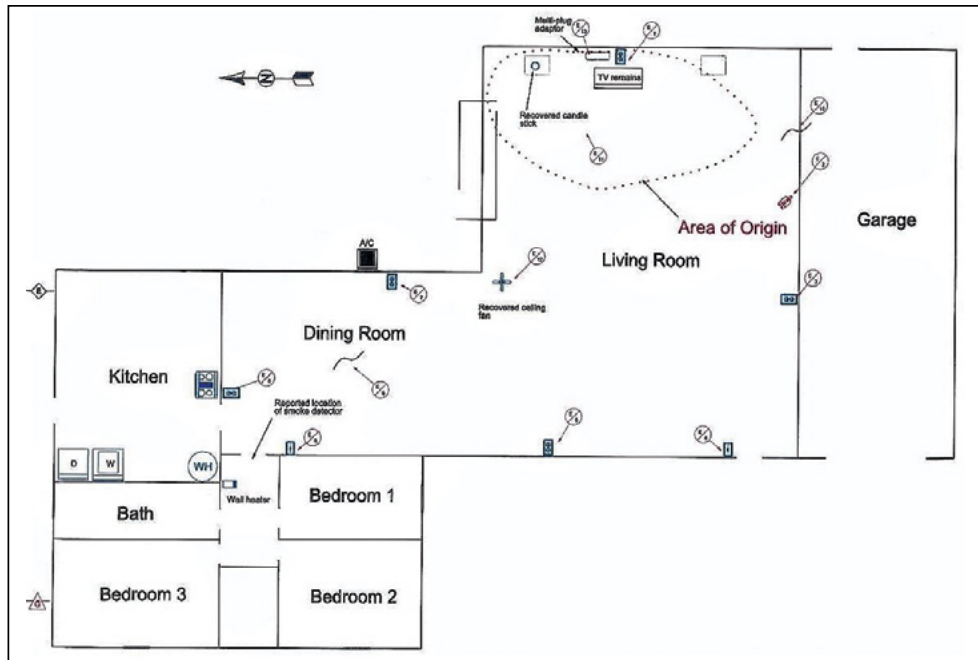
**Figure 5**  
Evidence locations.

1	Outlet	Living Room-East Wall
2	Male Plug	Living Room floor-South Wall
3	Outlet	Living Room-South Wall
4	Switch	Living Room-West Wall
5	Outlet	Living Room-West Wall
6	Switch	Dining Room-West Wall
7	Outlet	Dining Room-East Wall
8	Outlet	Dining Room-North Wall
9	Wiring	Dining Room-Ceiling
10	Unknown Wiring	South Living Room Wall
11	Motor	Living Room Floor
12	Ceiling Fan	Floor of LR/Dining Room
13	Power Cords & Debris	LR Floor-East Wall

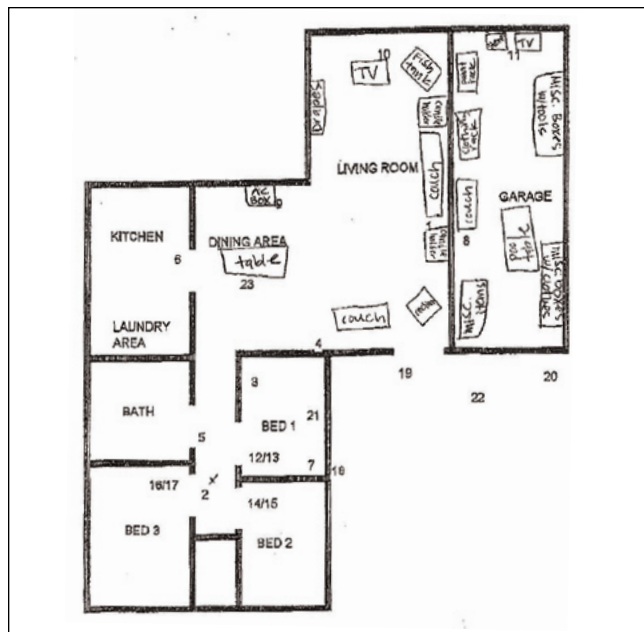
**Figure 9**  
Pre-fire contents in home.

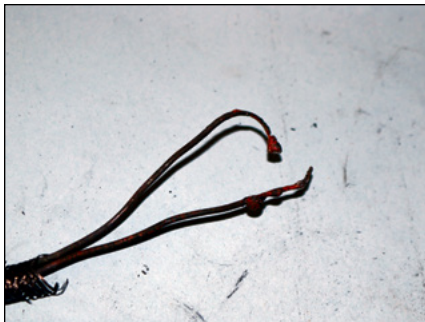
Analyses of the microscopic photos of evidence item #10 (Figure 12 and 13) and X-rays of evidence item #13 (Figure 14), combined with observed failure modes of these items, supported the hypothesis that there were no internal electrical failures within the items (causative of ignition) but that these items were damaged by external exposure to fire. Evidence item

**Figure 12**  
Evidence item #10 melted conductors.

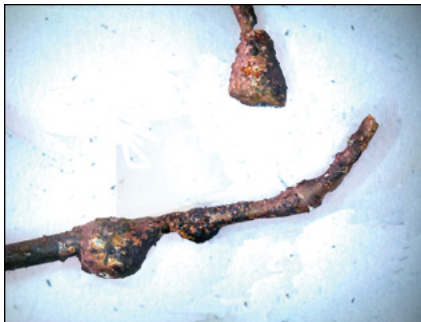
**Figure 13**  
Microscopic view of evidence #10.

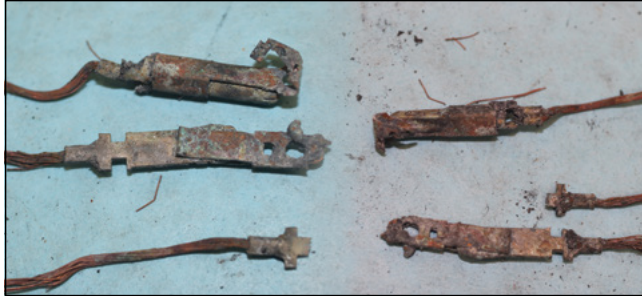
The two extension cords were daisy-chained, the failure-mode was localized, and internal melting of the prongs/blades was consistent with electrical resistance heating and faults/arcs (**Figure 17** and **18**). Evidence item #3 shows the remains of the outlet behind the couch in the south wall of the living room (**Figure 19**).

**Figure 17**  
Closer view of male-female prongs.

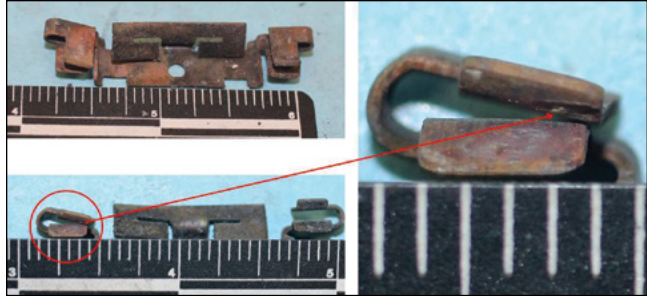
**Figure 20**  
Witness mark of parting arc within evidence #3.

Closer examinations found the witness mark of an arc within the line-side slot of the receptacle (**Figure 20**). This suggested that there was a plug in that receptacle, and a parting arc had occurred when the energized blade was pulled/separated from the receptacle during the fire spread.

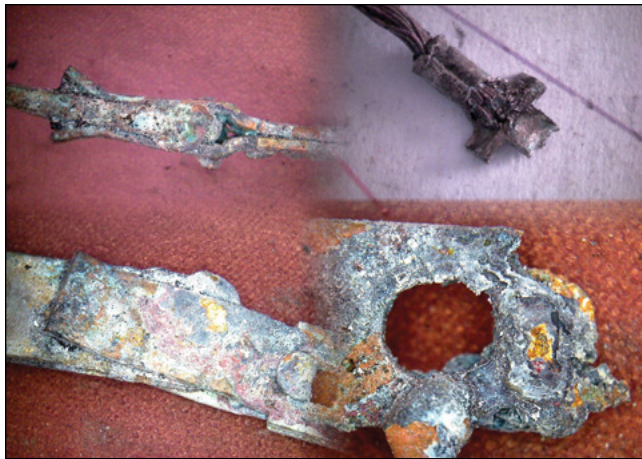
**Figure 18**  
Microscopic views of male-female prongs.

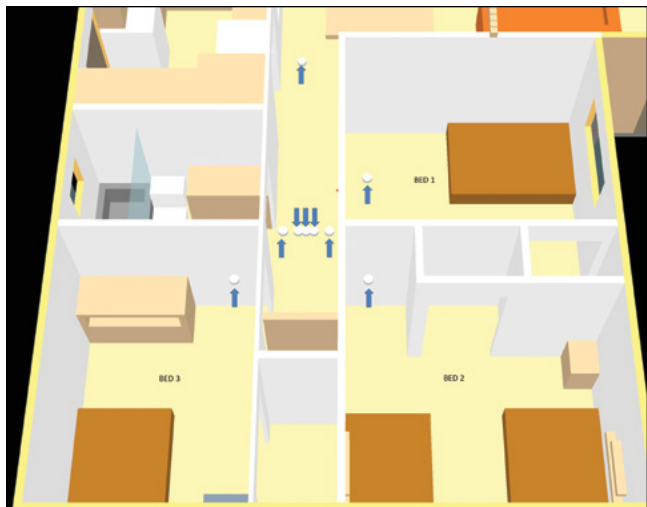
FDS software includes the two most common residential smoke detector types: ionization and photoelectric detectors. Both smoke detector types were placed in two ceiling locations in the hallway and in each bedroom (**Figure 24**). The sliding door and window glass panes were instrumented in the model with an array of temperature and heat-flux detectors to break the glass at the appropriate conditions. The drywall was instrumented in the model to cause failure of the wall to allow the fire to spread from the living room to the garage. The carbon monoxide (CO), temperature, heat flux, and smoke levels were monitored throughout the interior of the building at various locations.

**Figure 24**  
Hypothetical smoke detector locations.

Based upon the most probable simulation, a smoke detector in the hallway would have annunciated between 34 and 45 seconds after ignition-flame/fire originated, depending upon the detector location, and provided approximately 1 minute for egress through the kitchen and front entry doors. The annunciation would have provided approximately 2 minutes for safe egress through the bedroom windows.

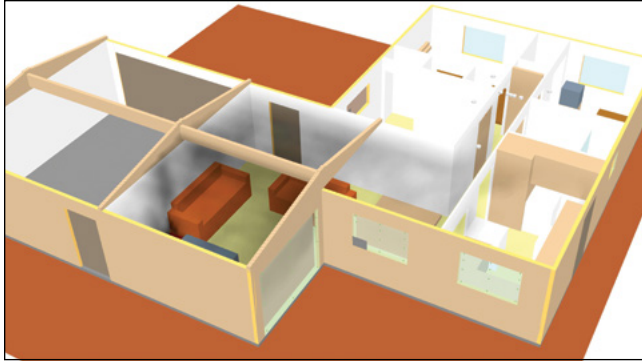
Using photographs, fire damage patterns, timeline(s), and witness information, the simulation labeled as Q5 was the best fit and most probable simulation for the subject fire (origin at the south wall of the living room near the east edge of the sofa) per #3 plaintiff investigator. The smoke level, CO (ppm at 2-meter elevation) and temperatures for the smoke detector

**Figure 27**  
Smoke @ 45 sec.

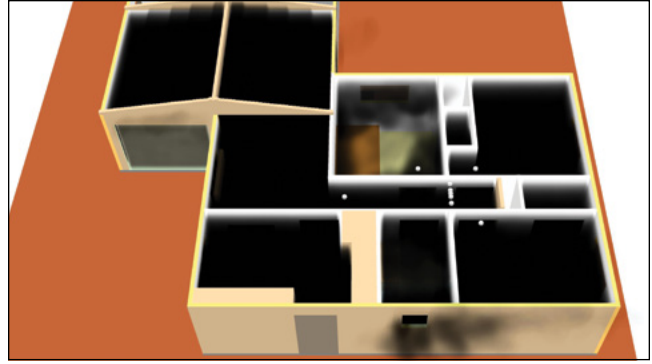
**Figure 30**  
Smoke @ 160 sec.

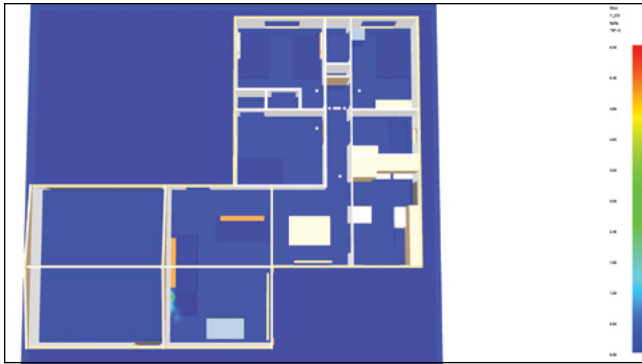
**Figure 28**  
CO @ 45 sec.

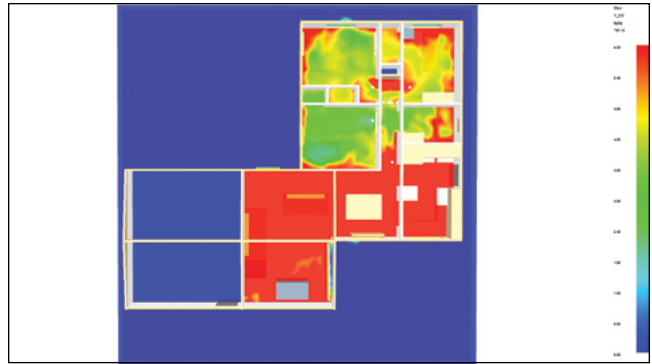
**Figure 31**  
CO @ 182 sec.

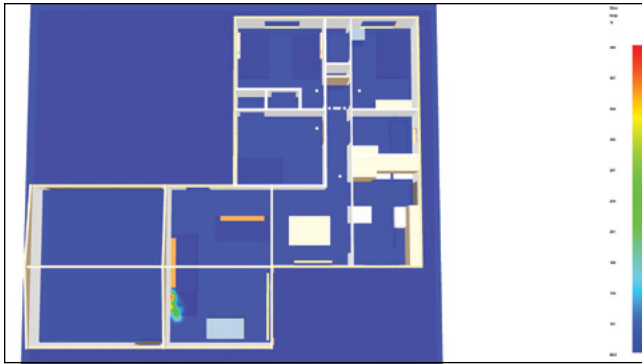
**Figure 29**  
Temps @ 45 sec.

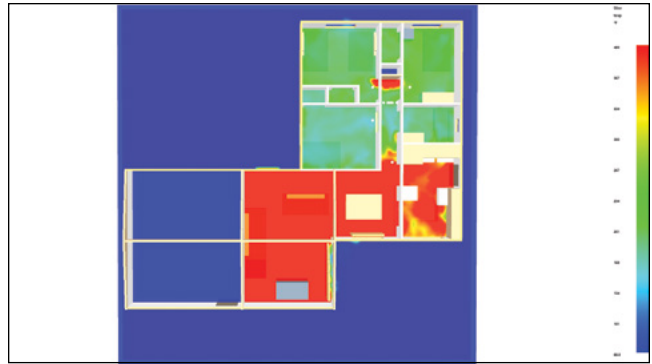
**Figure 32**  
Temp @ 182 sec.

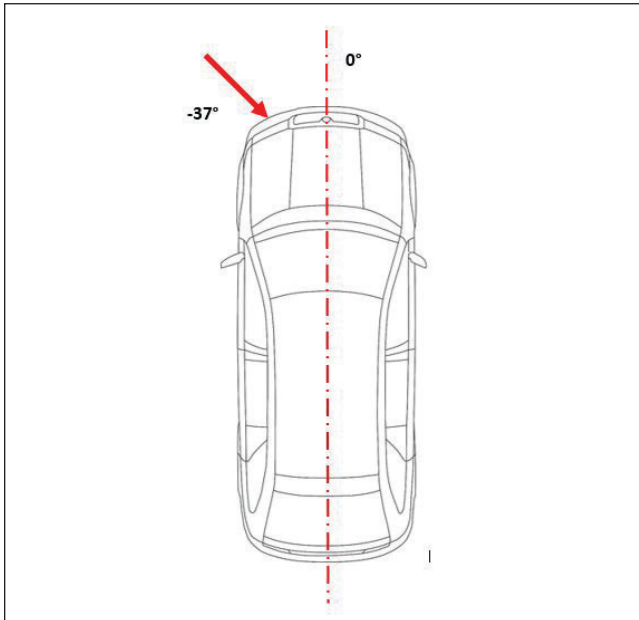
**Figure 1**

Diagram of principal direction of force (PDOF) of negative 37 degrees on plaintiff vehicle.

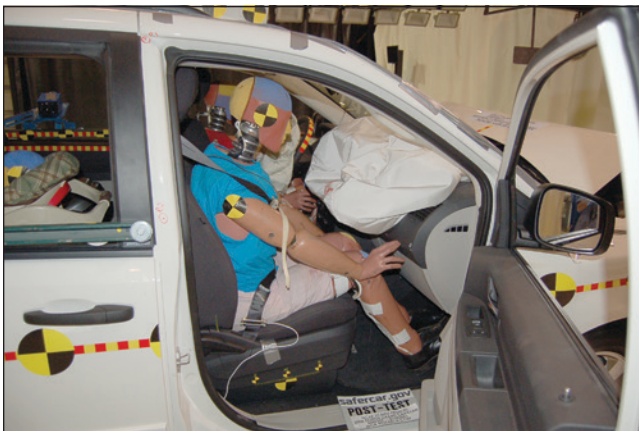
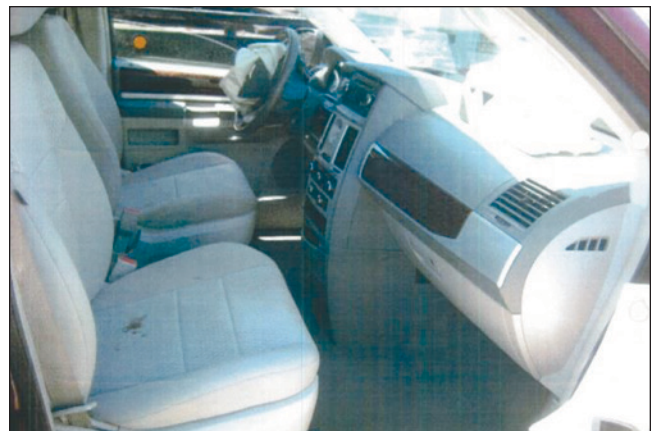
**Figure 2**

The plaintiff's wife argued that her husband was wearing a seatbelt, but nonetheless suffered a fatal injury. The defense argued the husband was not wearing a seatbelt, and he would have likely survived the accident if seatbelt restraints were utilized (**Figure 2**).

Photo on left shows an exemplar vehicle after a frontal impact at 35 mph where there was no contact with the interior, and the photo on the right is the subject vehicle post impact. This illustrates that the use of seatbelts prevented contact of the body with interior structures in the anthropometric dummy tests.

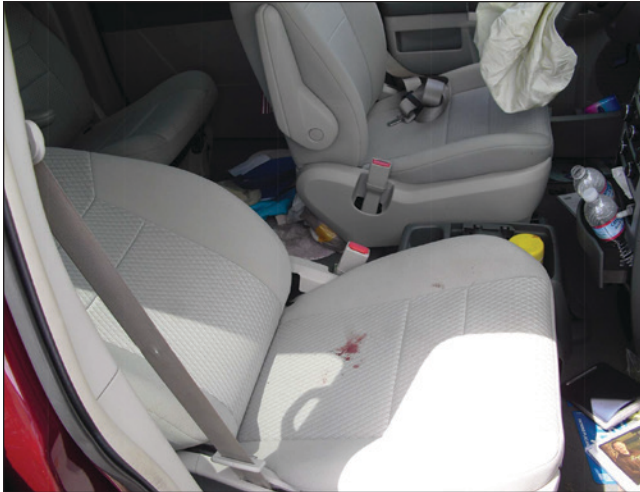
the wiring diagram exposed that there was no warning chime for the right front occupant's restraint, and the airbag and pre-tensioner could deploy without seatbelt use. This is consistent with the driver not hearing the warning chime and the pre-tensioner deploying with an unrestrained right front occupant. **Figure 3** shows the seatbelt on the passenger side is extremely taut compared to the driver's seatbelt post impact consistent with non-use of the restraint by the passenger.

The photo above of the right front passenger seatbelt illustrates extremely taut webbing. Note the difference between a used (driver) and unused (right front passenger) seatbelt after the pre-tensioners fire bilaterally.

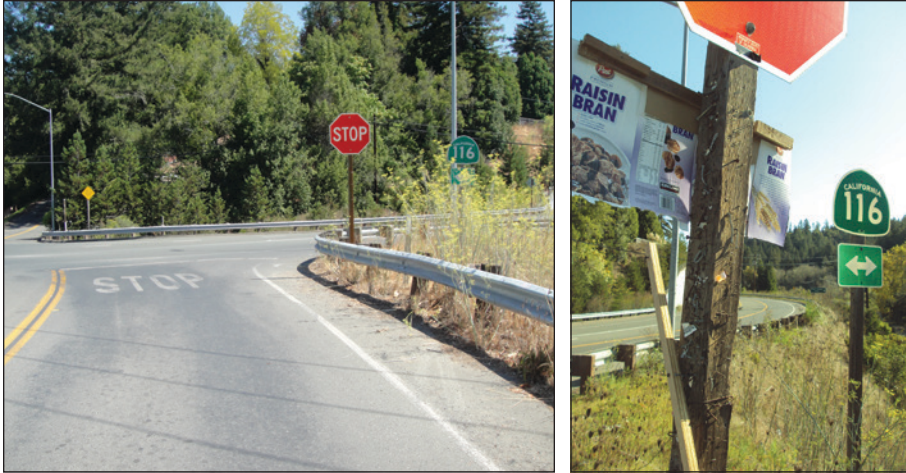
**Figure 5a and Figure 5b**

This case presents a 19-year-old female who was a passenger on a motorcycle. The rider was going uphill on a left-hand curve, struck a guardrail on the right (**Figure 5a**), which ejected the young woman from the back of the motorcycle. Her face was struck consistent with the facial trauma that included open fractures of the nasal complex, maxilla, frontal sinus, and mandible as well as extensive facial lacerations most prominently to the upper right lip (**Figure 6**). Prior to the forensic engineering analysis, the striking object was unknown and the narrow-most issue in the case. The

Incident scene with stop sign and thrie-beam barrier as well as a close-up of nails present in the stop sign post.

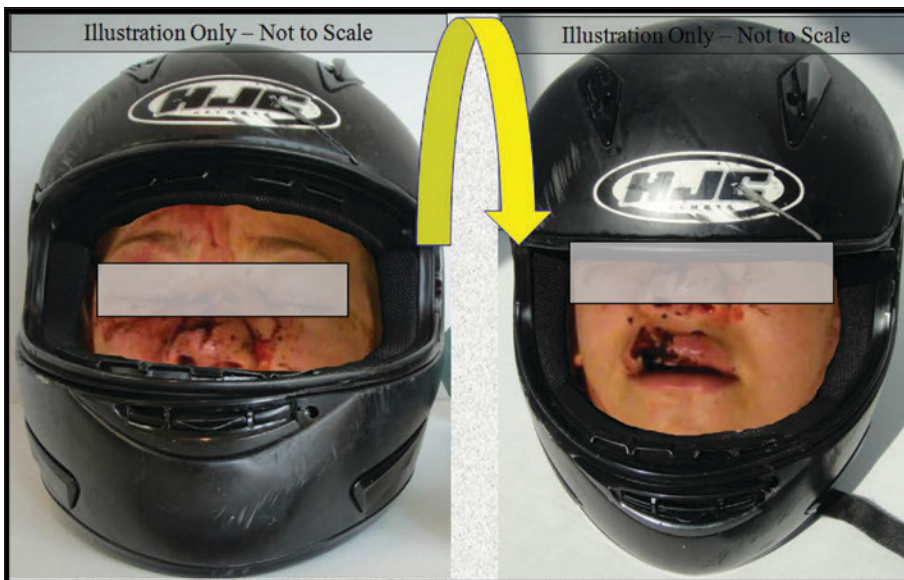
**Figure 6**

Loose-fitting helmet likely caused open fractures of the nasal complex, maxilla, frontal sinus and mandible as well as extensive facial lacerations most prominently to the upper right lip.

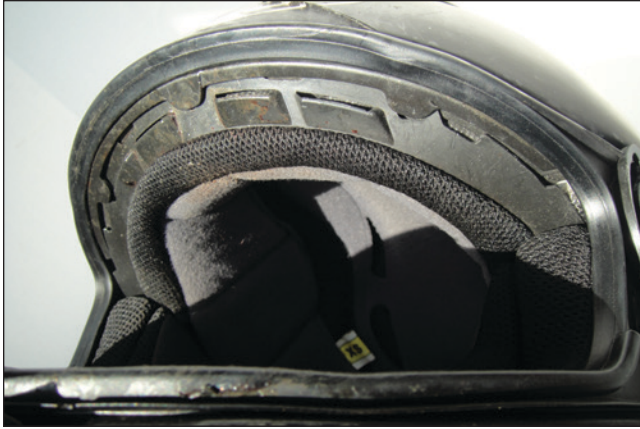
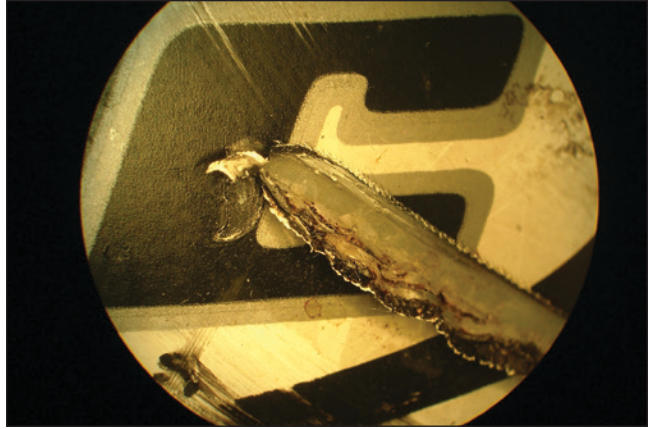
**Figure 7**

there was blood inside this peeled and curled up area of the helmet shell, as shown in **Figure 7**. Therefore, blood was deposited on the outside of the helmet prior to contact with the straight non-yielding surface that caused the gouge. This surface was determined from the scene investigation to be consistent with a thrie-beam barrier at the side of the road.

Blood/tissue-like evidence at the superior opening of the helmet internally (left) and in the interior of the curled polymer, resulting from the gouge externally (right).

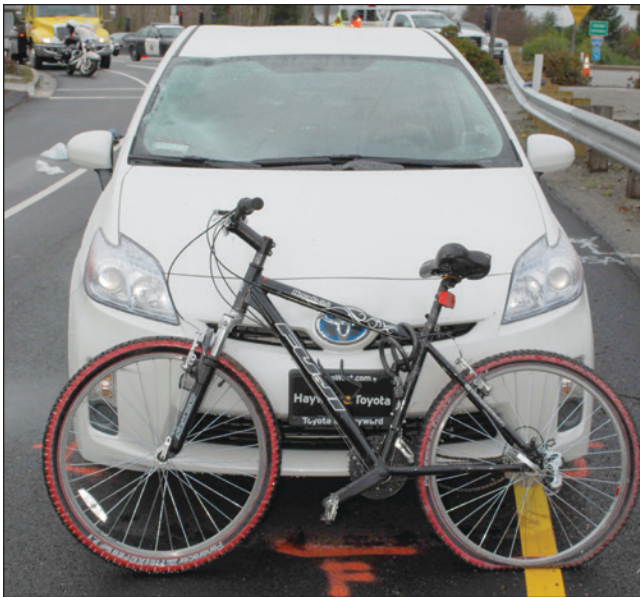
**Figure 8** illustrates the subject vehicle and bicycle from an un-helmeted male child bicyclist struck by a

With the vehicle at point of rest at the scene, the bicycle evidence is matched up to the Prius. The un-helmeted bicyclist stated he was not riding but was a modified pedestrian at the time of impact so therefore helmet use wasn't required.

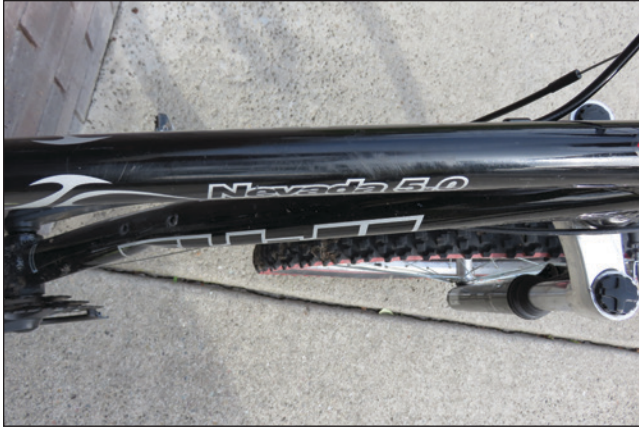
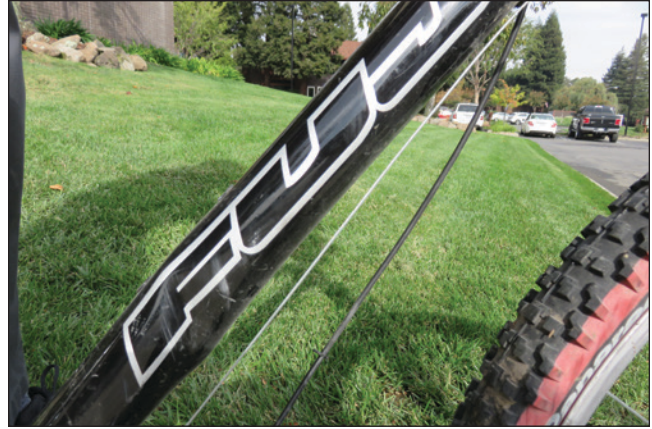
**Figure 9a and 9b**

The white scuff and indentation on the right side of the bicycle frame are consistent with color transfer from a white sole of a sneaker that was worn by the plaintiff.

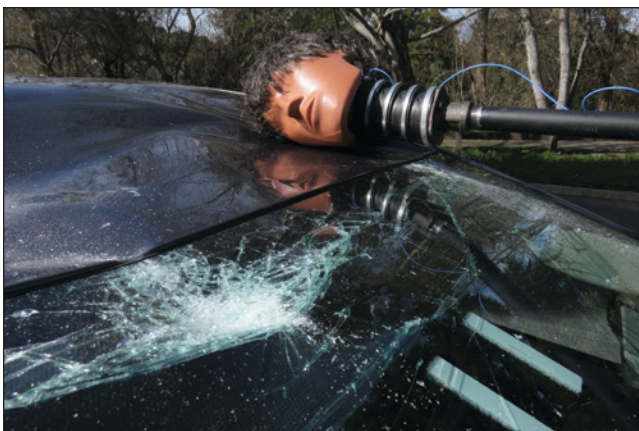
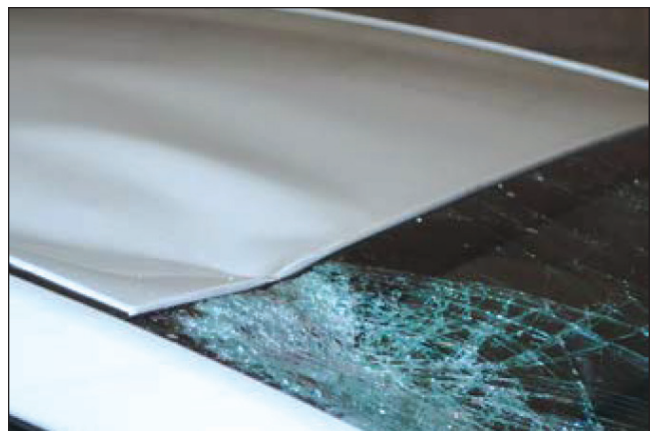
**Figure 10a and 10b**

Damage to the roof and windshield of the test exemplar vehicle is substantially similar to damage of the subject vehicle.
