Journal of the  
**National**  
**Academy** OF  
**Forensic**  
**Engineers**<sup>®</sup>

Vol. 34 No. 1 June 2017

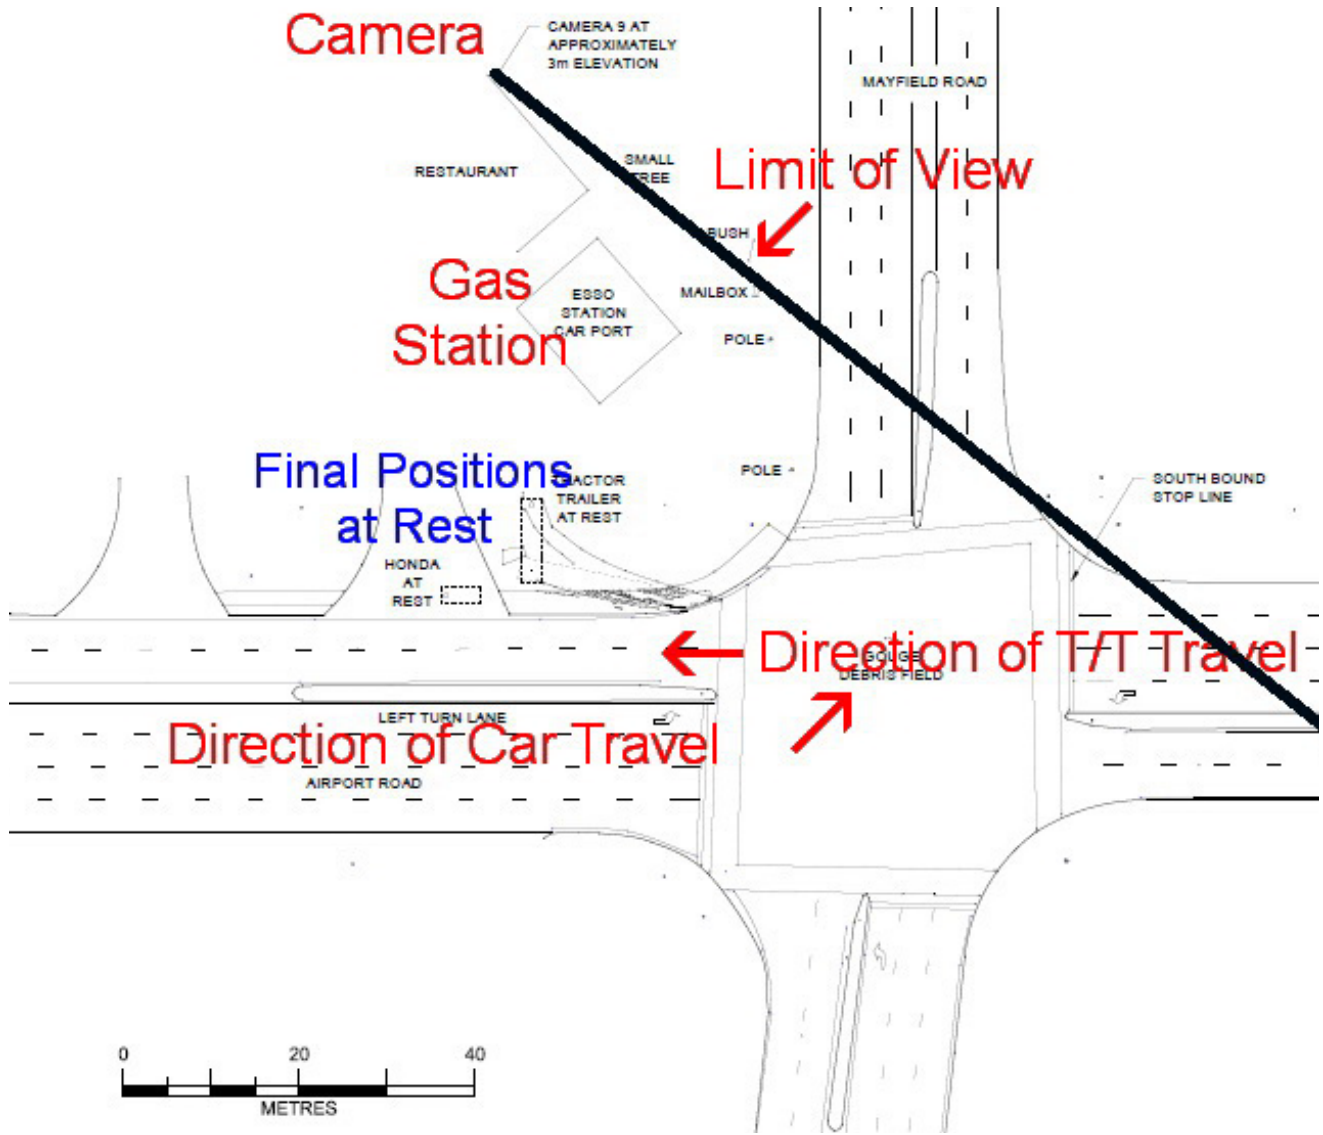
Figure 6

Photographs of the scene taken by police indicated that the tractor/trailer combination had come to rest in a jack-knifed position on the lawn area of the filling station. The passenger vehicle had been pushed in front of the tractor/trailer and came to rest in the driveway of the filling station (**Figure 6**). A short gouge in the asphalt was noted along the southward extension of the demarcation line of Lanes 1 and 2 traveled by southbound traffic at about 20 meters (66 feet) south of the southbound stop line. This gouge and the surrounding debris field indicated the probable area of impact (AOI), and their positions were specified by police data points. No tire marks were seen north of the gouge during the site inspection by

The scale diagram incorporates Arcon’s Total Station measurements and information from of the Ontario Provincial Police (O.P.P.) collision reconstruction team’s site drawings. It provides an excerpt that zooms in on the area of interest, showing the directions of vehicle travel, the final positions at rest, and the camera with the limit of view.

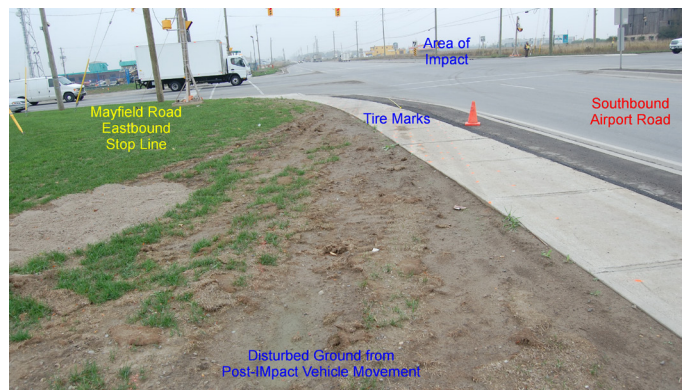
Figure 7

police officers. Tire marks extended from 6 meters (20 feet) beyond the gouge to the positions at rest. Tire impressions were seen in the soft ground on the lawn of the station, as shown in **Figure 7**.

View to the northeast along the path of post-impact vehicle movement.

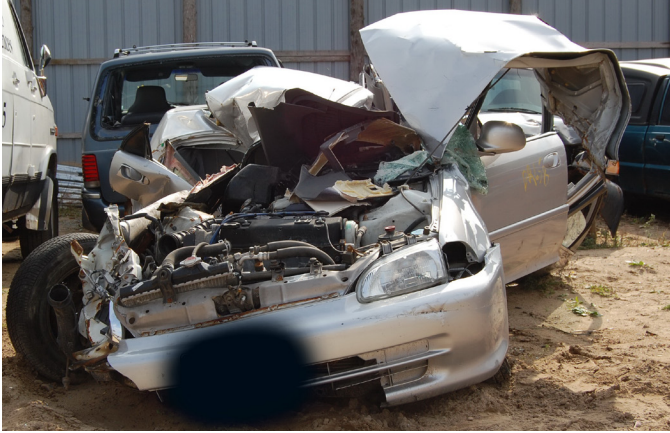
**Figure 8**

This vehicle was a silver-colored early '90s model year, four-door Honda Civic. There was a major crush laterally from the trailing edge of the right rear door forward to the front bumper, inboard past the centerline, from 85 cm (33.5 in.) to a maximum of 130 cm (51.2 in.) at a fold in the roof panel. The vehicle had characteristics of being rolled as if overridden in the engagement. There were tire marks on the central portion of the right rear door, and

Front view of the Honda, showing depth of lateral crush.

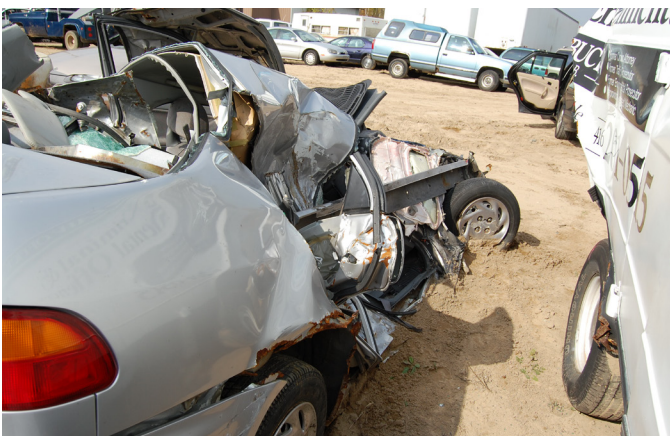
**Figure 9**

similar marks on the bumper fascia just forward of the right front wheel, as seen in **Figure 8** and **Figure 9**.

Right side view of the Honda.

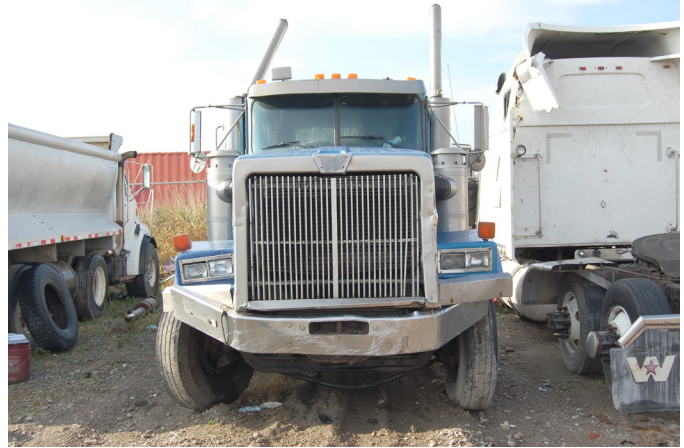
**Figure 10**

The Western Star tractor was a blue mid-'90s conventional. The trailer was a Cobra dump body fully loaded with gravel. The calculated length of the combination was 20.1 to 20.3 meters (65.9 to 66.6 feet). The right front tractor bumper had been deformed upward and aft (**Figure 10**), with the lower portion pushed back. Bumper deformation extended across to the left side, which was folded back and under the driver's side headlight assembly (**Figure 11**). The right front wheel suspension components had deformed to splay the wheel outboard at the front with respect to its typical position. Contact was noted on the suspension components. There was silver paint transfer on the forward portion of the bumper.

Front view of the tractor with post-impact bumper deformation.

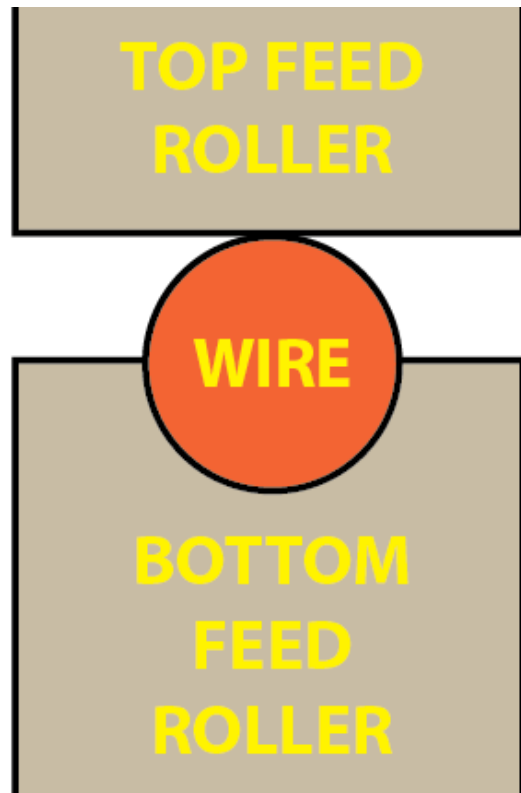
**Figure 6**

- The use of sampling is common in mass production of inexpensive parts such as the spring; the subject spring had a production price of \$0.03.
- Delmar utilized a typical type of spring forming machine, in which the spring coils are formed through a “wiping” plastic deformation; the coils are not formed by “rolling” plastic deformation. As such, the surface of the wire will exhibit some damage due to localized galling and abrasion of the wire where it rubs the concave “saddle surface” of the spring forming machine, during plastic deformation (**Figure 5**). Additionally, there was an opportunity for minor flattening of the spring wire as it went through the forming machine’s feed rollers (**Figure 6**).

Feed roller configuration.

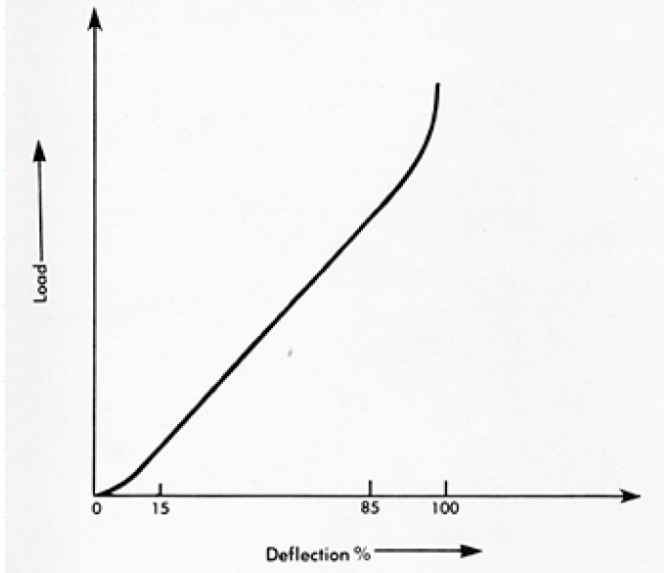
Figure 8

Load deflection versus load magnitude.

- Note that due to the non-linearity of the spring rate as the spring compression approaches 100% (**Figure 8**), the “loads based on print dimensions” trace in **Figure 9** is unrealistically constant in the “NOT RECOMMENDED” area of the plot.
- As facilitated by the near-solid-height maximum deflection of the spring, cyclical coil clashing will over time eventually cause the anti-corrosion plating to deform and/or wear away from the areas of coil contact, potentially allowing corrosion to introduce stress raisers in these areas. Clashing may also cause localized plastic deformation and other surface flaws that create fatigue crack initiation sites.
- As a backup to the ASD software analysis, manual calculations of the peak torsional stress in the spring were performed as follows, based on Spring Manufacturers Institute formulas<sup>4</sup>:

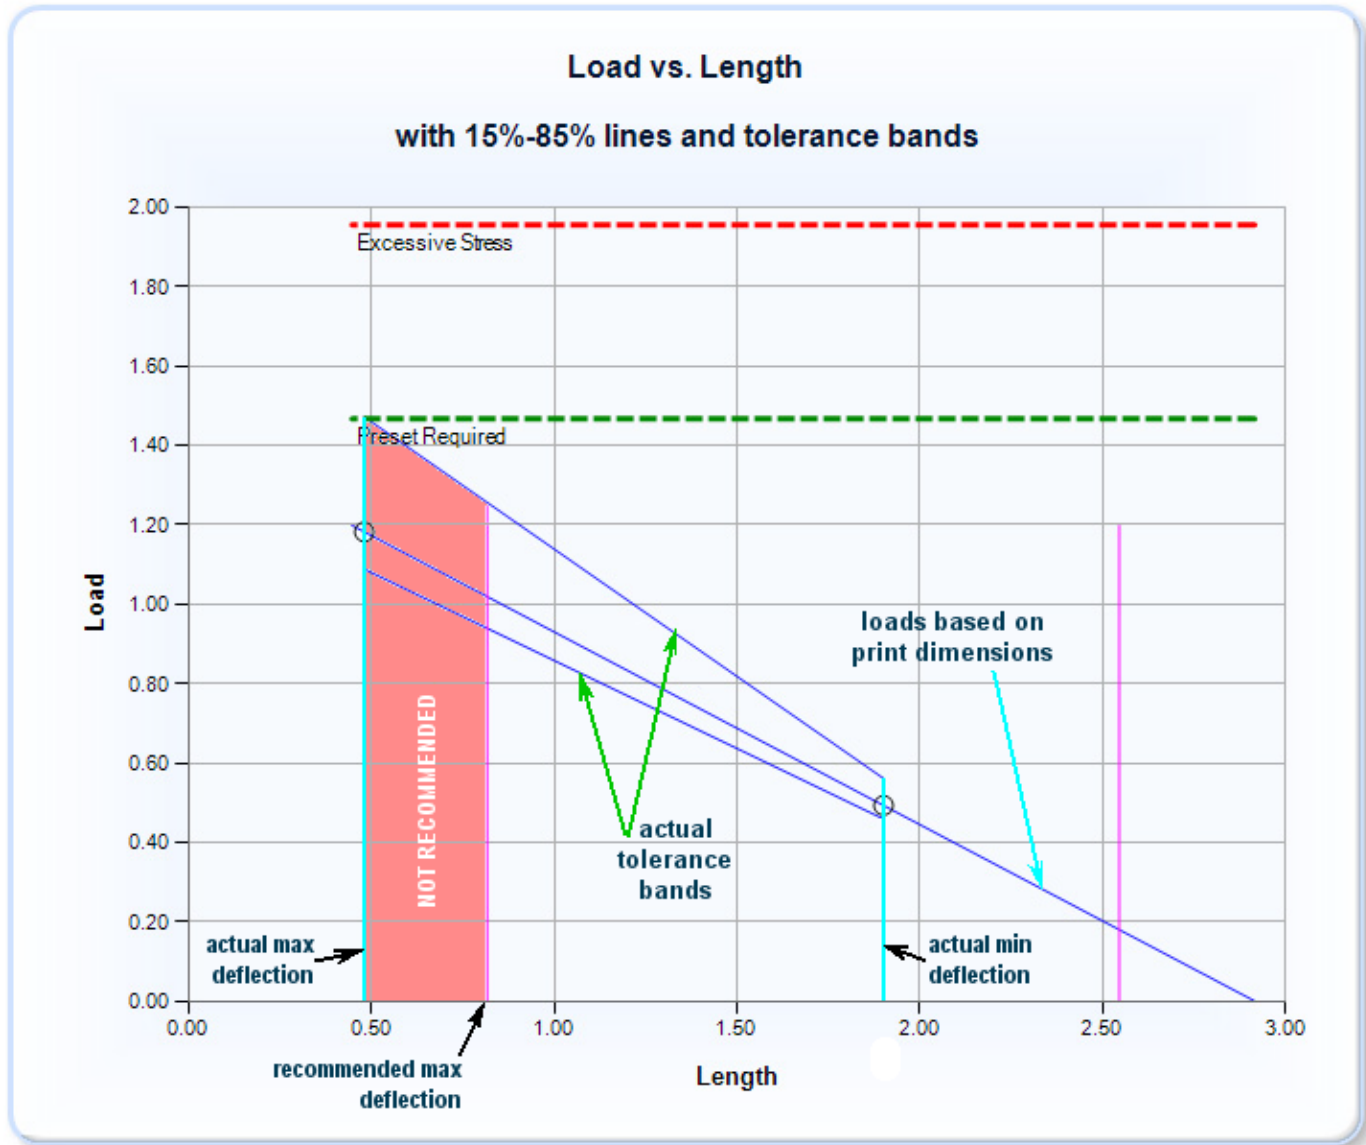
**Figure 9**  
Load vs. length composite image.

- The maximum Crown-designed working spring deflection was near the solid height (i.e., full compression) of the spring. Standard practice for the recommended extremes of working deflection range for compression springs are between 15% and 85% of full deflection, and as the spring approaches solid height, the effective spring rate, loads, and stresses rapidly increase<sup>2,3</sup>. See **Figure 8** from Associated Spring’s *Engineering Guide to Spring Design*<sup>2</sup>.
- Per the print dimensions, at full switch driver stroke, the spring deflection was over 98%. Utilizing the print dimensions and tolerances with the ASD software results in the load vs. length composite image in **Figure 9**, which has been

torsional stress was 160,000 psi, which when divided by 353,000 = 45.3%. This agreed closely with the spring in **Figure 9** reaching a “preset” (permanent plastic deformation) level of stress, and agrees with Spring Manufacturers Institute documentation of 45% as the threshold of preset<sup>4</sup>. Presetting, in which the spring is intentionally deformed beyond its yield strength, is used in some spring designs to reduce localized stresses, but the subject spring was not designed for preset.

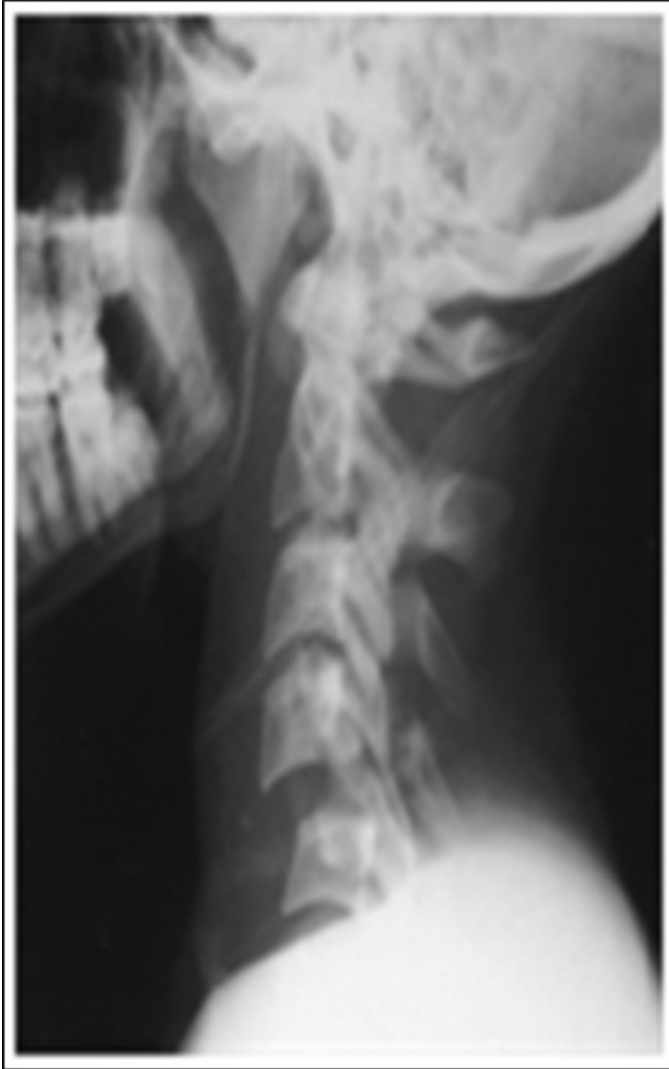
**Figure 10**  
Plaintiff's CT C-spine.

Bilateral facet dislocations are associated with compressive forces along the vertical axis of the front of the cervical spine. The diagnosis to the plaintiff was C4 on C5 with locked facets. The C5 facets “jumped” and “locked” on C4 facets (**Figure 10**). The mechanism to sustain a fracture dislocation is caused by a combination of flexion, rotation, and distraction (Im et al. 2012).

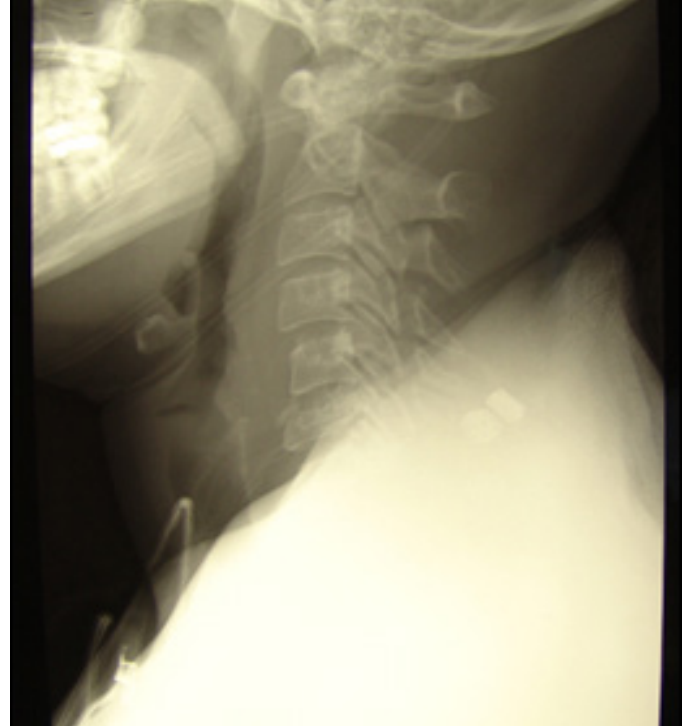
**Figure 12**  
Radiology of the fracture at C5-C7.

X-rays of the plaintiff's cervical spine showed multiple fractures from C5 to C7 (**Figure 12**). There was 6 mm of retropulsion of bone at the C6 level, causing spinal canal stenosis. There were also laminar fractures identified from C4 down to C7, probable anterior longitudinal

ligamentous injuries seen at C4-C5 and C5-C6, and also a fracture of the transverse foramen on the right at C5, which raises the possibility of a vertebral artery injury.

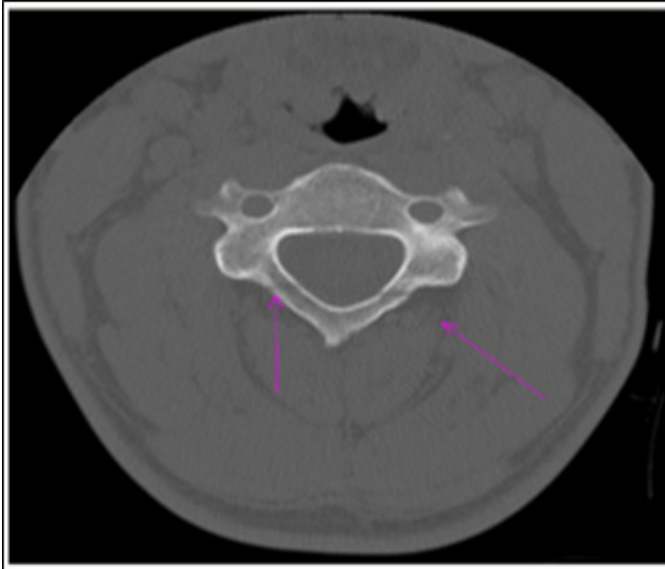
**Figure 13**

CT scan showing C5 burst fracture.

The plaintiff's cervical spine demonstrated multiple fractures. He had undergone a CT scan and an MRI of the cervical spine, which showed a C5 fracture (**Figure 13**). The plaintiff also had a fractured lamina of C2 and a fractured lamina of C4. C5-6 was offset by 2 mm, and C6-7 demonstrated a traumatic, herniated disc

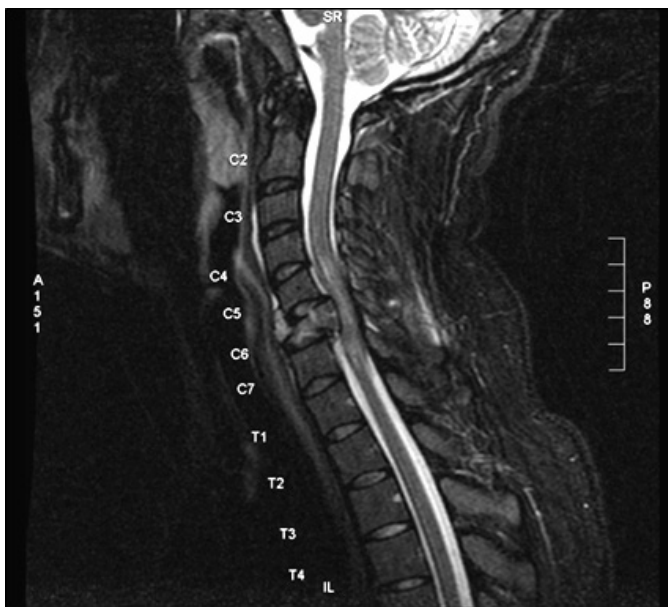
**Figure 16**

Burst fractures are also known as axially directed crush fractures. This type of injury is associated with high energy trauma, and it is characterized by a vertical loss of the vertebral body height. The mechanism of a burst fracture to C6 is caused by axial compression forces. The plaintiff was diagnosed with a burst fracture of the C6 vertebra with retropulsion as shown in **Figure 16**.

MRI of the C-Spine shows a burst fracture located at C6.

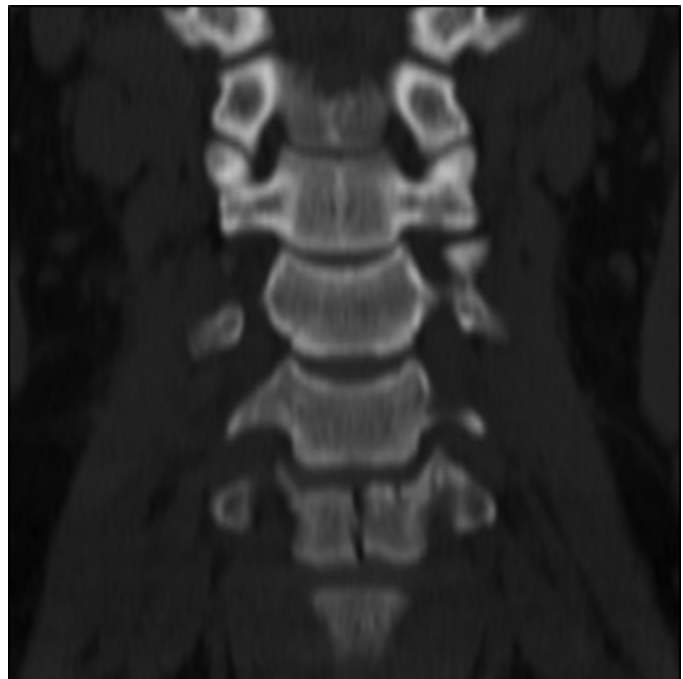
**Figure 18**

CT of the neck showed a burst fracture of C6 with fractures of C5 and C6 lamina (**Figure 18**). Burst fractures involve compressive axial-loading forces to the spine, and are characterized by loss of vertebral body

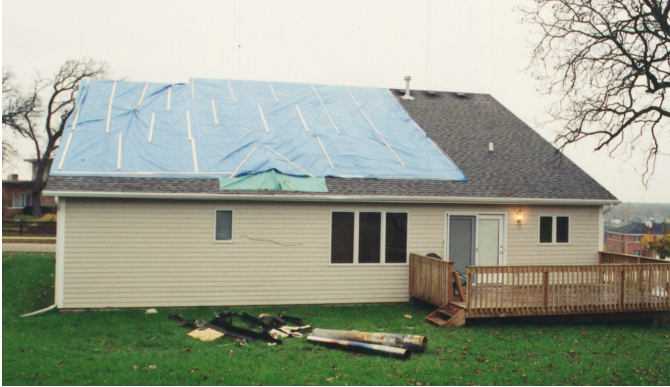
**Figure 1**

Rear of house showing chimney and chase debris in yard.

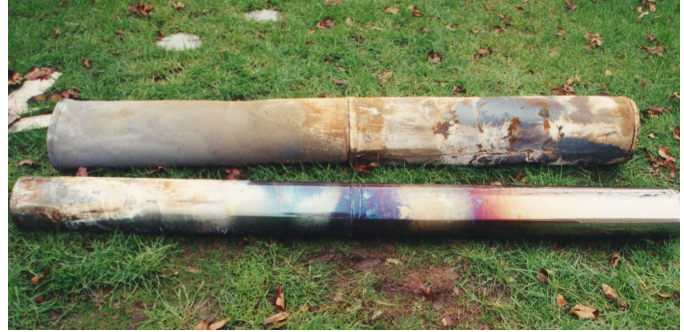
**Figure 3**

Chimney pipes in yard.

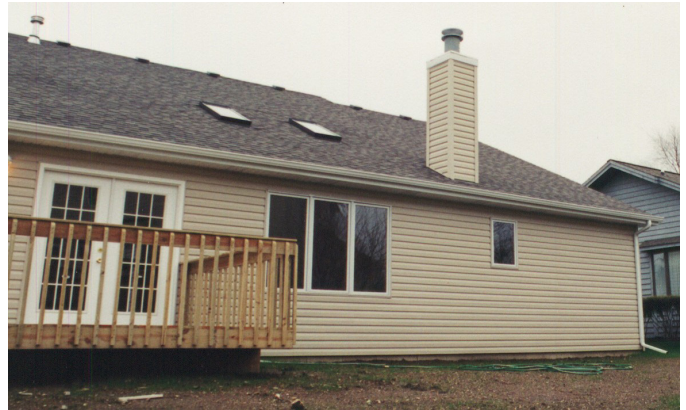
**Figure 6**  
Exemplar house showing chimney chase.

An inspection of an exemplar house that had been constructed by the same builder revealed that the upper portion of the fireplace chimney and rain cap clearly extended above the top of the wooden chase (**Figures 6 and 7**).

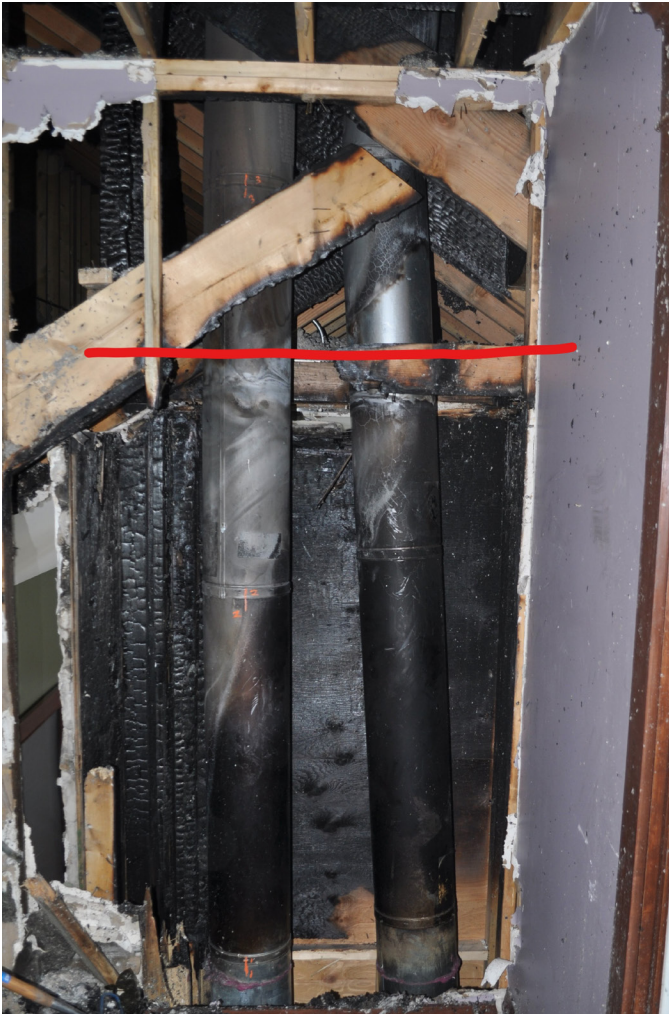
**Figure 10**

The upper portion of the fireplace chase was common to a second-floor bedroom wall. Drywall had been removed from that wall, exposing the chimney assembly (**Figure 10**). Significant fire damage was present in the second-floor portion of the chase and the attic above, and fire damage to the house was limited to this area. Cellulose insulation was located on top of framing that surrounded the original location of two sheet metal firestop spacers located slightly below the second-floor ceiling level.

Several openings existed between the chase and the surrounding attic. Those openings were not blocked or covered with plywood, netting, or any other insulation barrier, and they permitted cellulose insulation to be blown into the chase and against the chimney at the upper firestop spacer shelf position.

Second-floor level showing subject chimney pipe (left). Red line indicated original firestop spacer shelf position. An undamaged “protected area” was present on the unused (right) chimney pipe above the shelf.

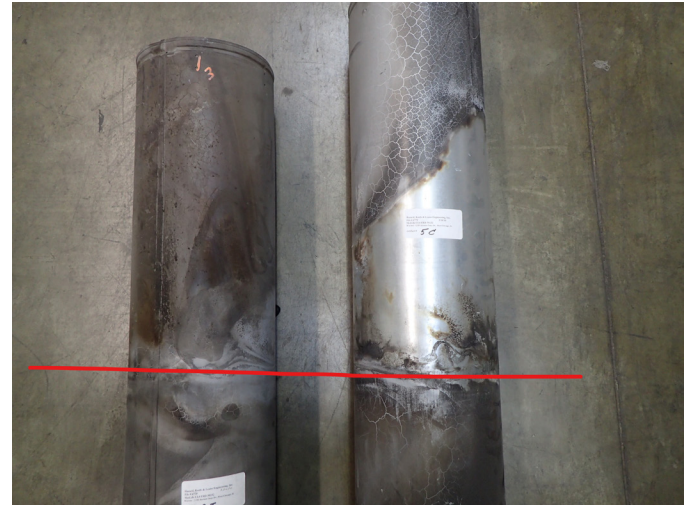
**Figure 11**

Fire patterns on the exterior surface of the subject chimney pipe, directly above the firestop spacer shelf, indicated an area of relatively intense heat located within a larger triangular shape, which was an area originally covered with insulation that burned away during the fire (**Figure 11**). A light coating of ash was located on the interior surface of the inner pipes of those sections. The termination cap contained black-colored deposits and loose material.

On the second (unused) parallel factory-built chimney, the portion located directly above the upper firestop spacer contained a “protected area” that was not heat/fire damaged. The maximum height of that protected area was approximately 18 inches above the firestop spacer. A pile of cellulose insulation had been located there during the fire, and protected that portion of the chimney section

Subject (left) and unused (right) chimney pipes. Red line indicates original firestop spacer shelf position.

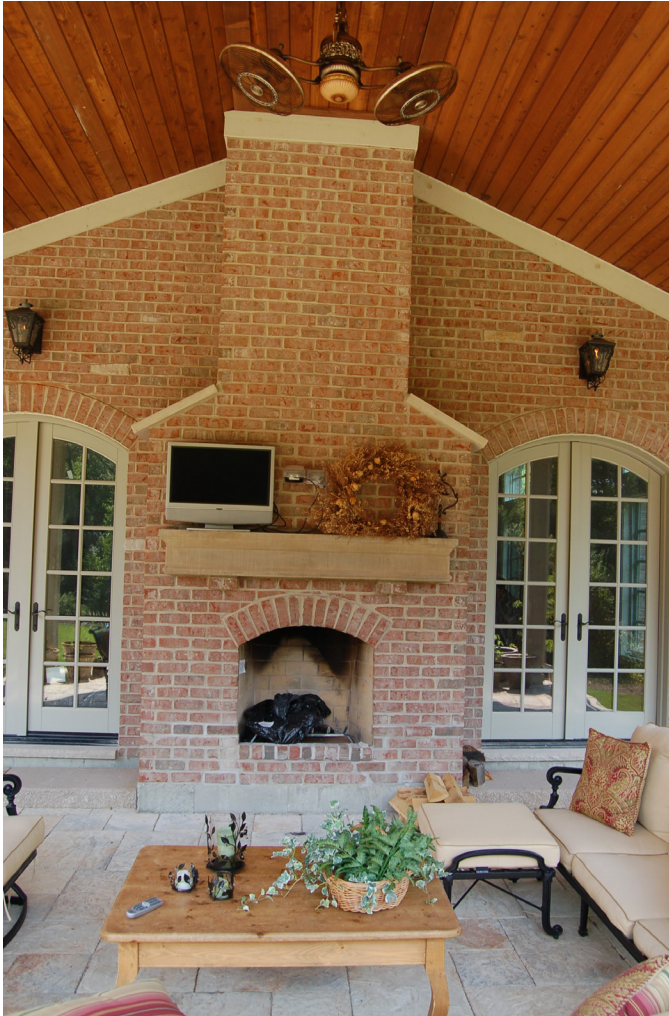
**Figure 12**

Outdoor masonry fireplace and chimney in veranda.

Incident: The subject house had been recently constructed. An outdoor veranda contained a masonry fireplace (**Figure 12**). That fireplace had been built common to the east exterior wall of the house. The wall of the house was frame construction with a brick veneer. The fireplace had been used approximately 20 times previously. That fireplace had been used from approximately 5 p.m. to 10 p.m. the evening before the structure fire, burning cut hardwood logs. At approximately 2:30 a.m. the next day, smoke detectors in the house activated. The owner saw smoke and fire behind a cabinet in the family room along the exterior wall common to the outdoor fireplace.

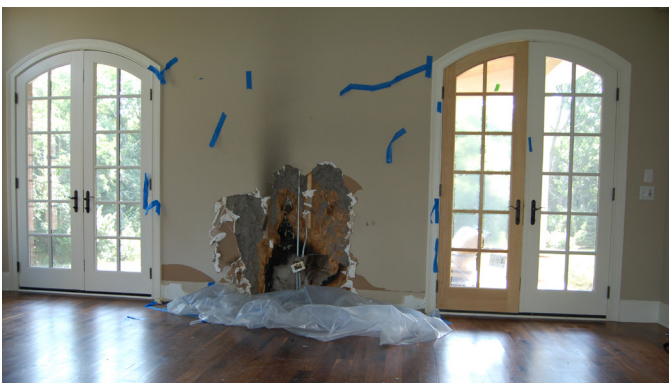
**Figure 13**

Wall of family room showing fire damage common to outdoor fireplace.

Investigation: The east wall of the family room, common to the outdoor fireplace, had sustained fire damage (**Figures 13 and 14**). The frame wall was located directly adjacent to (and in contact with) the masonry rear wall of the fireplace. This frame wall was comprised of: house wrap fabric, 1/2-inch OSB sheathing, wood 2x6 studs on approximately 16-inch centers, cellulose blown-in insulation in the stud spaces, and 1/2-inch drywall (interior surface). The OSB sheathing was contacting the masonry at the rear side of the exterior fireplace. A burn pattern

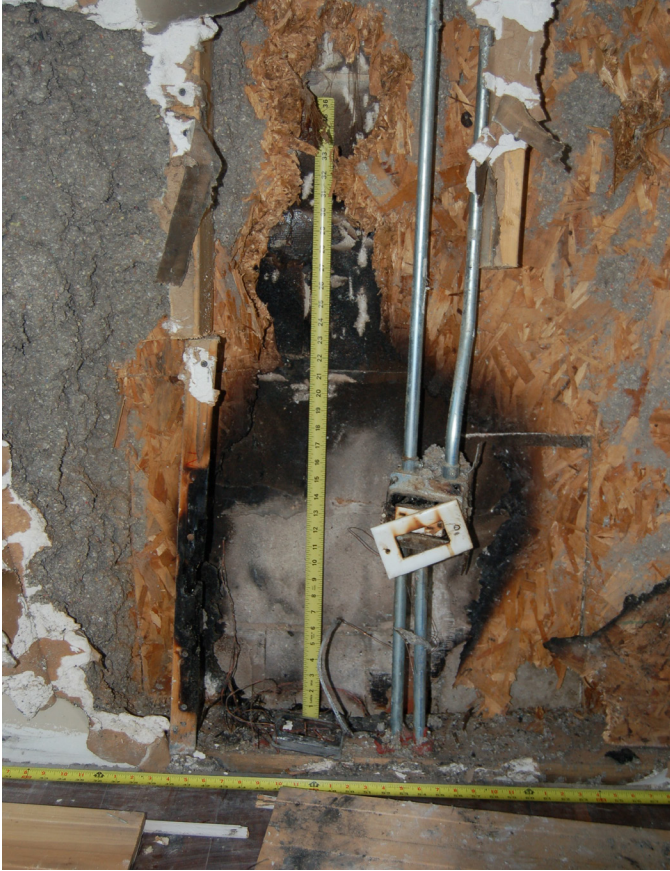
**Figure 14**

Fire damaged wall common to outdoor fireplace.

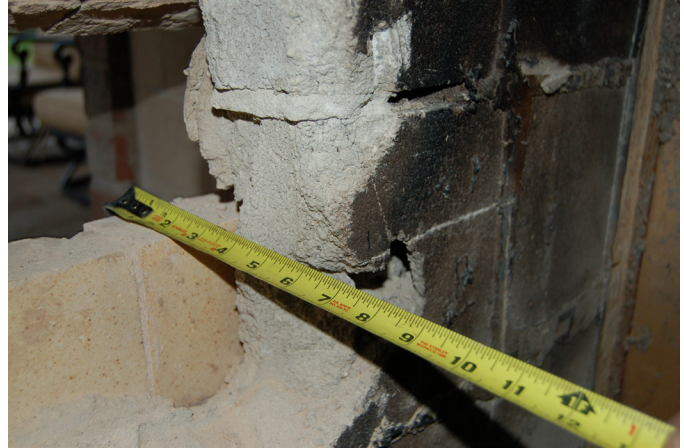
**Figure 15**

A portion of the rear wall of the fireplace was removed, which provided access to the entire cross-section of the rear wall of the fireplace (**Figure 15**).

The overall thickness of the rear wall of the fireplace was measured and found to be about 7 inches. It was comprised of a 2½-inch-thick single row of firebrick, which was the back wall of the firebox, and a 3½-inch-thick single row of concrete masonry units (CMUs). A gap measuring between ¾ and 1 inch, between the CMUs

Rear wall of fireplace with portion removed, showing dimensions.

and firebrick, was partially filled with mortar. Electrical components within that wall were inspected by an electrical engineer and eliminated as a cause.

**Conclusion:** The subject fire was caused by heat energy from the firebox of the outdoor fireplace conducting through the rear wall of the masonry fireplace and igniting combustible building materials directly adjacent to, and in contact with, the masonry wall. The construction of the masonry fireplace and wall was improper, dangerous, and a fire hazard. The construction violated the standard NFPA 211 and the local building code. The 7-inch thickness of the masonry back wall of the fireplace was less than the minimum required 8 inches. The OSB sheathing of the interior wall was contacting the inner surface of the masonry wall for zero clearance to combustibles, which was less than the minimum required clearance of 4 inches. The thickness of the back wall and the absence of an air space clearance to combustibles provided much less thermal resistance between the firebox and the combustible wall than the building code required. This permitted an unsafe elevated temperature of the combustible wall, which resulted in its ignition.

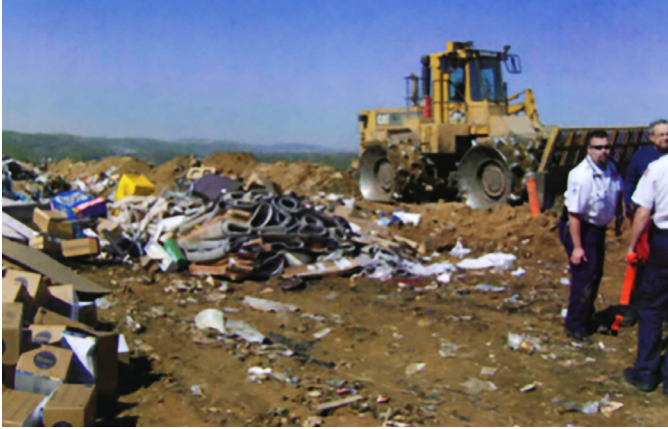
**Figure 1**

Accident site showing the steel-wheeled compactor and the gas vent pipe. Note the mounds of debris on the landfill face.

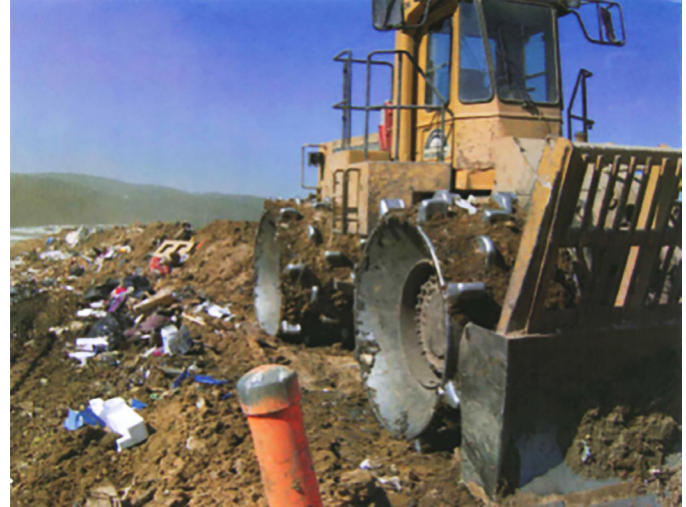
**Figure 2**

Close-up view of the steel-wheeled compactor and the gas vent pipe at the accident site.

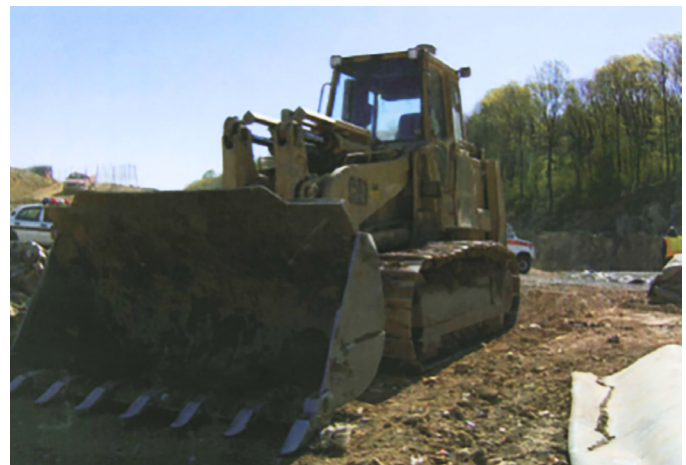
**Figure 3** shows the subject crawler loader at the accident site. The loader was being operated that day by a replacement operator who received no training in the safe operation of the loader on the landfill face. The loader, while traveling in reverse over a hillock of trash, struck and seriously injured the trash spotter. The incident was observed and witnessed by a truck driver delivering trash to the site. Other workers who observed the incident stood by in apparent disbelief/shock and offered no assistance. The injured worker himself called 911, describing his injury and requesting a heli-vac transfer to the closest hospital while drifting in and out of consciousness. The injured worker lost both legs so close to his hip that he was not a candidate for prosthetic surgery.

Subject crawler loader at the accident site.

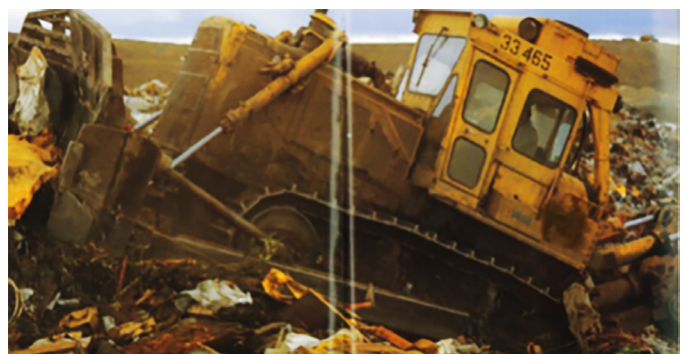
**Figure 4**

Generic-type bulldozer showing typical orientation while working on the landfill face. Note the reduction in visibility due to traveling over the trash mounds.

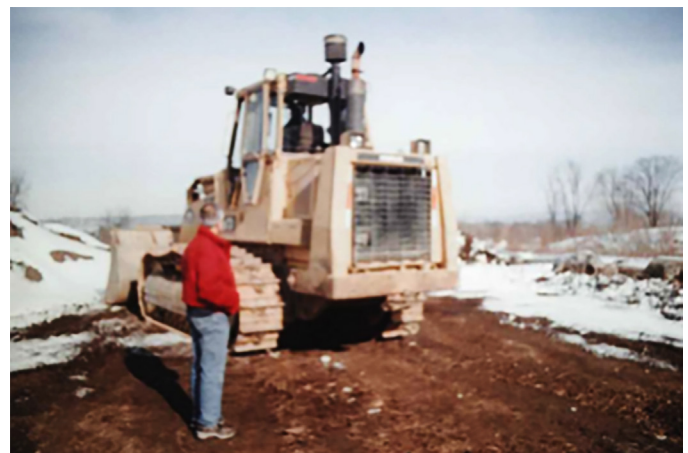
**Figure 5**

Left oblique static blind zone as depicted by the standing individual, who is invisible to the operator.

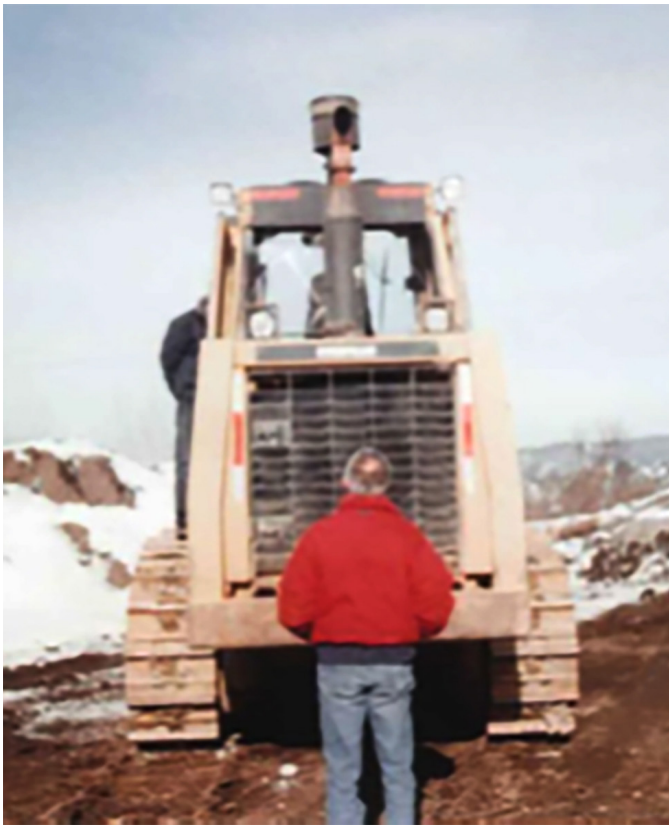
**Figure 6**

Rear view static blind zone as depicted by the standing individual who is invisible to the operator. Note exhaust stack further limiting operator's rearward visibility.

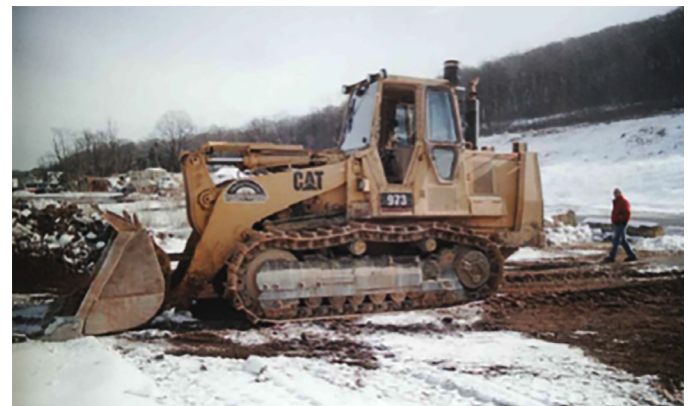
**Figure 7**

Left view of bulldozer, showing static blind zone of pedestrian worker, who is invisible to the loader operator in the location shown.
