Journal of the

Vol. 34 No. 2 December 2017

Forensic Engineering Analysis of Alleged Construction Defects

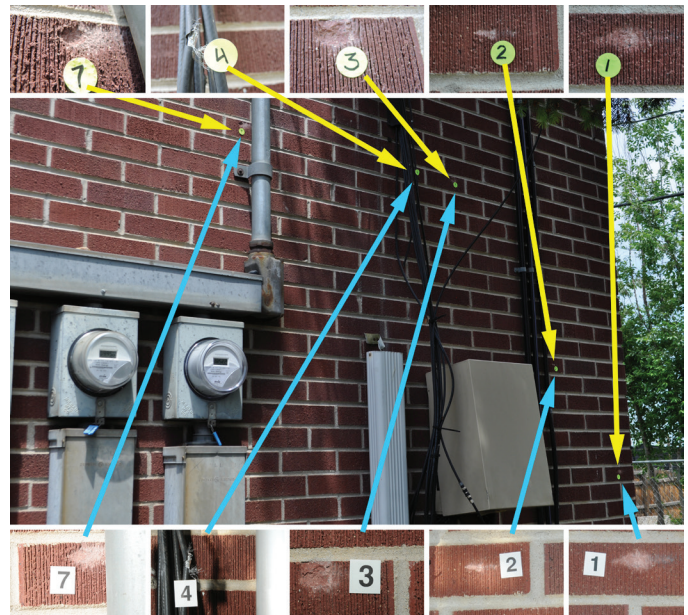
Figure 8

During the site inspection, the authors photographed, measured, and scanned five bullet marks, which were visible on the southern exterior wall of the neighboring two-story apartment building. The five marks present were consistent with marks documented during the police investigation (**Figure 8**). The police had documented two other marks on a portion of a downspout that had since been removed and was not available during the inspection.

Marks on southern wall of apartment building left by bullets (middle); the authors’ inspection photos (top); and police photos (bottom).

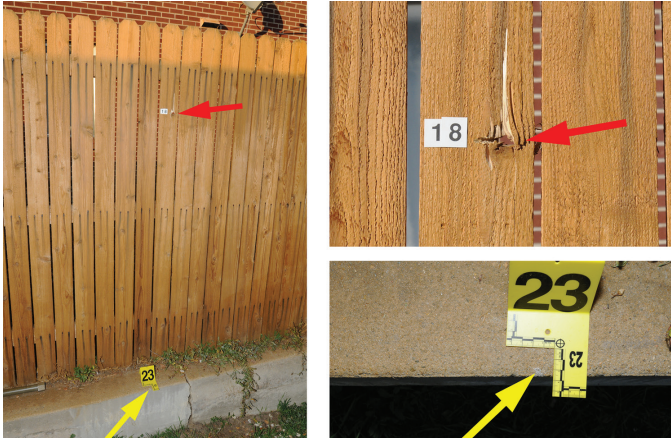
Figure 9

In addition to the marks on the brick wall, the authors also photographed, measured, and scanned a single hole in the wooden privacy fence and a scuff mark on the concrete footing below the fence, possibly left by Officer Dole’s handgun as it was released and fell to the ground (**Figure 9**).

Single bullet hole in wooden privacy fence picket (red arrow); scuff mark on concrete footing (yellow arrow).

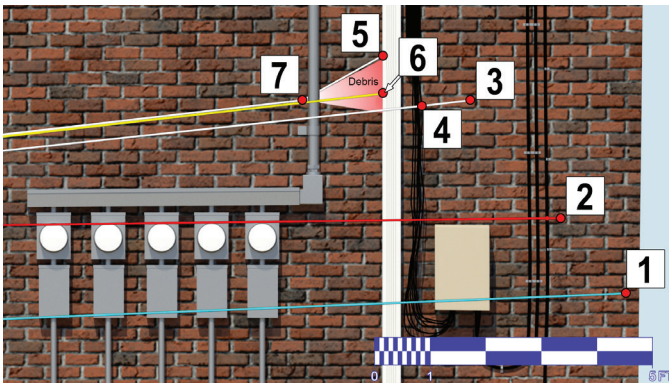
Figure 15

Evidence matched to bullet trajectories.

Evidence Item (see **Figure 15**):

- #1 – Mark on brick wall made from a bullet. This mark on the wall was below the elevation of the top of the privacy fence and the lowest mark left on the wall.
- #2 – Mark on brick wall made from a bullet. Before hitting the wall, the bullet clipped and left a gouge mark on a vertical cable fixed to the wall. These two marks (gouge mark on cable and mark

- #3 and #4 – A bullet made a mark on a vertical cable (#4) and then left a mark on the wall (#3).
- #5 – Mark on downspout made from ricocheted bullet after hitting the wall and leaving a mark at evidence item #7.
- #6 – A group of holes and marks in the downspout. Some of the holes and damage are made from debris from the bullet contact at evidence item #7. One to two of the holes may have been made by one or two of the shots fired (not the bullet that created the debris).
- #7 – Mark on wall made from a bullet, which then ricocheted, leaving evidence item #5 on downspout.
- #18 – Bullet hole in fence.
- #23 – Scuff mark on the concrete footing below the fence created by Officer Dole's handgun as it fell to the ground on the south side of the fence.

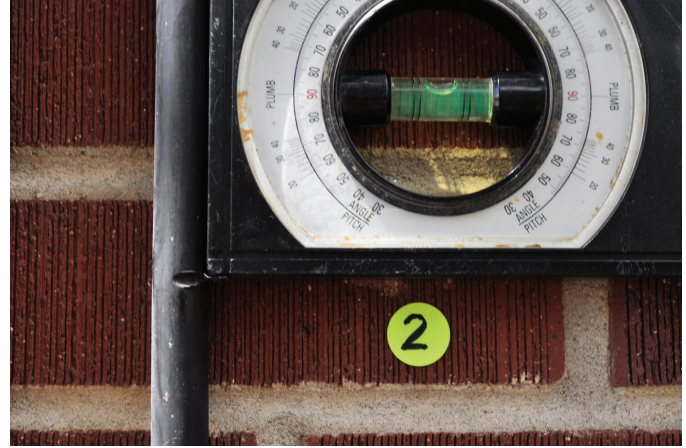
Figure 16

The gouge mark on the vertical cable and the mark on the wall at evidence item #2 are at the same elevation, indicating a relatively horizontal trajectory for the bullet that made these two marks.

on wall) were at the same elevation (**Figure 16**), indicating a relatively level trajectory for the bullet that made these two marks.

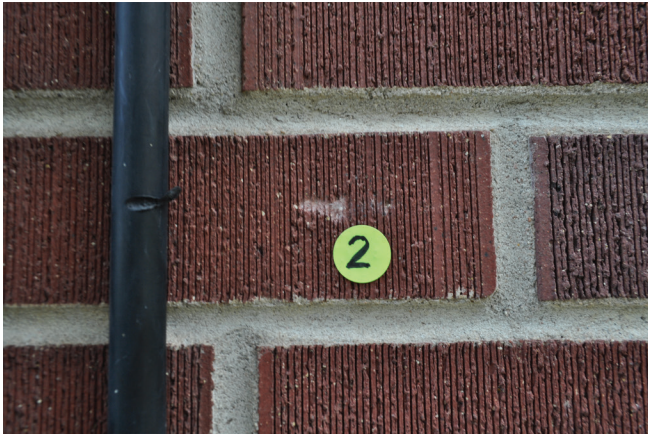
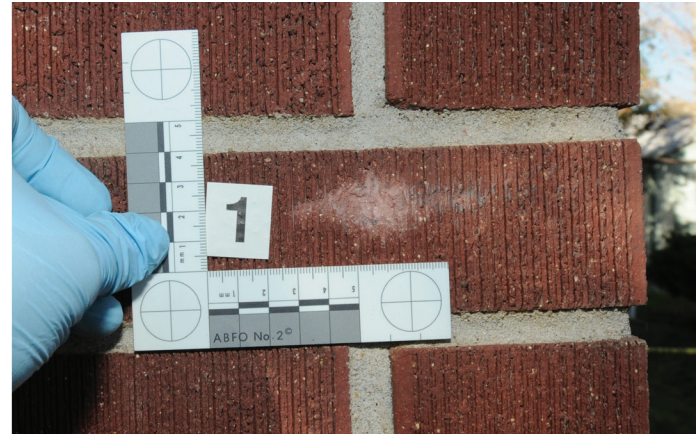
Figure 17

Horizontal bullet mark left at evidence item #1 and relatively horizontal mark left at evidence item #2.

The marks at evidence items #1 and #2 are both relatively horizontal marks on the wall (**Figure 17**), indicating that the bullets that left those marks had relatively level trajectories, which can be true of destabilized, deformed, and even tumbling, exiting bullets over short distances¹.

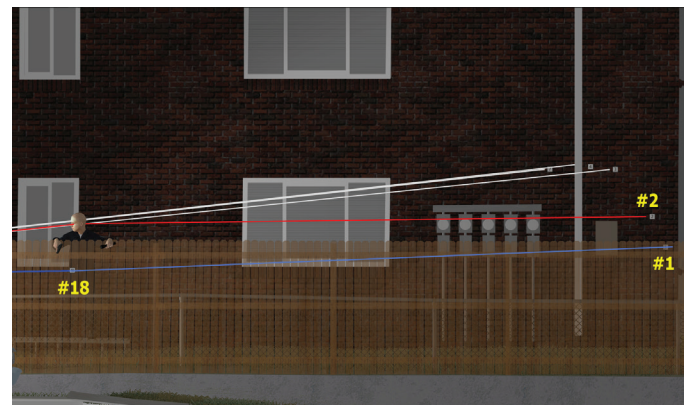
Figure 18

The authors' bullet trajectory analysis determined the bullet (red), which left mark #2 on the wall, was the bullet that passed through Agent Dole's head, and the bullet that left mark #1 was the bullet that passed through the fence (blue).

- Officer Baker fired a total of six shots.
- The first shot fired was the fatal shot (this was the consensus of all involved experts) and left mark evidence item #2 on the apartment building wall, as shown in **Figure 18**.
- One of the five remaining bullets passed through the fence (evidence item #18) and left mark evidence item #1 on the apartment building wall.
- All remaining four bullets were shot above the fence line.

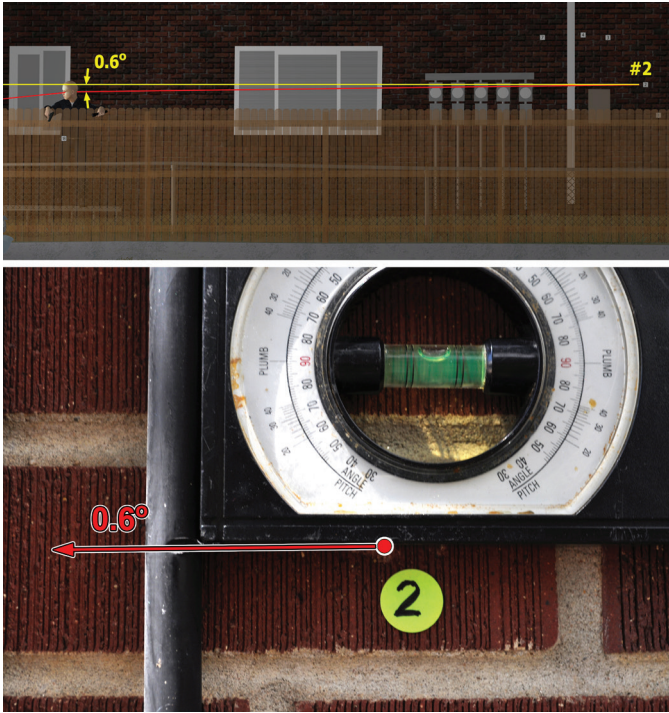
Figure 21

The trajectory of a bullet leaving the back of Officer Dole’s head from an elevation defined by the authors’ shooting reconstruction and leaving a mark at evidence item #2 was consistent with the physical evidence.

the lateral position along the fence (determined through photogrammetry and videogrammetry) as discussed previously. The authors posed the virtual character to be standing up and then connected the exit wound on the back of Officer Dole’s head to the bullet mark at evidence item #2 on the wall. The trajectory line passes through the gouge mark on the vertical cable and is consistent with a relatively level trajectory indicated by the horizontal mark of the fatal bullet, as shown in **Figure 21**.

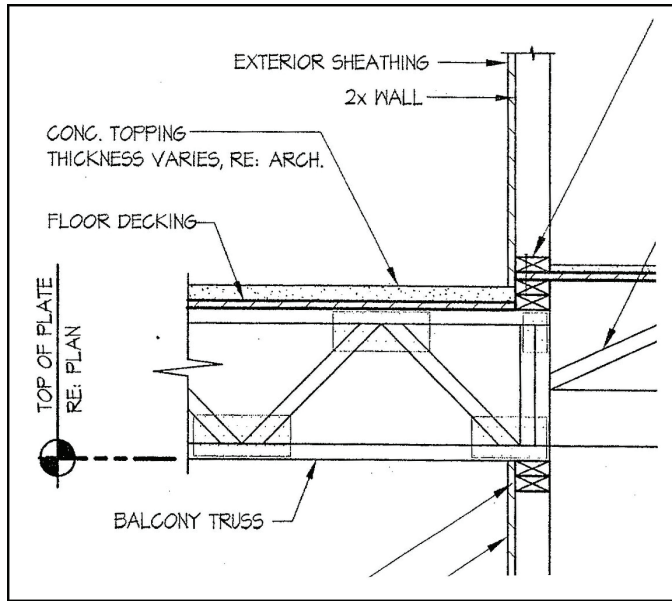
Figure 10
Wall/patio interface design.

Figure 11 shows the code-required distance between the stucco and the patio, which is not possible unless a system of flashing was designed to cover the bottom plates and the bottom edge of the sheathing — something that would not be acceptable because the threshold elevation would have to be raised to allow continuous integration of the wall flashing with a threshold door pan flashing assembly to ensure the threshold would not leak.

violate the requirements of the ADA. Additionally, the author has found that many deem this detail aesthetically objectionable; therefore, some people would likely object to the aesthetics of a metal flashing band on their balconies.

The “solution” is to raise the door threshold to the elevation of the top bottom plate and install a system of integrated door pan and wall flashing, but that would

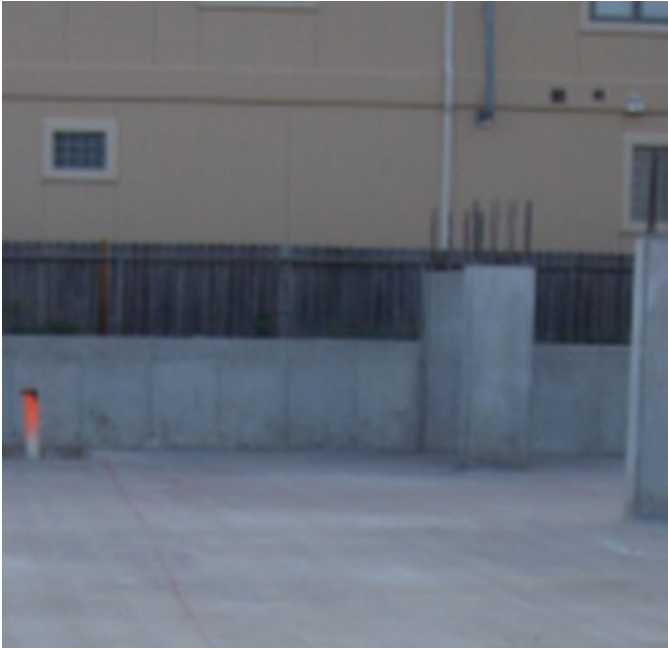
One of the important elements of a forensic evaluation the engineer failed to perform was to investigate the history of the condominium project before making definitive conclusion that the builder or developer failed to meet the standard of care. **Figure 19** is a photograph that was taken during construction, showing clear evidence that over time, site conditions (and related drainage) had changed between the buildings; the photo shows no bamboo was growing during construction and that there was a

Figure 19
Different site condition.

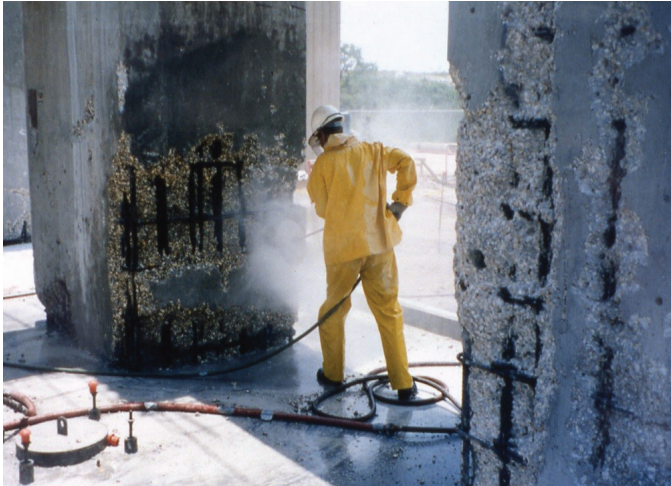
Figure 2

zone. Likely factors contributing to this condition ranged from exceeding the specified lift of deposited layer thickness during concrete placement to inadequate consolidation of placed concrete. **Figures 1** and **2** illustrate these conditions.

Voids and rock pockets being cleaned by hydro-blasting.

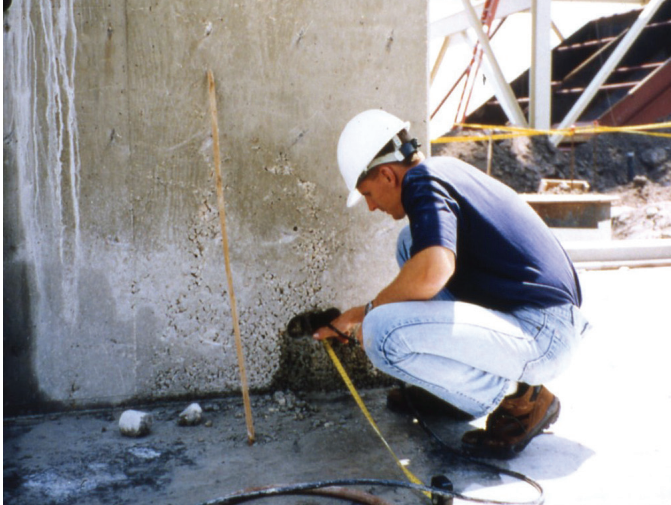
Figure 3

Insertion of the video camera through corehole near column base.

documented and evaluated any unusual characteristic within the concrete as is illustrated in **Figures 3** and **4**. All the 22 core locations were examined to complete the internal condition assessment.

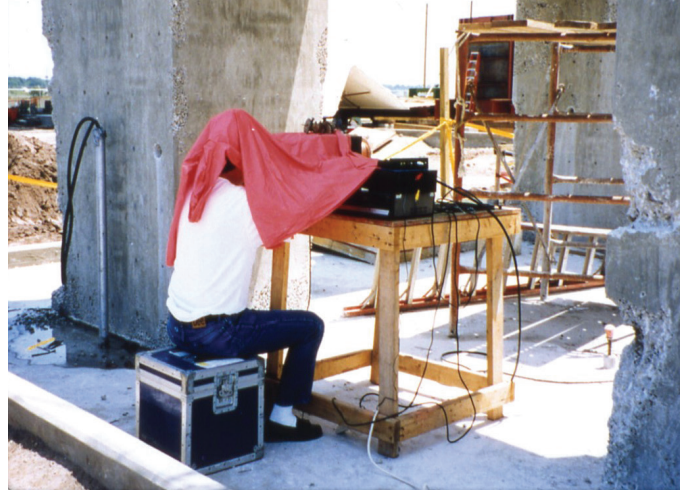
Figure 4

Petrographer examining the video screen for internal soundness.

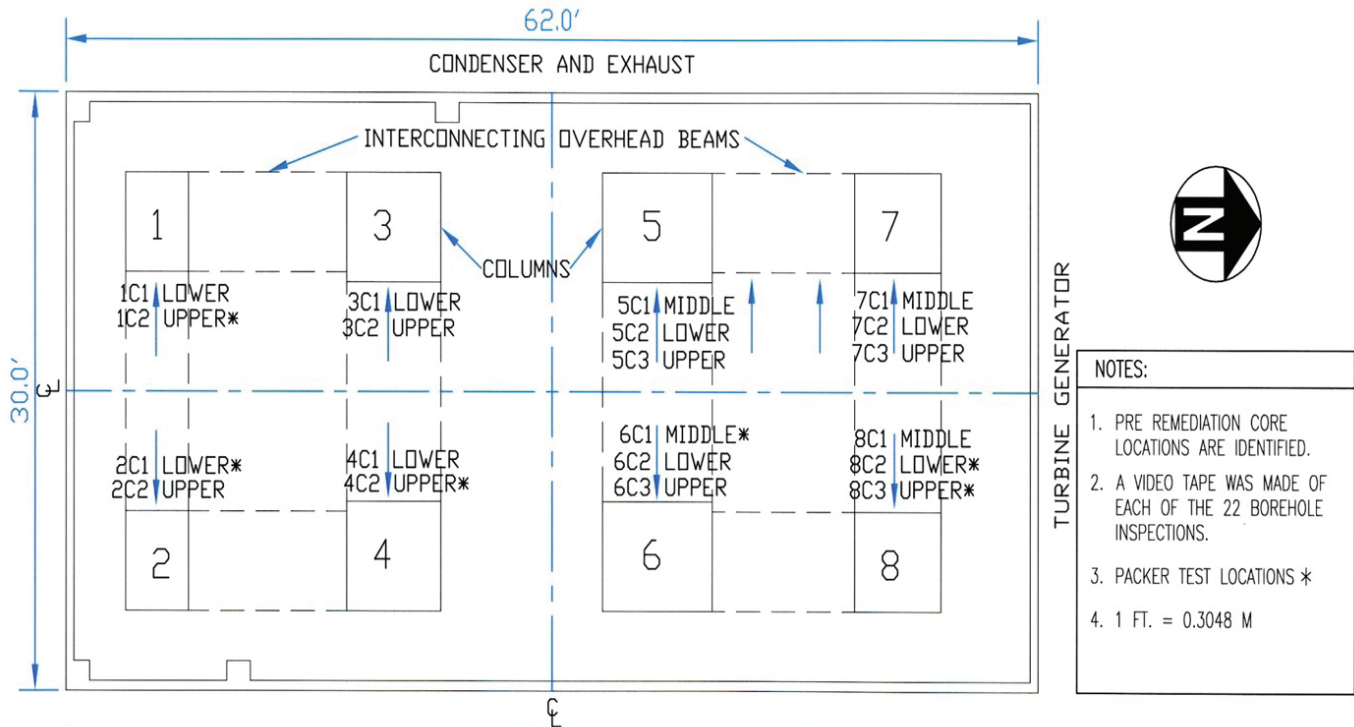
Figure 5

STG structure layout identifying columns, overhead beams, core, and Packer test locations.

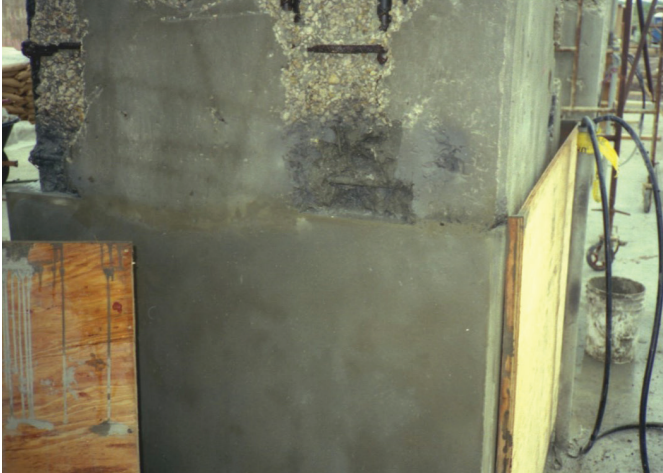
Figure 6

View of exposed column with pre- and post-restoration areas.

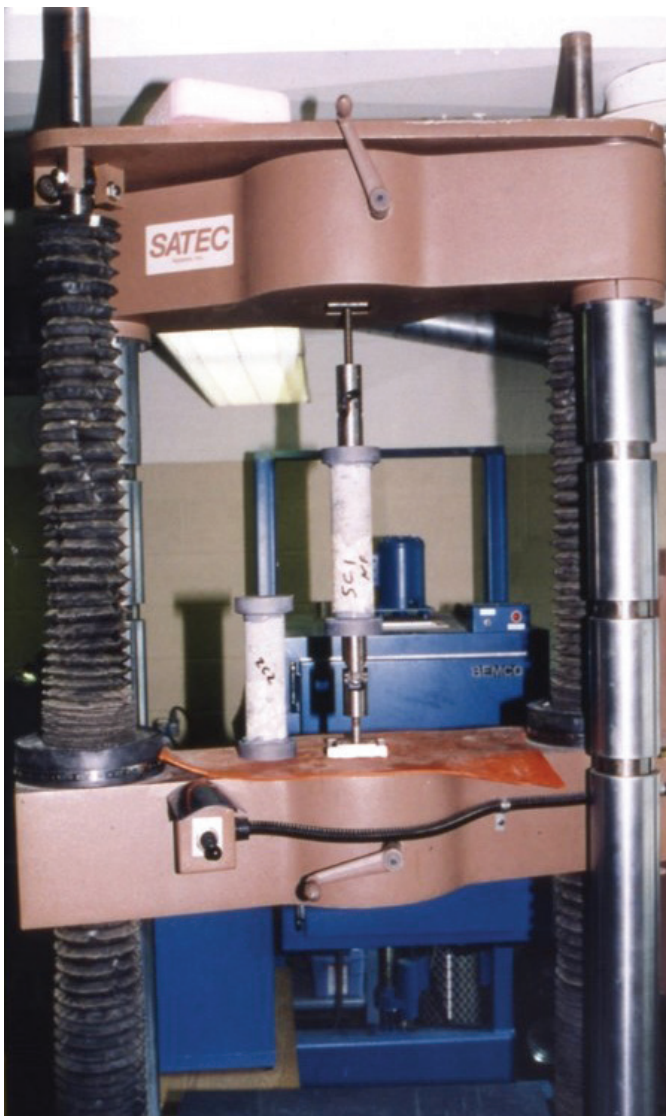
Figure 7

Tensile test set-up.

The core specimens were subjected to direct tensile strength tests (ASTM C496) and exhibited failure within the original concrete with the failure mode to be through paste and aggregate as illustrated in **Figures 7 and 8**. In addition, the average direct tensile strength values of the core specimens in remediated or restored areas compared favorably (i.e., equal or greater) with that of the original concrete core specimens. Failure characteristics were noted to be normal.

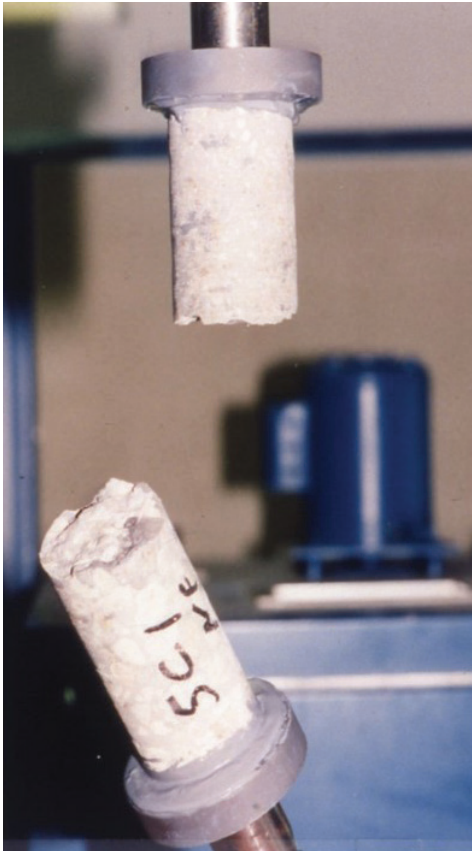
Figure 8
Tensile strength tested core.

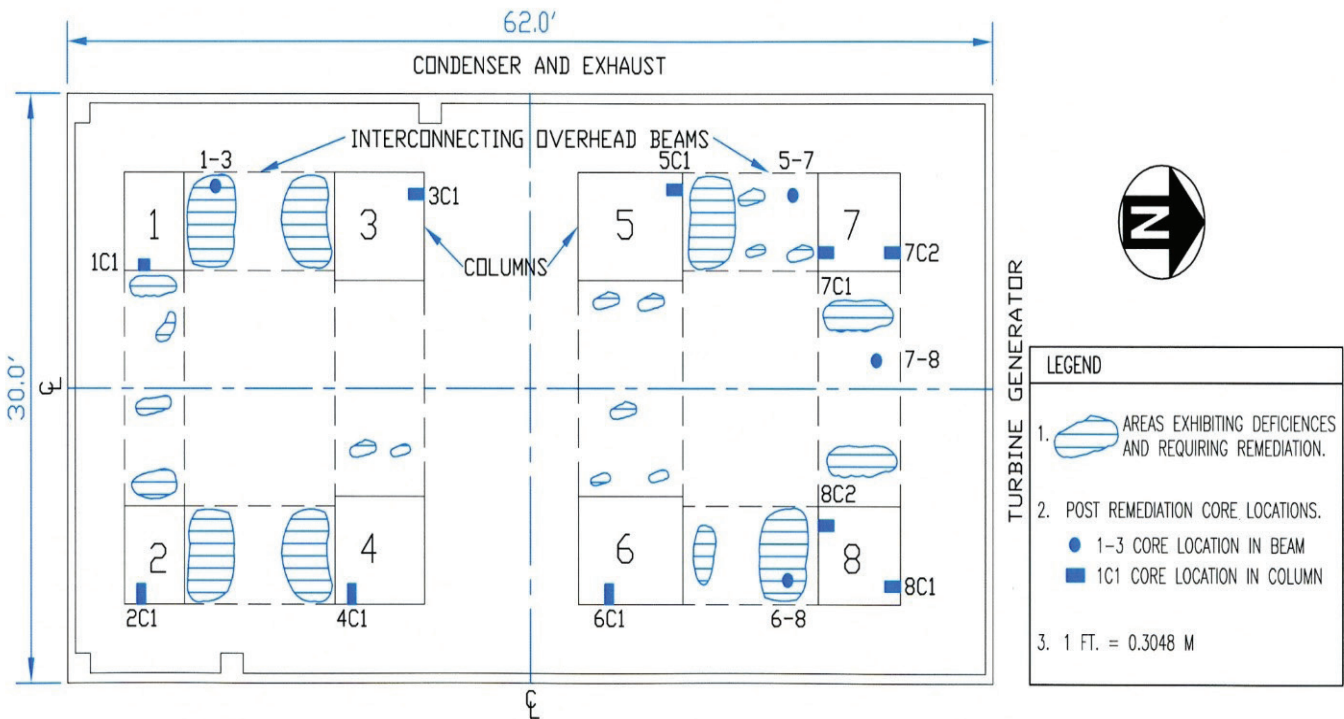
The STG structure layout showing areas exhibiting deficiencies and requiring remediation as well as the PostRS core locations is shown in **Figure 9**.

Figure 9
STG structure layout showing deficient areas and post-remediation core areas.

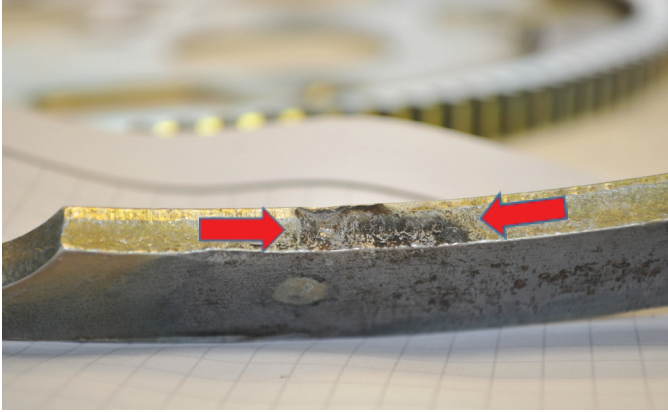
Figure 5
Lack of weld penetration.

Metallurgical analysis consisting of Scanning Electron Microscopy (SEM), sectioning of the counterweight, and metallography further confirmed the lack of weld penetration to the counterweight during the assembly of the flexplate. Metallurgical properties consistent with the machine blank formation of the part were also visible in the area where the weld was attempted. During the stamping process, the counterweight is machine stamped from a sheet of metal under extreme mechanical pressure using a custom die. The pressure initially cuts the materials, but as the process progresses, the remaining stock separates from the stamped sheet metal as a result of high shear forces.

The root cause of the flexplate counterweight detachment was due to a manufacturing defect and failure to properly secure the subject counterweight to the flexplate at the time of assembly. The lack of weld penetration over a small effective weld perimeter allowed the counterweight to fail after minimal use.

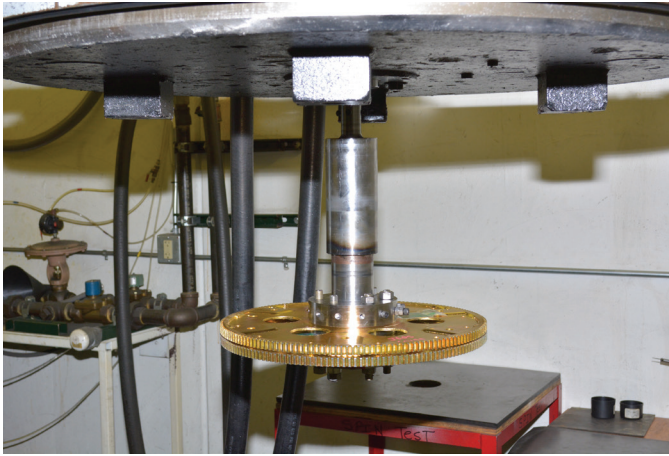
Figure 7

Testing of exemplar externally balanced flexplates.

two exemplar flexplate assemblies were coupled together with a test fixture having their counterweights opposite of each other to make a balanced assembly (**Figure 7**). Spin testing of the exemplar flexplates was conducted above 12,500 rpm for one hour in accordance with SFI 29.1 without failure to either of the flexplate assemblies or attachments of the counterweights.

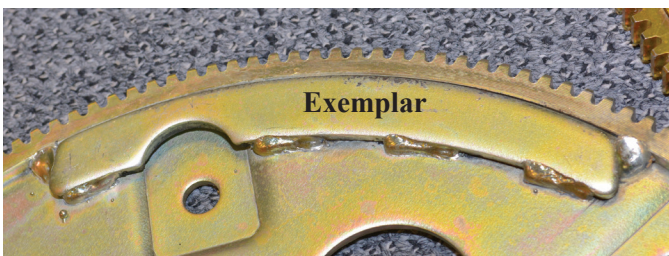
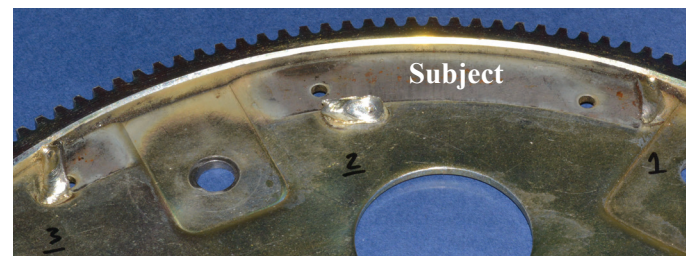
Figure 8

commercially available on the market. Examination of these flexplates shows that the common industry practice of securing the counterweight to the flexplate assembly is with five to six individual MIG welds encompassing the perimeter of the counterweight. This was different than the subject flexplate that used three relatively small MIG welds for securement of the counterweight, as shown in **Figure 8**. While stress analysis shows that the three welds would be adequate to secure the counterweight to the flexplate and even meet the requirements of SFI 29.1, the fewer number of welds increases the probability of a counterweight separation in the event of a defective weld.

Comparison of the counterweight securement between an exemplar and the subject flywheel.

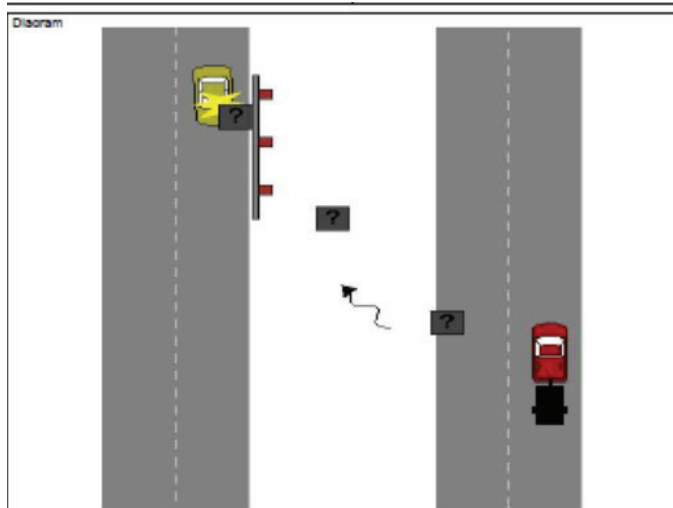
Figure 1
Accident diagram from police report.

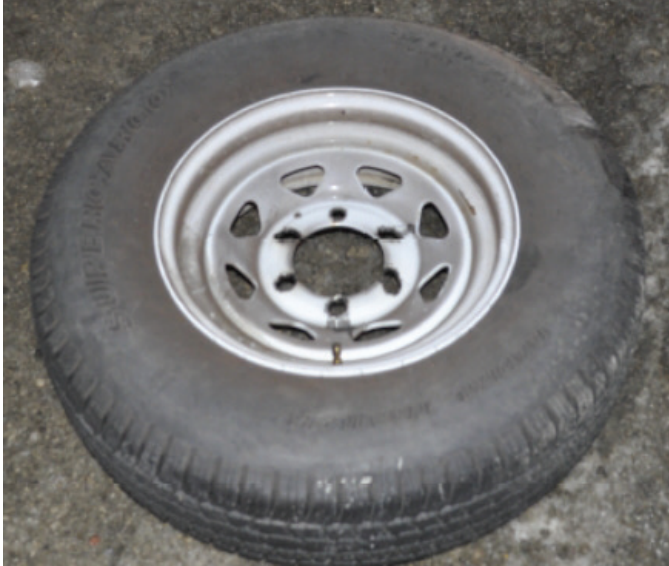
Figure 3

The wheel was in new condition when mounted prior to the subject trip. As shown in **Figure 3**, the detached wheel showed no rust whatsoever, while the other wheels on the trailer exhibited light to moderate rust.

Wheel at point of rest at the accident scene. Note rust-free exterior.

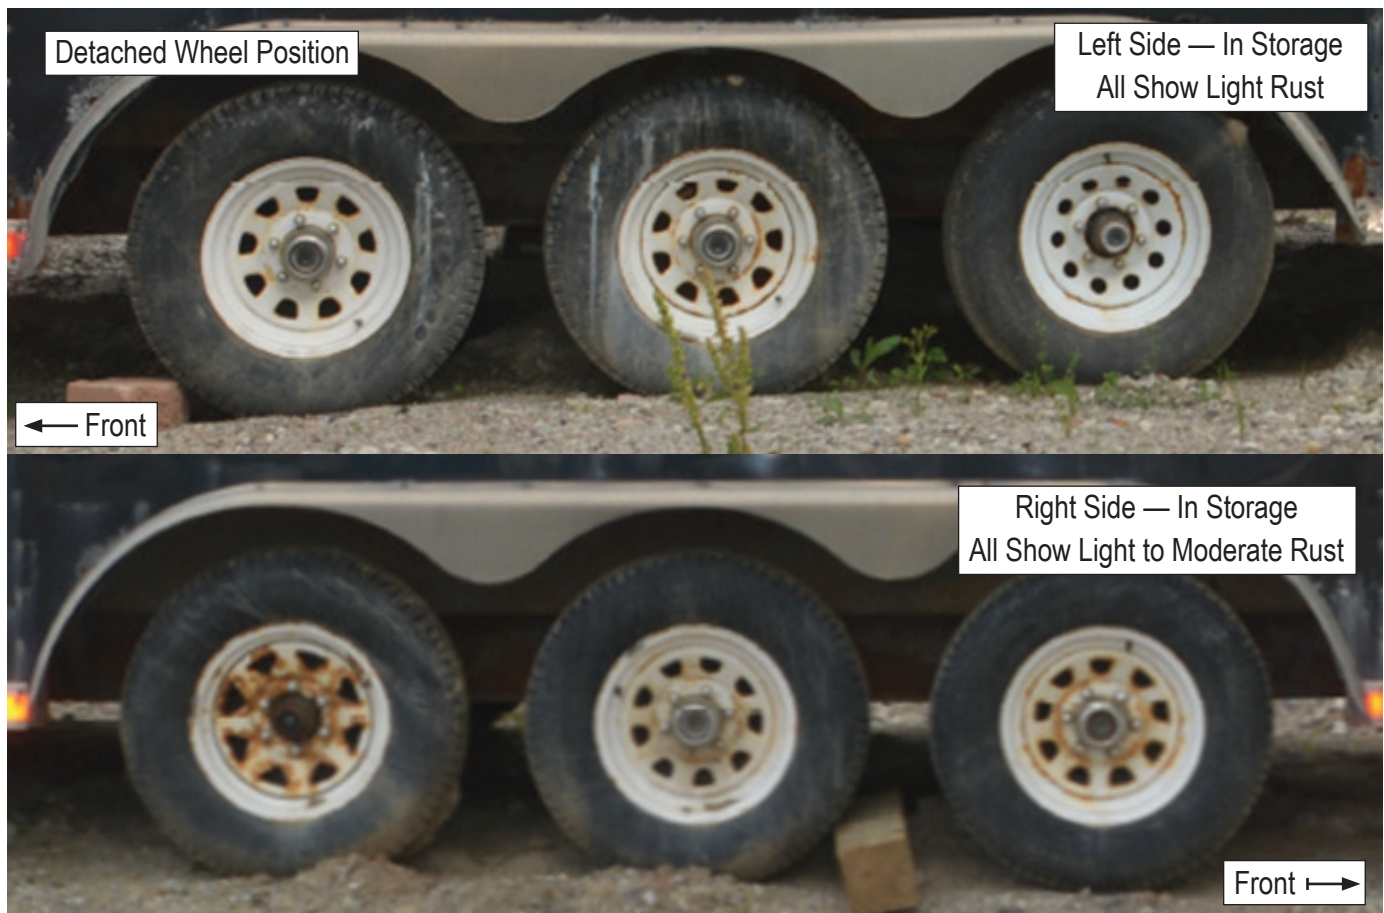
Figure 4 demonstrates both sides of the trailer in storage. These photos were taken after the trailer had been

the wheel cutouts do not match, indicating that the wheels are not identical in model. This shows that various wheels had likely been replaced over time on this trailer.

Accident trailer at a gasoline station; the left front wheel is missing.

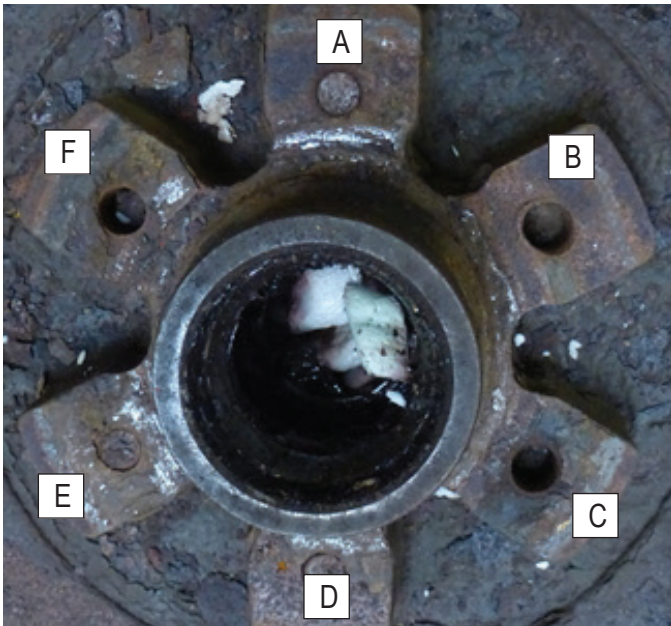
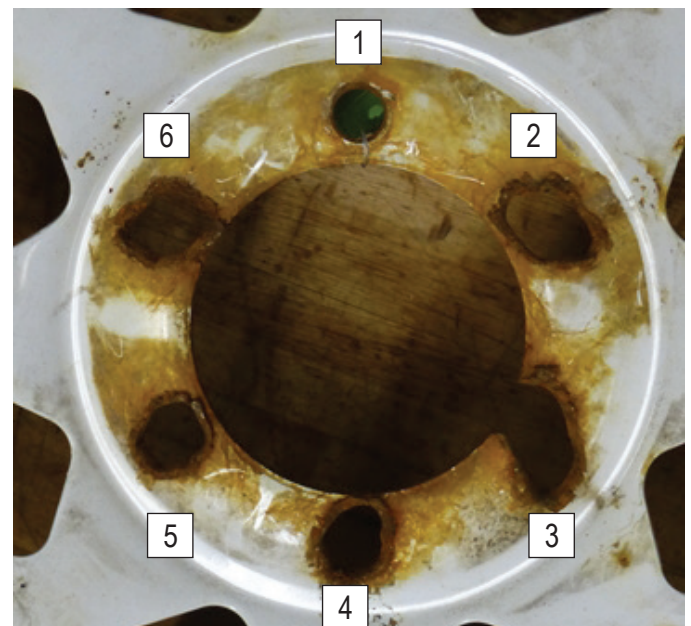
The basis for the postulated match-up of wheel to hub was comparison of maximum damage at each position. Therefore, it is reasonable to assert that the maximum wheel damage, as evidenced by the most elongation of the stud mounting holes, matches the maximum hub damage, as shown by below-flush fracture of the studs. The three most damaged holes are B, C, and F. These correlate to the same positions on the aligned hub photo 2, 3, and 6. Note that the wheel in **Figure 6** is shown from the out-board side, so the hole to stud positions match; they are not mirror images, which they would be if the mounting face of the wheel were shown.

Figure 6
Accident trailer wheel and hub oriented to most likely mounting alignment.

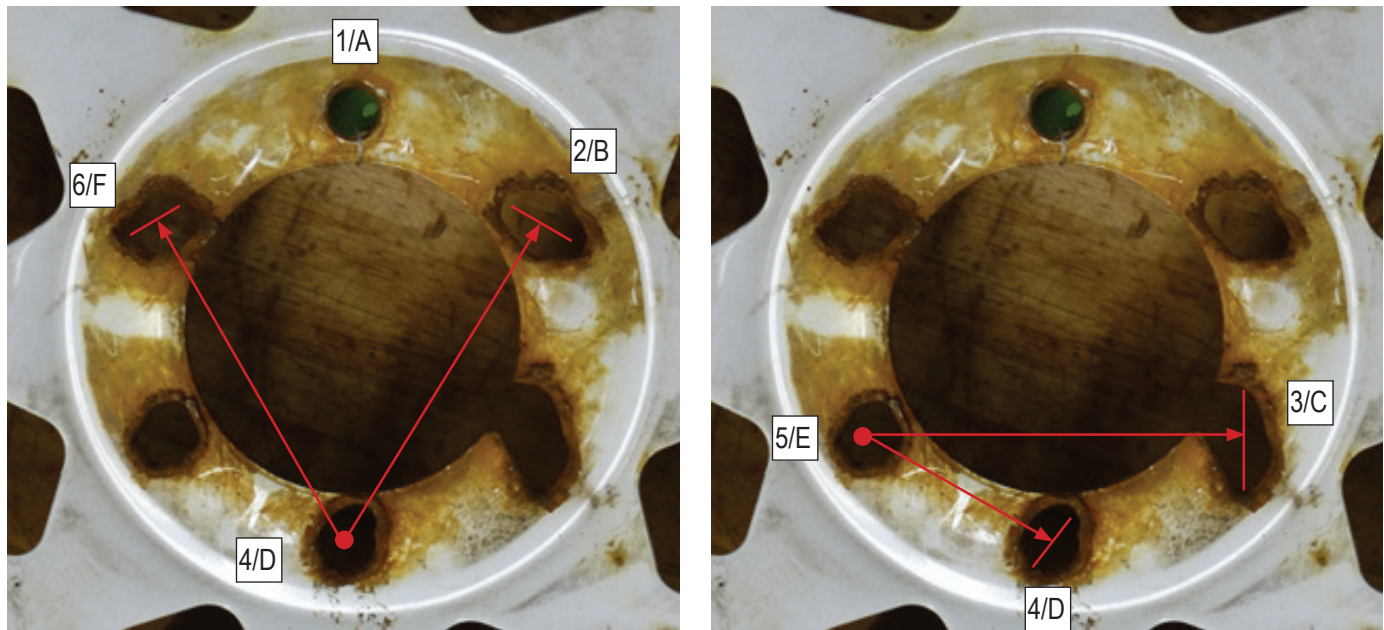
Figure 7

Graphic analysis of stud fracture sequence caused by changing fixation forces.

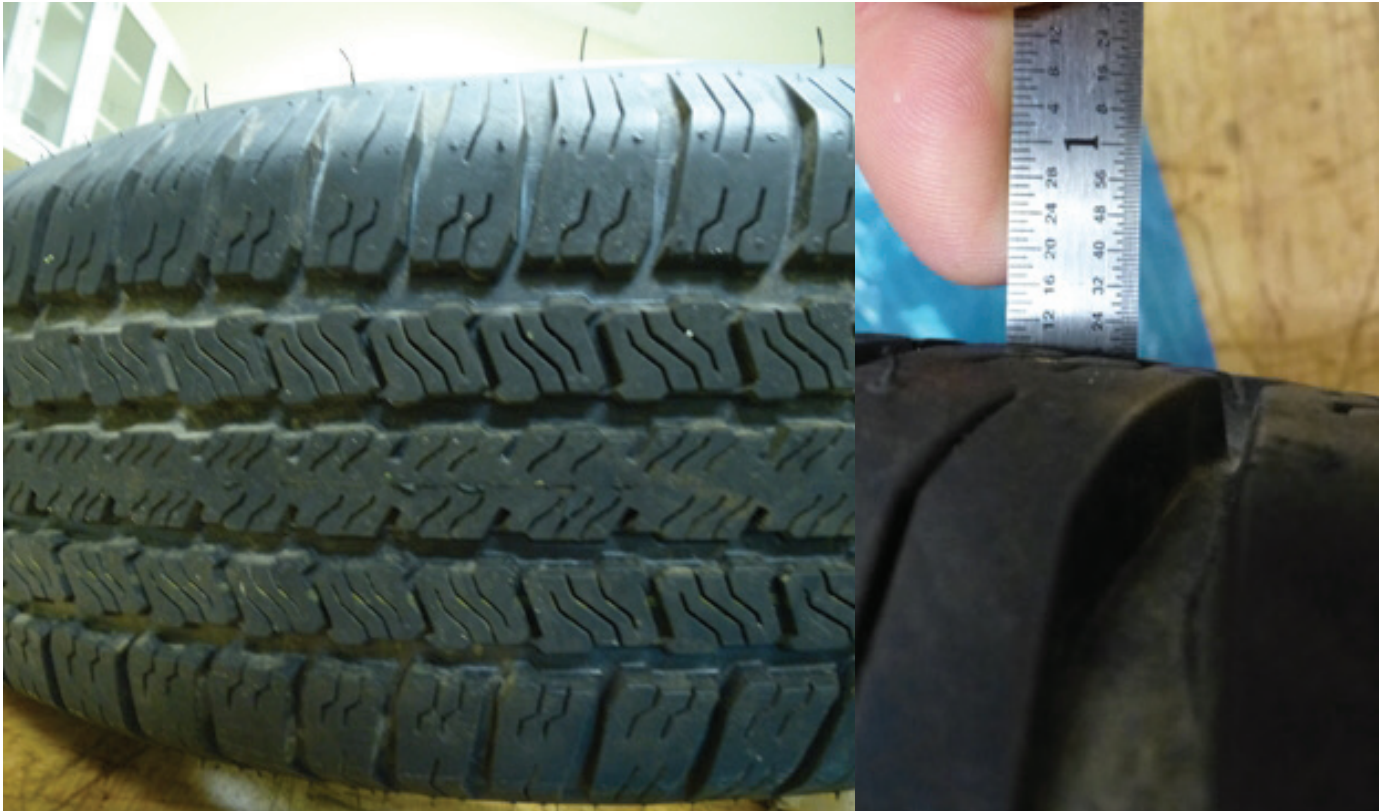
Examination of the accident tire shows that it was in new condition at the time of mounting, just prior to the wheel detachment (**Figure 8**). The measured tire tread depth measured minimum 9/32 inches while new tread depth is 10/32 inches. This is a radial tubeless tire, size ST225/75R15, labeled "FOR TRAILER SERVICE." Maximum load is 2,830 pounds, Load Range E, 80 psi maximum. The overall diameter is 28.5 inches. As the photo documents, the mold sprues were still present.

Figure 8
Accident trailer tire showing manufacturing sprues and deep tread.

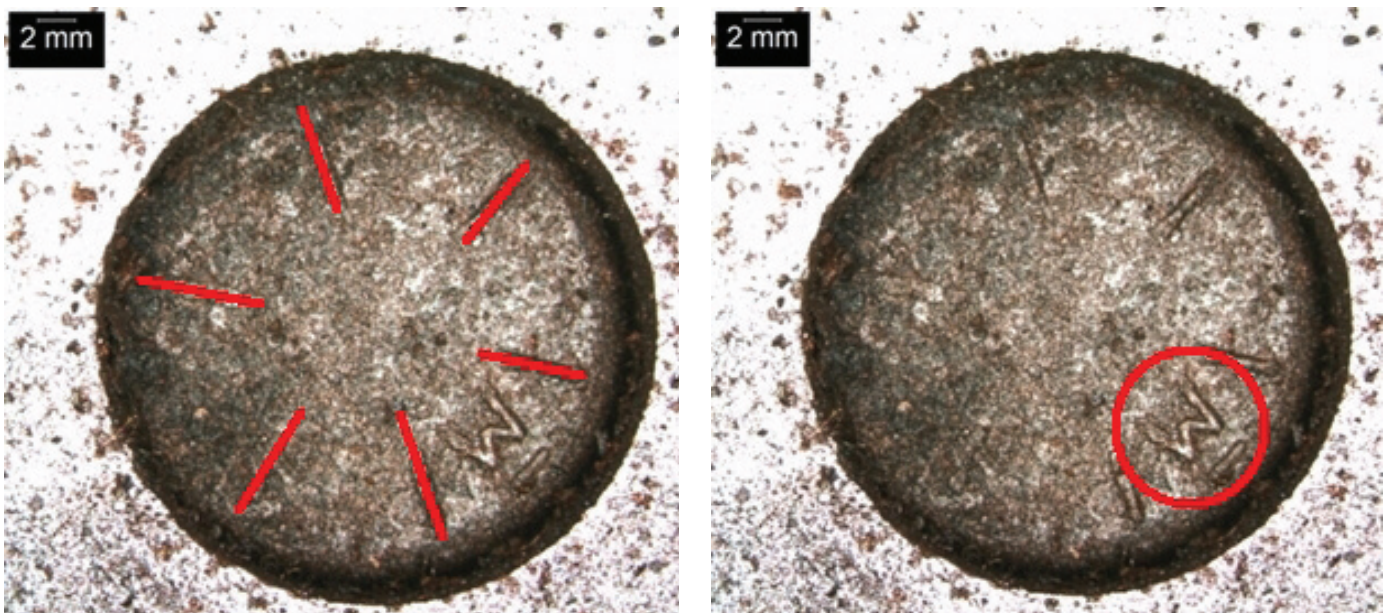
To determine if the studs incorporated a material defect, they needed to be removed from the hub and destructively tested. Prior to destructively cutting into the hub to remove each stud, outside fracture and inside head surfaces were examined using an optical microscope. Each stud was an SAE (Society of Automotive Engineers) $\frac{1}{2}$ -20 Grade 8 fastener (**Figure 9**). This means the thread body is nominally $\frac{1}{2}$ inch in diameter with 20 threads per inch. Grade 8 fasteners are medium-carbon alloy steel that has been heat treated. This means that they have been heated above their austenitization temperature and then quenched/tempered. These studs were pressed into an interference fit within the hub using splines. The mating hole had been counter-bored to accept the head. The heads are round without wrench flats. The SAE grade marking is evidenced by six radial marks, shown at the lower left photo. The manufacturer's mark **W** appeared at the periphery of each head, as shown at lower right. By

referencing the Fastener Quality Act registry¹, it was determined that these studs were manufactured by Westland Steel Products, Winnipeg, Canada.

Figure 9
Stud marking indicating SAE grade (left, highlighted in red) and manufacturer (head stamp encircled in red highlight).

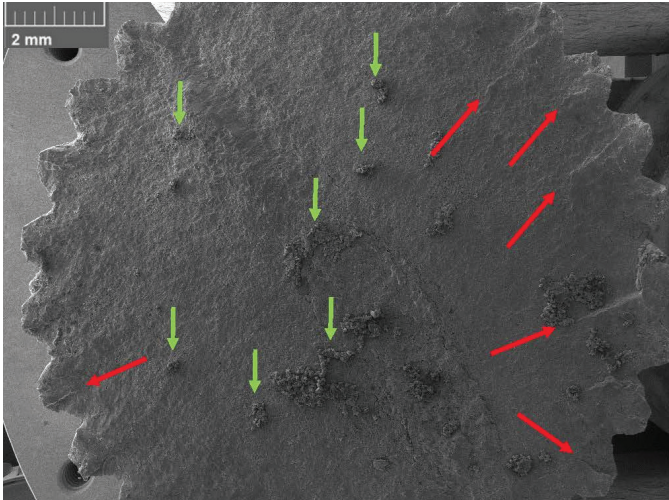
Figure 10
SEM photograph of stud fracture surface.

bath to remove superficial corrosion. Each stud was removed from the bath before the corrosion transformation was complete to prevent collateral damage. The remaining corrosion is clearly depicted by the SEM (scanning electron microscope) photograph set forth in **Figure 10**. Various untransformed surface corrosion areas on the fracture surface of stud A are called out with short downward-facing green arrows.

A macro-indication of fatigue is contained in the SEM photograph. These ratchet marks are called out by red arrows pointing to the periphery, which, in this case, are the splines. SEM photographs of studs A, B, C, E, and F exhibited peripheral ratchet marks, a common feature of fatigue initiation. The uncleaned fracture surface of stud F was subjected to an EDS (energy dispersive spectroscopy) analysis. The principal elements recorded included Fe, O, C, Ca, Cl, Si, and Mn, as documented in **Figure 11**. Trace aluminum was also present. The explanation of each element is straightforward. Iron (Fe) and manganese (Mn) are components of the steel. Oxygen is ubiquitously present and a component of the corrosion product. Carbon may come from oil or biological contamination. Calcium (Ca) and chlorine (Cl) are present in road salt, and are contained in the corrosion products. The aluminum likely came from bearing grease or dirt. A portion of stud F was then destructively tested to provide bulk composition analysis to determine conformance with grade 8 fastener composition. The results of this further analysis are recorded in tabular form in **Figure 11**.

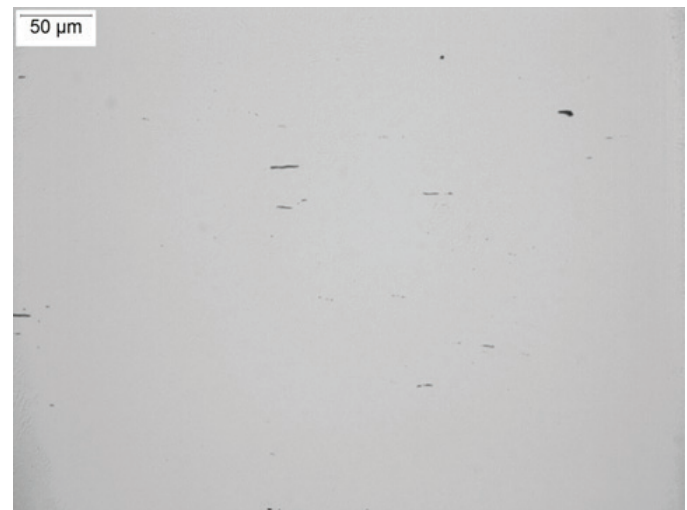
The EDS analysis is consistent with 4037 steel, which is an appropriate alloy for heat treated Grade 8 threaded fasteners. Metallography was conducted on a longitudinal segment of a representative stud (**Figure 12**). This sampling technique was appropriate as the raw material used to manufacture these studs is drawn wire, which produces linear inclusions. No objectionable impurities or pores were detected.

Figure 12
Metallographic sample of representative stud to examine inclusions.

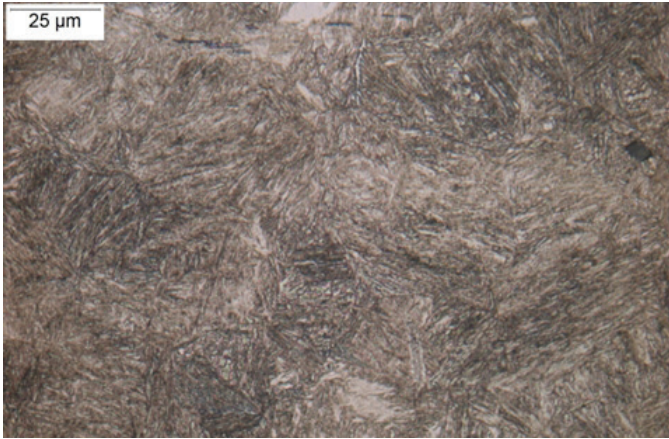
The stud sample was then given a nital (nitric acid 2% in alcohol) etch. This revealed the microstructure as shown in **Figure 13**. This photograph shows martensite,

Figure 13
Metallographic sample of representative stud to examine grain structure.

indicative of an austenitized, quenched and tempered heat treatment to provide strength and toughness. No objectionable grain structure or alloy segregation was detected.

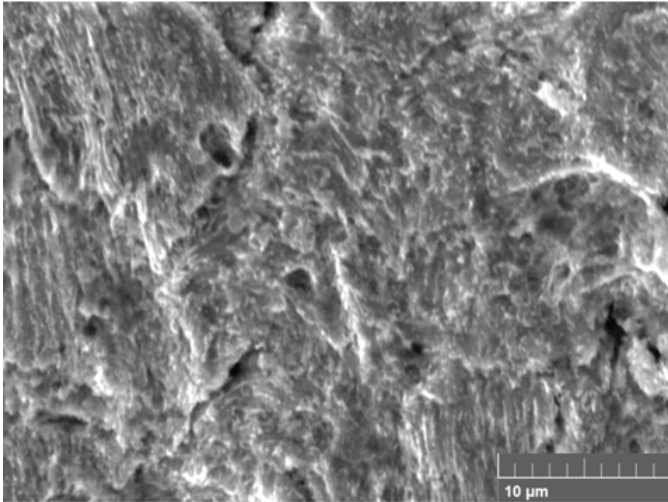
Figure 17

When examined, the cleaned fracture surfaces of the studs showed a variety of features, including residual corrosion products, rubbing of the fracture surfaces, overload dimpling, and fatigue marks. Three different stud SEM micrographs are now shown. The most frequent observation was “no fracture data,” as is shown in **Figure 15**. **Figure 16** shows a region of a stud with residual corrosion products and overload dimples. **Figure 17** shows what was found clearly in five of the six studs: fatigue crack marks. As for the sixth stud, which did not show clear

Fatigue striations documenting the stud failure mechanism.

residual fatigue marks, fatigue as a failure mechanism could not be eliminated.

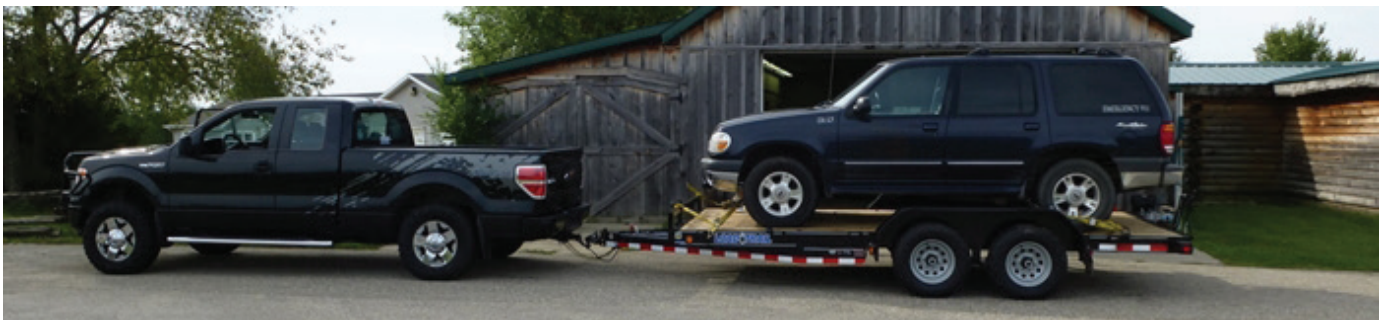
Figure 18

To better understand the progression of the damage to failure, destructive testing was conducted using an exemplar trailer. A 16-foot-long unenclosed conventional ball hitch flat trailer with two axles was purchased new for the testing. This was demonstrative testing to shed light on trailer wheel detachment. It was not performed to replicate the accident. The test setup is shown in **Figure 18**.

Setup of trailer wheel testing.

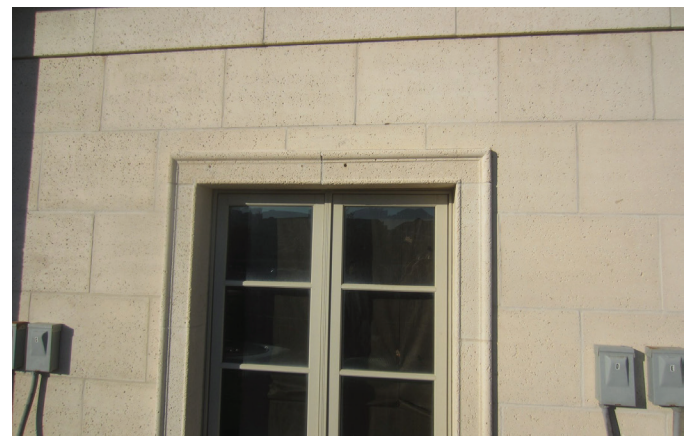
Figure 6

Cast stone panels installed on first floor.

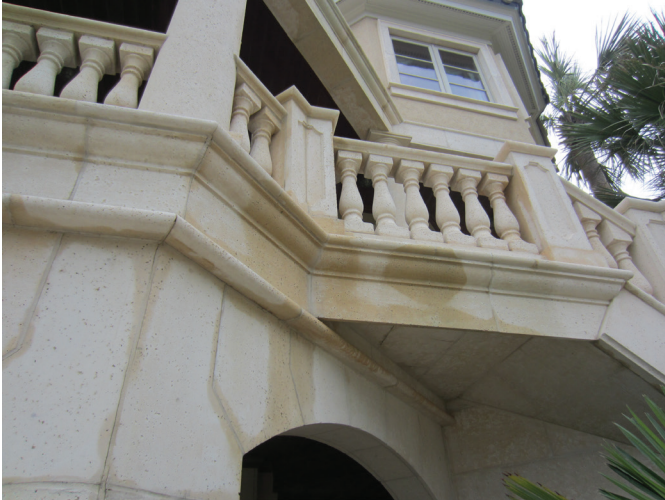
Figure 7

Vertical face of rear balconies.

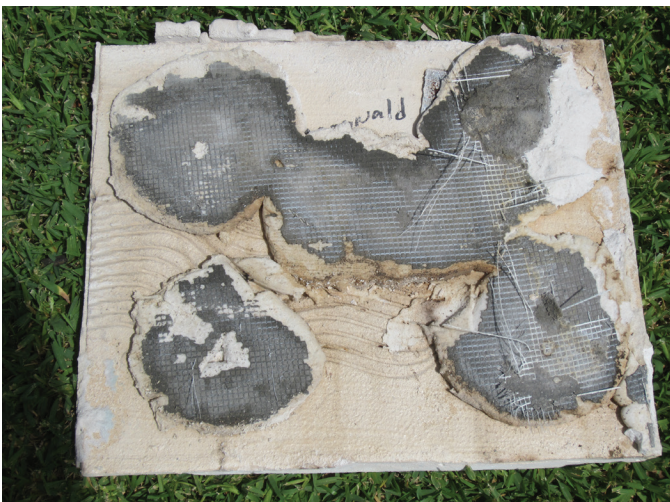
Figure 8

The size of the typical cast stone panels was measured to be approximately 24 inches by 36 inches and one inch in thickness. Custom cast stone panels were noted to have dimensions greater than 36 inches in some areas. The cast stone panels were adhered using thinset-type mortar over a waterproofed CMU wall. In some instances, the cast stone panels were observed to be attached to the exterior walls with a combination of thinset-type mortar and carbon steel masonry screws (**Figure 8** and **Figure 9**). The thinset mortar did not cover the entire backside of the cast stone panels. It was installed using the “spot bonding” method. The spot bonding method is where the mortar provides only partial coverage of the cast stone panel (Goldberg 1998). The cast stone veneer did not include flashing or weep

“Spot bonding” on backside of cast stone panel.

The primary method of attachment for the subject cast stone veneer units was adhesion via thinset-type mortar installed in a “spot bonding” method, supplemented by the installation of steel masonry screws. In Goldberg’s *Technical Design Manual for Direct Adhered Ceramic Tile, Stone and Thin Brick Facades*, he describes limitations of the “spot bonding” method of attachment (Goldberg 1998). Specifically, the following “important principles” are outlined for the architect and contractor to consider:

- Spot bonding is only suitable when using adhesives with very high bonding strength and flexibility, such as new technology epoxies and structural silicone, and may require supplemental mechanical anchorage.
- Spot bonding should not be used in wet climates

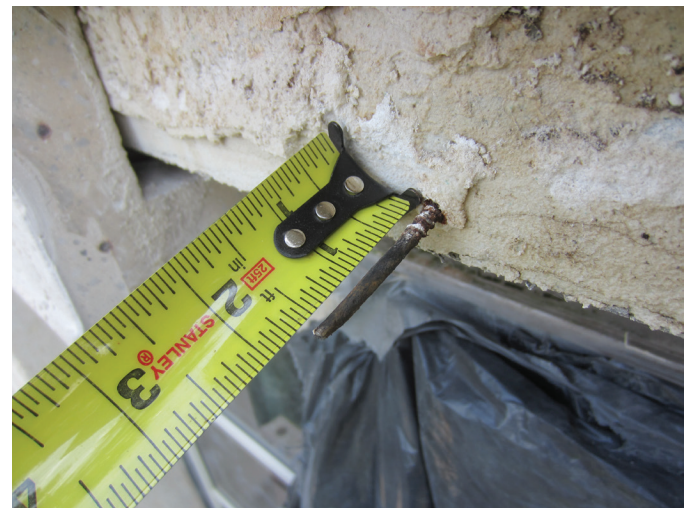
Figure 9

Masonry screw used to attach a cast stone panel.
