Journal of the
National
Academy OF
Forensic
Engineers[®]

Vol. 35 No. 1 June 2018

On a Saturday afternoon in March of 2014, a low-order explosion occurred within a first-floor dwelling unit of a multi-tenant apartment building located in Georgia. Due to the explosion, the building sustained extensive damage, and the occupant of the unit of origin sustained serious burn injuries. This paper examines the origin and cause of the explosion.

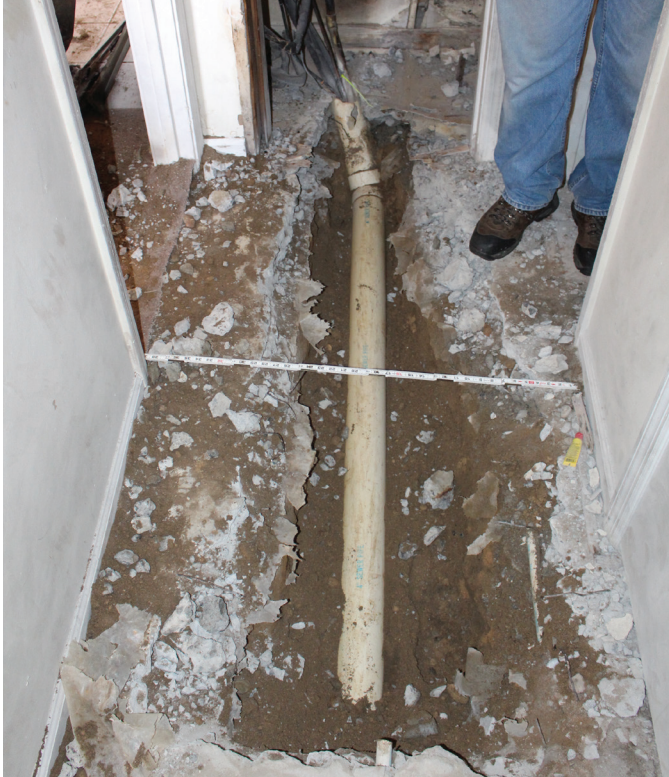
Figure 6

Excavated PVC conduit routed beneath slab and terminated at floor level of mechanical closet. Refrigerant line set continues up to the FCU located inside the closet.

Pressurized liquid refrigerant (propane) was discharged through the rupture opening in the pipe, flash vaporized in the PVC conduit, and then flowed into the mechanical closet. The release of pressurized refrigerant into the PVC conduit and flowing of the refrigerant into the mechanical closet is consistent with the witness observations of a hissing noise — strongest in the area of the mechanical closet/thermostat. The south side of the PVC conduit was below ground, and the outlet was packed with soil, which would create a barrier to the free flow of gas on that end of the conduit.

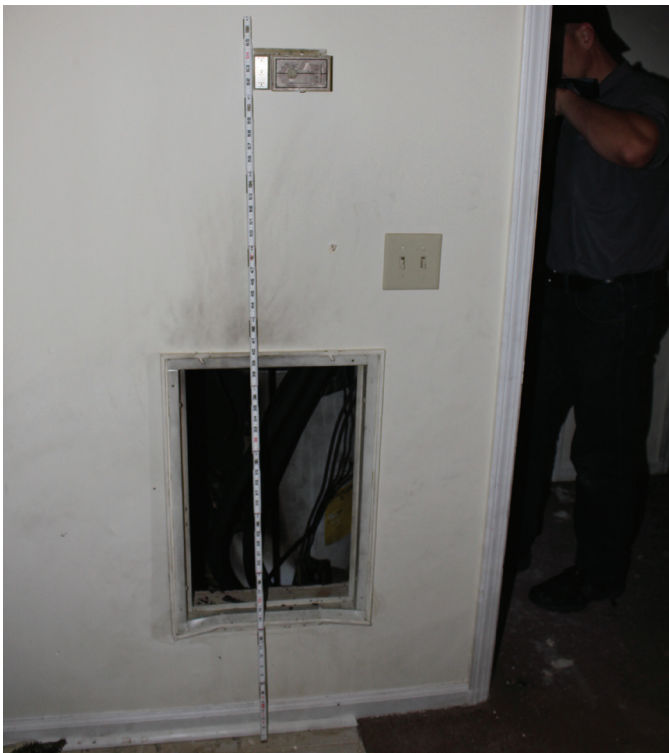
Figure 7

The single occupant of P-3 was in the south bedroom when he heard a hissing noise. Upon investigation, he determined the noise originated from the area around a wall-mounted thermostat located on the east wall of the living room/dining room. He detected no unusual odors. Believing there might be a problem with the air-conditioning system, he proceeded to switch the thermostat to the off position, at which time the explosion occurred. The occupant was facing the thermostat at the time and experienced a blast of pressure and flames coming from the direction of the thermostat.

The thermostat was mounted directly above a 16-inch by 25-inch non-ducted return air wall grille opening. The vent opening directly communicated the air space of P-3's mechanical closet to the air space area around the thermostat and the occupant. Responding firefighters used a fire extinguisher to put out a small fire in the mechanical closet. The involved occupant was transported to the hospital with burn injuries.

East wall of living room/dining room area with wall thermostat and return air grille of the mechanical closet.

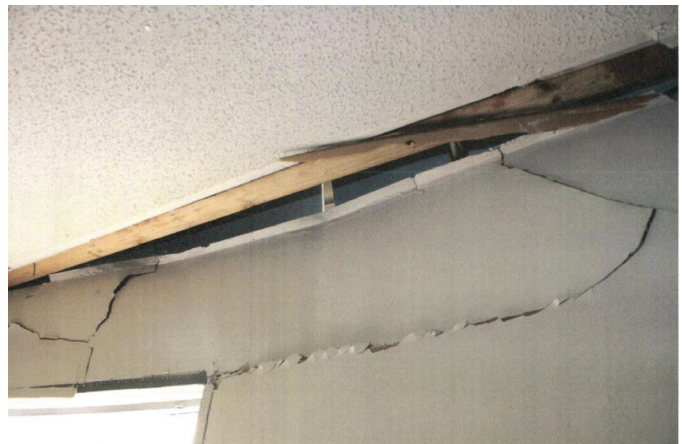
Figure 9

Building wall structures and components were primarily intact although cracked, bulged, and displaced due to overpressure. Windows and doors were broken, dislodged, and displaced over short distances. The damages were consistent with low-order explosion damage, as characterized in NFPA 921 Section 23.3.1¹. **Figures 8** through **13** depict typical overpressure damages observed to the building.

Wall / ceiling joint separation.

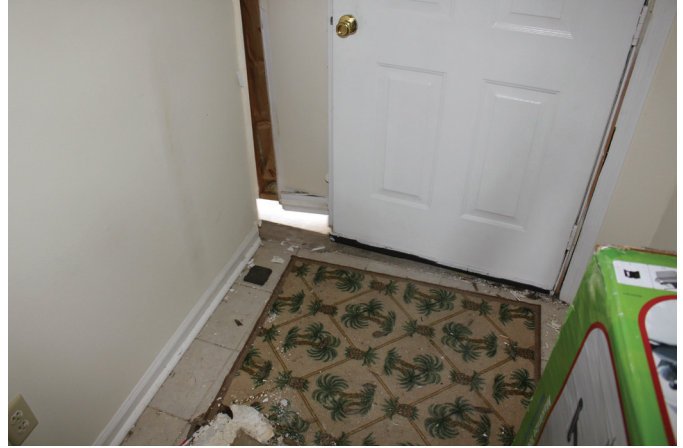
Figure 11
Exterior walls dislodged.

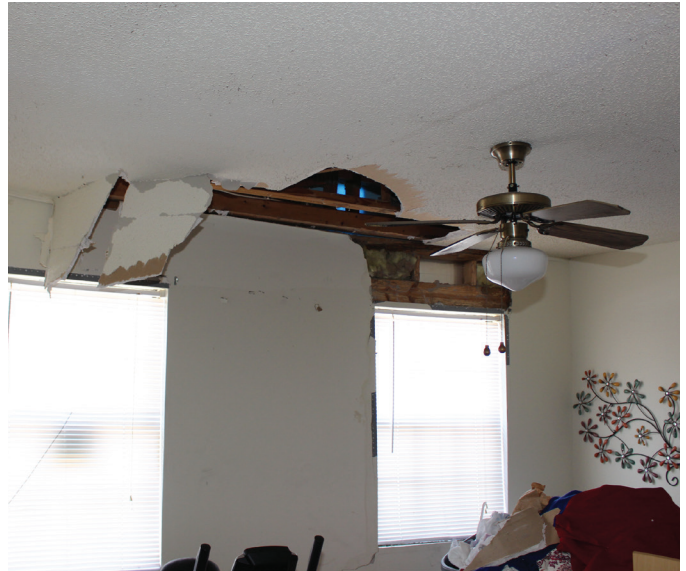
Figure 12
Interior and exterior walls separated from ceiling structures — windows intact.

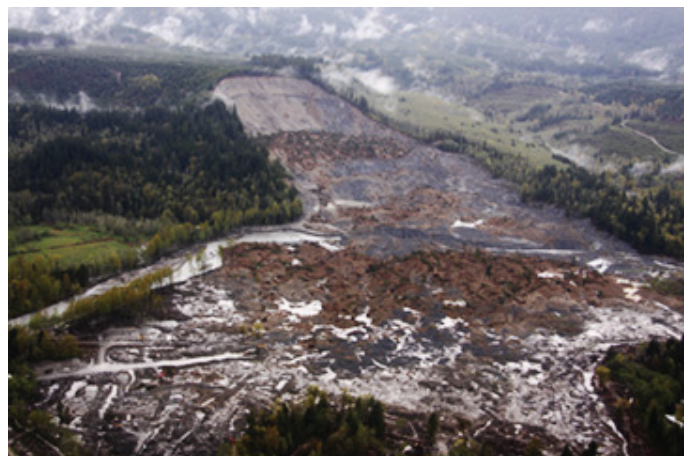
The March 2014 Oso Landslide, however, was (regionally) unprecedented with respect to the volume of material displaced during the event, the speed at which the landslide debris traveled through the community of Steelhead Haven, and the distance traveled by the debris (runout). In a matter of 3 to 5 minutes, more than 10,000,000 cubic yards of material displaced, with landslide debris traveling up to a mile at the distal end. **Figure 3** shows a comparison between the 1967, 2006, and 2014 landslide extents. There was a sharp contrast in runout between an anticipated event (1967-type movement) and the largely unexpected event of 2014. A comparison of debris volume of known landslide events prior to the 2014 Oso Landslide, based on comparisons of aerial photos taken before/after each landslide occurrence, is shown in **Figure 4**. A view of the Oso Landslide body prior to the March 2014 event is shown in **Figure 5**, and a similar view following the March 2014 event is shown in **Figure 6**.

Figure 6
View of the March 2014 Oso Landslide in April 2014, looking northeast (photo by King County Sheriff's Department).

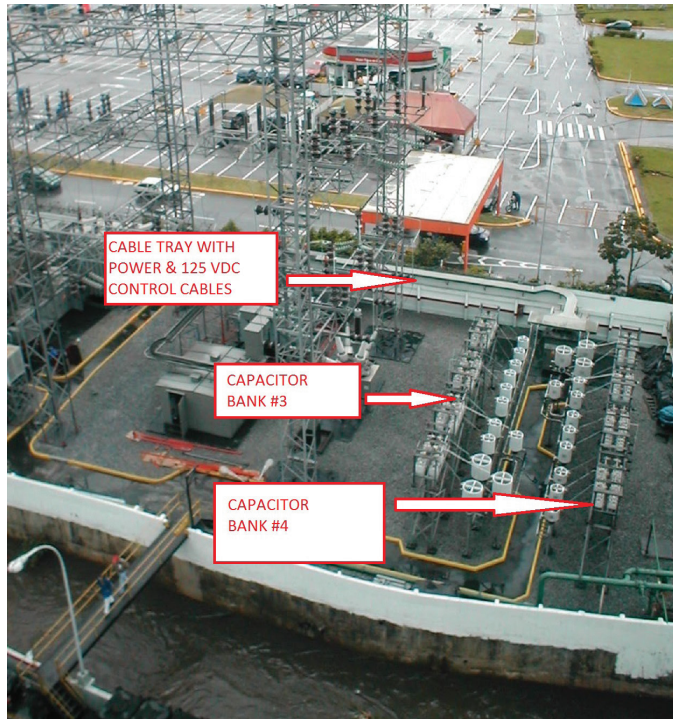
Figure 4
Relocated capacitor Bank #3 and #4.

Transformer No. 5 (**Figure 4**). The power cables in the trays were spliced with additional cables to reach the relocated capacitor banks (**Figure 5**).

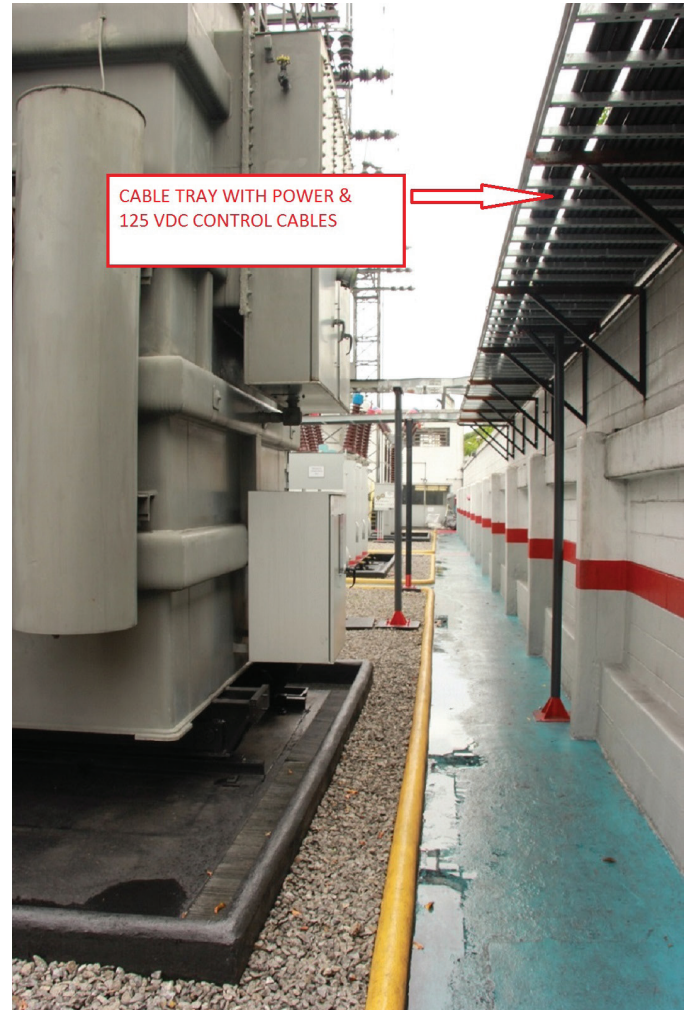
The electrical power for the 4.16kV, 6 MVAR capacitor banks was derived directly from the 4.16kV busbars in the substation. In light of this, the spliced power cables (from the 4.16kV substation busbars to the relocated circuit breakers and capacitor banks) were not protected by the 4.16kV distribution system in the substation, since the spliced power cables became an extension of the substation 4.16kV busbars.

Figure 5
Cable tray for capacitor bank cables.

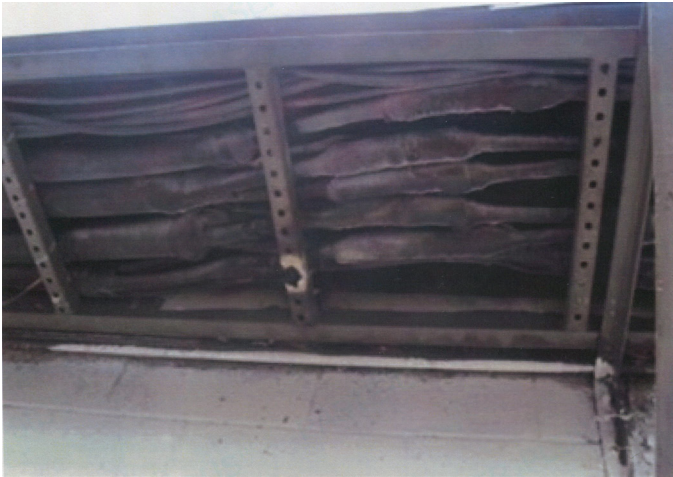
In the spring of 2015, a second cable splice failure occurred in one of the power cables associated with one of the capacitor banks. The cable splice failure caused a short circuit and a fire in the cable tray where the power and 125 VDC cables for the capacitor banks were located (**Figure 6 through 9**).

The fire in the cable tray caused the catastrophic failure of the entire 125 VDC control system in the substation. This prevented the 88kV and 4.16kV circuit breakers in the substation from providing the protection and control for all the equipment in the substation. The only

Figure 6
Capacitor bank cable splices.

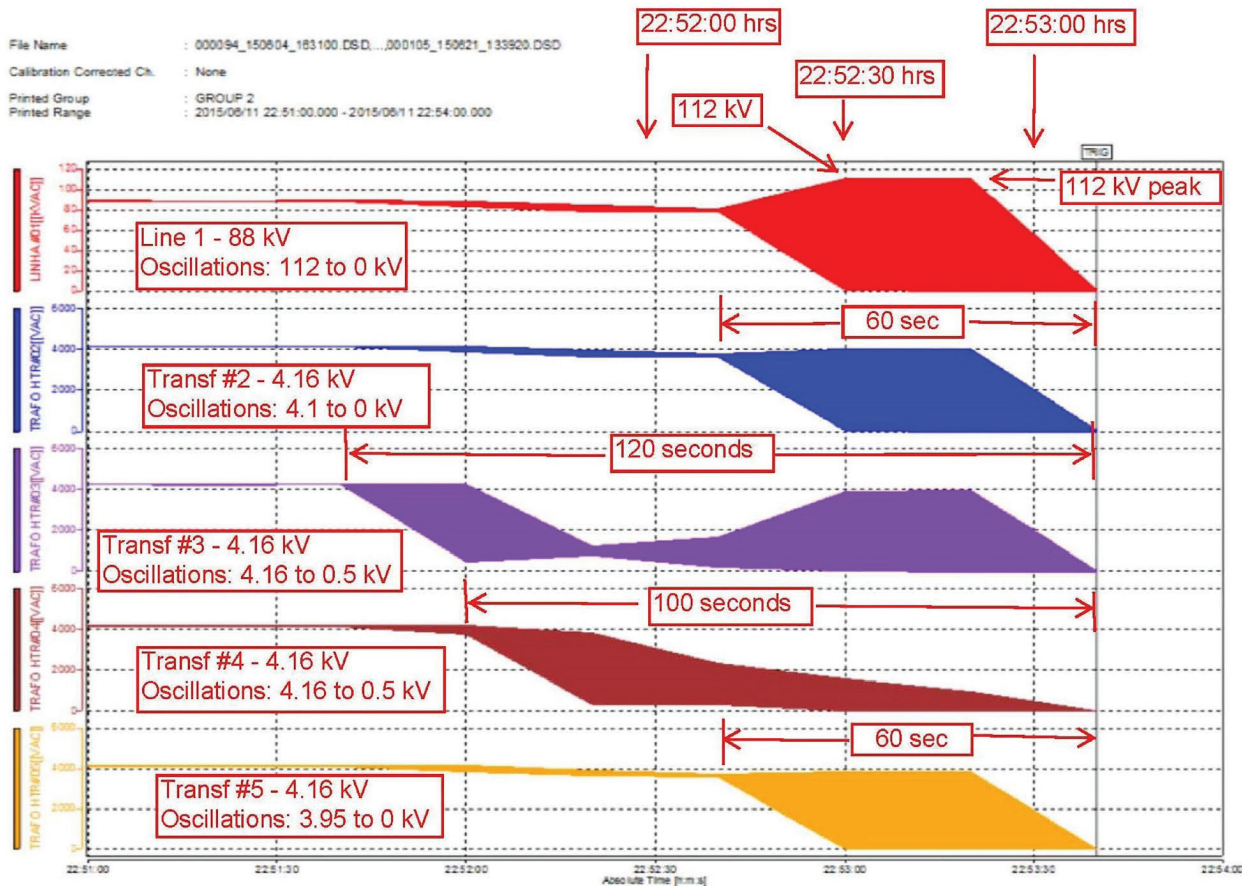
Figure 10

Recorder graphs — 88kV utility overhead line and customer Transformers 2 through 5.

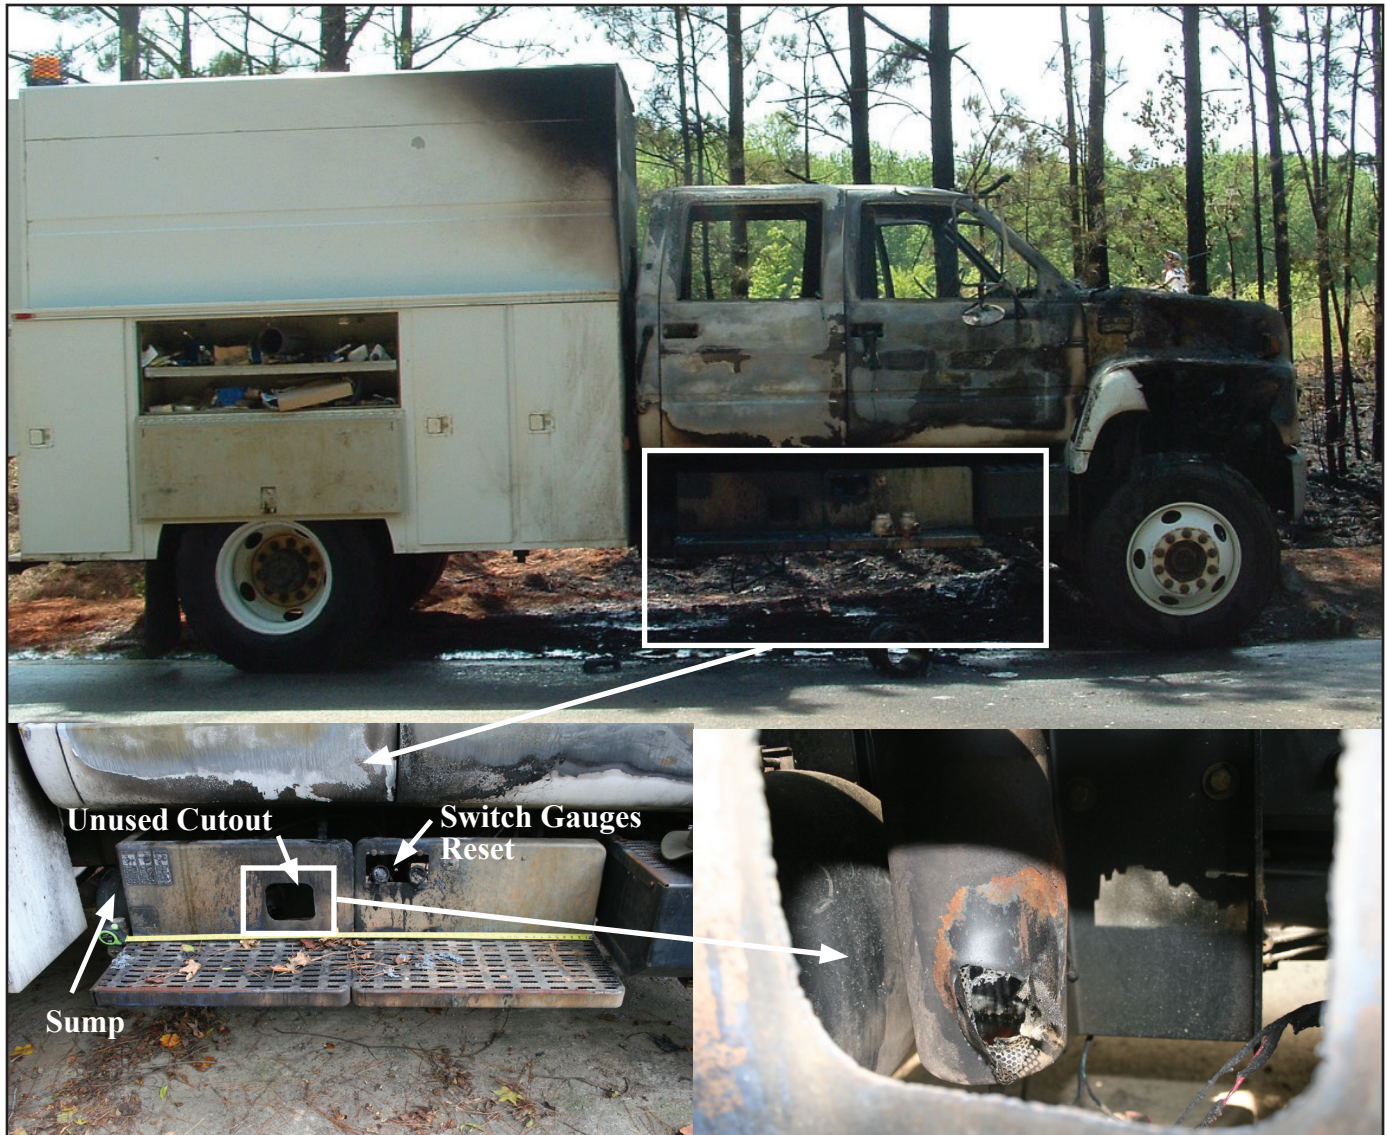
Figure 2

Pictures showing relationships between truck, step, reset button, gauges, and coalescer.

The oil/air mixture enters the sump tank, which acts as both a pressure tank and an oil sump. The oil collected in the sump is circulated through a filter that removes particulate prior to entering the heat exchanger where the oil is cooled and returned to the compressor. The pressurized air leaves the sump and is circulated through a coalescer to reclaim atomized oil before exiting the system and going to the work tool. The coalescer was ruptured, as shown in **Figure 2**, allowing the release of burning oil in the direction of the operator.

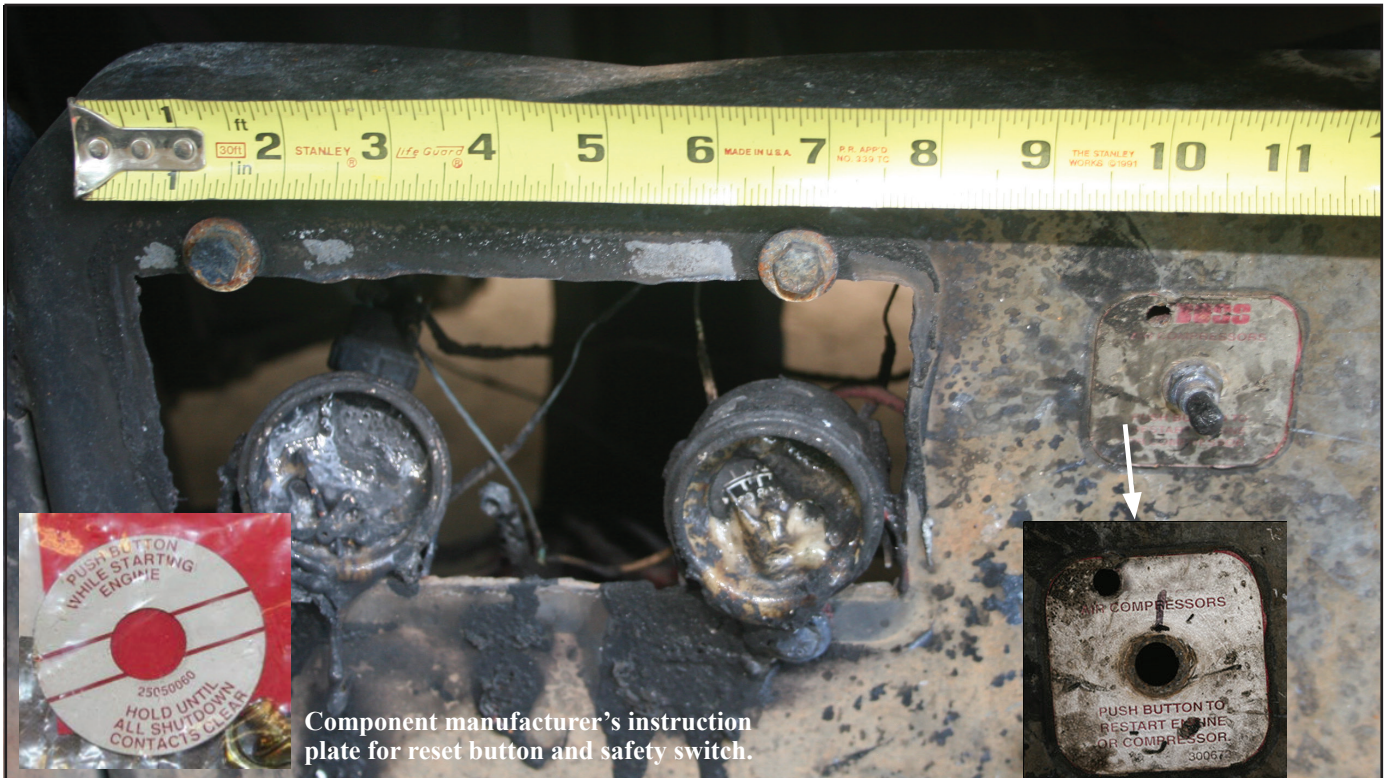
Figure 3

Component manufacturer's instruction plate for reset button and safety switch.

Damaged temperature and pressure switch gauges. The reset button switch is shown to the right mounted 2½ inches from the switch gauge cluster. Note instructions. Manufacturer names are hidden.

The manufacturer never evaluated or considered the consequence of the reset button energizing the air compressor. The language on the reset button shown in **Figure 3** even invites the operator to attempt to restart the air compressor regardless of the present state of the system's temperature and pressure. The subject reset button instructions are different from the component manufacturer's instructions (**Figure 3**). However, the component manufacturer's instructions are even more inviting to hold the reset button. It is not operator error to perform a

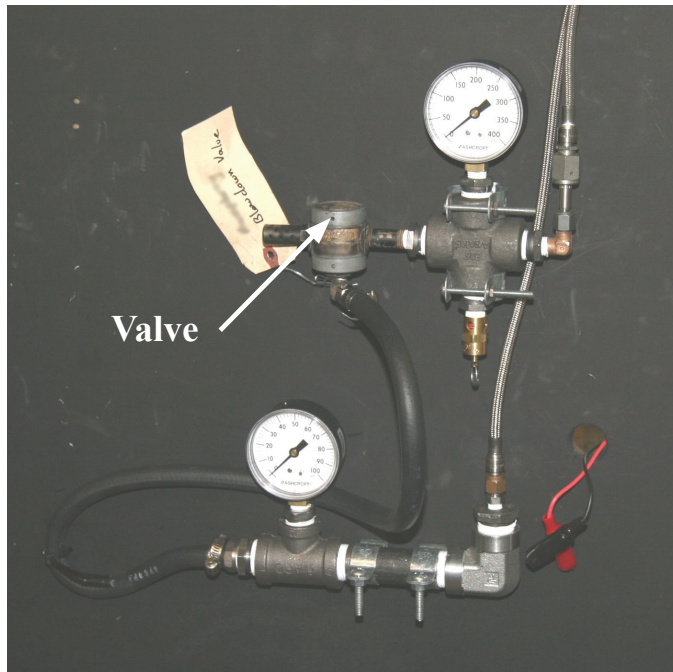
Figure 4

The purpose of the automatic blowdown valve was to relieve pressure from the system when it was shut down. **Figure 4** shows the testing apparatus used for testing pressure-related components such as the automatic blowdown valve. It proved to be operating as designed.

Test apparatus used to test the automatic blowdown valve and the pressure switches. The system is shown with the automatic blowdown valve installed.

The air compressor system used two pressure switches that were responsible for performing certain control operations by converting mechanical pressure into an electrical response. The pressure switches were tested by pneumatically actuating the devices (**Figure 4** typical) and monitoring the pressure at which the contact state changed. The testing showed that both pressure switches operated as intended.

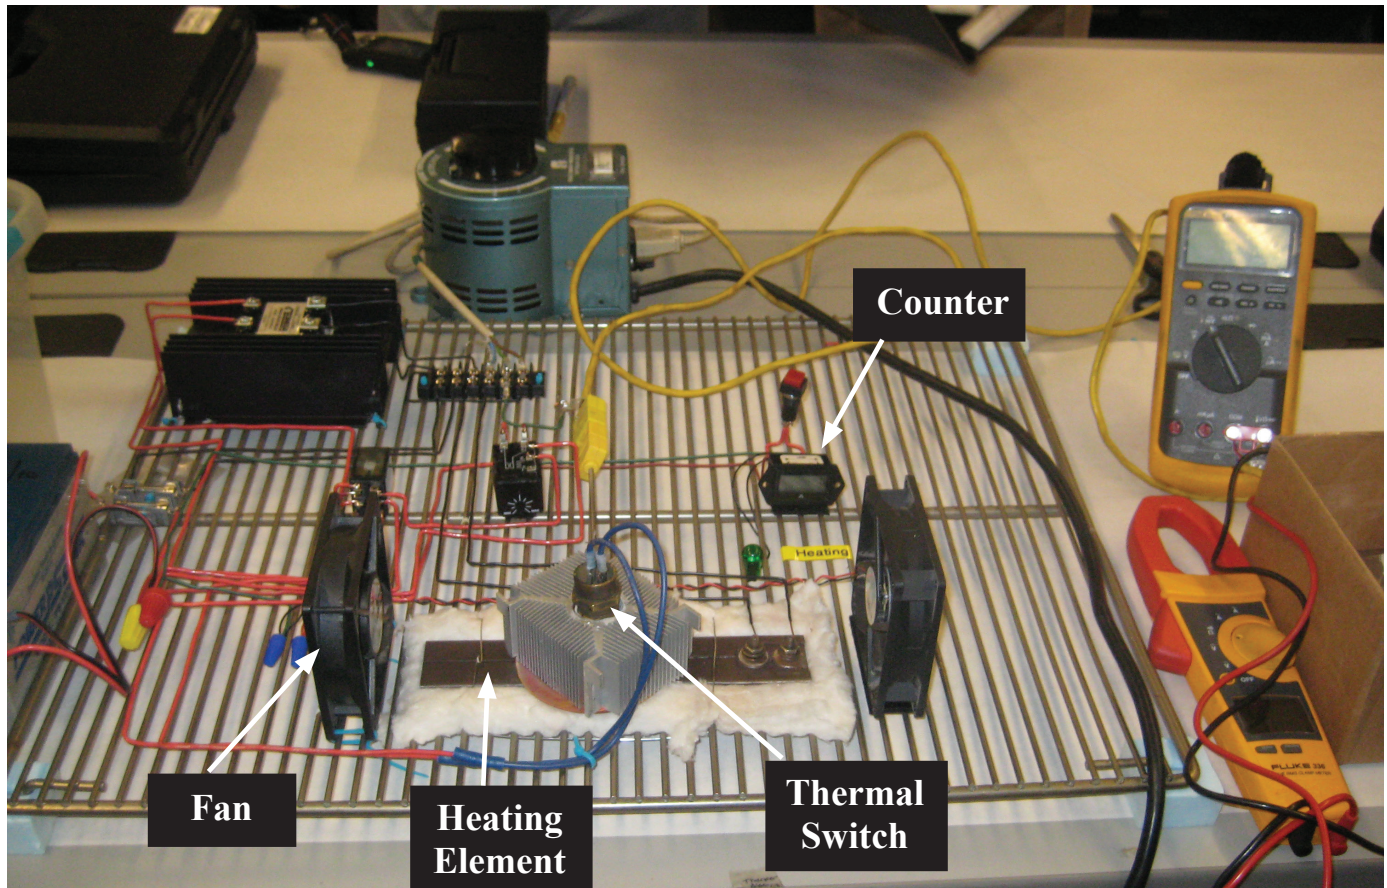
Figure 6

A second series of tests was performed on the thermal switch to test its long-term cyclic performance. **Figure 6** shows the thermal switch mounted in a heat sink connected to a 350W Omega resistive heating element. Heat was applied to the thermal switch until the contacts changed state, simultaneously energizing a 12V relay to turn off the heating element, turn on the 12V fans for cooling, and increment a step counter. The step counter would not increment until the next high temperature cycle. The test was a fully automated process and was not halted until the consensus of the experts agreed to conclude. The testing showed that the thermal switch operated as intended.

Test apparatus to measure cyclic temperature performance of thermal switch.

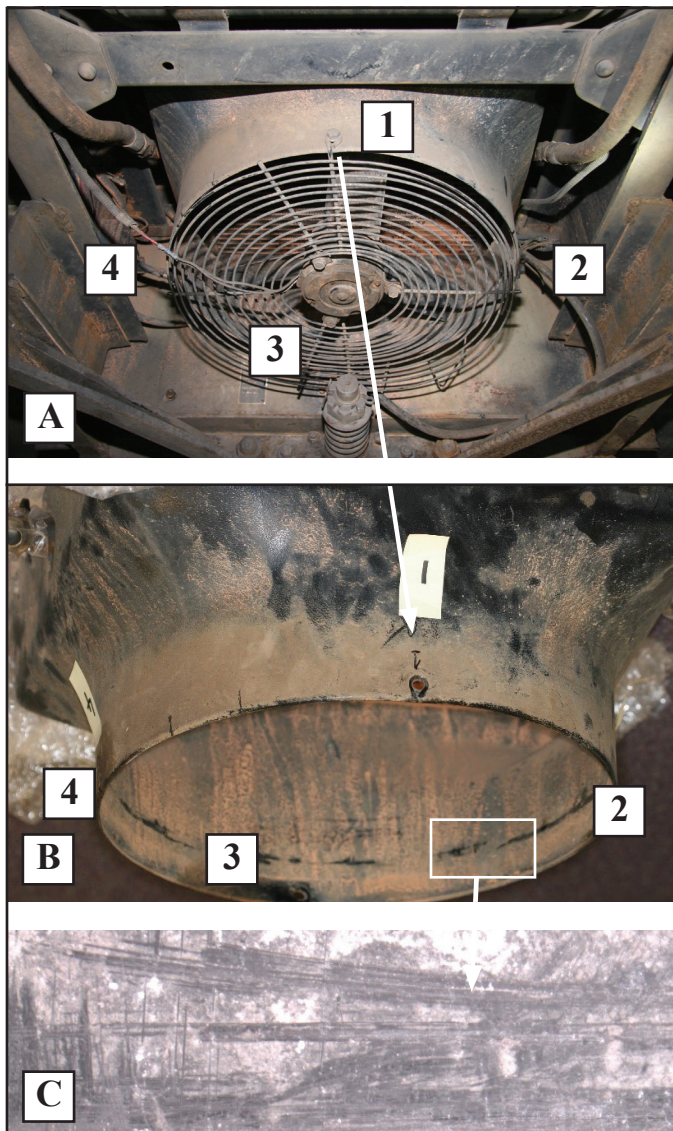
Figure 7

controlled by the combination of the thermal switch and a 12V relay; both were shown to be functional. Inspection of the fan and fan grill showed that the fan grill had suffered damage by an outside source, such as road debris. The fan blades and motor are attached to, and supported by, the grill, which is attached to the heat exchanger shroud by four grill wires. Three of the four grill support wires had suffered fatigue failure. The broken support wires allowed the fan to fall downward, pinning the fan blades against the shroud. The fan, in the final resting position, is shown in **Figure 7**.

Subject fan shown at top (A) with its four grill support wires identified as shown (1 – 4). Witness marks on the inside surface seen in B and C of the heat exchanger shroud showing that the fan ran against the shroud for short time before binding. The grill was held in place at wire [1] which was not broken.

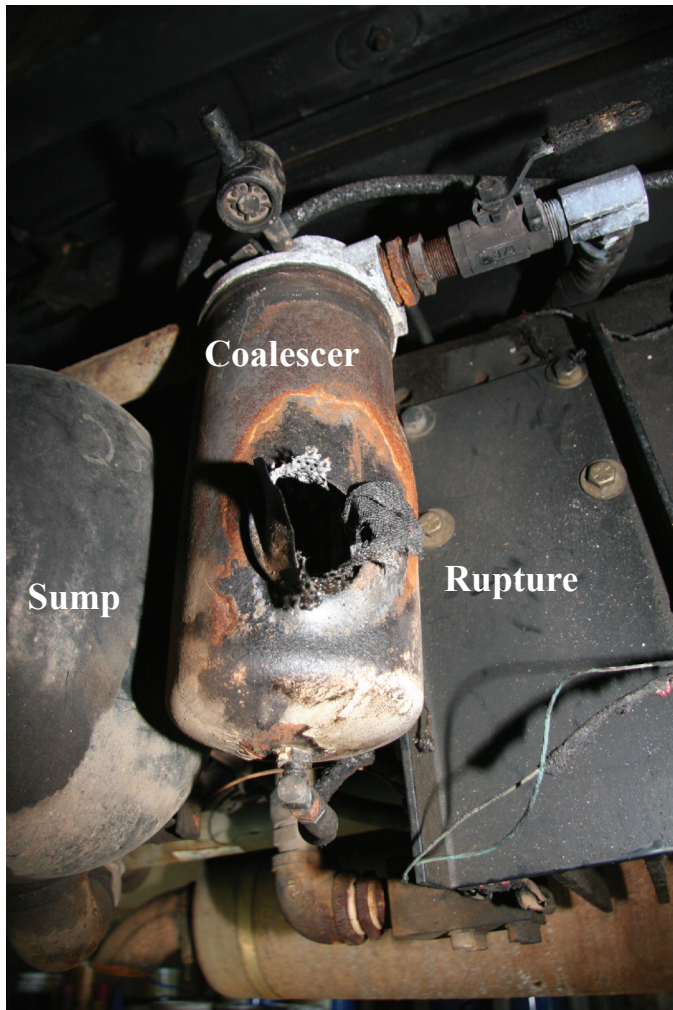
Figure 9

Image of the coalescer ruptured after the step was removed. The coalescer is located forward of the sump directly behind the rear hole in the passenger side step.

a coalescer to remove oil vapor from the air supply upon exit and return the reclaimed oil to the compressor. The coalescer contained a large rupture, as shown in **Figure 9**, which allowed rapid depressurization and the instantaneous release of burning oil at high pressure. The location of the rupture aligned with the release of burning oil in the direction of the operator. The coalescer was examined by visual inspection, X-ray inspection, and CT inspection. The properties of the metal were examined metallurgically and by microhardness testing.

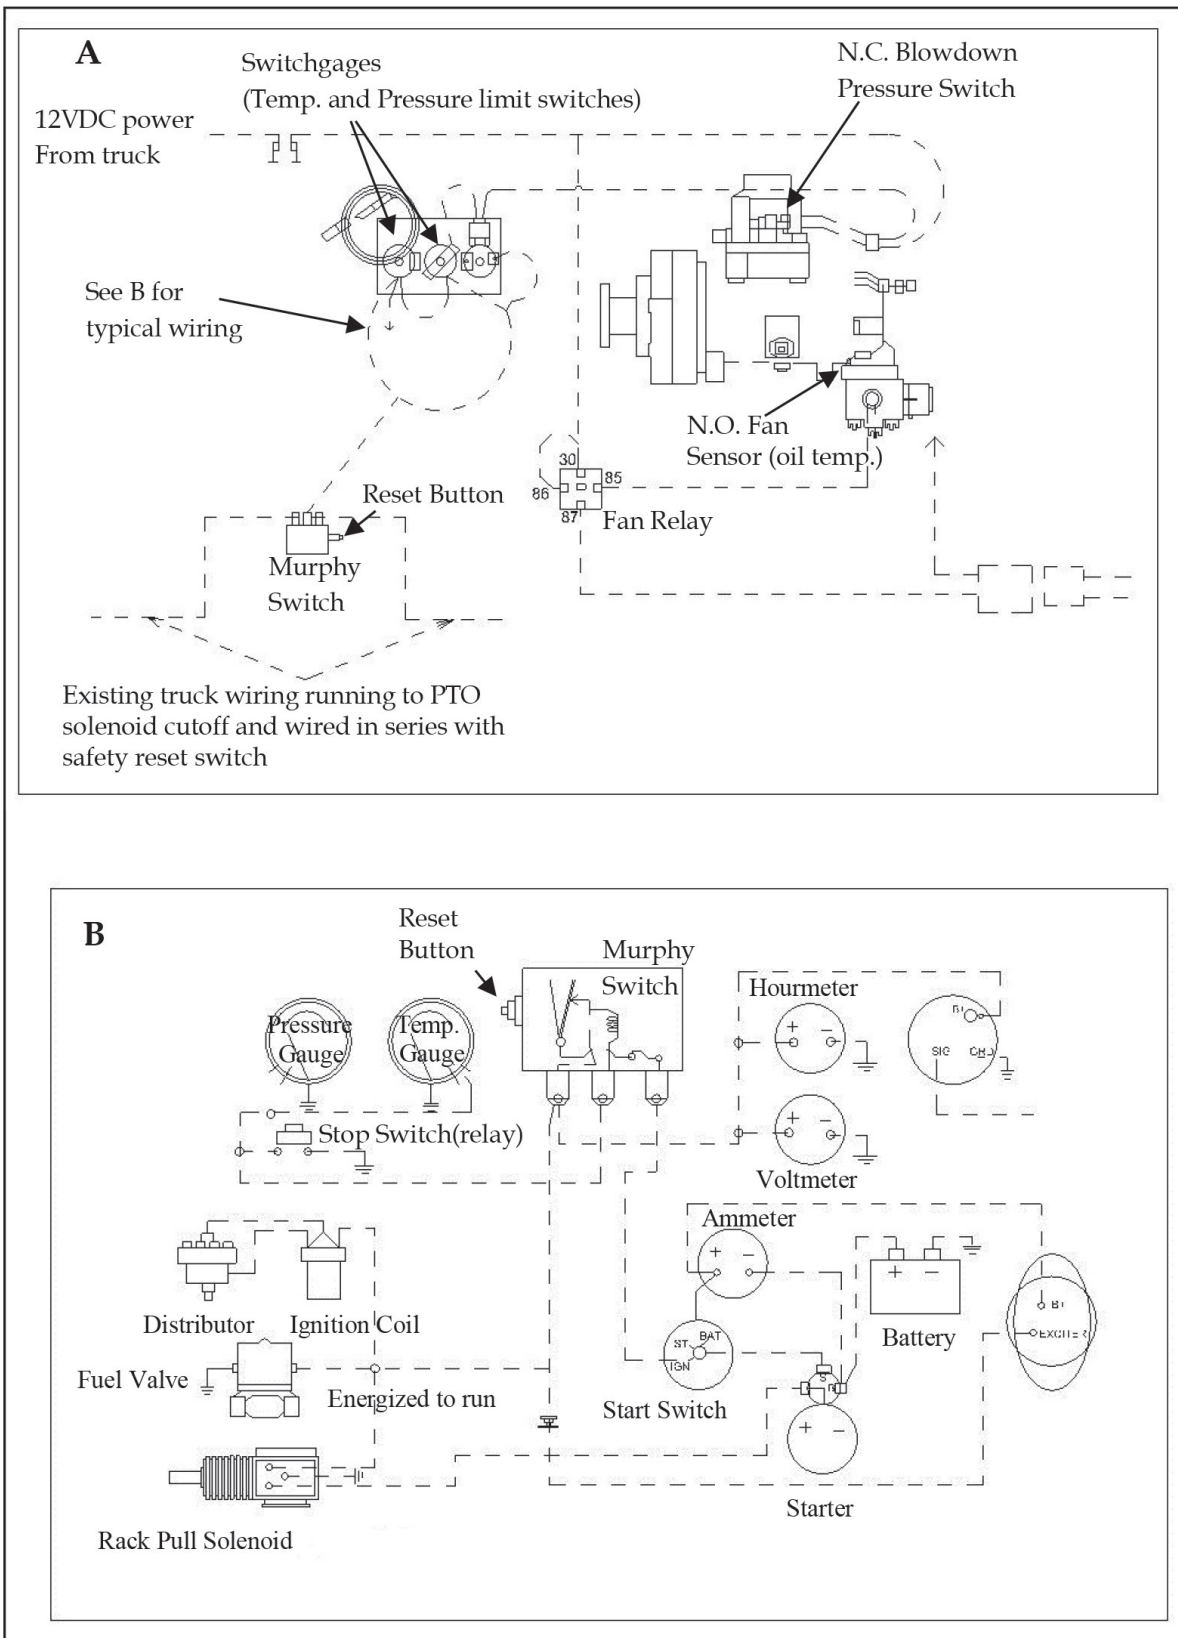
Figure 12

A. Diagram showing the air compressor manufacturer’s subject safety shutoff circuit that allows the operator to manually override the out-of-limit condition and continue operating the air compressor system. B. Component manufacturer’s design of a typical circuit (stop switch [relay] and reset button) resulting in same override outcome.

The reset button (and safety shutoff), temperature gauge and pressure gauge are individual components that are designed and produced by the same company to perform as a control system that monitors the air compressor temperature, and pressure — and that shuts the system down if one or both exceed its operating limit. Although these components are sold separately, the company provides design drawings on how to connect them together as a control system. **Figure 12** shows the control circuit of the subject air compressor with the component manufacturer's circuit design for comparison.

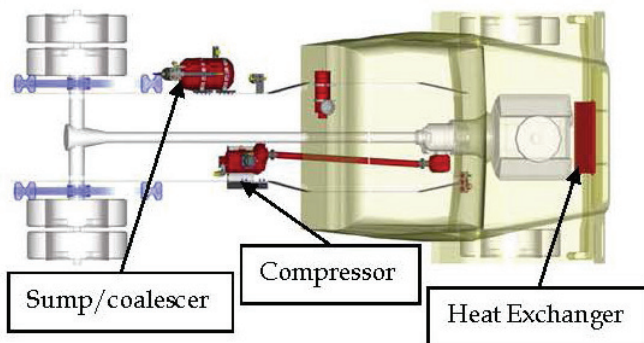
Figure 15

Typical system installation presented by system manufacturer.
Heat exchanger vertically mounted.

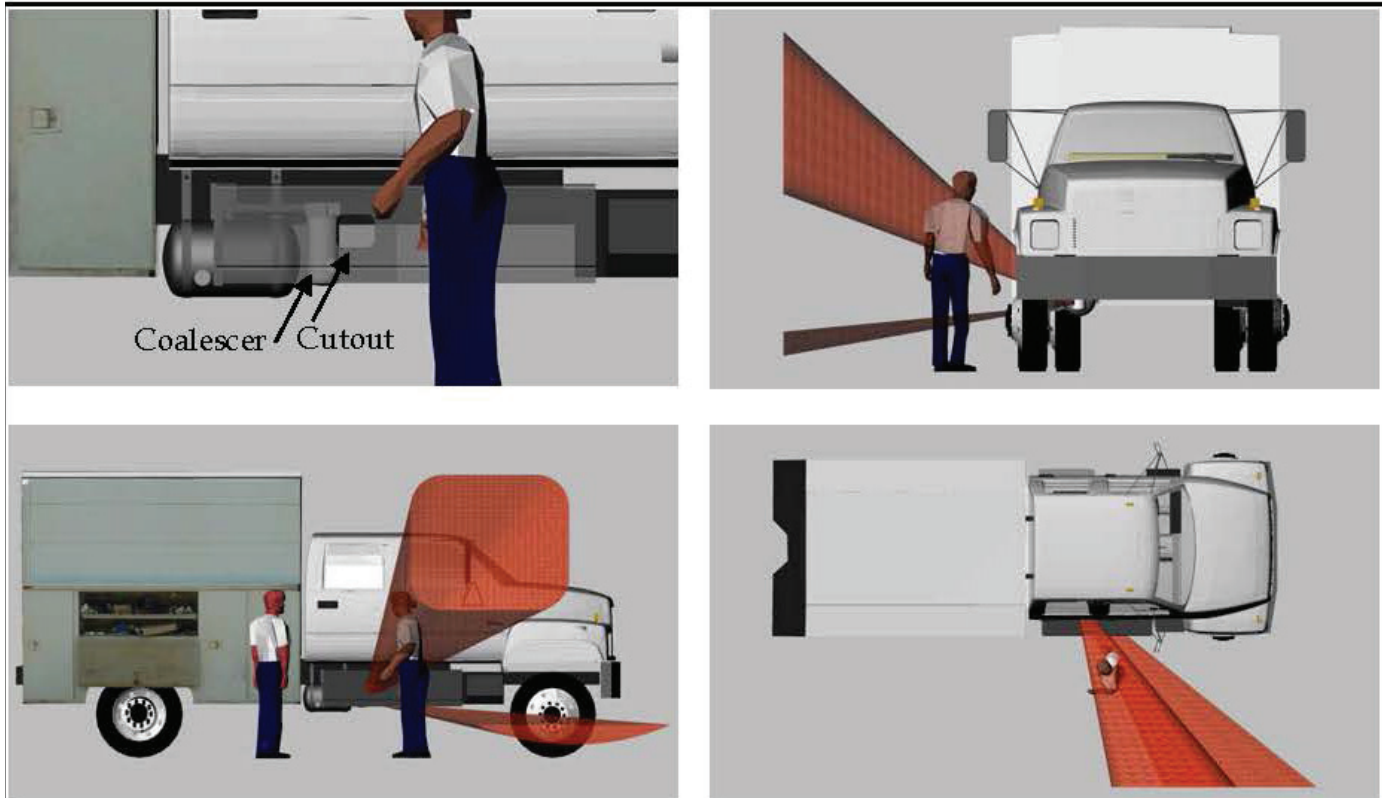
Figure 16

The open hole proved to be the opening that the burning oil needed to exit the truck and strike the operator over a large part of his body (**Figure 16**). The path of the oil, from the rupture through the open hole, was analyzed and shown to be consistent with the injuries in the case. A root cause of the injuries suffered was the open cutout in the step.

Operator at location required to operate reset button. B-D. Perspectives of fluid spray from coalescer.

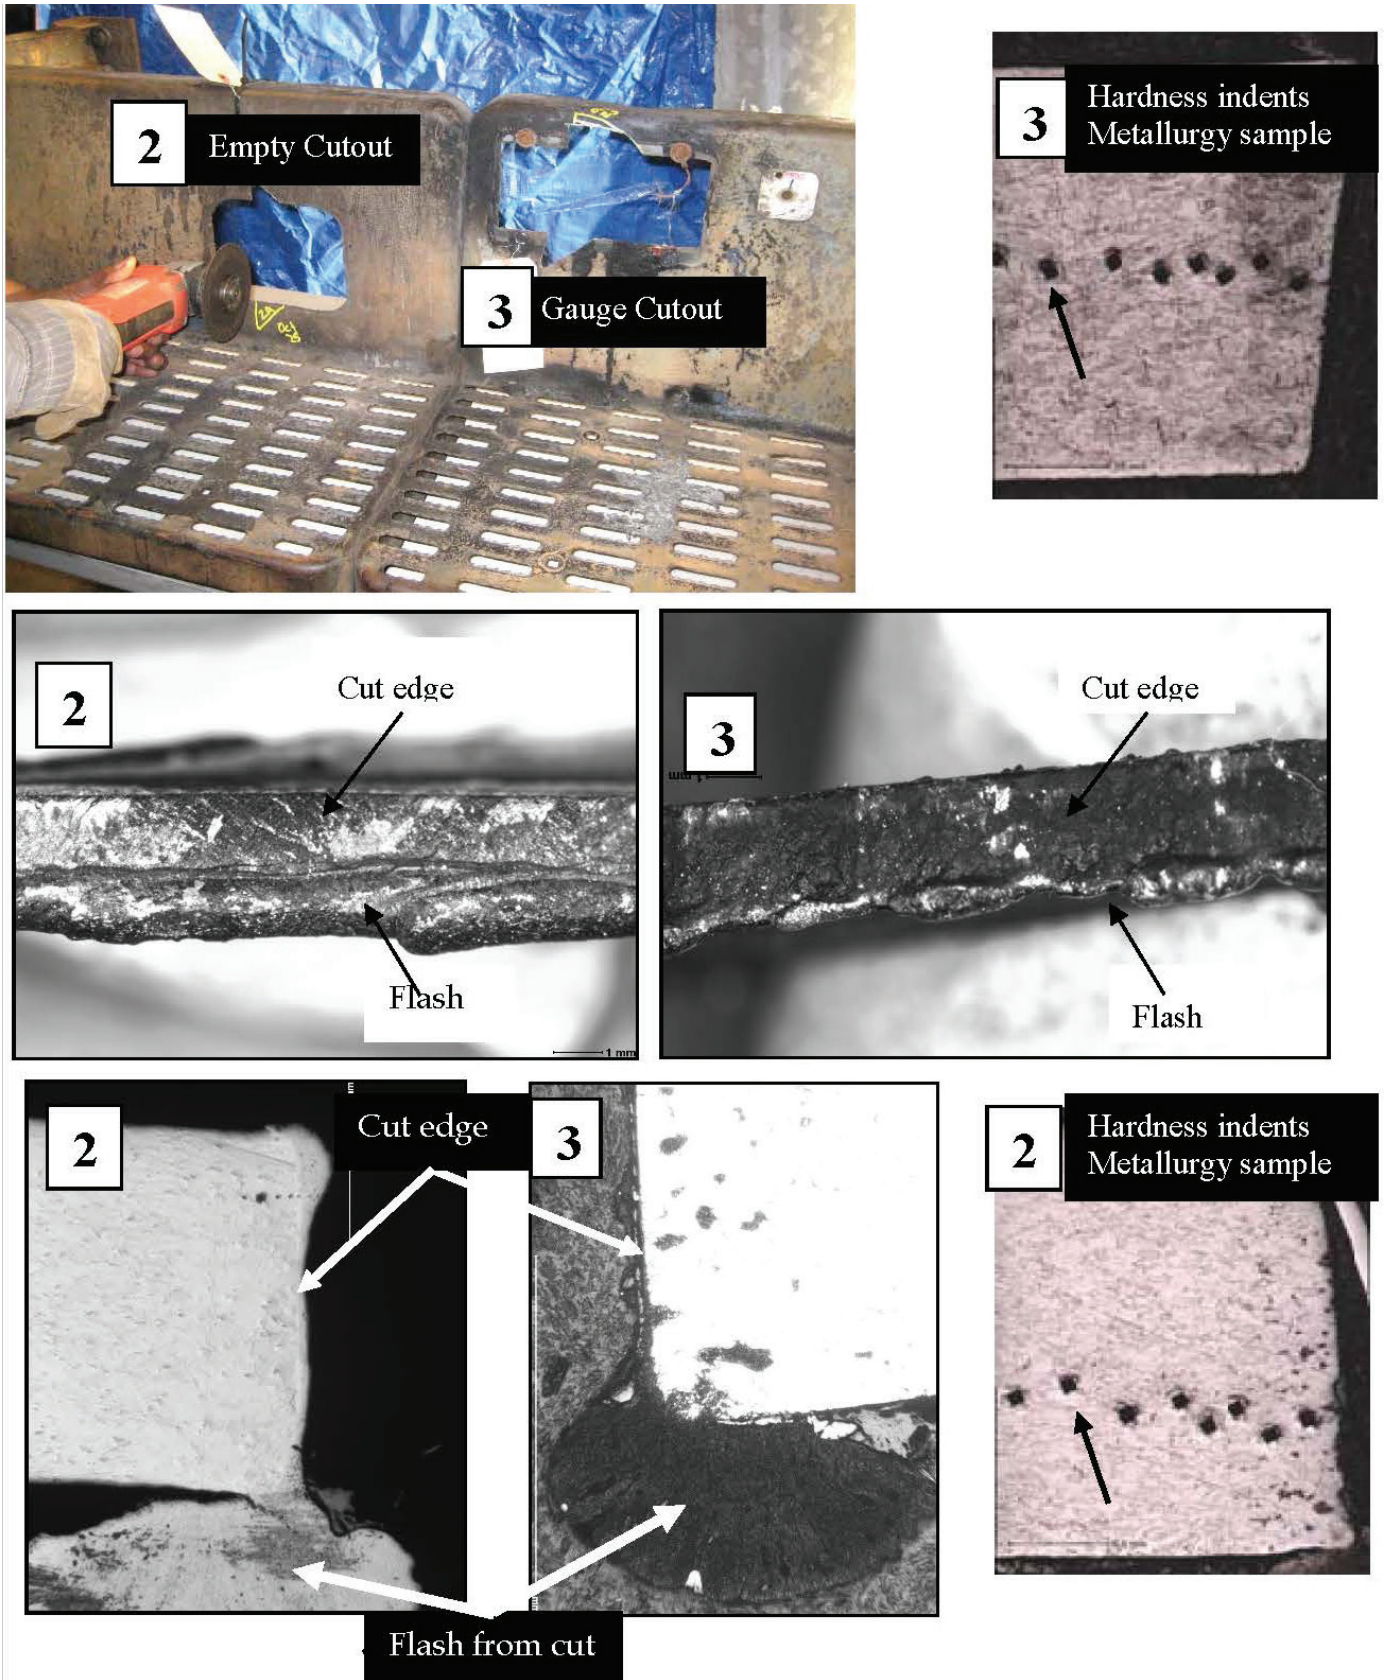
Figure 17

Samples taken from cutouts in step. 2. Cutout #2 is the empty cutout. 3. Cutout #3 is the gauge cluster cutout. The cut edge with metal and oxide flash was found to be the same in each cut. The hardness and metallurgical heat zone were found to be the same in both cuts.

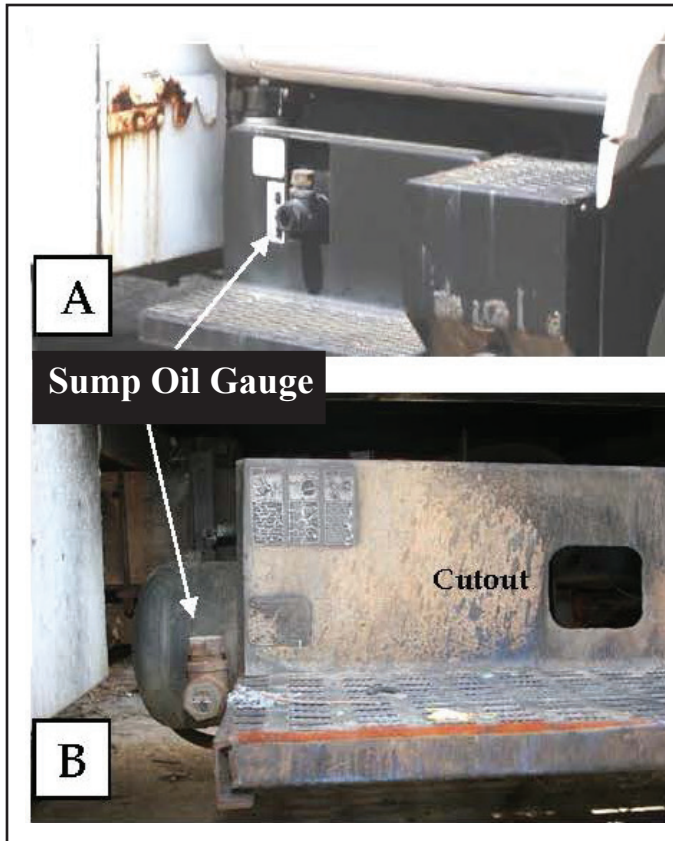
Figure 18

Exemplar truck oil gauge location. B.
Subject truck oil gauge location and open cutout.

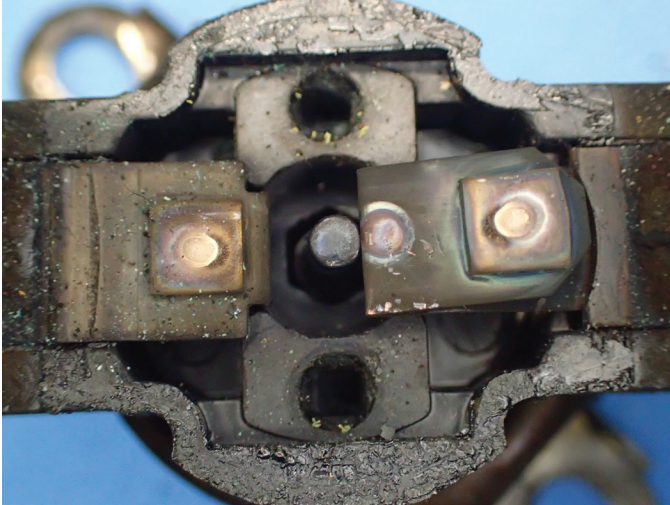
Examination of the safety thermostat switch contacts will indicate if the switch has been cycling. The contacts on the high temperature limit switch from a gas dryer will generally have less damage, since the switch interrupts the low current from the gas valve coils. The switch contacts on a high temperature limit for an electric dryer will show relatively greater damage due to interrupting the larger current of the electric heating elements. **Figures 14** and **15** show the high temperature limit contacts from a

Figure 14
Contacts of gas dryer safety thermostat.

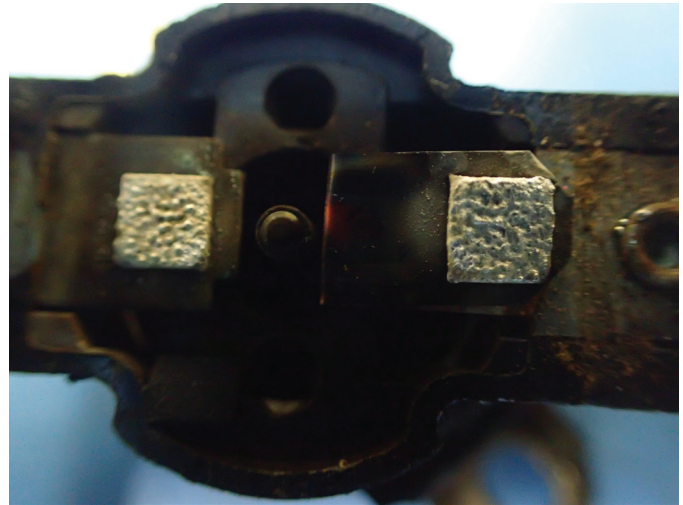
Figure 15
Contacts of electric dryer safety thermostat.

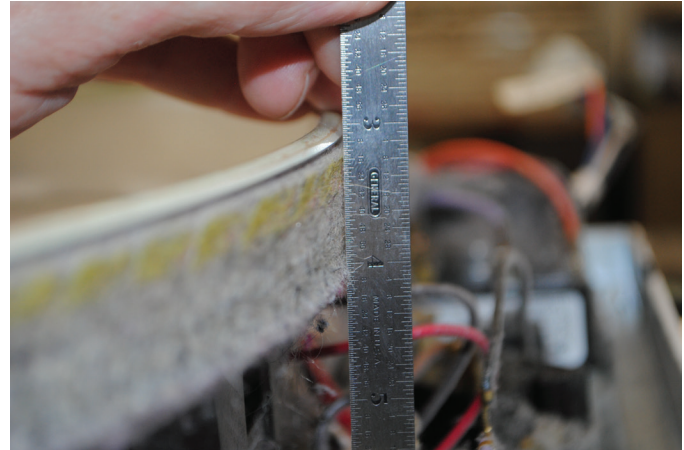
Figure 23
Crushed seal.

For example, in ball hitch dryers, the rear of the drum is supported by a single shaft in a bearing. The front end of the drum is supported by the front drum seal. During use, the seal can become crushed and create a gap to open at the lower end of the drum (Figures 22, 23 and 24).

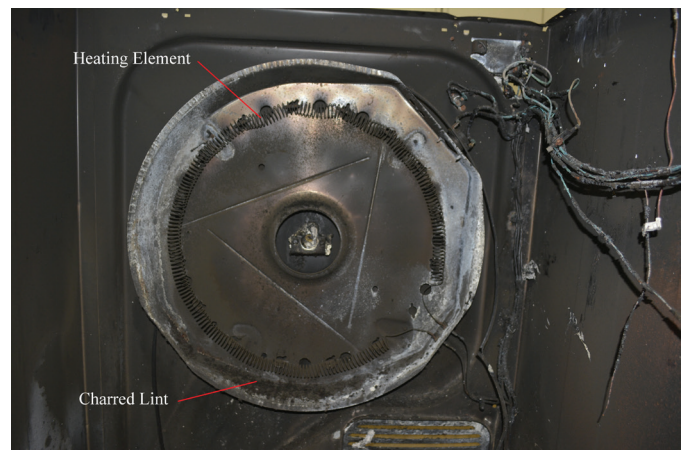
Figure 27
Heater pan of electric ball hitch dryer showing heating element and accumulated lint.

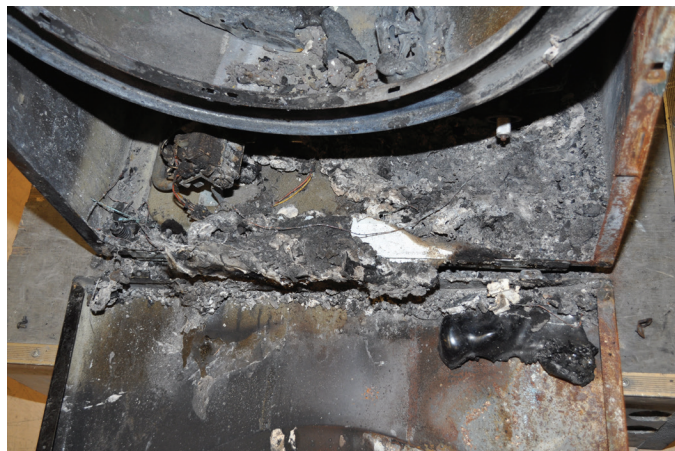
Figure 30
Base of dryer showing mostly consumed combustible plastic components.

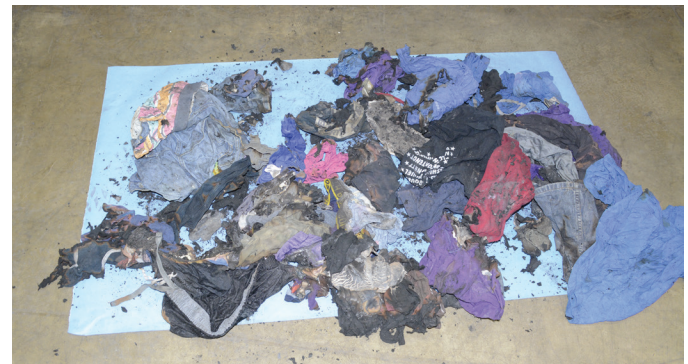
Figure 34
Load with minimal fire damage.

event and dispersal of molten metal into the dryer ignited lint within the dryer. The load had minimal fire damage (**Figure 34**). Most of the combustible plastic components burned (**Figure 35**).

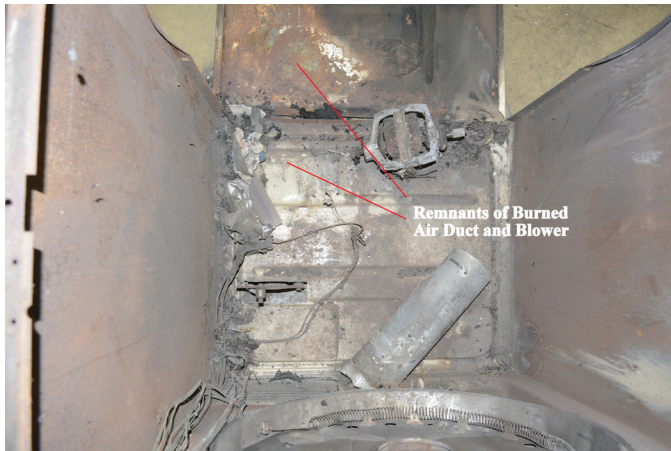
Figure 35
Consumed plastic components.
