Journal of the
National
Academy OF
Forensic
Engineers[®]

Vol. 35 No. 1 June 2018

On a Saturday afternoon in March of 2014, a low-order explosion occurred within a first-floor dwelling unit of a multi-tenant apartment building located in Georgia. Due to the explosion, the building sustained extensive damage, and the occupant of the unit of origin sustained serious burn injuries. This paper examines the origin and cause of the explosion.

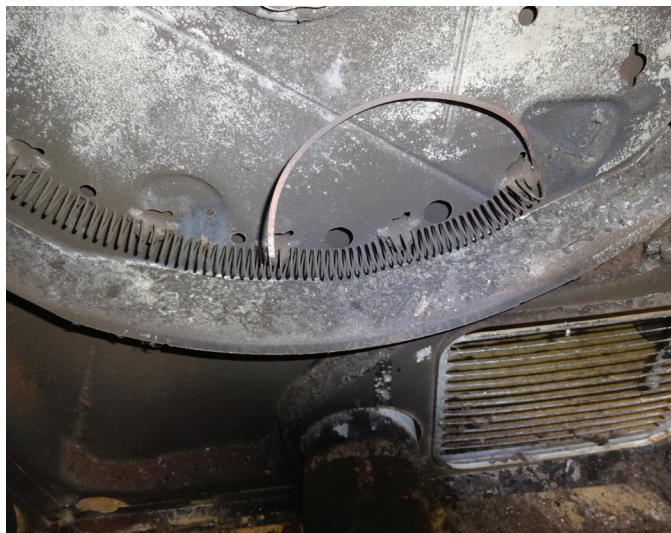
Figure 36
Bra underwire welded to heating element.

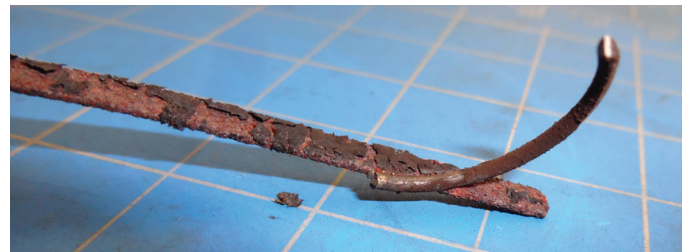
Figure 37
Bra underwire welded to heating element.

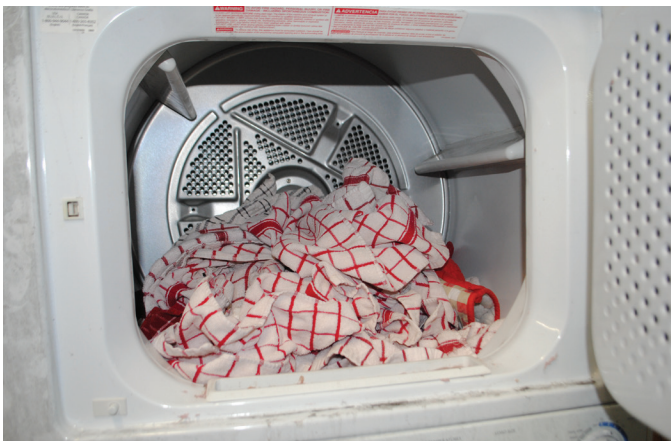
Figure 40
Undamaged dryer and load.

was found in both dryers. No testable remnants of the load remained in the fire damaged dryer. However, the towels in both dryers had been used in the same manner with the same kitchen products. A sample of the towels of the unburned dryer was sent out for chemical analysis. The presence of unsaturated vegetable-type oils was detected in the sample. It was concluded that the fire was likely caused by self-heating of the vegetable oil-contaminated towels.

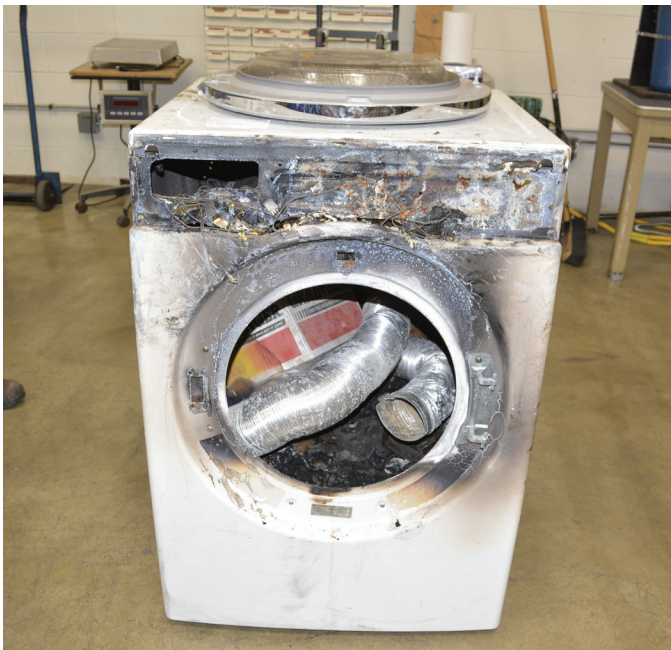
Figure 41
Front of dryer.

A user discovered a fire in an operating gas clothes dryer (**Figure 41**). When the fire was discovered, the load was not burning. A detailed lab exam of the dryer found a large amount of charred clothing items in the base of the dryer (**Figure 42**). A large section of the dryer drum at the

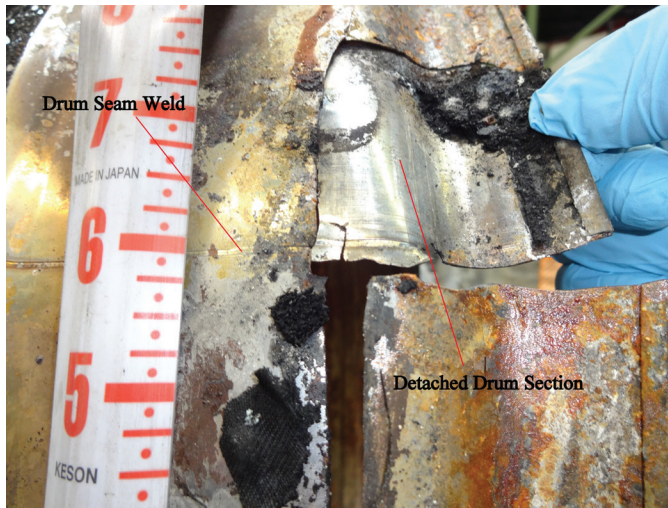
Figure 44

rear edge had detached from the drum (**Figures 43 and 44**). This missing section permitted small laundry items to fall into the dryer base near the burner assembly and onto the top of the burner tube where they were ignited. One edge of the fractured section was part of the longitudinal drum seam weld.

Rear of drum showing separated section of drum.
