Vol. 34 No. 1 June 2017

Landfill Operations and Off Highway Construction Vehicle Visibility Impairment Issues Result in a Serious Injury: A Case Study

By Harold Josephs, PhD, PE (NAFE 295F)

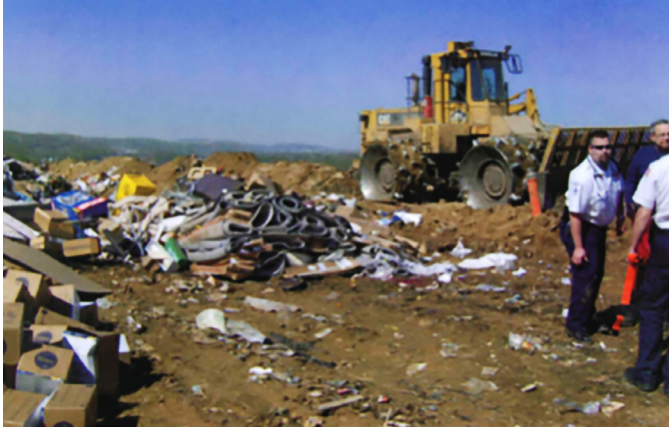
Figure 1

Accident site showing the steel-wheeled compactor and the gas vent pipe. Note the mounds of debris on the landfill face.

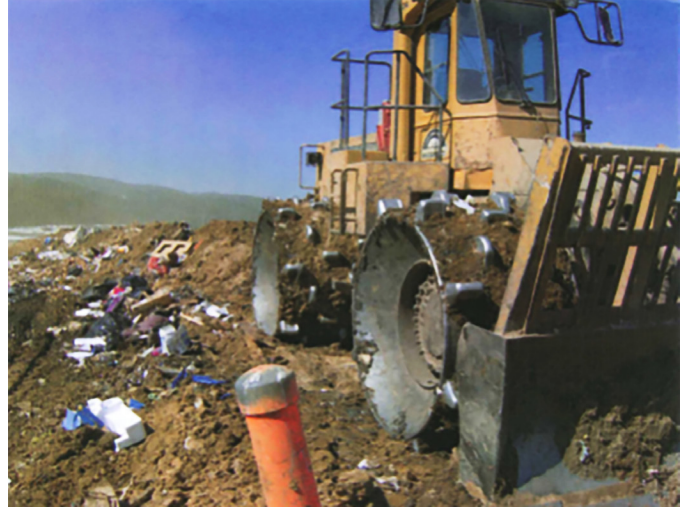
Figure 2

Close-up view of the steel-wheeled compactor and the gas vent pipe at the accident site.

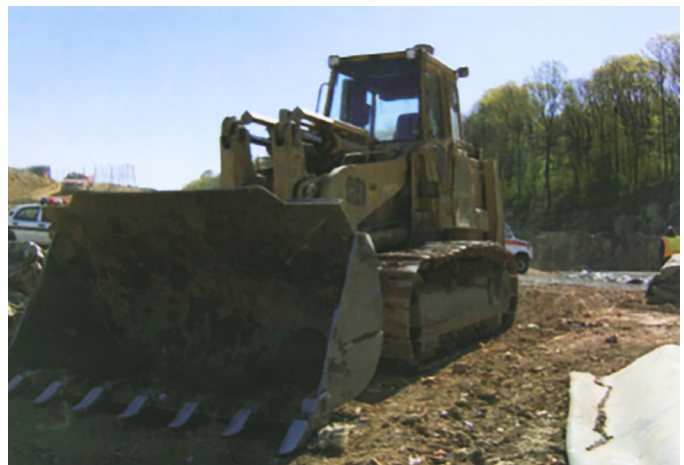
Figure 3 shows the subject crawler loader at the accident site. The loader was being operated that day by a replacement operator who received no training in the safe operation of the loader on the landfill face. The loader, while traveling in reverse over a hillock of trash, struck and seriously injured the trash spotter. The incident was observed and witnessed by a truck driver delivering trash to the site. Other workers who observed the incident stood by in apparent disbelief/shock and offered no assistance. The injured worker himself called 911, describing his injury and requesting a heli-vac transfer to the closest hospital while drifting in and out of consciousness. The injured worker lost both legs so close to his hip that he was not a candidate for prosthetic surgery.

Subject crawler loader at the accident site.

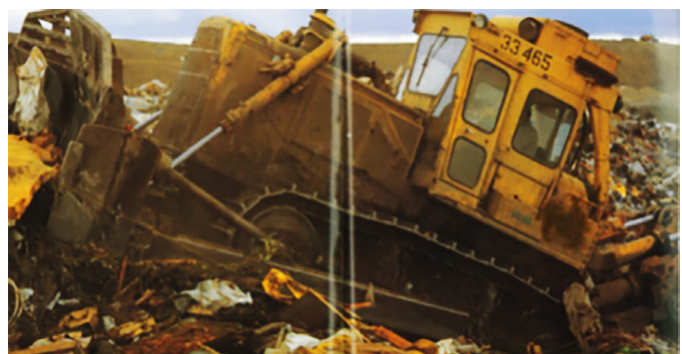
Figure 4

Generic-type bulldozer showing typical orientation while working on the landfill face. Note the reduction in visibility due to traveling over the trash mounds.

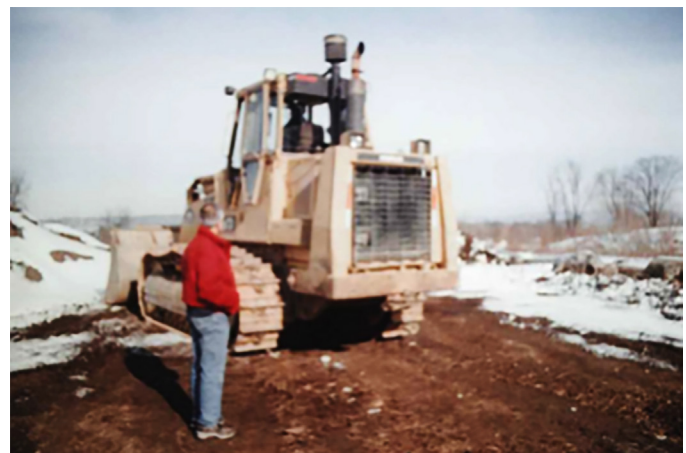
Figure 5

Left oblique static blind zone as depicted by the standing individual, who is invisible to the operator.

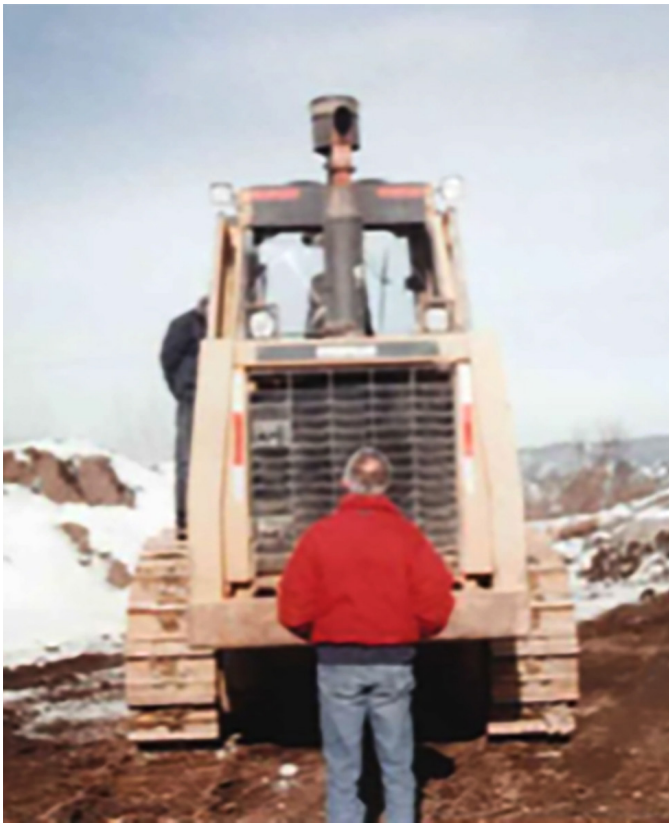
Figure 6

Rear view static blind zone as depicted by the standing individual who is invisible to the operator. Note exhaust stack further limiting operator's rearward visibility.

Variable blind zones were noted in a static mode in each vehicle direction. Rearward visibility was especially compromised wherein in some rearward directions a worker would not be visible until located approximately 40 feet from the bulldozer. In a dynamic mode, any attempt to look over one's shoulder to gain rearward visibility would immediately cause the other shoulder (or other side) to become totally blind and obscured. This one side developed blind zone was also created when the driver/operator would attempt to look down and back at hip level. Hence, following the manufacturer's scan procedure as a stratagem to gain rearward visibility would assure that at any given instant of time, one entire side of the vehicle would be totally hidden. Other types of large industrial vehicles also share this rearward traveling visibility issue, such as in large forklift trucks (Josephs 2003).

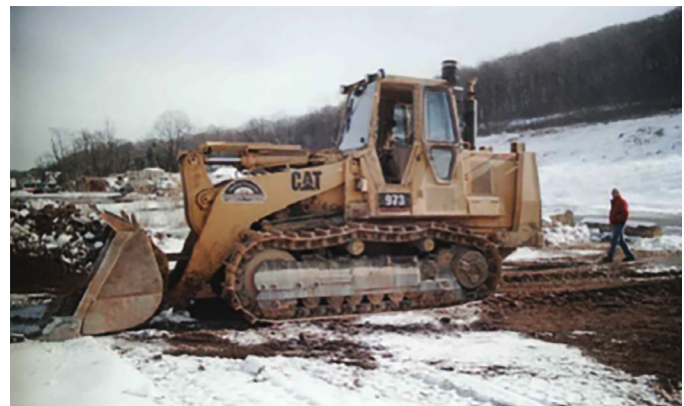
Figure 7

Left view of bulldozer, showing static blind zone of pedestrian worker, who is invisible to the loader operator in the location shown.

The subject bulldozer was not equipped with rear vision closed circuit TV systems. It had been reported as early as 1998 that rear vision camera technology was available to prevent the rear traveling blind spot as well as the common right side turning blind spot hazard (Brown-ing and Simpson 1998).
